PHASE I GEO-ENVIRONMENTAL APPRAISAL

CASTLE STREET BUILDINGS, WATERHOUSE LANE, HULL, HU1 2DA

Project Reference: JMS/AC/42263/Rp-001 Rev A

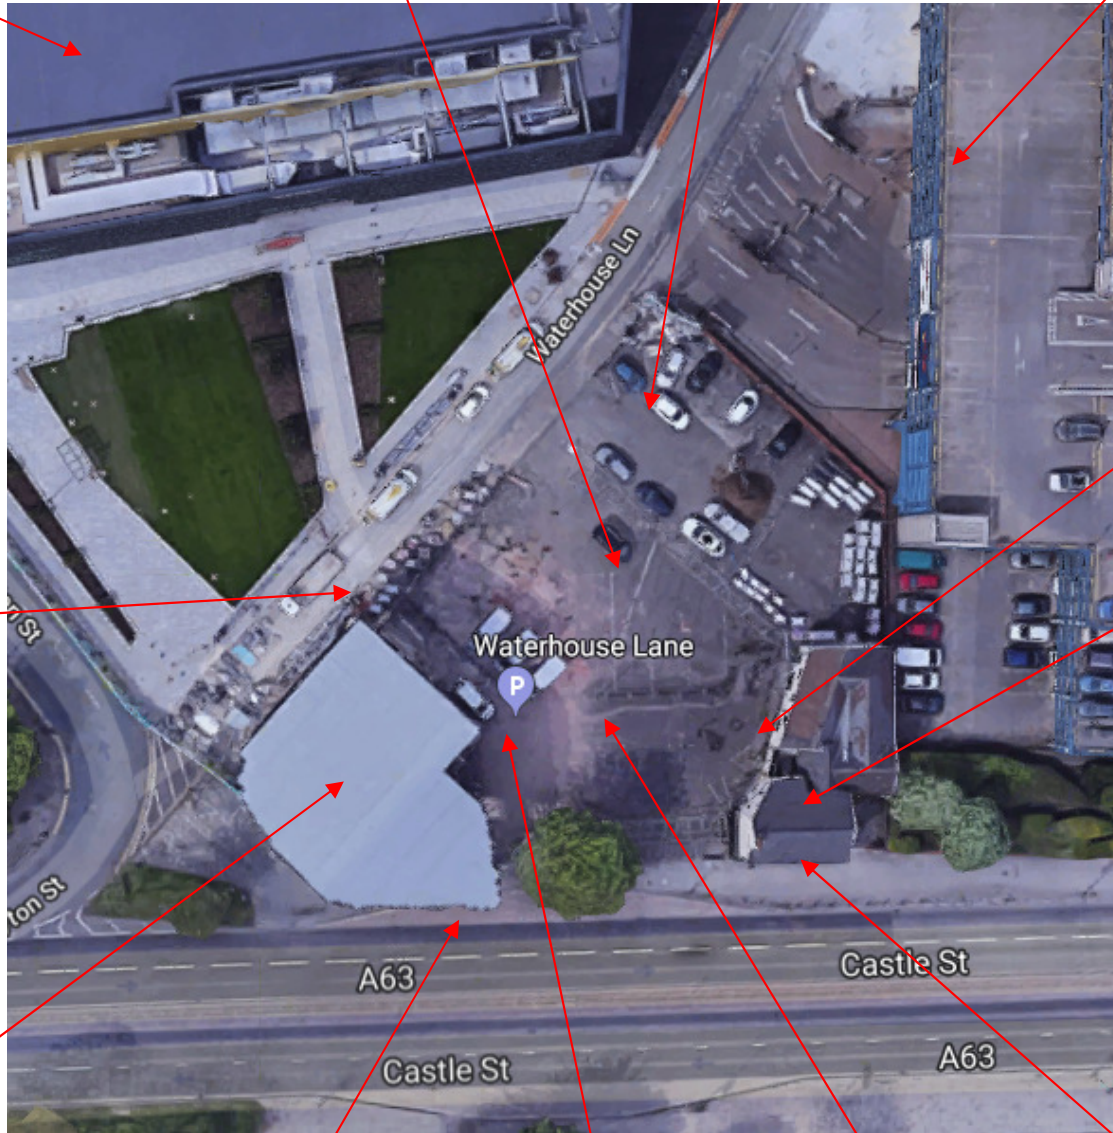
Client. Wykeland Group		
Project. Castle Street Buildings		
Drawing. Site Features Plan		
Date. 20.03.19	Scale. NTS	
Drawn by. AC	Check by. SLR	Approved by. SLR
Status: FOR INFORMATION		
Job no. 42263	Fig. no. 002	Rev.

2.2.2 The site area is approximately 0.28ha and its shape in plan is roughly triangular. A photographic record of the walkover is presented as Plates 1-9. Key site features are shown on Figure 42263/002.

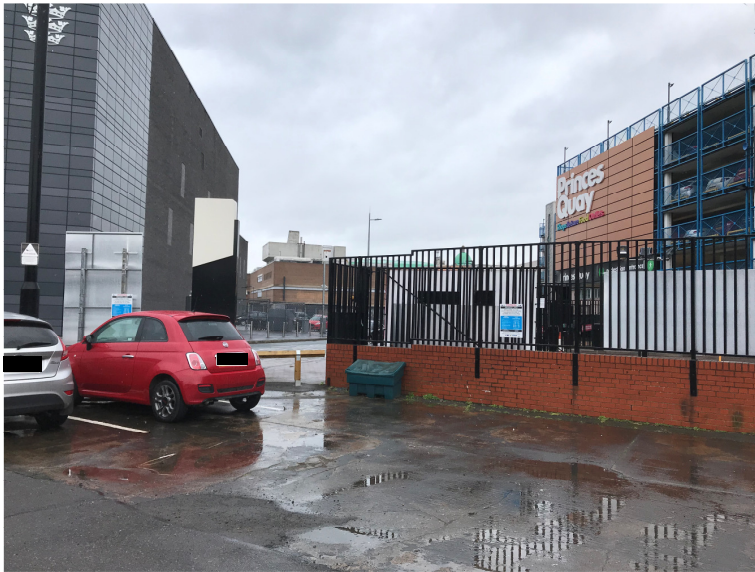
Photograph No. 1

View to the north of the site with the Bonus Arena pictured on the left and the Princes Quay multi-storey car park on the right.

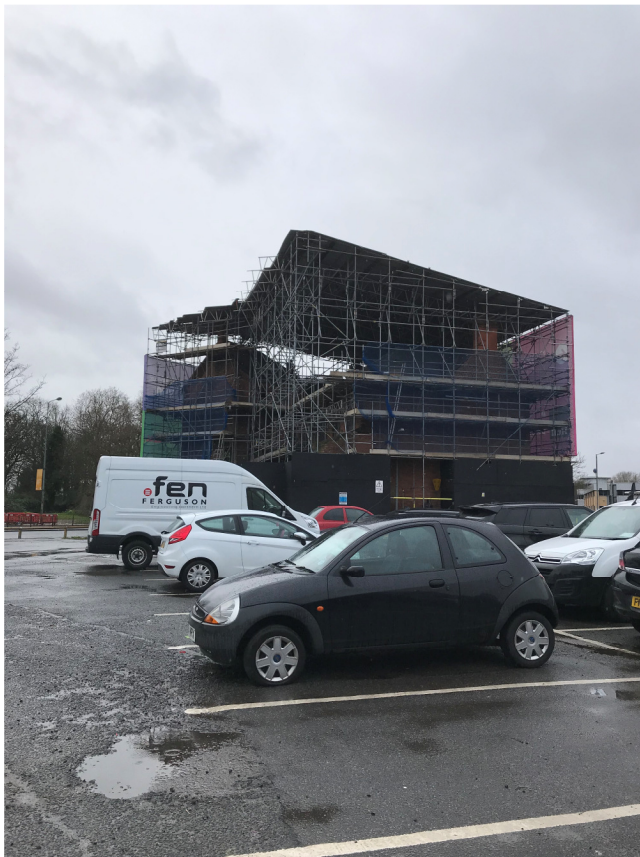
Photograph No. 2

2.2.5 The Castle Street Buildings are surrounded by scaffolding and netting, with a temporary roof over it. It is constructed from red brick and comprises three stories. It is currently boarded up around the first floor and was deemed unsafe to enter.

View to the south of the existing Castle Street Buildings surrounded by scaffolding.

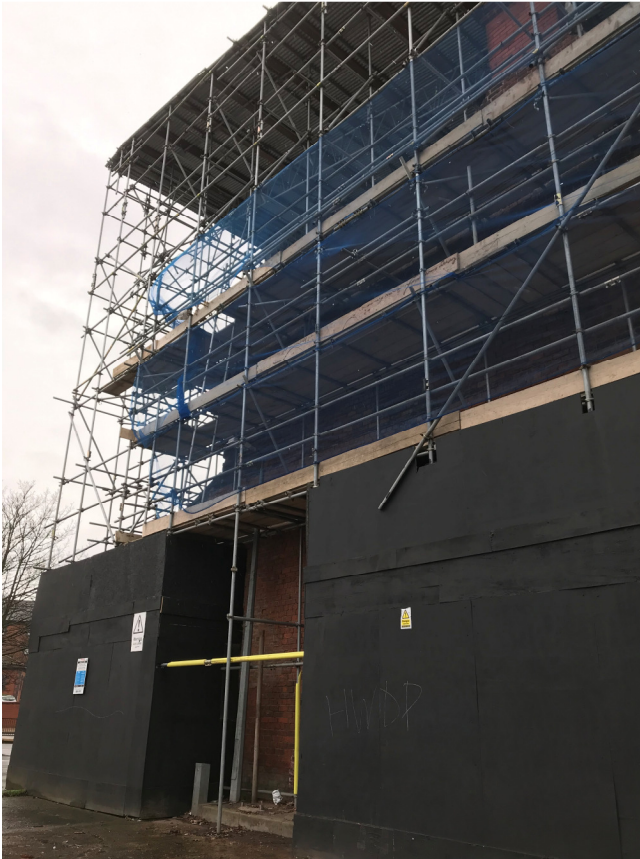
Photograph No. 3

View looking south of the existing Castle Street Buildings.

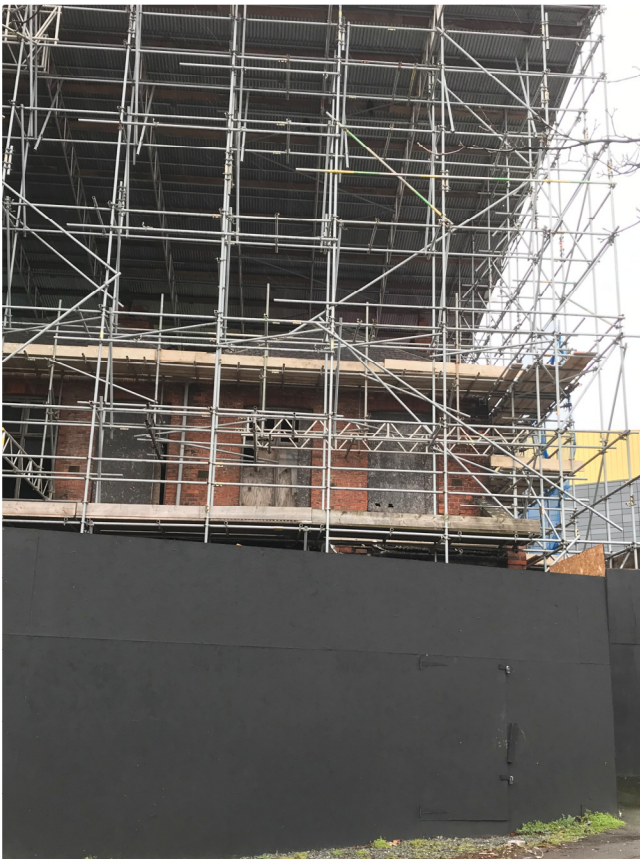
Photograph No. 4

View looking north of the existing Castle Street Buildings.

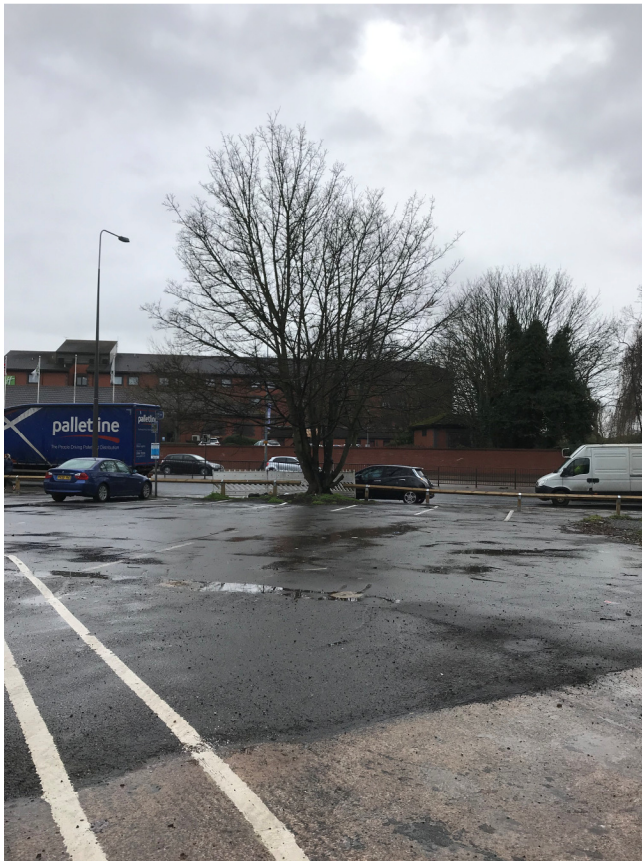
Photograph No. 5

4.4.3 There is one tree on the southern boundary of the site, so precautions may be required should structures lie within influencing distance when in clay. In addition, precautions may be required where trees are to be removed or where new planting is proposed. All foundations should be constructed in accordance with current guidelines (e.g. NHBC Standards, Chapter 4.2). If foundations are built off competent bedrock, no precautions are likely to be required.

View to the south of the A63. Tree located on the southern boundary tentatively identified as Maple.

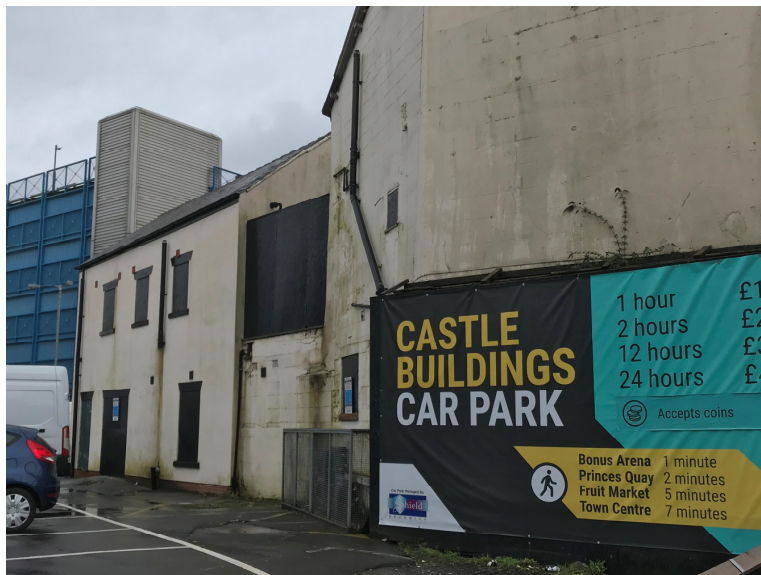
Photograph No. 6

View to the east of the existing Earl de Grey Public House.

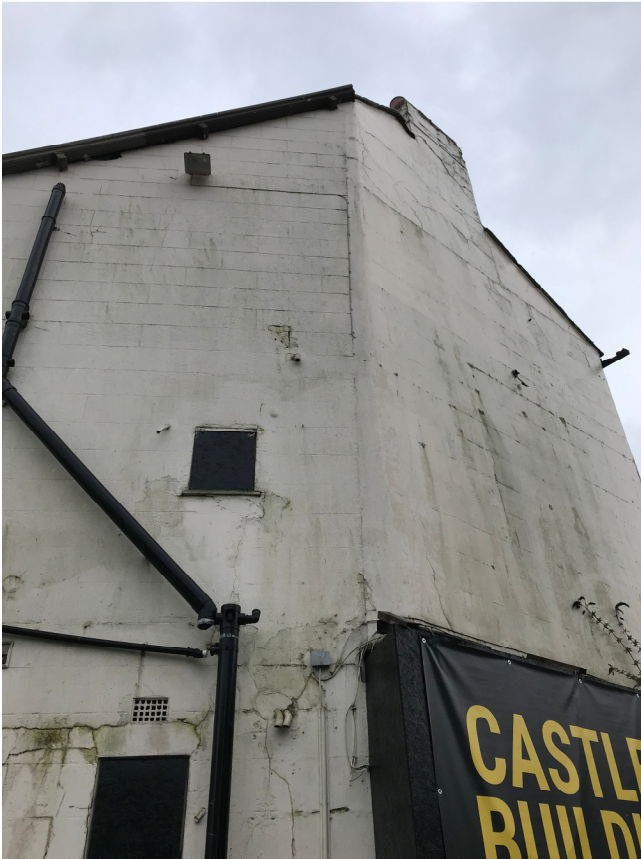
Photograph No. 7

2.2.4 The Earl de Grey public house is currently fully boarded up, and as it is coated in a cream render, its construction material is not visible. The building is three-stories at the front, with a two storey extension at the back, and the roof of the building is tiled with slates.

Western side of the Earl de Grey Public House.

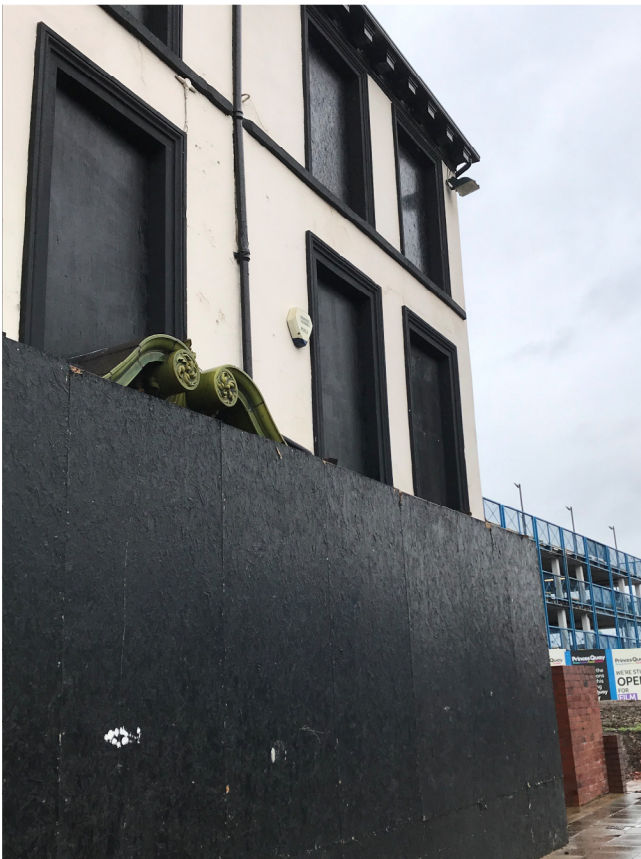
Photograph No. 8

Front of the Earl de Grey Public House currently boarded up.

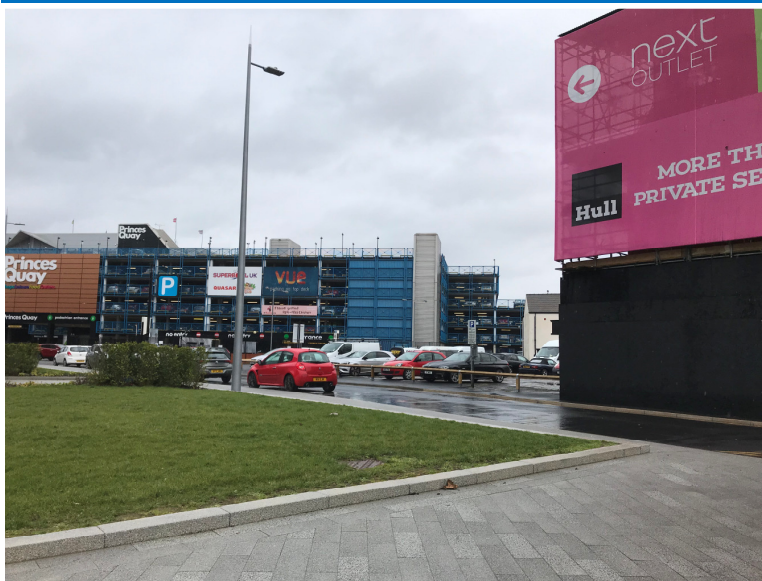
Photograph No. 9

View to the east over the site, with the Castle Street Buildings on the right hand side and the Princes Quay multi-storey in the background.
