A14 Improvement  
Ellington to Fen Ditton  
Geophysical Surveys of Areas GP1 to GP7  
November 2008

Figure 5.3: Survey data (Area GP5 + survey by Pre-Construct Geophysics) with aerial photography interpretation and services

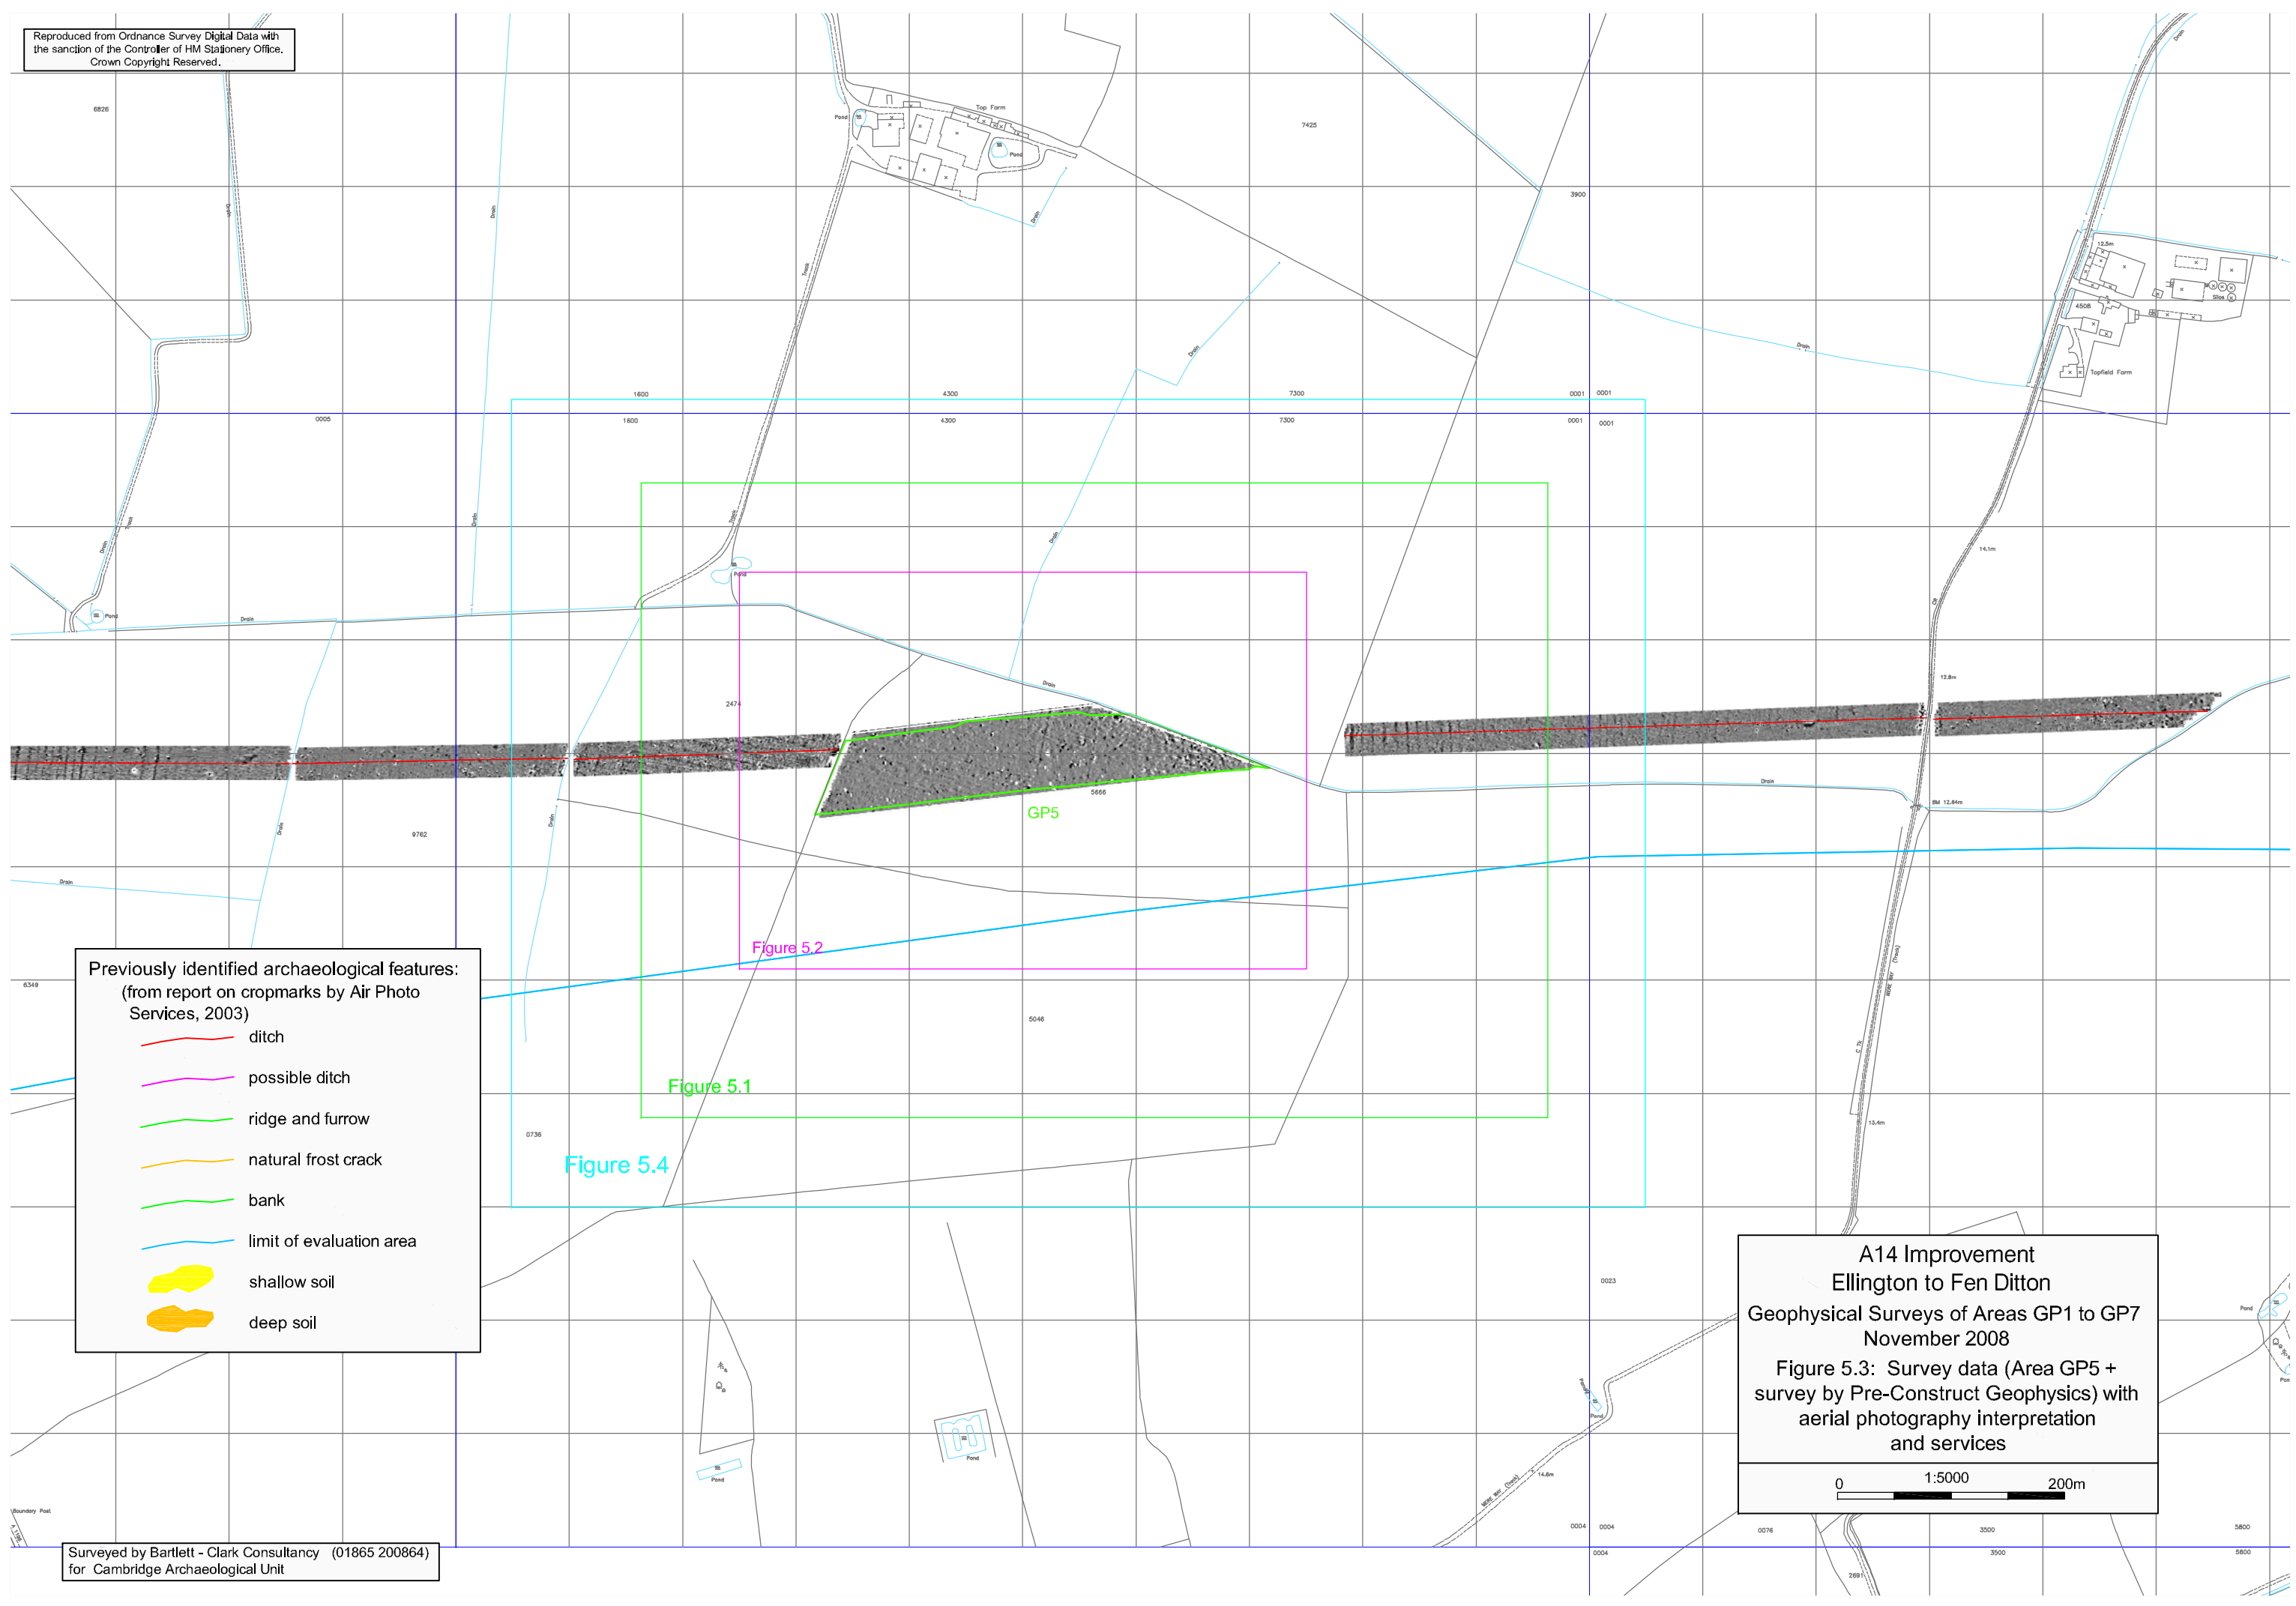
- Previously identified archaeological features:  
(from report on cropmarks by Air Photo Services, 2003)
- ditch
  - possible ditch
  - ridge and furrow
  - natural frost crack
  - bank
  - limit of evaluation area
  - shallow soil
  - deep soil
