A14 Improvement
Ellington to Fen Ditton
Geophysical Surveys of Areas GP1 to GP7
November 2008
Figure 6.3: Survey data (Area GP6 +
survey by Pre-Construct Geophysics) with
aerial photography interpretation
and services

Surveyed by Bartlett - Clark Consultancy (01865 200864)
for Cambridge Archaeological Unit

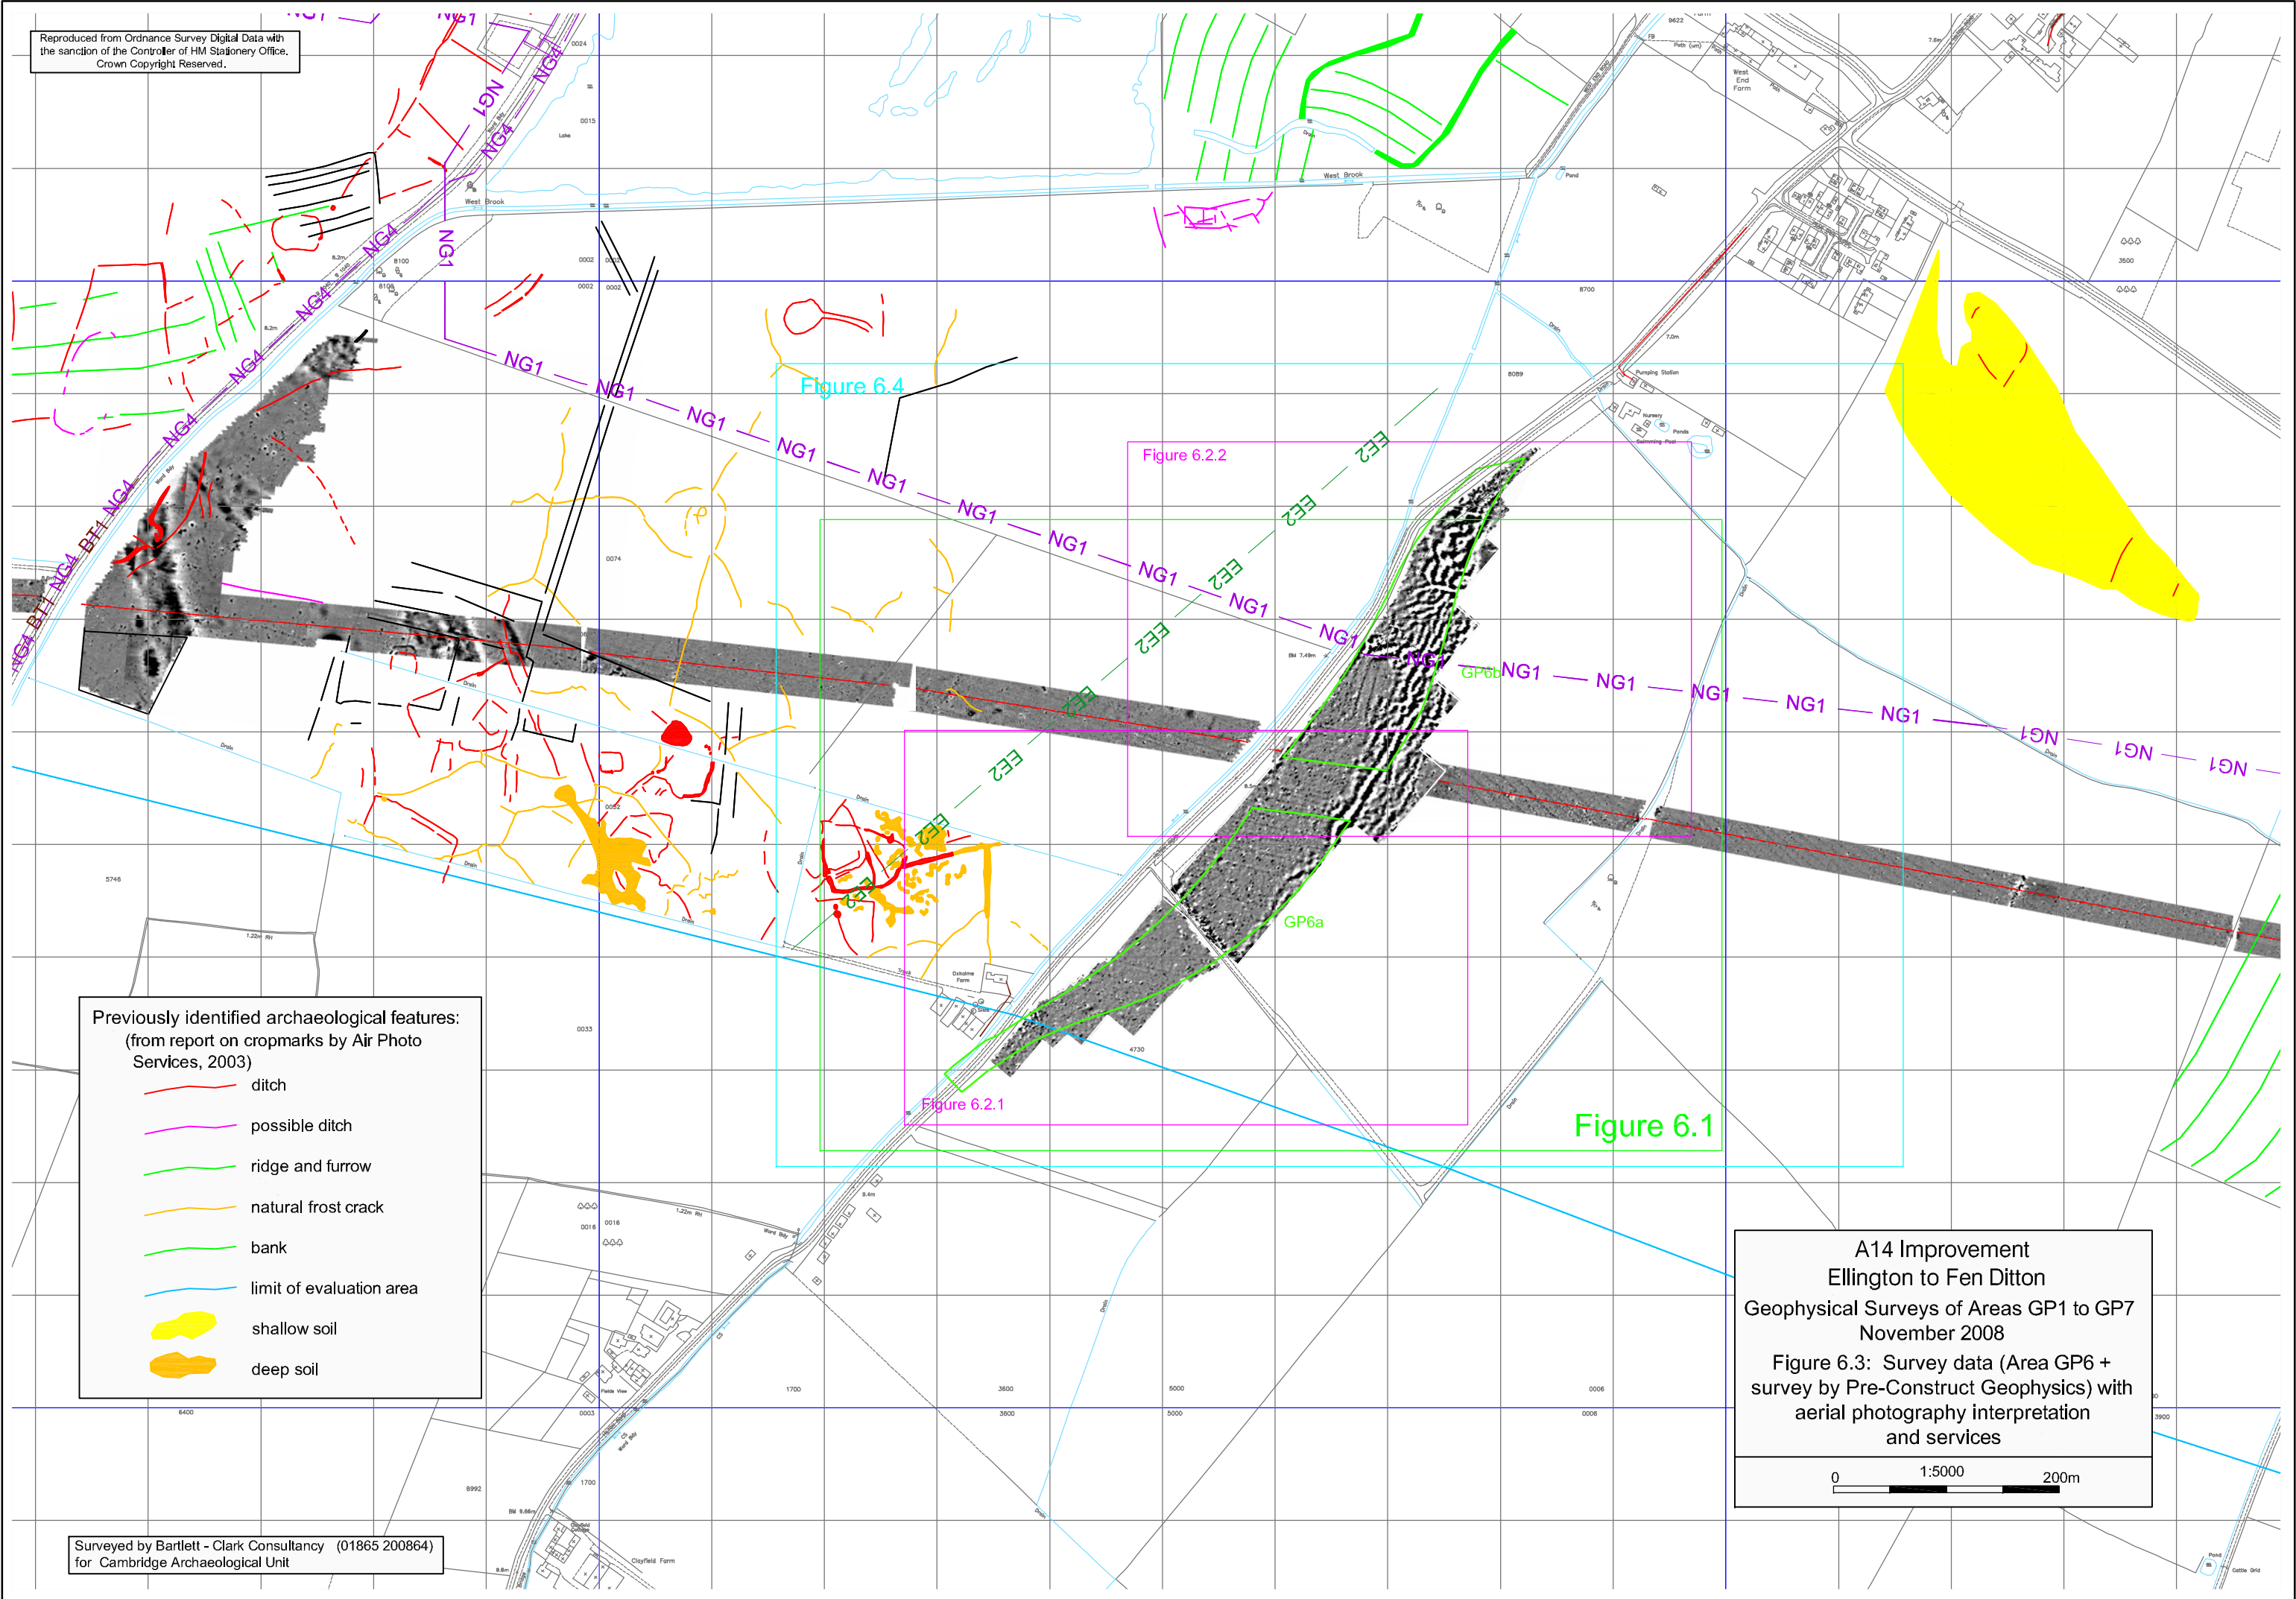
- Previously identified archaeological features:
(from report on cropmarks by Air Photo Services, 2003)
- ditch
 - possible ditch
 - ridge and furrow
 - natural frost crack
 - bank
 - limit of evaluation area
 - shallow soil
 - deep soil
