Surveyed by Bartlett - Clark Consultancy (01865 200864) for Cambridge Archaeological Unit

A14 Improvement
Ellington to Fen Ditton
Geophysical Surveys of Proposed Reservoir
Locations: April 2009
Figure R3: Site R3 (Bar Hill)
Magnetometer Survey

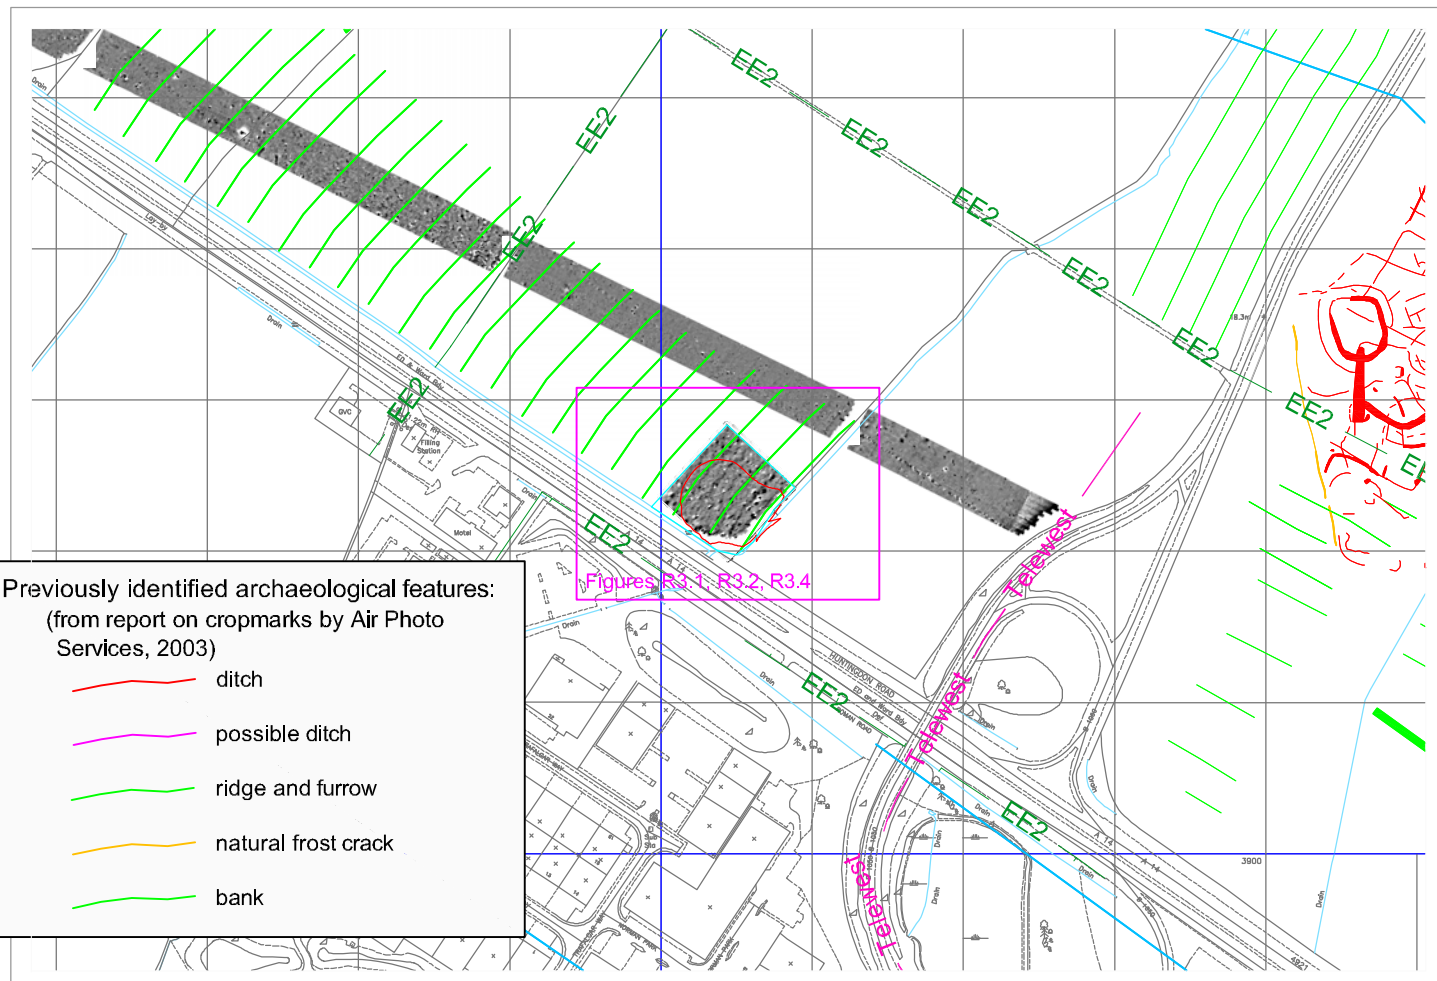
Figure R3.3: Site R3 Survey data (with aerial photography interpretation) 1:5000

- Previously identified archaeological features:
(from report on cropmarks by Air Photo Services, 2003)
- ditch
 - possible ditch
 - ridge and furrow
 - natural frost crack
 - bank

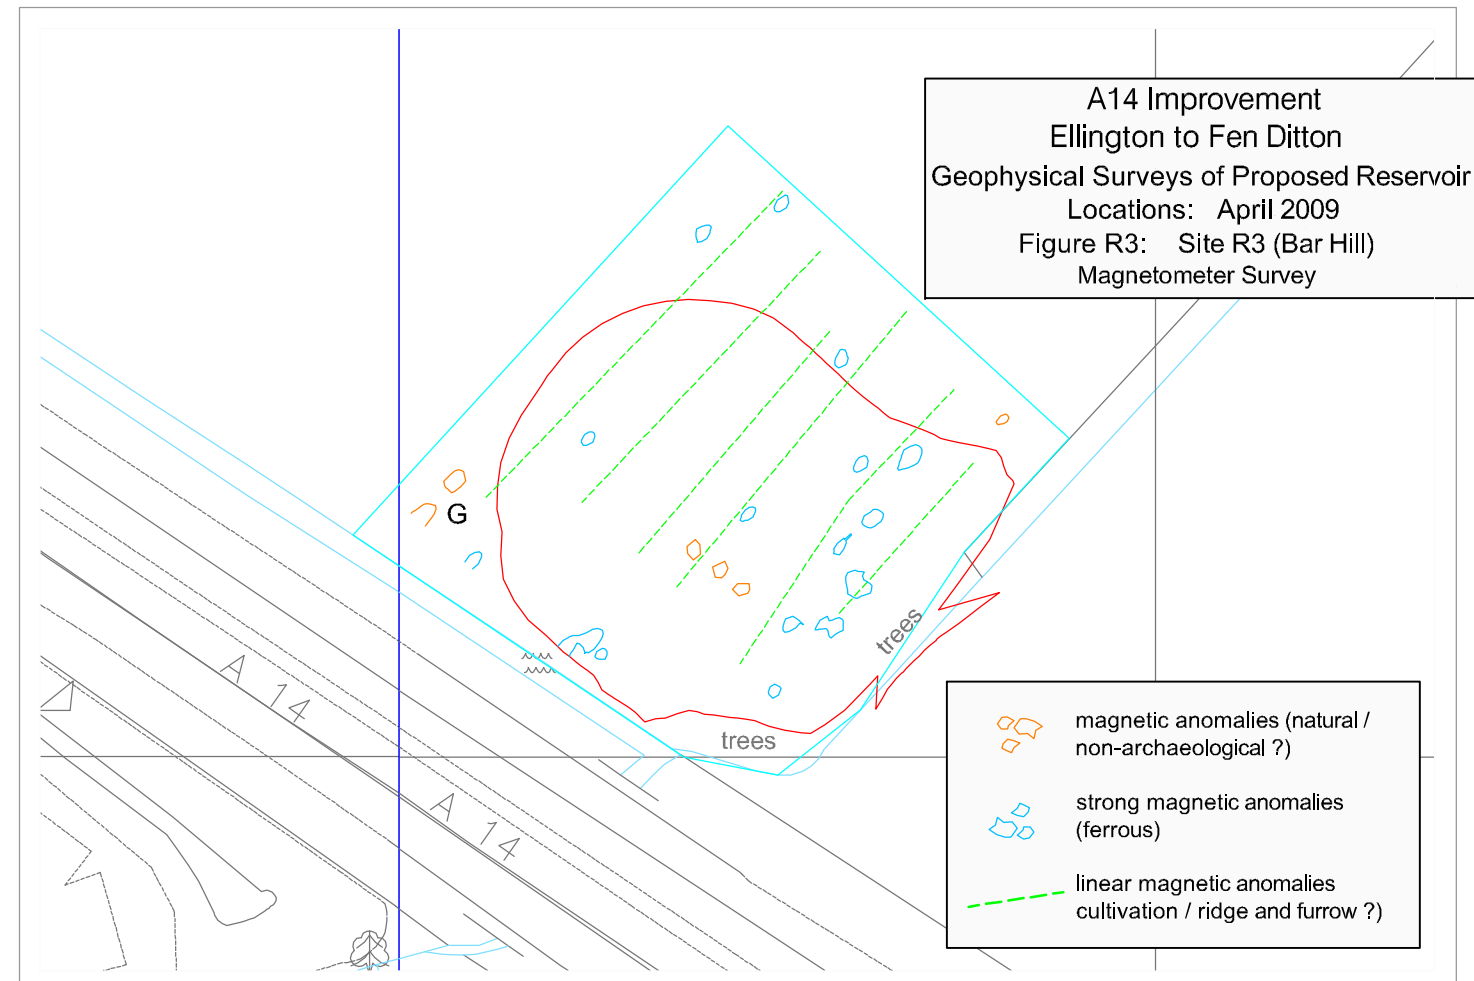
Figure R3.4: Site R3 Summary of findings 1:1000

- magnetic anomalies (natural / non-archaeological ?)
- strong magnetic anomalies (ferrous)
- - - linear magnetic anomalies cultivation / ridge and furrow ?
