A38 Derby Junctions

Appendix 8.15: Fish Survey in 2018

Dam Brook and Watermeadows Ditch Fish Survey Report

**Report Number: HE514503-ACM-EBD-A38_SW_PR_ZZ-RP-EG-0021 P02 S4
December 2018**

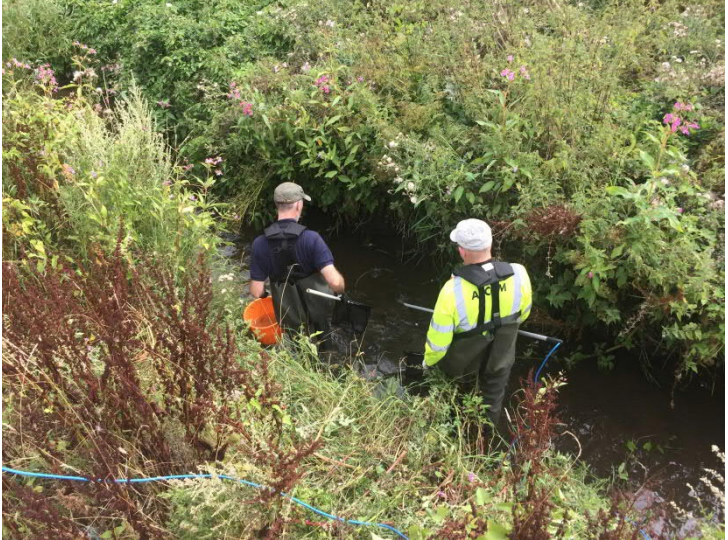
Plate number	Notes	Plate
P1	Surveying in Dam Brook 1

A photograph showing two surveyors in a ditch. The ditch is filled with dense, tall vegetation, including green grasses and pink flowers. One surveyor, wearing a dark blue shirt and a cap, is on the left, holding a blue bucket. The other surveyor, wearing a high-visibility yellow vest with 'ACM' on the back and a white cap, is on the right, holding a blue measuring tape. A blue line is stretched across the ditch in the foreground.
P2	Surveying in Dam Brook 2

- 3.1.1 Survey photographs are provided in Appendix B and referenced throughout the report.
- 3.1.2 Dam Brook is bordered by pastoral farmland on one bank and follows the A61 for a significant portion of its length on the other bank (Plate 1; Plate 2, Appendix B).
- 3.1.3 Details of the survey conditions of Dam Brook at the time of the surveys are presented in Table 1.

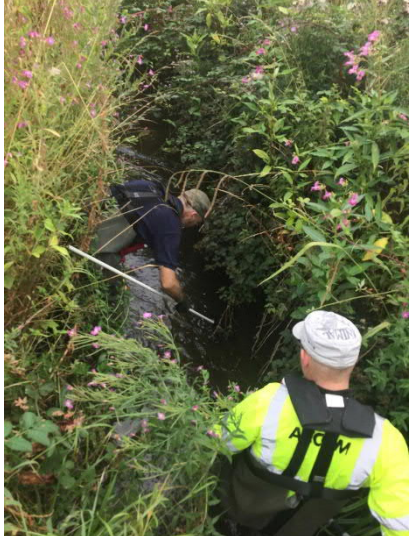
A photograph showing two surveyors in a ditch. The ditch is filled with dense, tall vegetation, including green grasses and pink flowers. One surveyor, wearing a dark blue shirt and a cap, is on the left, holding a blue measuring tape. The other surveyor, wearing a high-visibility yellow vest with 'ACM' on the back and a white cap, is on the right, holding a blue measuring tape.

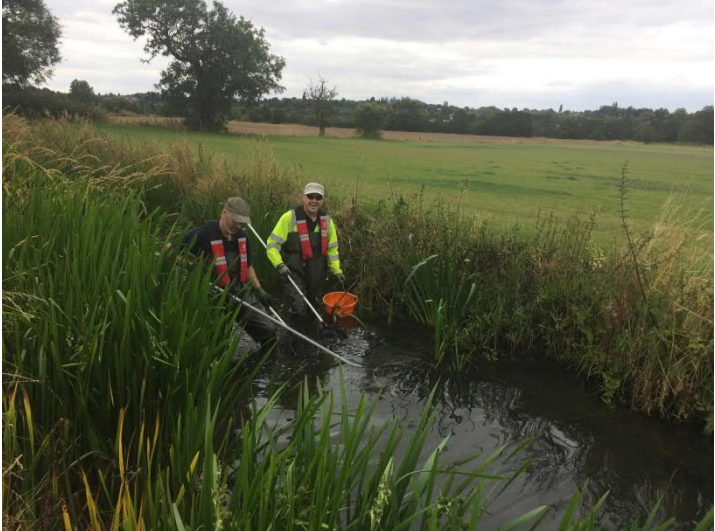
Plate number	Notes	Plate
P3	Surveying in Watermeadows Ditch 1

A photograph showing two individuals in high-visibility gear and waders working in a narrow ditch. The ditch is heavily lined with tall green reeds. One person is using a long-handled net or tool in the water, while the other stands nearby. The background shows a grassy field under a cloudy sky.
P4	Surveying in Watermeadows Ditch 1

- 3.1.4 At the survey site, Watermeadows Ditch runs adjacent to the railway on the right-hand bank and has arable land on the left bank currently used as a turf farm (Plate 3; Plate 4, Appendix B).
- 3.1.5 Details of the survey conditions of Watermeadows Ditch at the time of the surveys are presented in Table 2.

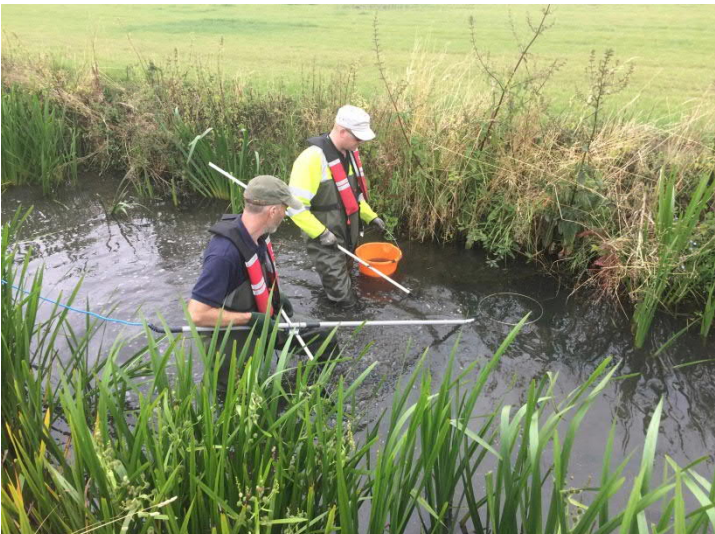
A photograph similar to P3, showing two surveyors in a ditch with reeds. One person is using a long-handled net, and the other is holding an orange bucket. The scene is a narrow waterway surrounded by dense vegetation.
P5	Brown trout caught at Dam Brook

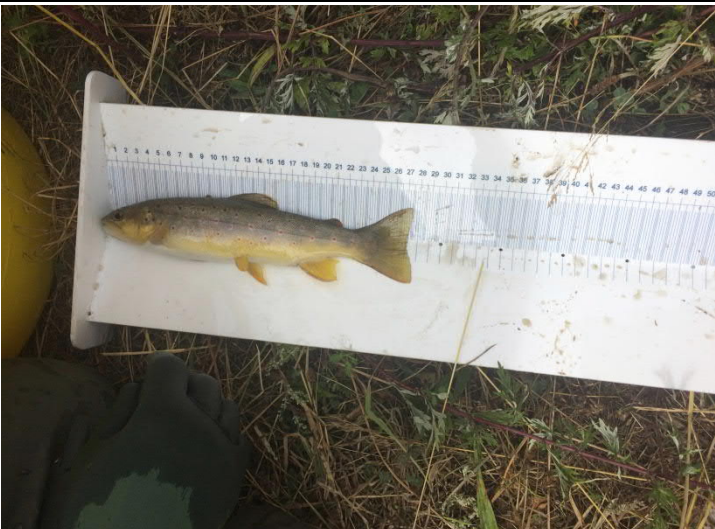
A close-up photograph of a brown trout lying on a white ruler. The ruler is marked in centimeters, showing the fish is approximately 25 cm long. The fish is positioned horizontally, and its head is to the left. The background consists of dry grass and twigs.

- 4.1.4 The fish community structure at Dam Brook differed amongst each site. The primary site held a good number of brown trout (*Salmo trutta*; Plate 5, Appendix B), perch (*Perca fluviatilis*; Plate 9, Appendix B), brook lamprey (ammocoetes) and bullhead. Whereas the survey section upstream of the weir contained small numbers of trout, three-spined stickleback (*Gasterosteus aculeatus*) and stone loach (*Barbatula barbatula*; Plate 8, Appendix B). The Dam Brook weir pool, however, only contained one trout and one perch.
