Document SCC/LLTC/EX/35: Environmental Statement Volume 3 - Appendix 12C

Piling Works Risk Assessment – Track changes

LAKE LOTHING THIRD RIVER CROSSING

Piling Works Risk Assessment

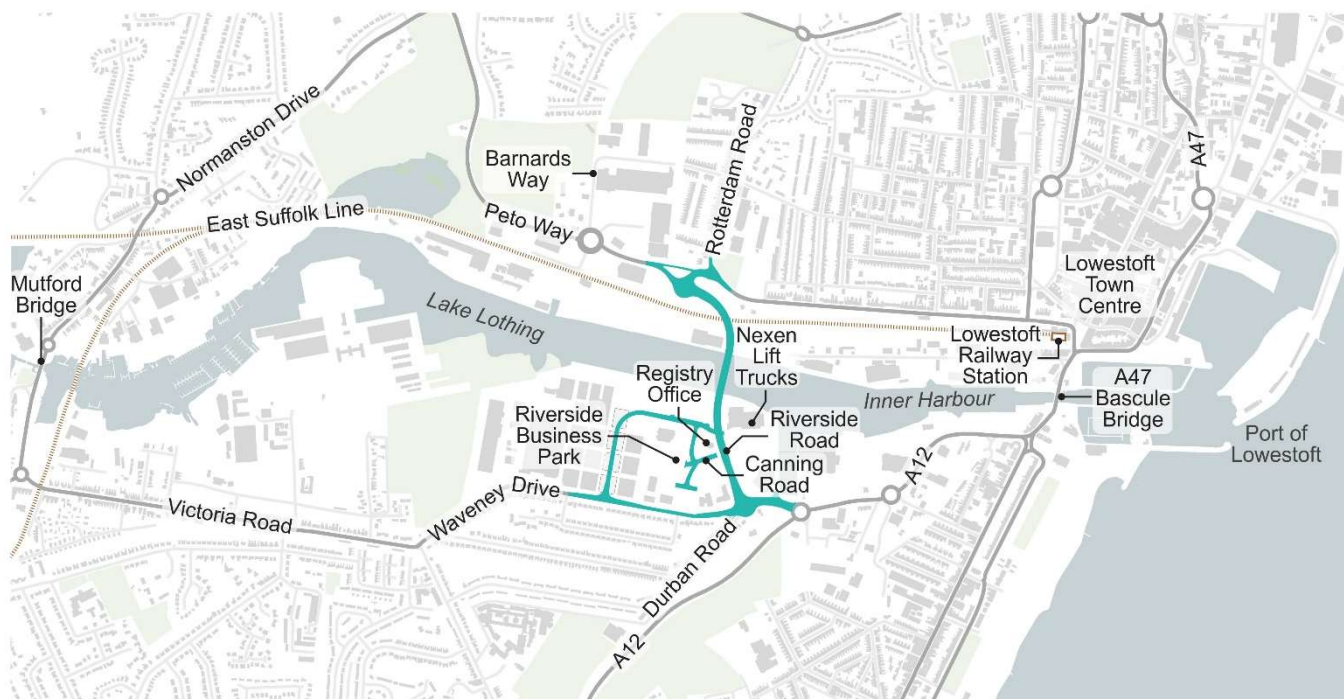
Figure 1 – Location of the Scheme in Lowestoft

The figure below provides a diagrammatic representation of the Scheme:

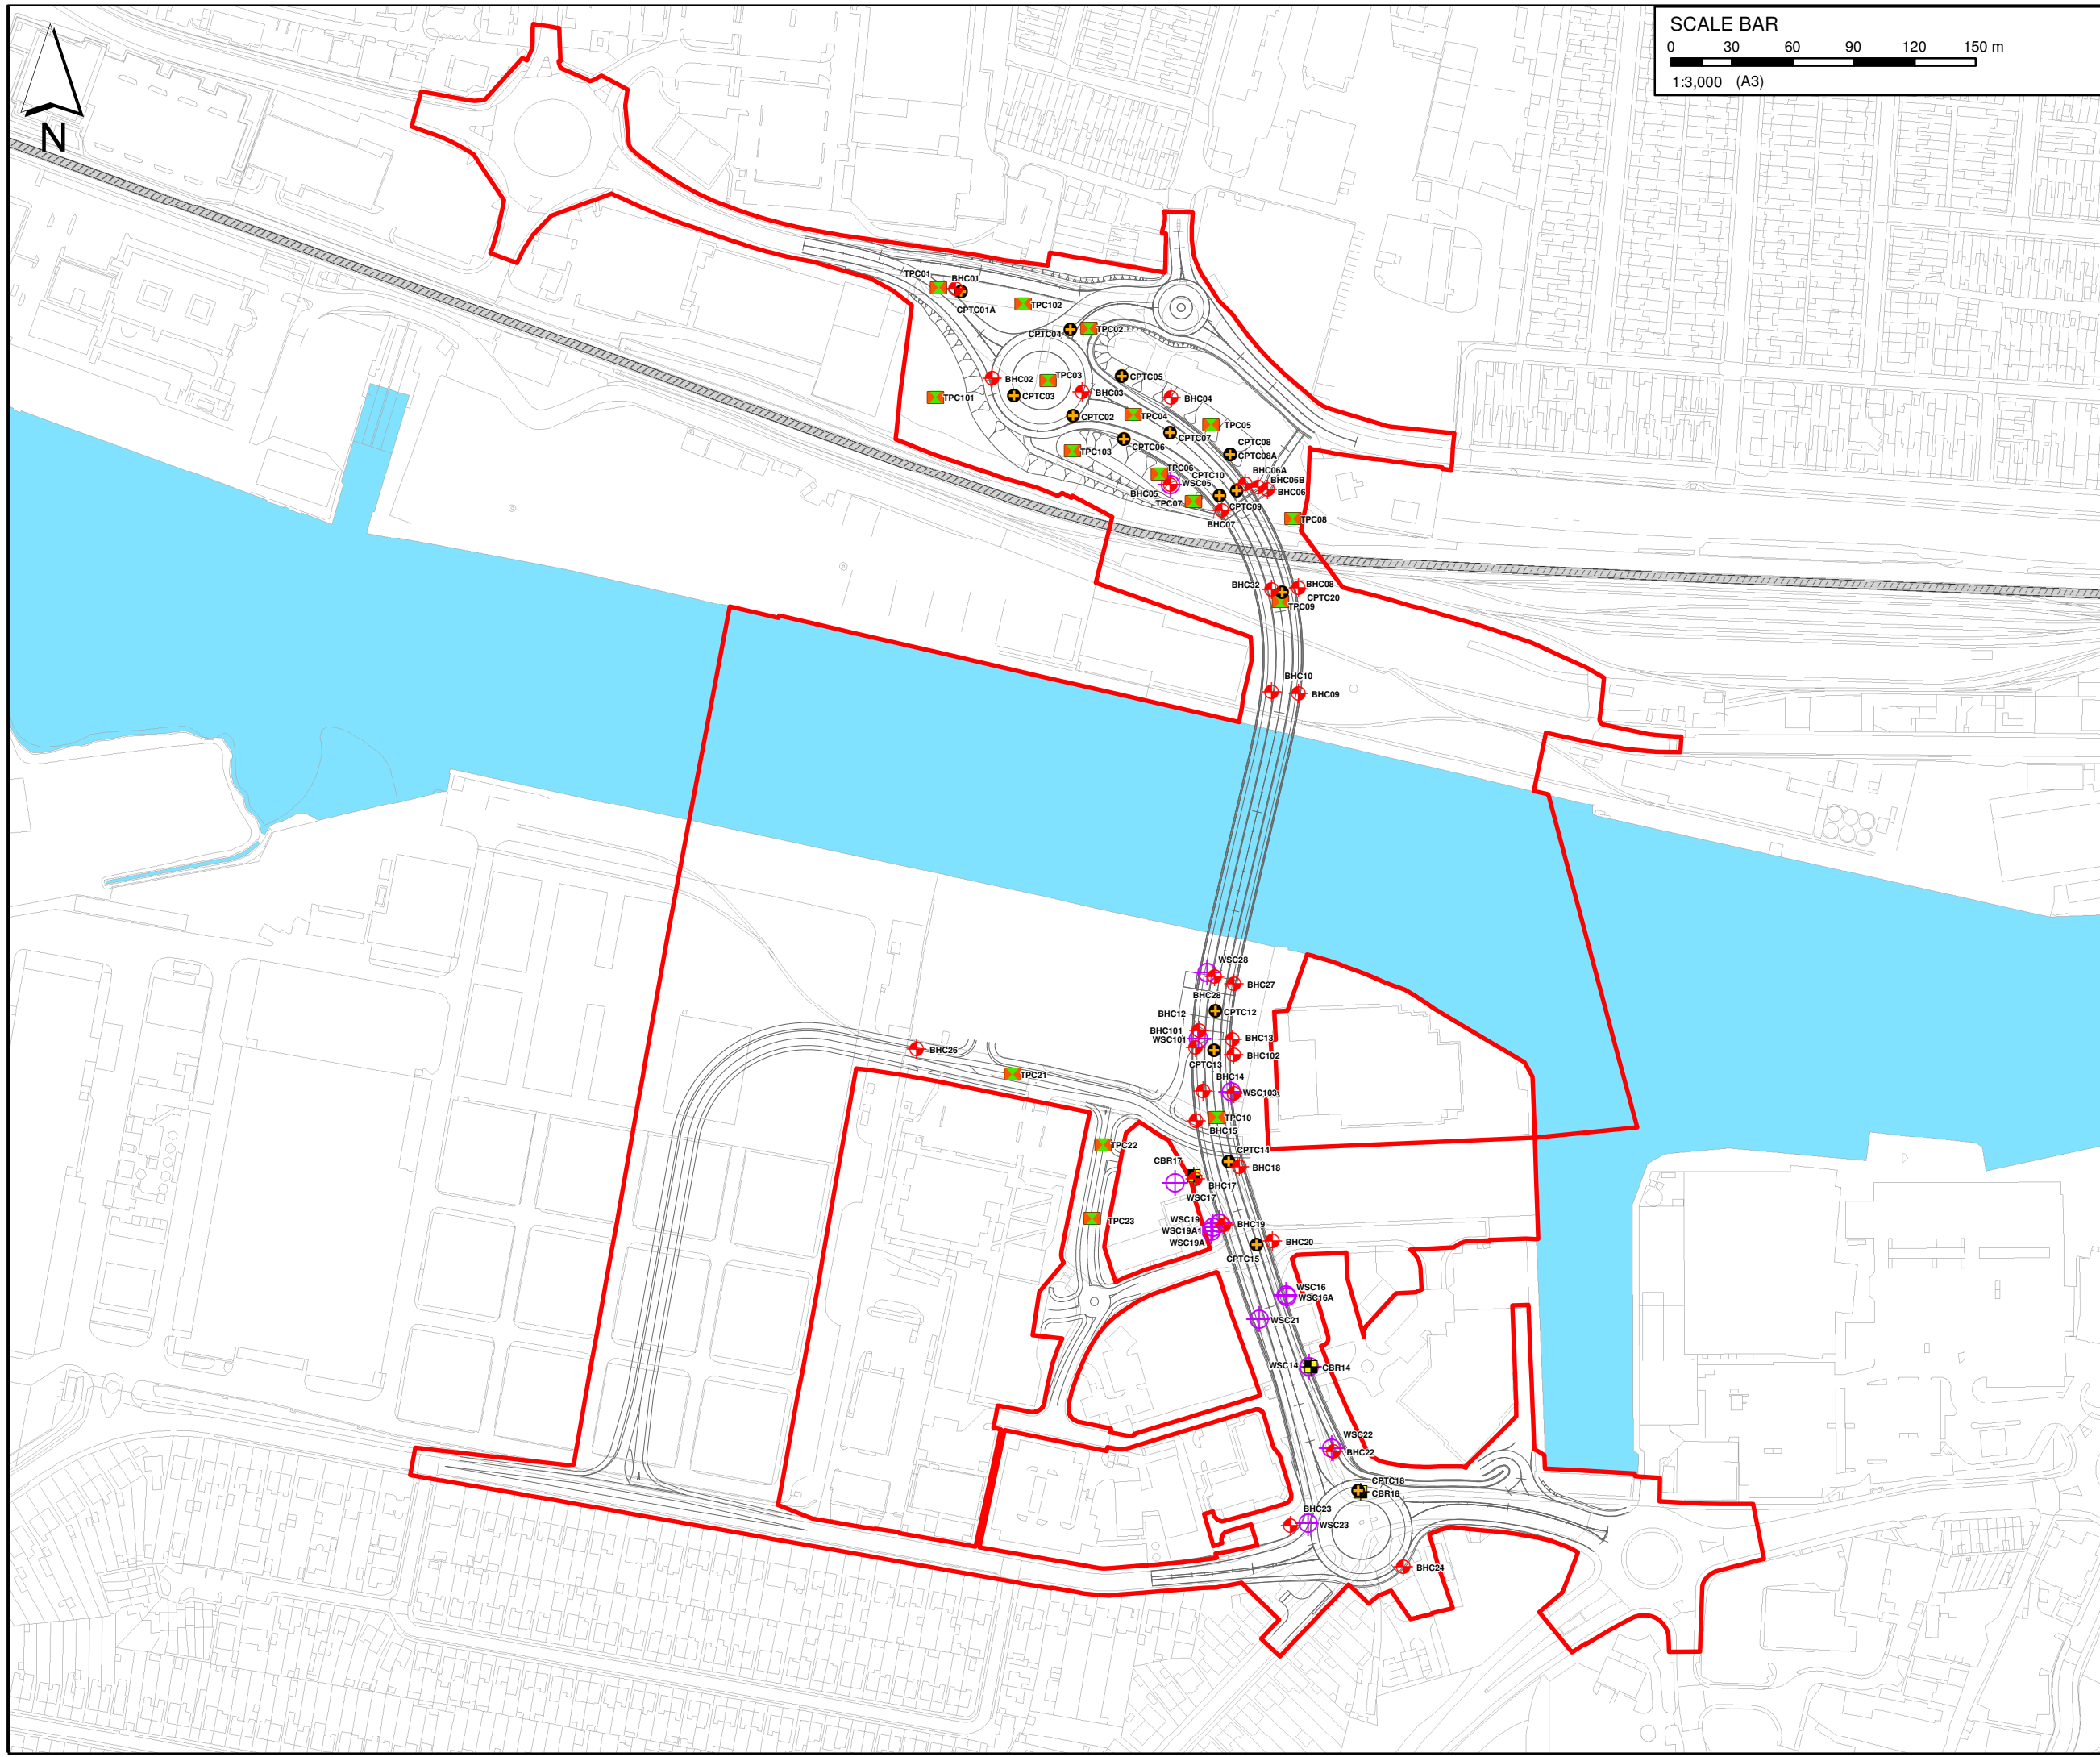
Exploratory hole locations are presented on Drawing [1069948-WSP-EGN-LL-SK-LE-0020 s-entitled 'Lake Lothing Third Crossing - Preliminary As-Built Plan of Exploratory Holes \(Sheet 1 of 2 and Sheet 2 of 2\), ref. 1069948 entitled Sampling Locations Regulation 5\(2\)\(a\) Figure 12.2](#) included in Annex A.

- KEY**
- The Scheme (illustrative)
 - Existing Rail Track
 - Order Limits
 - GI Sampling Locations**
 - Borehole
 - Cone Penetration Test
 - California Bearing Ratio
 - Trial Pit
 - Window Sample
