Appendix 7.1 CULTURAL HERITAGE – ASSESSMENT METHODOLOGY

A19 DOWNHILL LANE JUNCTION, SUNDERLAND, TYNE AND WEAR

GEOPHYSICAL SURVEY

A19 Downhill Lane
Junction Improvements
Sunderland
Tyne and Wear

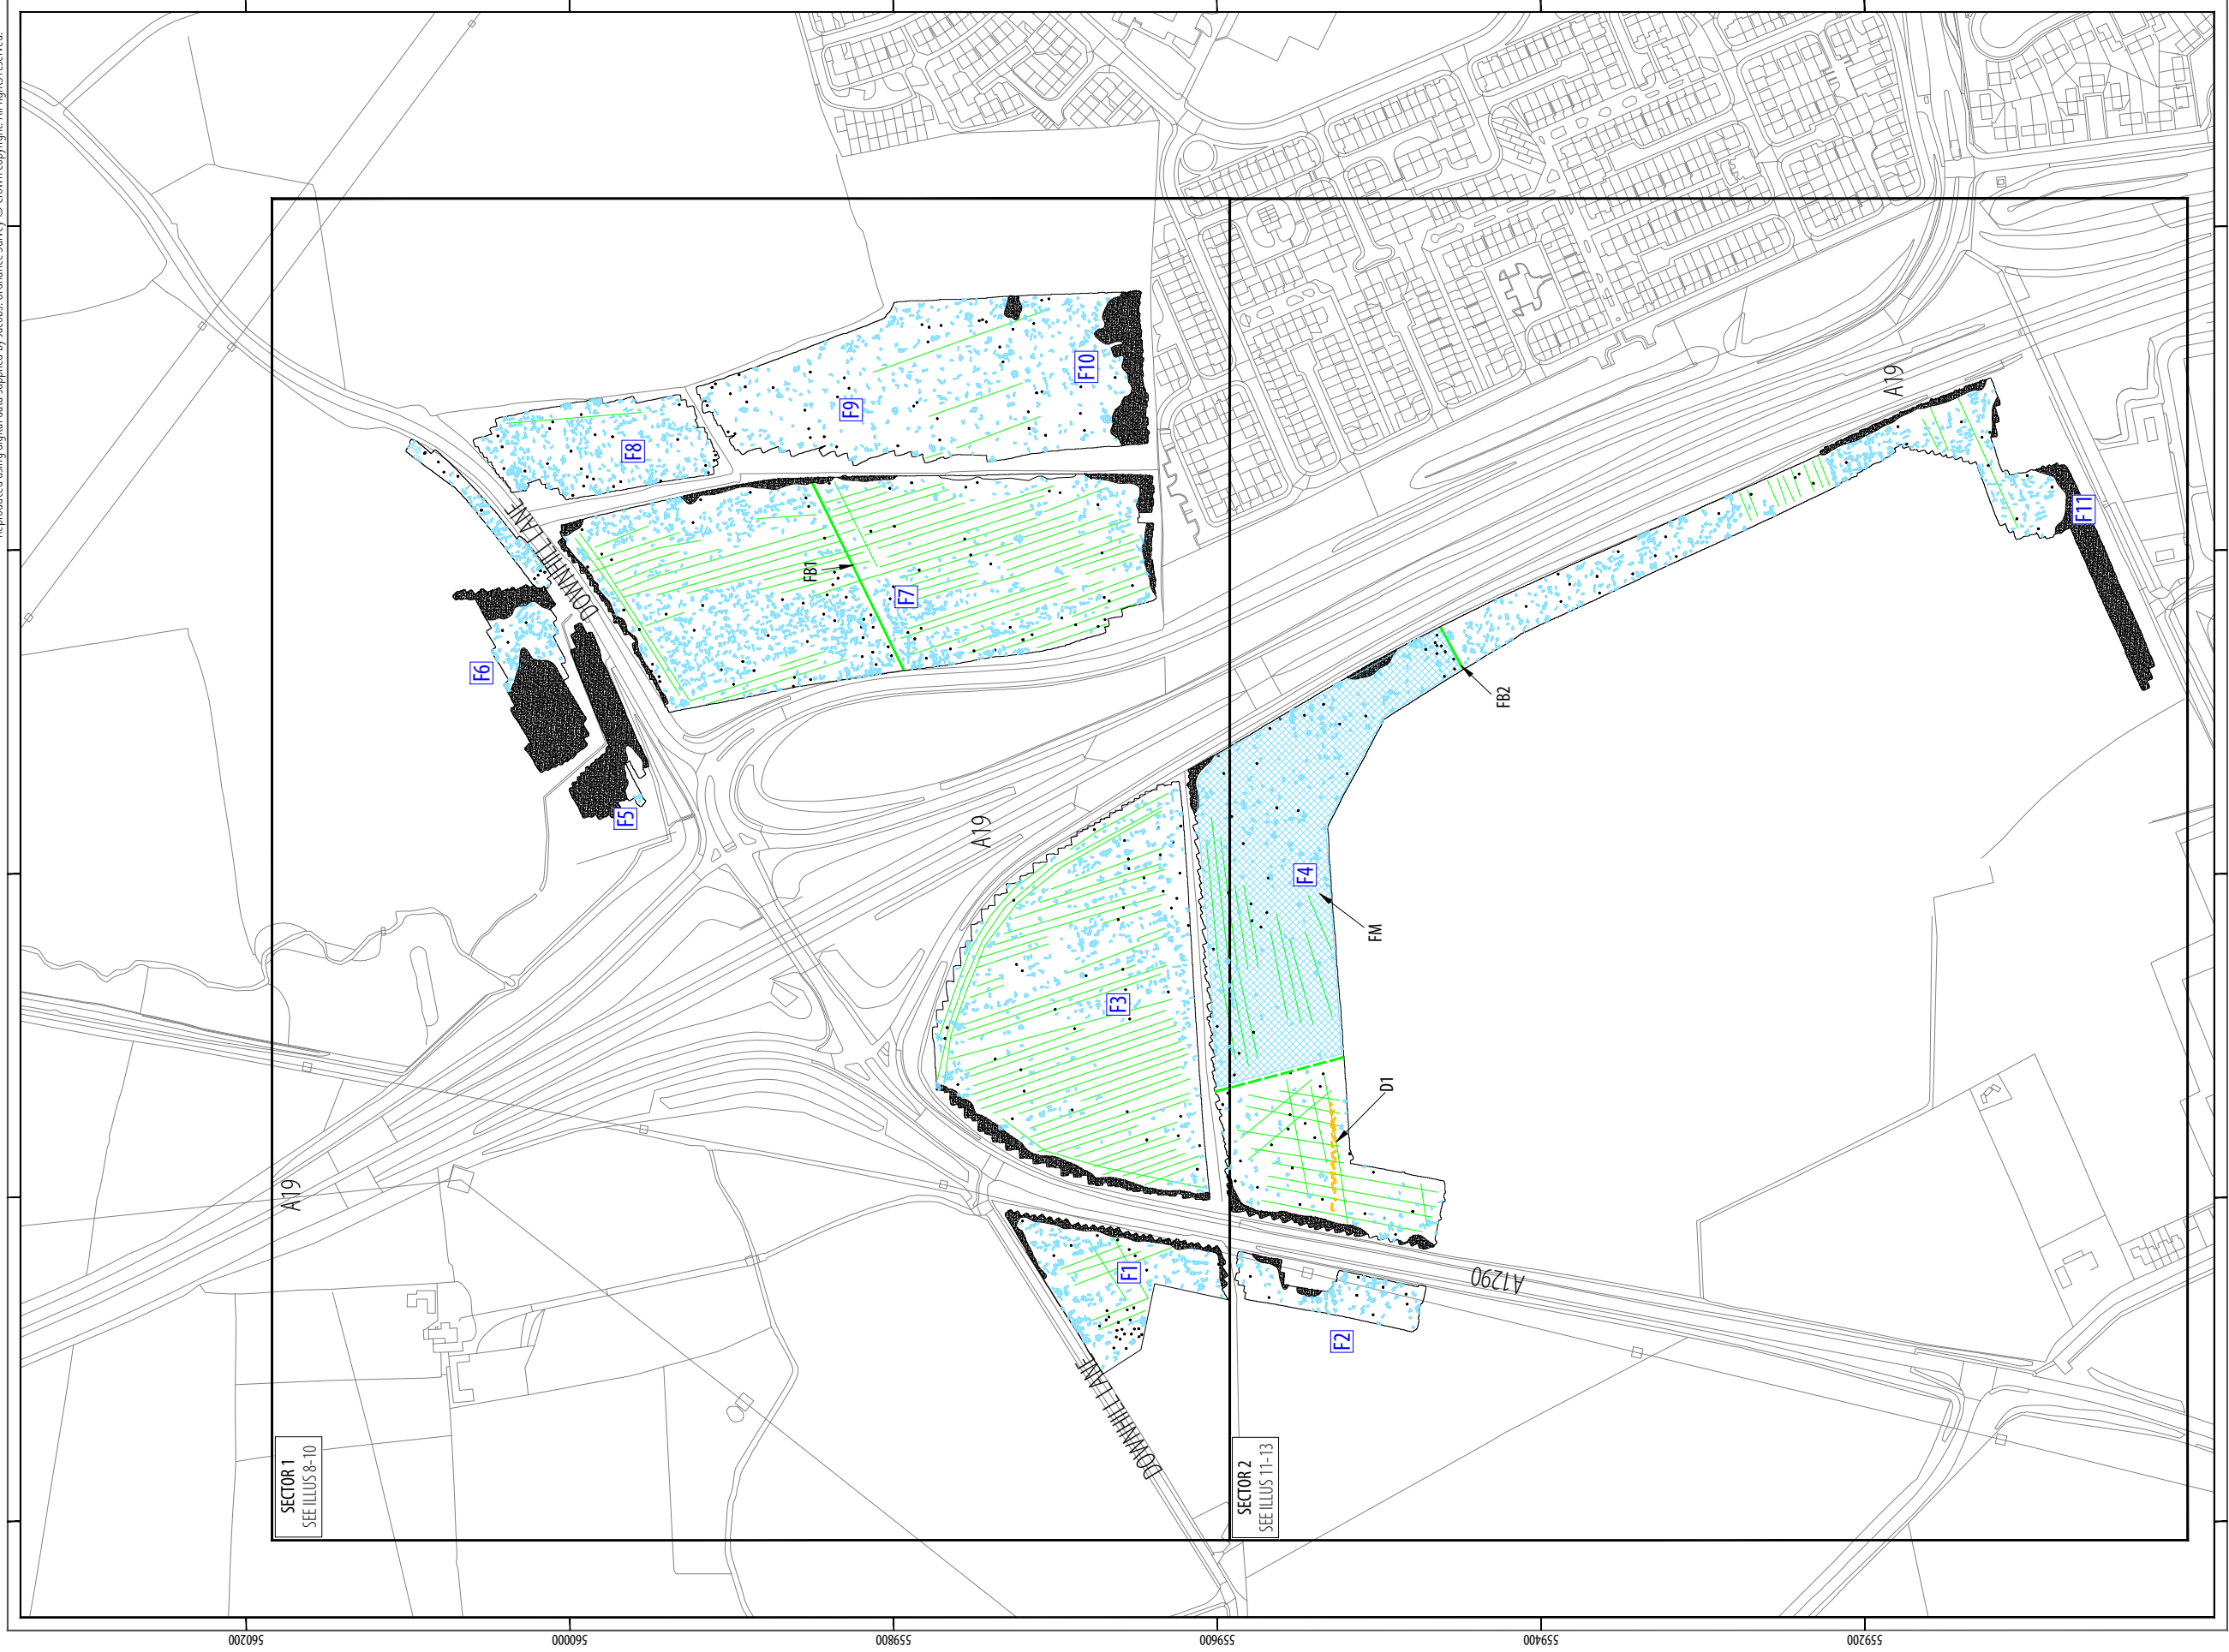
Illus 7 Overall interpretation of magnetometer data

SECTOR 1
SEE ILLUS 8-10

SECTOR 2
SEE ILLUS 11-13

The survey has successfully evaluated the PDA identifying anomalies caused by post-medieval agricultural activity (ploughing) and the removal and infilling of former field boundaries. Previous ground conditions have also had an effect on the magnetic background across the PDA with former areas of marshland much less 'noisy' than areas which have been cultivated over a longer period of time. The extent of areas affected by dumping or infilling of modern, magnetically enhanced, material have also been defined.

Only a single linear anomaly in the west of F4, has been ascribed a possible archaeological origin as it cannot definitely be interpreted as agricultural or modern in origin, although a modern/agricultural cause is thought most likely. On the basis of the geophysical survey, the PDA is assessed as having a low archaeological potential.

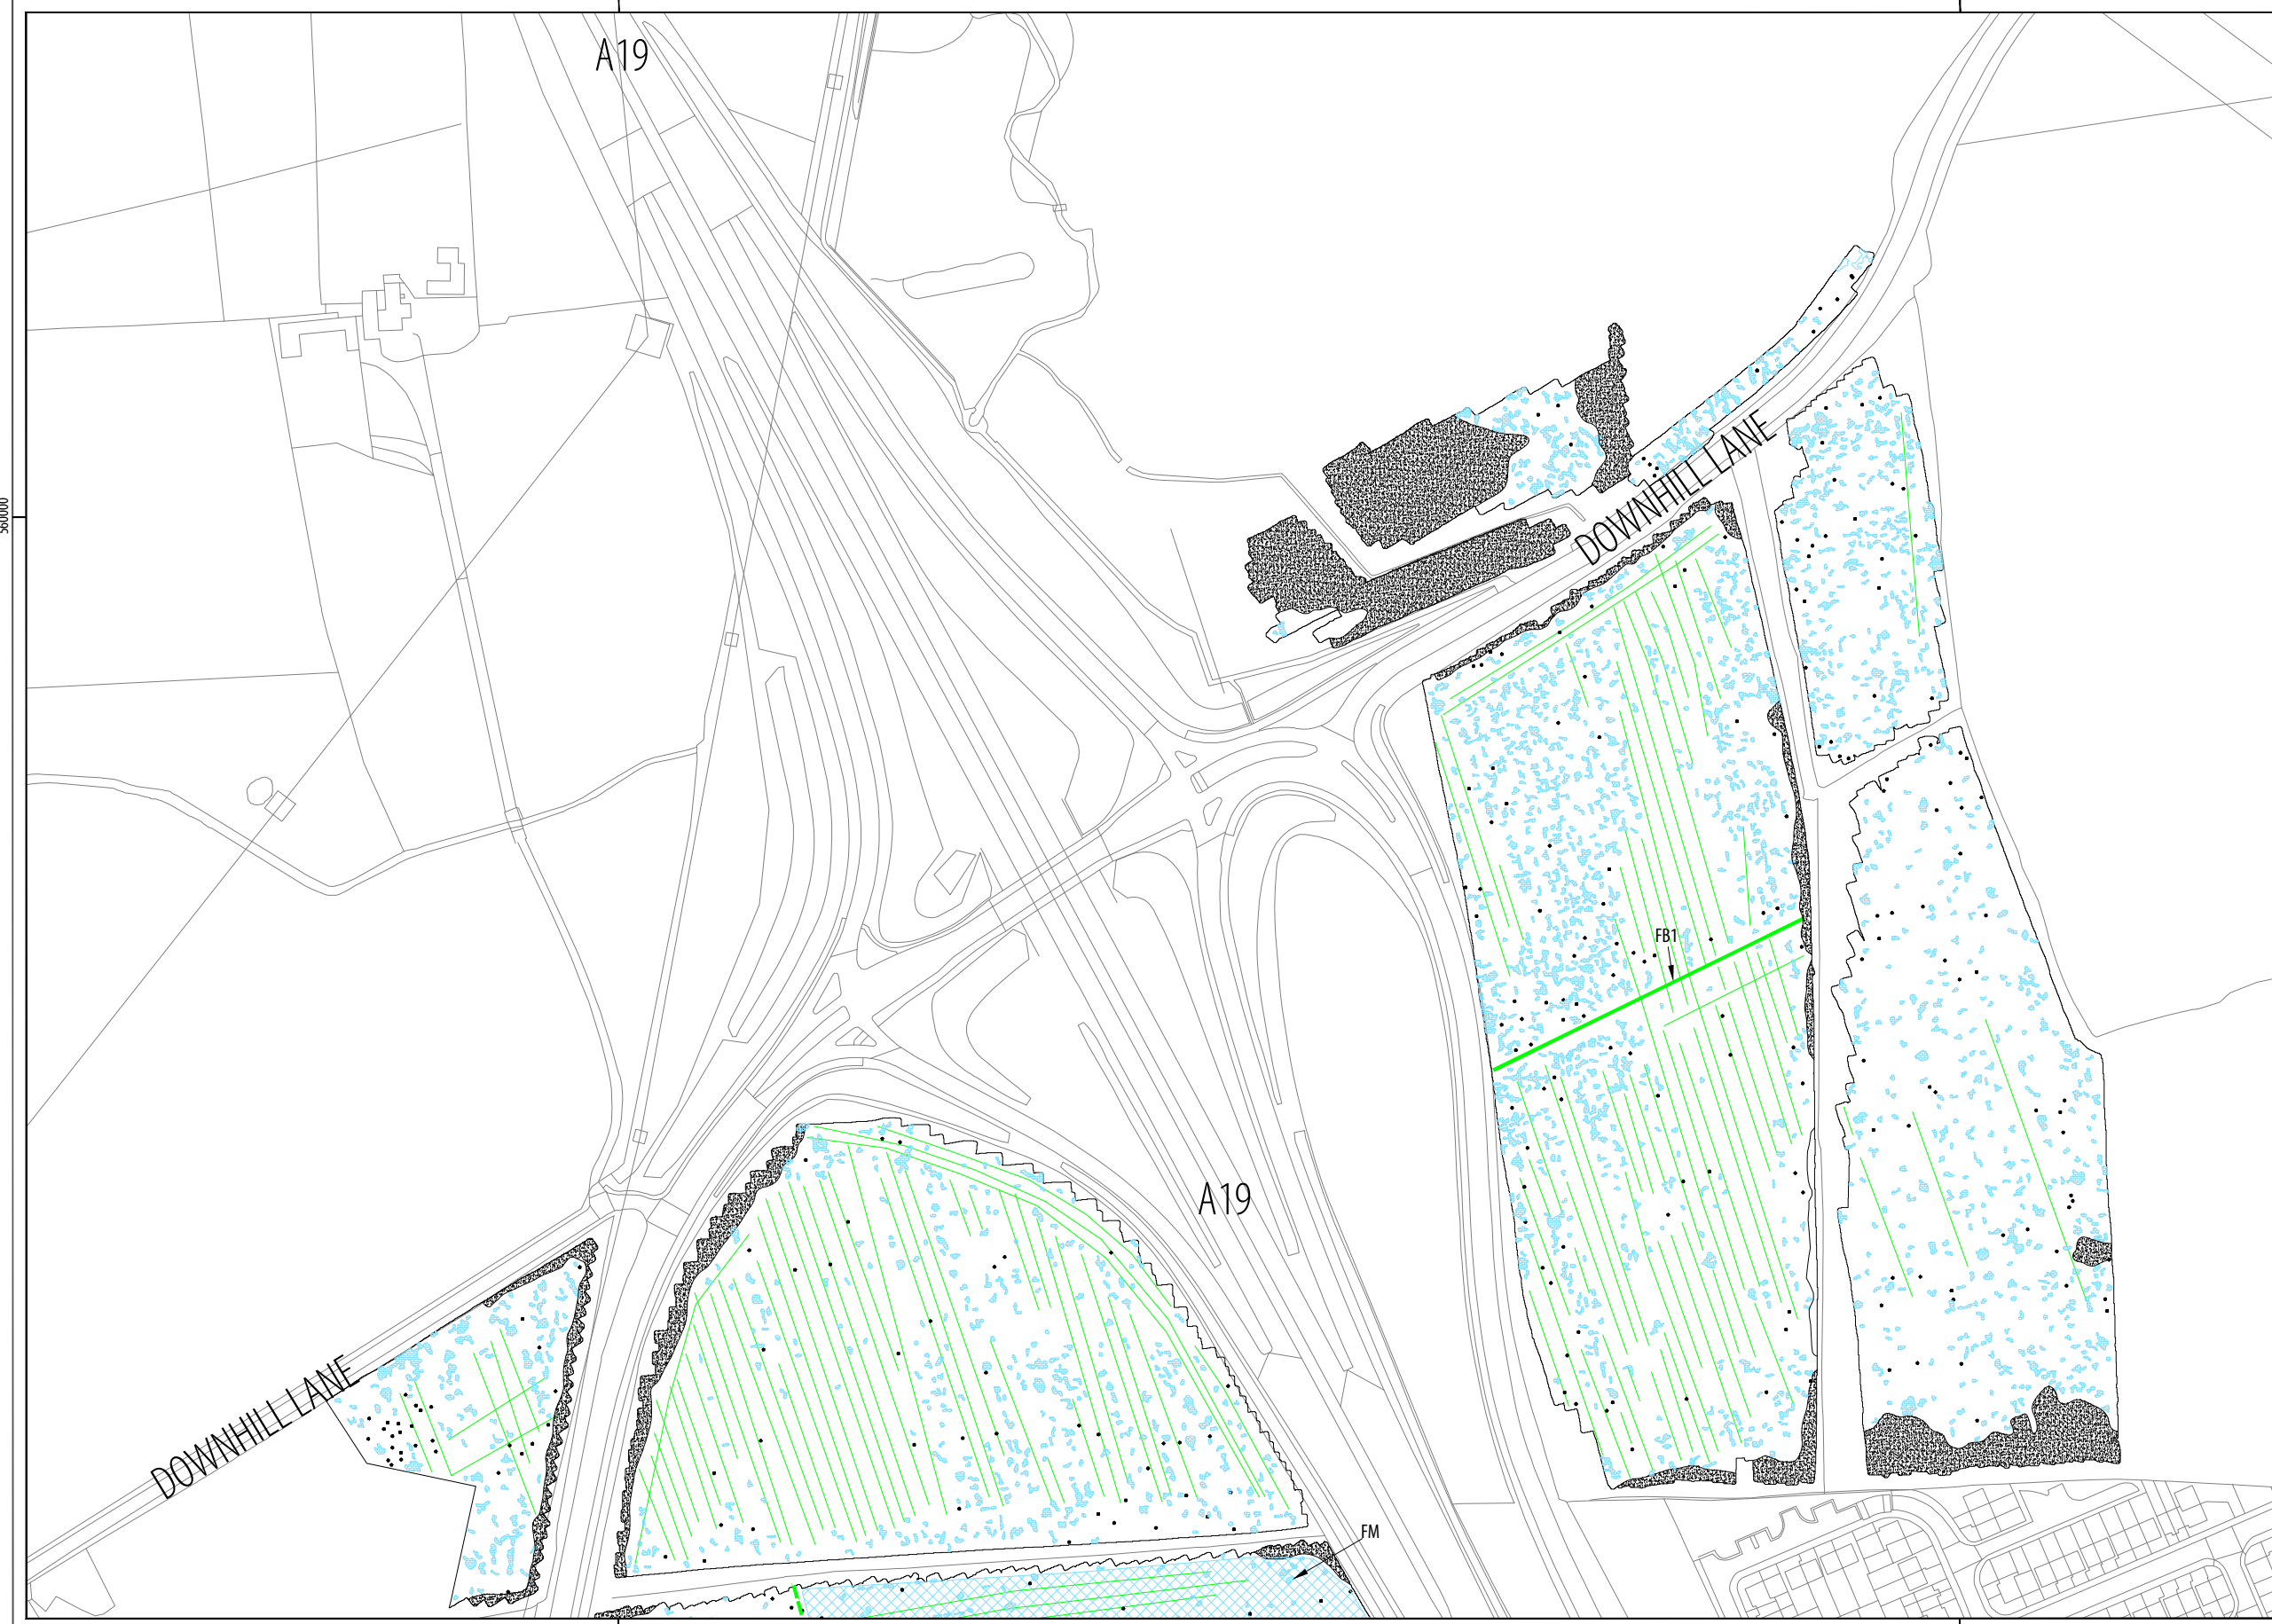
TYPE OF ANOMALY	INTERPRETATION
● dipolar isolated	ferrous material
● magnetic disturbance	ferrous material
— linear trend	agricultural
— linear	former field boundary
— linear	former field boundary
● magnetic enhancement	geology
● low variation	former marsh

ABBREVIATIONS
 FB former boundary
 FM former marsh
