A303 Amesbury to Berwick Down

TR010025

Appendix 10.1 Preliminary Ground Investigation Report

October 2018

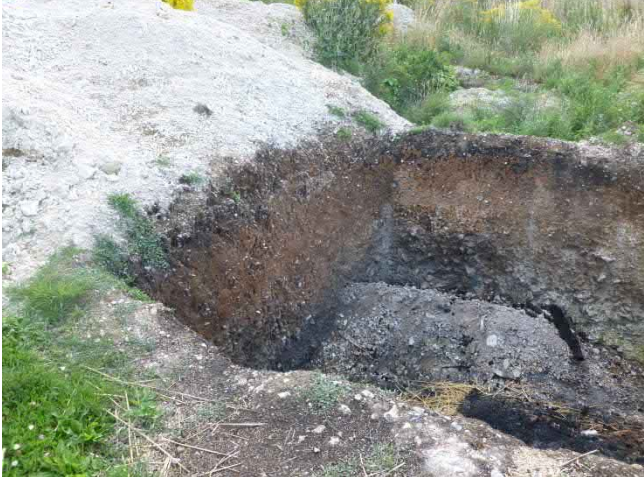
<p>Public footpath between fields, approaching the A303 to the east of Winterbourne Stoke. Just north of the point where the proposed route crosses the footpath.</p>	<p>(N/A)</p>	<p>“Dumping” pit observed, with chalk present (minimal to no Flint in excavated material).</p>

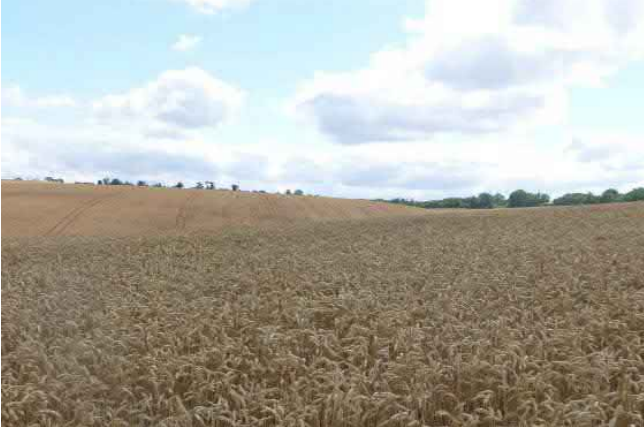
<p>Public footpath between fields, approaching the A303 to the east of Winterbourne Stoke. At the point where the proposed route crosses the footpath.</p>	<p>East</p>	<p>Proposed cutting looking ahead to the east.</p>
