A303 Stonehenge

Amesbury to Berwick Down

Archaeological Evaluation Report:

Eastern Portal - Part 2: Figures

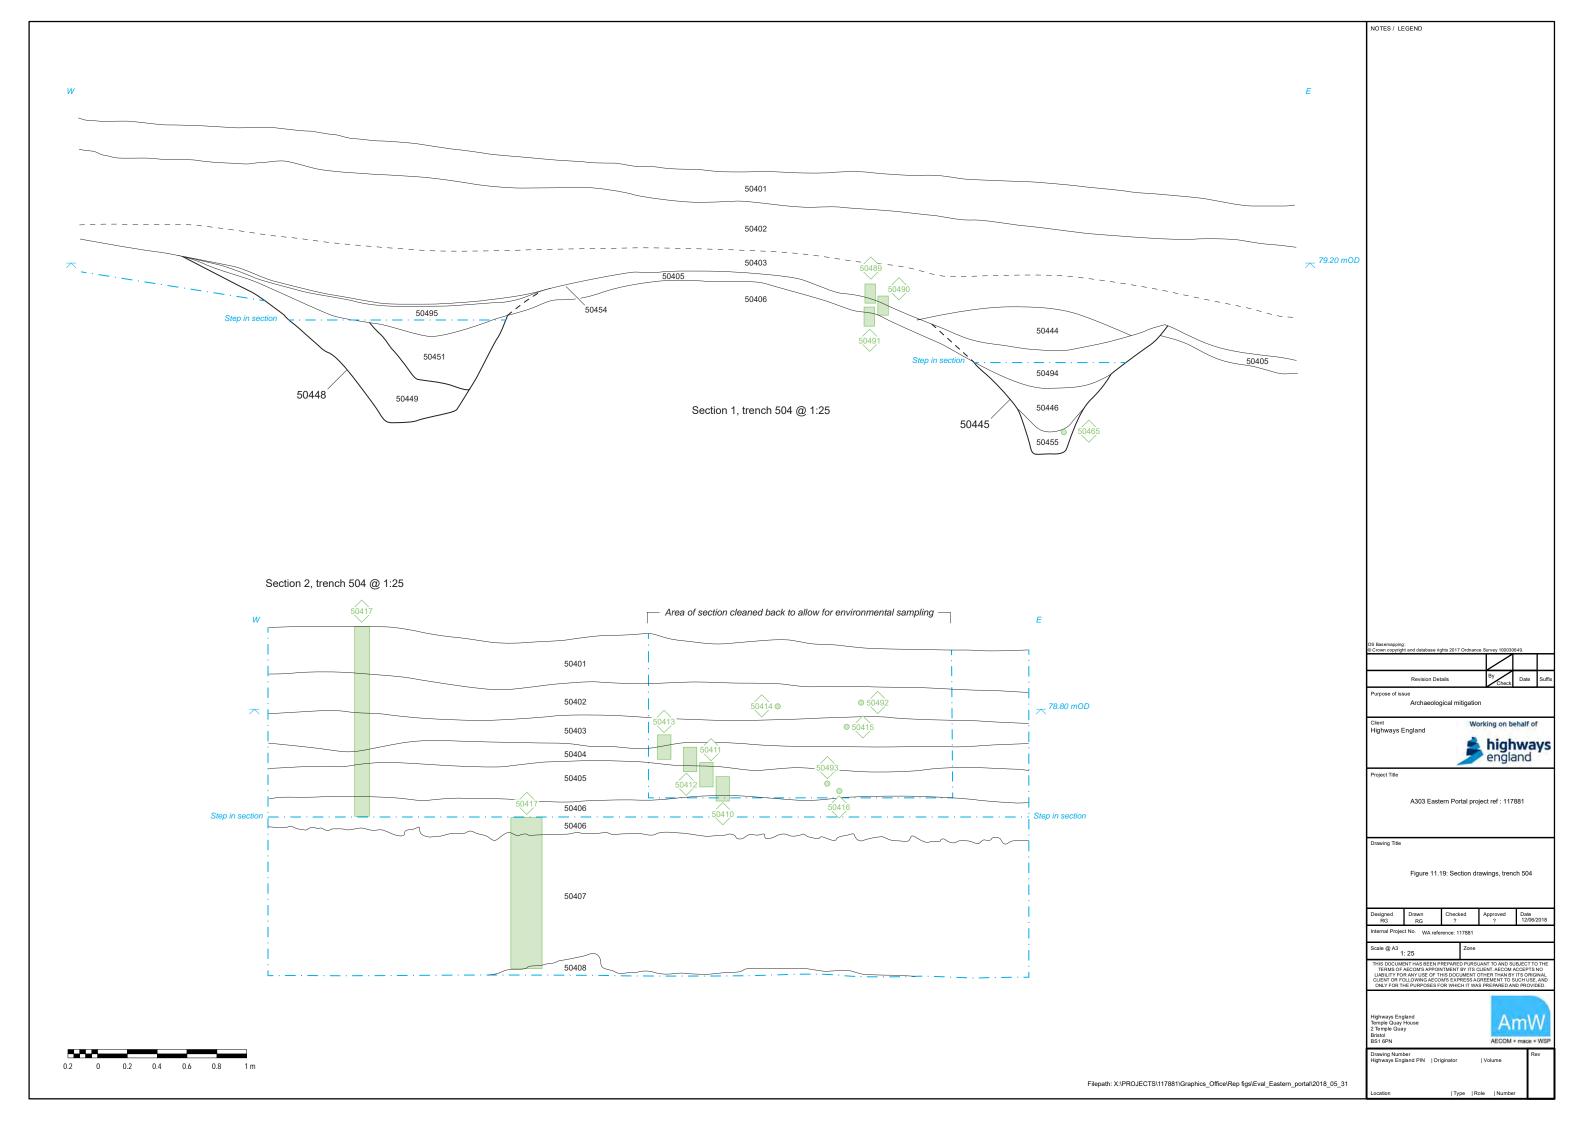
Section 3: ditch 50603 @ 1:25

Section 4: Tree-throw 50606 @ 1:25

Section 5: Tree-throw 50714 @ 1:25

Section 6: Post hole 51127 @ 1:25

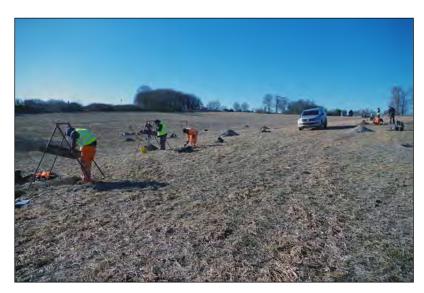
Plate 12.1: Working shot of test pitting in east of the Site showing narrow east-west dry valley

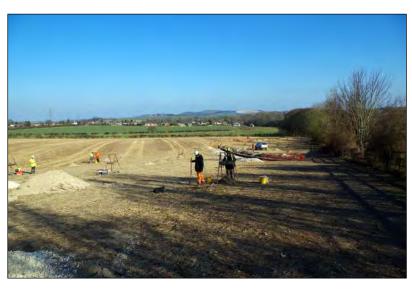
Plate 12.2: Test pitting and investigating trenches 511 and 512, showing drop in ground level to River Avon

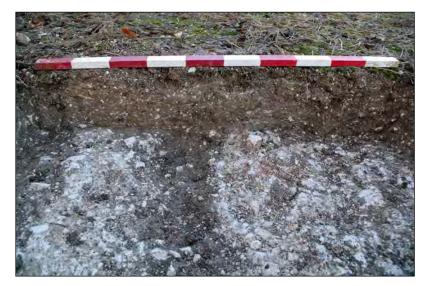
Plate 12.3: Representative section of test pit 1407 4206 showing plough scars

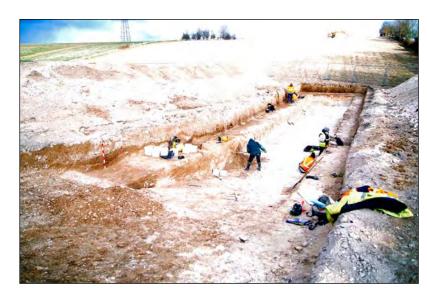
Plate 12.4: View from the west of archaeologists investigating colluvial sequence and parallel ditches in trench 504

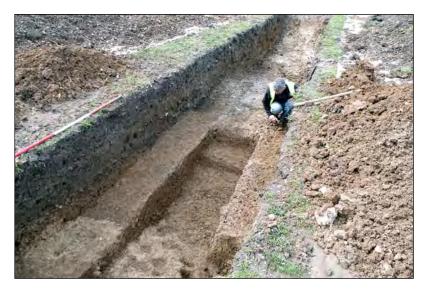
Plate 12.5: Oblique view of north-west facing section through natural hollow 51224, with stony horizon 51224 at base of upper colluvium and lower colluvium below

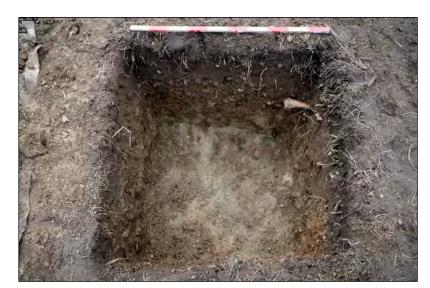
Plate 12.6: Test pit 1506 4210 showing shallow post-medieval or modern pit (with animal bone on right) cut into colluvium, above natural soliflucted chalk 201783 D53 5100105

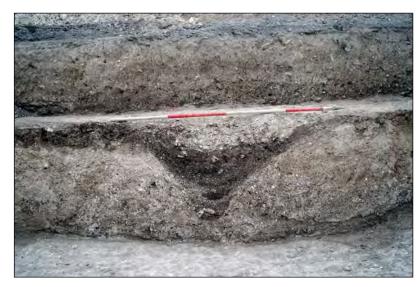
Plate 12.7 North-facing section of ditch 50442=50445

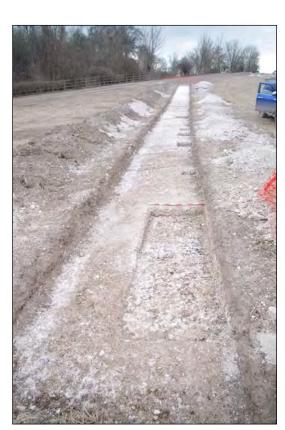
Plate 12.10: View from the north-east of shallow cut 50905 truncating the chalk (excavated in hand-dug slots)

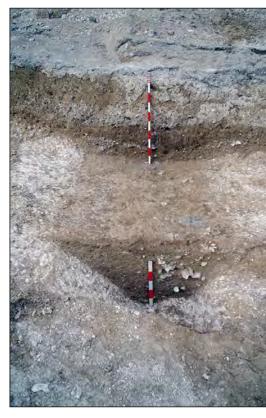
Plate 12.8 South- facing section of ditch 50448

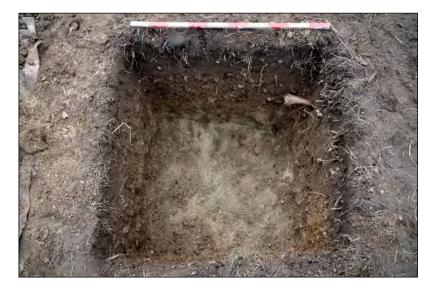
Plate 12.9 Deeper test pit 201783_D53_5100105
