A303 Amesbury to Berwick Down

Ground Investigation - Phase 7ai Factual Report

A303 Amesbury to Berwick Down - Phase 7a (i)

Factual Report

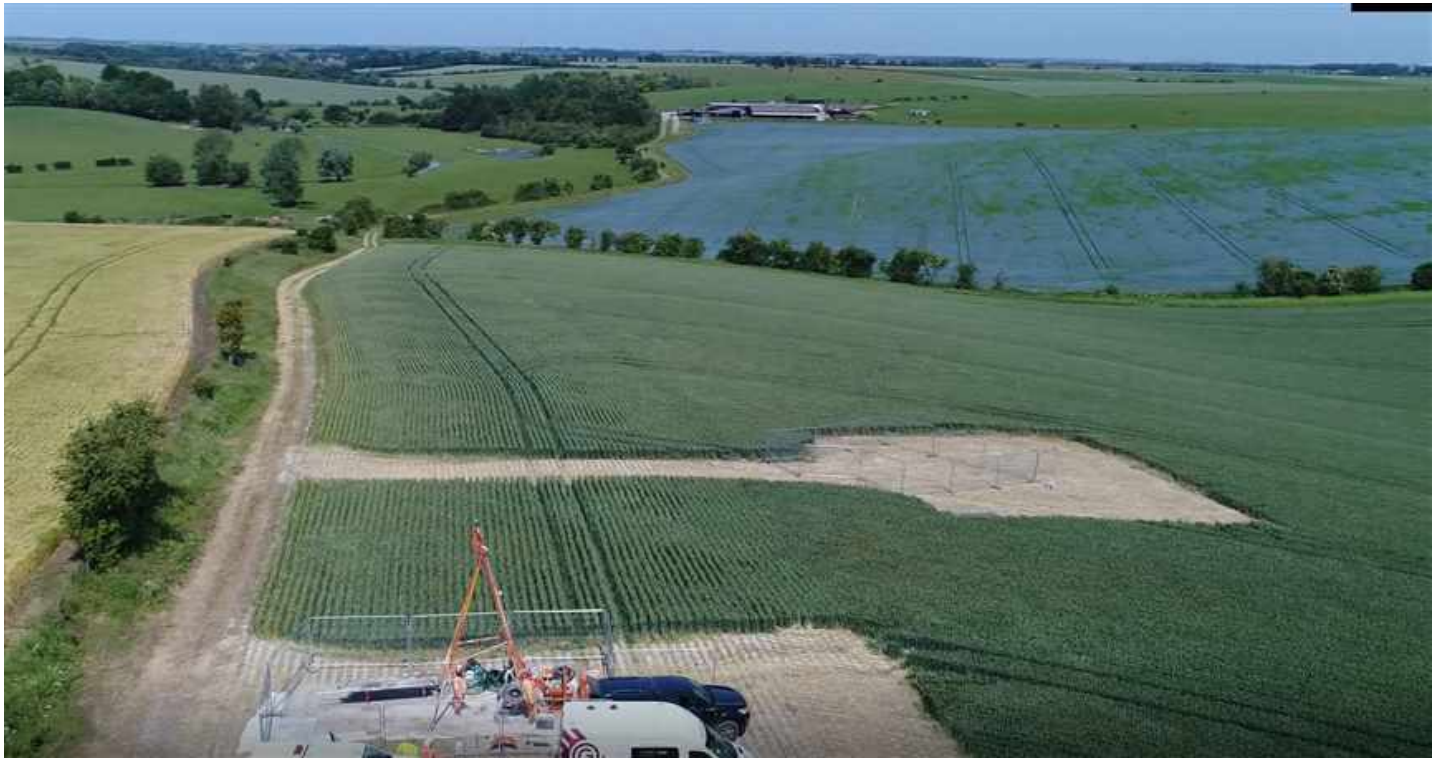
Aerial view looking north towards CP71002

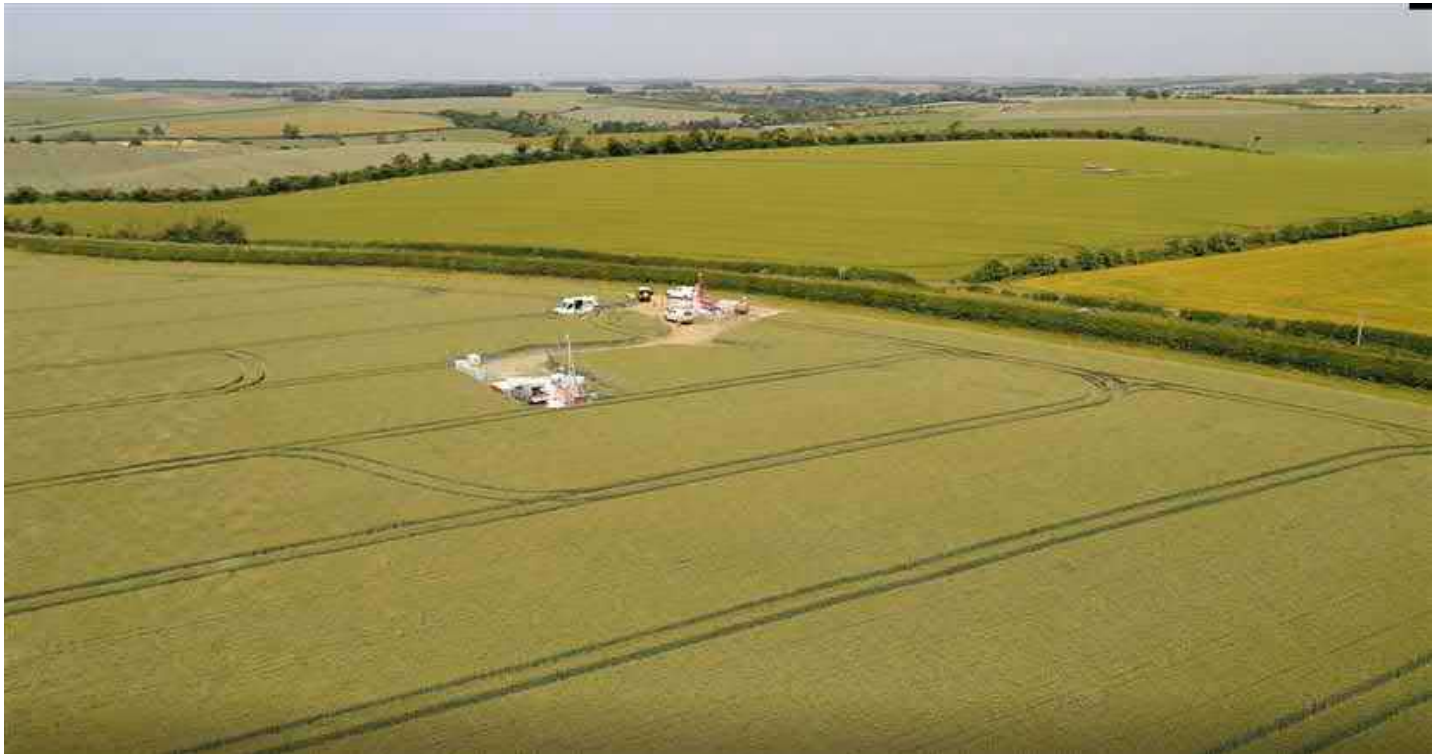
Aerial view looking north west towards CP71302 and R71301

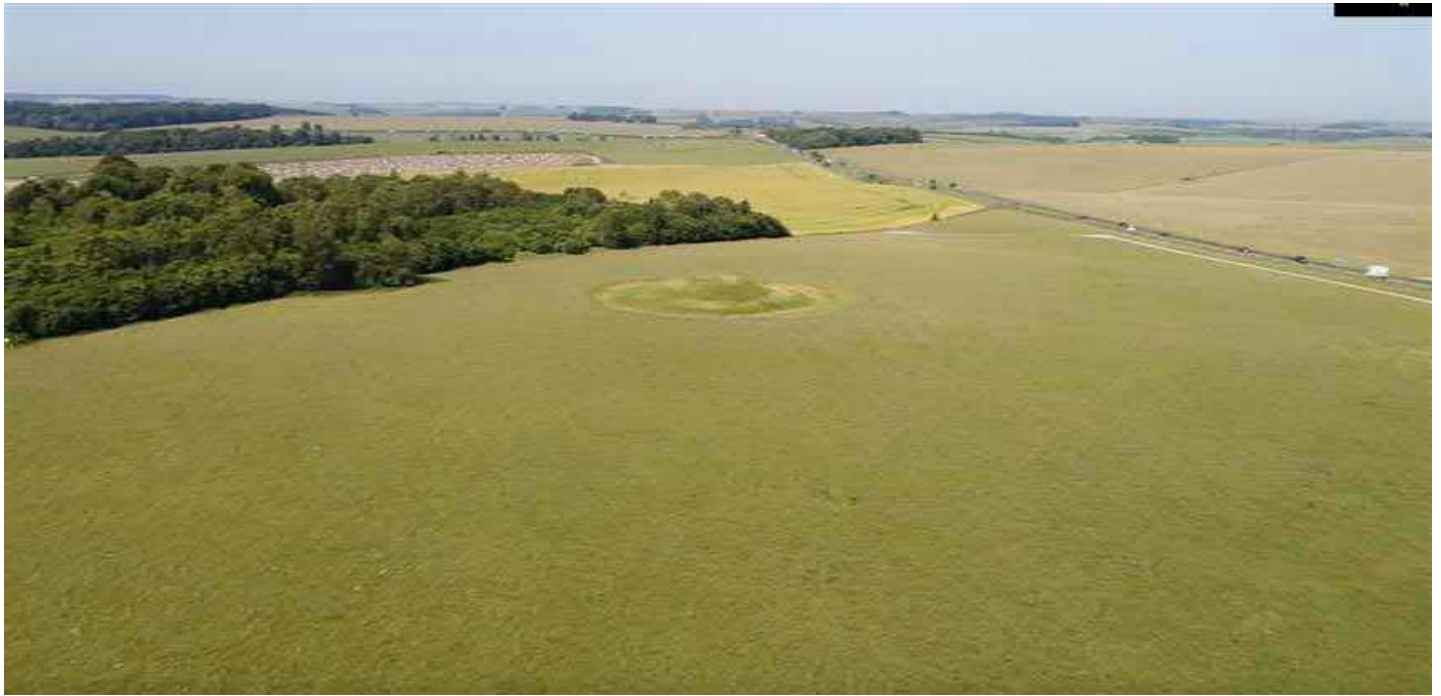
Aerial view over R71903 looking north west

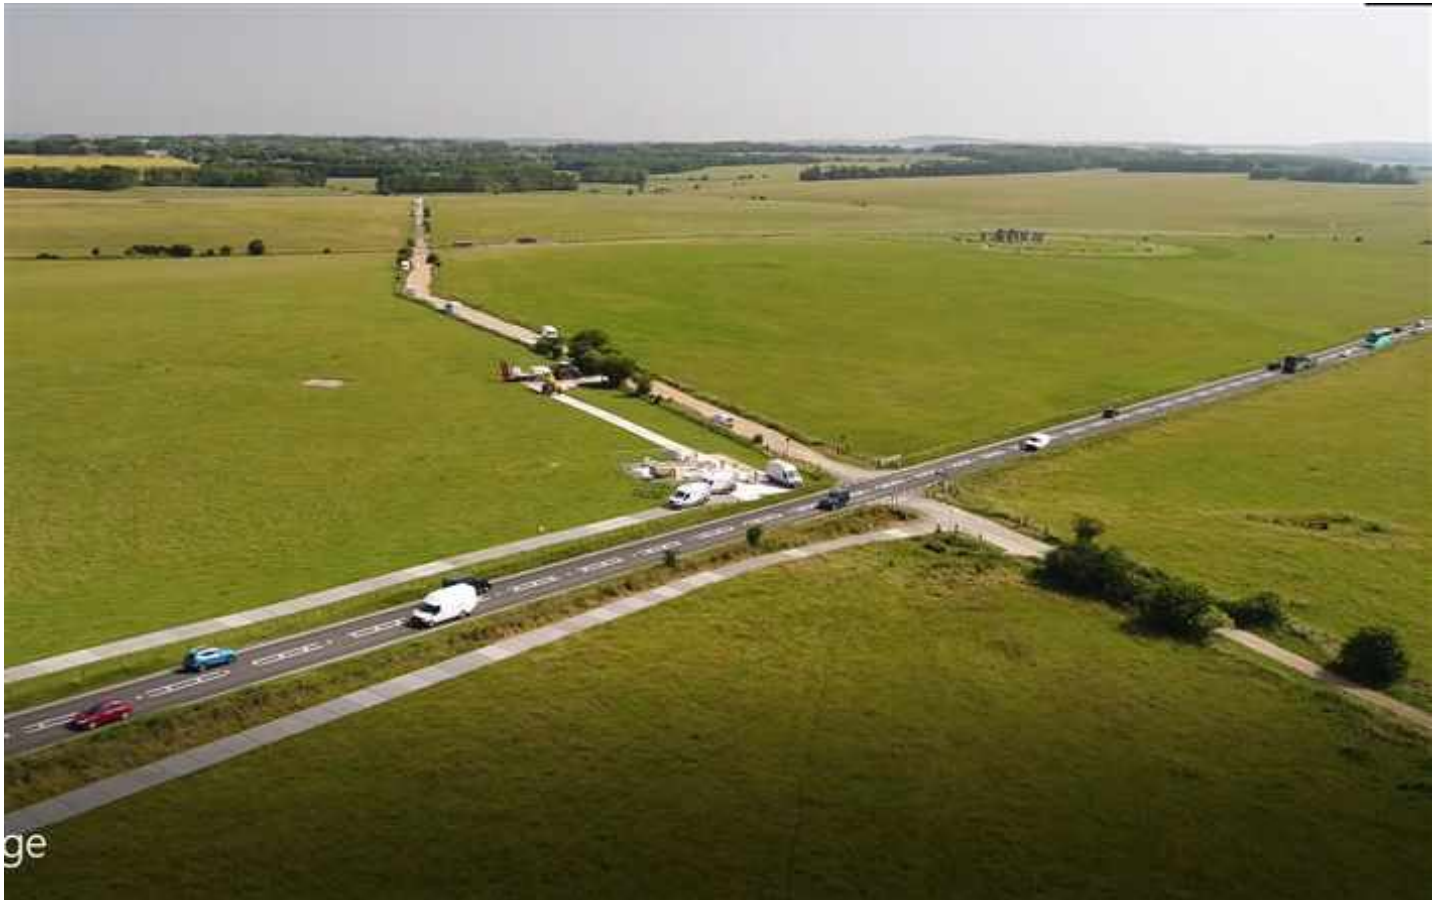
Aerial view over R71903 looking north east

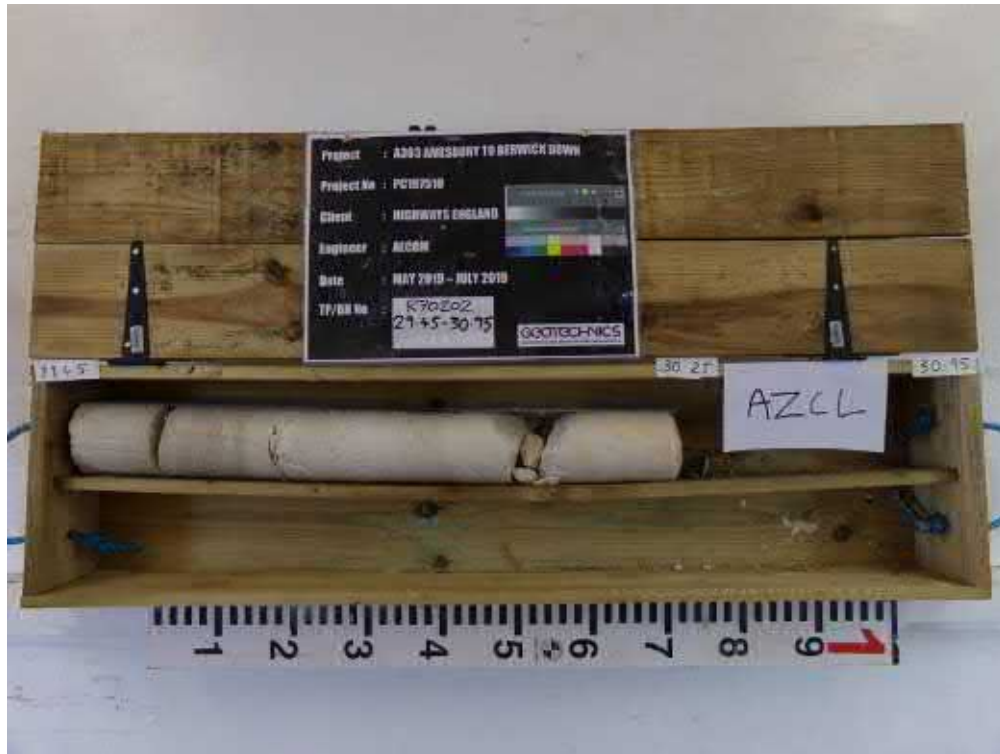
R70202 29.45-30.95m

29.65-31.15	29.65	95 88	0.43 0.15	85		Weak, medium to high density, white with occasional black specks CHALK. Discontinuations are: Set 1 are subhorizontal (0-15 degrees), closely to medium spaced (90/200/400), clean rarely infilled (0/0/2) with comminuted chalk or marl, stepped and rough with many black specks and rare orangish brown surface staining and rare wispy grey marl partings (<2mm thick). Set 2 are 35-60 degrees, medium spaced (420/440/530), clean or infilled (0/0/2) with comminuted chalk, stepped and rough with occasional black specks and rare orangish brown surface staining. Set 3 are 80-90 degrees, clean rarely infilled (0/0/1) with comminuted chalk or marl, undulating or stepped and rough with occasional black specks and rare orangish brown surface staining. [Grade A2/3] Between 29.65-30.10m with many grey wispy marl partings (<1mm thick) and orangish brown surface staining on clasts (up to 100mm in size). Between 30.30-30.44m, with occasional grey wispy marl seams (<1mm thick) with occasional orangish brown surface staining (<2mm in size).	29.65 (76.44)		3

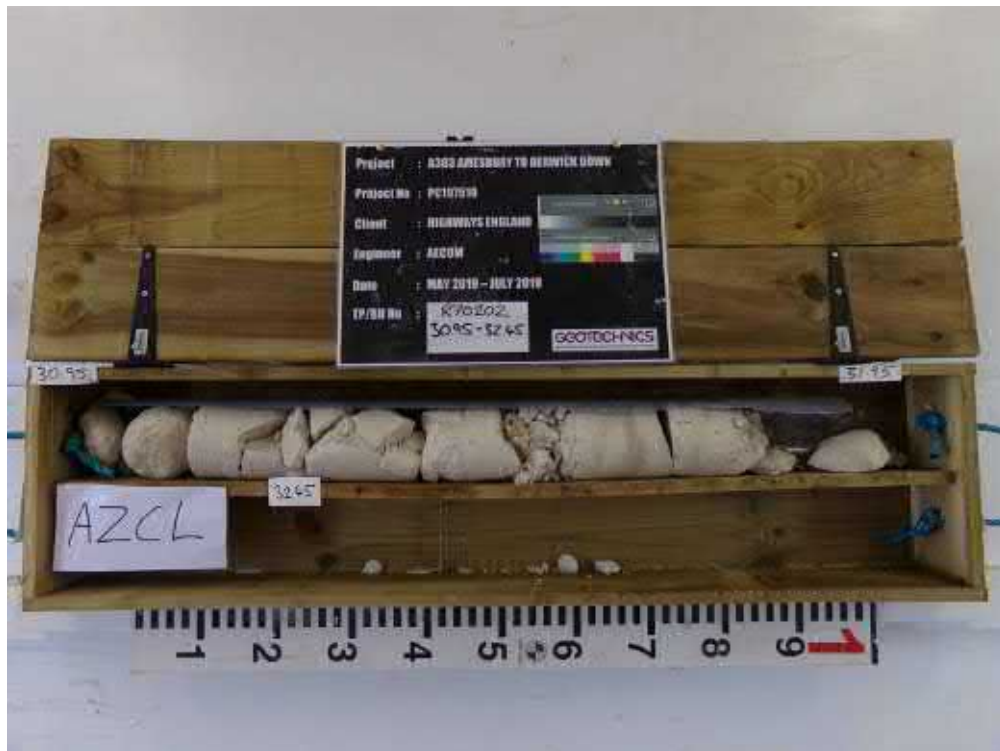
R70202 30.95-32.45m

(2)	Between 31.80-32.00m, with occasional orangish brown surface staining. (Possible sponge fossils).

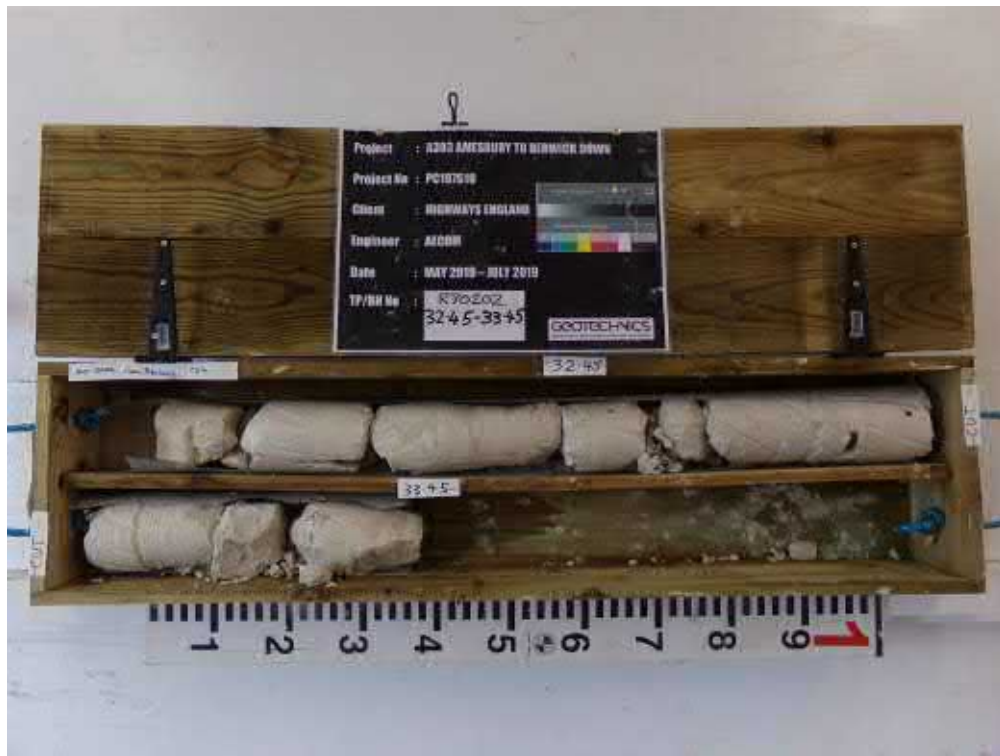
R70202 32.45-33.45m

(3)	At 32.40m, 32.50m and 32.65m, with rare orangish brown circular staining (up to 10mm in size). (Possible fossils).				
32.65-34.15	32.65	73 59	0.25 0.09	53	(NI)	Between 32.75-32.87m, with many subangular small and medium nodular flint fragments (up to 90mm in size). (Possibly flint band)

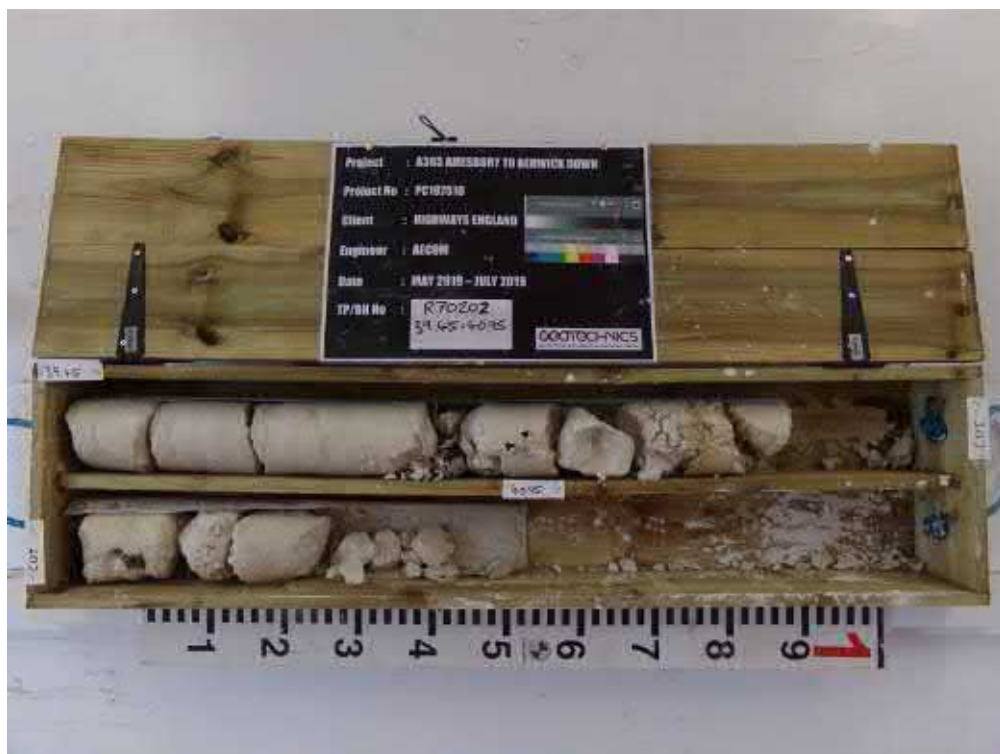
R70202 39.45-40.95m

40.15-41.65	40.15	100 63	0.26 0	59	(3)	Between 40.20-40.60m, with much orangish brown surface staining on clasts (up to 3mm in size).			2	
					(NI)	Between 41.20-41.65m, non intact, recovered as silty angular to subangular fine to coarse gravel. Clasts have rare orangish brown surface staining (up to 2mm in size). (Possible fossils)			1

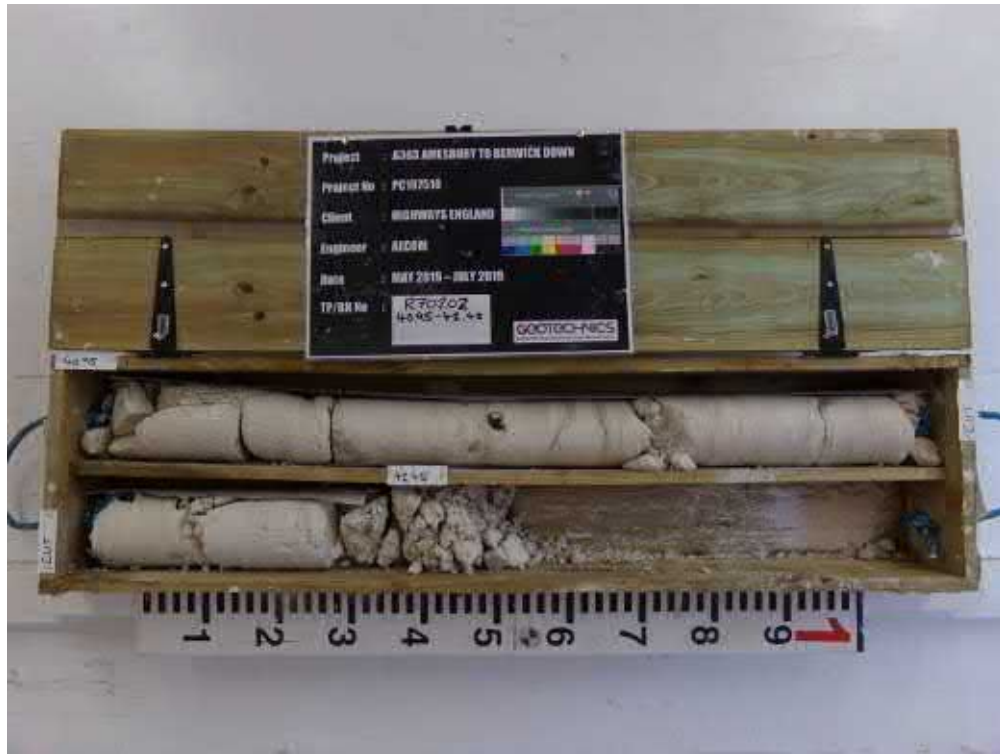
R70202 40.95-42.45m

41.65-43.15	41.65	100 69	0.23 0.06	60	(3)	At 45.25m, with occasional orangish brown surface staining (<3mm in size).			1	
42.20-42.43		C			(NI)	At 42.50m, with a subangular to subrounded small nodular flint (50mm in size).			1

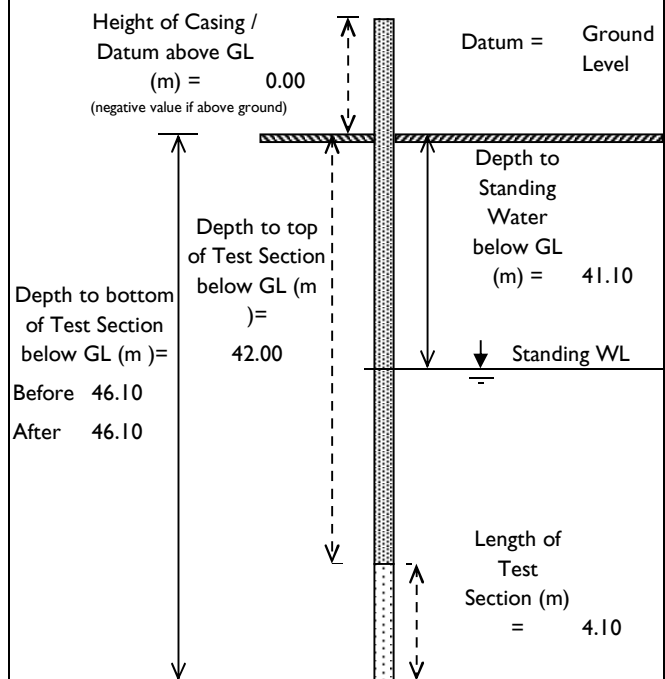
Test Measurements			
Elapsed Time (minutes)	Depth of Water below Ground Level (m)	Elapsed Time (Continued) (minutes)	Depth of Water below Ground Level (continued) (m)
0.0	20.18		
0.3	24.01		
0.5	25.50		
0.8	25.90		
1.0	26.21		
1.5	28.49		
2.0	30.47		
2.5	32.08		
3.0	33.55		
3.5	34.76		
4.0	35.93		
4.5	36.96		
5.0	37.68		
6.0	38.67		
7.0	39.25		
8.0	39.60		
9.0	39.74		
10.0	39.82		
15.0	40.00		
18.0	40.11

Depth to Standing Water Level below Datum	41.10 m
Depth to Induced Water Level below Datum	20.18 m
Differential head at start of Test (H_o)	20.92 m
Differential Head at end of Test (H_t)	0.99 m
Time Elapsed at end of test (t_t)	18.0 mins

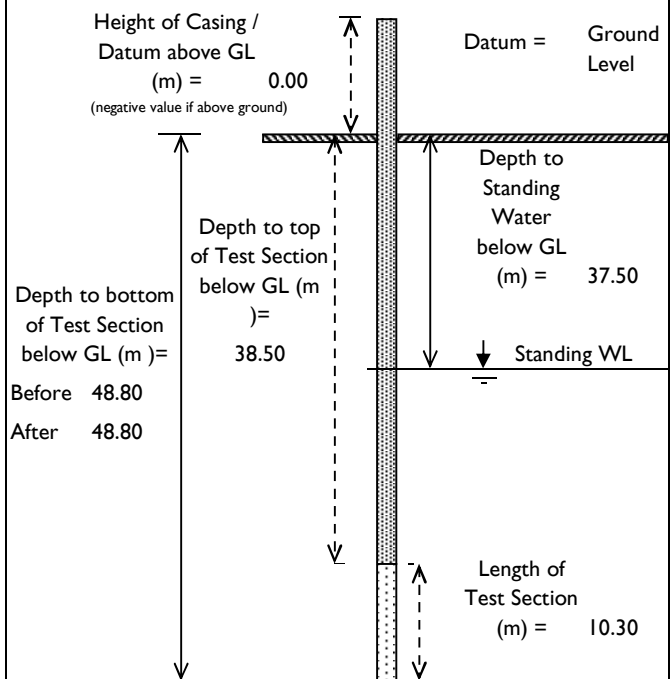
Test Measurements			
Elapsed Time (minutes)	Depth of Water below Ground Level (m)	Elapsed Time (Continued) (minutes)	Depth of Water below Ground Level (continued) (m)
0.0	17.89		
0.3	18.28		
0.5	20.03		
0.8	25.72		
1.0	27.29		
1.5	27.70		
2.0	28.56		
2.5	29.38		
3.0	30.10		
3.5	30.70		
4.0	31.33		
4.5	31.88		
5.0	32.35		
6.0	33.29		
7.0	34.03		
8.0	34.65		
9.0	35.12		
10.0	35.50		
12.0	36.06

Depth to Standing Water Level below Datum	37.50 m
Depth to Induced Water Level below Datum	17.89 m
Differential head at start of Test (H_o)	19.61 m
Differential Head at end of Test (H_f)	4.21 m
Time Elapsed at end of test (t_f)	12.0 mins

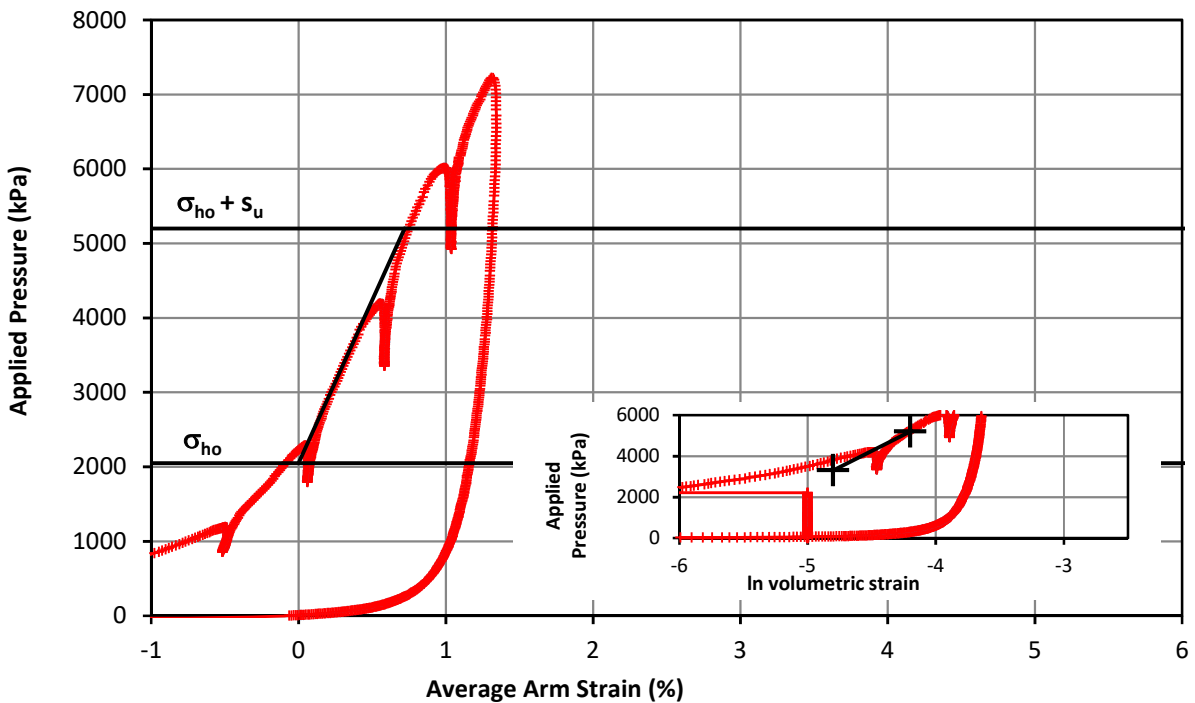
Initial Modulus	Shear Modulus	220.3 MPa
------------------------	---------------	-----------

Marsland & Randolph	In situ horizontal stress	2050 kPa
	Undrained Strength	3150 kPa

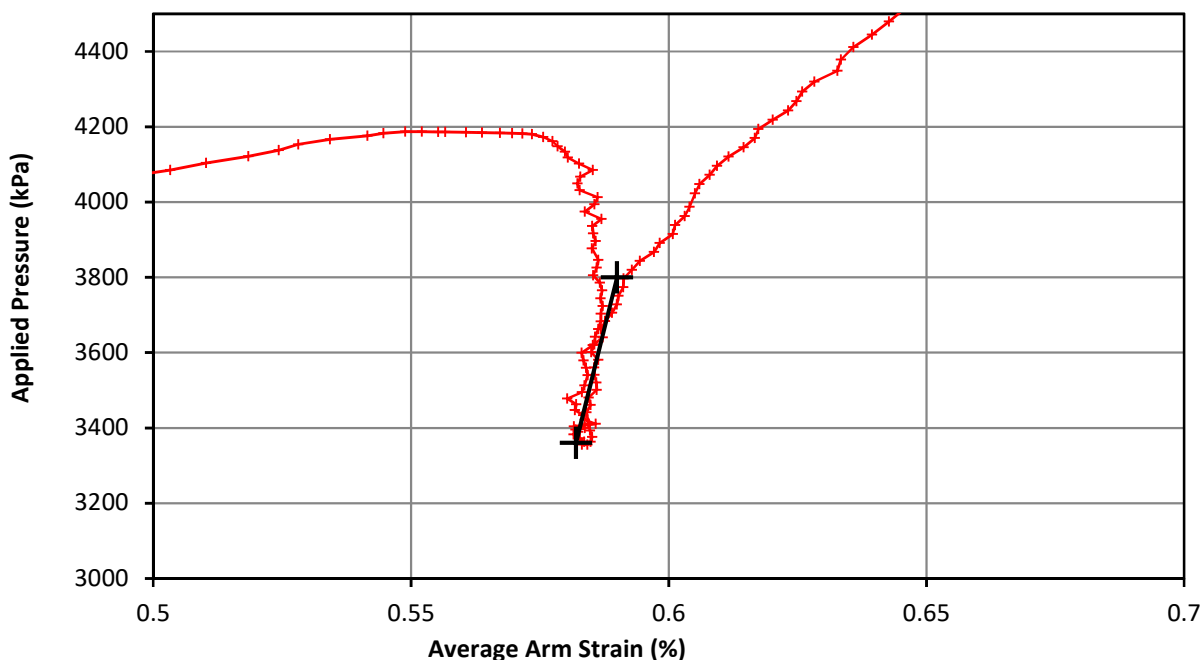
Loop 1	Shear Modulus	834.0 MPa
	Cavity Strain Range	0.015 %

Loop 2	Shear Modulus	2766.2 MPa
	Cavity Strain Range	0.008 %

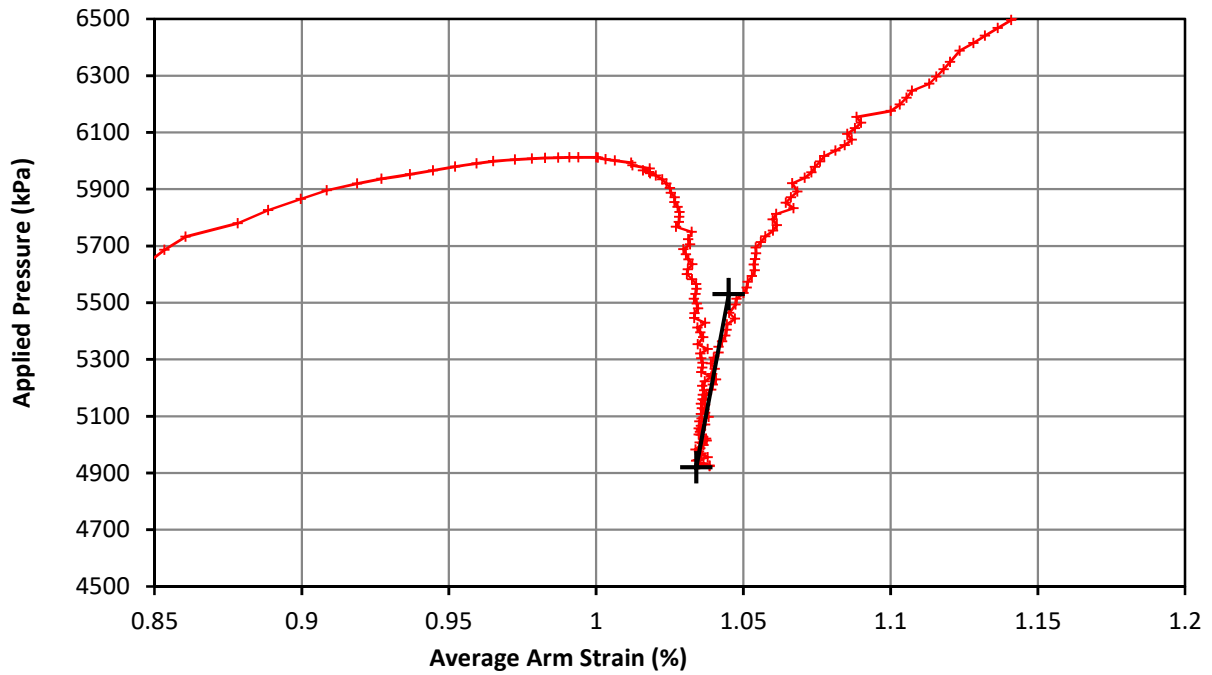
Test Date	26/06/2019	Test No.	4
Borehole	R71903	Test Depth (m)	31.00

Loop 3	Shear Modulus	2801.7	MPa
	Cavity Strain Range	0.011	%

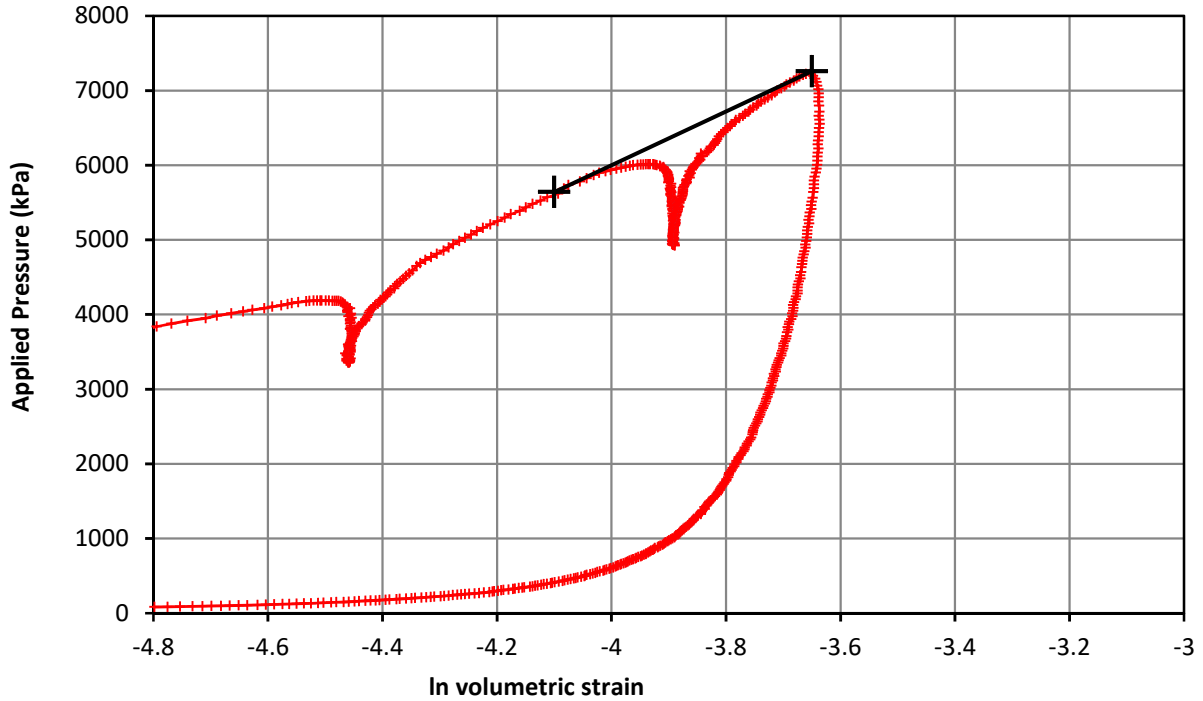
Test Date	26/06/2019	Test No.	4
Borehole	R71903	Test Depth (m)	31.00

Strength	Undrained Shear	3600 kPa
	Limit Pressure	20400 kPa

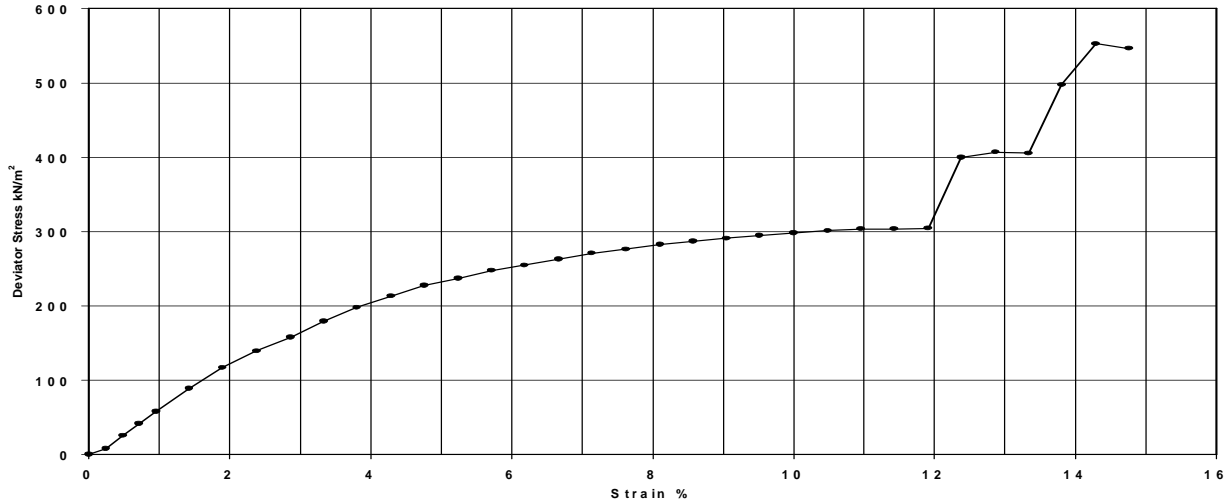
BS1377 Part 8 1990 : Clause 8.0

Stage 1	Stage 2	Stage 3	Strain %	Corrected Deviator Stress kN/m ²	Strain %	Corrected Deviator Stress kN/m ²
Sample Condition	Undisturbed			0.2	7.7	10.0	298.3
Orientation of sample	Vertical			0.5	25.3	10.5	301.1
Initial Diameter (mm)	104.07	104.07	104.07	0.7	42.0	11.0	303.3
Initial Length (mm)	209.98	209.98	209.98	1.0	57.9	11.4	303.6
Initial Water Content (%)	31.1	31.1	31.1	1.4	88.8	11.9	304.1
Initial Bulk Density (Mg/m ³)	1.97	1.97	1.97	1.9	117.3	12.4	399.6
Initial Dry Density (Mg/m ³)	1.50	1.50	1.50	2.4	139.6	12.9	406.7
Particle Density (Mg/m ³)				2.9	157.8	13.3	405.3
Cell Pressure (kPa)	60	120	240	3.3	179.2	13.8	497.7
'Specimen Height' at start of Shearing Stage (mm)				3.8	197.8	14.3	552.4
Membrane Thickness/Correction (mm/kPa)	0.30 / 0.71	0.30 / 0.77	0.30 / 0.88	4.3	212.9	14.8	546.1
Rate of Strain (%/min)	1.95	1.95	1.95	4.8	227.2		
Corrected Deviator Stress (kPa)	304	407	552	5.2	237.2		
Undrained Shear Strength (kPa)	152	203	276	5.7	247.5

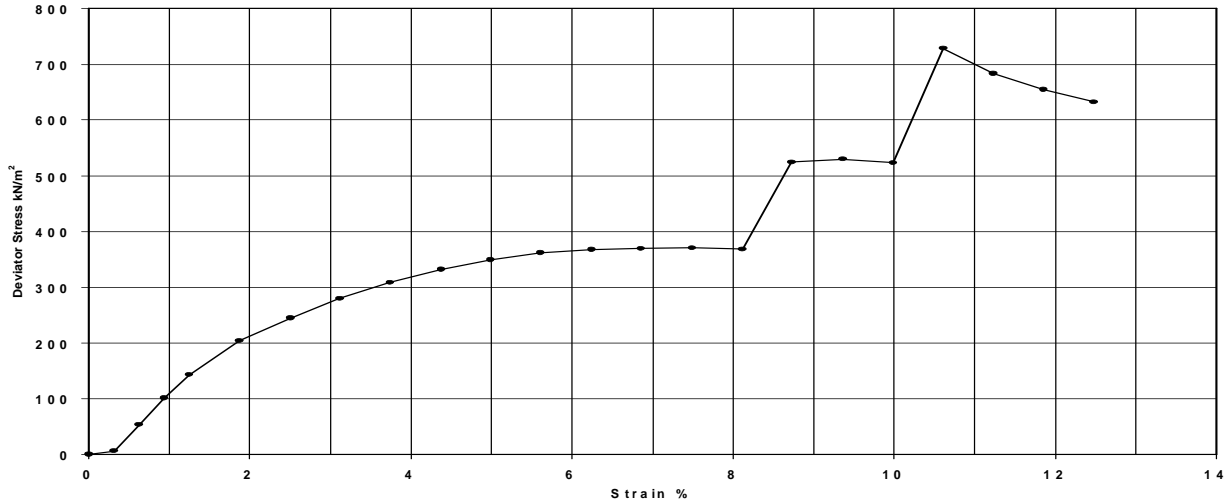
BS1377 Part 8 1990 : Clause 9.0

Stage 1	Stage 2	Stage 3	Strain %	Corrected Deviator Stress kN/m ²	Strain %	Corrected Deviator Stress kN/m ²
Sample Condition	Undisturbed			0.3	6.1		
Orientation of sample	Vertical			0.6	53.7		
Initial Diameter (mm)	102.61	102.61	102.61	0.9	101.1		
Initial Length (mm)	160.29	160.29	160.29	1.2	143.4		
Initial Water Content (%)	21.9	21.9	21.9	1.9	203.6		
Initial Bulk Density (Mg/m ³)	2.68	2.68	2.68	2.5	244.9		
Initial Dry Density (Mg/m ³)	2.20	2.20	2.20	3.1	279.7		
Particle Density (Mg/m ³)				3.7	308.5		
Cell Pressure (kPa)	160	320	640	4.4	331.9		
'Specimen Height' at start of Shearing Stage (mm)				5.0	349.6		
Membrane Thickness/Correction (mm/kPa)	0.30 / 0.50	0.30 / 0.61	0.30 / 0.67	5.6	361.7		
Rate of Strain (%/min)	1.95	1.95	1.95	6.2	367.5		
Corrected Deviator Stress (kPa)	371	530	728	6.9	369.8		
Undrained Shear Strength (kPa)	185	265	364	7.5	370.8		
Strain at Failure (%)	7.5	9.4	10.6	8.1	368.7		
Failure Zone Water Content (%)				8.7	524.8

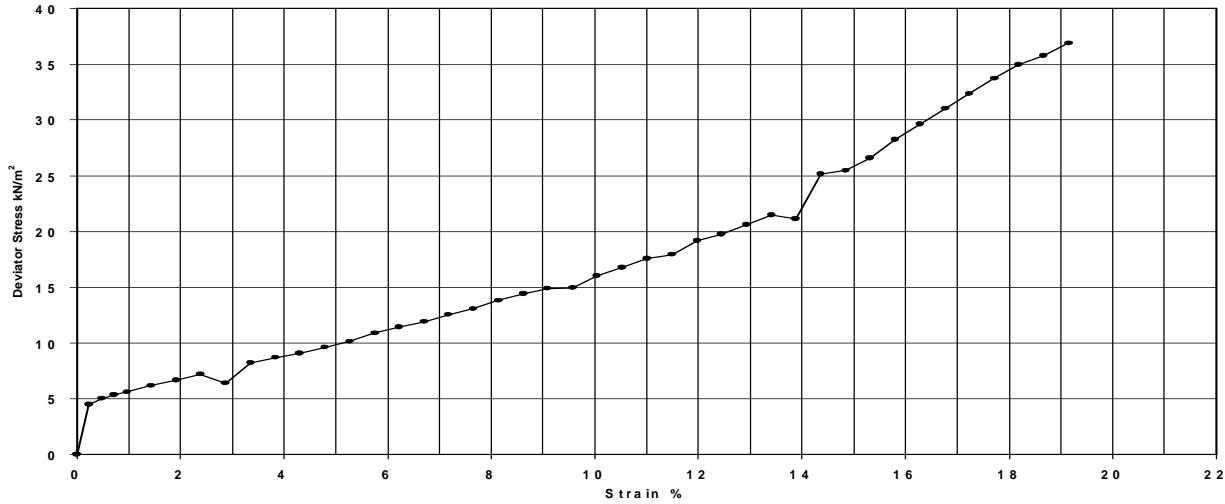
BS1377 Part 8 1990 : Clause 9.0

Stage 1	Stage 2	Stage 3	Strain %	Corrected Deviator Stress kN/m ²	Strain %	Corrected Deviator Stress kN/m ²
Sample Condition	Undisturbed			0.2	4.5	10.1	16.0
Orientation of sample	Vertical			0.5	5.0	10.5	16.8
Initial Diameter (mm)	104.81	104.81	104.81	0.7	5.4	11.0	17.5
Initial Length (mm)	208.86	208.86	208.86	1.0	5.6	11.5	18.0
Initial Water Content (%)	24.4	24.4	24.4	1.4	6.2	12.0	19.2
Initial Bulk Density (Mg/m ³)	2.12	2.12	2.12	1.9	6.7	12.4	19.7
Initial Dry Density (Mg/m ³)	1.70	1.70	1.70	2.4	7.2	12.9	20.6
Particle Density (Mg/m ³)				2.9	6.4	13.4	21.5
Cell Pressure (kPa)	40	80	160	3.4	8.2	13.9	21.1
'Specimen Height' at start of Shearing Stage (mm)				3.8	8.7	14.4	25.1
Membrane Thickness/Correction (mm/kPa)	0.30 / 0.82	0.30 / 1.03	0.30 /	4.3	9.1	14.8	25.5
Rate of Strain (%/min)	1.95	1.95	1.95	4.8	9.6	15.3	26.6
Corrected Deviator Stress (kPa)	21	37		5.3	10.2	15.8	28.3
Undrained Shear Strength (kPa)	11	18		5.7	10.9	16.3	29.6

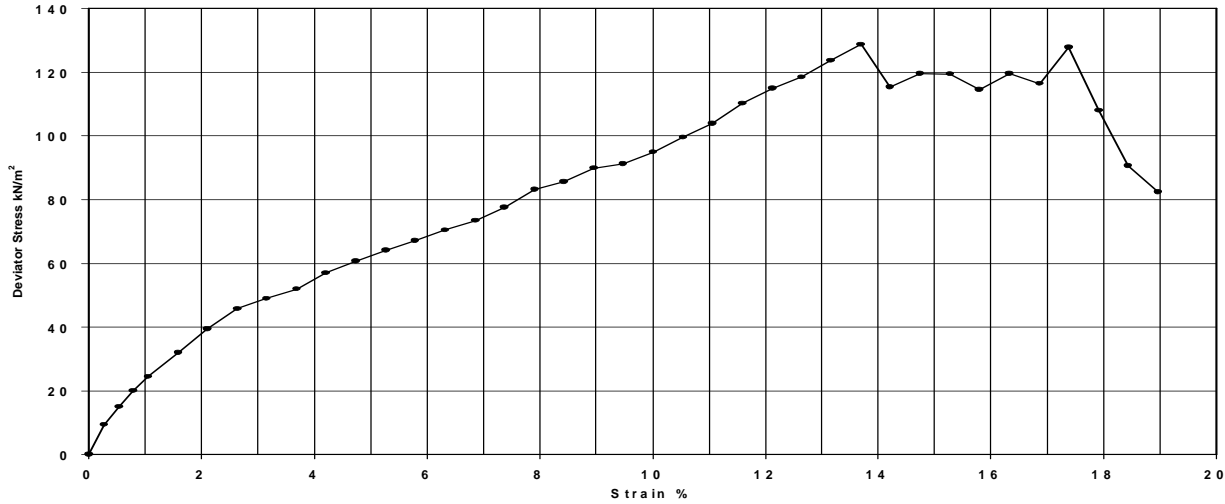
BS1377 Part 8 1990 : Clause 9.0

Stage 1	Stage 2	Stage 3	Strain %	Corrected Deviator Stress kN/m ²	Strain %	Corrected Deviator Stress kN/m ²
Sample Condition	Undisturbed			0.3	9.3	11.1	103.8
Orientation of sample	Vertical			0.5	14.9	11.6	110.2
Initial Diameter (mm)	104.85	104.85	104.85	0.8	20.0	12.1	115.0
Initial Length (mm)	189.82	189.82	189.82	1.1	24.4	12.6	118.5
Initial Water Content (%)	22.7	22.7	22.7	1.6	32.0	13.2	123.7
Initial Bulk Density (Mg/m ³)	2.08	2.08	2.08	2.1	39.4	13.7	128.8
Initial Dry Density (Mg/m ³)	1.70	1.70	1.70	2.6	45.7	14.2	115.4
Particle Density (Mg/m ³)				3.2	49.0	14.8	119.6
Cell Pressure (kPa)	50	100	200	3.7	52.0	15.3	119.5
'Specimen Height' at start of Shearing Stage (mm)				4.2	56.9	15.8	114.5
Membrane Thickness/Correction (mm/kPa)	0.30 / 0.82	0.30 / 0.92	0.30 / 0.92	4.7	60.8	16.3	119.6
Rate of Strain (%/min)	1.95	1.95	1.95	5.3	64.1	16.9	116.5
Corrected Deviator Stress (kPa)	129	120	128	5.8	67.2	17.4	127.9

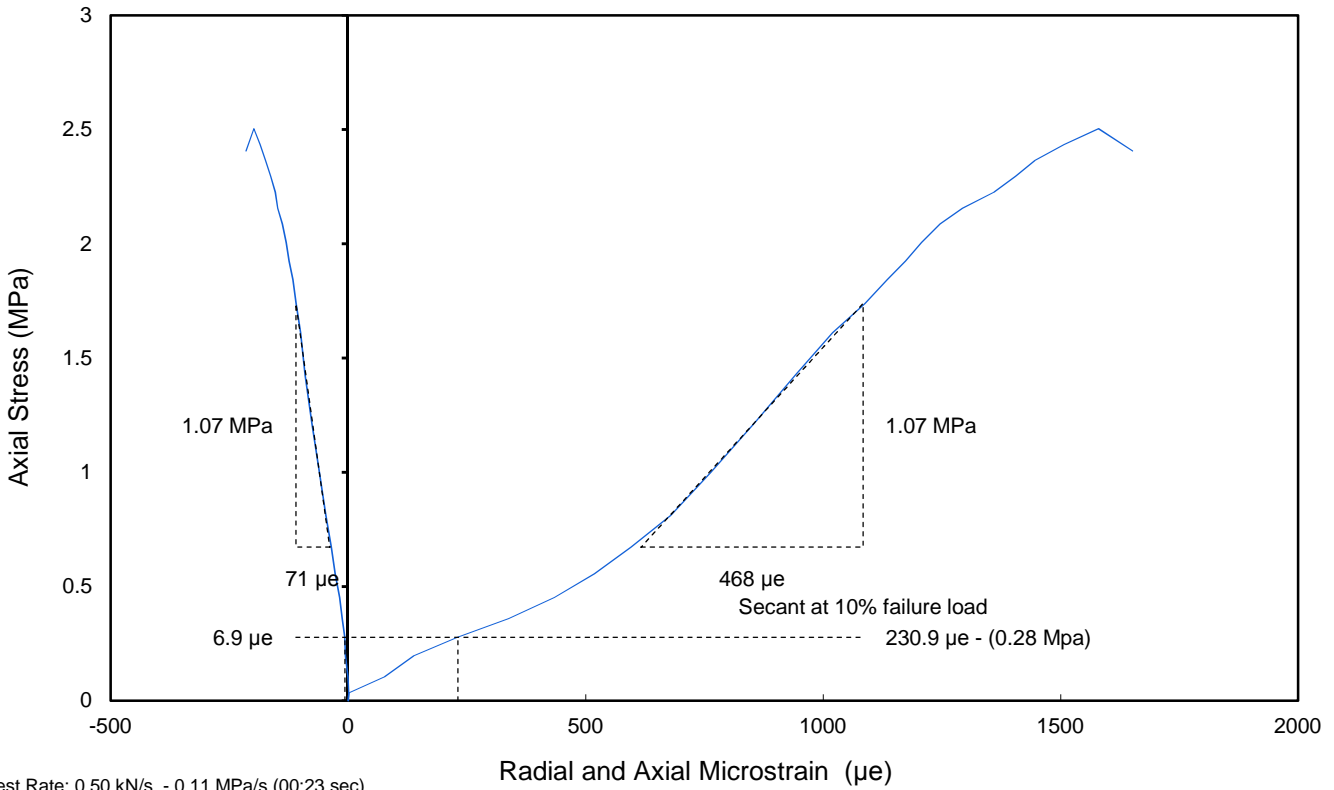
Unconfined Compressive Strength	2.5 MPa
Young's Modulus (tangential at 50% failure load)	2.28 GPa
Poisson's Ratio (tangential at 50% failure load)	0.15
Young's Modulus (secant at 10% failure load)	1.2 GPa
Poisson's Ratio (secant at 10% failure load)	0.03

Test Rate: 0.50 kN/s - 0.11 MPa/s (00:23 sec)

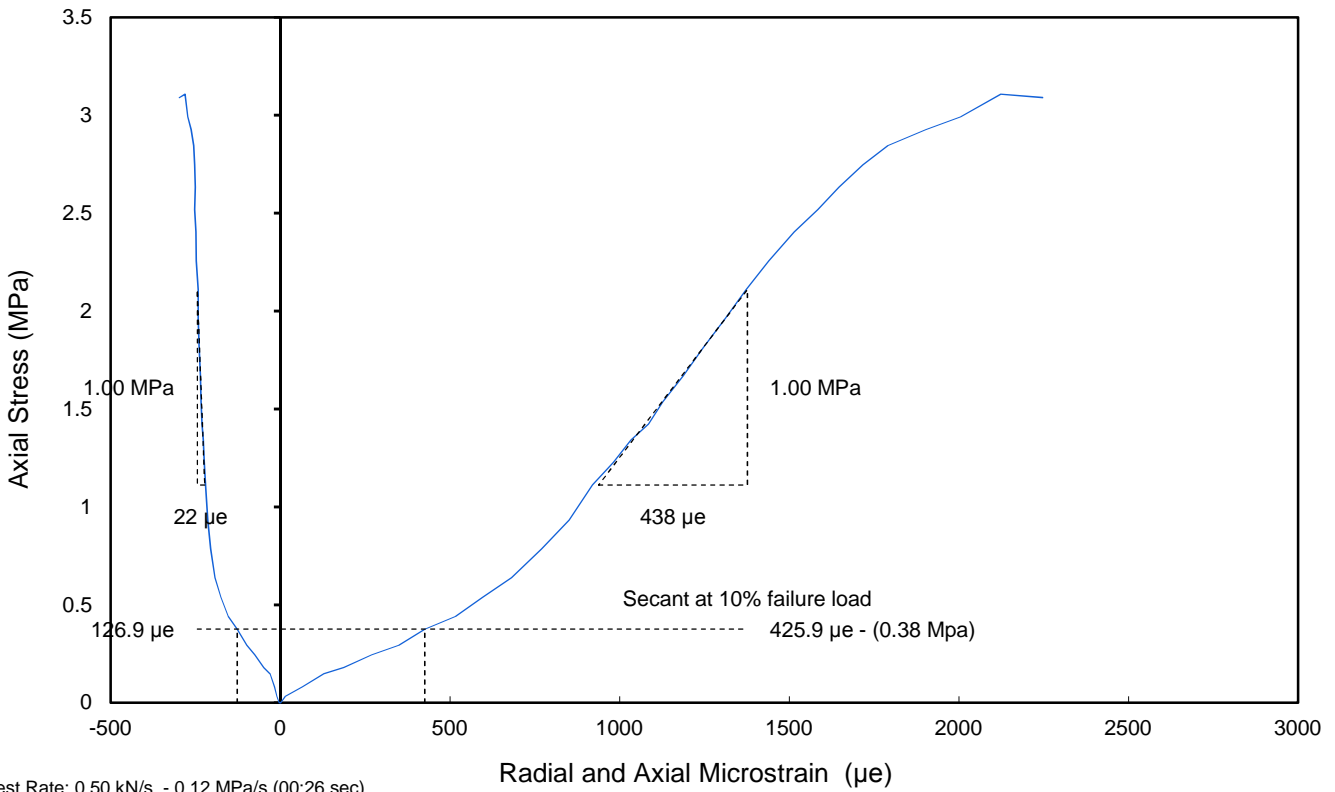
Unconfined Compressive Strength	3.11 MPa
Young's Modulus (tangential at 50% failure load)	2.28 GPa
Poisson's Ratio (tangential at 50% failure load)	0.05
Young's Modulus (secant at 10% failure load)	0.883 GPa
Poisson's Ratio (secant at 10% failure load)	0.30

Note: The dimensional requirements of Flatness (<0.02 mm), Perpendicularity (<0.05 / 50 mm) and Straightness (0.3 mm deviation) are not met.

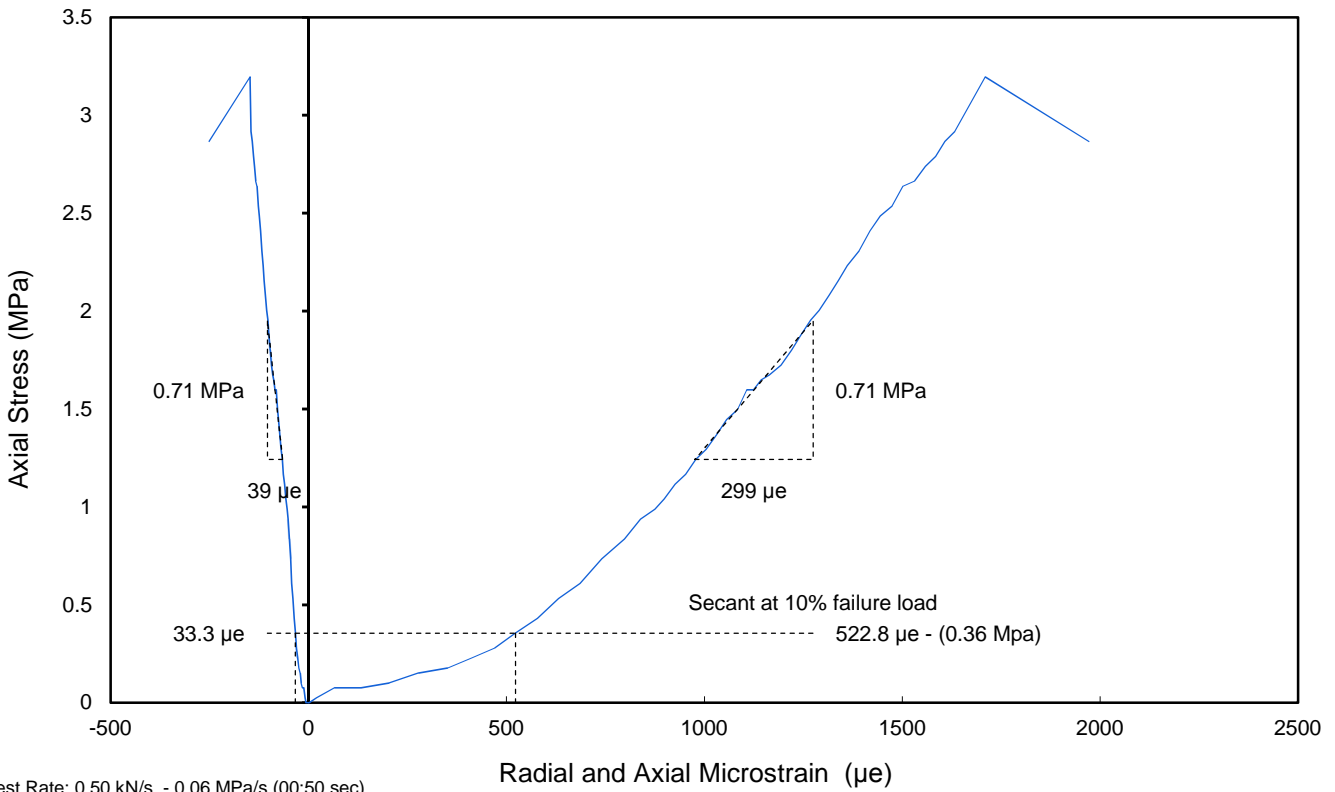
Unconfined Compressive Strength	3.2 MPa
Young's Modulus (tangential at 50% failure load)	2.38 GPa
Poisson's Ratio (tangential at 50% failure load)	0.13
Young's Modulus (secant at 10% failure load)	0.679 GPa
Poisson's Ratio (secant at 10% failure load)	0.06

Note: The dimensional requirements of Flatness (<0.02 mm), Perpendicularity (<0.05 / 50 mm) and Straightness (0.3 mm deviation) are not met.

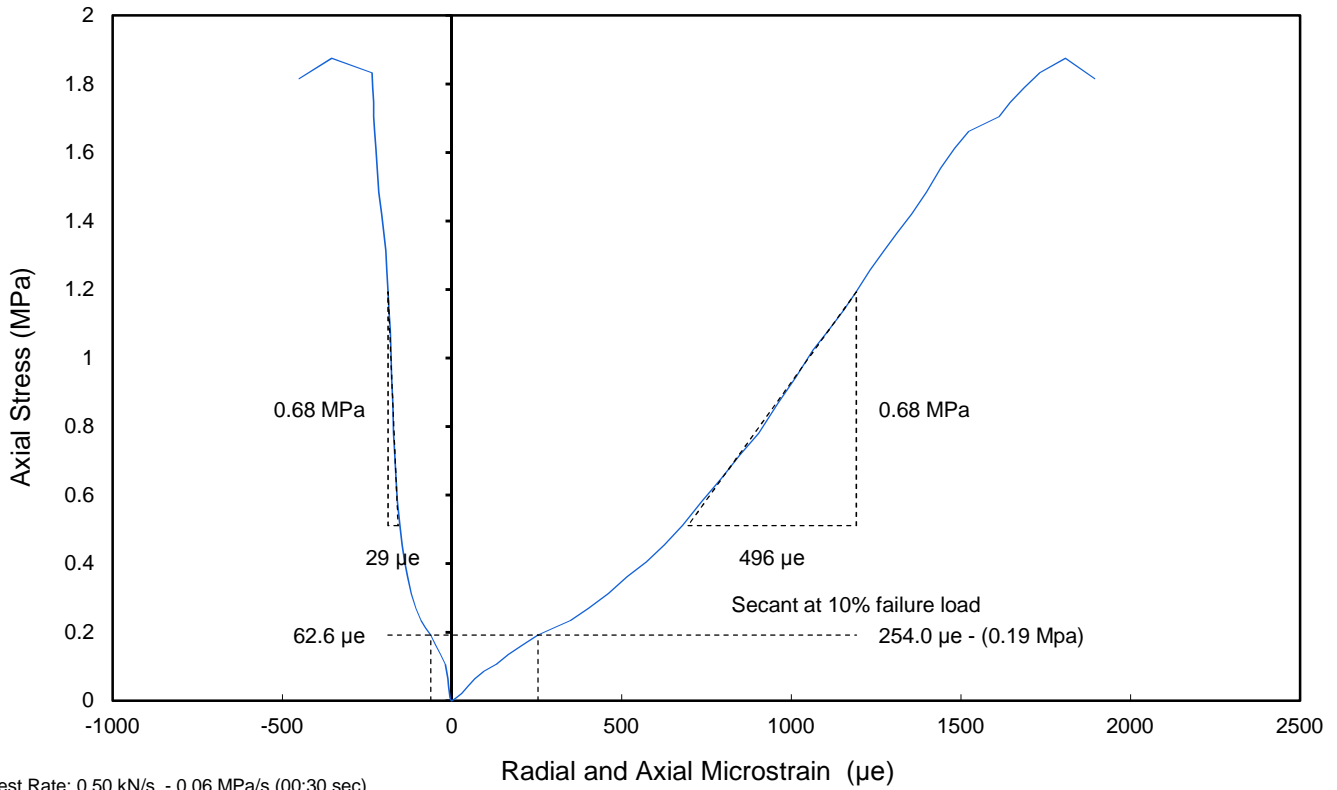
Unconfined Compressive Strength	1.87 MPa
Young's Modulus (tangential at 50% failure load)	1.37 GPa
Poisson's Ratio (tangential at 50% failure load)	0.06
Young's Modulus (secant at 10% failure load)	0.755 GPa
Poisson's Ratio (secant at 10% failure load)	0.25

Note: The dimensional requirements of Flatness (<0.02 mm), Perpendicularity (<0.05 / 50 mm) and Straightness (0.3 mm deviation) are not met.

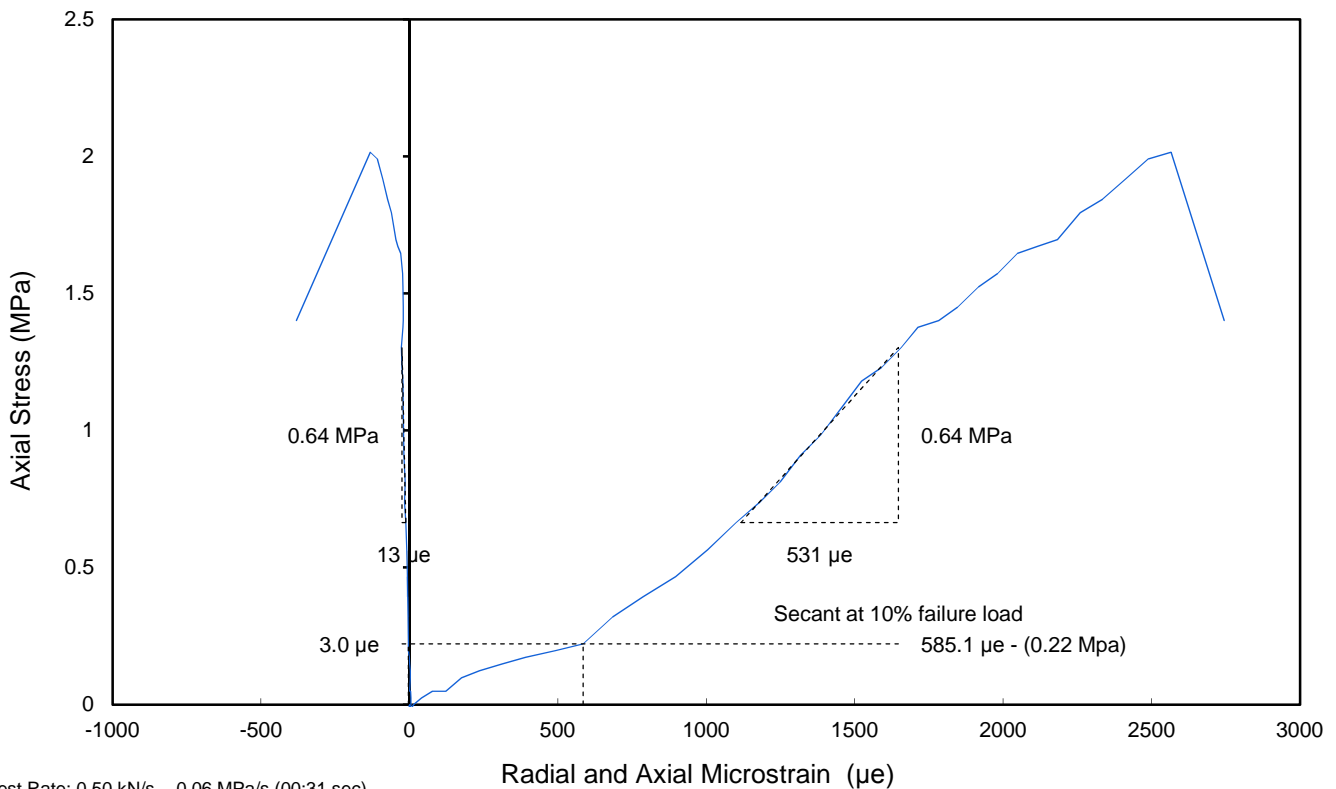
Remarks: Failed on weakness plane
