A30 Chiverton to Carland Cross Environmental Statement

**Volume 6 Document Ref 6.4 ES Appendix 8.16
Otter Survey Report**

A30 Carland Cross to Chiverton Cross Improvement Scheme

Report on otter surveys and proposed mitigation

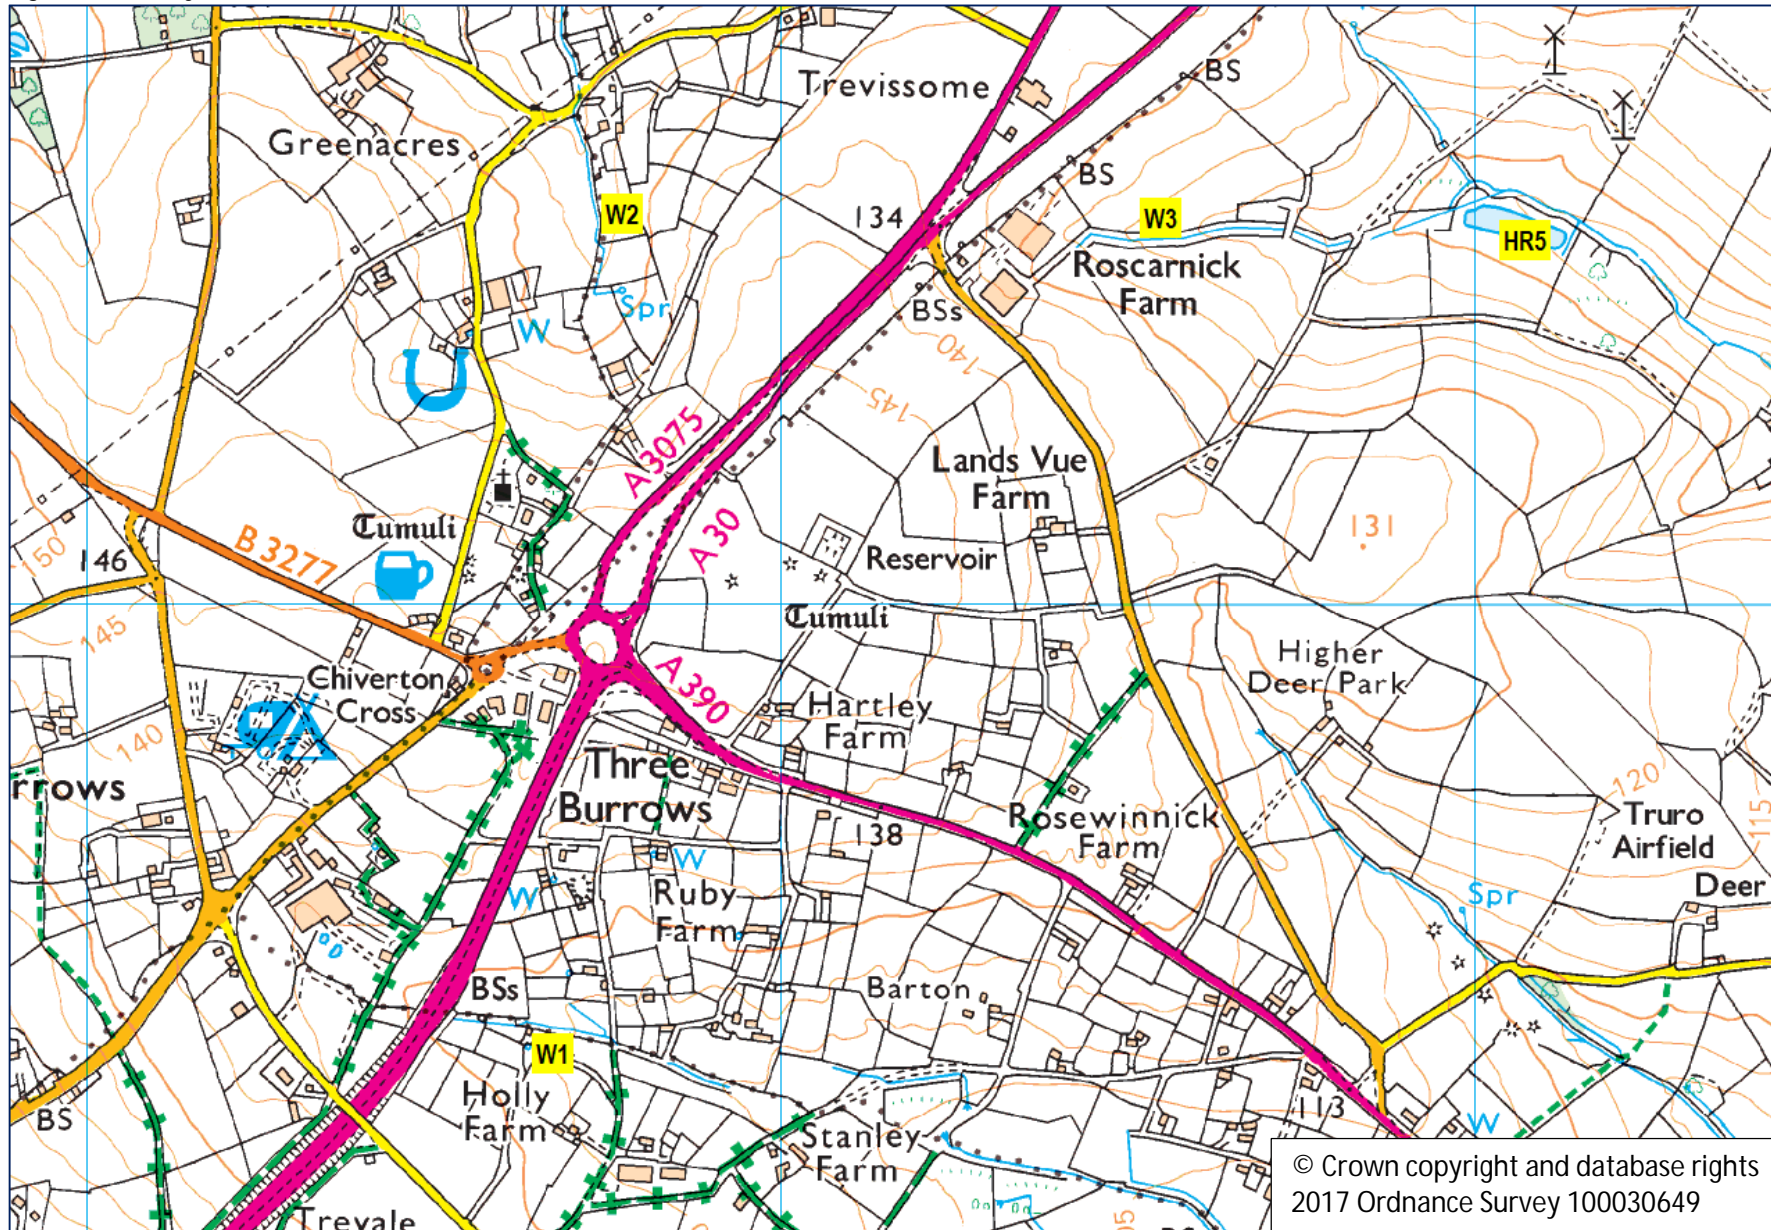
Figure 1. Survey Sites

Resting sites were numbered W1 – W15; grid references are listed in table 3 and maps showing the location of each are in Figures 1-5.

Potential breeding sites were numbered LR1 – LR7 and HR1 - HR5; grid references are listed in table 3 and maps showing the location of each are in Figures 1-5.

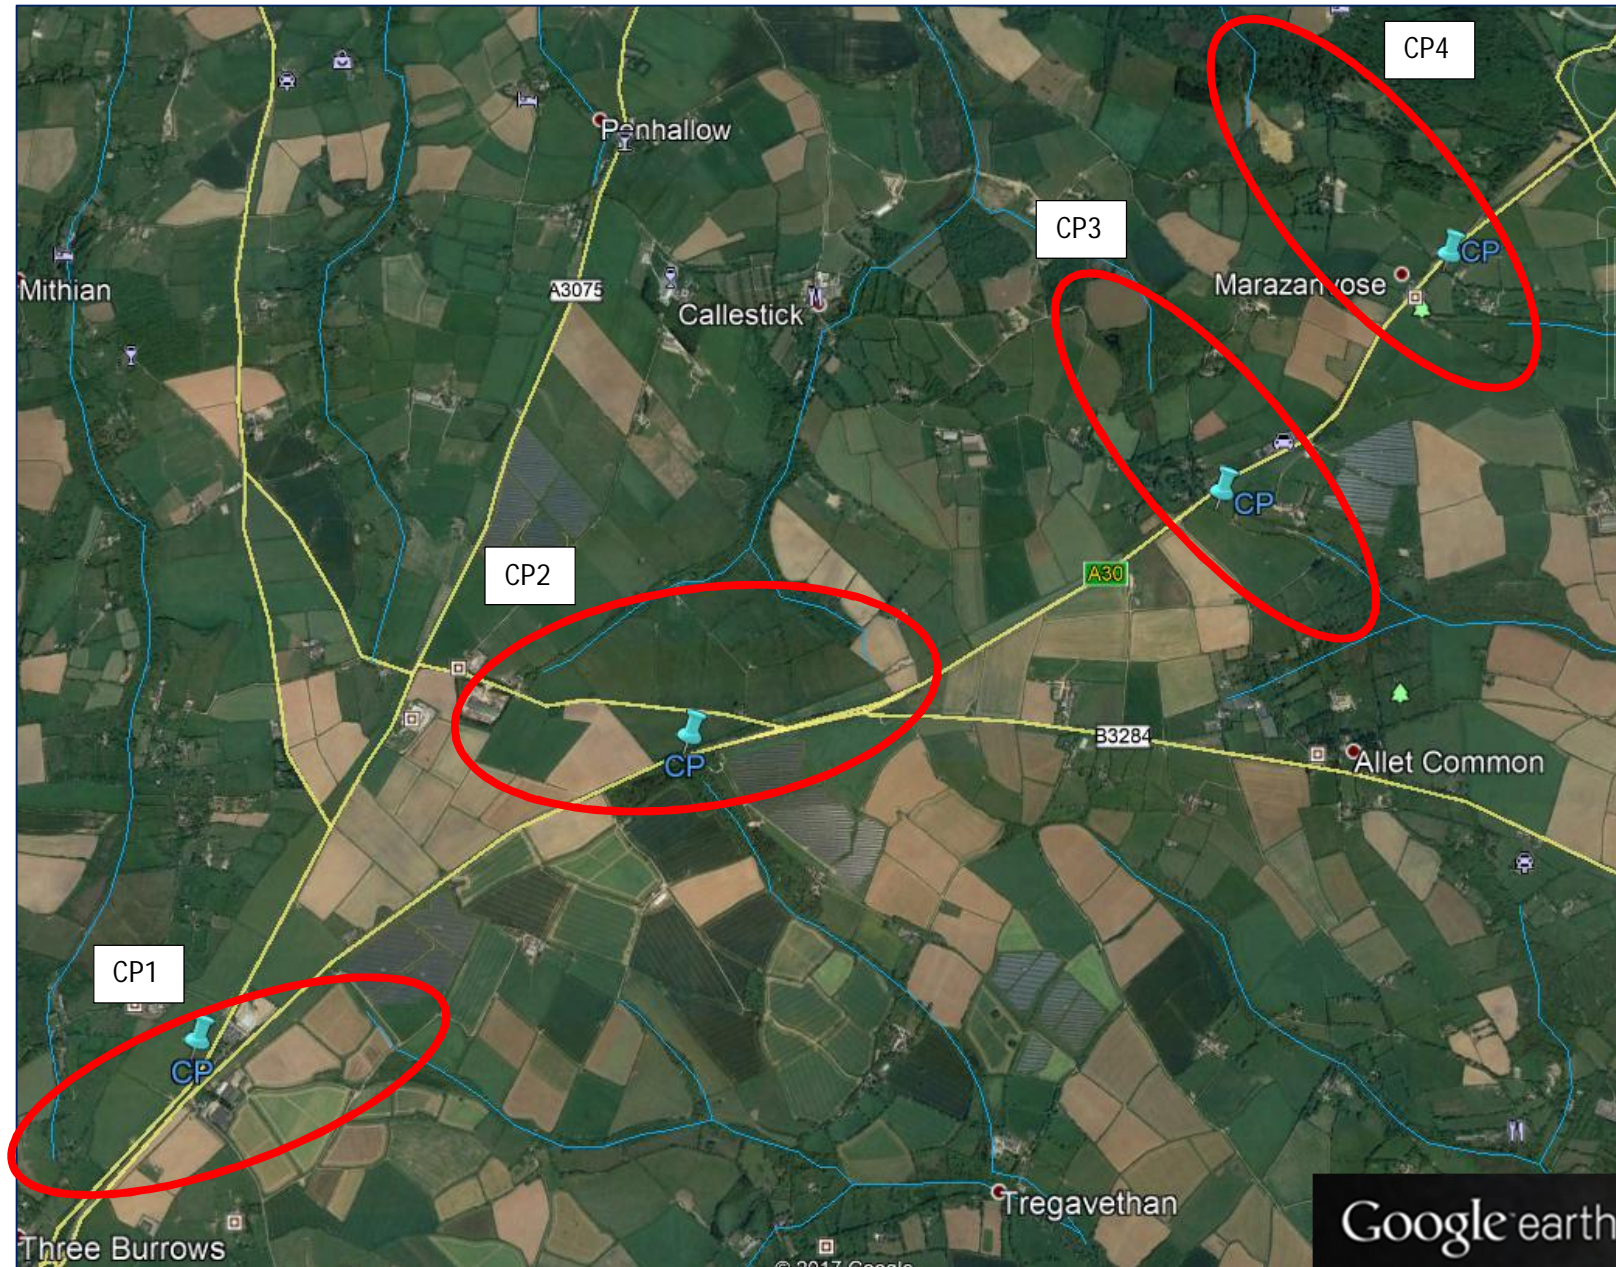
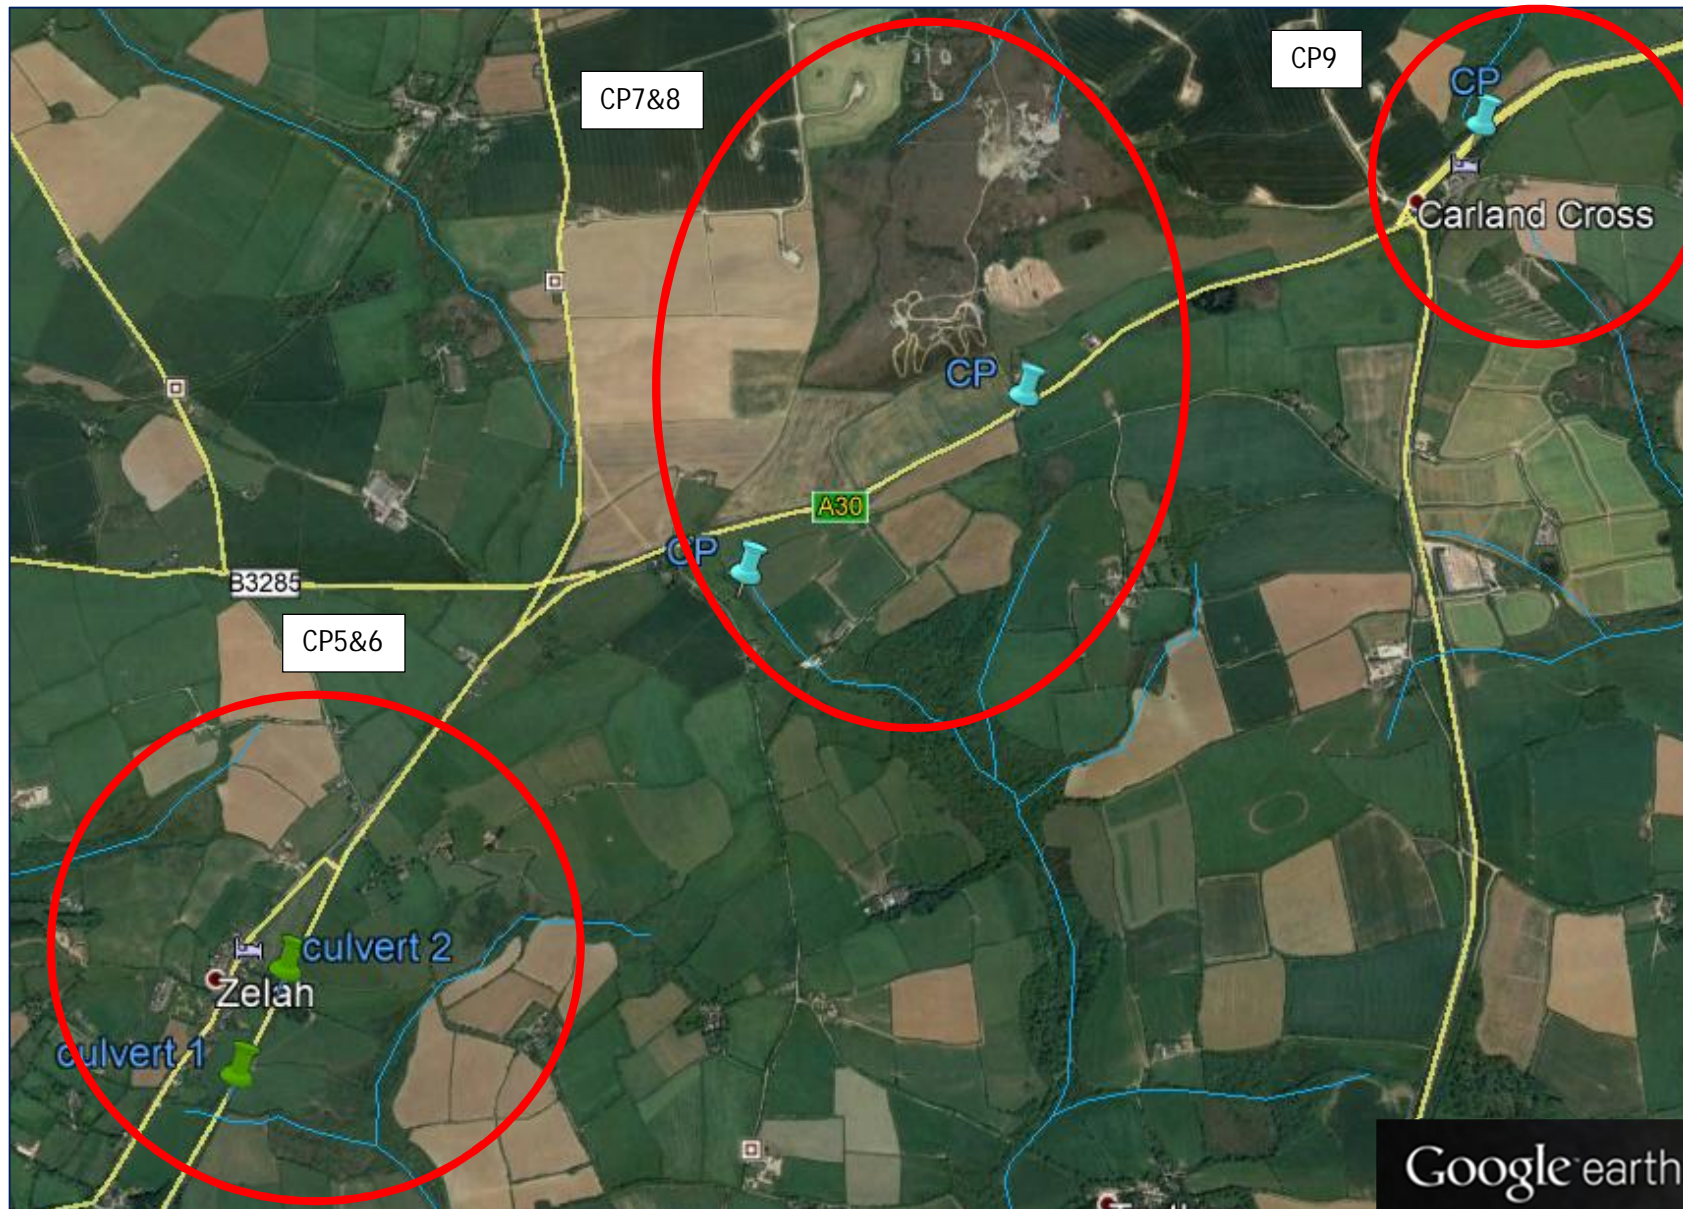
Location of Crossing Points in relation to watersheds

Maps in Appendix B show how sites selected for otter crossing points provide linkage across the watershed between catchments north and south of the proposed road.

The following maps show the locations of proposed crossing points and nearby headwater streams, illustrating how otters crossing between catchments north and south of the road will have a crossing point in the vicinity.
