A30 Chiverton to Carland Cross Improvement Scheme Environmental Statement

Volume 6 Document Ref 6.4 ES Appendix 8.19 Bat roost report

BAT ROOST REPORT

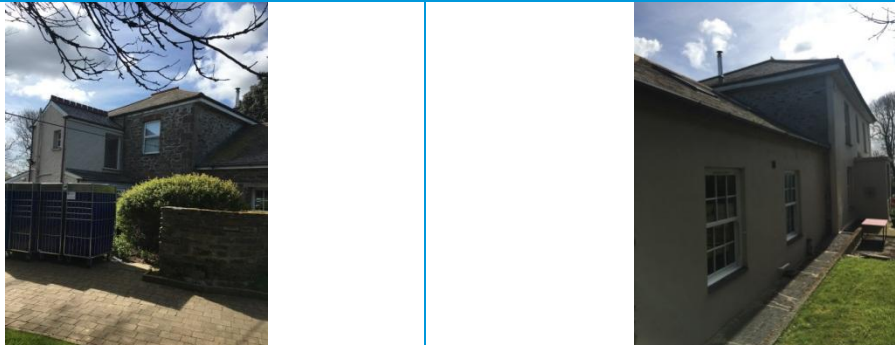
| BUILDING 1A | | | | | |
|--|---|--|--|---|--|
| Results | No Emergence / Re-entry | No Emergence / Re-entry | NA | | |

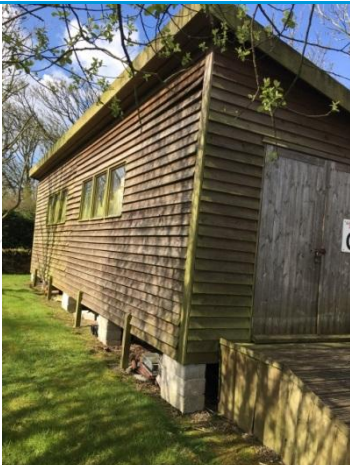
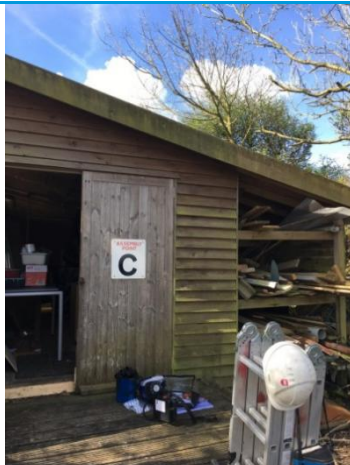
| BUILDING 1B | | | | | |

| BUILDING 1B | | | | | |
|---|---|--|---|--|---|
| Grid ref | SW 75338 47706 | | Final Potential | LOW | |
| Results | No Emergence / Re-entry | No Emergence / Re-entry | NA | | |

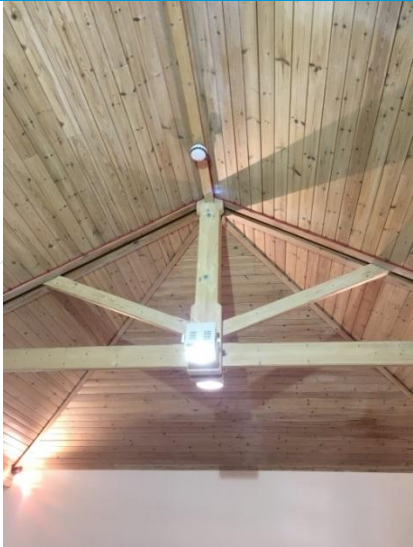
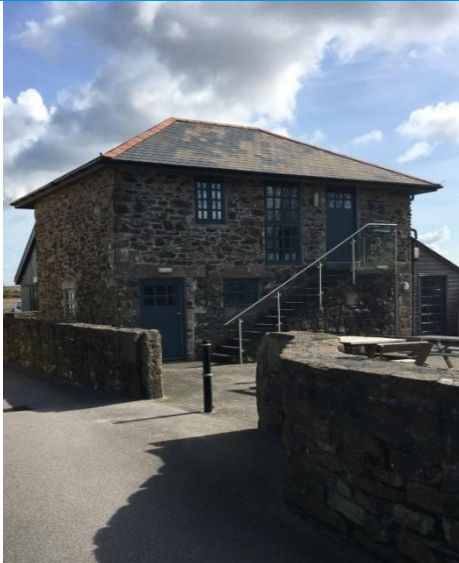
| BUILDING 1C | | | | | |

| BUILDING 1C | | | | | |
|---|--|---|---|---|---|
| Grid ref | SW 75353 47710 | Final Potential | NEGLIGIBLE | | |

| BUILDING 2 | | | | | |
|---|---|--|---|---|---|
| Results | No | No | NA | | |

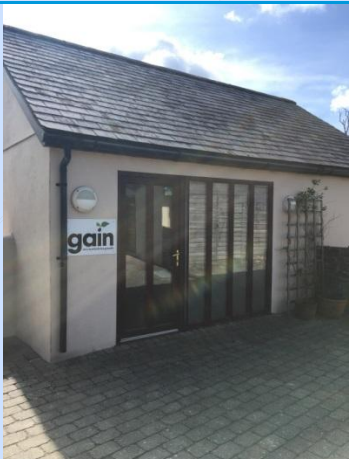
| BUILDING 3 | | | | | |

| BUILDING 3 | | | | | |
|---|---|---|---|--|--|
| Grid ref | SW 75376 47703 | Final Potential | LOW | | |
| Results | No emergence or re-entry. | NA | NA | | |

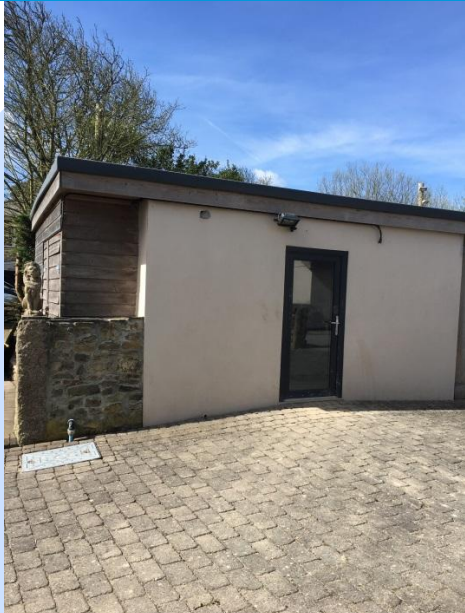
| BUILDING 3A | | | | | |

| BUILDING 3A | | | | | |
|---|---|---|---|---|---|
| Grid ref | SW 75391 47081 | | Final Potential | LOW | |
| Results | NA | NA | NA | | |

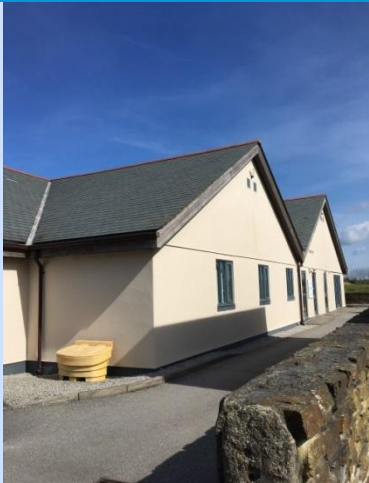
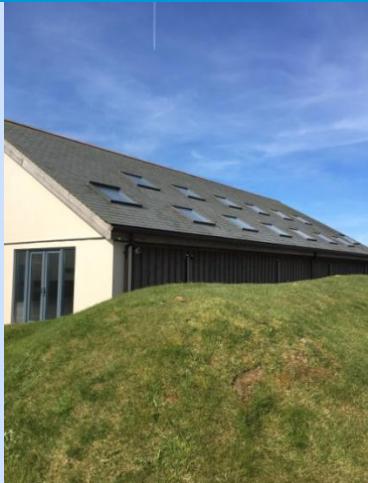
| BUILDING 3B | | | | | |

| BUILDING 3B | | | | | |
|---|--|---|---|---|---|
| Grid ref | SW 75391 47081 | Final Potential | NEGLIGIBLE | | |

| BUILDING 4 | | | | | |
|---|--|--|--|--|---|
| Results | No emergence or re-entry. | No emergence or re-entry. | NA | | |

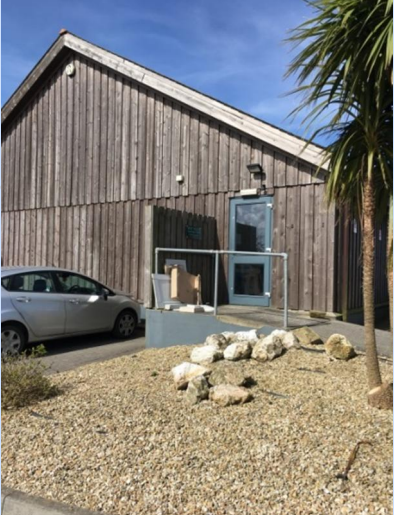
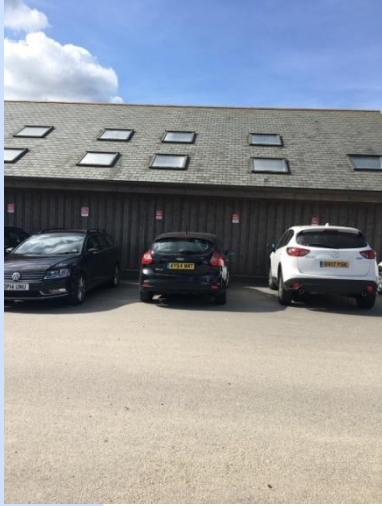
| BUILDING 5 | | | | | |

| BUILDING 5 | | | | | |
|---|---|---|--|---|--|
| Grid ref | SW 75395 47727 | | Final Potential | MODERATE | |
| Results | No emergence or re-entry. | No emergence/re-entry. | NA | | |

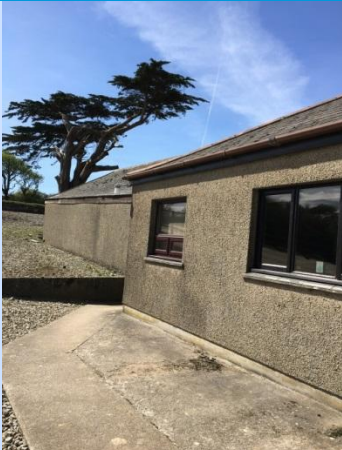
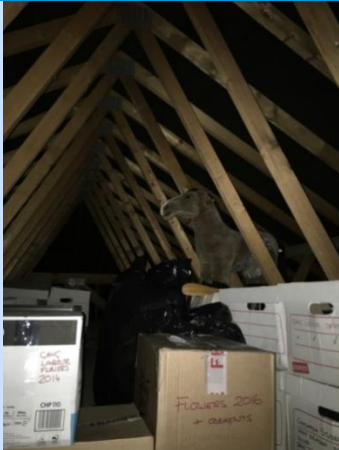
| BUILDING 6 | | | | | |

| BUILDING 6 | | | | | |
|---|--|---|---|---|---|
| Grid ref | SW 75275 47492 | | Final Potential | LOW | |

| BUILDING 6A and 6B | | | | | |
|---|---|--|--|--|--|
| Results | No emergence/ re-entry | NA | NA | | |

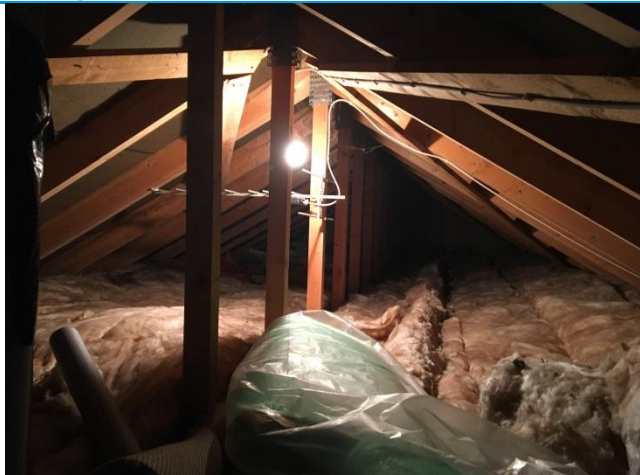
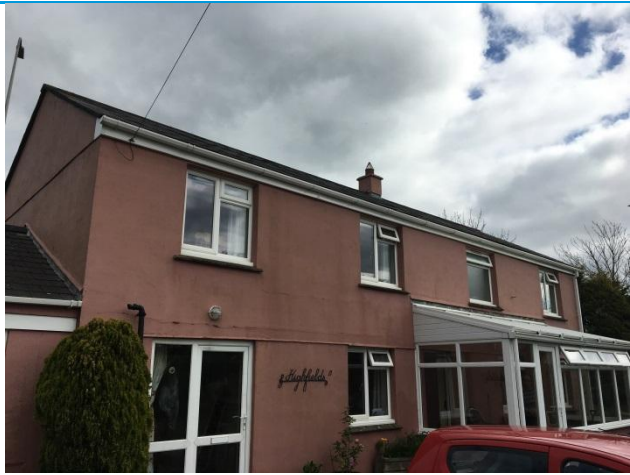
| BUILDING 7 | | | | | |

| BUILDING 7 | | | | | |
|---|---|---|--|--|--|
| Grid ref | SW 74848 46832 | | Final Potential | LOW | |
| Results | NA | NA | NA | | |

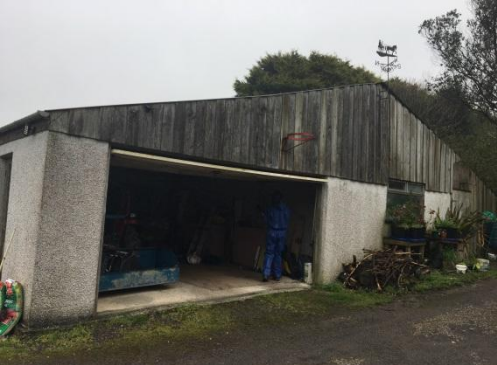
| BUILDING 11B | | | | | |

| BUILDING 11B | | | | | |
|---|---|---|---|---|---|
| Results | No emergence/ re-entry | NA | NA | | |

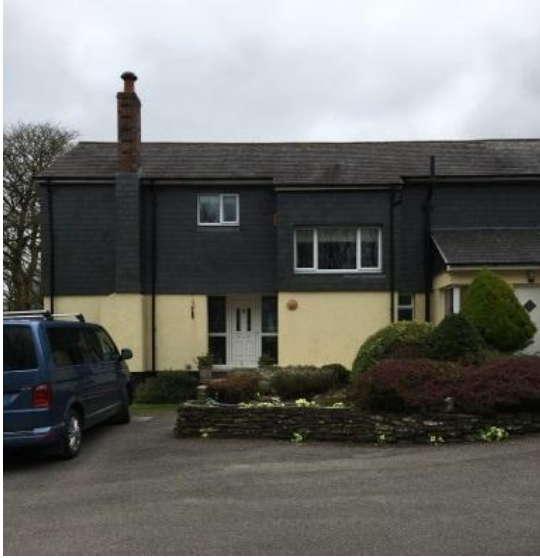
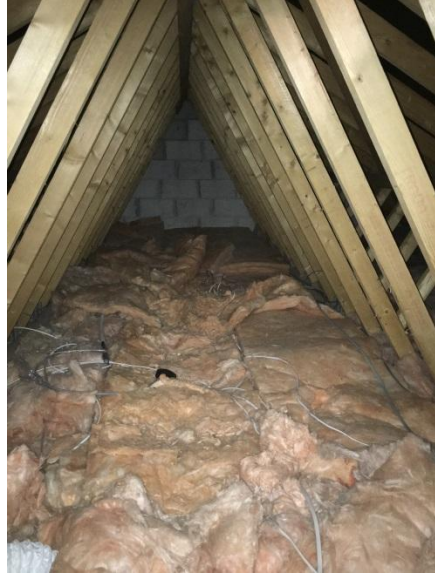
BUILDING 12

| BUILDING 12 | | | | | |
|---|--|---|--|---|---|
| | One area but in three parts. Bitumen felt lining. Used for storage. Garage area is open roof space apart from a few boards for storage. | No Data | King Post truss system in old roof section. Used for storage. Other areas are heavily trussed and so no access possible. | None | Droppings found in loft space - four distinct locations, one with a few hundred droppings, and each of the others with less than 100. |

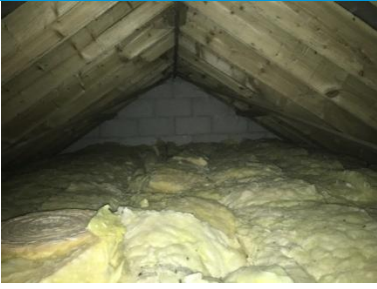
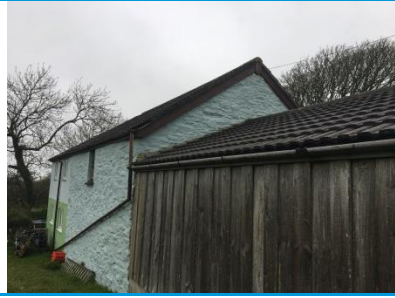
| BUILDING 13 | | | | | |

| BUILDING 13 | | | | | |
|---|--|--|--|--|--|
| | Dust free and clean and dark. Breeze suggests gaps under tiles. BRM present. | 8x5m Height of 1m Uncluttered | No truss just roof beams | Access point at ridge where it meets gable end | Many remains of feeding activity (wing remains) but could be caused by spiders. Rat / squirrel droppings present No bat evidence but suitable to support large numbers of bats. |
| Date | 26/07/2016 | 22/06/2017 | 20/07/2017 | Emergence and re-entries, at southern gable end. Continuous Ppip foraging activity recorded during the July 2016 and 2017 surveys.. Typical swarming behaviour was observed during the July 2016 and July 2017 surveys | NA |
| Results | Yes-5xPpip emergence | No emergence / re-entry | Yes-8xPpip re-entry (many false re-entries) | | |

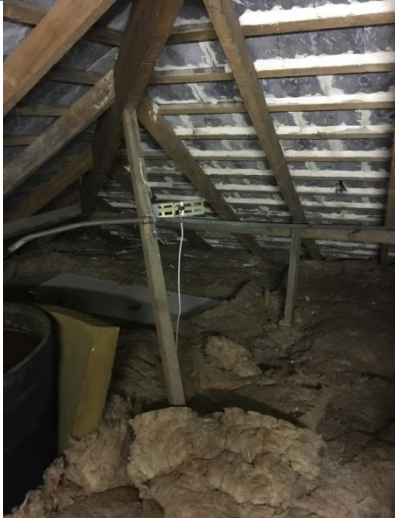
| BUILDING 14 | | | | | |

| BUILDING 14 | | | | | |
|---|--|---|---|--|---|
| Description | → Farm bungalow with pebble dashed walls, not very well maintained. → Garage also on site, ill-maintained damaged tin roof and open fronted | | | | |

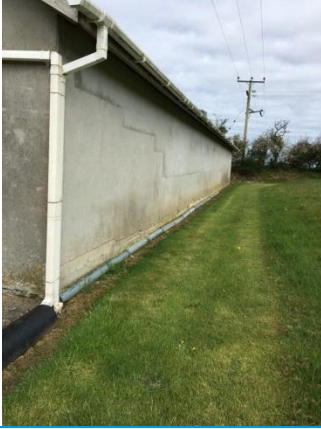
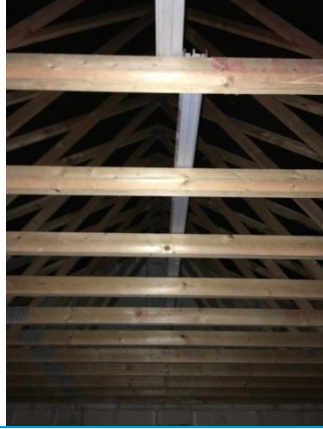
BUILDING 16A and 16B (Same building, two loft spaces)

| BUILDING 16A and 16B (Same building, two loft spaces) | | | | | |
|---|---|--|--|--|---|
| | Recently repaired trussed loft space. | 12x3x1m | Trussed | Gaps into wall traps. | When attic was being repaired, evidence of droppings in the below fascia but not present now. |

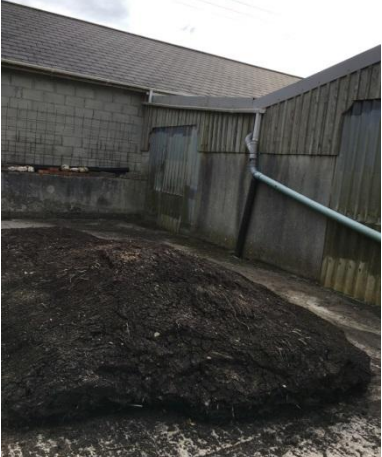
| BUILDING 16D | | | | | |
|---|---|---|---|--|--|
| | Old barn that is open fronted and has no loft void. | 10m x 25m | NA | Lots of gaps above wall tops. | Droppings found all over the site. <100. |

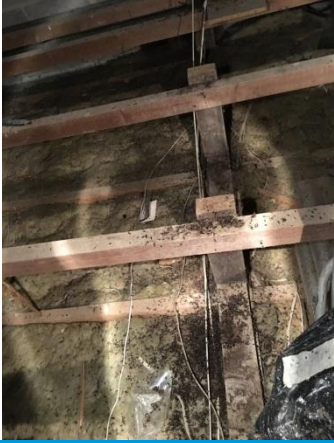
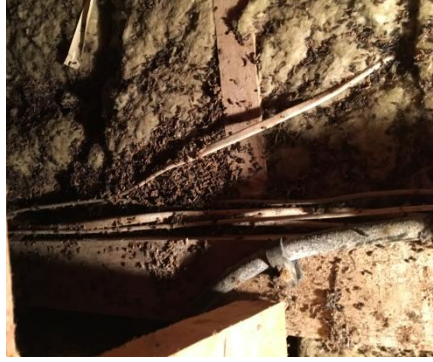
BUILDING 19

| BUILDING 19 | | | | | |
|---|---|--|---|--|--|
| | Pitched roof with gable ends, slate tiles & flat roof with slate tiles | Stone Barge boards and Soffit box | Wooden frame windows | Gaps behind badge boards and soffits. Facia has come loose creating gaps Some gaps in stone work | Wood, glass conservatory - corrugated plastic roof. |
| | Insulation present Bitumen roof felt Many holes noted in felt. | 7 x 15 x 2m (height) Uncluttered | Simple truss design | Access present under eaves at gable ends | Bat droppings (1000's) Dead Bat – brown long-eared (DNA analysed) Ppip sized droppings & larger droppings Droppings noted mainly underneath the wooden timbres Minimum of x2 species |

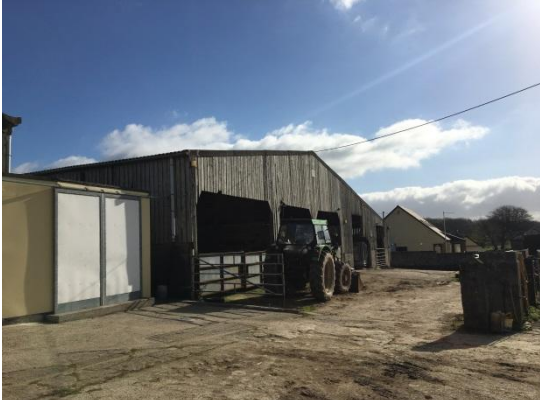
| BUILDING 22 | | | | | |
|---|---|---|--|--|--|
| | | | <p style="text-align: center;">Notes</p> <p>A common pipistrelle was recorded to fly into and out of the barn during the survey undertaken at Building 21 on 31/07/2017. The bat was not considered to be roosting, just flying within the large open barn.</p> | | |

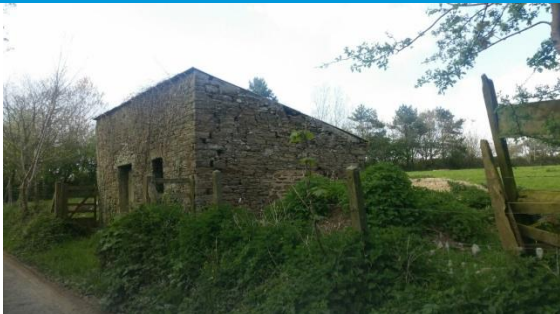
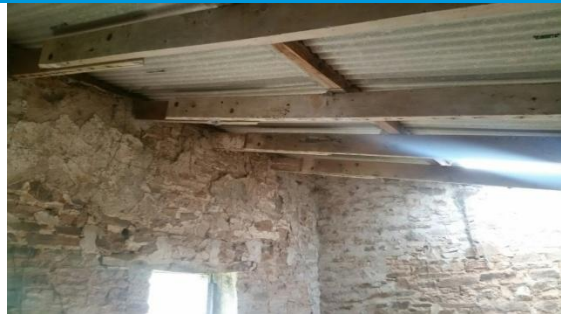
Photographs:- External of the building

| Results | No emergence/re-entry | No emergence/re-entry | 3x Ppip re-entered and 2 x Ppip emerged. 1 x Ppip re-entered and emerged | | |

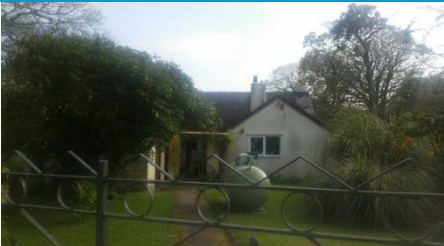
| BUILDING 36 | | | | | |

| BUILDING 36 | | | | | |
|---|---|--|--|---|---|
| Results | Ppip re-entry | Bat not echolocating re-entry. | 2 xPpip and 2 x not echolocating emerged | | |

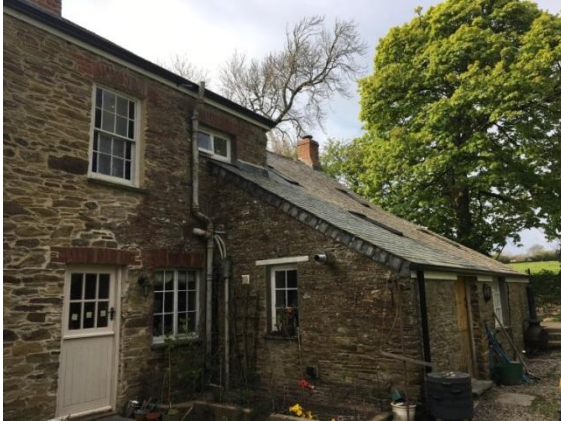
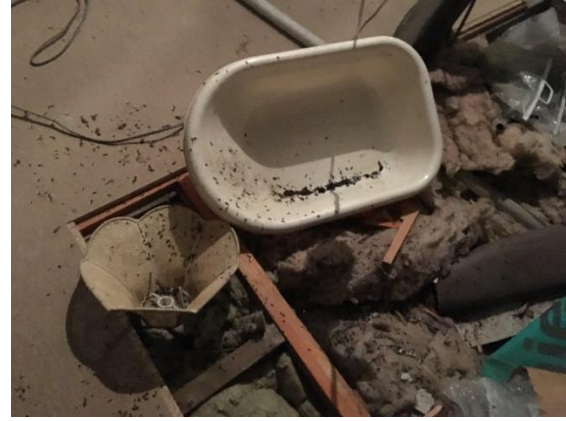
Photographs

| Results | ~10-19 Paur (maternity) in roof void ~14-20 Ppip (maternity) roof void by the porch behind guttering. Single <i>Myotis</i> re-entry. | NA | NA | | |

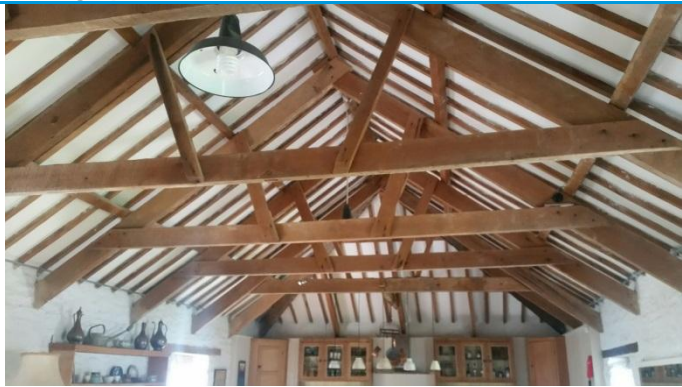
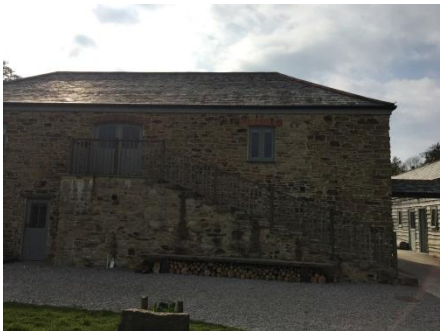
| BUILDING 40 | | | | | |

| BUILDING 40 | | | | | |
|---|--|---|--|--|---|
| Results | A total 11 Ppips recorded emerging from under the eaves. Two re-entries recorded. Roost of at least nine Ppip | NA | NA | | |

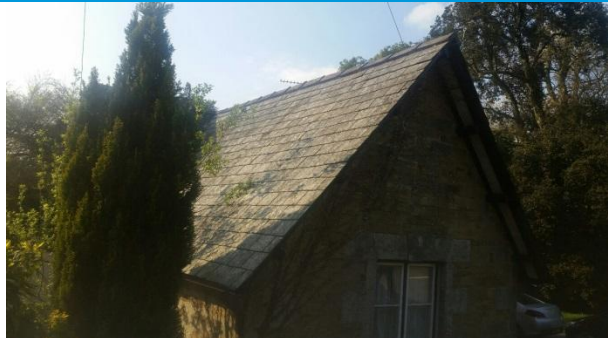
| BUILDING 42 | | | | | |
|---|--|--|--|---|--|
| Results | Ppip emergence | No emergence / re-entry | NA | | |

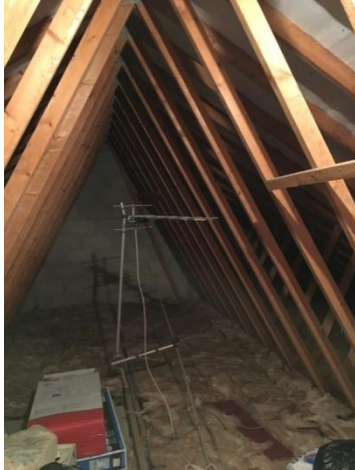
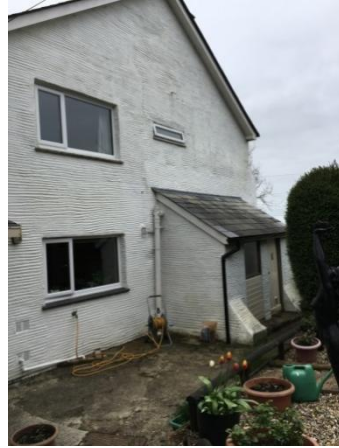
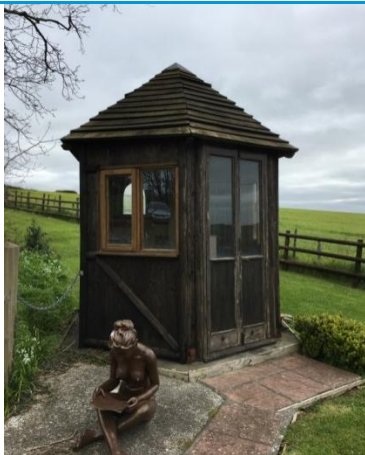
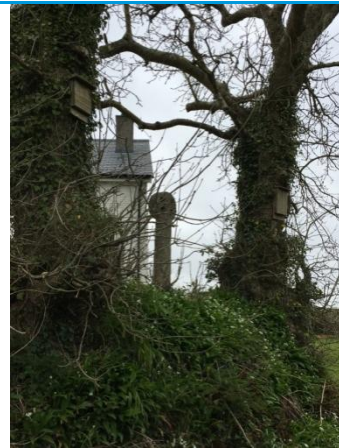
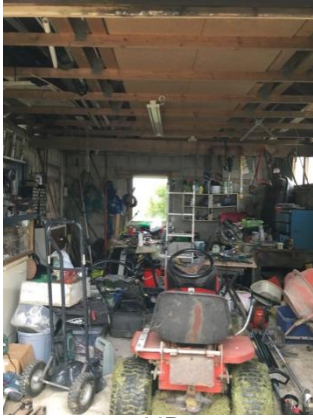
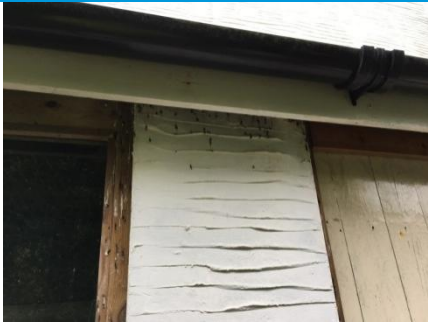
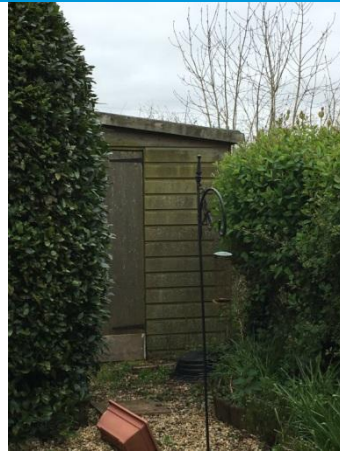
BUILDING 44A-G

| BUILDING 44A-G | | | | | |
|--|--|---|---|--|--|
| Description | <ul style="list-style-type: none"> → 44A: House-Confirmed roost: Day / transitional / occasional roost of brown long-eared bats and common pipistrelle. → 44B: Garage: Regularly used store, very cluttered an unable to fully inspect, no roof void, slate roof in good condition, considered negligible (did not undergo further surveys) → 44C: Lean-to space at top of wall under fascia where bats can get under (surveyed as part of the main house survey) → 44D: Wooden tool shed in good condition, with no evidence. Considered to have negligible condition (did not undergo further surveys) → 44E: Old well and wood store: well covered up, wooden door, asbestos present, considered to have negligible potential (did not undergo further surveys) → 44F: Old privy-no evidence, slipped tiles open to roof internally, no liner, ivy covered, low to moderate potential for crevice dwellers. → 2x bat boxes in ash trees (no droppings noted). Checked with torch at the beginning of each survey. → 44G: Summer house: 2 or 3 bats flew out when painted (incidental sighting by resident). Likely Ppip (according to resident) summer day roost. Wooden roof boards lifted and provided good crevice space. Could be fully surveyed using torch (checked at the beginning of each survey). | | | | |
| | 44A: No data | Stone walls | Side hung | Gaps noted along ridge beam | Bat boxes in trees |
| DNA Analysis | Positive 44A: Brown long-eared. 44C: Fail | | | | |

| <p>Results</p> | <p>Emergence of a single Paur from the main building 44A. Bat boxes checked with torch</p> | <p>No emergence/re-entry Bat boxes checked with torch.</p> | <p>Single Ppip emerged from the main building 44. A bat not echolocating emerged from the main building 44C.</p> | | |

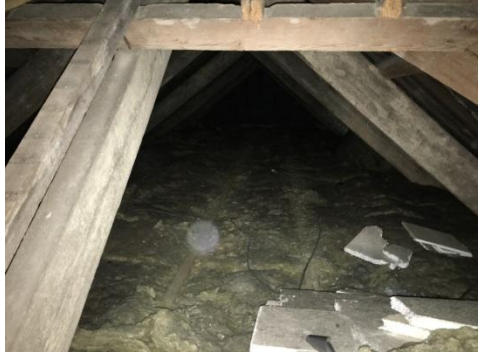
| BUILDING 45 / A / B | | | | | |
|---|--|--|--|---|--|
| | Complex hipped ridge building with a flat slate roof single storey extension | Stone No obvious crack / access point within the wall. The building has wooden fascia's. | Wooden frames, no gaps. | None recorded | NA |
| Results | No emergence / re-entry | NA | NA | | |

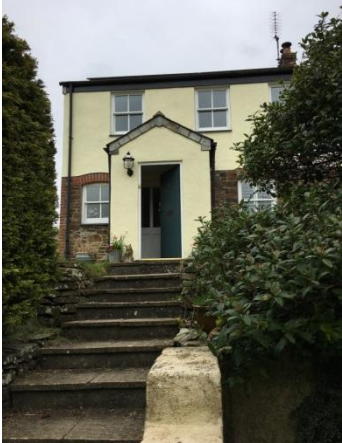
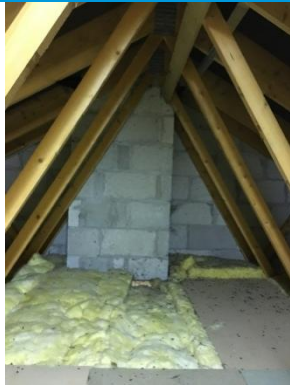
| BUILDING 47A-Main house | | | | | |

| BUILDING 47A-Main house | | | | | |
|---|--|---|--|--|---|
| Results | 3 x Ppip re-entry recorded | NA | NA | | |

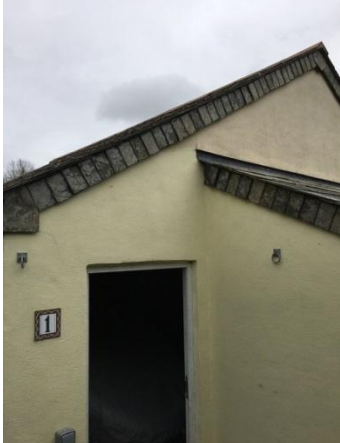
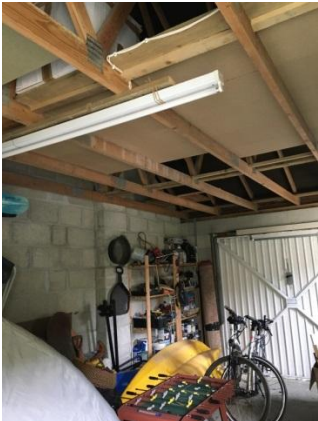
| BUILDING 47B-Garage | | | | | |

| BUILDING 47B-Garage | | | | | |
|---|---|---|--|---|---|
| Results | No emergence / re-entry | NA | NA | NA | NA |

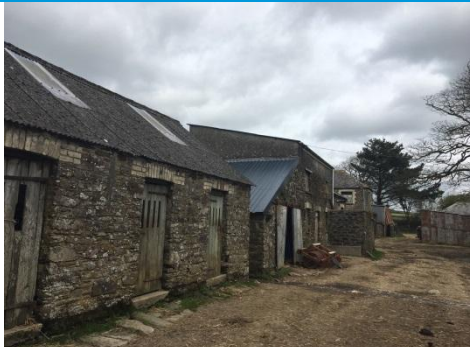
| BUILDING 55A | | | | | |
|---|---|--|---|--|---|
| Description | <ul style="list-style-type: none"> → Sheds were made from stone, with large access points and cracks leading into the wall voids. → Confirmed common pipistrelle day / transitional / occasional roost. → Scoped out due to distance from proposed Scheme. | | | | |
| Results | Re-entry of 2 Ppip on the building next door (part of same building). No re-entry for the surveyed building. | No emergence/re-entry | NA | | |

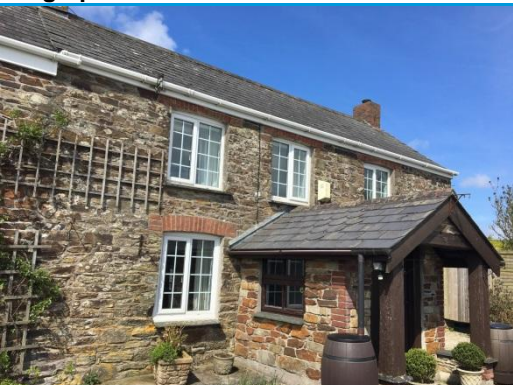
| BUILDING 56A and B (Same Building, two loft spaces) | | | | | |

| BUILDING 56A and B (Same Building, two loft spaces) | | | | | |
|---|---|--|--|--|---|
| Results | 2 Ppip re-entry | 1x Ppip emerged from porch, S elevation. | No emergence/re-entry | | |

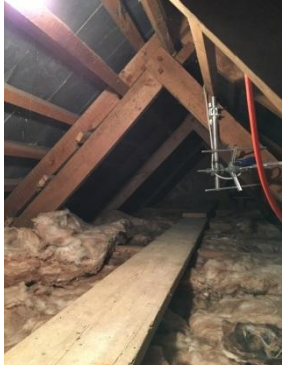
| BUILDING 57 | | | | | |

| BUILDING 57 | | | | | |
|---|--|---|--|--|---|
| Results | Individual Ppip re-entry recorded in the chimney of the building. | Individual Ppip re-entry recorded in the chimney of the building. | No bats were recorded emerging or re-entering the building. | | |

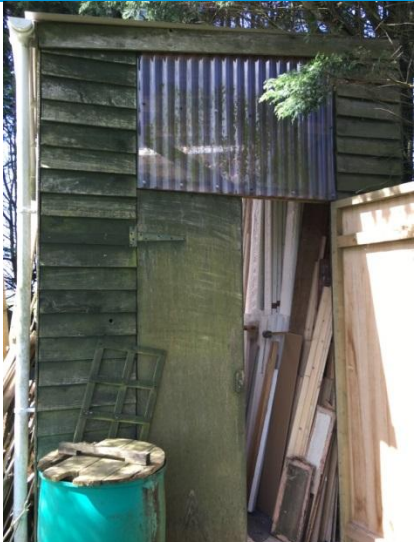
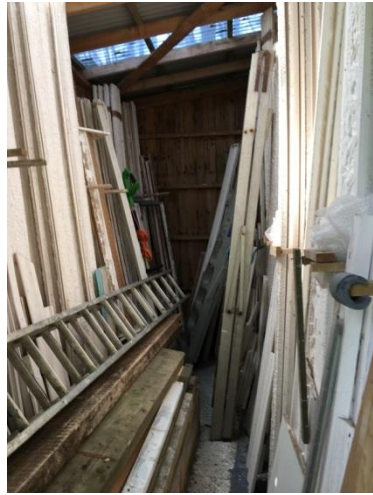
| BUILDING 57A & B | | | | | |

| BUILDING 57A & B | | | | | |
|---|--|---|--|---|---|
| Results | No bats were recorded emerging or re-entering the building. | No bats were recorded emerging or re-entering the building. | No bats were recorded emerging or re-entering the building. | | |

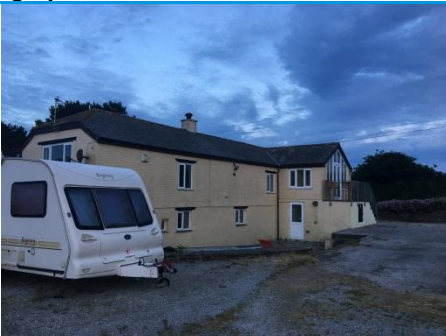
| BUILDING 64 | | | | | |
|---|---|--|---|---|---|
| Results | Possible re-entry of one unidentified bat (not echolocating). Possibly a brown long-eared bat. | 2x Ppips emerged from S elevation, under eaves over 2nd window from right side of house. | | | |
