# **A30 Chiverton to Carland Cross Environmental Statement**

**Volume 6 Document Ref 6.4 ES Appendix 8.4  
River Habitat Appraisal Report**

**HA551502-ARP-EBD-SW-RP-LE-000016**

**A30 River Habitat Appraisal**

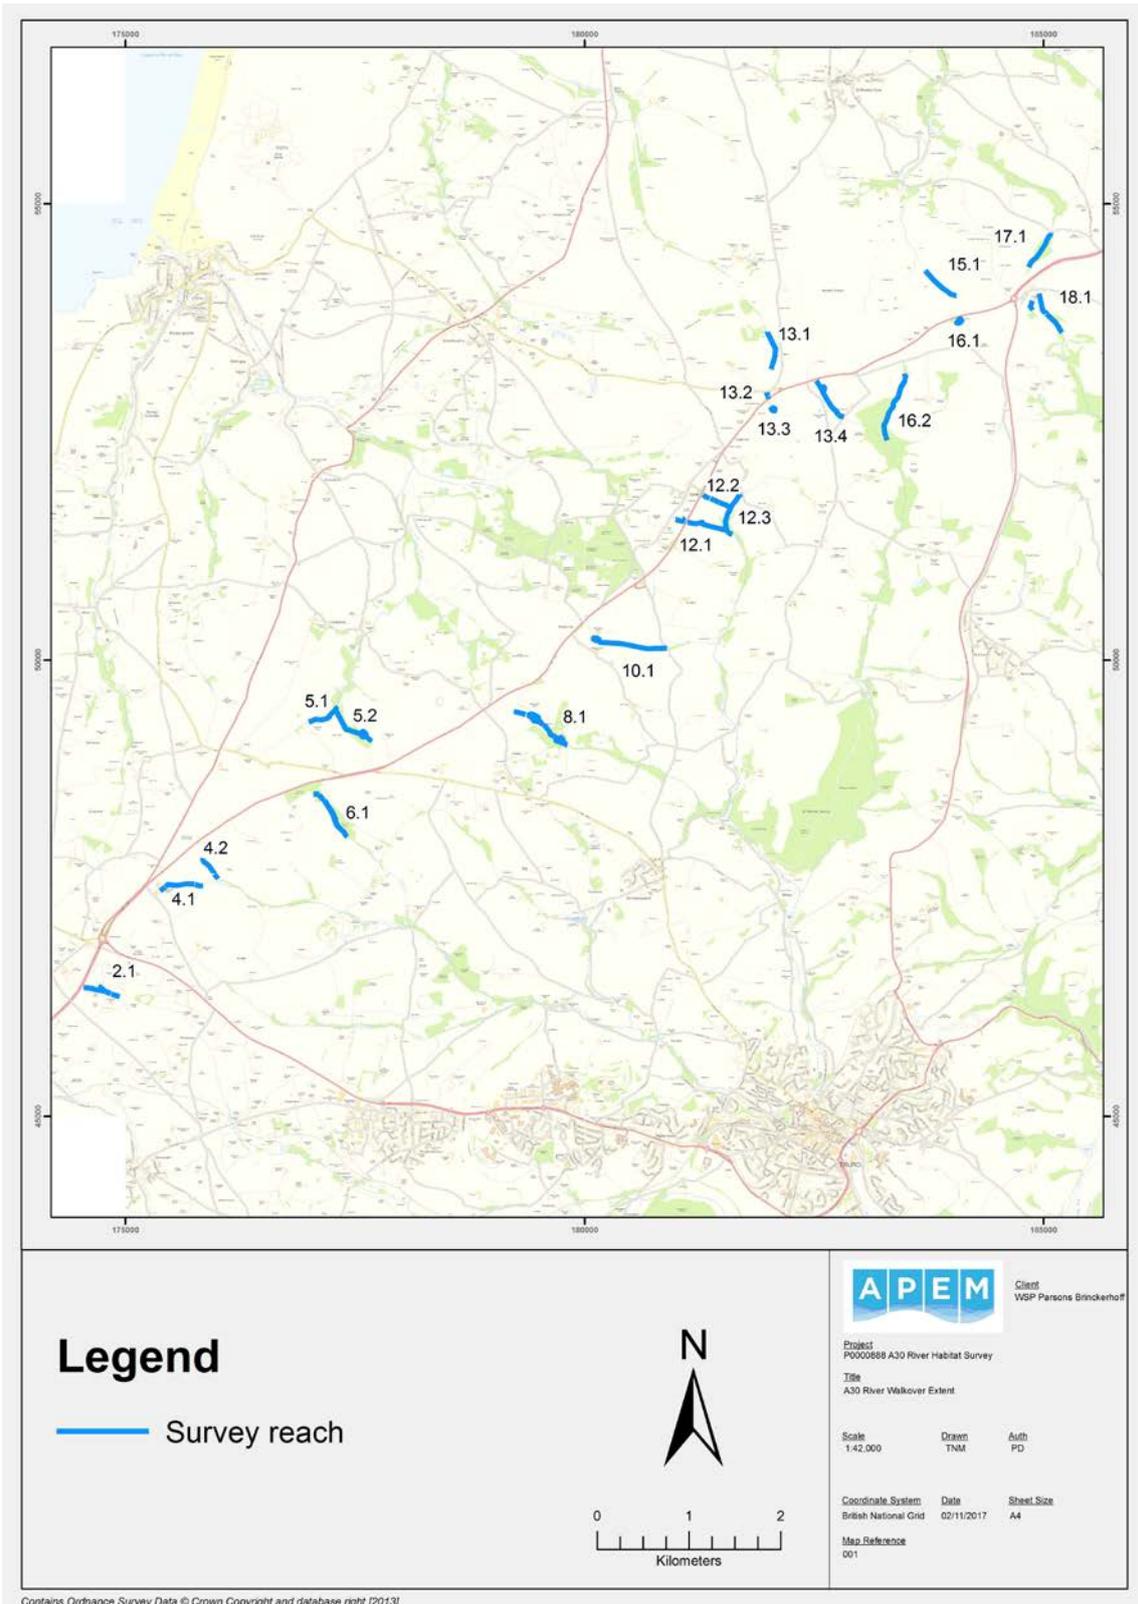
**Figure 2-1** The extent of the reaches covered by the habitat walkover survey (note 13.3 and 16.1 are stillwaters)

The walkover survey covered approximately 7.5 km of water courses that were within the vicinity of the proposed route options (Figure 2–1); all water courses, still waters and their tributaries within 100m of an option boundary (as visible on OS10k mapping) were included within the scope of the walkover. Of each watercourse identified, at least 500m was surveyed (survey reach), from the upstream extent. Figure 2–2 presents the location of the ponds surveyed.

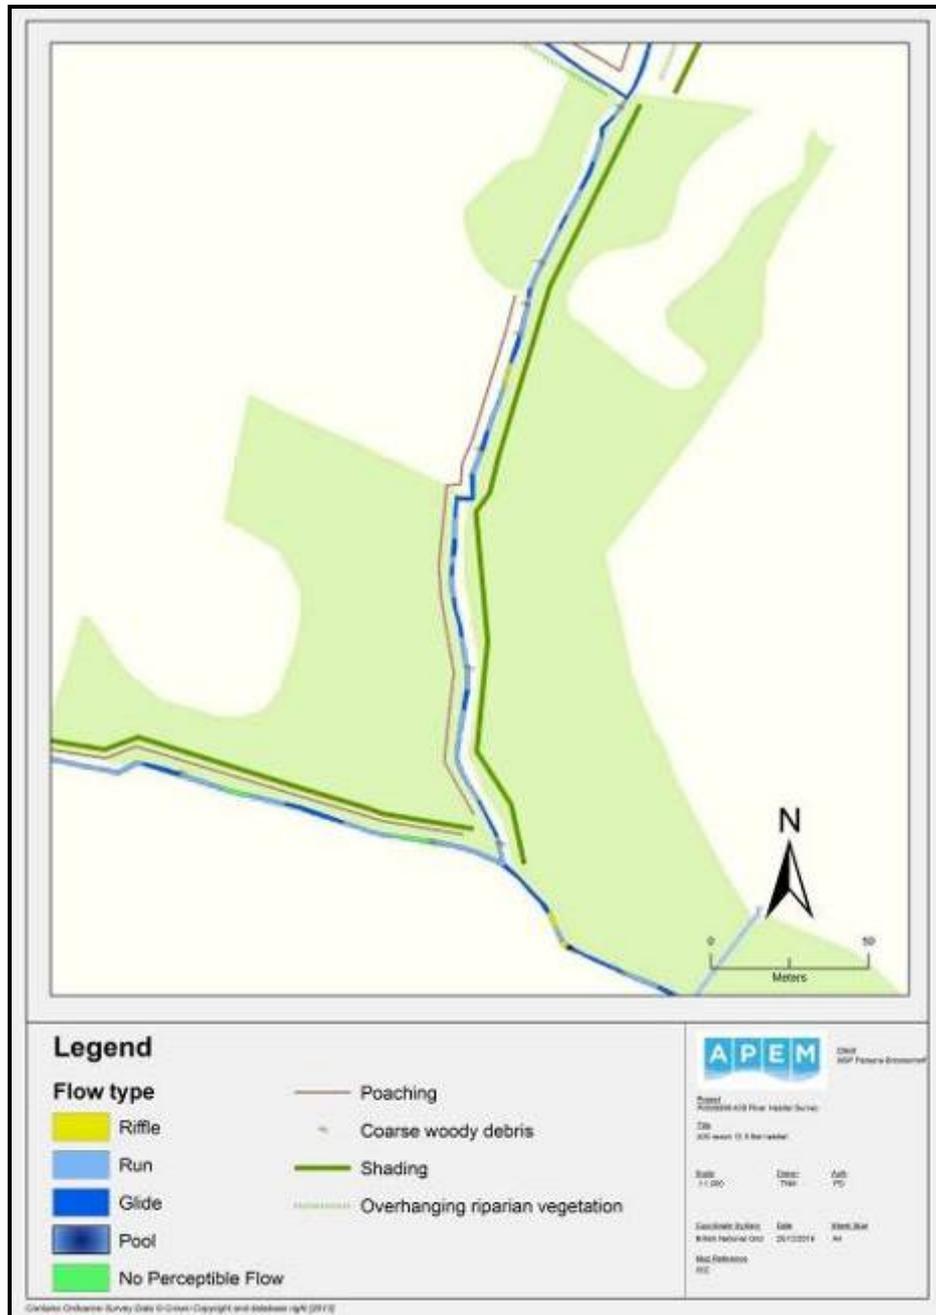
Figure 3–1 An example of the fish habitat mapping output.

There were 18 reaches in the survey area which may be impacted by the proposed works. Due to the independent and varied nature of each reach the findings of the walkover survey are discussed on a reach by reach basis below. An example of the GIS mapping of habitat is provided in Figure 3–1. The full extent of the habitat data will be provided in GIS format.

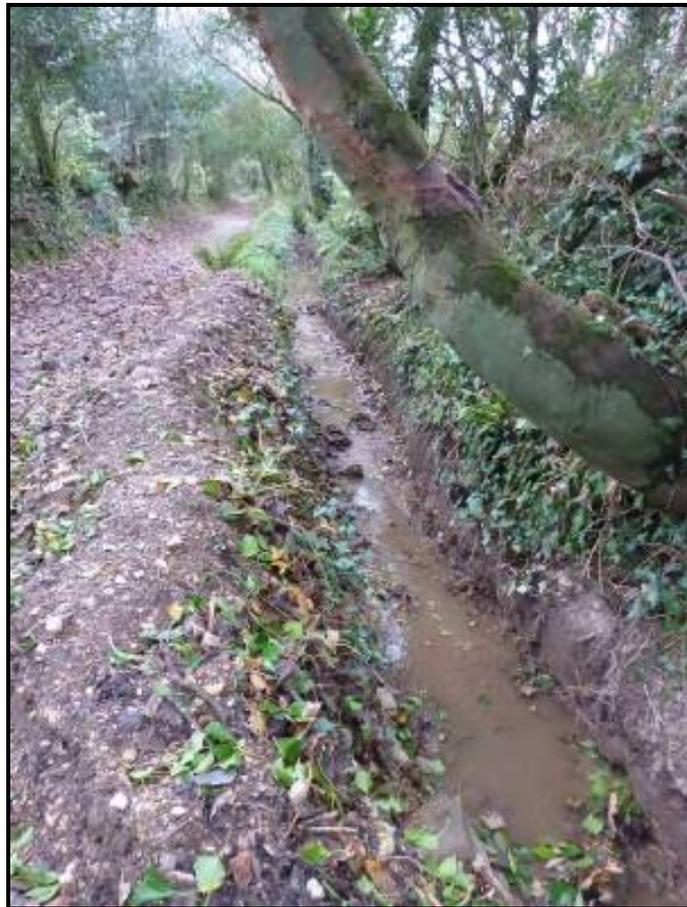
Reach 2.1 was approximately 400m in length and lies at the western extent of the survey area. The water on the day of the survey was very shallow (<5cm) and the channel was narrow (0.5m) throughout the reach walked. The substrate clast size was heterogeneous throughout and potentially suitable for juvenile salmonids and macroinvertebrates however, however a layer of fine sediment silt was observed throughout the reach. This siltation may be in part due to track runoff from the two road crossings. A short section had recently been dredged (Figure 3–2), which would have improved the flow, though would likely have suspended a significant amount of silt. Due to the size, the observed flow and the state of the substrate, this reach may support a population of small fish such as bullhead or stickleback and macroinvertebrates however; this would depend on connectivity downstream of the surveyed reach.

Figure 3–2 Reach 2.1 – Dredged section

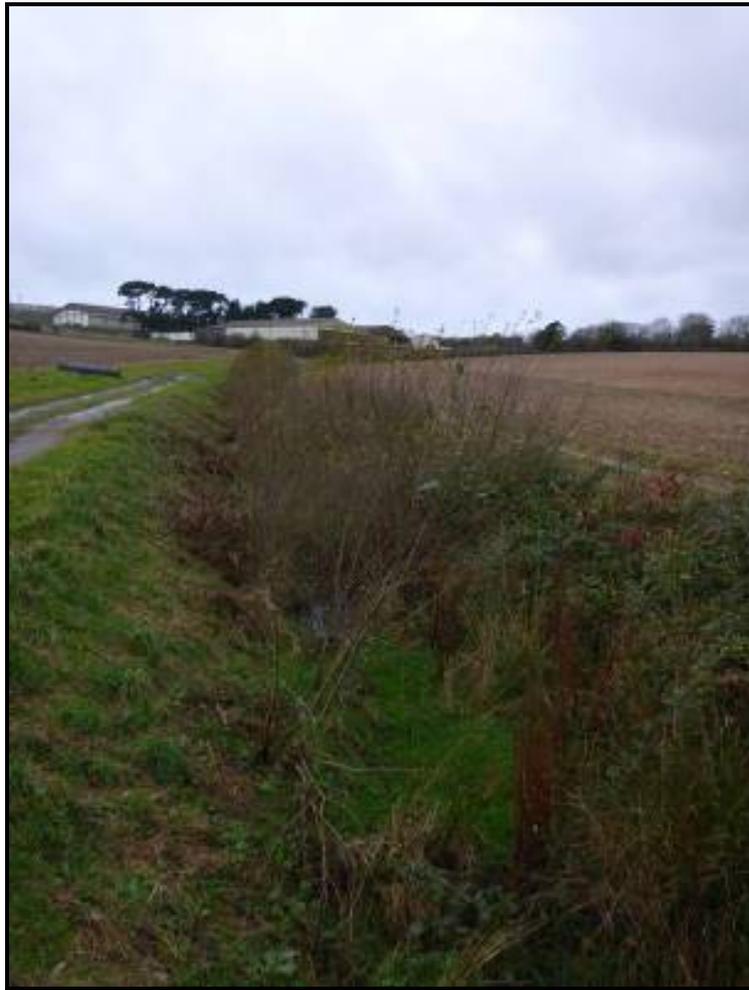
Reach 4.1 was 500m long and lies at the western end of the survey area. The stream was shallow with flow barely perceptible at the time of the walkover survey. The channel was dry at the upstream extent at the time of survey, with ponding further down, eventually turning into a slowly flowing run and glide. The substrate was silted throughout, potentially due to arable runoff from surrounding farm land. The channel has been modified to act as a farm drain with re-profiled banks evident along the reach (Figure 3–3). The channel was inundated by dense vegetation cover; particularly towards the downstream end of the reach. Reach 4.1 is very unlikely to support fish or significant macroinvertebrate populations with presence of conservation species thought to be particularly improbable due to the lack of habitat and the ephemeral nature of the flow in the area.

Figure 3–3 Reach 4,1 –Modified channel

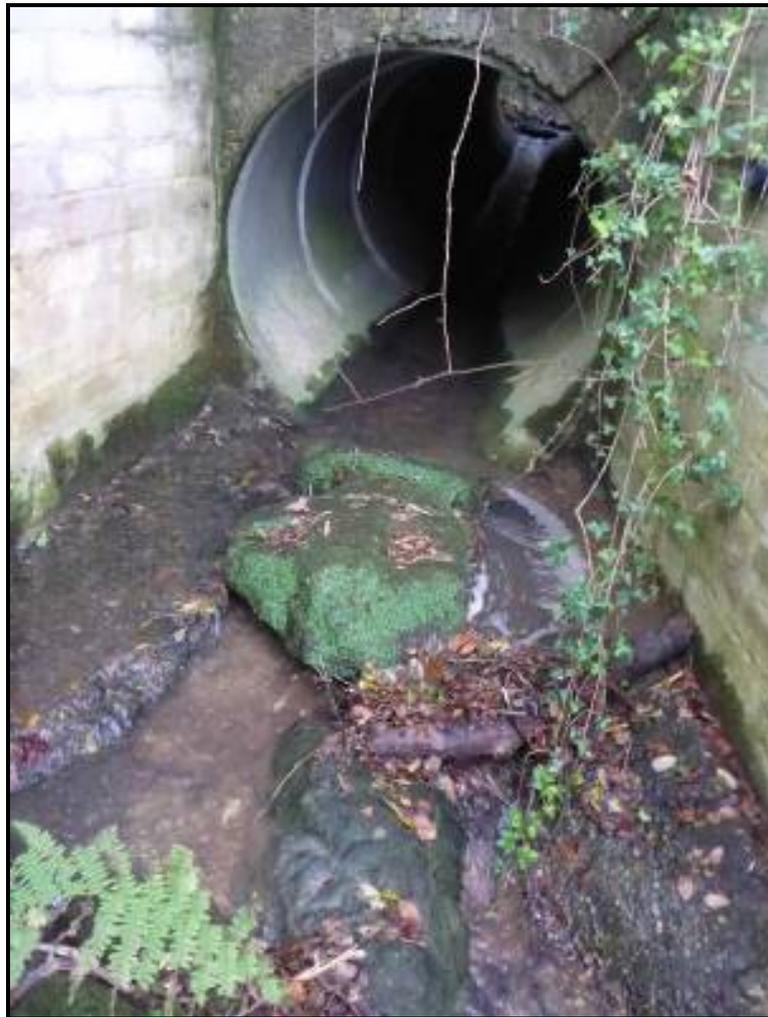
The substrate of Reach 4.2 was of mixed grain size including pebble and gravel with a layer of silt and silted interstices evident. The source of the reach was from a pipe flowing from under a recently developed solar farm, from which sediment-rich runoff was considered highly likely. The water was sediment laden on the day of the walkover survey, with evidence of deposition throughout the reach. A culvert was creating a small barrier to fish movement near the downstream end of the reach (Figure 3-4).

This reach was thought to be unlikely to support a salmonid population due to the shallow nature and silted substrate however, it may support smaller fish species like bullhead or stickleback and limited macroinvertebrates communities are likely to be present.

**Figure 3-4 Reach 4.2 – Barrier to fish movement**

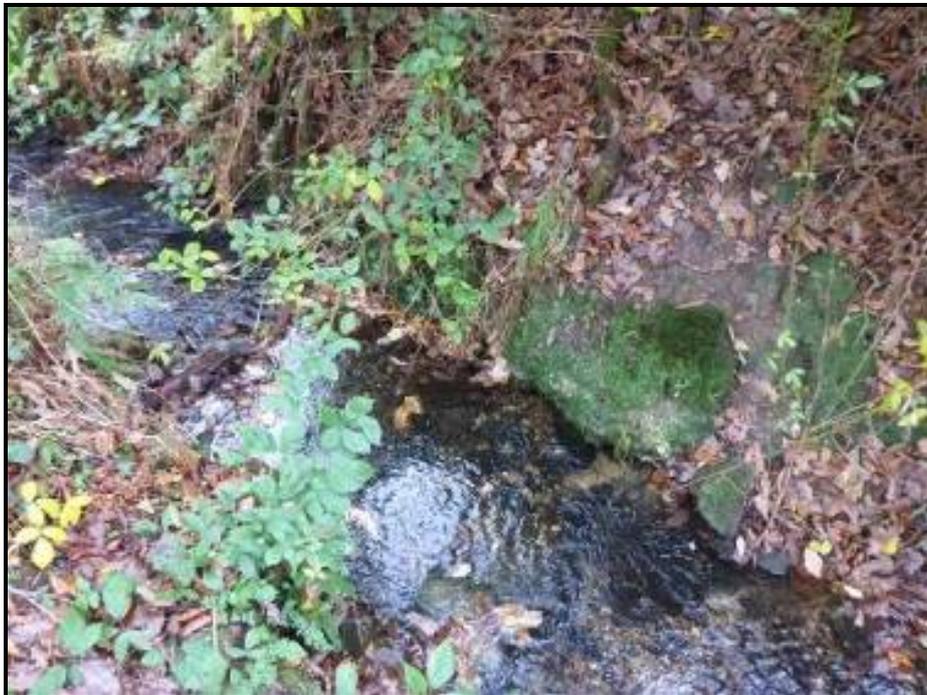
Reach 5.2 was approximately 500m long and lies at the western end of the surveyed area and flows from south to north. The reach was divided into two sections by a large pond. The upstream section was notably shallow and extensively impacted by silted deposition. Downstream of the pond the water was slightly deeper, though generally less than 5cm, and the substrate was less affected by silt deposition (Figure 3–5).

In Reach 5.2 there was a large barrier at the pond outfall, thought to be impassable to all fish species under all flow conditions. This reach was considered unlikely to support a significant fish population, though designated species such as bullhead and lamprey may be present. It is also likely that limited macroinvertebrate populations are present. Downstream of the pond, sub-optimal lamprey habitat around coarse woody debris was observed with the possibility of a small lamprey population within these small patches of habitat.

Figure 3–5 Reach 5.2 – Downstream habitat

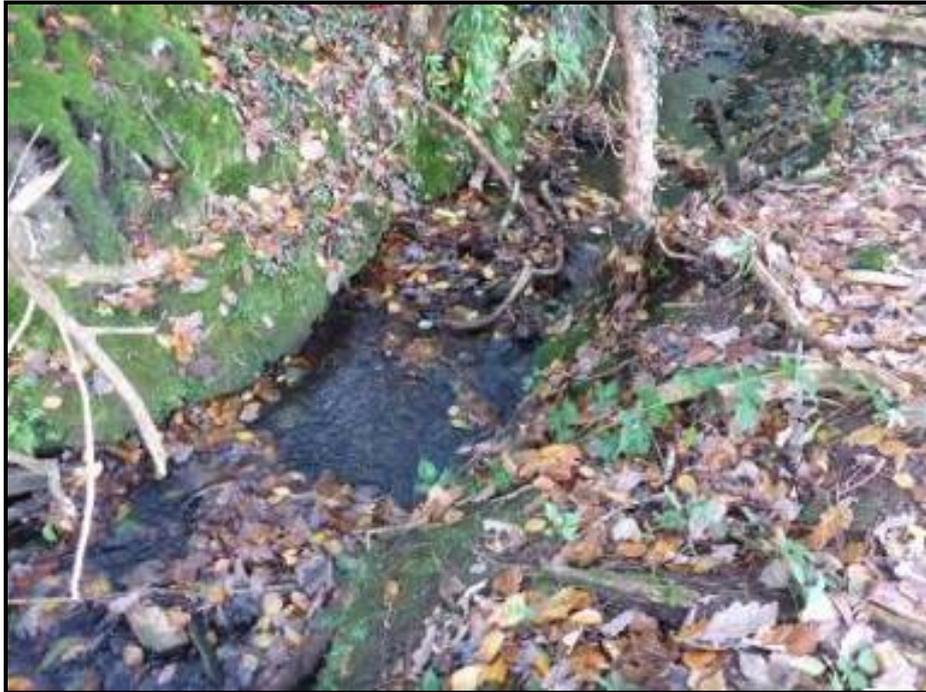
Reach 6.1 was approximately 600m long and was characterised by very shallow water and a narrow channel approximately 0.5m wide (Figure 3–6). The reach was split into two parallel streams, running on both sides of an old boundary wall. The substrate of both watercourses was dominated by gravel and pebble though which was covered by fine sediment throughout. Several likely sources of siltation were identified, including woodland runoff, drainage pipes, arable runoff and track runoff from a solar farm. It is thought that the reach is unlikely to support any significant fish populations, with salmonids unlikely to be present, although limited macroinvertebrate and smaller fish species, including bullhead may be capable of tolerating the conditions.

**Figure 3–6 Reach 6.1 – Typical habitat**

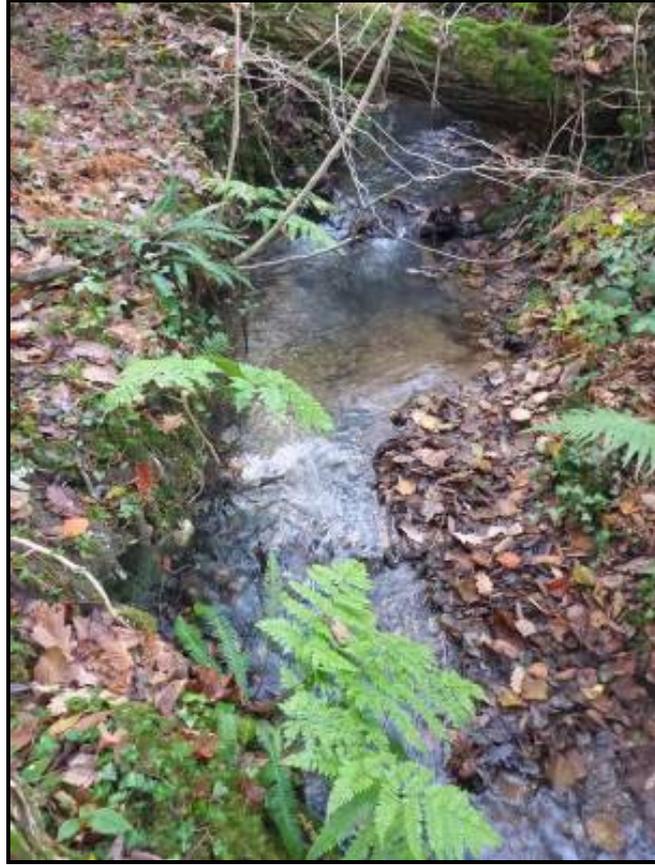
The downstream section of reach 8.1 around Little Nanteague was somewhat deeper with heterogeneous instream habitat recorded (Figure 3–7). This reach was interspersed by woody debris causing varied flow types with a series of micro pools and runs cleaning the gravel substrate required by salmonids for spawning. Some small accumulations of deeper fine organic sediment were also observed in the deeper glide sections which are thought to be suitable as juvenile lamprey nursery habitat.

**Figure 3–7** Typical habitat in lower stretches of Reach 8.1

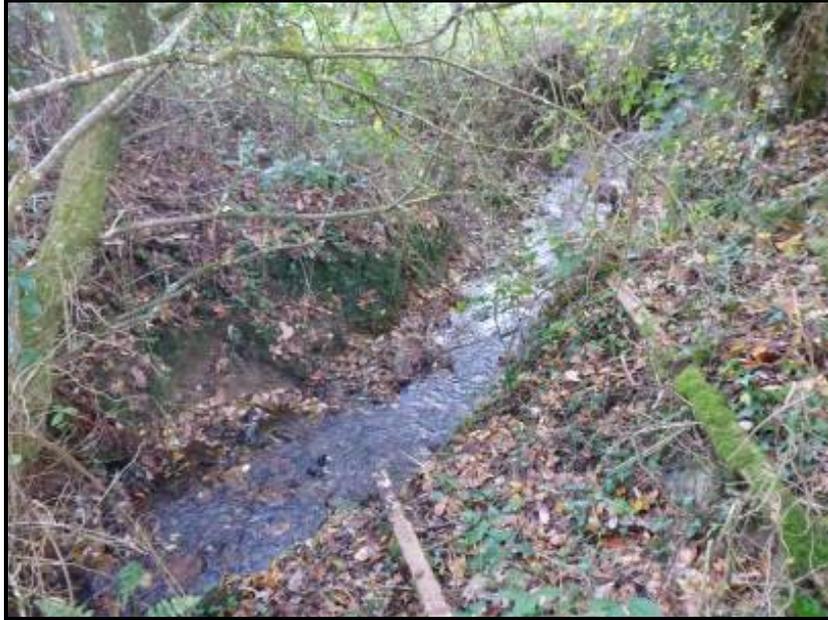
Reach 10.1 was approximately 800m long and predominantly shallow in a deeply incised channel approximately 1m wide (Figure 3–8), though it was wider in places. The reach is fed by a pond in the headwaters of the catchment, which was not accessed due to landowner restrictions. Other small tributaries were also observed entering from the southern bank

The substrate of the survey reach was dominated by gravel and pebble although fine sediment was observed smothering the substrate at a number of locations. The sources of silt were likely to be from bank erosion and intermittent cattle poaching.

**Figure 3–8** Narrow, incised channel in Reach 10.1

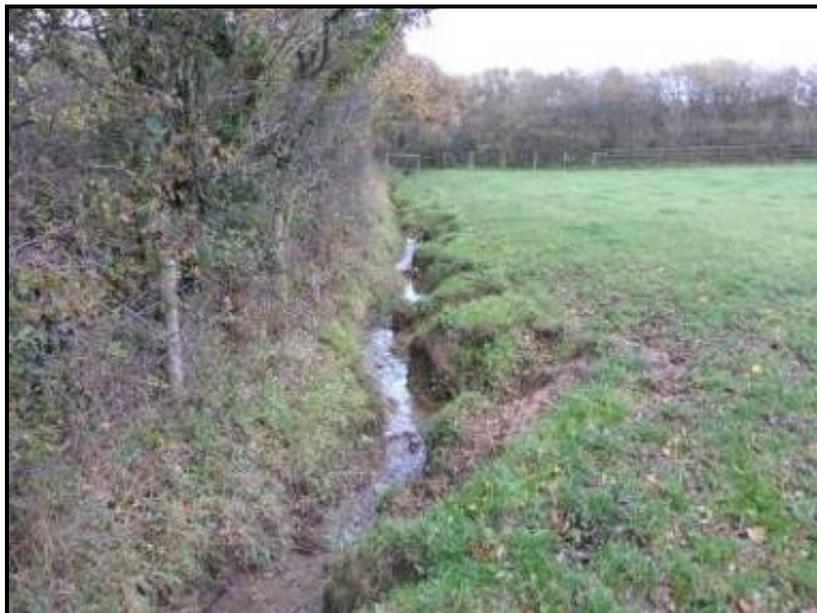
Reach 12.1 lies near the middle of the A30 survey footprint and flows into reach 12.3. The survey stretch was 600m long and was narrow and shallow throughout. The gravel / pebble substrate in Reach 12.1 was extensively silted throughout, which was thought to be the result of cattle poaching on the banks and instream (Figure 3–9). It is thought that the reach upstream of the A30 is unlikely to support a significant fish or macroinvertebrate population due to its water depth and denuded substrate, although immediately downstream of the A30, where the water is deeper there may be a limited aquatic ecological community including fish and macroinvertebrates.

**Figure 3–9** Reach 12.1 – Upstream of the A30

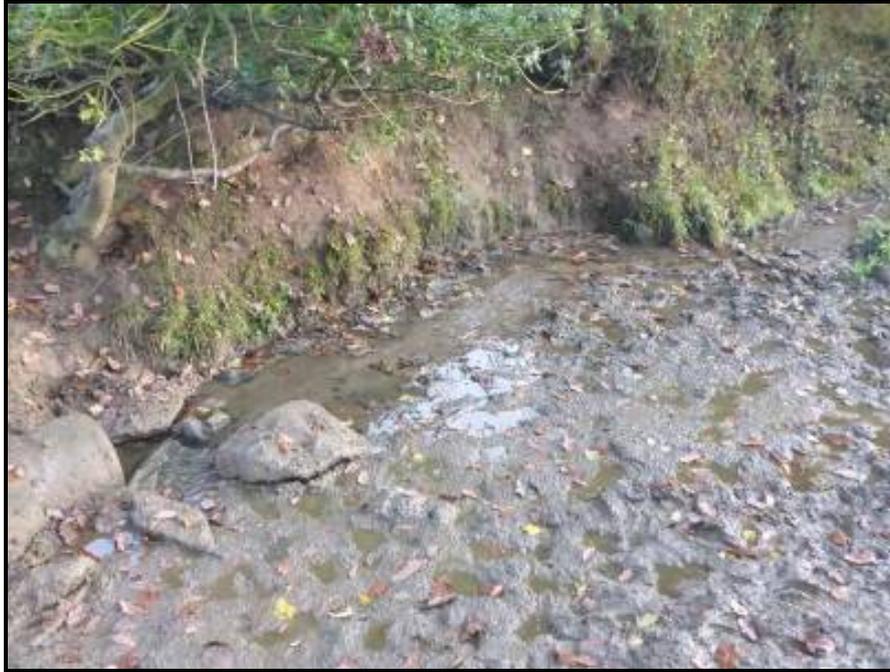
Reach 12.2 flows into reach 12.3 and is approximately 300m long. The reach was narrow, shallow and slow flowing throughout. The substrate was generally homogenous with silt and fine sediment dominating throughout. The stream initially flows through a wooded area before entering a cattle field where extensive poaching was observed which was thought to be the source of the fine sediment (Figure 3–10). The aquatic habitat of reach 12.2 was considered to be poor and unlikely to support any significant fish or macroinvertebrate populations.

Figure 3–10 Reach 12.2 – Poaching of the stream in Reach 12.2

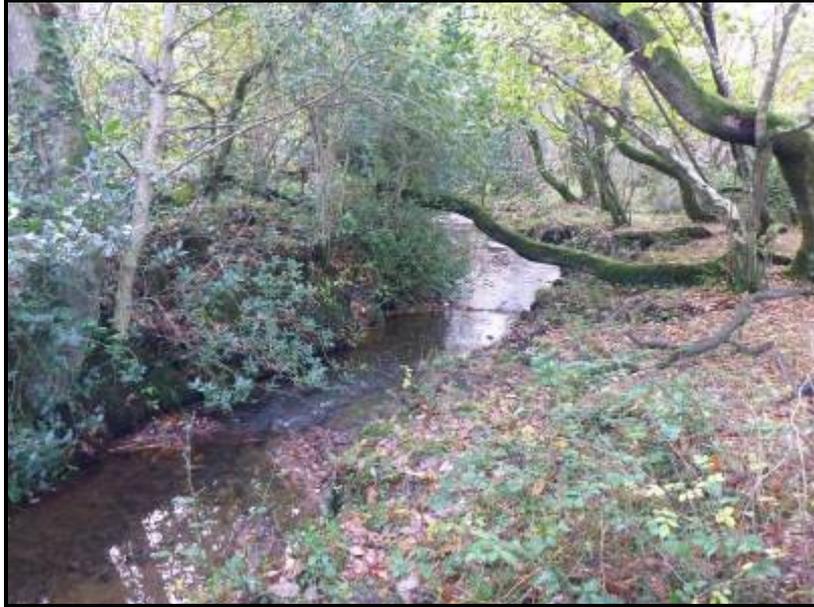
Reach 12.3 was approximately 500m long and was fed by reaches 12.1 and 12.2, both of which are extensively poached and denuded. The reach was narrow and shallow throughout (<10cm), with substrate a mix of fine grained sediment with some gravel and pebble present. Shallow glide and run dominated the flow types though several slightly deeper areas were observed, which may serve as holding areas for salmonid fish (Figure 3–11). Poaching was present along much of the reach, which was a likely source of the silt as well as the inflow from reaches 12.1 and 12.2.

Due to heterogeneous instream habitat and the presence of coarse woody debris and deeper holding areas, this reach may support a limited salmonid and macroinvertebrate population.

**Figure 3–11** Typical habitat at Reach 12.3

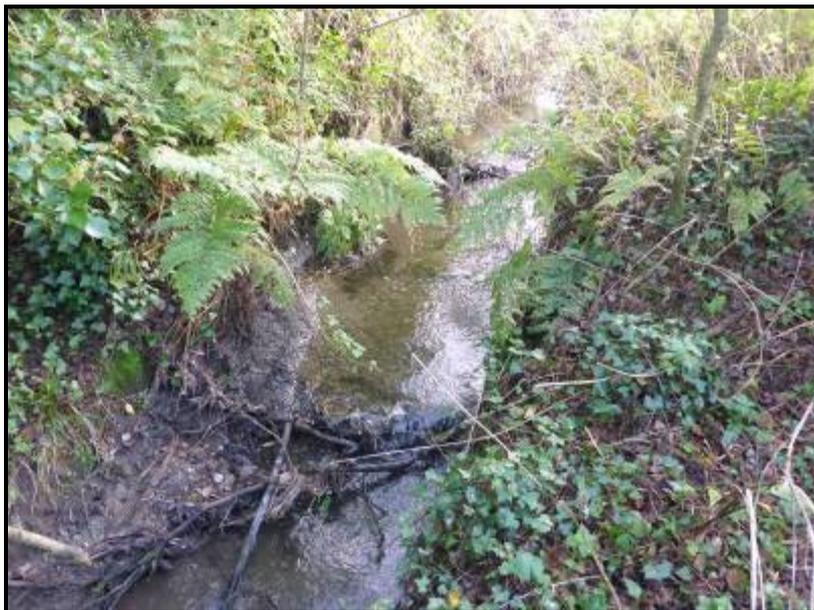
Reach 13.1 was 500m in length and lies near the eastern end of the survey footprint. Upstream of the village of Lemain the stream was shallow and inundated by silt, making it generally unsuitable for fish and macroinvertebrate populations. While downstream, the habitat was more diverse, including gravel and pebble substrates and limited cobble and boulder pockets. Shallow glide and run dominated the flow types throughout the reach however, some deeper sections (<30cm) were recorded, which may provide holding areas for salmonid species (Figure 3–12). It is thought that the reach could support fish and macroinvertebrate populations and that salmonid species may be present in deeper areas.

**Figure 3–12** Fish habitat in the downstream stretch of Reach 13.1

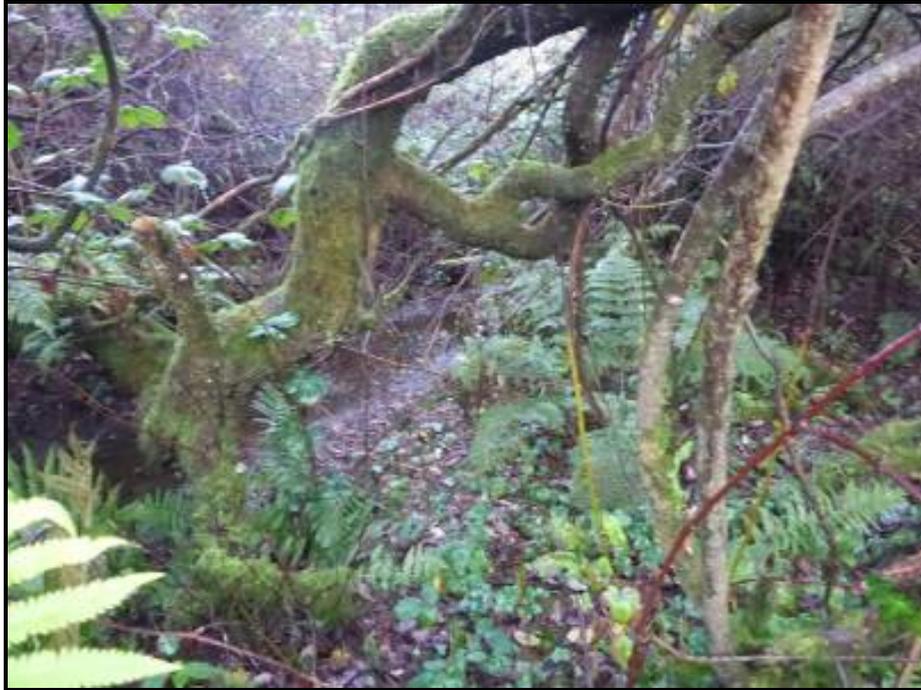
Reach 13.2 was approximately 100m long and was connected to reach 13.1, with a large dry section in-between. This reach was made up of several overgrown, ponded sections (Figure 3–13), which likely are fed by intermittent runoff from the three road crossings. There was no evidence of recent connectivity up or downstream. The ephemeral nature of this reach makes it unlikely to support fish or meaningful macroinvertebrate populations.

Figure 3–13 Reach 13.2 – Typical ponded stream with limited aquatic habitat

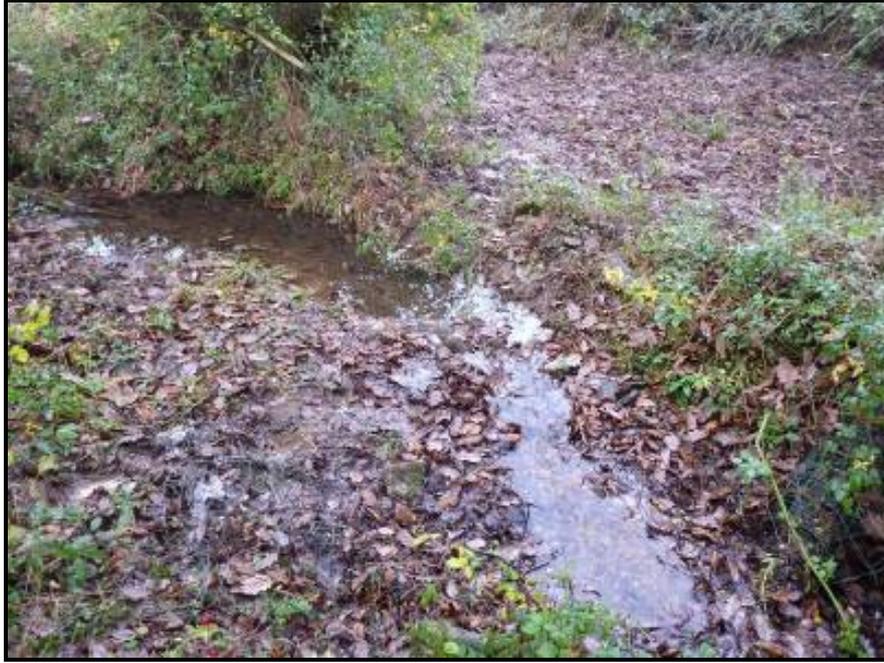
Reach 13.4 was approximately 500m long with a narrow, incised, channel throughout. Very little flow was observed in the upper reaches, although the channel was slightly wider downstream of an online pond in the lower reaches. The substrate was generally gravel and pebble with a covering of fine sediment thought to be originating from overland runoff from adjacent arable fields and horse poaching (Figure 3–14).

Due to the depth, lack of habitat diversity, presence of silt and an impassable barrier at the downstream extent, Reach 13.4 was thought to be unlikely to support significant fish populations though smaller species such as bullhead and limited macroinvertebrate communities may be present.

**Figure 3–14 Reach 13.4 – Horse poaching**

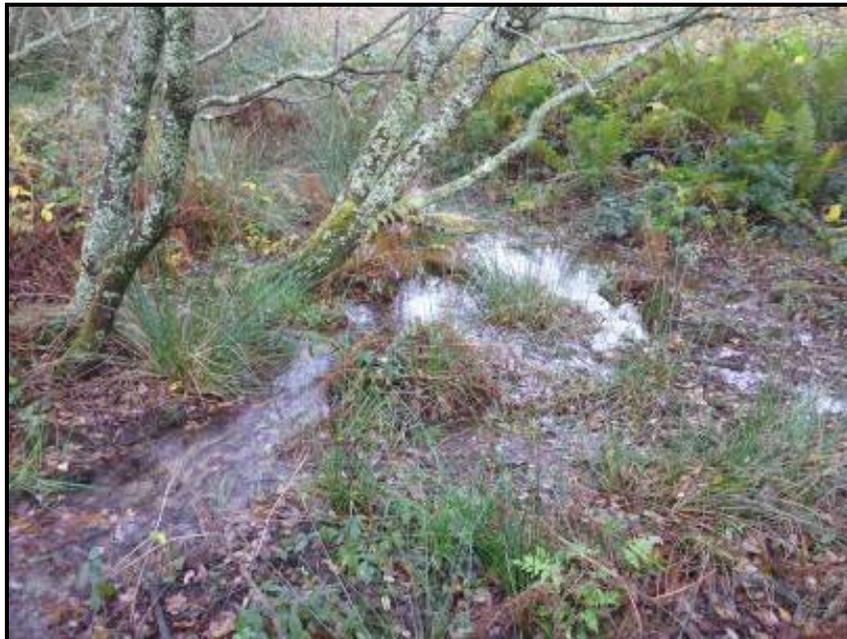
Reach 15.1, was dominated by a narrow and steep channel with fast flowing, shallow water throughout, although some pooled areas were observed in a woodland area (Figure 3–15). Very little optimal fish and macroinvertebrate habitat was observed during the survey with fine sediment dominating substrate. It is also thought that the flow is ephemeral in Reach 15.1 with a likelihood of desiccation during the summer.

**Figure 3–15 Reach 15.1 –Pooled woodland reaches**

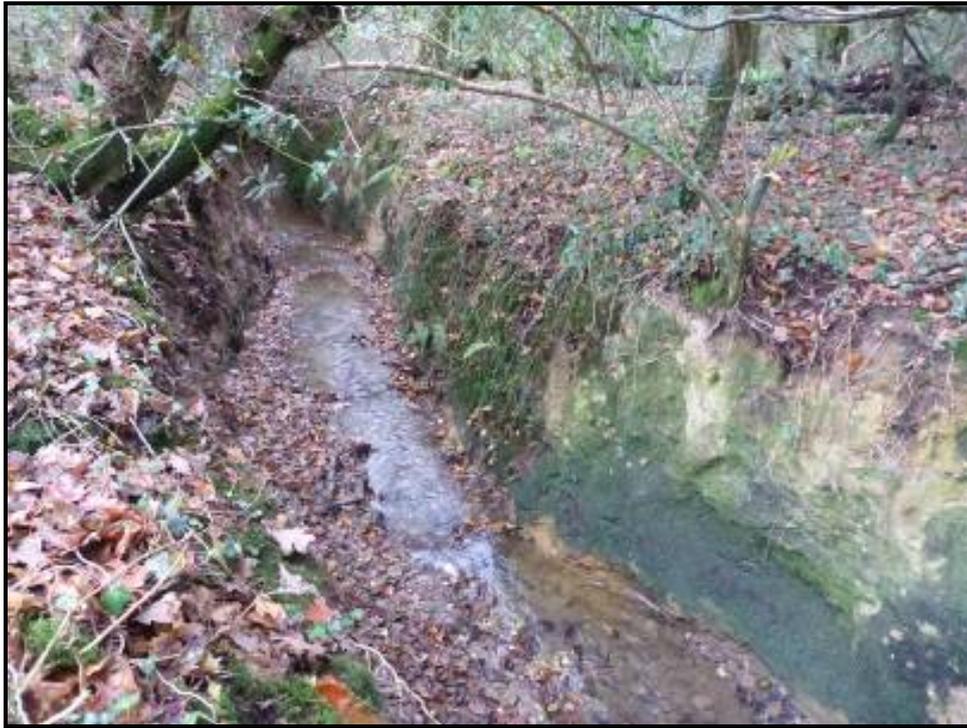
Reach 16.2 was approximately 800m long with a deep and incised channel in many areas (Figure 3–16). The reach was split into two channels within a section of deciduous woodland, with accretion of flow from the surrounding land observed.

Flow types were heterogeneous throughout the reach with glide, run, riffle and cascade all present over a mixed substrate, which included gravel, pebble and limited cobble. Siltation was evident within the interstices of all substrate types. The reach is generally unlikely to be capable of supporting a well-developed salmonid population, although intermittent fish and macroinvertebrate communities are likely where the habitat allows.

Figure 3–16 Incised channel in reach 16.2

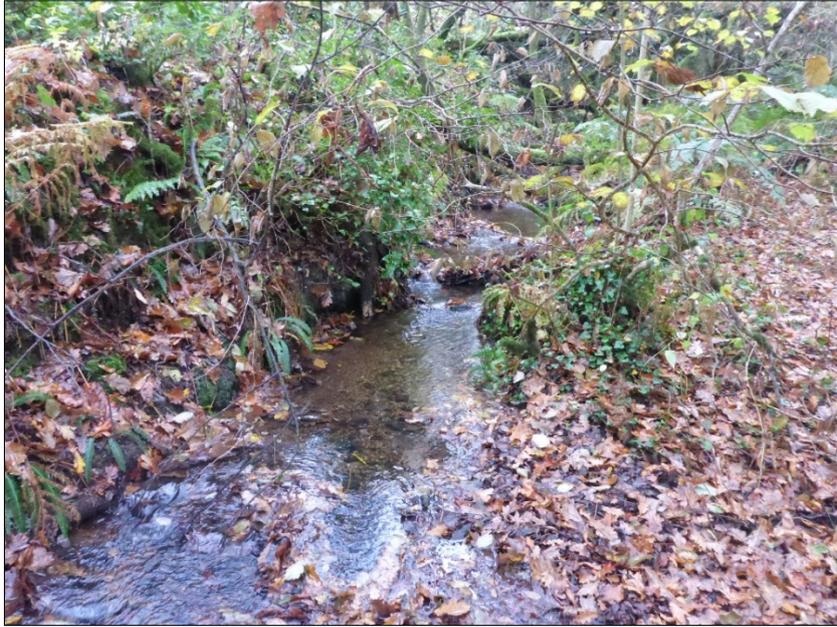
Reach 17.1 was 450m long and lies at the eastern extent of the survey footprint. The reach was generally shallow and narrow with varied flow types, notably shallow run and glide (Figure 3–17). The substrate was dominated by compacted gravel and pebble, which was extensively silted. Arable runoff was observed at the upstream extent of the reach, which was likely contributing to the siltation of the reach.

An obstruction to fish movement was recorded in the lower catchment, in the form of a culverted road crossing, limiting upstream movement of fish into this reach. It is therefore considered that this reach is unlikely supports a significant fish population due to the shallow depth, compacted substrate and lack of connectivity. However, some minor fish species and macroinvertebrates may be present where the habitat allows.

**Figure 3–17** Typical habitat in Reach 17.1

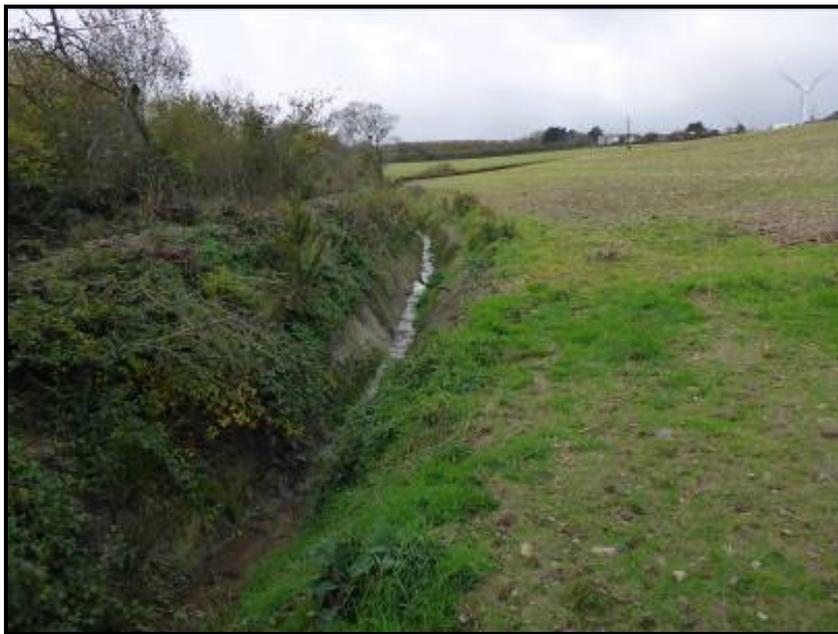
Reach 18.1 was approximately 600m with a narrow, heavily modified channel to serve as a field drain. There were multiple potential sediment inputs due to small or absent arable field buffers (Figure 3–18). The stream has been dredged, deepened and the course has been altered from its original woodland path. A Tributary, entering from the east, near the downstream extent of the reach, increases the depth and flow of the stream. Due to the heavy modification of the channel and shallow homogeneous nature of the flow, this reach is considered unlikely to support a fish or macroinvertebrate population.

**Figure 3–18** Lack of field buffer on Reach 18.1

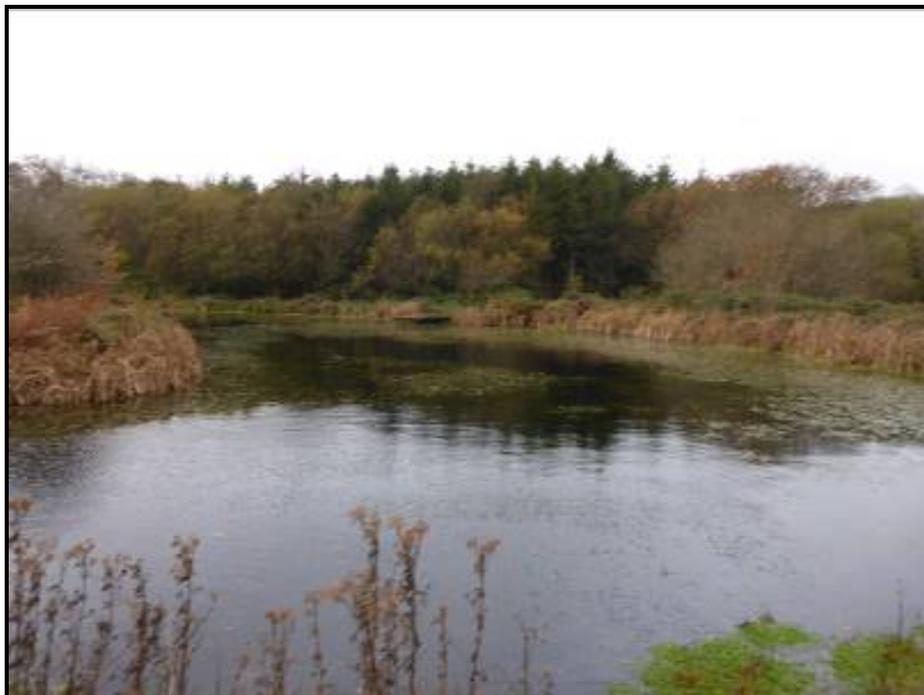
Pond 5.2 was a small, manmade waterbody with angler's access at a number of locations. The waterbody was inundated with emergent macrophyte, with a significant amount of submerged macrophyte cover throughout (Figure 3–19). Upstream fish movement into the pond is impeded by a barrier at the outfall. Habitat within the pond was considered favourable for supporting a small coarse fish population however no fish were observed at the time of survey and it is unclear whether the pond has been stocked. It is thought that the pond is capable of supporting a well-developed still water macroinvertebrate community.

Figure 3–19 Online pond with submerged and emergent macrophyte cover

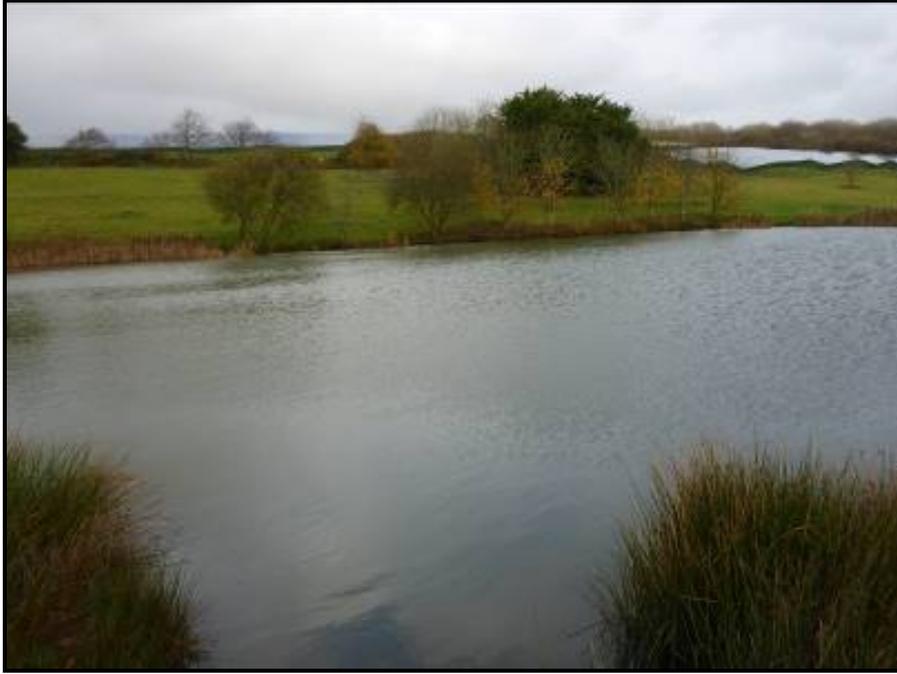
The online pond 8.1 has commercial fishing lake usage, although the stocking of fish is unconfirmed. The pond appears to be deep with a uniform depth throughout. Connectivity to the pond is limited with movement of fish from downstream impeded by barriers at the pond outfall. Emergent macrophyte was observed around the margins of the pond (Figure 3–20) but is relatively under established, suggesting the pond has been recently excavated. It is thought that the pond is capable of supporting a well-developed fish population and still water macroinvertebrate community.

**Figure 3–20 Online pond 8.1 used for angling**

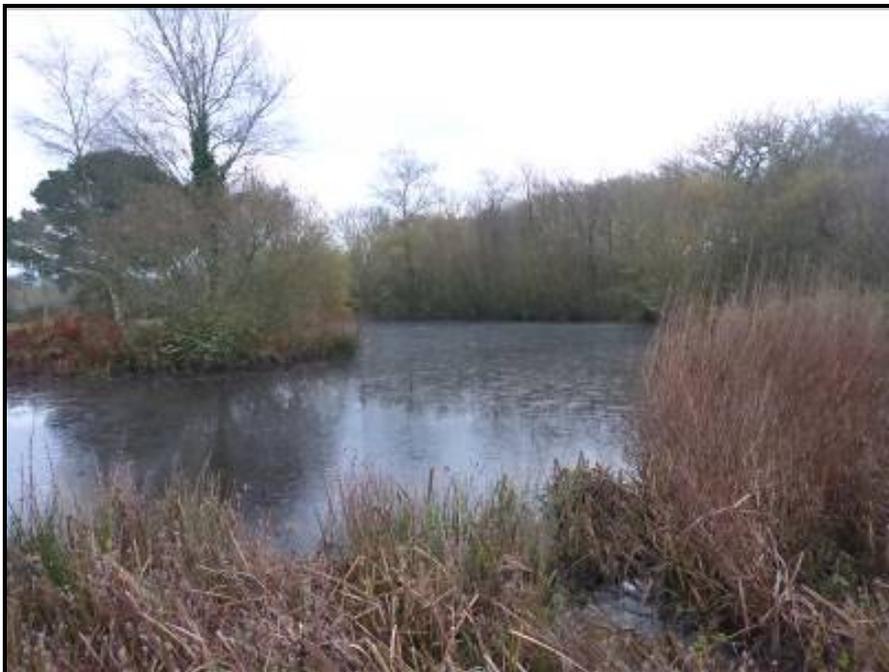
The offline pond 8.1 at Little Nanteague is a well-established, mature waterbody which is inundated with submerged macrophyte. Marginal emergent macrophyte stands were also observed throughout (Figure 3–21). Assuming that the water quality is satisfactory the pond would provide ideal habitat for cyprinid fish species such as carp and roach and it is likely to have been colonised by a diverse macroinvertebrate community.

**Figure 3–21 Well-established offline pond 8.1**

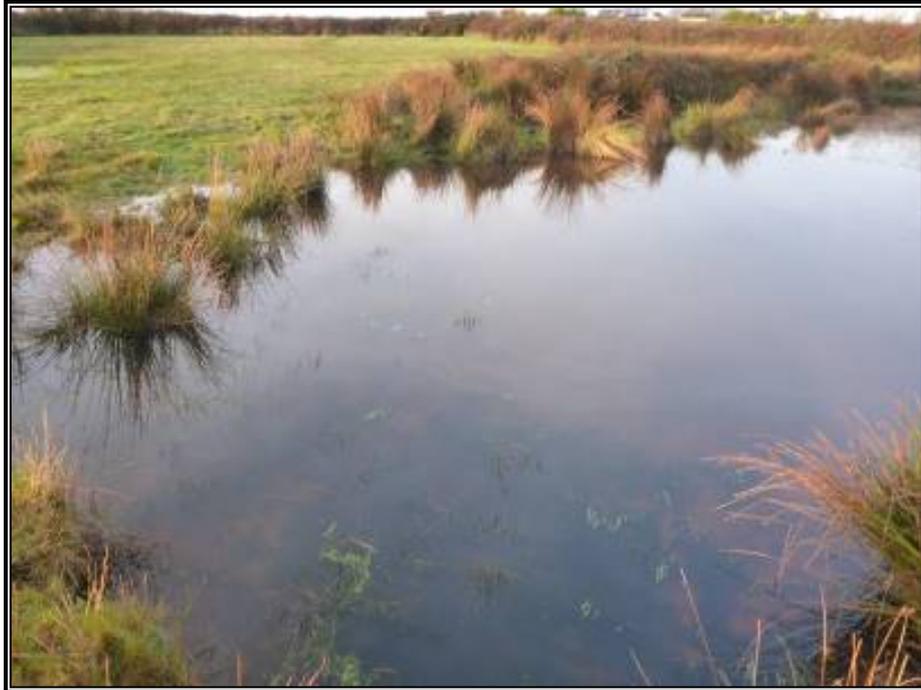
Pond 13.3 is a small pond at the upstream extent of reach 13.2. Some evidence of historical connectivity was observed, though there was no evidence of recent flow. It was shallow and silted and there was no obvious use other than a livestock drink (Figure 3–22). Limited emergent and submerged macrophyte was recorded. Although a fish and macroinvertebrate community may be present in the waterbody it is unlikely that the population diversity will be high.

Figure 3–22 Shallow, homogenous habitat at Pond 13.3

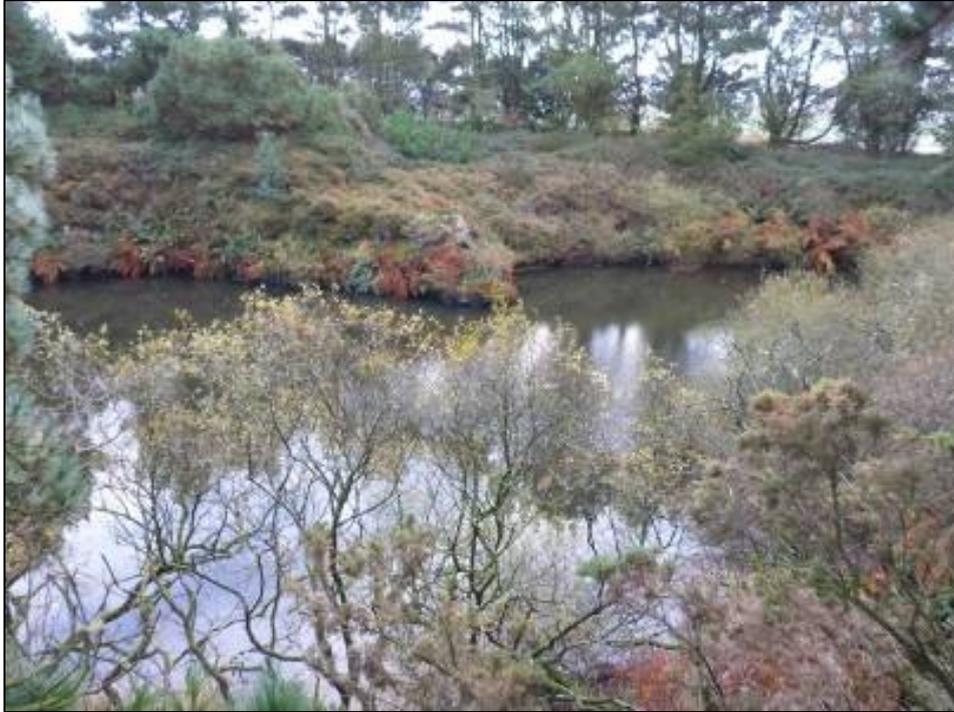
Pond 16.1 was a flooded quarry with very steep banks and no access to the waters edge (Figure 3–23). There was no obvious macrophyte cover and due to its inaccessibility is considered unlikely to have been stocked with fish in the past. An extensively overgrown dry ditch leading to the site through dense gorse was observed, though this was likely to be an old quarry access track rather than a feeder tributary.

Although containing a large volume of water it is thought that pond 16.1 is unlikely to support a significantly population of fish unless previous introductions have occurred. A

**Figure 3–23** Deep water at Pond 16.1

through dense gorse was observed, which is likely to be an old quarry access track rather than a feeder tributary. No additional surveys are recommended on health and safety grounds. As such, National Pond Surveys are recommended for 5 of the 6 ponds initially surveyed.
