# **A30 Chiverton to Carland Cross Environmental Statement**

**Volume 6 Document Ref 6.4 ES Appendix 9.1  
WSP Preliminary Sources Study Report**

**HA551502-WSP-EGT-SW-RP-LE-000001**

**August 2018**

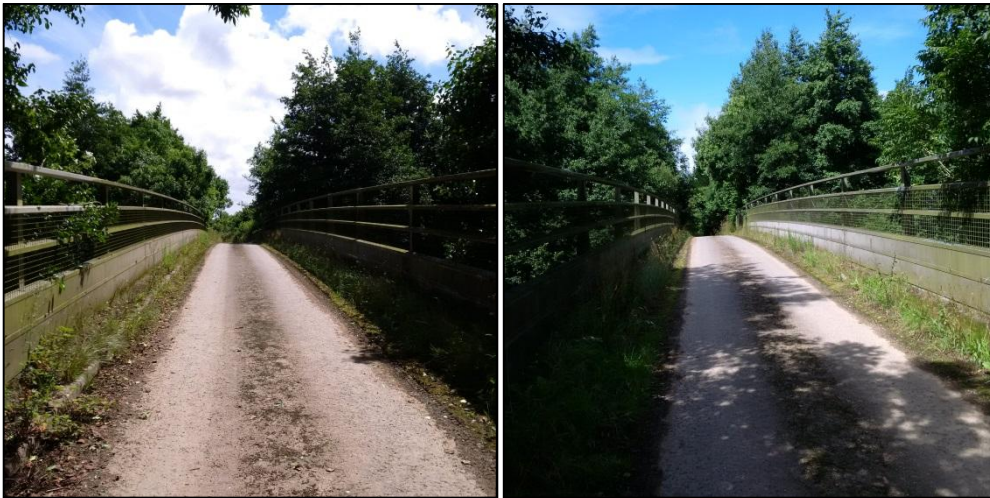
Figure 3.28: Walkover photograph set K– Existing bridge over A30 looking north-west (LEFT) and south-east (RIGHT).

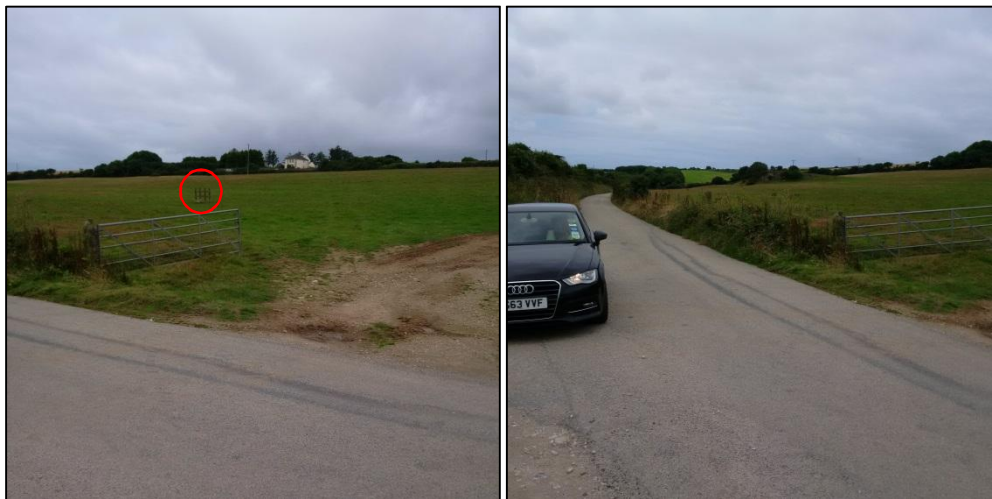
Figure 3.41: Walkover photograph set Q- Field through which route alignment passes, looking west, this photo also shows the location of a gas (red circle) (LEFT) and showing private farm gate access (RIGHT).

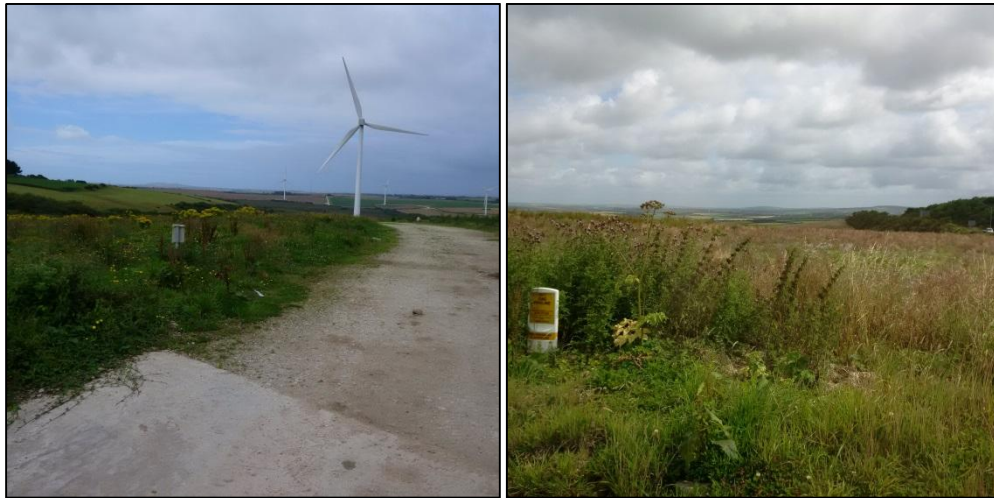
Figure 3.43: Walkover photograph set R- Field through which route alignment passes, looking west (LEFT) and northeast, this photo also shows the location of a gas pipeline running through (RIGHT).
