A30 Chiverton to Carland Cross Environmental Statement

**Volume 6 Document Ref 6.4 ES Appendix 9.2
WSP Ground Investigation Report**

A30 Chiverton to Carland Cross

Ground Investigation Report

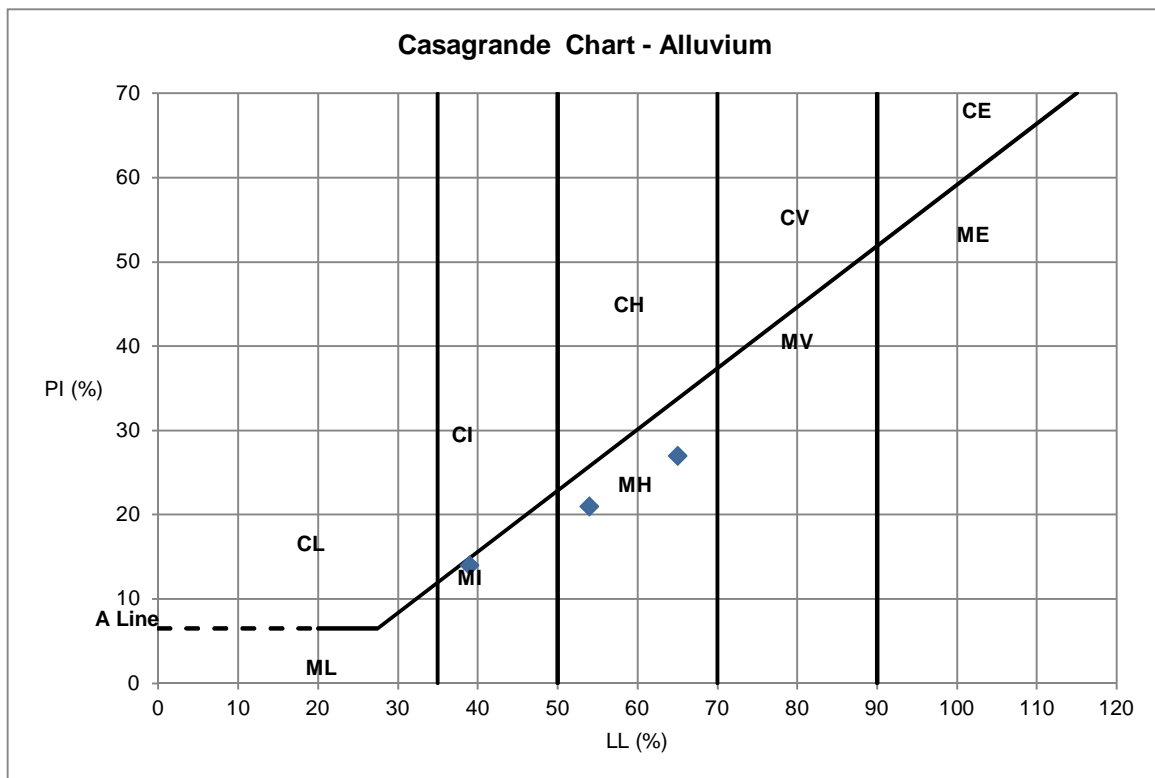
Figure 6-2 Casagrande Chart – Alluvium

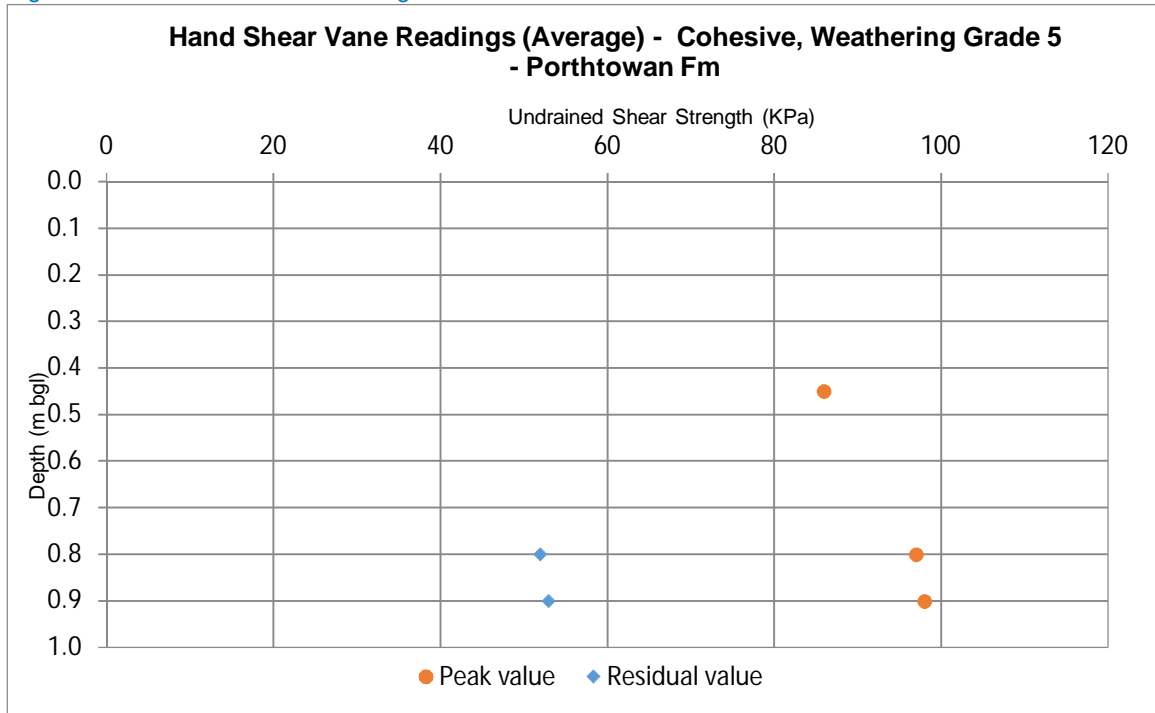
Figure 6-5 Hand Shear Vane Readings – Porthtowan

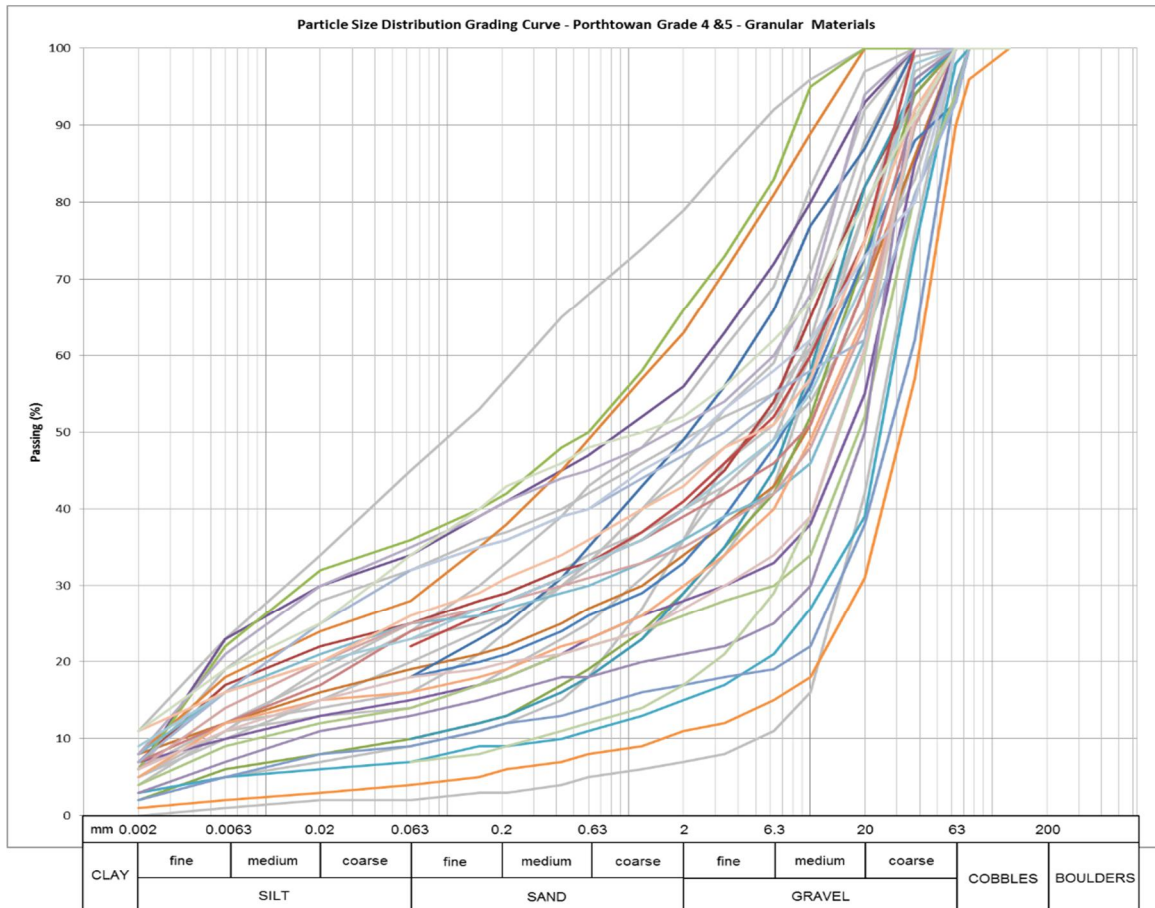
Figure 6-6 Particle Size Distribution Grading Curve – Porthtowan Formation – Coarse Grade 4&5

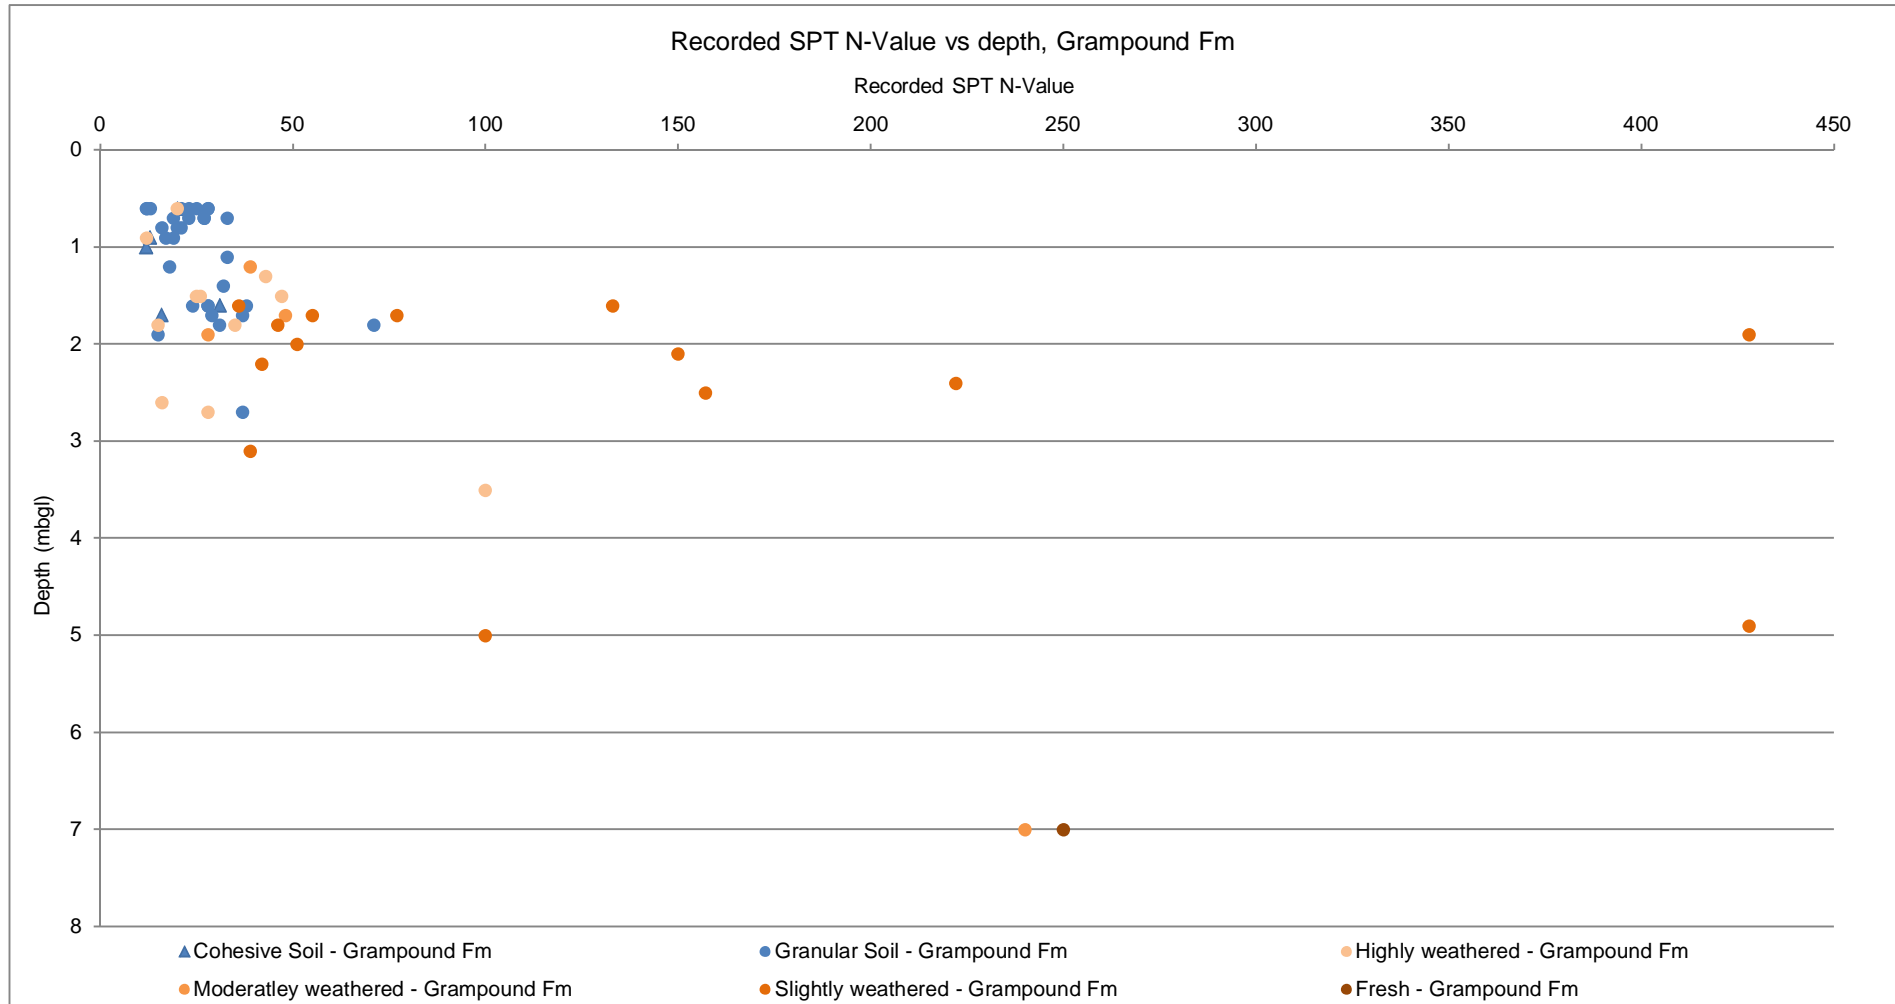
Figure 6-28 Recorded SPT N-Values versus Depth – Grampound Formation

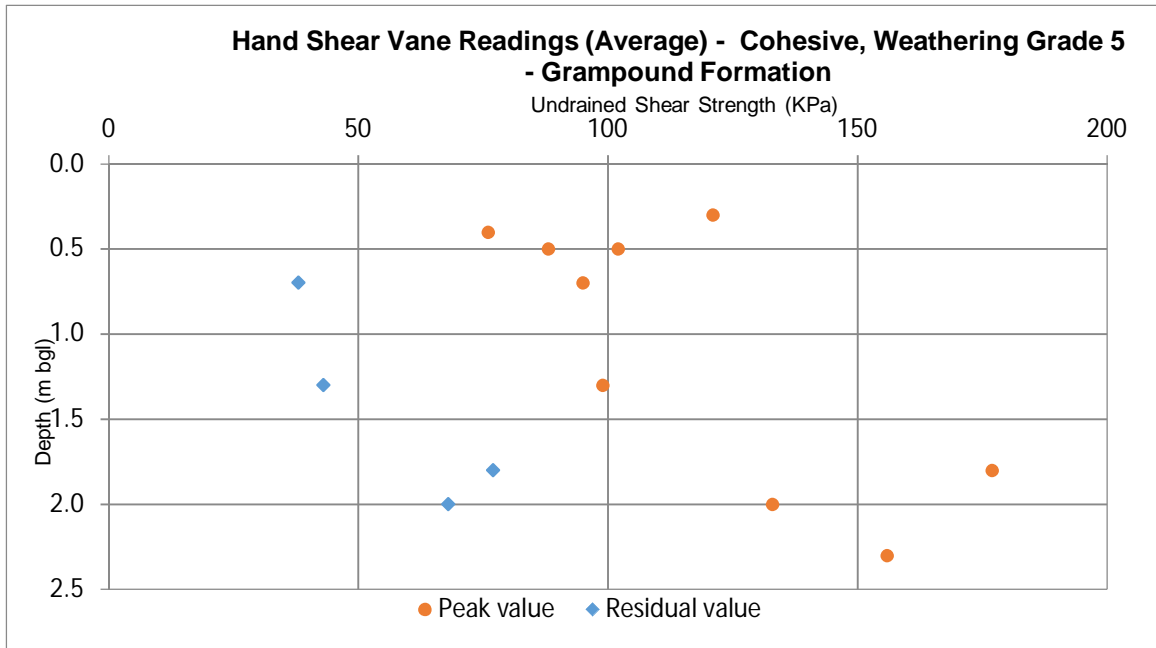
Figure 6-29 Hand Shear Vane Readings – Grampound Formation

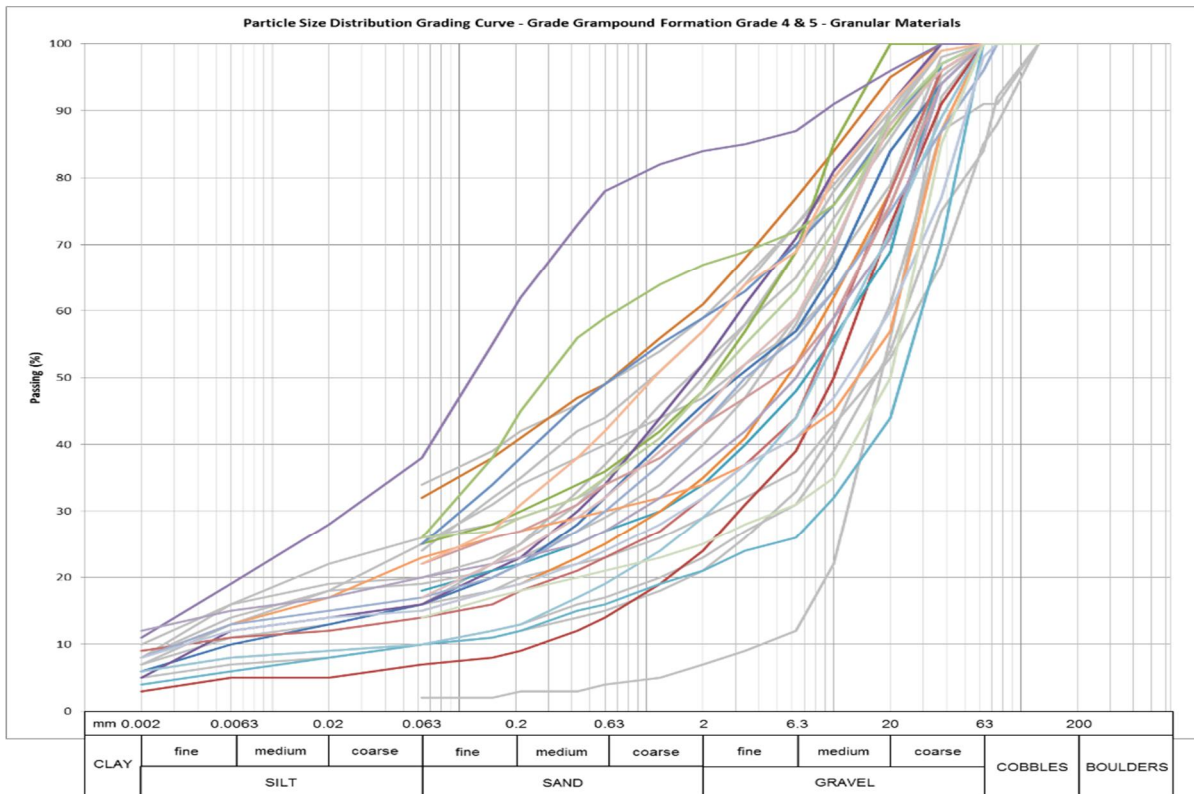
Figure 6-30 Particle Size Distribution Grading Curve – Grampound Formation – Coarse

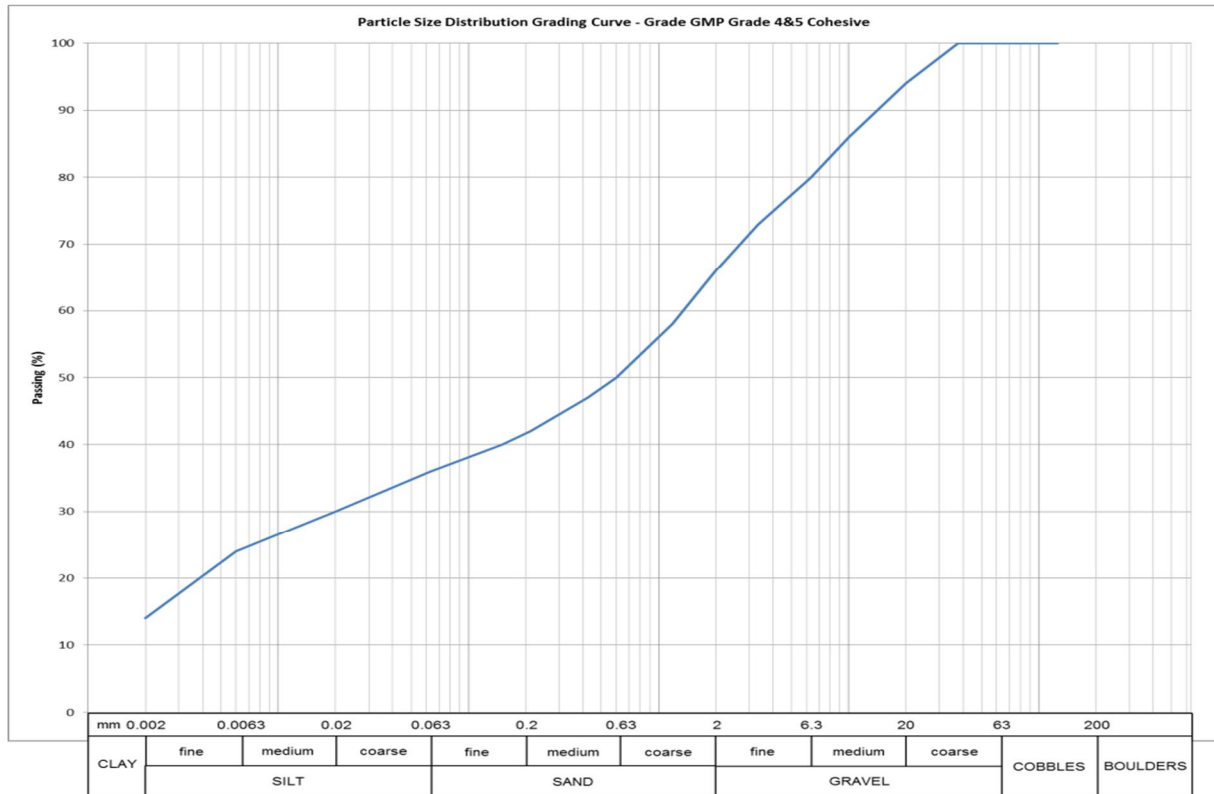
Figure 6-31 Particle Size Distribution Grading Curve – Grampound Formation - Fine

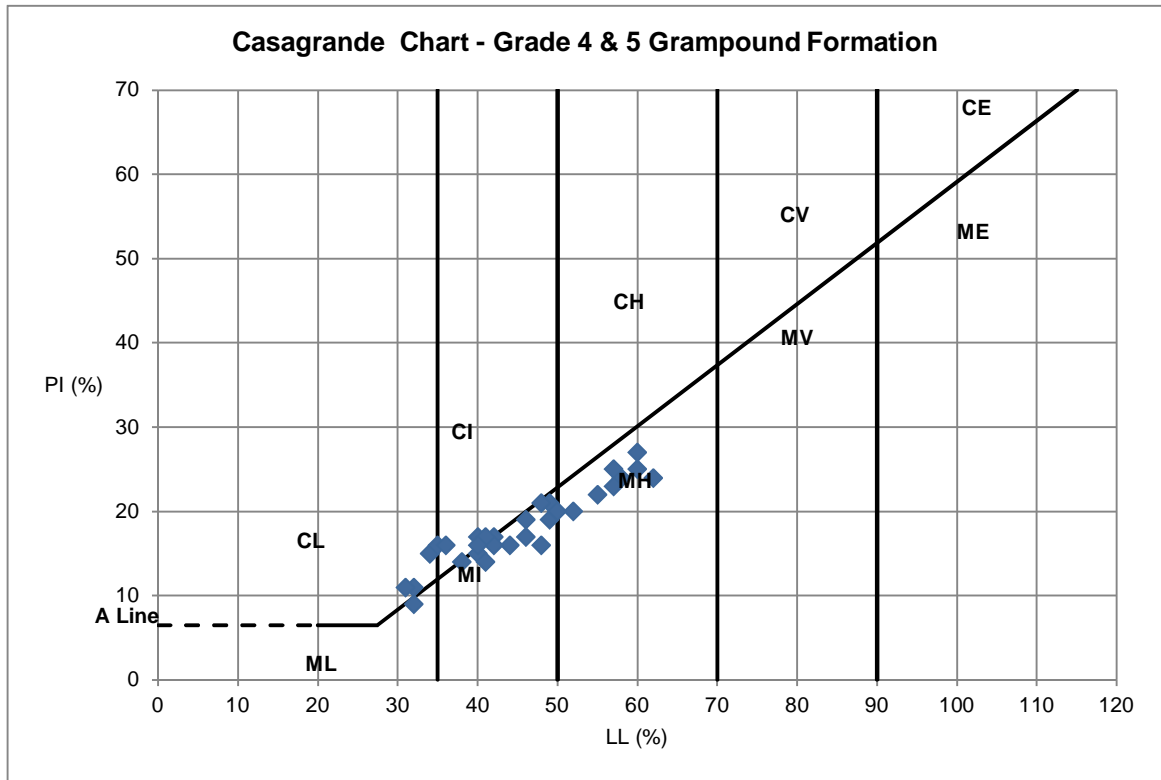
Figure 6-32 Casagrande Chart – Grampound Formation Grade 4&5
