**M42 Junction 6 Improvement  
Scheme Number TR010027  
Volume 6**

**Appendix 14.2 Bickenhill Meadows SSSI –  
Preliminary Hydrological Investigation  
Technical Note**

***BICKENHILL MEADOWS SITE OF SPECIAL SCIENTIFIC  
INTEREST – HYDROLOGICAL INVESTIGATION TECHNICAL  
NOTE (V7)***

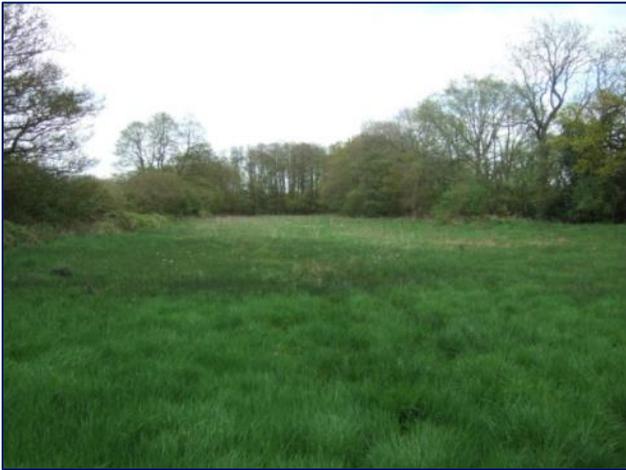
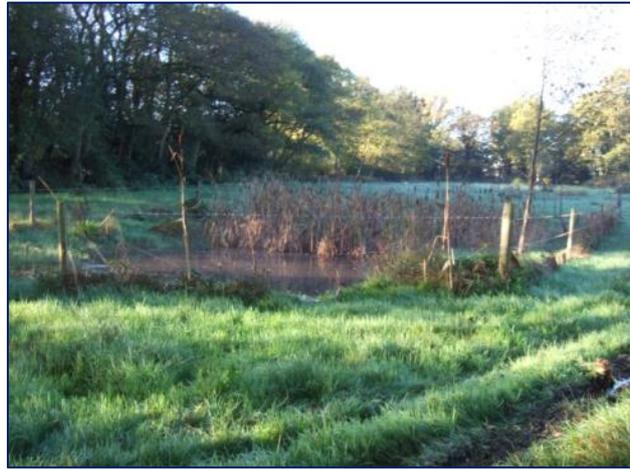
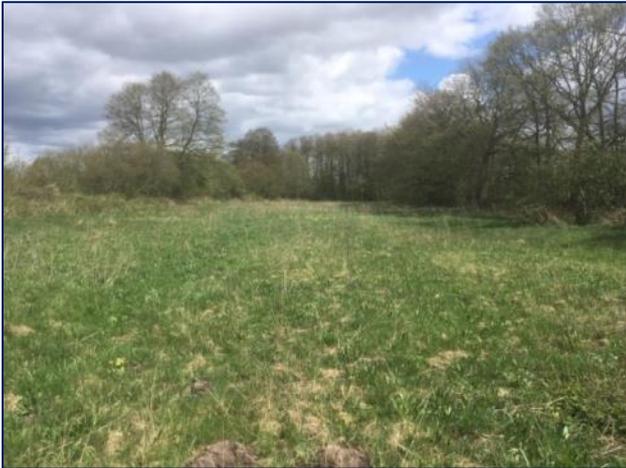
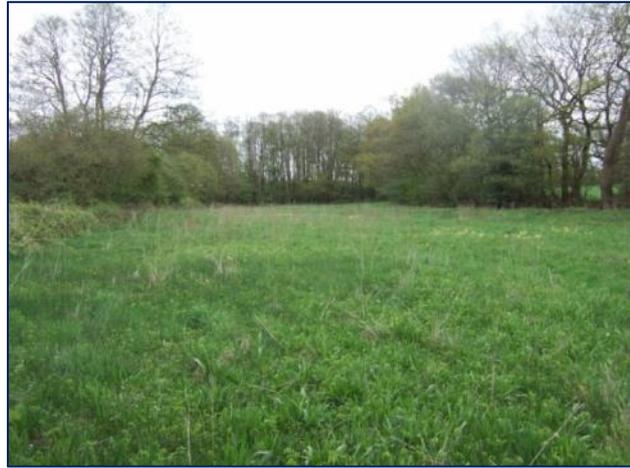
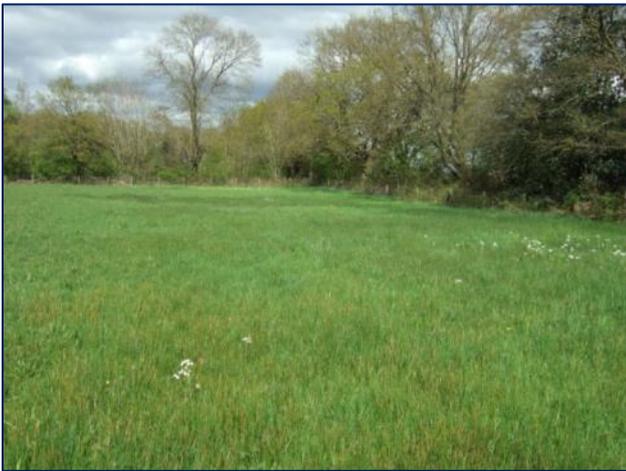
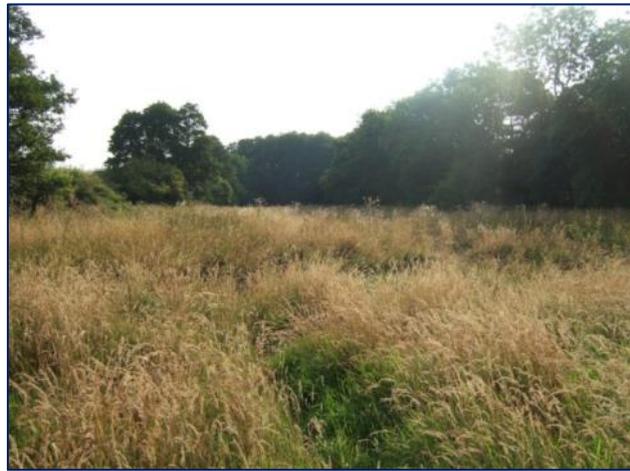
**Photo 1 (top left) and Photo 2 (top right) Wet meadow fields at Bickenhill Meadows SSSI SE Unit / Shadowbrook Meadows LNR in cold/wet conditions; Photo 3 (middle left) Wet meadow fields at Bickenhill Meadows SSSI SE Unit in warm/dry conditions; Photo 4 (middle right) and Photo 5 (bottom left) Bickenhill Meadows SSSI SE Unit in warm/dry conditions; Photo 6 (bottom right) Bickenhill Meadows SSSI SE unit southern field after a prolonged period of hot summer weather.**

5.2 The southeastern unit consists of four fields (three of which are in the SSSI boundary) and wet woodland at the far north of the site, and (along with the LNR) covers 4.4ha. The stream that flows through the centre of the site (from southwest to northeast) is a tributary of Shadow Brook. It meets Shadow Brook to the east of the M42 approximately 2km downstream at NGR SP 20625 82231. The dry meadows are to the east of the site, and wet meadows are to the west. General views of the wet meadows are shown in Photos 1 to 6 under different conditions.

- 5.12 In the northeastern (wet) field of the SE Unit, the ridge and furrow topography gives rise to diverse ecological communities. The furrows tend to be saturated and support grassland species designated as MG4 under the National Vegetation Classification (NVC). MG4 represents a nationally rare flood meadow community. Characteristic species include greater burnet (*Sanguisobra officinalis*) and meadowsweet (*Filipendula ulmaria*). The ridges are drier and support MG5 neutral grassland species with assemblages of English crested dog's tail (*Cynosurus cristatus*) and common knapweed (*Centaurea nigra*), amongst others. Subtle changes in colour across the wet meadow, shown in Photo 1, indicate the changes in vegetation across the site.

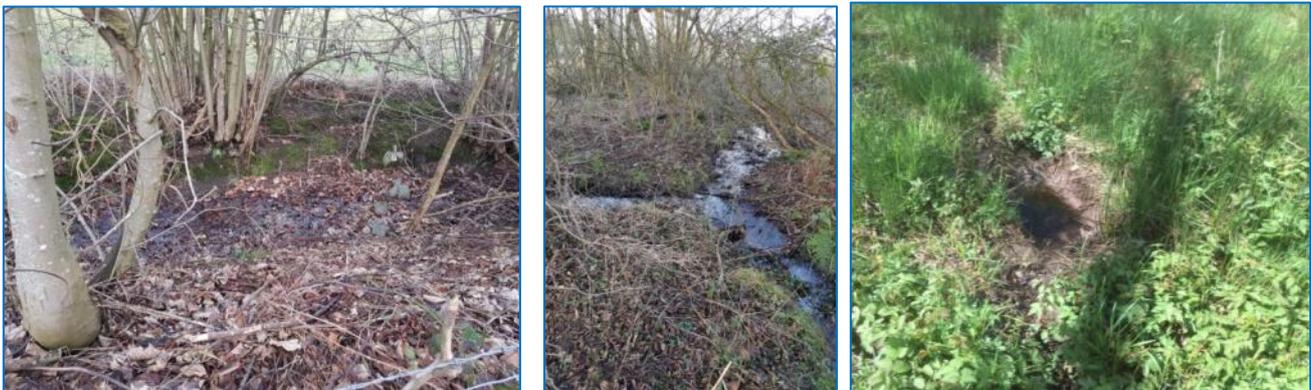
**Photo 7 (left) Ponded water in agricultural drainage ditch at NW border of SE Unit; Photo 8 (right) confluence of the tributary of Shadow Brook and the drainage ditch within the alder woodland; Photo 9. Furrows and depressions saturated with water following rainfall in meadow field of SE Unit.**

- 5.9 There is also an ephemeral drainage ditch bordering the northwest of the site (Photo 7), which varies between 1m and 1.5m wide. This was largely dry on the majority of site visits, with some ponded water in places of 1-2cm depth adjacent to the upper wet meadow. However, when observed after heavy rain there was obvious flow in the ditch, which presumably was sourced from runoff from the adjacent arable field which slopes significantly down to the SSSI. As the ditch enters the alder woodland at the northern extent of the SSSI there was a small amount of flow even during the drier site visits, which drains into the tributary of Shadow Brook (approximate NGR SP 18950 81743), see Photo 8.

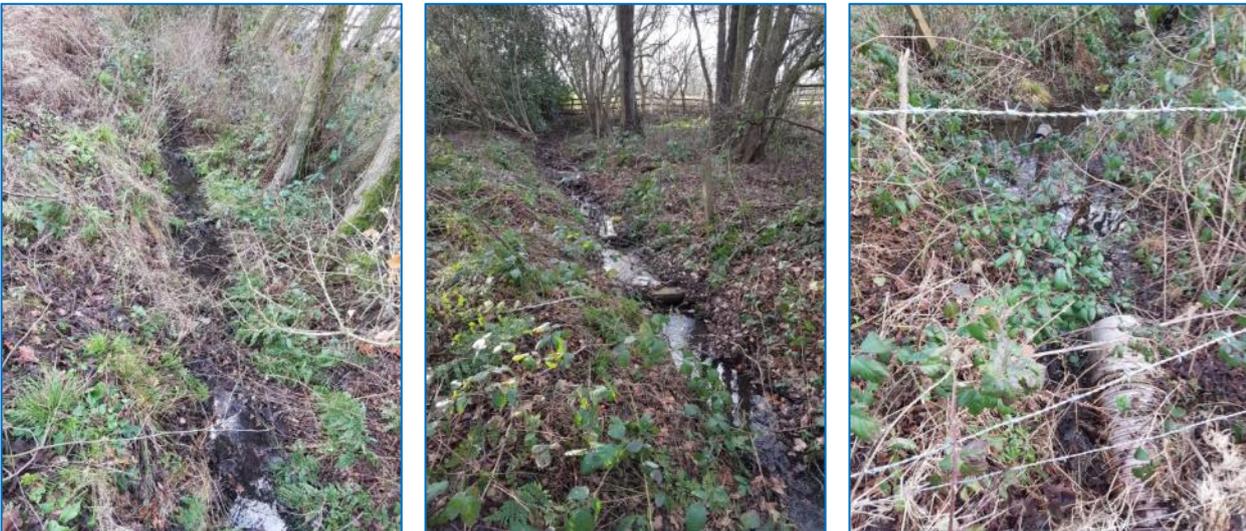
**Photo 10 (left) and Photo 11 (centre): Tributary of Shadow Brook within the wet woodland. Photo 12: (right) Culvert exit downstream of the grassed land bridge.**

- 5.11 Towards the centre of the SE Unit the brook is culverted under a grassed land bridge through a plastic pipe of around 400mm diameter (Photo 12). Upstream the culvert is partially buried, and there is potential for impoundment of flow during extreme rainfall events, which may result in occasional flooding of the immediate grasslands, although there was no evidence of this. Several blockages across the stream from woody debris and accumulations of leaves were observed during the site visits, which again could cause localised impoundment of flows and encourage

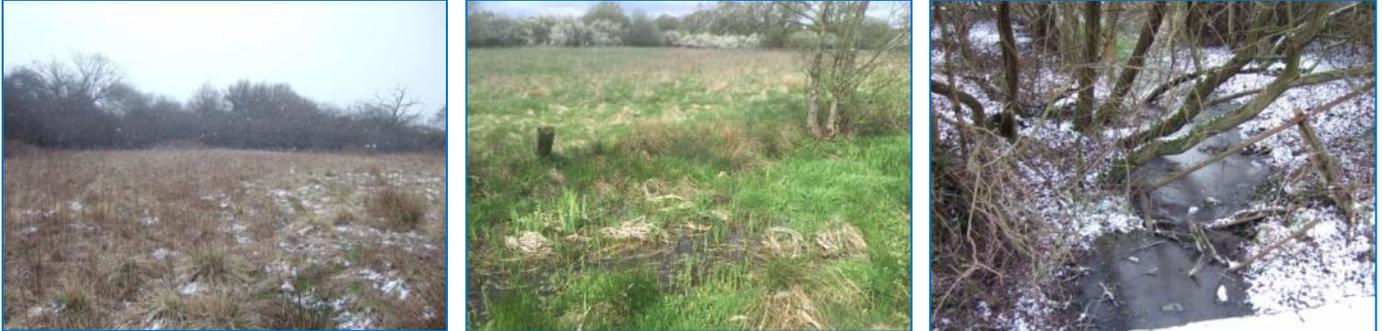
**Photo 13 (left), Photo 14 (centre) and Photo 15 (right) - Bickenhill Meadows SSSI NW Unit.**

- 5.14 The NW Unit is a small, roughly square grassland area of 2.7ha, bordered on all sides by a scrub and woodland margin (Photo 13). A tributary of Low Brook flows from south to north and divides the field approximately in half, with the topography rising away from the tributary gently on both sides initially, becoming steeper further afield. The brook itself is surrounded by intermittent hedgerow vegetation. Immediately south of the site is a historic landfill site of raised elevation, from which groundwater (of unknown quality) may flow out towards the SSSI, as indicated by iron staining seeping from the embankment.
- 5.15 The watercourse appears to emanate from numerous ephemeral drainage ditches which flow around the elevated historic landfill area and coalesce at the south of the site to then flow north

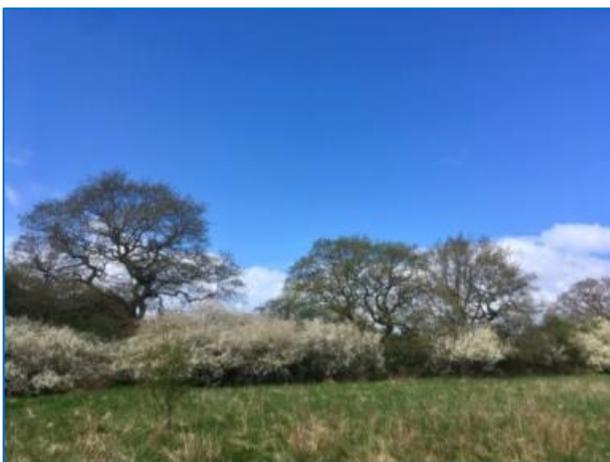
**Photo 16 (left) – eastern field within the NW Unit showing the fringing blackthorn trees.**

- 5.17 The western field has a generally drier and more uniform character than the eastern field (Photo 16), and is at a slightly greater elevation than the eastern field. The spatial distribution of the MG4 and MG5 grasslands across both fields is a likely consequence of local variability in moisture content in the upper 30-40 cm of soil, with tussocks and ridges across the site providing slightly drier conditions than localised depressions and troughs.

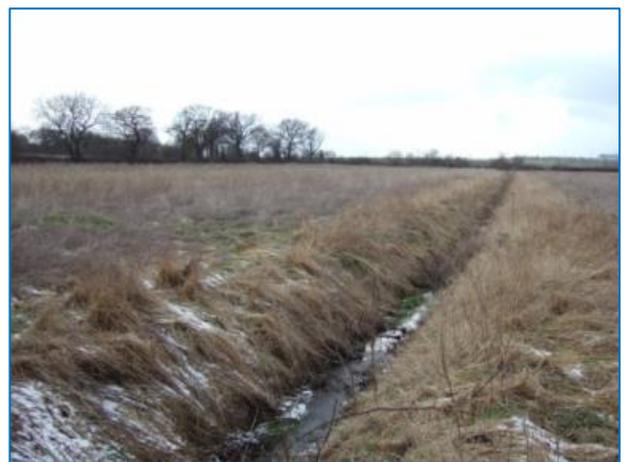
**Photo 17 (right) tributary of Low Brook immediately north of the SE Unit boundary looking towards Birmingham Airport.**

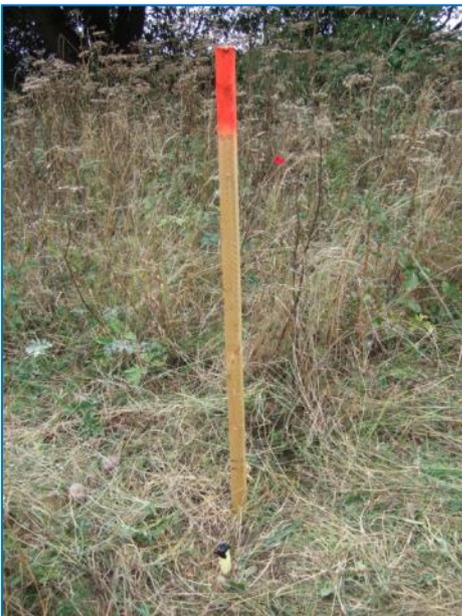
Photo 18. Dipwell T2-D at the SE SSSI unit.

- 9.4 Dipwells were installed in the SE Unit on 13-14 August 2018 (see Figure 12A for locations and Photo 18 for an example). A total of 10 dipwells were installed, covering MG4 grassland, MG5 grassland and transitional grassland areas. The dipwells were prefabricated from a perforated plastic pipe of 32mm diameter. They are sealed above ground to prevent rainwater from filling the pipe. The plastic pipe is perforated at regular intervals along its length on all sides, to allow throughflow of soil water, and to allow equilibration to be achieved with the surrounding water table.

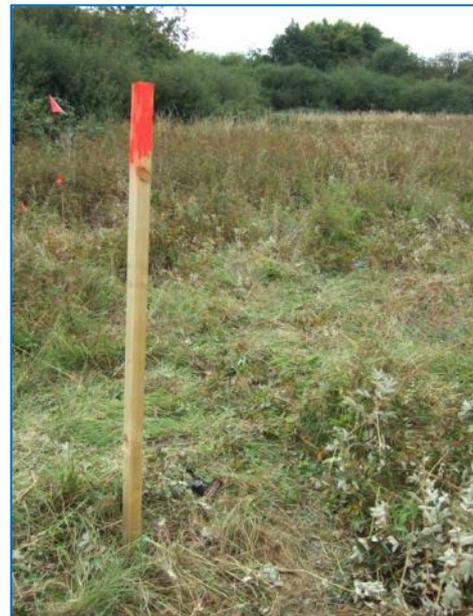
Photo 19. Dipwell N2-B on the NW SSSI unit.

- 9.6 The dipwells in the NW Unit were installed on 5-6 September 2018 (see Figure 12B for locations, and an example in Photo 19). Despite sporadic rainfall in the period since the installation of the SE unit dipwells, the ground conditions at the NW unit remained extremely dry with no groundwater encountered during augering of any of the holes. In total, 4 dipwells were installed to 90cm depth, two to 70cm depth, and additional dipwells to 66cm, 60cm, 50cm and 43cm depth. The shallower depths of some dipwells are a result of impenetrable stiff clay layers being encountered. In general, the top soil at the NW Unit was up to 20cm to 40cm depth below ground, before trending to extremely stiff, dark grey clay to the base of the dipwells. The main exceptions were the two dipwells towards the centre of the eastern half of the SSSI, where sand and gravel layers were encountered at depths below 50cm. Further details are described in Annex B.

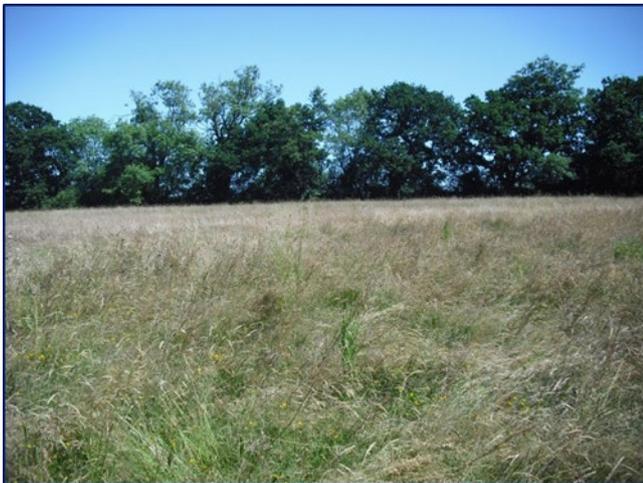
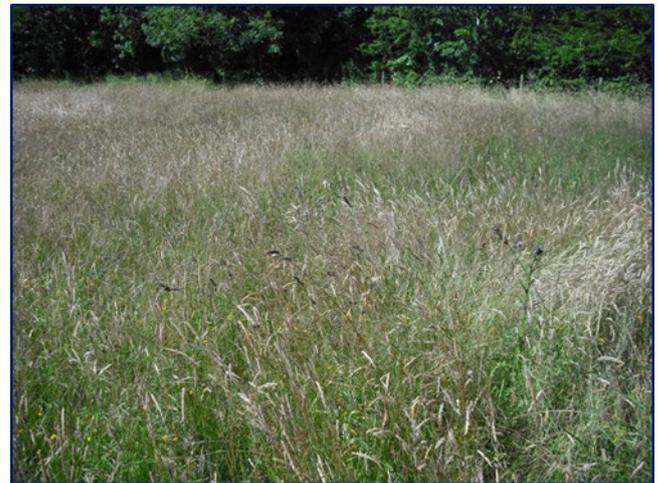
- 11.4 The two fields on the eastern side slope down to the watercourse and the vegetation on the day of the survey was grass dominated (tall and lodging in places) and dry (Photo 20 and 21). Yorkshire fog (*Holcus lanatus*) was abundant with other grasses such as cock's foot (*Dactylis glomerata*), common bent (*Agrostis capillaris*), red fescue (*Festuca rubra*), crested dog's tail (*Cynosurus cristatus*) and meadow fescue (*Schedonorus pratensis*). A range of generally common forbs were recorded and included ribwort plantain (*Plantago lanceolata*), common knapweed (*Centaurea nigra*), bird's foot trefoil (*Lotus corniculatus*) and red clover (*Trifolium pratense*). Less common species included yellow rattle (*Rhinanthus minor*) and tormentil (*Potentilla erecta*).

**Photo 20 (left) and Photo 21 (right) - typical vegetation in the SE SSSI unit eastern fields.**

- 11.5 Seven quadrats were recorded in the two fields, as they were uniform in appearance and structure. The data obtained was run through TABLEFIT and the goodness of fit to the NVC community type MG5; *Cynosurus cristatus* - *Centaurea nigra* was around 83% and classed as very good fit. The second best fit was to the MG5a *Lathyrus pratensis* sub-community type.

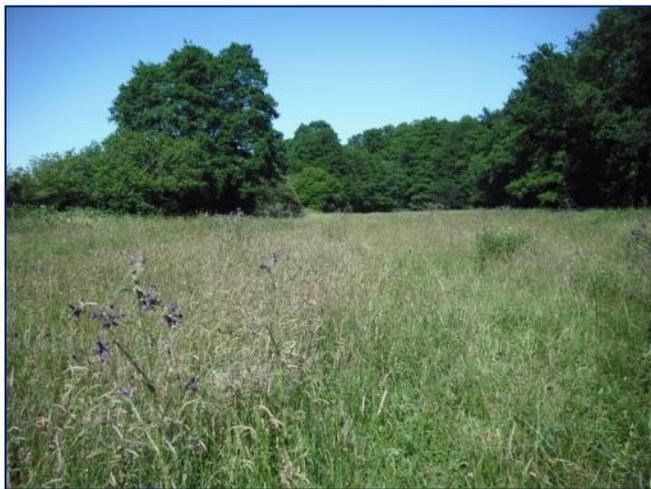
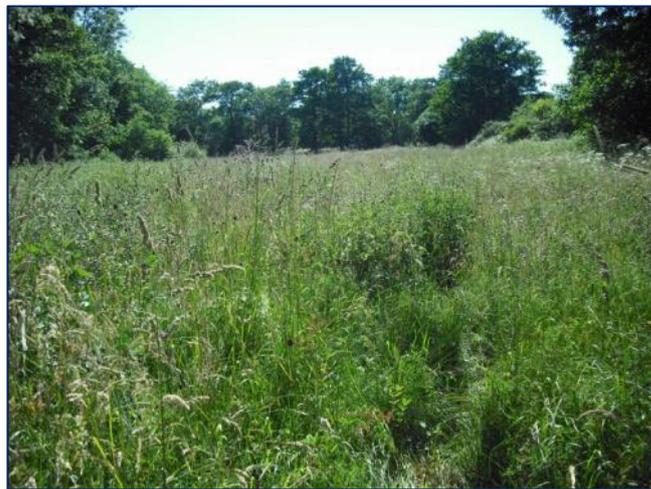
- 11.6 The field within the SE Unit on the western side of the watercourse was generally flat but with an apparent rise towards the northern boundary; the grasses did not dominate to the degree they did in the dry fields and there were patches of meadowsweet (*Filipendula ulmaria*) and great burnet (*Sanguisorba officinalis*) (Photo 22 and 23). Meadowsweet and other wetland species such as wild angelica (*Angelica sylvestris*) seemed to be more frequent towards the watercourse where the vegetation was taller and coarser. Interesting species recorded here were betony (*Stachys officinalis*) and tormentil (*Potentilla erecta*). It has been reported that meadow thistle (*Cirsium dissectum*) is also present but this was not found during the current survey.

**Photo 22 (left) and Photo 23 (right) - typical vegetation in the SE SSSI unit wet meadow field.**

- 11.7 Five quadrats were recorded in this western field and along with the data collected from similar vegetation recorded in the NW section of the SSSI (described below) were run through TABLEFIT. The goodness-of-fit to the NVC community type MG4; *Alopecurus pratensis* – *Sanguisorba officinalis* was around 63% and classed as a fair fit. Any variation in the vegetation from topographical variation was masked by the tall growth and a better understanding of this would be obtained once the field has been cut. This will provide information on the relationship of the community boundaries to topography, depth to water and ditch levels, and enable the communities to be tied with soils information to determine the mechanism whereby any vegetation changes are driven.

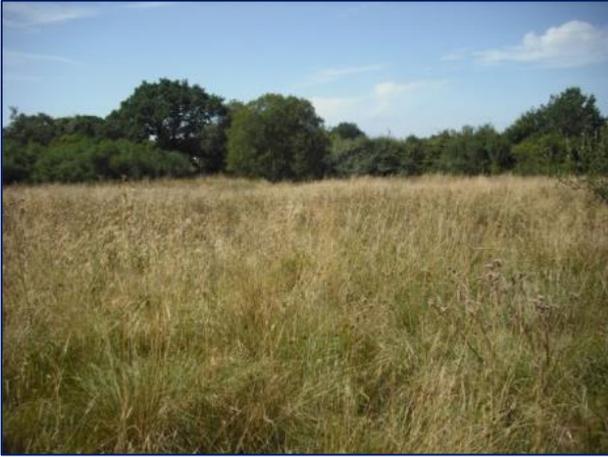
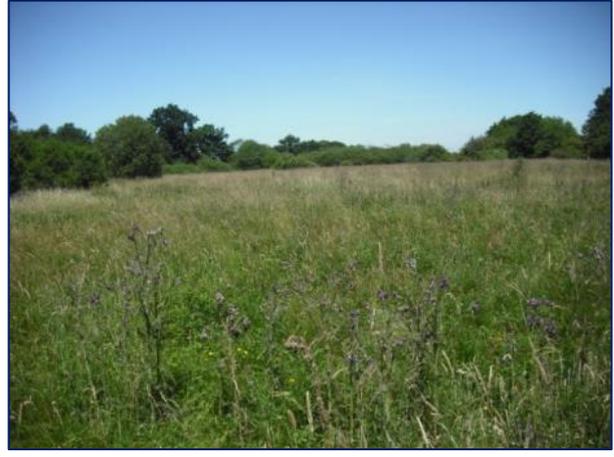
- 11.8 The NW Unit comprises two fields separated by a small, ephemeral watercourse, which was dry on the day of the survey. The western field appeared to be uniform in structure and was generally a mix of patches of larger forbs such as great burnet (*Sanguisorba officinalis*) and meadowsweet (*Filipendula ulmaria*), and grasses with a range of smaller forbs including several legumes scrambling through the vegetation (Photo 24 and Photo 25). This field appeared to be more diverse than the corresponding field in the SE Unit and here saw-wort (*Serratula tinctoria*), quaking grass (*Briza media*) and devil's bit scabious (*Succisa pratensis*) were recorded in addition to the more typical and commoner forb species. When visited in August 2018, tufted hair grass (*Deschampsia cespitosa*) was the dominant species in this field.

**Photo 24 (left) and Photo 25 (right) - typical vegetation in the NW SSSI unit western field.**

- 11.9 Five quadrats were recorded in the field and along with the data collected from similar vegetation recorded in the SE SSSI unit were run through TABLEFIT. The goodness-of-fit to the NVC community type MG4; *Alopecurus pratensis* – *Sanguisorba officinalis* was around 63% and classed as a fair fit.
- 11.10 The eastern field of the NW Unit was only visited in August 2018 and had much coarser vegetation and the dominant grass across large areas was tufted hair grass (*Deschampsia cespitosa*) but with meadowsweet and great burnet also frequent throughout the field. Sedges appeared to be more common in this field and included hairy sedge (*Carex hirta*), false fox sedge (*Carex otrubae*), common sedge (*Carex nigra*) and tufted sedge (*Carex acuta*). Otherwise it was very similar to the western field (Photos 26 and 27).

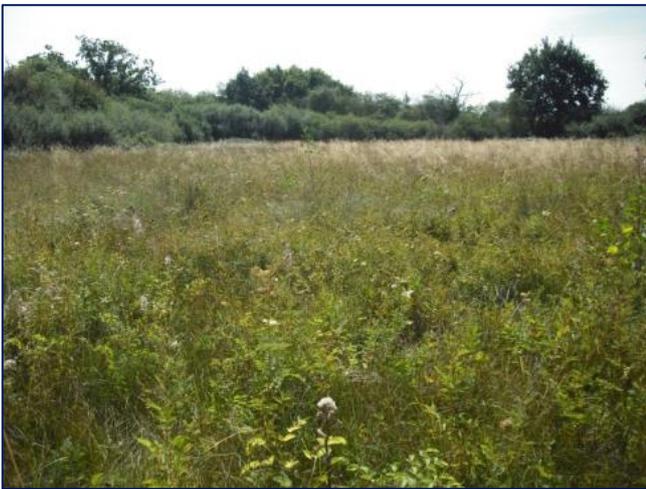
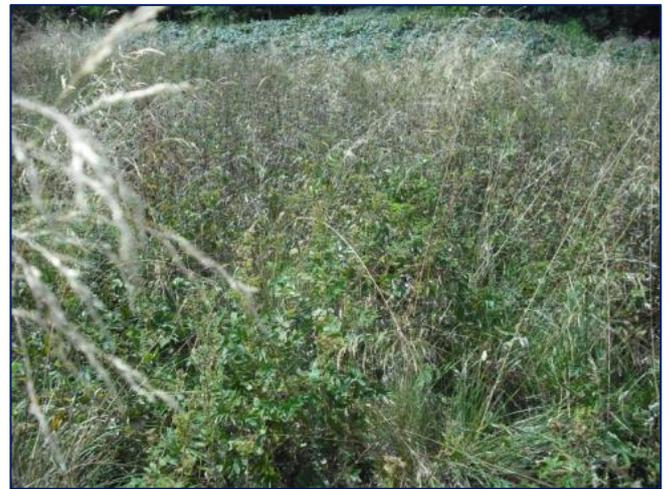
**Photo 26 (left) and Photo 27 (right) - typical vegetation in the NW SSSI unit eastern field.**

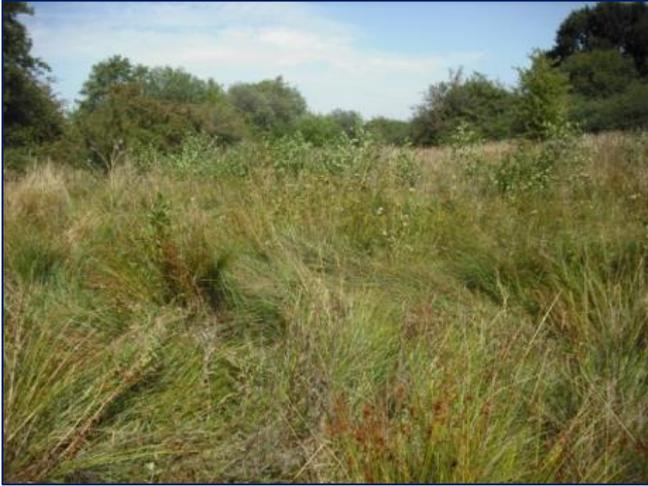
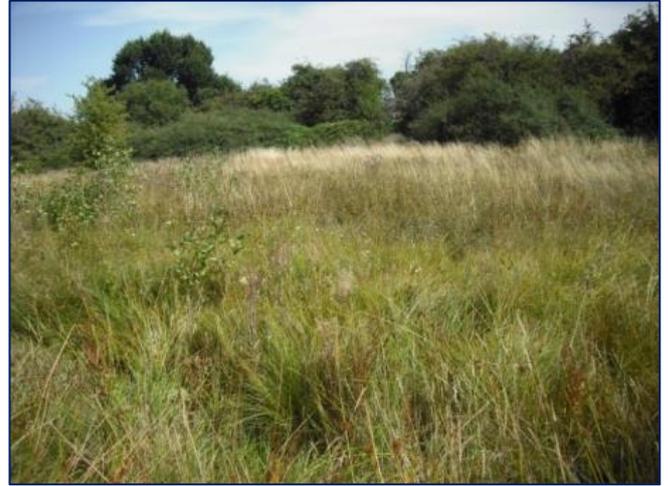
- 11.11 Part way along the western boundary of the field, there was a distinctive change in vegetation and whilst this will have to be shown by survey, it appeared to be delineated by a low spot, possibly linked to the ditch and was demarked by young alders (*Alnus glutinosa*). The vegetation here was dominated by tall rushes including soft rush (*Juncus effusus*), hard rush (*Juncus inflexus*) and sharp flowered rush (*Juncus acutiflorus*), along with sedges with abundant great hairy willowherb (*Epilobium hirsutum*) and in the wettest areas patches of fool's watercress (*Apium nodiflorum*). This is the area considered to be a potential spring in the preceding discussion (Photo 27 and Photo 28).

**Photo 27 (left) and Photo 28 (right) - typical vegetation in the distinct wetter area within the NW SSSI unit eastern field.**

- 11.12 Five quadrats were recorded in this area and the data was run through TABLEFIT. The goodness-of-fit to the NVC community type OV26; *Epilobium hirsutum* community was around 58% and classed as a fair fit. A similar fit was obtained from the MG9 community; *Holcus lanatus-Deschampsia cespitosa* grassland. This community is found in area where the ground is seasonally waterlogged and can be found in association with MG4 grassland but is not usually as species diverse and is tolerant of less free draining soils.

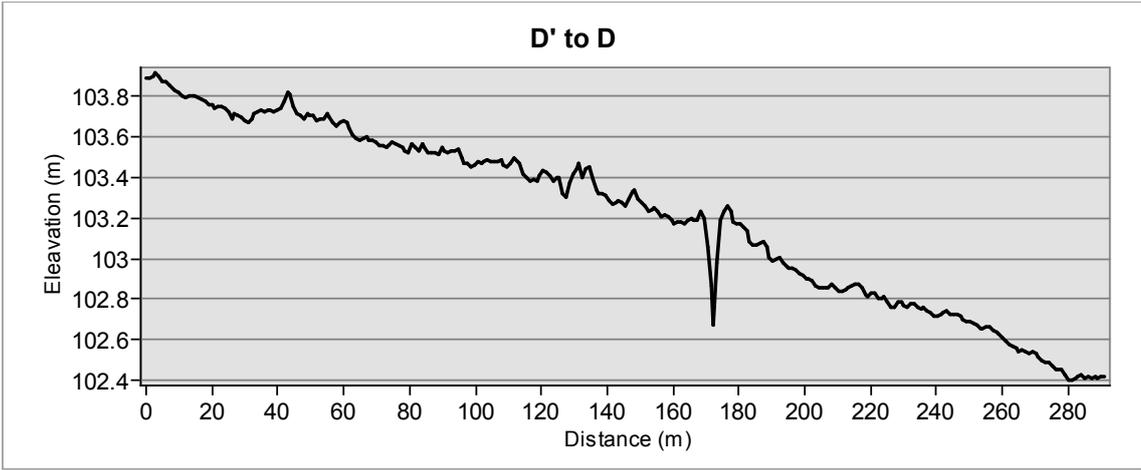
### NW SSSI unit

Note. Indicative cutting of up to 9m depth shown in blue.
