M25 junction 28 improvement scheme TR010029 6.3 Environmental Statement Appendix 7.5: River corridor survey

6.3 ENVIRONMENTAL STATEMENT 7.5: RIVER CORRIDOR SURVEY

Appendix 7.5 River corridor survey

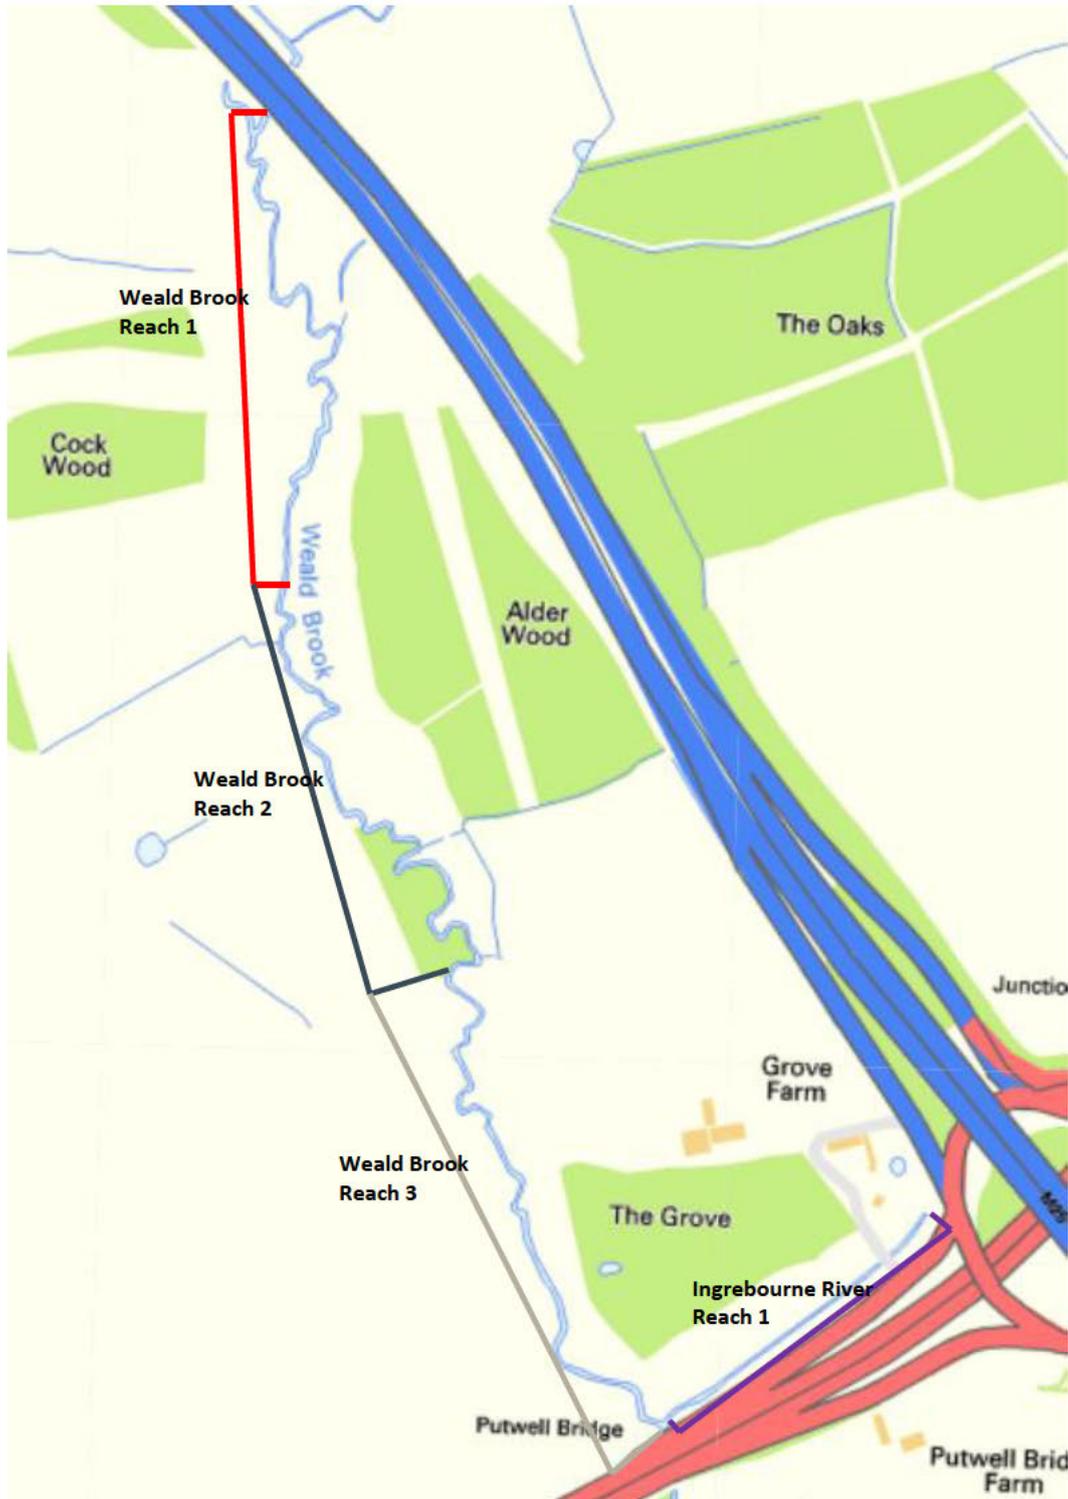
Figure 7.2: Reaches of the Weald Brook and Ingrebourne River surveyed

7.3.1 The RCS's were undertaken as per the methodology within the National Rivers Authority "River Corridor Surveys – Technical Handbook No 1"⁴. For this scheme, three 500 m reaches were identified using Ordnance Survey mapping for the Weald Brook. The length of the the Ingrebourne River were surveyed between the culvert beneath the M25 and the confluence with the Weald Brook, a total of 270 m. The reaches surveyed for this Scheme are shown in Figure 7.2 and summarised in Table 7.1.

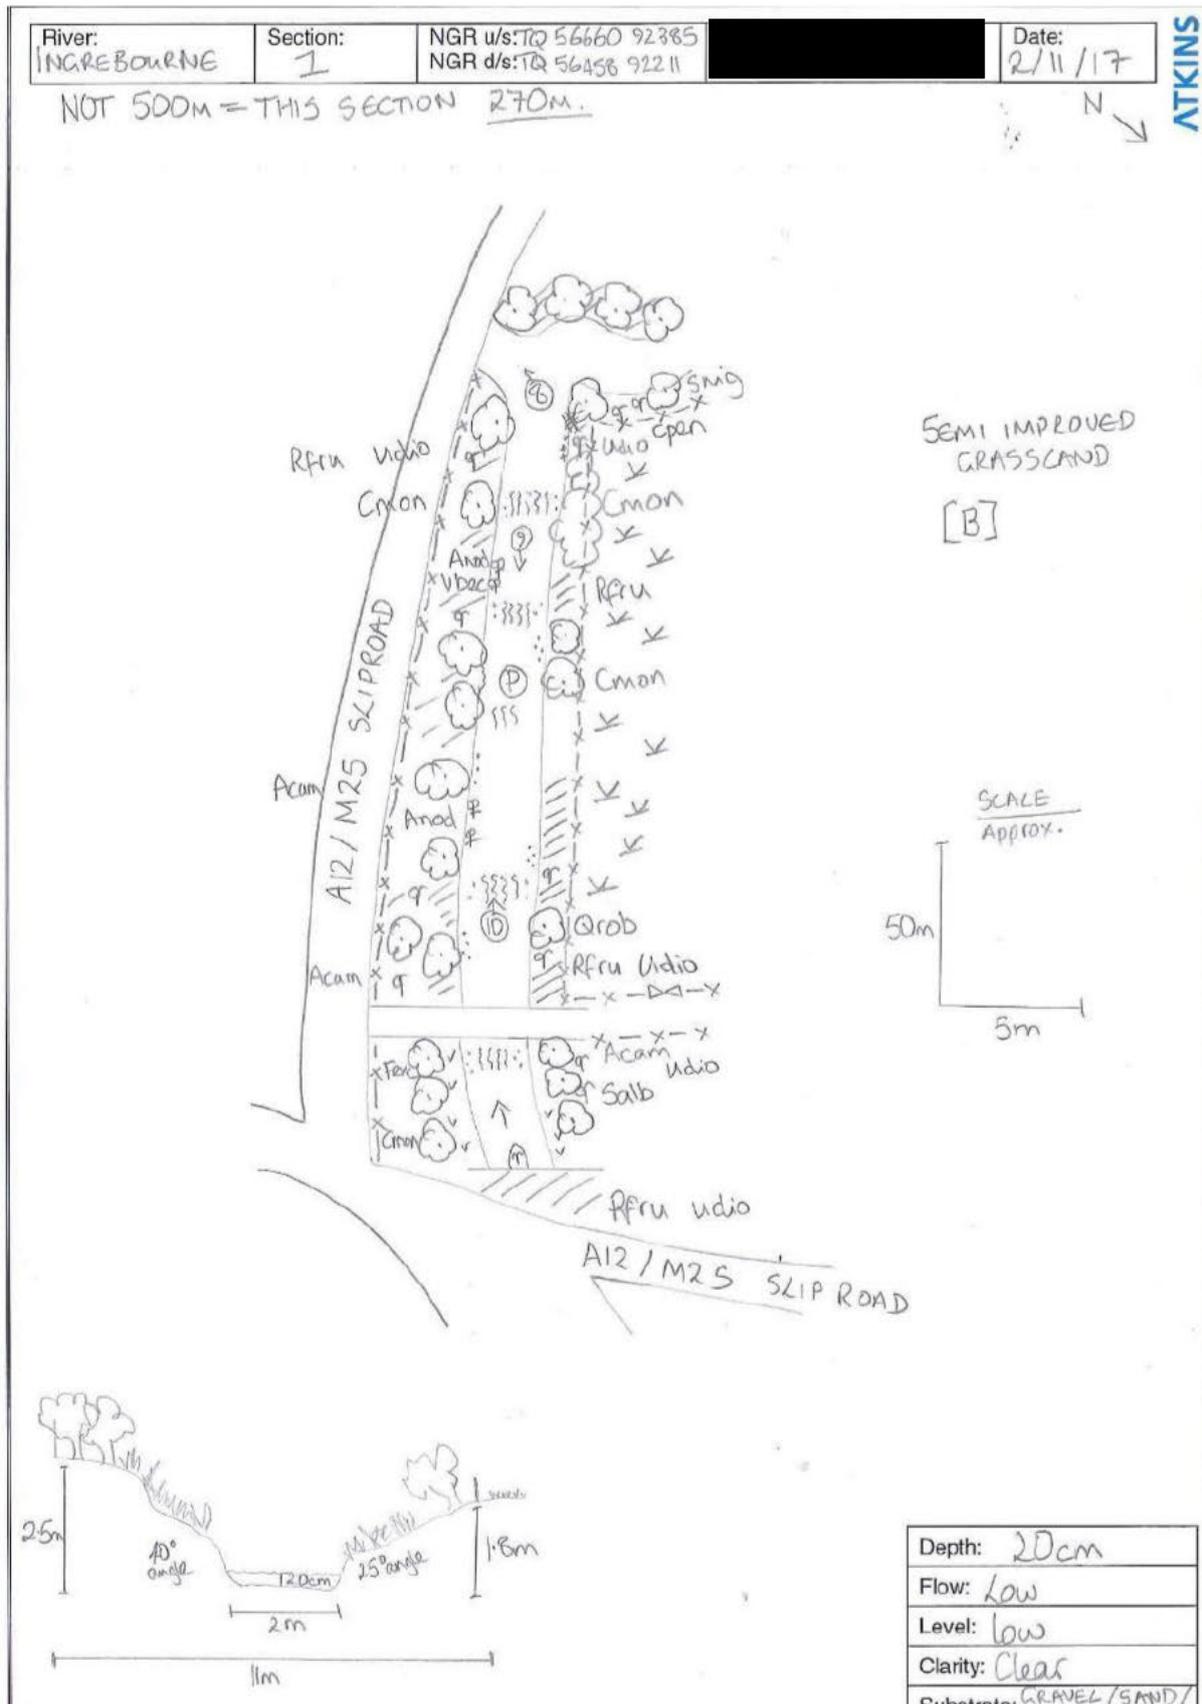
Figure 7.3: River Corridor Survey Map –Ingrebourne River Reach 1

- 7.5.1 The Ingrebourne River in this reach has been historically straightened to run adjacent to the A12/M25 slip road. At the most upstream point the river flows beneath the M25 from a north-easterly direction through a double box culvert. As it flows adjacent to the slip road, it is shaded by a variety of tree species and hedgerows. While there is very little sinuosity within the channel, there are five riffles through the reach and areas of erosion and deposition occurring along the margins. The dominant flow type recorded was smooth glide. At the downstream end of the surveyed reach is the confluence with the Weald Brook which has resulted in a slow flowing, deeper section with increased sedimentation.

- 7.5.2 The wetted width of the channel varied little through the reach, and was at most 2.5 m wide with areas of riffles or gravel deposits being approximately 1.5m wide. Average depth throughout the reach was approximately 0.2 m with deeper areas at the downstream end, of approximately 0.4 m.

- 7.5.3 Water clarity was good at the time of survey, with the bed visible throughout the survey reach. The substrate was predominantly gravel and pebble with some areas of silt, particularly in slow flowing areas such as the downstream end close to the confluence with the Weald Brook.

- 7.5.4 An embankment flanks the left bank (A12/M25 slip road) for the entire length of the reach which is approximately 2.5 m high. There is an embankment along the right bank which at the upstream end is approximately the same height as the left. An access road crosses the river approximately 40 m from the upstream end of the reach. From here the embankment gradually reduces in height to bank top at the confluence. The left bank is steep, at approximately 40°. Downstream of the access road, the right bank is shallower at approximately 25°. Both banks are vegetated with a mixture of grass, tall herbs, shrubs and trees. The bank height is approximately 0.4 m on both banks. Bank material was earth with potential signal crayfish burrows identified at the downstream end.

- 7.5.5 An access road crosses the river approximately 40 m from the upstream end of the reach. At the downstream end the river is joined by the Weald Brook.

- 7.5.6 Aquatic vegetation within this reach was limited to fool's water-cress (*Apium nodiflorum*) and brooklime (*Veronica beccabunga*) in the margins, with most of the channel devoid of vegetation. Filamentous algae was also recorded. In places, the bankside vegetation such as grasses and herbs overhung the river channel.

- 7.5.7 Bankside vegetation was dominated by a mix of trees and shrubs, including field maple (*Acer campestre*), oak (*Quercus robur*) and alder (*Alnus glutinosa*), with extensive areas of hawthorn (*Crataegus monogyna*) hedgerows, particularly on the left bank. Where light and space was available below trees, the understory consisted of predominantly of bramble (*Rubus fruticosus*), nettle (*Urtica dioica*) and other tall herbs. A small amount of Himalayan Balsam (*Impatiens glandulifera*) was present at the culvert under the M25.

- 7.5.8 The left hand bank was flanked by the A12/M25 slip road, the right bank by semi-improved grassland/pasture.

- 7.5.9 This channel has a mix of habitats suitable for a variety of fish and aquatic macro-invertebrate species, with a number of riffles, tree roots and marginal vegetation present throughout.
- 7.5.10 However, it has been historically straightened and would benefit from restoration, including restoring sinuosity (e.g. through berm installation), creating backwaters and introduction of woody debris. Increasing the light entering the channel by selective removal of bankside trees and hedgerows is likely to act to improve ecological condition through improved distribution and abundance of in-stream vegetation.

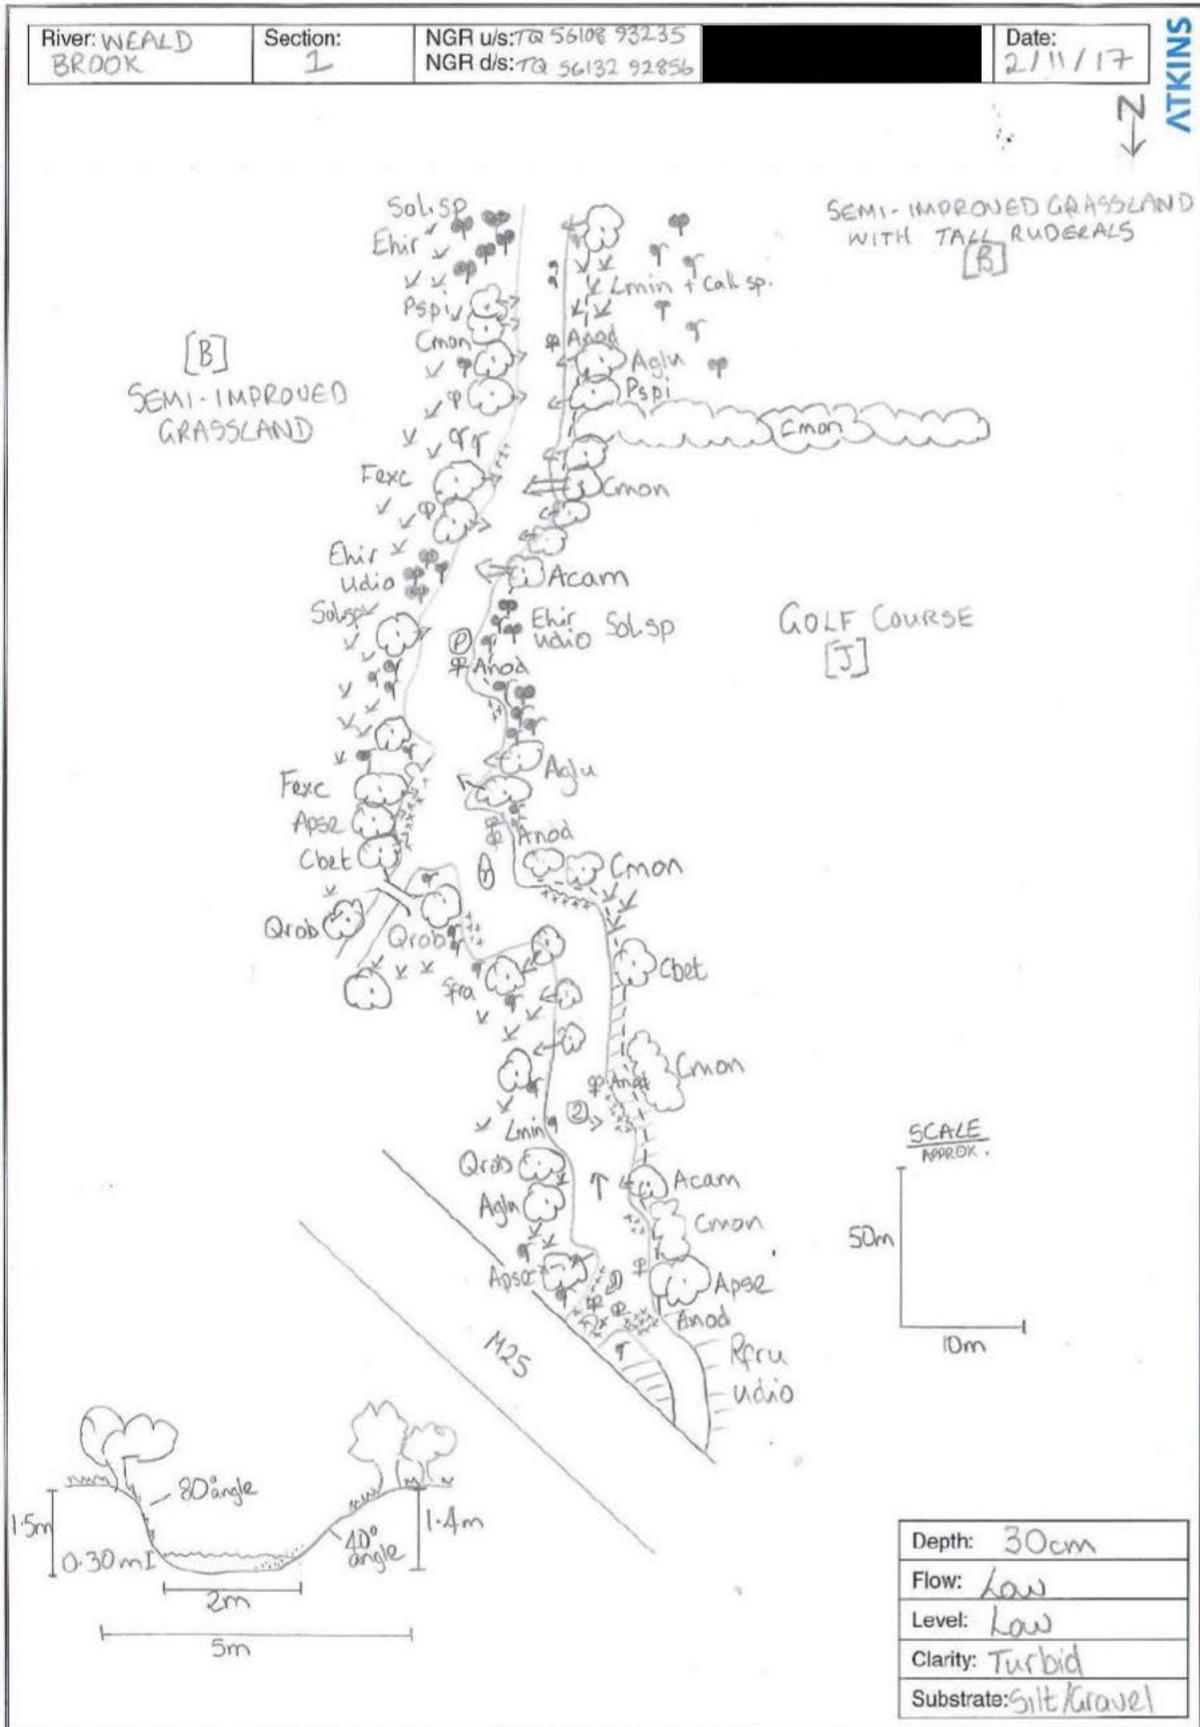
Figure 7.4: River Corridor Survey Map – Weald Brook Reach 1

- 7.7.1 This reach was heavily shaded by mature trees and scrub along both banks, primarily consisting of alders and hawthorn. The watercourse flows from the north-east beneath the M25. The channel is wide at the most upstream end (approximately 3 m), with a vegetated mid-channel bar. The bed substrate at this location appears reinforced with cobble, although downstream the substrate quickly changes to silt with occasional areas of gravel. This reach meanders through a golf course on the right bank and rough pasture and scrub on the left bank with large amounts of woody debris and fallen trees within the channel. The wetted width is variable through the reach as a result of woody debris accumulations and silt deposition. Where the bankside canopy is open, small areas of aquatic vegetation are present.

- 7.7.2 The average bank top width was approximately 2 m with the wetted width varying greatly between 0.5 m and 1.5 m. Average depth was approximately 0.3 m with shallower areas caused by woody debris and silt deposition. There was no perceptible flow through much of the reach, with smooth flow evident in narrow sections of the channel.

- 7.7.3 The reach was heavily sedimented with frequent silt marginal bars and occasional gravel/pebble accumulations. At the upstream end, where the river flows from beneath the M25, the bed is reinforced with cobbles.

- 7.7.4 Both banks consist of earth and are both approximately 1.5 m high. The right bank has a more gentle slope towards the golf course, while the left hand bank is at approximately 80°.

- 7.7.5 A small side channel is present at the most upstream end. It was discharging a small flow volume to the Weald Brook at the time of survey despite being blocked by debris. A larger side channel is present approximately half way down the reach, which is crossed by a footbridge. There is a large amount of woody debris and fallen trees within the reach which create natural obstructions to water flow and add habitat complexity.

- 7.7.6 Due to heavy shading, there was very little instream or marginal vegetation. Occasionally, where there was a break in the canopy shading, there were small patches of fool's water-cress, duck weed (*Lemna minor*), starwort (*Callitriche* species) and celery-leaved buttercup (*Ranunculus sceleratus*).

- 7.7.7 Large mature trees occurred along both banks (including dead specimens), with many overhanging the channel. Dominant tree species included hawthorn, ash (*Fraxinus excelsior*), field maple, oak, alders and sycamore (*Acer pseudoplatanus*). A dense understory consisted of nettle, willowherb (*Epilobium hirsutum*), goldenrod (*Solidago* species) and bramble. A small amount of Himalayan balsam was present at the culvert under the M25.

- 7.7.8 Beyond the mature trees and tall herbs, a golf course was on the right bank, with rough pasture at the most downstream end. Rough pasture with tall herbs occurred along the entire length of the left bank.

- 7.7.9 This reach is heavily shaded by bankside trees, hedgerows and scrub. Removing occasional trees from the bank top could improve the amount of in-channel and marginal vegetation present.

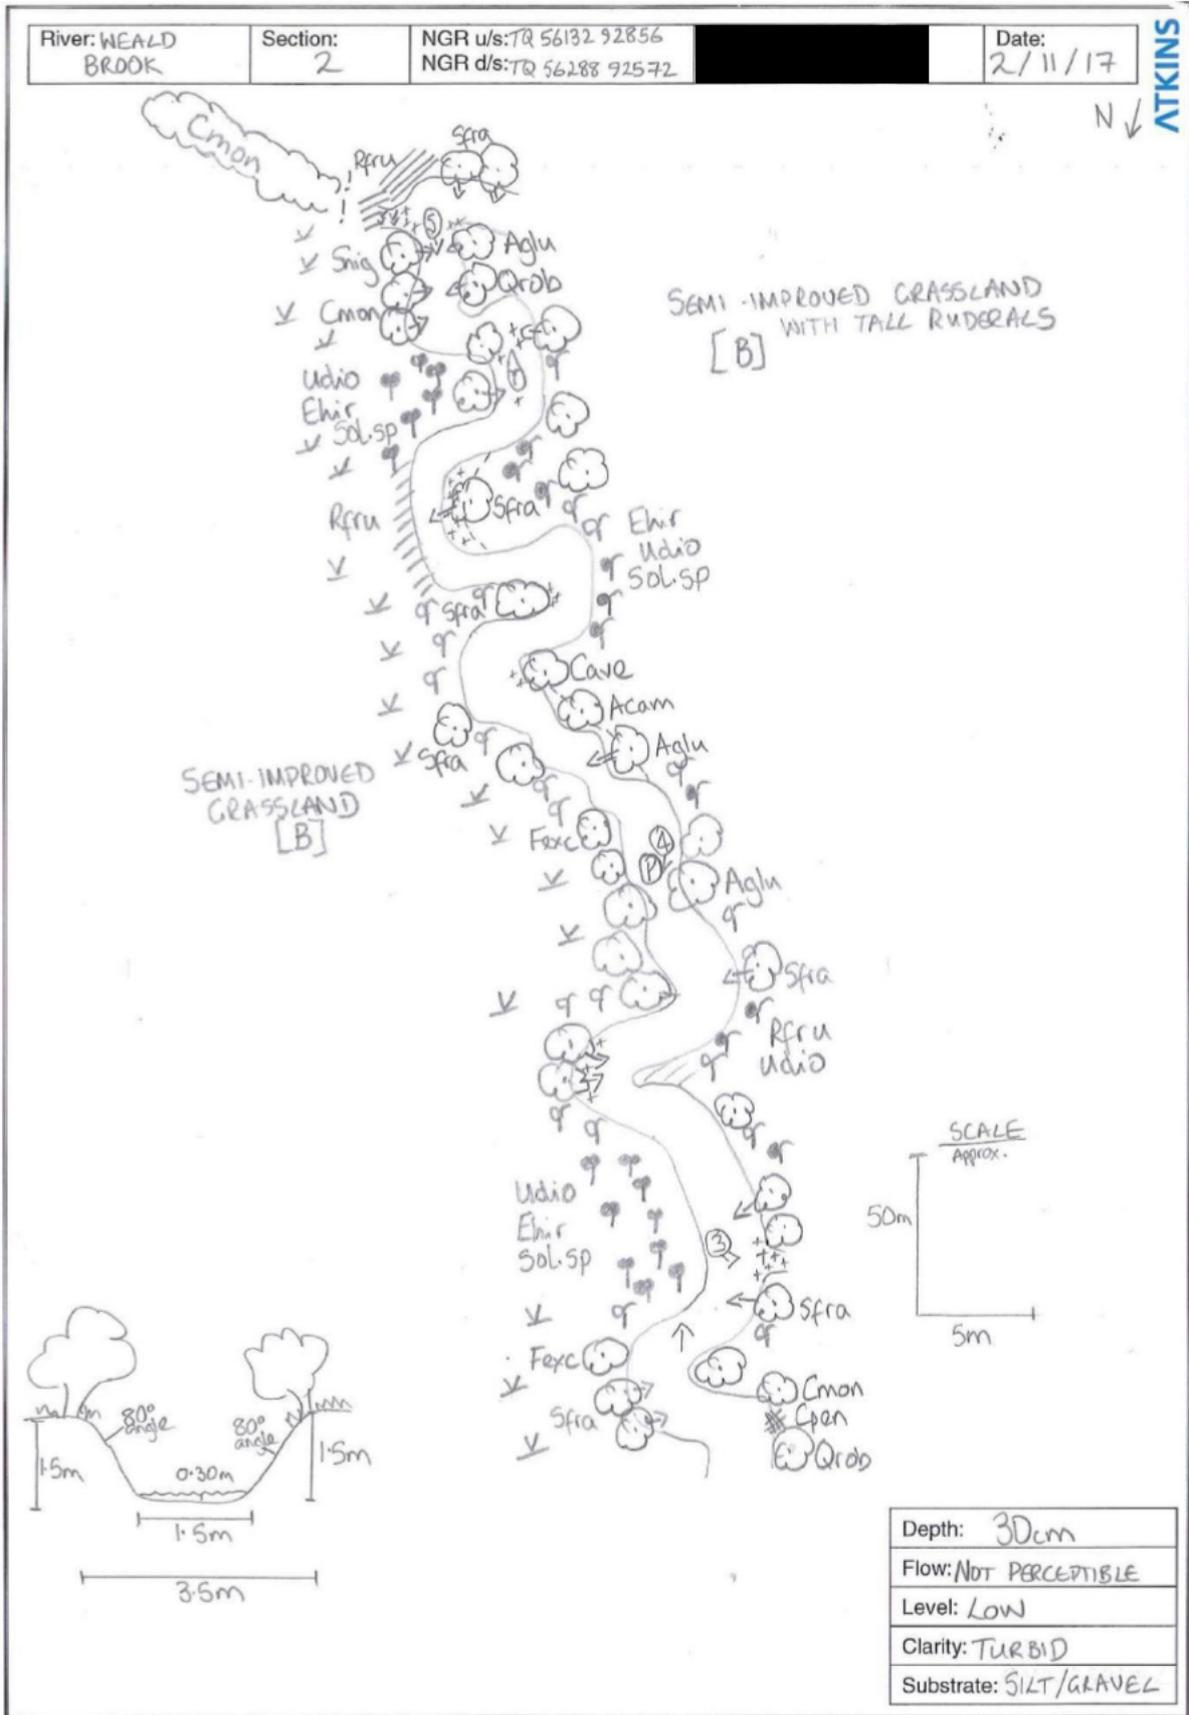
Figure 7.5: River Corridor Survey Map – Weald Brook Reach 2

- 7.9.1 This reach was heavily shaded by mature trees and scrub along both banks, primarily consisting of crack-willow (*Salix fragilis*), with field maple, alders and hawthorn. The watercourse flows north to south through a naturally sinuous channel. The bed substrate consists of large amounts of silt with occasional gravel. Many of the trees overhang the channel with occasional instances of mature trees growing in the channel. The bank top width is narrower than upstream reach, at an average of 1.5 m. Wetted width ranged from 0.1 m to 2.5 m. Adjacent land use on both banks consisted of rough pasture with large stands of goldenrod and nettle.

- 7.9.2 The average bank to bank width was approximately 1.5 m with the wetted width varying greatly due to wide meanders and in-channel trees, between 0.1 m and 2.5 m. Average depth was approximately 0.3 m with shallower areas caused by woody debris and silt deposition. There was no perceptible flow through much of the reach, with smooth flow evident in narrower sections of the channel.

- 7.9.3 The reach was heavily sedimented with frequent silt marginal bars and very occasionally gravel/pebble deposits.

- 7.9.4 Both banks consist of earth and are both approximately 1.5 m high. Both banks have a steep slope, at approximately 80°.

- 7.9.5 Three side channels were identified during the survey, all were dry at the time of survey, but are likely to act as field drainage discharge points during wet periods. There is a large amount of woody debris, fallen trees and in-channel trees within the reach, which create natural obstructions to water flow and add habitat complexity.

- 7.9.6 Due to heavy shading from trees no in-stream or marginal vegetation was present. A vegetated mid-channel bar was present with terrestrial grasses and herbs.

- 7.9.7 Large mature trees occurred along both banks (including dead specimens), with many overhanging the channel. The dominant tree species in this reach was crack-willow, with hawthorn, field maple and alders. A dense understory consisted of nettle, goldenrod, willowherb and bramble.

- 7.9.8 Rough pasture with tall herbs, ran the entire length of the left bank. Extensive stands of goldenrod and nettle were present on the left bank.

- 7.9.9 This reach is heavily shaded by bankside trees, hedgerows and scrub. Removing occasional trees could improve the amount of in-channel and marginal vegetation present.

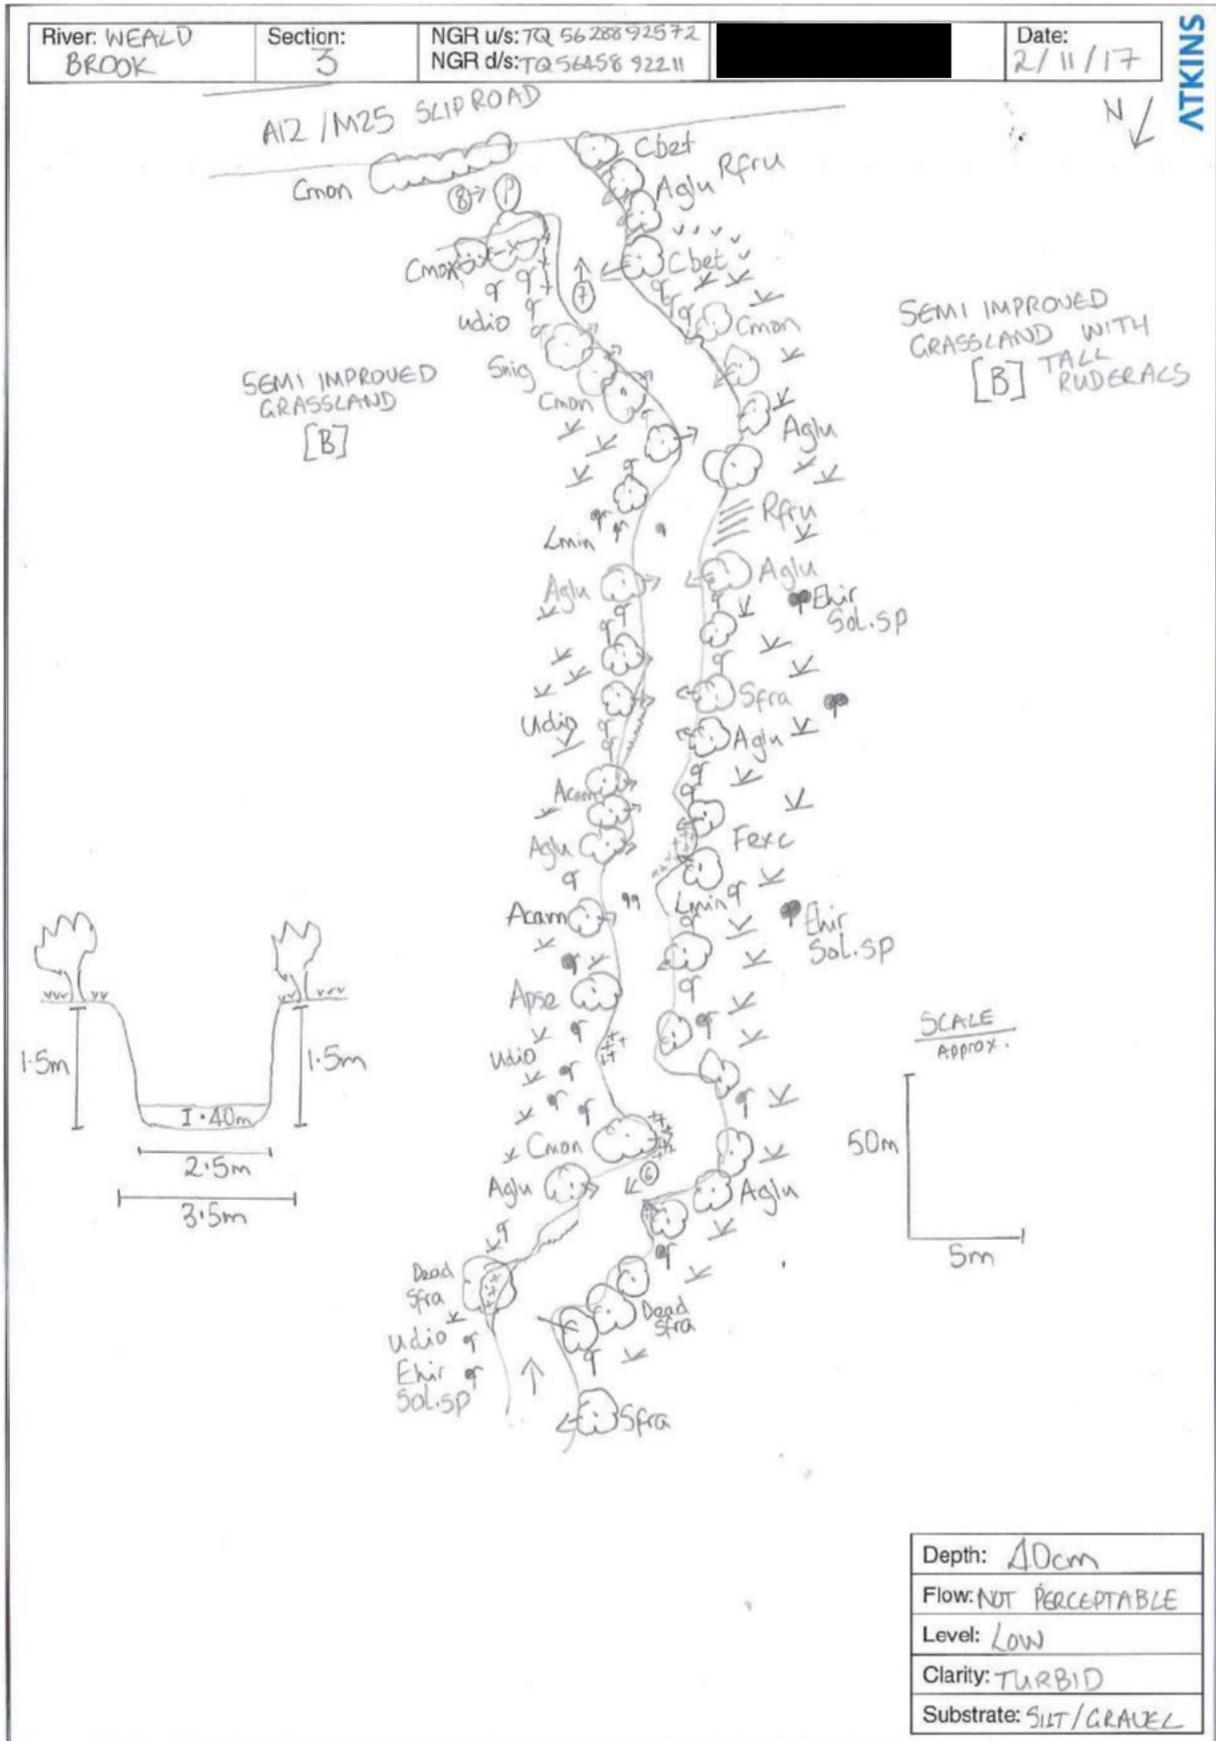
Figure 7.6: River Corridor Survey Map – Weald Brook Reach 3

- 7.11.1 In common with Reach 1 and Reach 2 this reach was also heavily shaded by mature trees and scrub along both banks, primarily consisting of alders, hawthorn and hornbeam (*Carpinus betulus*). The channel in this reach becomes less sinuous in the downstream direction, due in part to the impoundment caused by the confluence with the Ingrebourne River at the downstream end. Upstream, the channel is more sinuous with the wetted width varying due to silted side bars. Downstream the watercourse is deeper and consistently wider. Where the bankside canopy is open, small areas of aquatic vegetation were recorded.

- 7.11.2 At the most upstream end, the wetted width varies between and 1 m and 2 m with a depth of approximately 0.25 m. Soon the wetted width fills the entire channel which widens to approximately 2.5m with a depth of approximately 0.4m. There was no perceptible flow through this reach.

- 7.11.3 The reach was heavily sedimented with occasional silt marginal bars. Moving downstream, the turbid water prevented visibility of the bed but it is presumed that silt substrate remains dominant.

- 7.11.4 Both banks consist of earth and are both approximately 1.5 m high and approximately 80°. Some liverworts were present on the bank face in the downstream section of the reach.

- 7.11.5 No side channels were present, other than the confluence with the River Ingrebourne. Woody debris in the upstream section creates some natural obstructions to water flow.

- 7.11.6 Where there was a break in the canopy shading, there were small patches of duck weed.

- 7.11.7 Large mature trees occurred along both banks (including dead specimens), with many overhanging the channel. Dominant tree species included hornbeam, alder and hawthorn. Upstream a dense mix of tall grass and herbs was present beneath and between trees on both banks. Growth became less dense further downstream.

- 7.11.8 Rough pasture with tall herbs, ran the entire length of both banks.

- 7.11.9 It is likely that heavy shading by the mature broadleaved woodland has limited the presence of any in-channel and marginal aquatic macrophytes. The removal of occasional trees and/or scrub to allow more light into the channel could encourage aquatic macrophytes to establish within this reach.
