M25 junction 28 improvement scheme
TR010029
6.3 Environmental Statement
Appendix 10.5: UXO risk map

6.3 ENVIRONMENTAL STATEMENT APPENDIX 10.5: UXO RISK MAP

STAGE 2 DETAILED UXO RISK ASSESSMENT

Report Reference: DRA-19-1096

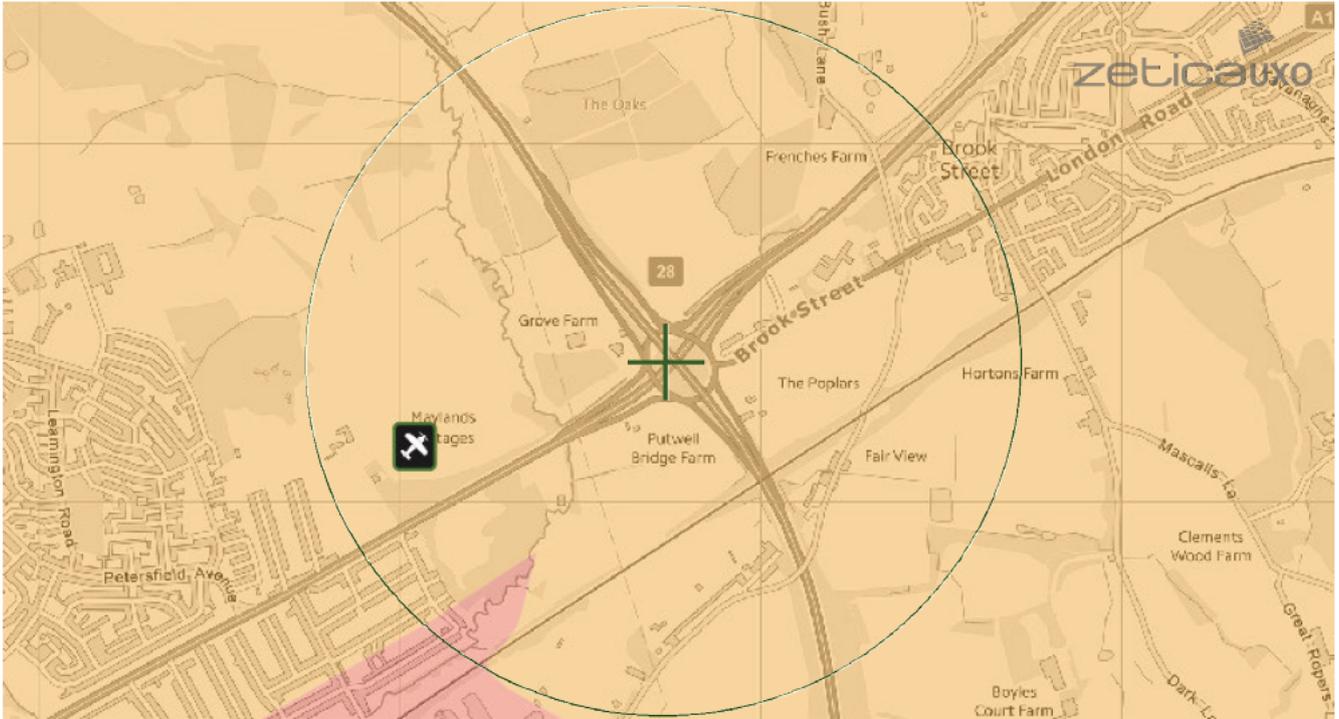
Map Centre: 556744,192396

- High:** Areas indicated as having a bombing density of 50 bombs per 1000acre or higher.
- Moderate:** Areas indicated as having a bombing density of 15 to 49 bombs per 1000acre.
- Low:** Areas indicated as having 15 bombs per 1000acre or less.

The map indicates the potential for Unexploded Bombs (UXB) to be present as a result of World War Two (WWII) bombing.

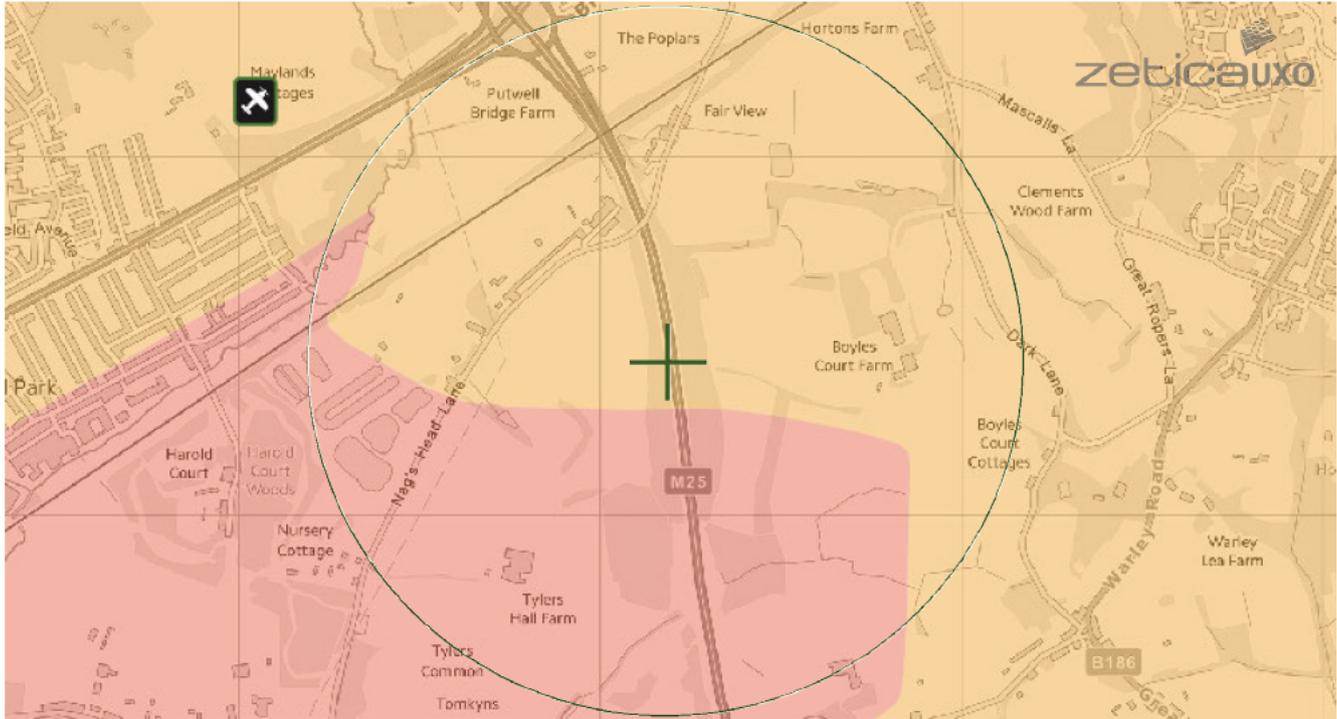
Map Centre: 557193,191433

- High:** Areas indicated as having a bombing density of 50 bombs per 1000acre or higher.
- Moderate:** Areas indicated as having a bombing density of 15 to 49 bombs per 1000acre.
- Low:** Areas indicated as having 15 bombs per 1000acre or less.

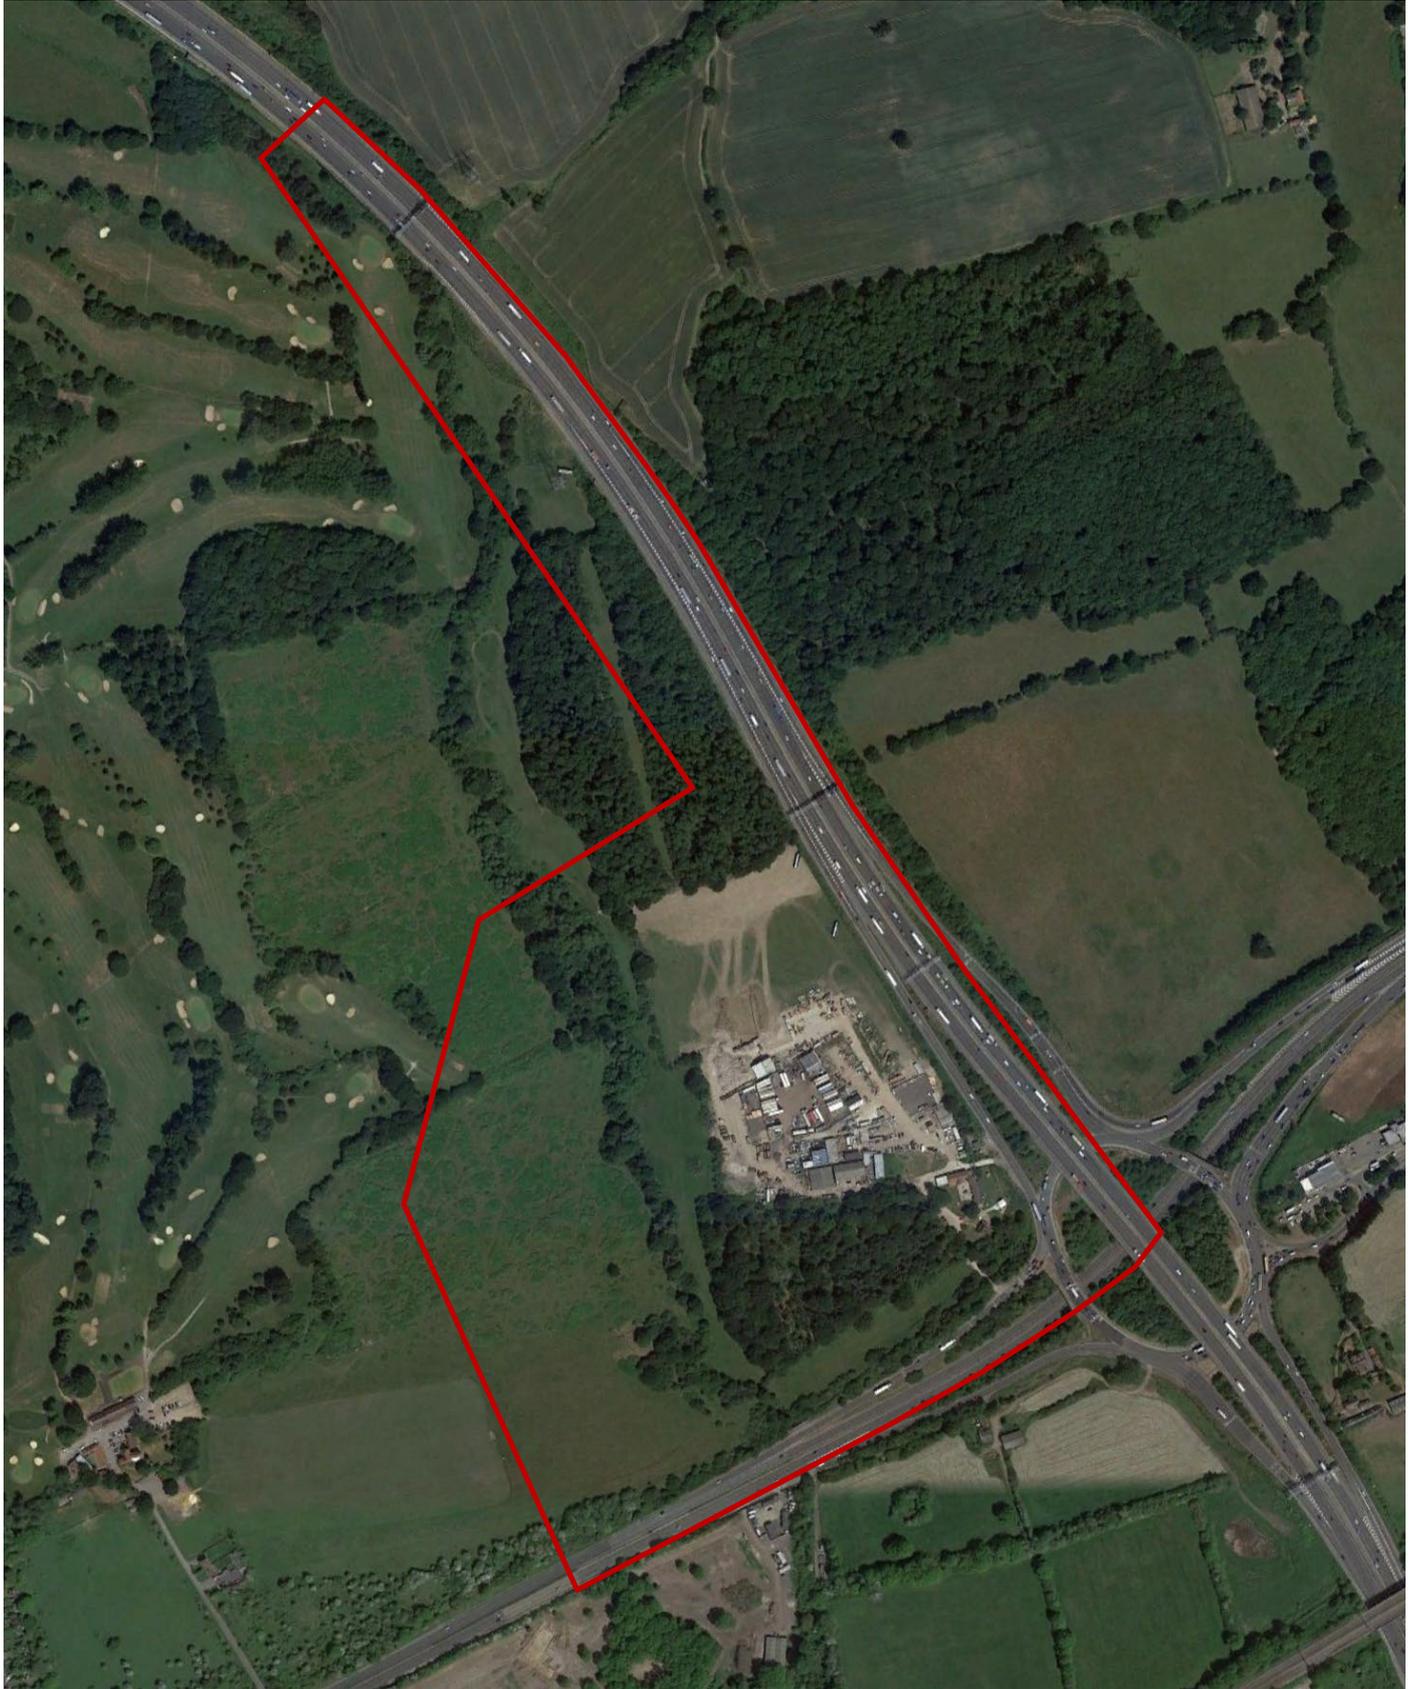
Project	M25 Junction 28, Romford
Client:	Geotechnical Engineering Ltd
Report Ref:	DRA-19-1106
— Approx. Site Boundary	Info Source: Google (open-source)

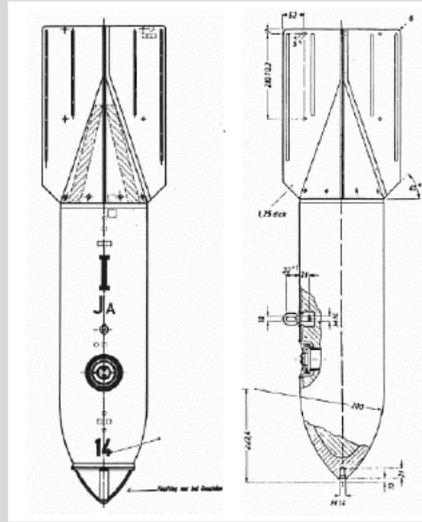
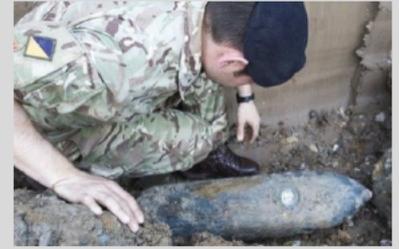
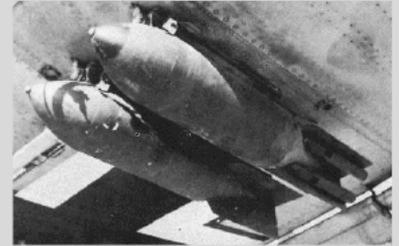
SC 50

Bomb Weight: 40-54kg (110-119lb)
Explosive Weight: 25kg (55lb)
Filling: TNT, Amatol or Trialen
Charge/Weight Ratio: 46%
Fuse Type: Electrical impact fuse or mechanical delayed action fuse
Body Dimensions: 1,100mm length x 200mm diameter
Appearance: Bomb body and tail painted grey/green with a yellow stripe on the tail unit. Steel construction.
Variants: 8 x variants. Additional fittings: Kopfring nose for limited penetration and Stabbo nose for dive-bombing.

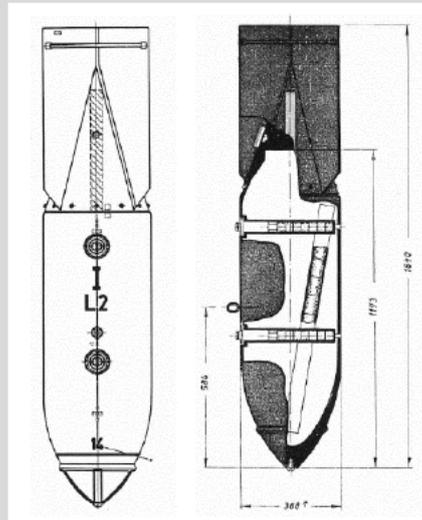
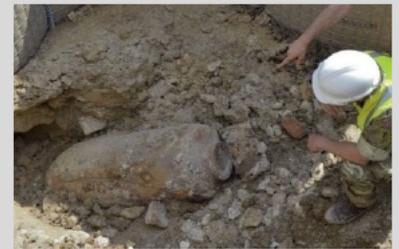
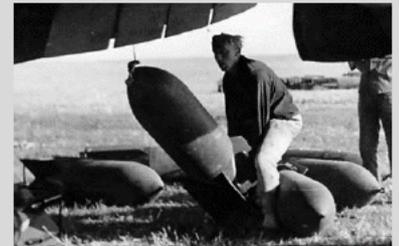
SC 250

Bomb Weight: 245-256kg (540-564lb)
Explosive Weight: 125-130kg (276-287lb)
Filling: TNT, Amatol and Trialen mix
Charge/Weight Ratio: 44%
Fuse Type: 1 or 2 electrical impact fuse(s) or mechanical delayed action fuse(s)
Body Dimensions: 1,173mm length x 368mm diameter
Appearance: Bomb body and tail painted grey/green with a yellow stripe on the tail unit. Steel construction.
Variants: 8 x variants. Kopfring nose for limited penetration. Stabbo nose for dive-bombing.

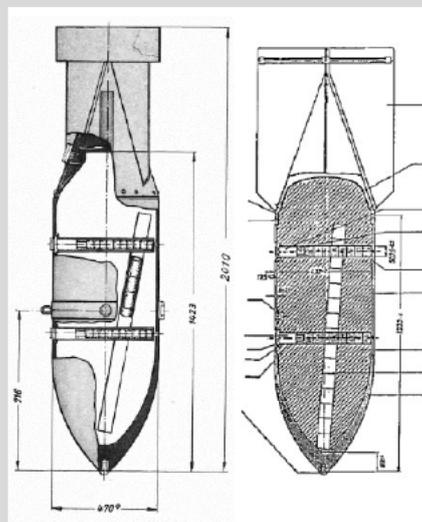
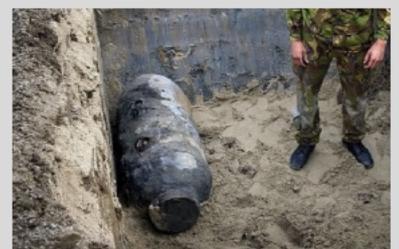
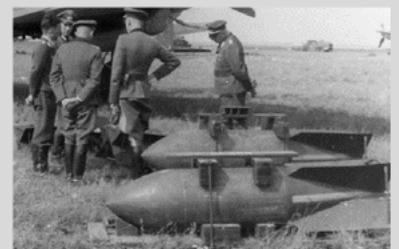
SC 500

Bomb Weight: 480-520kg (1,058-1,146lb)
Explosive Weight: 220kg (485lb)
Filling: TNT, Amatol and Trialen mix
Charge/Weight Ratio: 44%
Fuse Type: 2 electrical impact fuses or mechanical delayed action fuses
Body Dimensions: 1,423mm length x 470mm diameter
Appearance: Bomb body and tail painted grey/green or buff with a yellow stripe on the tail unit. Steel construction.
Variants: 3 x variants. Kopfring nose for limited penetration.

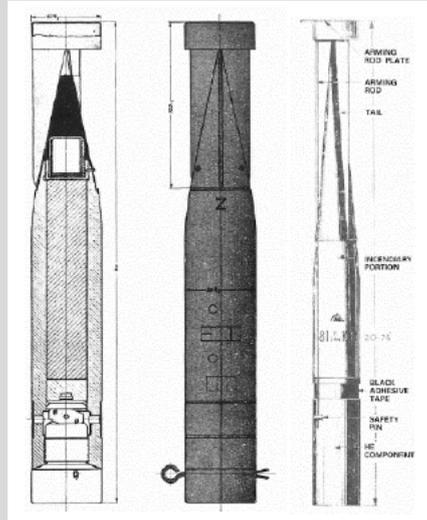
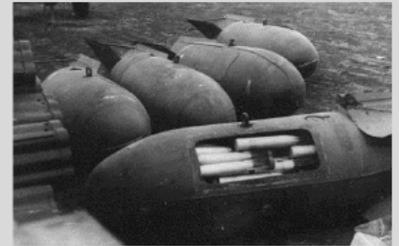
B-1E Sub-Munition

Bomb Weight: 1-1.3kg (2 2-2 87lb)
Incendiary Weight: 680g (1.4lb)
Filling: Thermite
Fuse Type: Simple impact fuse
Body Dimensions: 247mm length x 50mm diameter
Appearance: Grey body and dark green painted tail unit. Magnesium alloy case.
Operation: Small percussion charge ignites Thermite (>1,000°C burn).
Variants: Most common variant: B 2EZ (2kg) included a small HE charge
Remarks: Drop containers varied in size. The smallest cluster bomb held 36 x B-1Es and the largest 620 x B-1Es.

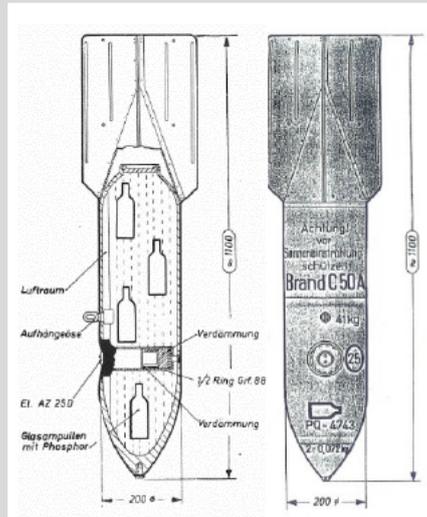
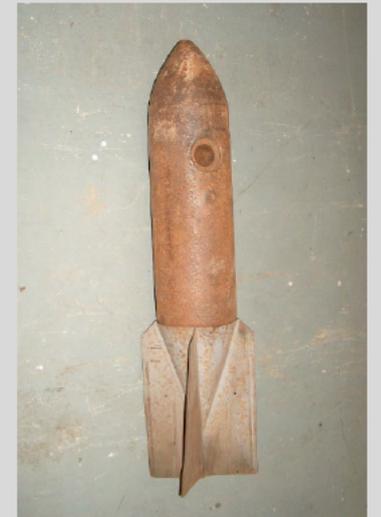
Brand C50

Bomb Weight: 41kg (90.4lb)
Incendiary Weight: 13kg (30lb)
Filling: Main fill (86% Benzine, 10% Rubber) plus 4% Phosphorus in glass bottles
Fuse Type: 1 x electrical impact fuse
Bomb Dimensions: 762mm length x 203mm diameter
Appearance: bomb body and tail painted grey or green with the rear of the bomb painted red and a red band around the centre of the body.
Variants: C 50 B: 77% White Phos fill
 C 250 A: 87.7% Petroleum, 11.7% Polystyrene, 0.5% White Phos (185kg version)

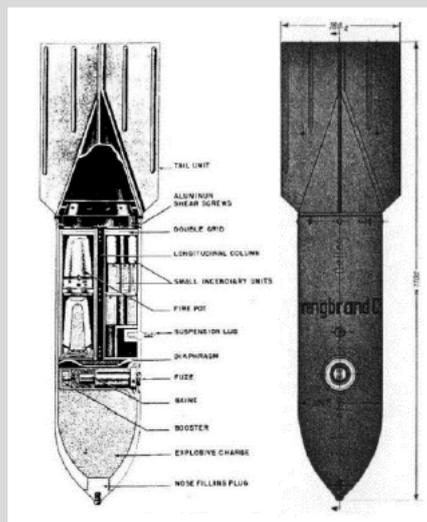
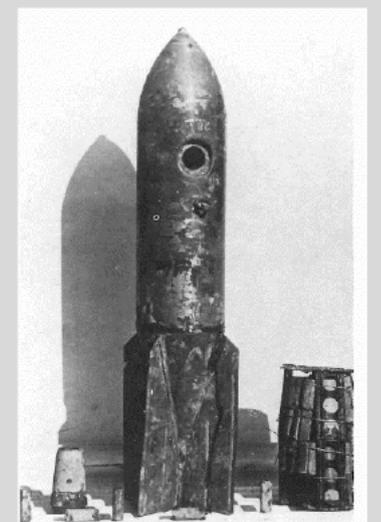
Spreng-Brand C50 - Fire Pot

Bomb Weight: 34kg (75lb)
Explosive Weight: 9kg (20lb)
Filling: TNT burster charge, 6 x Thermite containers (fire pots) and 67 x small triangular incendiary elements.
Fuse Type: 1 x electrical impact fuses or aerial burst fuse
Bomb Dimensions: 711mm length x 203mm diameter
Appearance: Bomb body and tail painted grey/green or pale blue with red base plug and red or green incendiary markings. Steel construction.
Operation: A charge blows off the base plate, firing a plume of incendiary mixture 100 yds. Approx 1 second later the HE charge detonates.

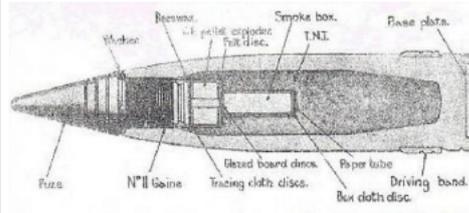
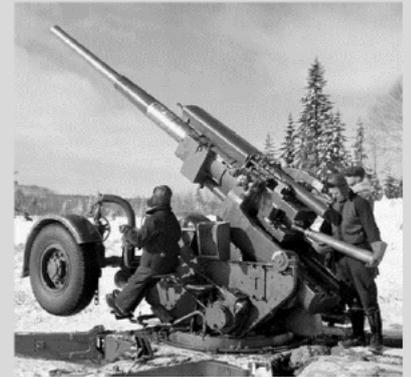
HAA Battery - 3.7" QF Shell

Shell Weight: 12.7kg
Shell Dimensions: 94mm x 438mm
Fill Weight: 1.1kg
Fill Type: TNT
Fuse Type: Mechanical Time Delay fuse
Appearance: Grey body, copper driving bands, brass neck
Rate of Fire: 10 - 20 rpm
Ceiling: 9,000 - 18,000m
Variants: HE or shrapnel shells.
 Note, the 4.5" gun was also used in an HAA role throughout the UK.

British time fuses were poorly manufactured during WWII and this led to high failure rate for HAA shells, up to 30%. Unexploded HAA shells had the potential to land up to 27km from their battery, although more typically landed within a 15km radius.

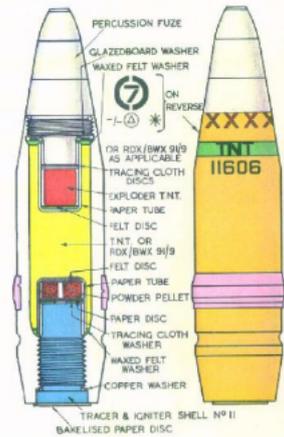
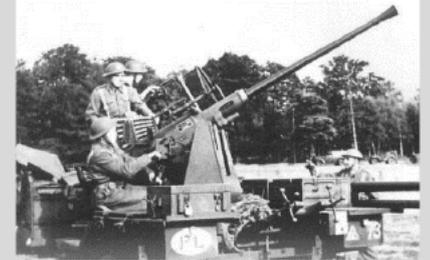
LAA Battery - 40mm Bofors Shell

Shell Weight: 0.84kg
Shell Dimensions: 40mm x 180mm
Fill Weight: 70g
Fill Type: TNT
Fuse Type: Impact fuse
Appearance: Grey body, copper driving bands, brass neck
Rate of Fire: 120 rpm
Ceiling: 7,000m
Variants: HE or AP shells. Both with rear tracer compartment

The 40mm Bofors gun could fire 120 x HE shells / minute to a ceiling of 1,800m. Each shell was designed to self-destruct if it didn't strike an aircraft, however, inevitably some failed and fell back to earth.

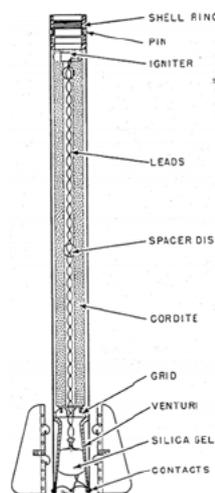
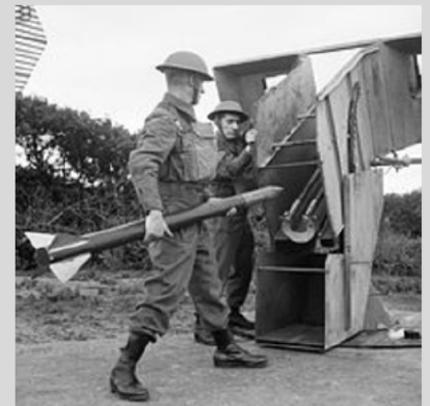
Z Battery - 3" U.P Rocket

Rocket Weight: 24.5kg
Warhead Weight: 1.94kg
Filling: TNT warhead. Black Powder solid fuel rocket motor.
Fuse Type: Mechanical Time Delay fuse
Rocket Dimensions: 1,930mm x 76mm
Ceiling: 6,770m
Operation: Fired from single, tandem and (later) 36 x rail launchers (Z Batteries). Limited use throughout the UK.

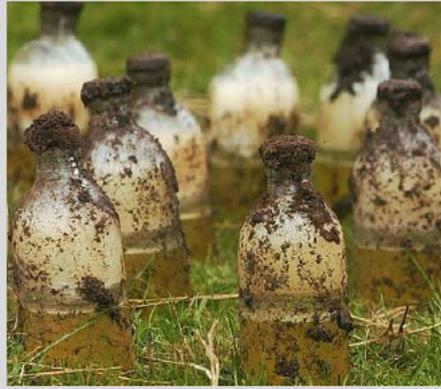
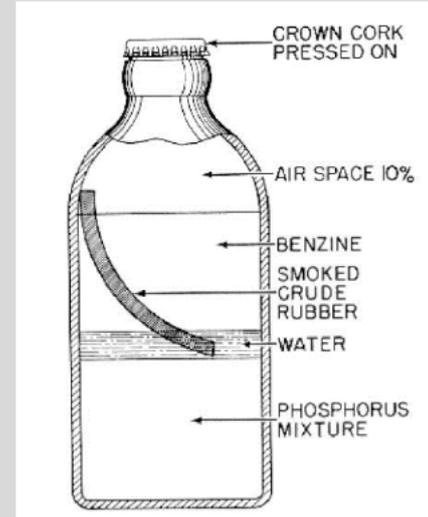
No. 76 Self Igniting Grenade (SIP)

Construction: Glass bottle and metal stopper
Weight: 0.59kg
Dimensions: 152mm x 63mm
Hazardous Fill: White Phosphorus and Benzene
Fuse: n/a
Appearance: White / off yellow milk bottle
Hazards: Choking fumes of Phosphorus Pentoxide and Sulphur Dioxide, as well as heat. Severe burns if comes into contact with skin.
Remarks: By August 1941 well over 6,000,000 of these grenades were available and mainly issued to the Home Guard.

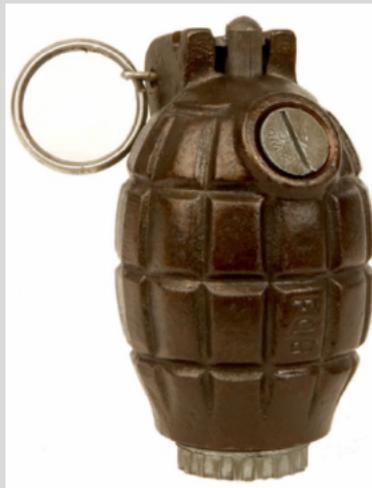
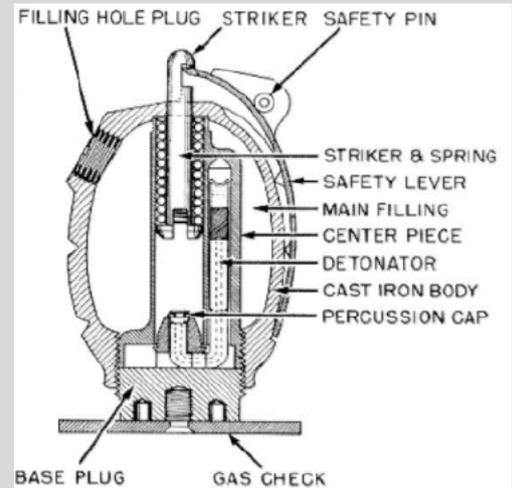
No. 36 Hand Grenade (Mills Bomb)

Construction: Metal
Dimensions: 95mm x 61mm
Weight: 760g
Fill weight: 71g
Hazardous Fill: Baratol
Fuse: Percussion cap and 4 second time delay fuse
Hazards: Blast, fragmentation. ~30m effective range.
Remarks: >70 million were produced between 1915 and the 1980s

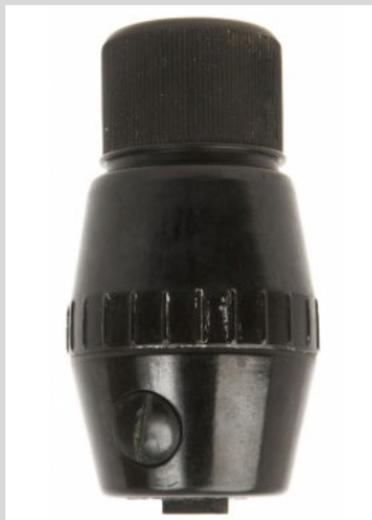
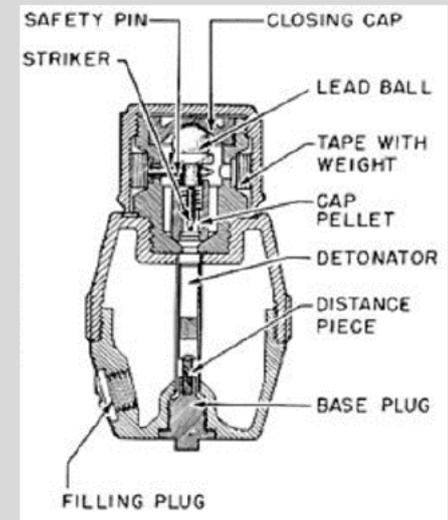
No. 69 (Blast) Hand Grenade

Construction: Bakelite (plastic)
Dimensions: 114mm x 60mm
Weight: 383g
Fill weight: 92g
Hazardous Fill: Baratol, Amatol or Lyddite
Fuse: 'All-Ways' Impact fuse
Hazards: Blast effect. <20m effective range.
Remarks: Green bands around the grenade signified a HE fill.

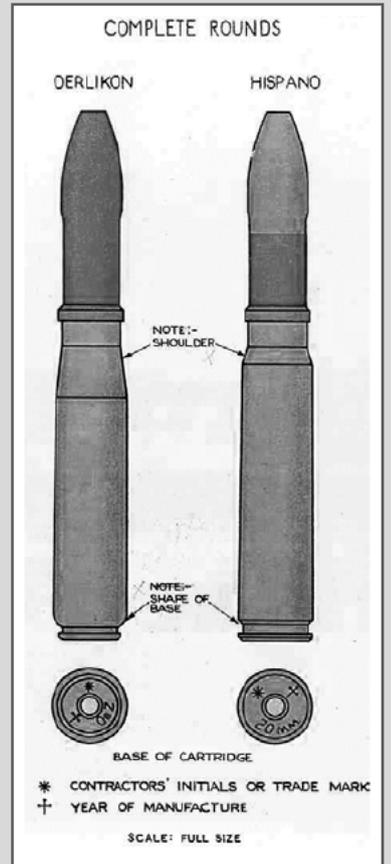
20mm Cannon Ammunition (various)

- Cartridge Weight:** 256g (approx.)
- Total Cartridge length:** 182mm (approx.)
- Hazardous Fill:** Various HE, incendiary and tracer compositions. Typically TNT, Tetryl and Pentolite.
- Fuse:** Impact fuse
- Appearance:** Cylindrical shape. Brown body, green and red bands, five finned tail
- Variants:** Oerlikon and Hispano 20mm ammunition was deployed in the UK during WWII. These varied slightly in shape and also in the colours used to identify different projectile types.
- Remarks:** Today, 20mm rounds of WWII vintage may be found unexpended as full single cartridges or in belts of multiple cartridges. Or expended, i.e just the fused projectile without the brass base.

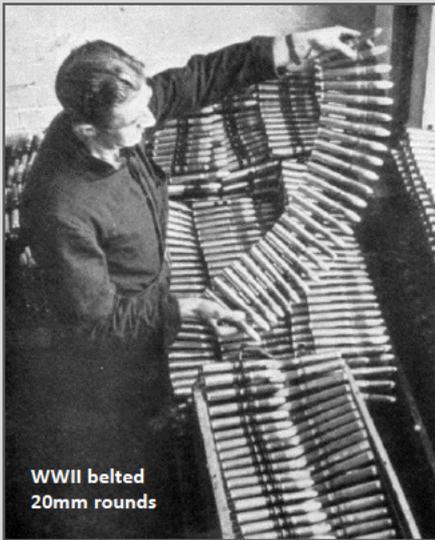
Recent WWII 20mm rounds find

WWII belted 20mm rounds
