M25 junction 28 improvement scheme

9.25 Ground Investigation Report

Regional Investment Programme M25 Junction 28 Improvements Ground Investigation Report 26/11/20

Document Ref: HE551519-ATK-GEN-XX-RP-CE-000001

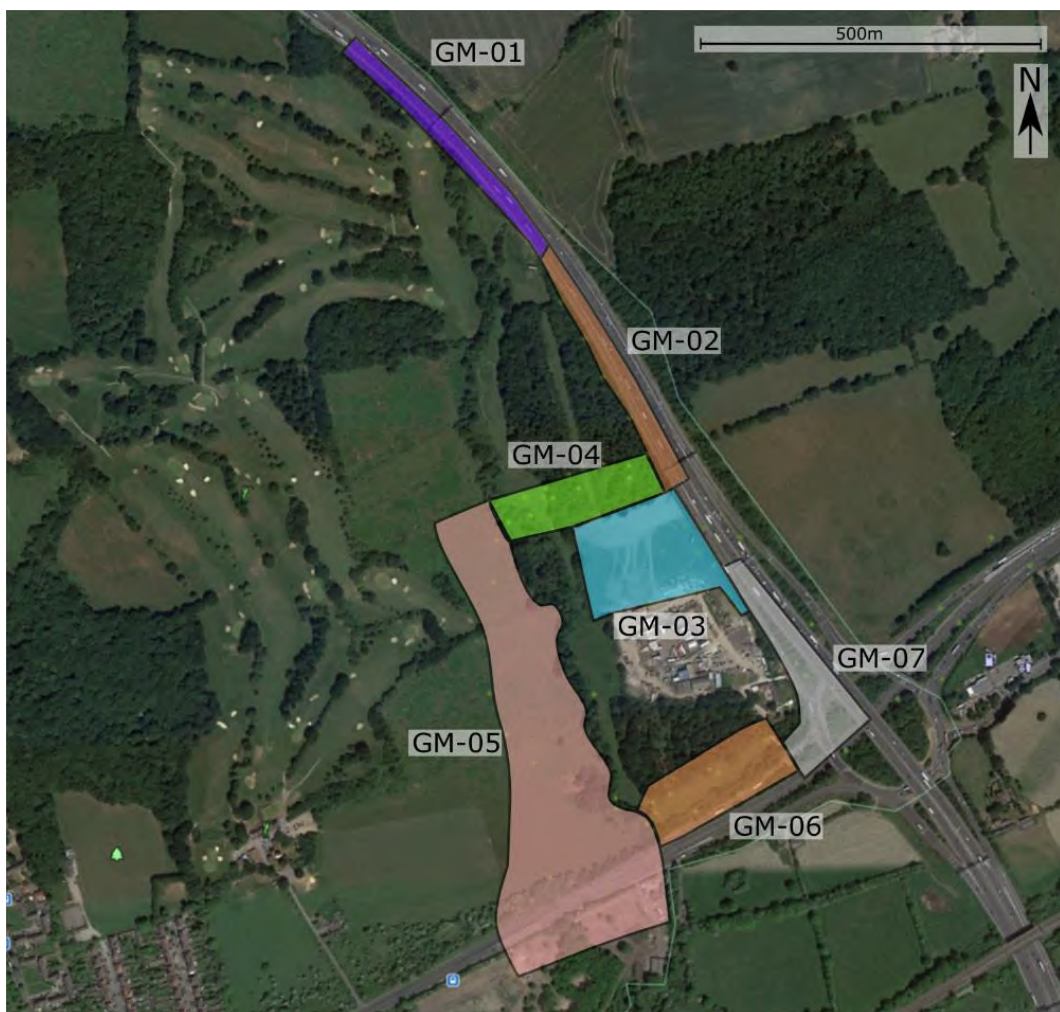
Figure 4-1 GIR Ground Model location plan (based on Google Earth [12])

- GM-01 - Northern M25
- GM-02 - Central M25
- GM-03 - Grove Farm
- GM-04 - Alder Wood & Weald Brook
- GM-05 – Glebelands
- GM-06 - A12 & Ingrebourne River
- GM-07 - junction 28

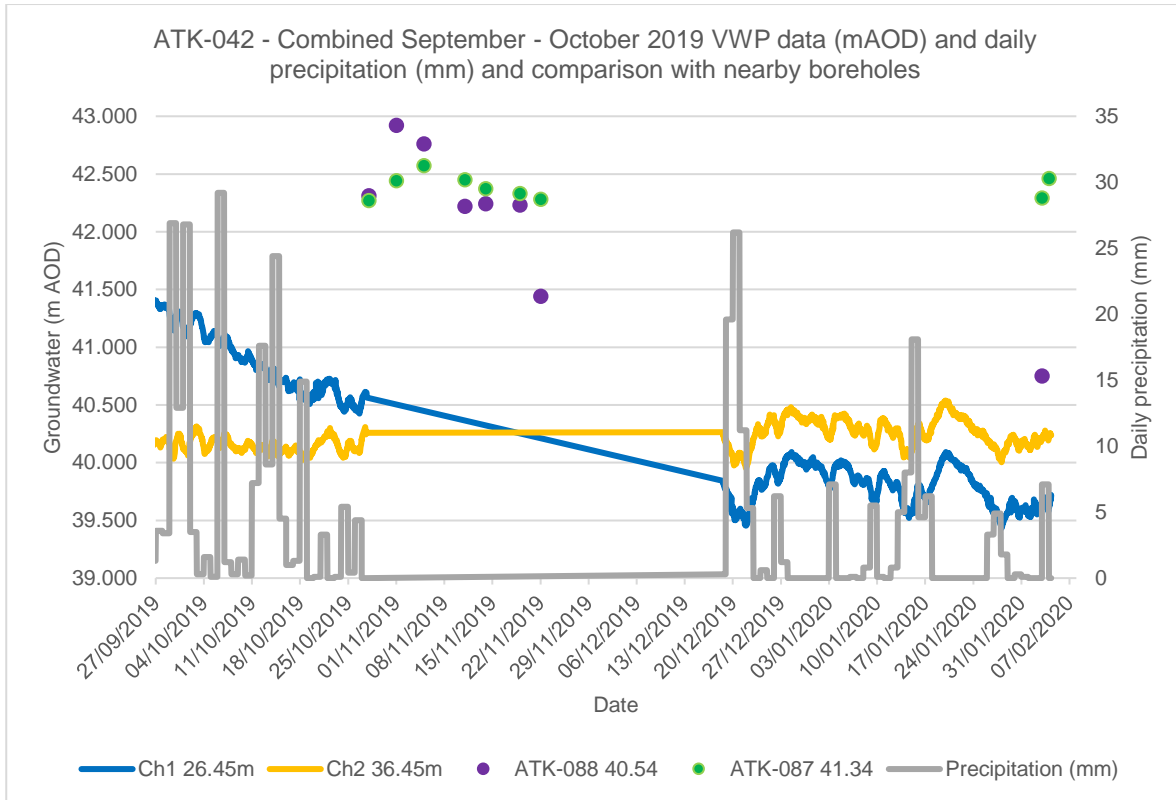
Figure 4-2 Groundwater Elevation Graph, ATK-042

Groundwater elevation data shows a maximum variability of approximately 2.2 m across the monitoring period with an average variability of 1.11m with higher elevations in January/February.

The VWPs installed were non-vented, meaning that they are affected by changes in barometric pressure. The data has not been corrected; however, all three locations show similar patterns within the winter months with the deeper installation recording a higher groundwater elevation (pressure) than the shallow installation, representing an upward vertical hydraulic gradient at the site. All three locations also show peaks in groundwater elevation (pressure) after rainfall events with gradual declines and a general increase in groundwater levels between December and March.

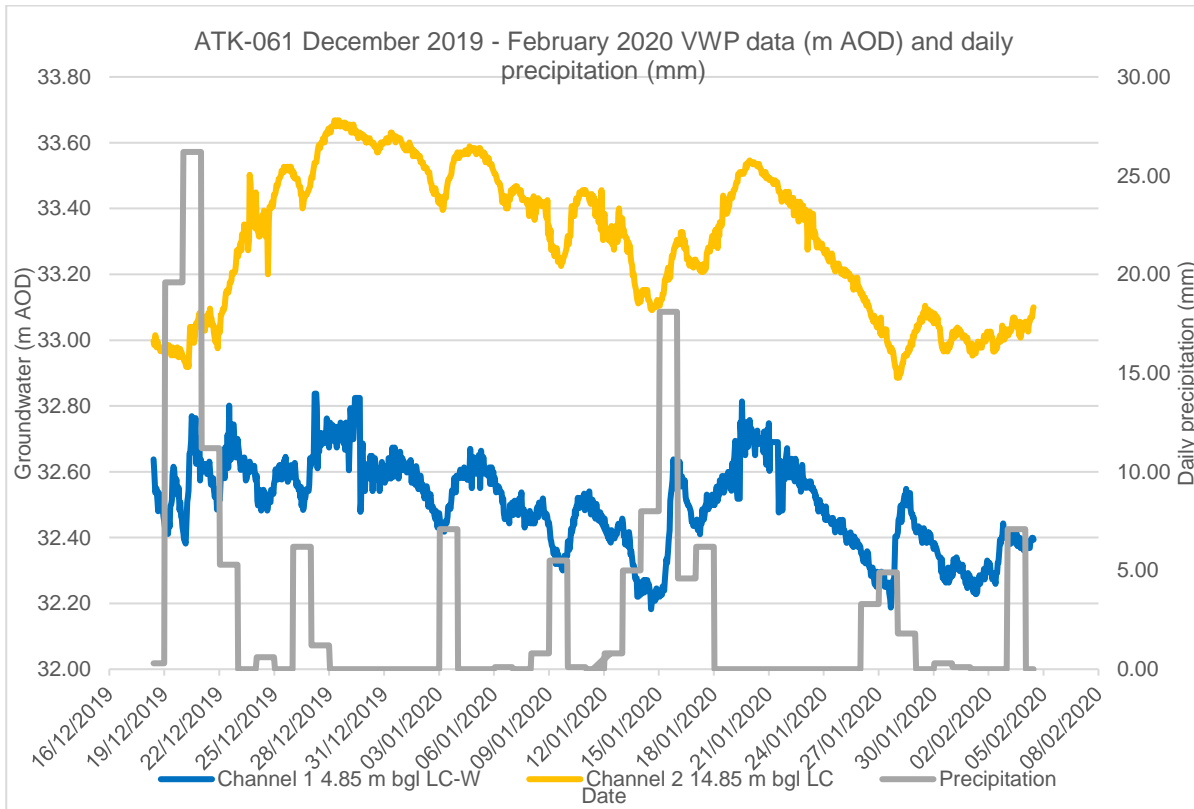
Figure 4-4 Groundwater Elevation Graph, ATK-061

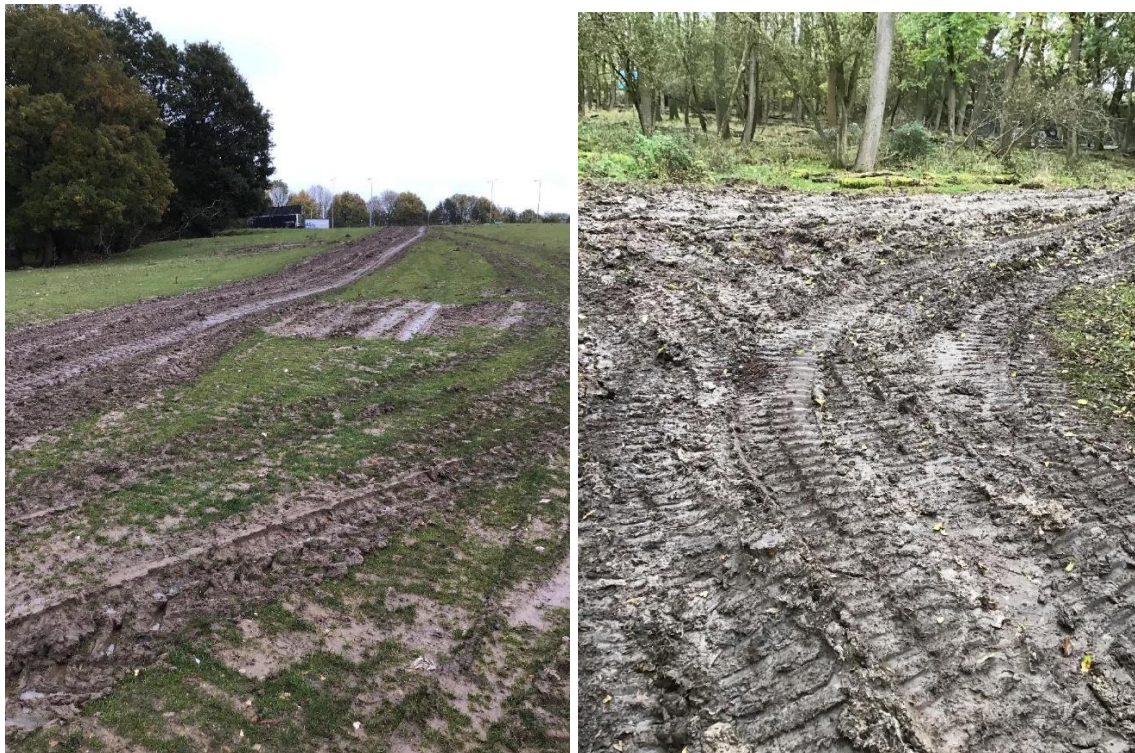
Figure 6-1 Images of trafficability issues around site taken 01/11/2019 during the 2019 GI.

Close to the ground surface the undrained strength can be as low 10 to 50kPa across all strata, which could create considerable issues for efficient plant operation. In addition, the fine nature of the materials will render them susceptible to significant reductions in undrained strength in periods of wet weather. The undrained strength of clay materials controls its trafficability and at strengths below approximately 50kPa, significant rutting/deformation under the weight of compaction or construction plant can, and is likely, to occur, (Nowak & Gilbert, 2015). Thus, all strata have the potential to have low trafficability during earthworks operations, which will be exacerbated in sustained periods of wet weather. Should works be proposed within winter or wetter months the Contractor should consider forms of mitigation such as all-weather haul roads or by employing lighter plant where possible.

Trafficability issues were encountered during the ground investigation, with extensive rutting and access difficulties which results in delays and access restricted to tracked vehicles. Images of access track conditions is provided in Figure 6-1 below.
