M25 junction 10/A3 Wisley interchange TR010030 5.4 Water framework directive compliance assessment report

5.4 WATER FRAMEWORK DIRECTIVE ASSESSMENT REPORT

Regulation Number:	Regulation 5(2)(q)
Planning Inspectorate Scheme Reference	TR010030
Application Document Reference	TR010030/APP/5.4
Author:	M25 junction 10/A3 Wisley interchange Project Team, Highways England

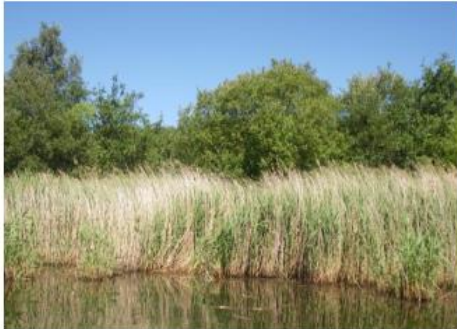
Sample 1 - Northwest shore (TQ0748358430)

Sample taken within the submerged stems of dense Common reed *Phragmites australis*.

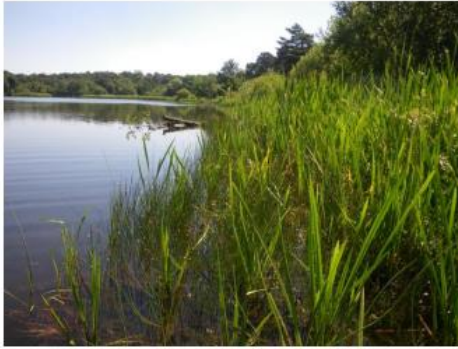
Sample 2 - Southwest shore (TQ0749158328)

Sample taken within the shallow littoral zone amongst emergent stands of Common spike-rush *Eleocharis palustris* and Branched bur-reed *Sparganium erectum*. Submerged plants included shallow-growing *Myriophyllum alterniflorum*, *Elodea nuttallii* and *Crassula helmsii*.

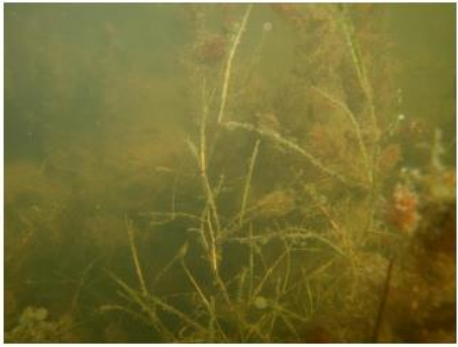
Sample 3 - South shore (TQ0771758330)

Sample taken in 30 – 50 cm water depth within beds of submerged aquatic vegetation dominated by *Myriophyllum alterniflorum* and *Potamogeton pusillus*. *Elodea nuttallii* and *Crassula helmsii* were also present, but rare. This area had no emergent vegetation and was typical of the shallow littoral around the south shore

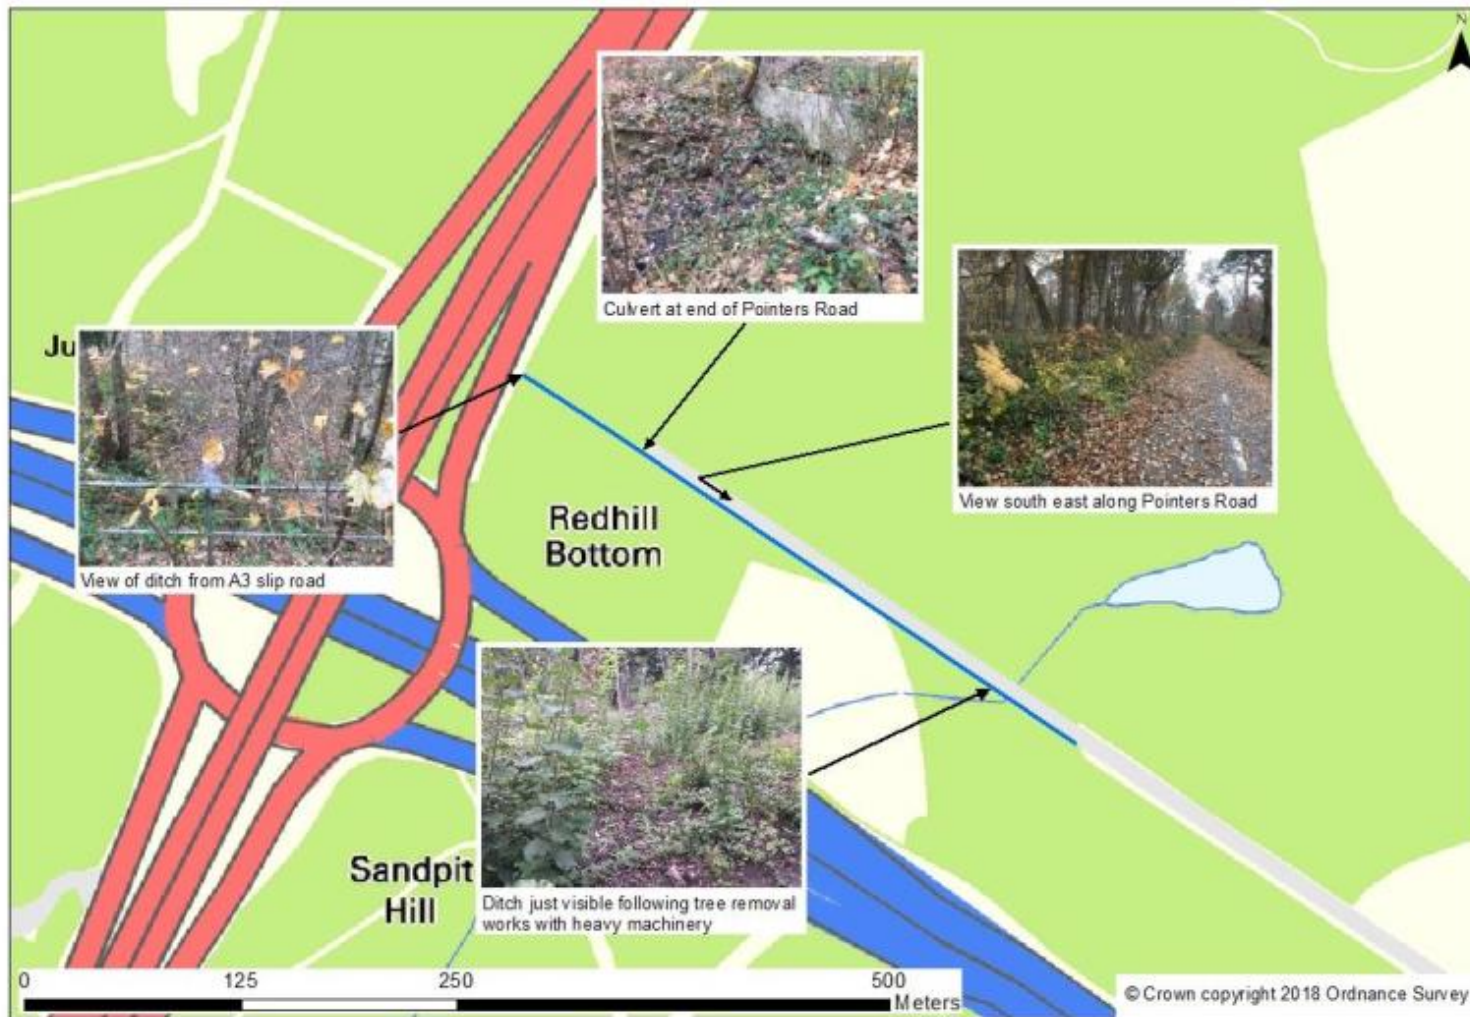
Figure E.6: Chatley Wood pond and ditch

- 4.6.21 Chatley Wood Ditch and Pond are to the north-east of the M25 junction 10/A3 Wisley interchange, in part within Replacement land at Chatley Wood. An area of disturbed land / potential wet woodland at the south west end of the ditch is affected by Scheme component ML2 (Appendix B). Also note that habitat improvement works to Chatley Wood Pond are proposed as additional specific mitigation for the effect of the Scheme on ephemeral headwater ditches in the Mole catchment (Appendix F).
