M25 junction 10/A3 Wisley interchange TR010030

6.5 Environmental Statement: Appendix 7.3 Veteran trees and Arboricultural Impact Assessment

6.5 ENVIRONMENTAL STATEMENT

APPENDIX 7.3 VETERAN TREES AND ARBORICULTURAL IMPACT ASSESSMENT

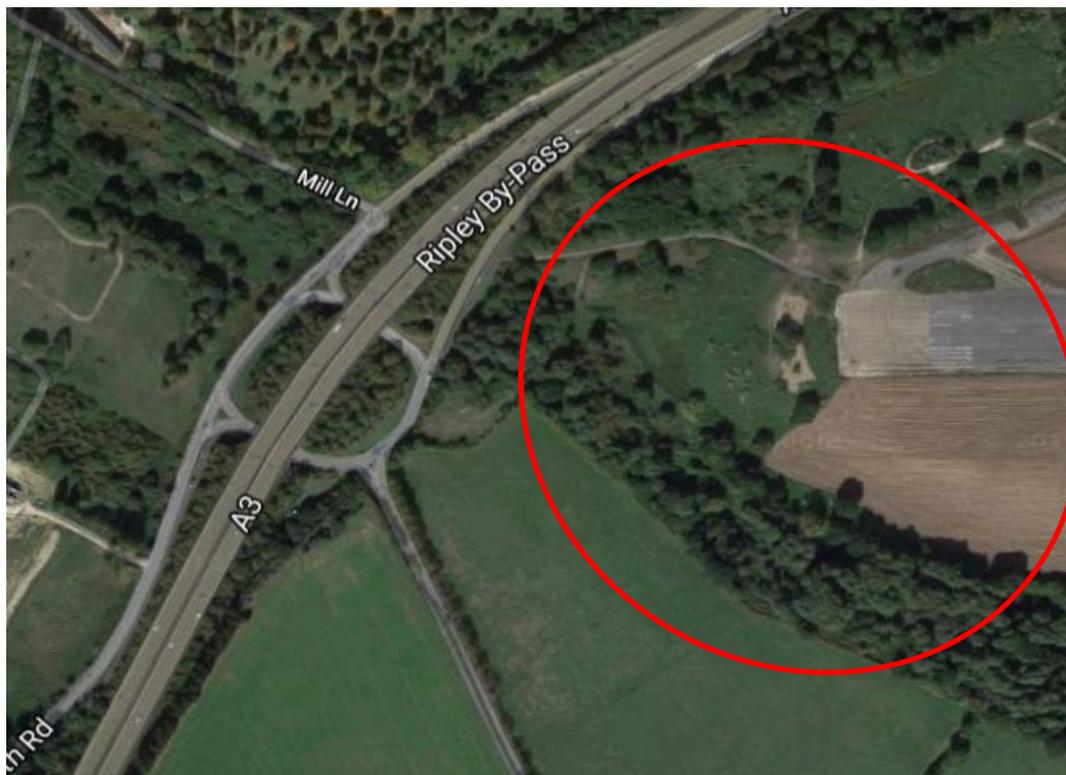
Insert 7.1 land to east of A3, adjacent to former Wisley airfields

7.5.1.2 The areas of land that were not accessible will be assessed prior to the commencement of construction and surveyed in accordance with BS5837:2012 guidelines. The main areas that were not accessed during the tree survey are illustrated on the inserts below within the red outlines:

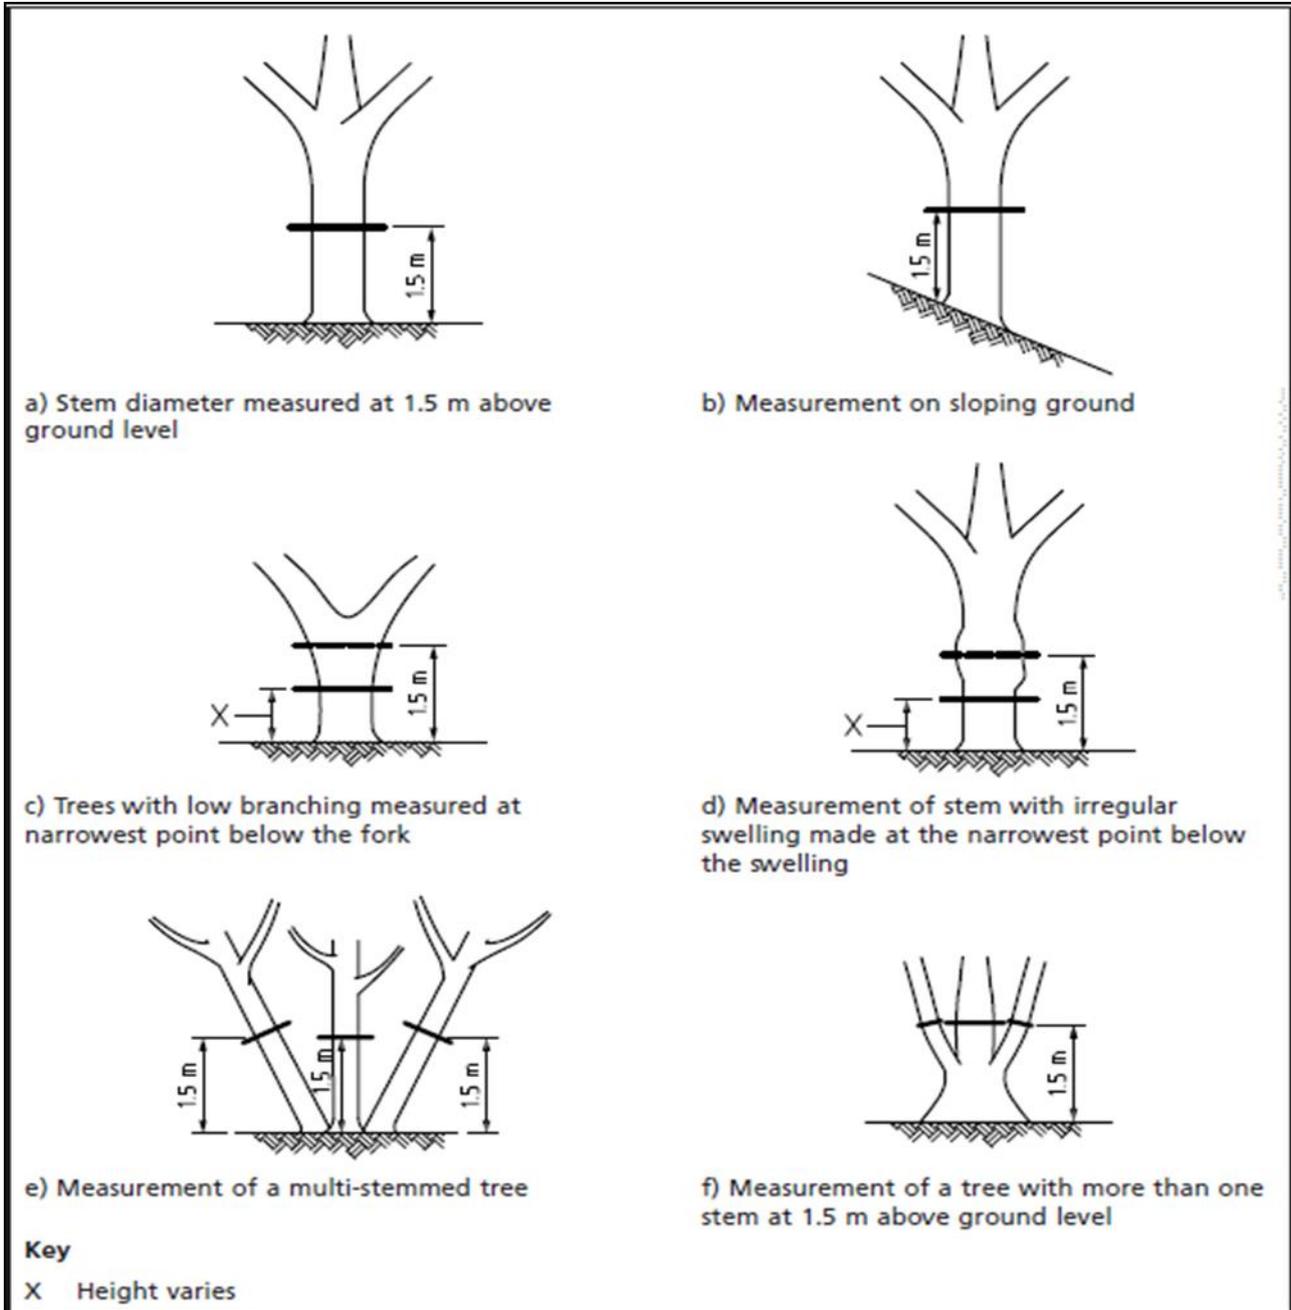
A2.1 Measurement of tree stems dependant on tree form

Insert 7.4: BS5837:2012 measurement of tree stems dependant on tree form methods
