M25 junction 10/A3 Wisley interchange TR010030

6.5 Environmental Statement: Appendix 7.6 Aquatic ecology

6.5 ENVIRONMENTAL STATEMENT: APPENDIX 7.6 AQUATIC ECOLOGY

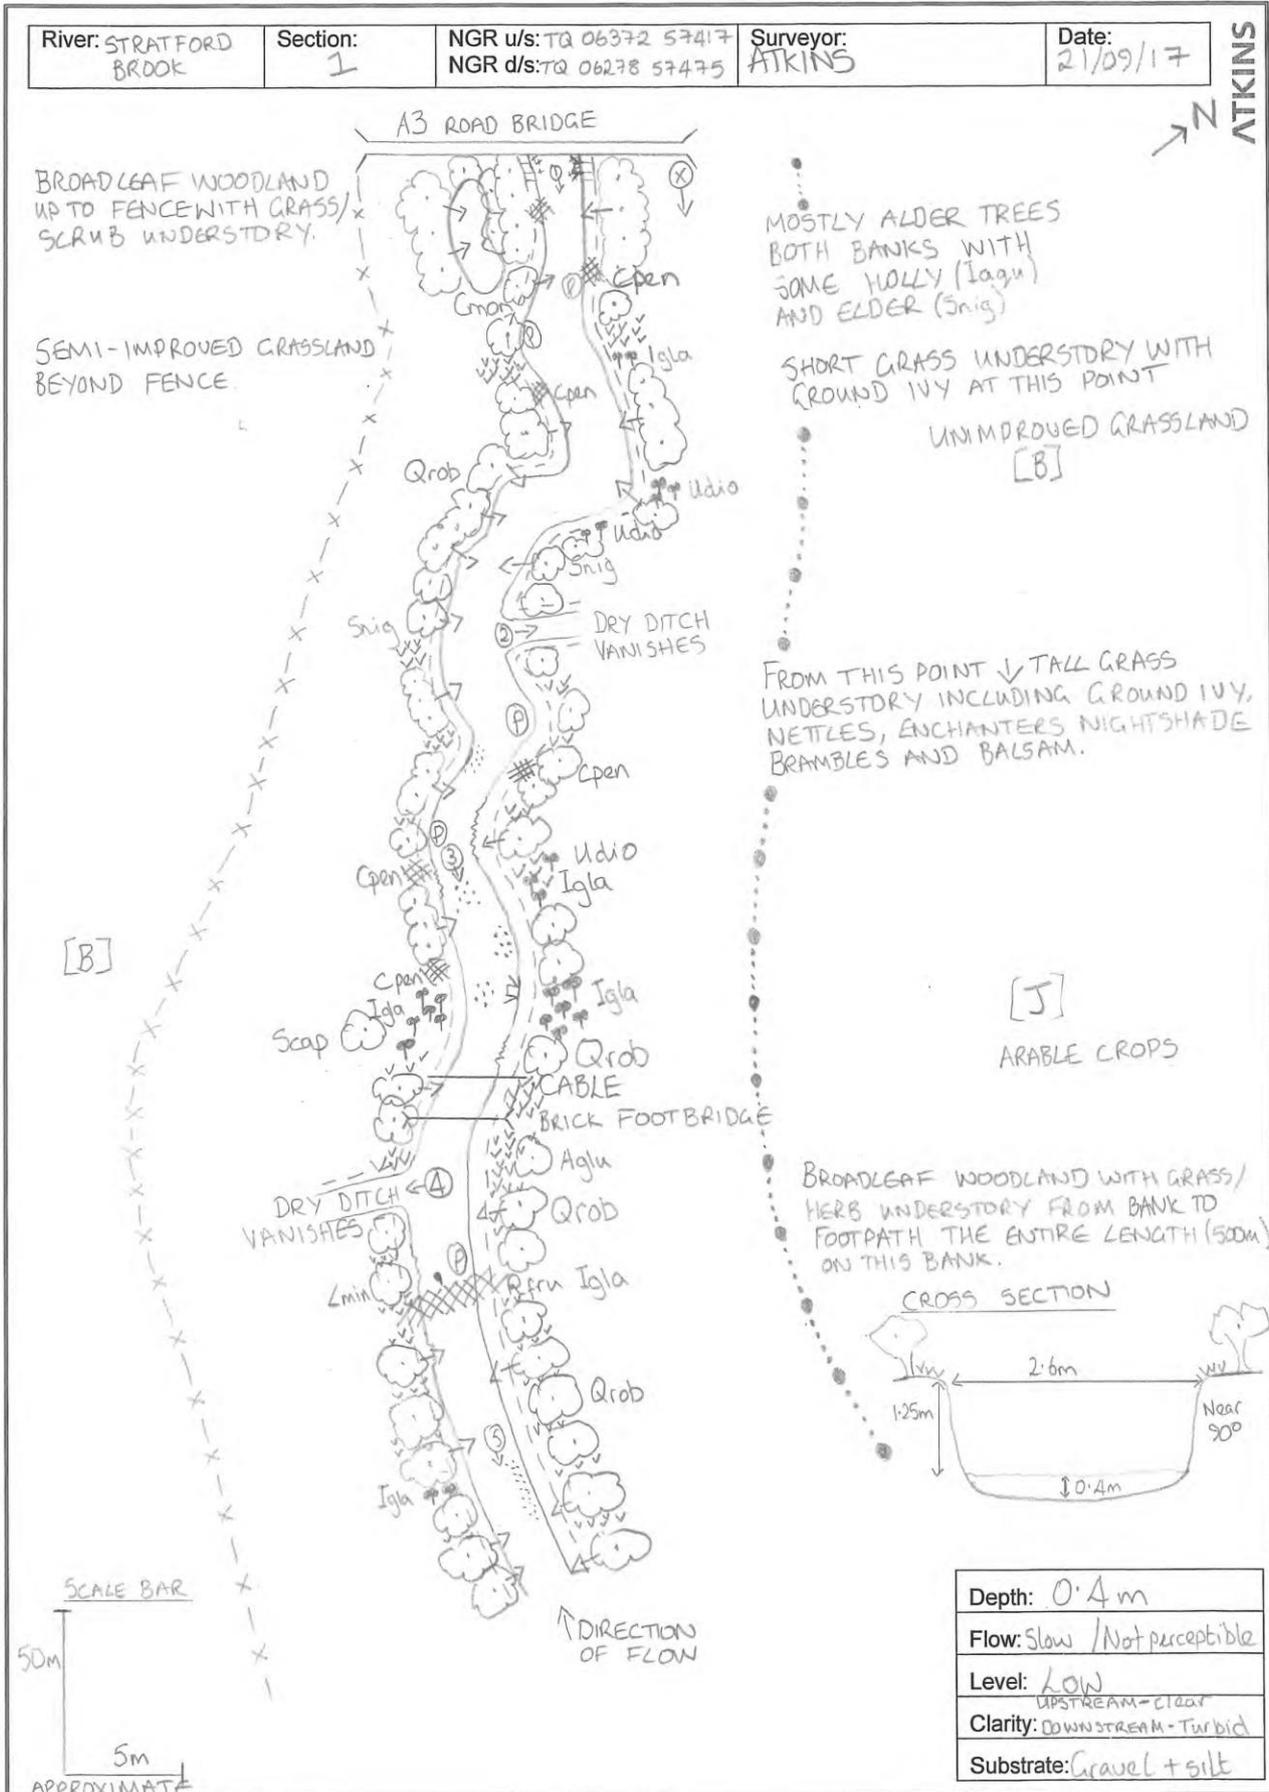
Abbreviations within the Stratford Brook Section 1 River Corridor Survey sketch are:

The 500m of the Stratford Brook surveyed was found to be heavily shaded by mature woodland, predominantly alder within the first 300m of the culvert, with a mixture of oak and other species along the banks of the most upstream 200m. This shading prevented the presence of any in-stream aquatic vegetation.

There was very little marginal vegetation throughout the 500m reach, although there was some terrestrial grasses and liverworts on bank face. Pendulous sedge were recorded in places on the bank top along with terrestrial grasses and scrub species. The only instream vegetation found was one small patch of common duckweed (*Lemna minor*).

Large stands of the invasive non-native species Himalayan balsam, were present along the 500m reach. The largest stand had been cut in a recent management attempt. An American mink (*Neovison vison*) was also observed in the channel.

There was evidence of recent management of a large stand of Himalayan balsam for which continued management/removal is recommended.

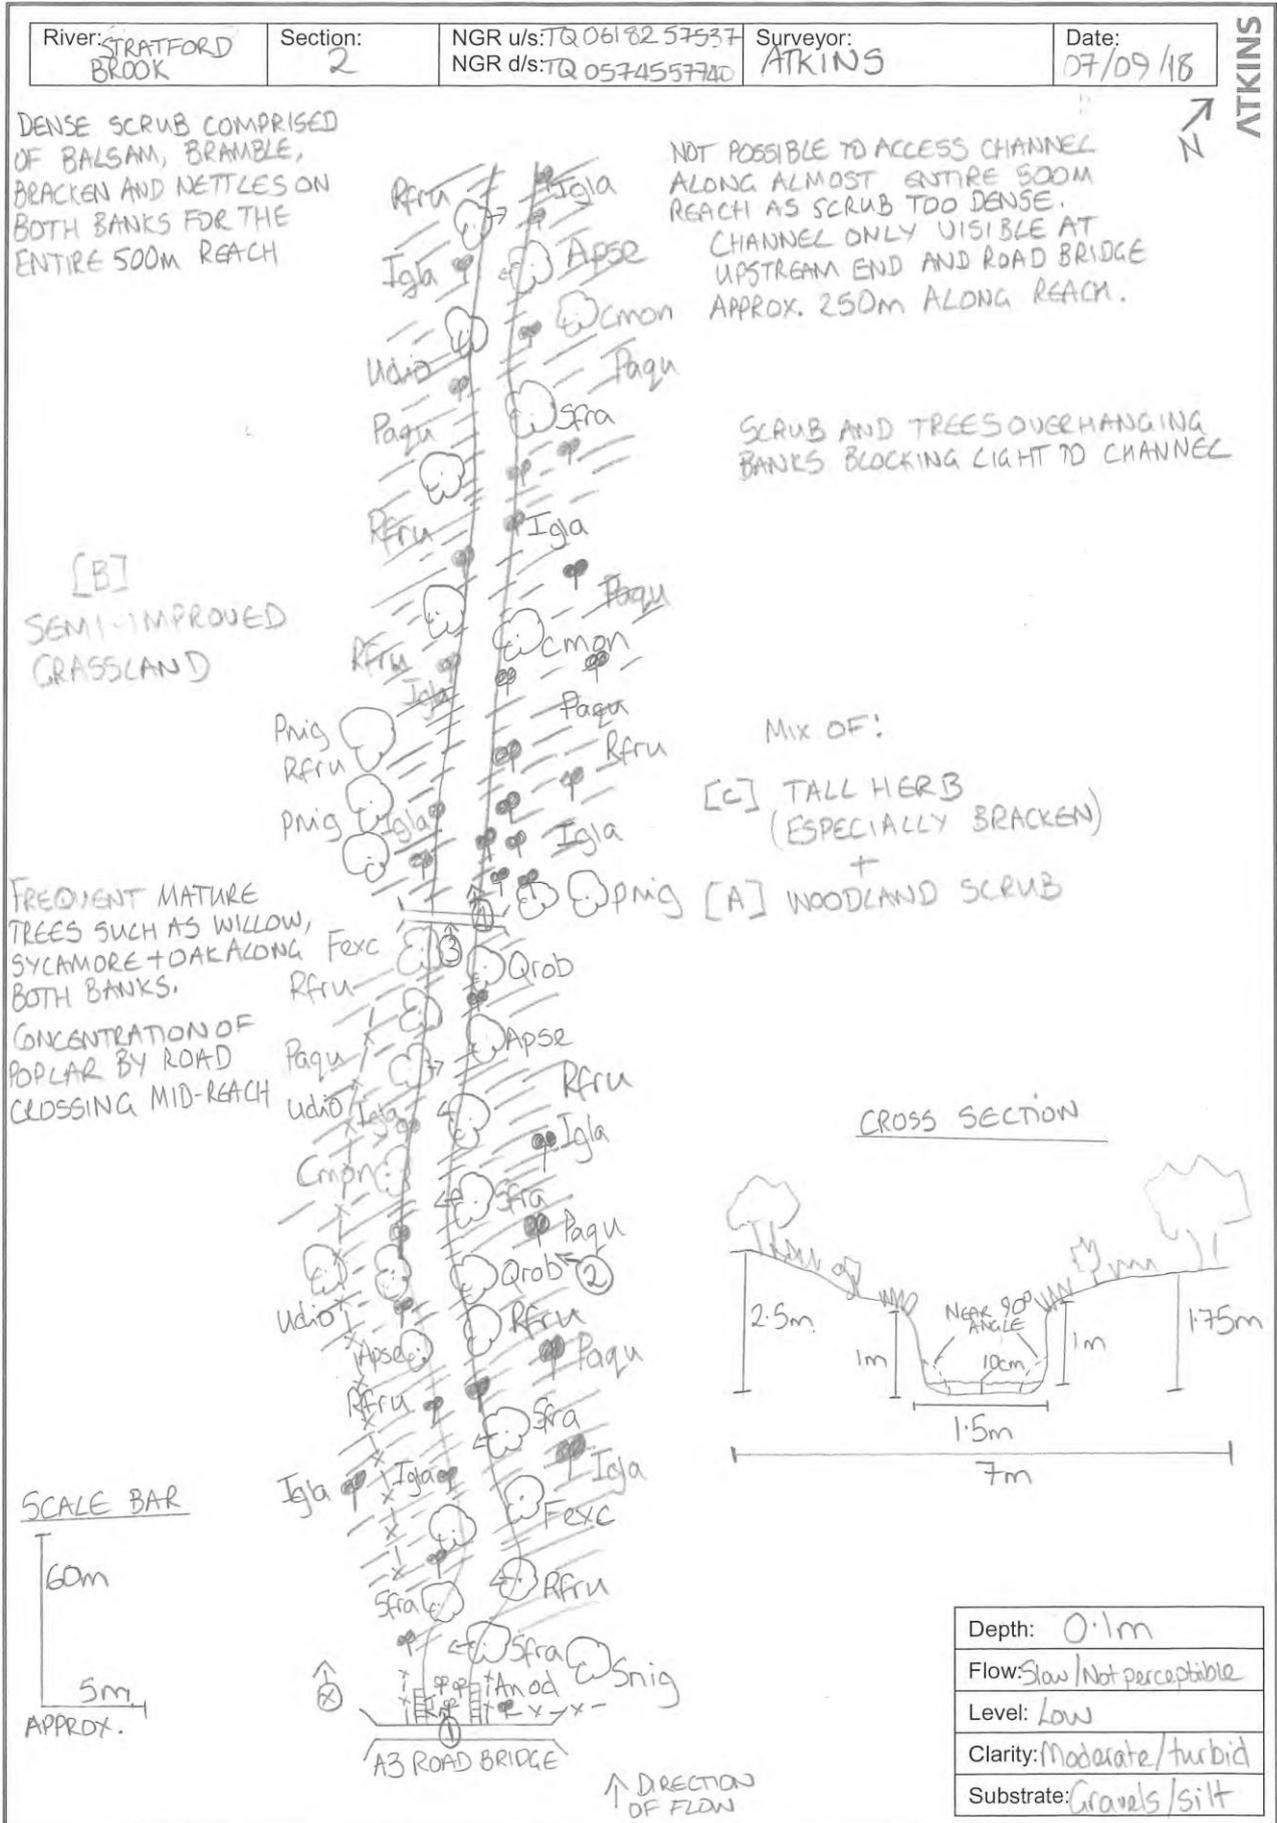
Abbreviations within the Stratford Brook Section 2 River Corridor Survey sketch are:

No side channels were noted, however only a small section of the 500m reach was visible. The Stratford Brook Culvert at the most upstream end, is a large structure, approximately 90m long. There is a small access track/road crossing approximately 240m downstream of the culvert end.

Adjacent land use consisted of a dense mix of tall grasses and herbs with woodland scrub directly adjacent to the channel, with semi-improved grassland used as a car boot sale site behind, to the south of the river (left hand bank). North of the river (right hand bank) consisted of a mixture of woodland scrub and tall grasses and herbs. Along with the dense bramble/bracken/nettle/balsam mix, were occasional mature trees including crack willow (*Salix fragilis*), ash (*Fraxinus excelsior*) and sycamore (*Acer pseudoplatanus*). A large number of poplar (*Populus nigra*) were present close to the small access track/road.

It is likely that heavy shading by mix of trees and scrub has limited the presence of any in-channel and marginal aquatic macrophytes. The removal of occasional trees and/or scrub to allow more light into the channel could encourage aquatic macrophytes to establish within this reach. The removal of the large stands of Himalayan balsam is also recommended.

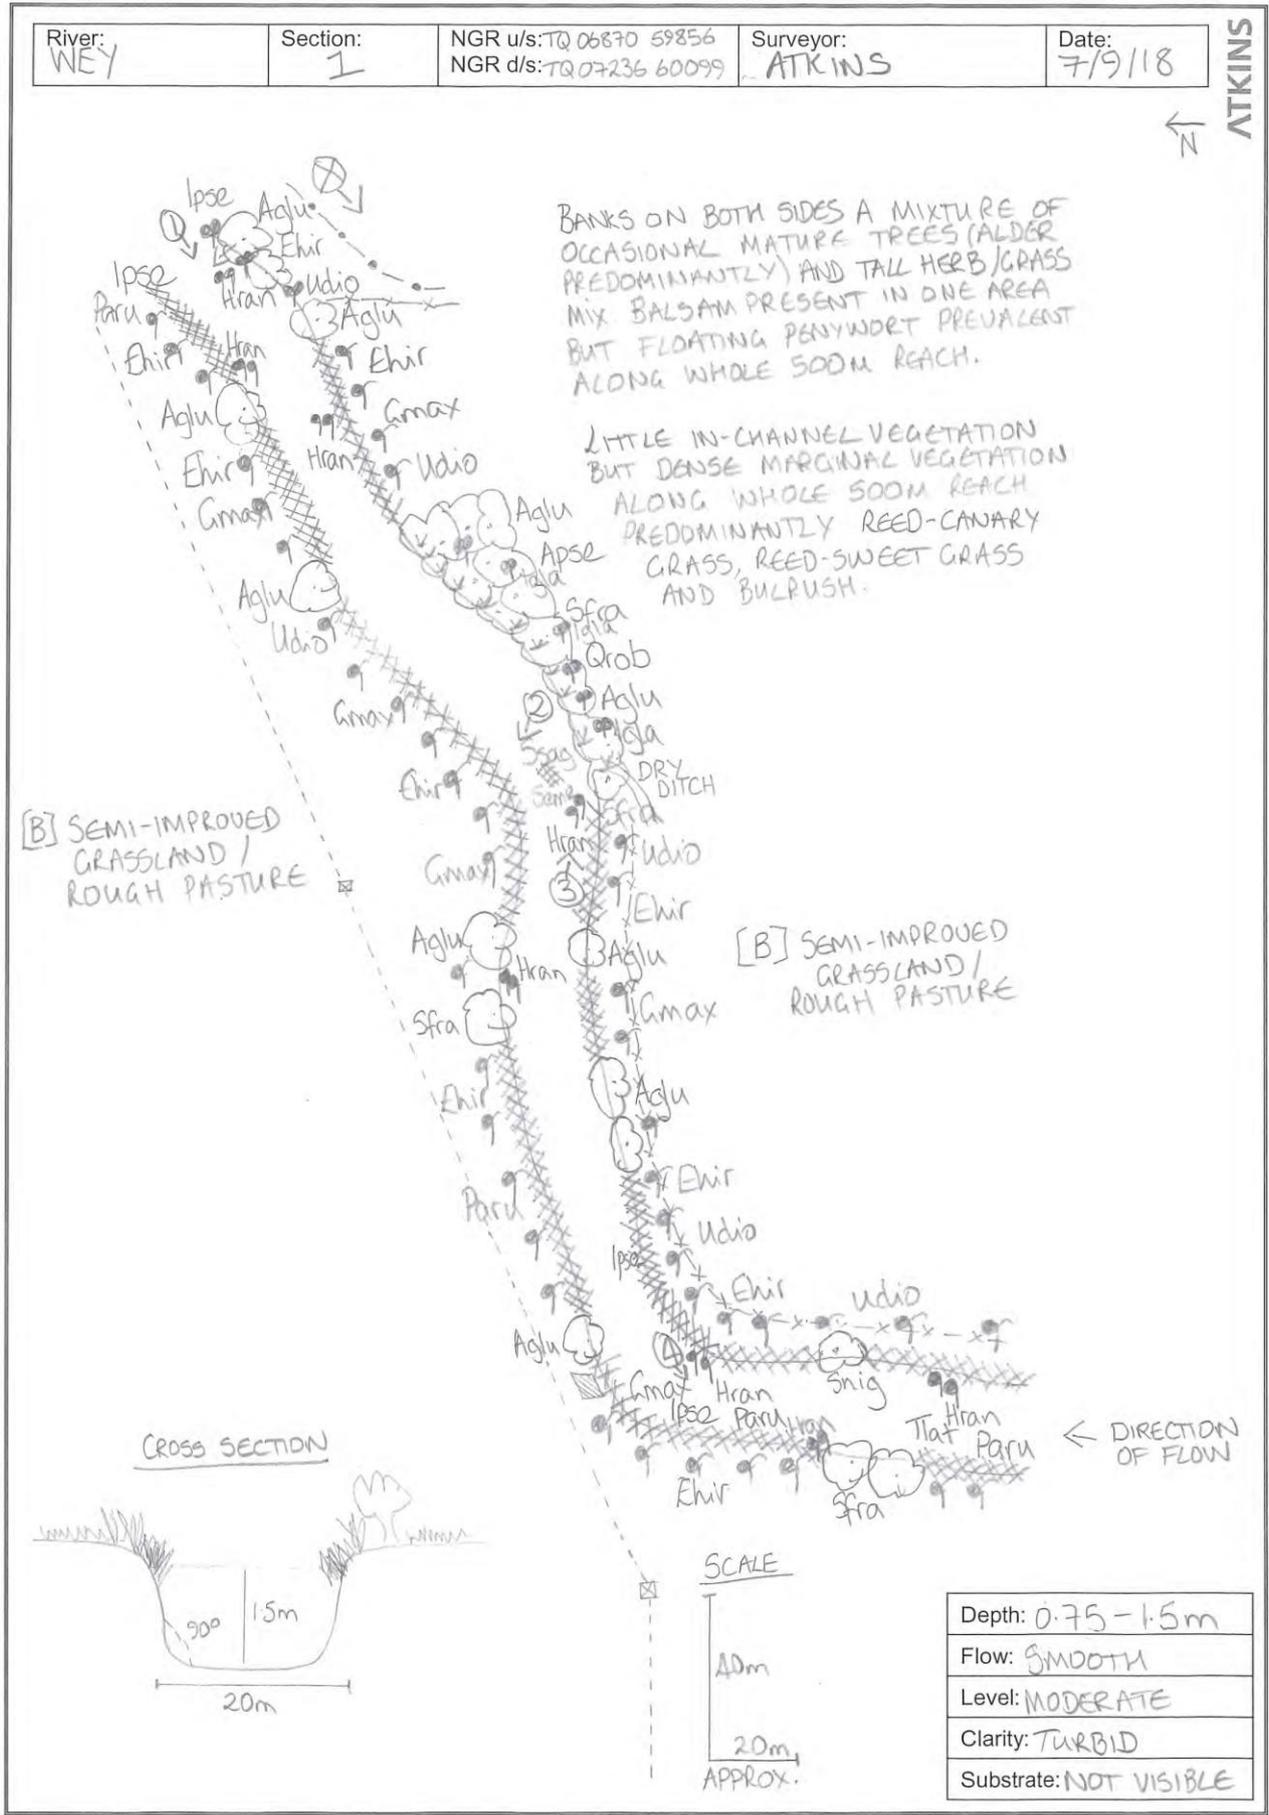
Abbreviations within the River Wey River Corridor Survey sketch are:

The map suggests several side channels flow into the river throughout the 500m reach. The bank was surveyed from the right with one indistinct side channel present, although this entered the main channel close to bank top. No side channels were observed entering the main channel from the left hand bank.

The large amounts of floating pennywort present could potentially limit other native vegetation present in a short space of time. Himalayan balsam (*Impatiens glandulifera*) was also present, mostly within woodland adjacent to the river but on occasion at the waters edge also.

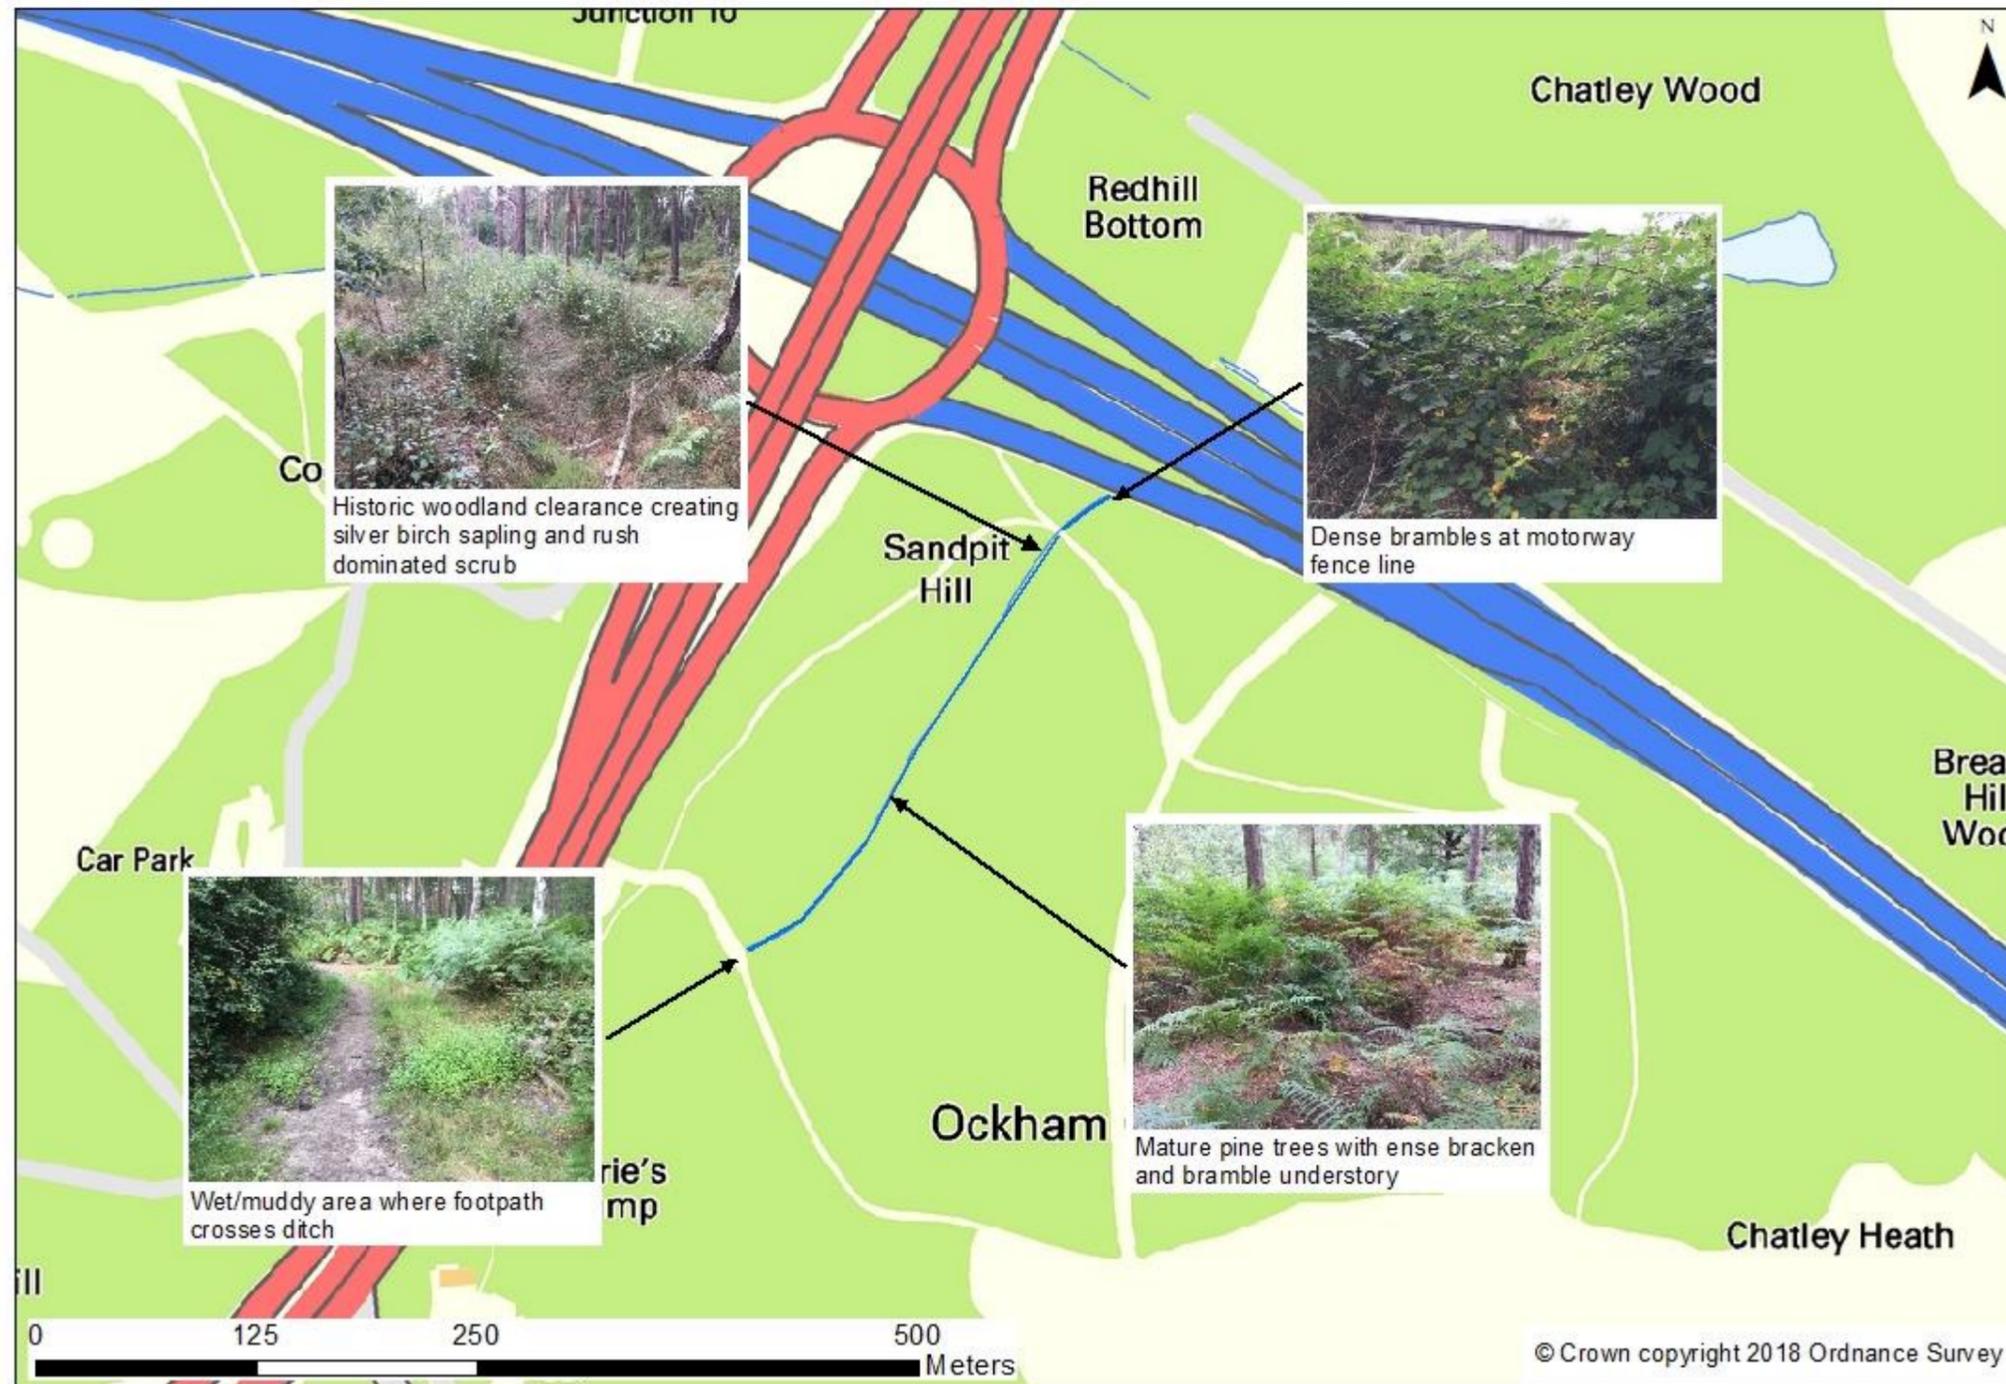
Ockham Common ditch

Shallow, ephemeral drainage ditch (dry at time of survey) and approximately 0.5 m wide. It flows through a dense woodland (a mix of broadleaf trees and conifers) with an understory of bracken and brambles. No wetland species were identified within the ditch. The ditch extends approximately 350 m north easterly towards hording adjacent to the M25. An area of wet woodland and a pond were found adjacent to the ditch, towards the north eastern end.

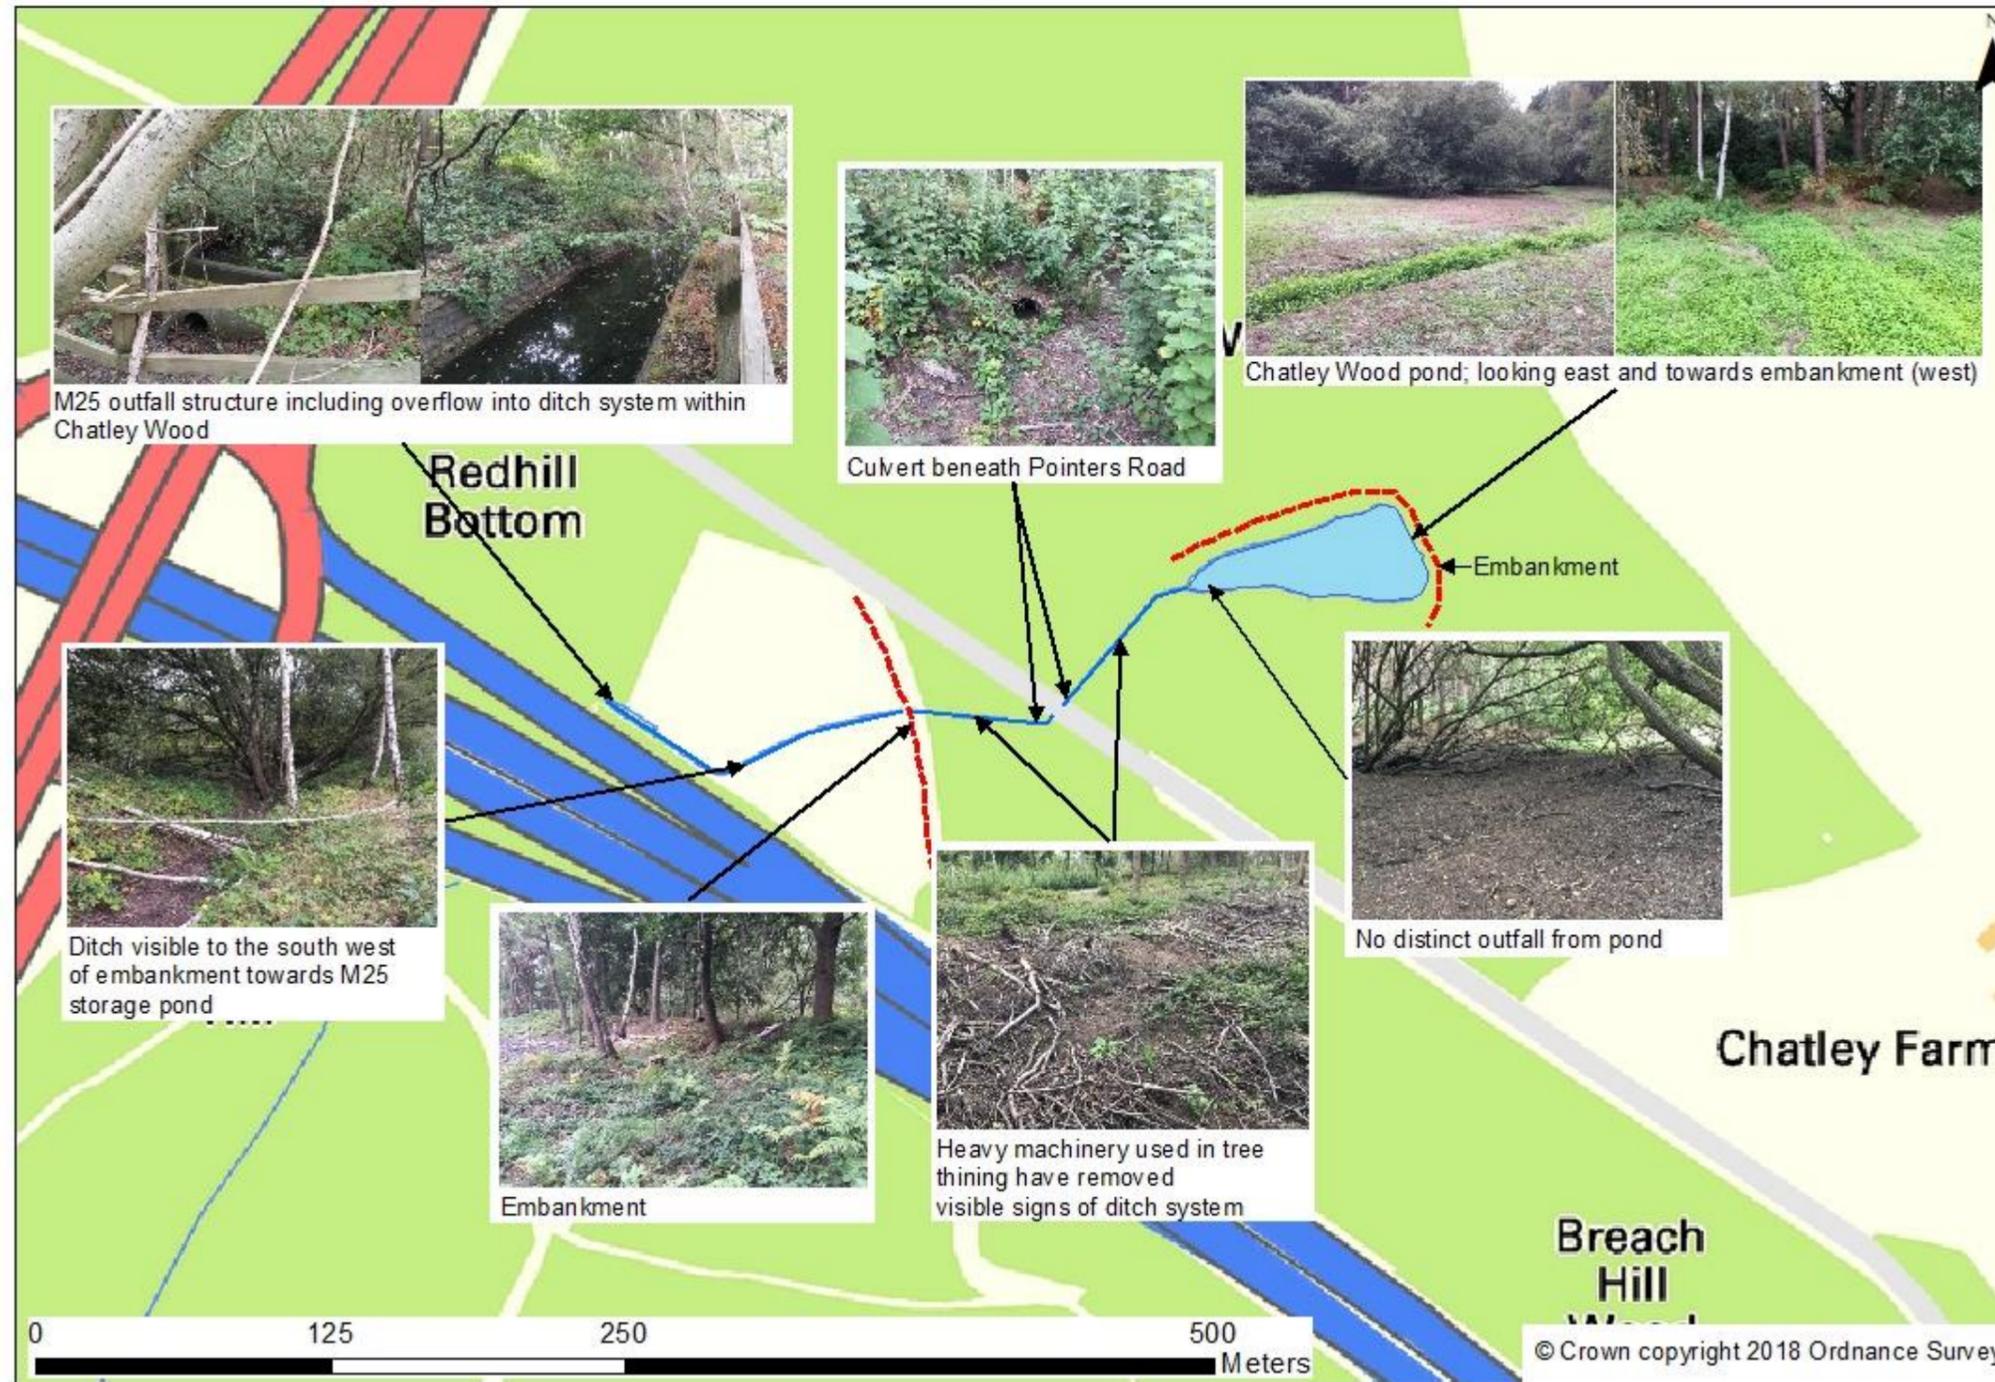
Chatley Wood pond and ditch

Large pond within mature woodland consisting predominately of Scots pine (*Pinus sylvestris*). The pond is noticeably embanked on the eastern and northern edges with occasional overhanging silver birch (*Betula pendula*) and willow species. At the time of survey, the pond was dry, with only a small amount of water present within a distinct channel within the pond extent, which contained a large amount of water-pepper (*Persicaria hydropiper*). Marsh pennywort (*Hydrocotyle vulgaris*) covered the entire area of the pond, with occasional areas of gypsywort (*Lycopus europaeus*), sedges and rushes.

An indistinct ditch runs from Chatley Wood pond in a south western direction becoming more distinct in places, however, the use of heavy machinery for recent extensive tree removal works have removed any trace of a distinct ditch at other points and created the potential for a wet woodland in the winter. A brick culvert runs beneath Pointers Road to another area of disturbed land/potential wet woodland. An artificial embankment to the south of Pointers Road creates a divide, with water to the south of the embankment flowing north from an outfall adjacent to the M25. Here, a concrete retention structure holds back water before it flows north easterly towards the embankment.

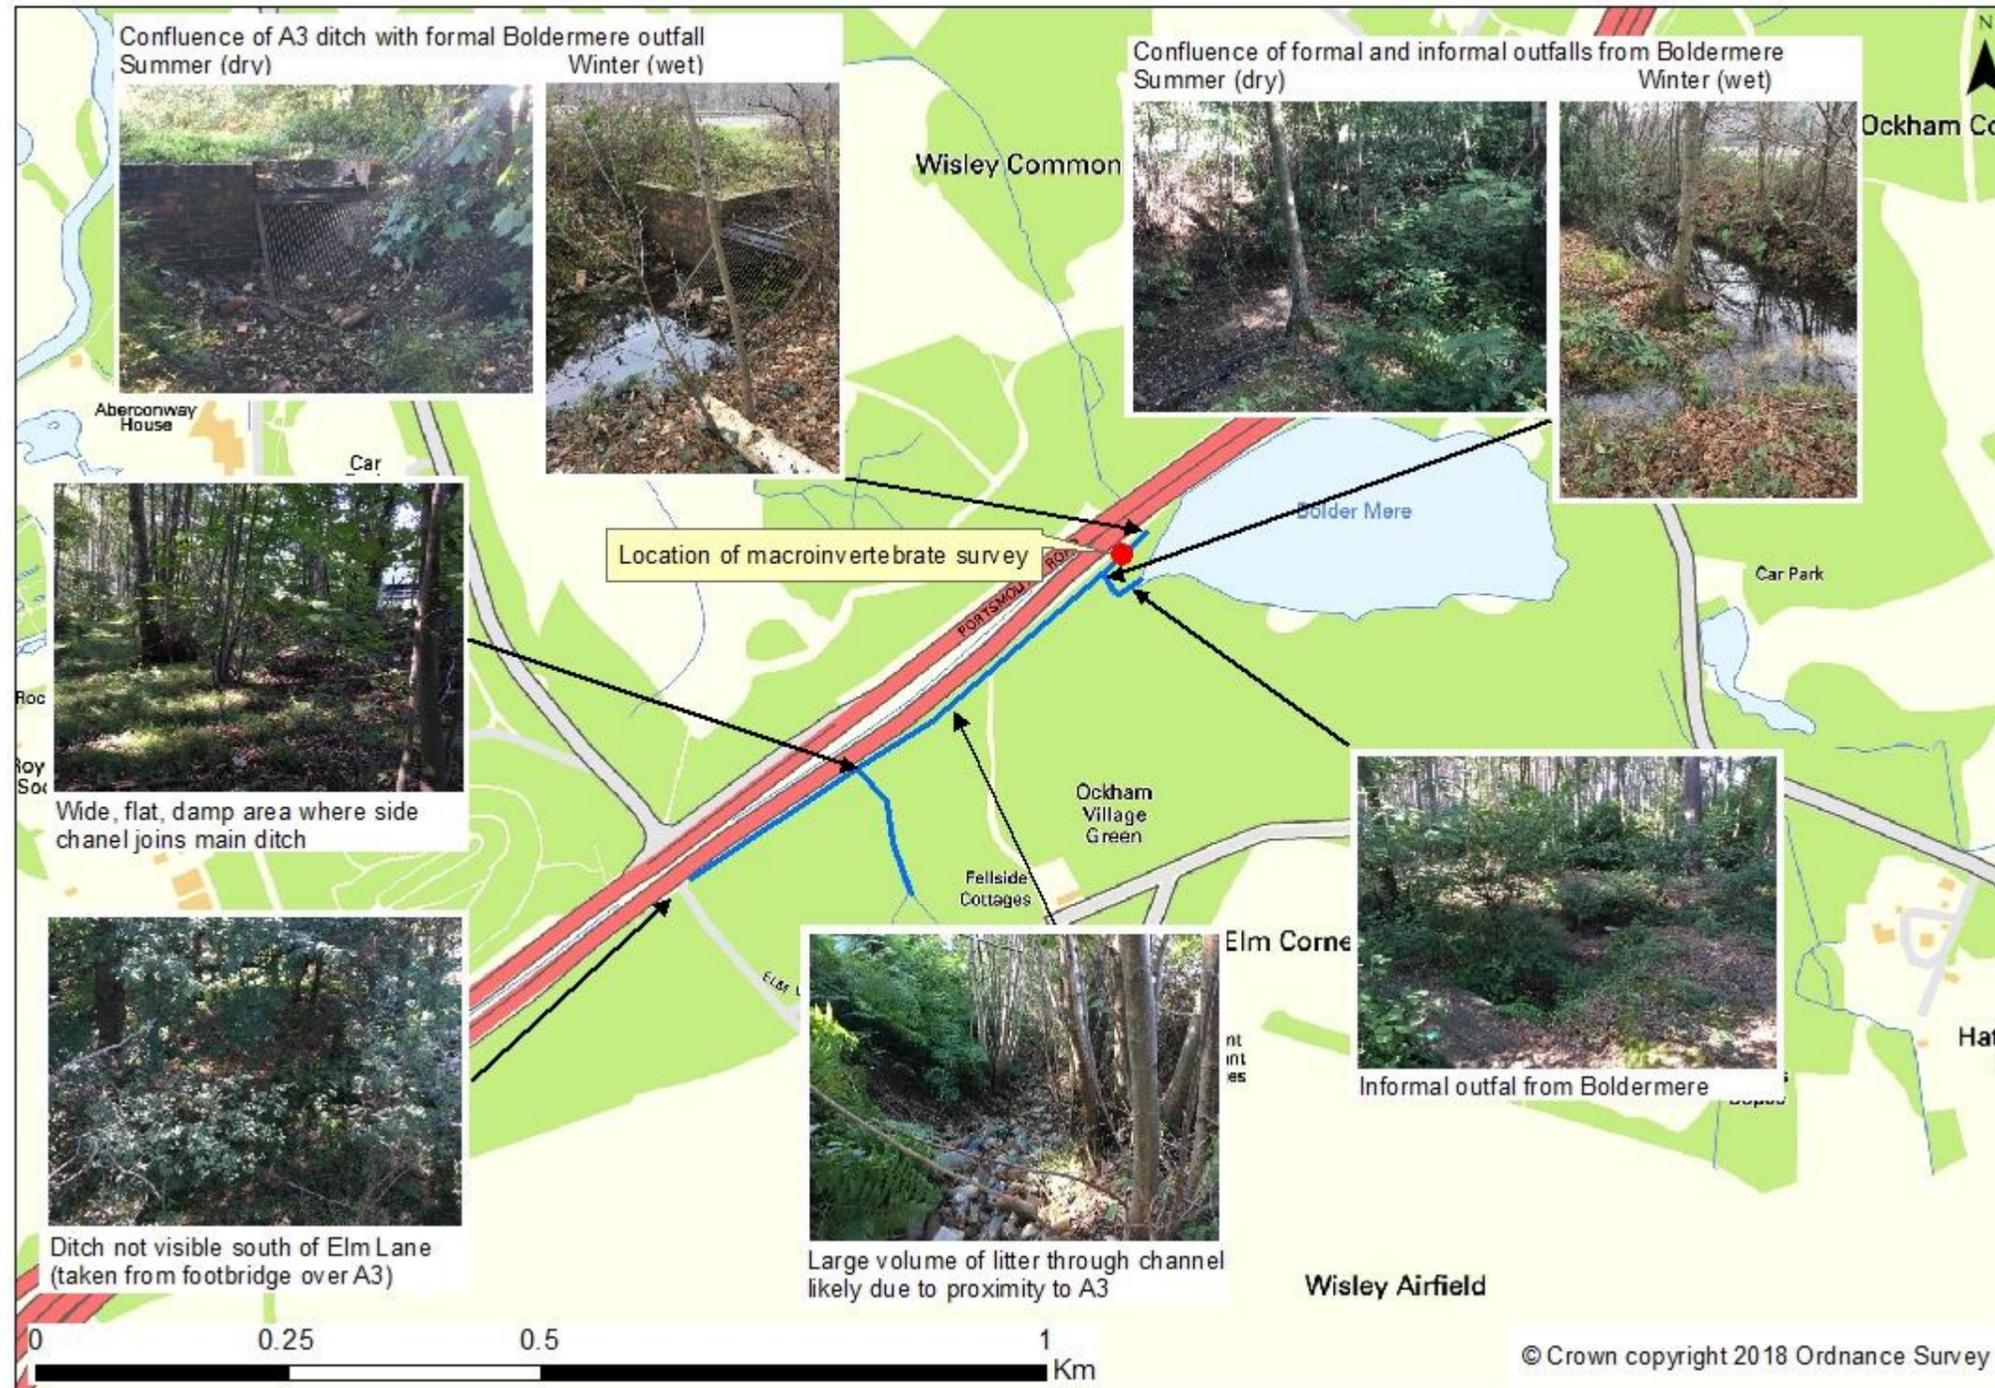
A3 ditch (adjacent to A3)

When surveyed in September 2018, the ditch adjacent to the A3 (southbound side) was completely dry and contained a large volume of litter along the entire stretch (from Bolder Mere to Elm Lane). The ditch contained water when surveyed in January 2018 (in January this ditch was also receiving water from the both Bolder Mere outfalls). No aquatic vegetation was present at any survey, only bankside brambles and bracken encroaching in places and it is heavily shaded along the entire stretch from broadleaf trees. It is approximately 1 m wide and at the downstream end banks are up to 0.5 m high. Upstream, while the right bank remains high (adjacent to the road), the left bank disappears as a number of small ditches run into a wide wet area.

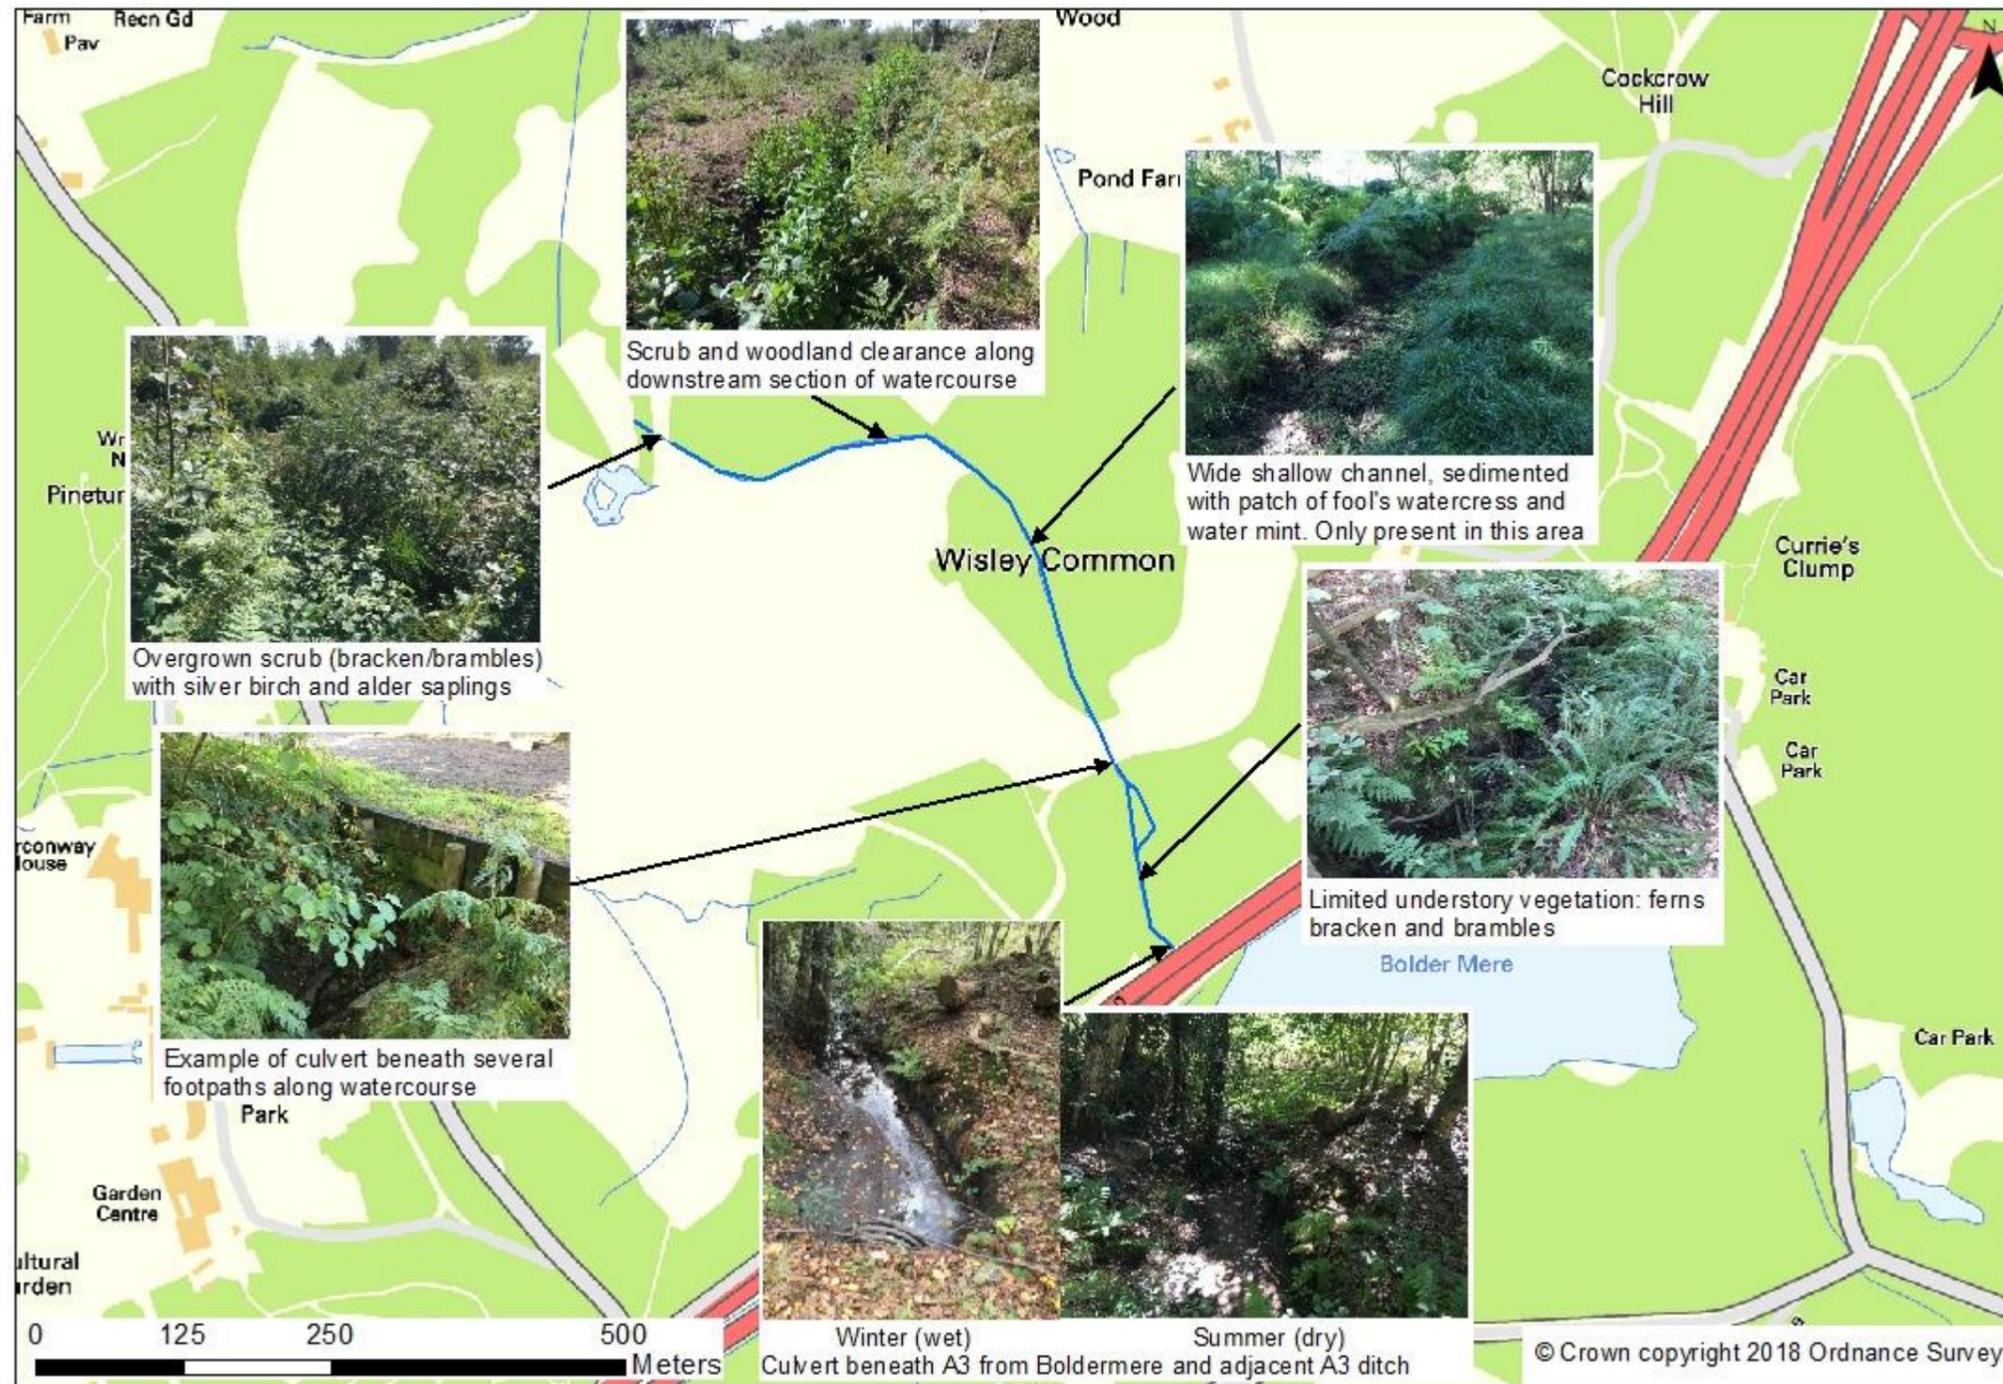
Pond Farm south ditch

This ditch receives water from Bolder Mere and from the ditch adjacent to the A3. It flows through mature woodland (a mix of conifer and broadleaf) with occasional woody debris and tree roots creating natural dams. When surveyed, no flow was visible although damp areas were present containing water mint (*Mentha aquatica*) and fool's watercress (*Apium nodiflorum*) further downstream. In November 2018, the channel contained water with visible flow, courtesy of flow from the ditch adjacent to the A3 (no flow was emanating from Bolder Mere).

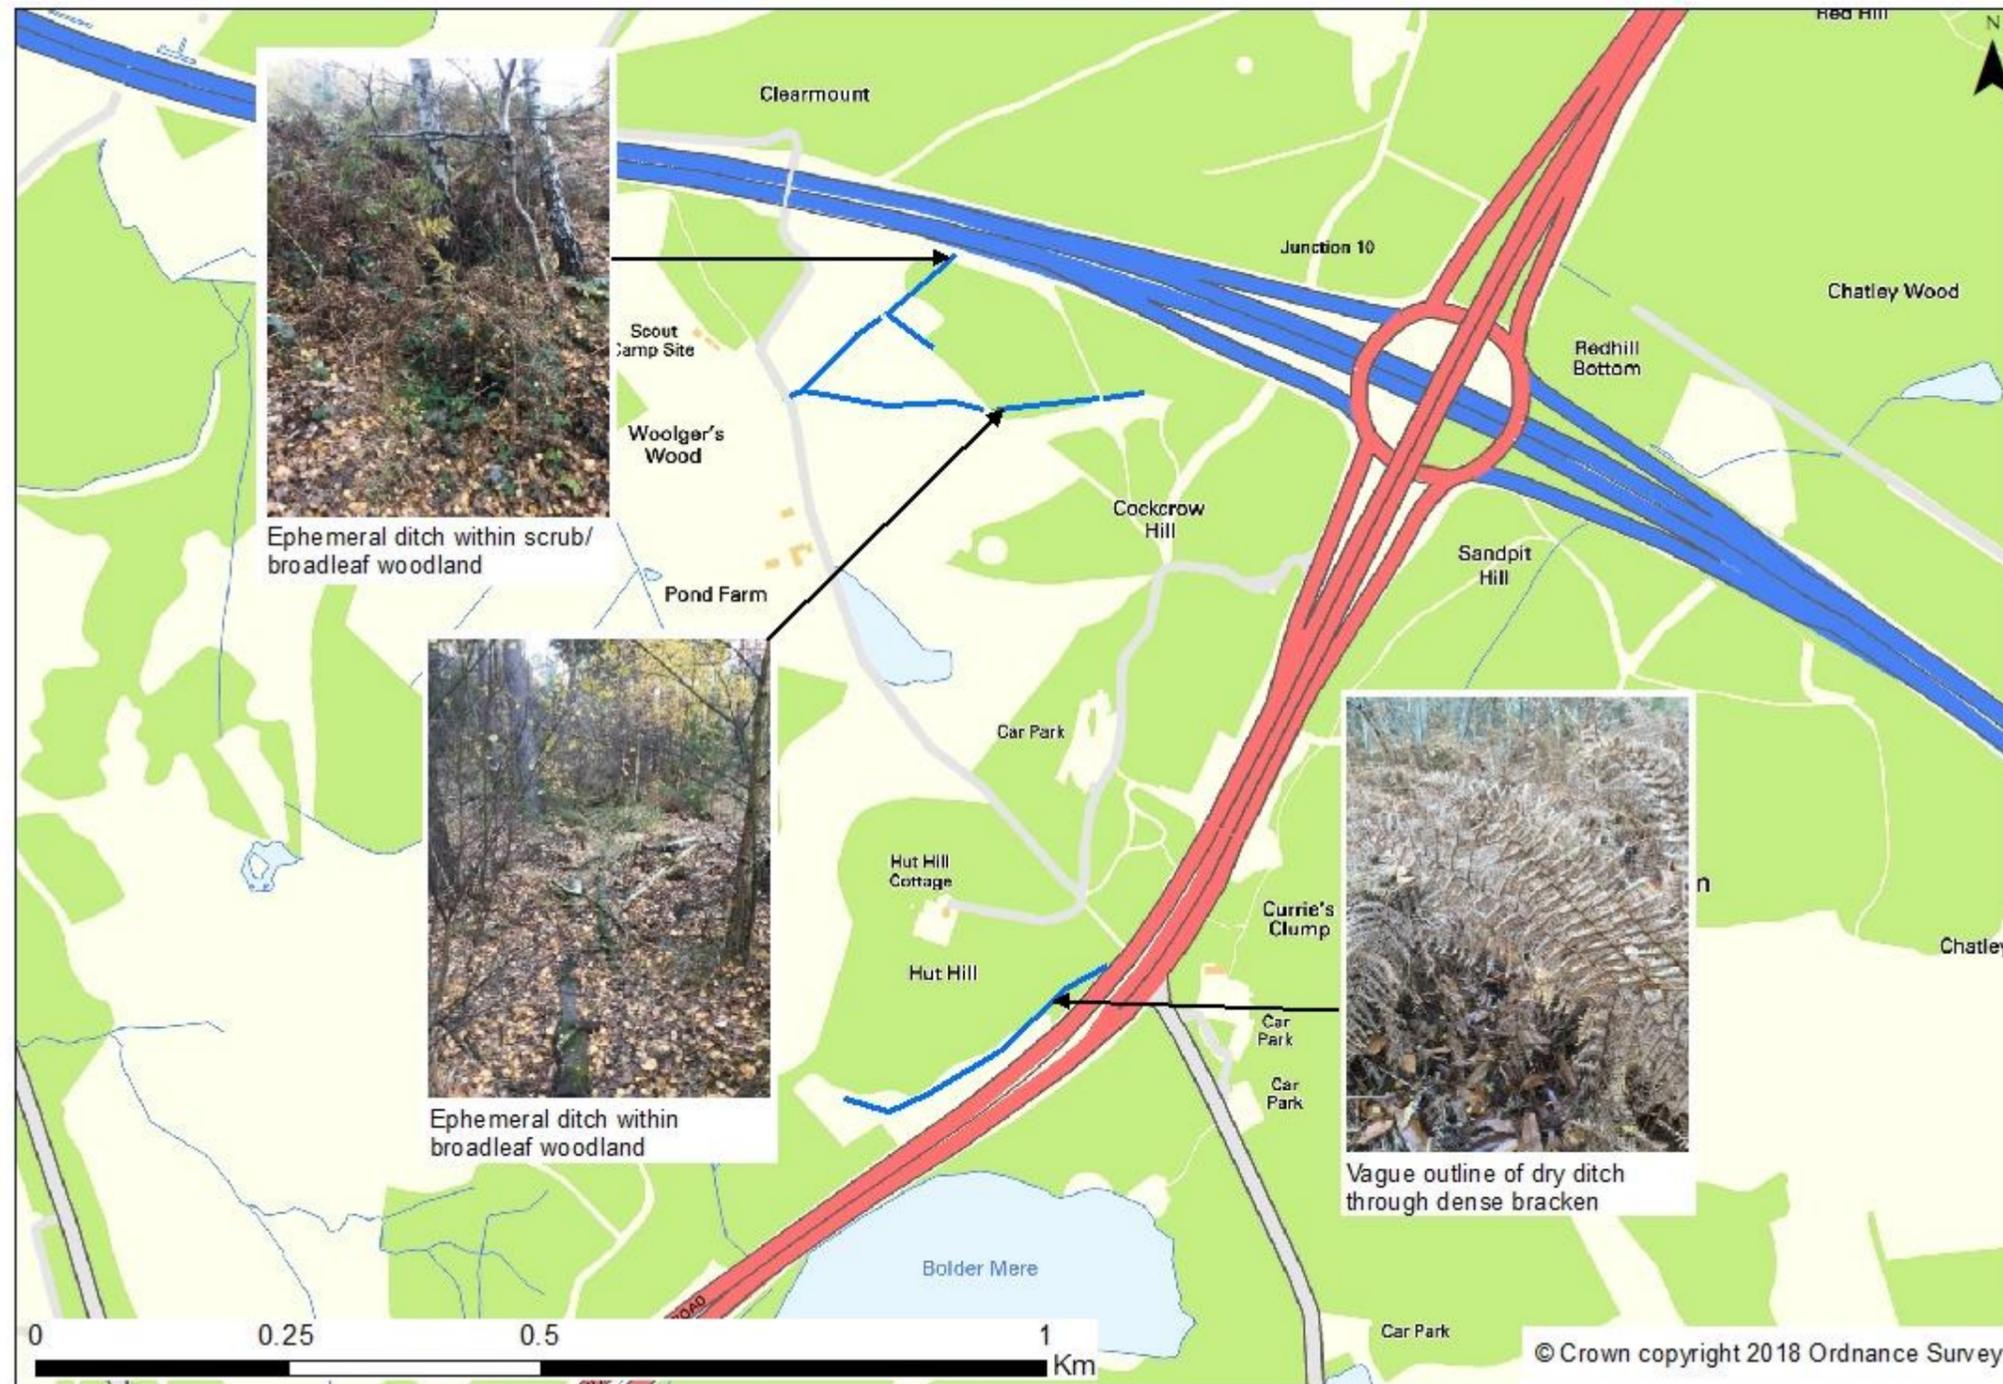
Cockrow Hill ditches & Hut Hill ditch

Cockrow Hill – An ephemeral ditch system with no in-channel vegetation and within a mix of conifer and broadleaf woodland, and heathland. The ditch runs in a westerly direction into an area of wet heath.

Hut Hill – An ephemeral ditch running along the side of a hill within mixed conifer and broadleaf woodland. Running in a north easterly direction, the channel is very indistinct and is hidden beneath dense bramble and bracken scrub.
