M25 junction 10/A3 Wisley interchange TR010030

6.5 Environmental Statement: Appendix 7.8 Bolder Mere ecological survey and condition assessment

6.5 ENVIRONMENTAL STATEMENT: APPENDIX 7.8 BOLDER MERE ECOLOGICAL SURVEY AND CONDITION ASSESSMENT

7.1 Bolder Mere: Ecological survey and condition assessment

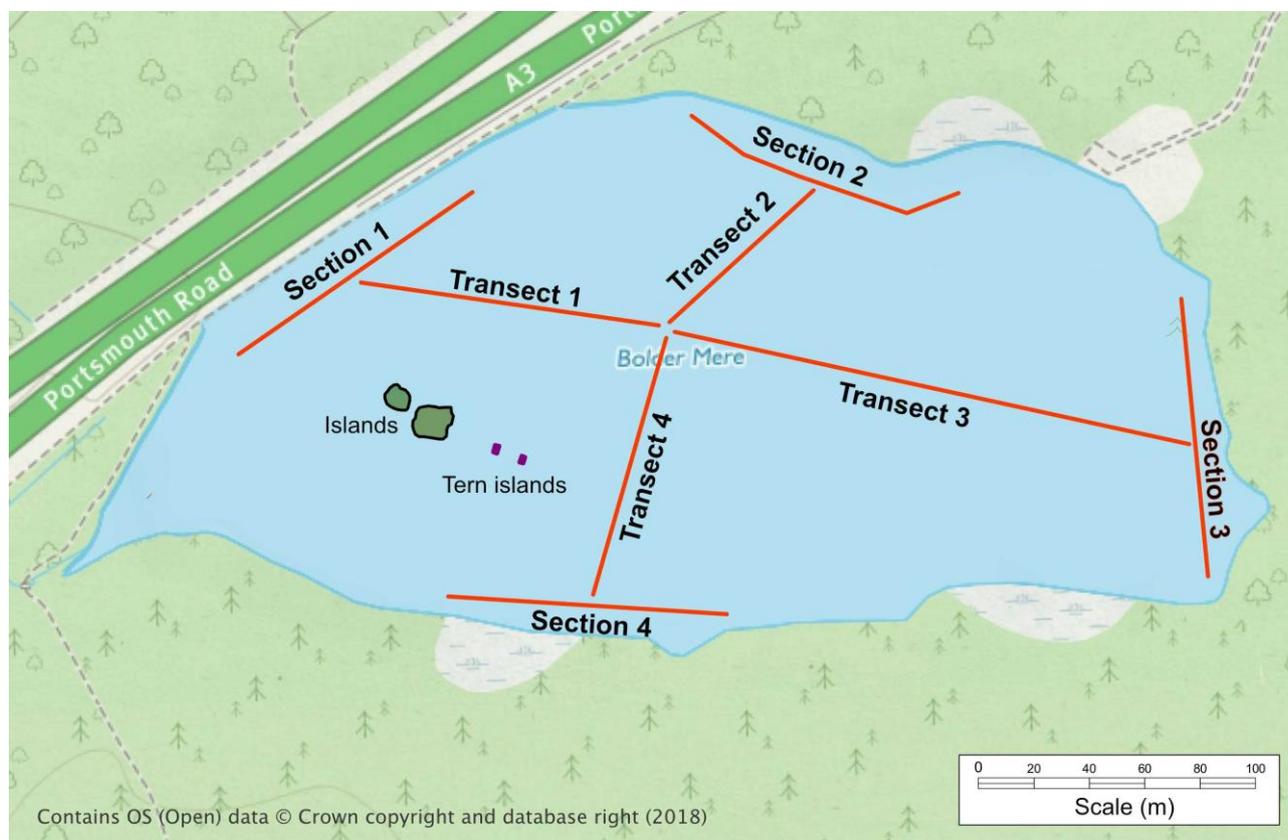
Figure 7.1.1 Map of Bolder Mere showing CSM transect locations

- 7.1.3.1 Water levels on 26 June were estimated to be 15 cm below normal top water level. This was based on the vertical drop below the lip of the outflow grill at the north-western side (TQ0744158397).

- 7.1.3.2 Four sections were surveyed at Bolder Mere using the CSM methodology. The sections were chosen to focus on areas of different habitat types within the lake, as well as giving good geographical coverage (Figure 7.1.1). The lake is very shallow (maximum recorded depth of 1.0 m) and had aquatic plants growing throughout the entire expanse of open water. Boat transects were therefore conducted approximately perpendicular to each section to a point in the centre of the lake (TQ0761358414).

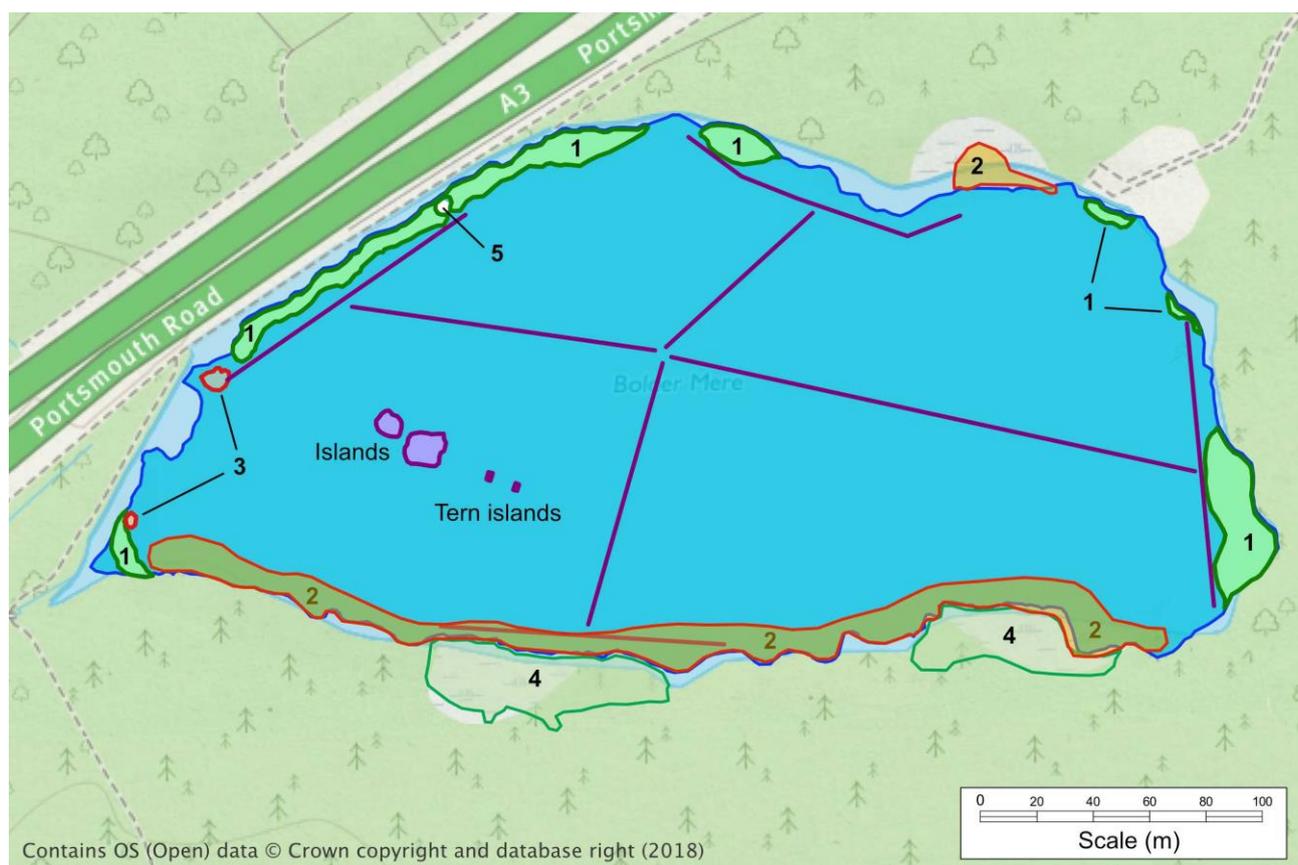
Figure 7.1.2 Bolder Mere habitats map

component of the emergent flora forming the narrow emergent zone against the A3, growing on the rocky artificial substrate bordering the A3 (see areas marked 1 on Figure 7.1.2).

- 7.1.3.13 This habitat is of moderate conservation interest. It provides important shelter and nesting habitat for water fowl and dragon / damselflies. There is a well-used mute swan nest site within the A3 reed margin (5 on Figure 2). *Phragmites* reed is a common habitat in this area and at Bolder Mere is relatively species poor in terms of other wetland plants due to the reed out-competing most other plant species. Very few aquatic macrophytes grow beneath the *P. australis* stands.

- 7.1.3.14 To the west, south-west and north-east of the lake, the margins have extensive areas of dense overhanging trees, mainly comprising willow and alder at the lake edge, with a mix of coniferous and deciduous species behind, including mature oak and birch with understory of Bracken *Pteridium aquilinum*. Where the wetter areas extend into the woodland to the west and southeast of the site, there are stands of sedges (Lesser pond-sedge *Carex acutiformis* and Bottle sedge *C. rostrata* and occasional Cyperus sedge *C. pseudocyperus*).

- 7.1.3.15 The most species rich and botanically interesting areas are along the southern margin of the lake (areas 2 grading into 4 on Figure 2). Here the substrates are mainly gravels and pebbled, bound by organic silts. Mixed stands of emergent vegetation include Common spike-rush *Eleocharis palustris*, Water horsetail *Equisetum fuviatile*, Amphibious bistort *Persicaria amphibia*, Branched bur-reed *Sparganium erectum*, Great reedmace *Typha latifolia* and Marsh pennywort *Hydrocotyle vulgaris*.

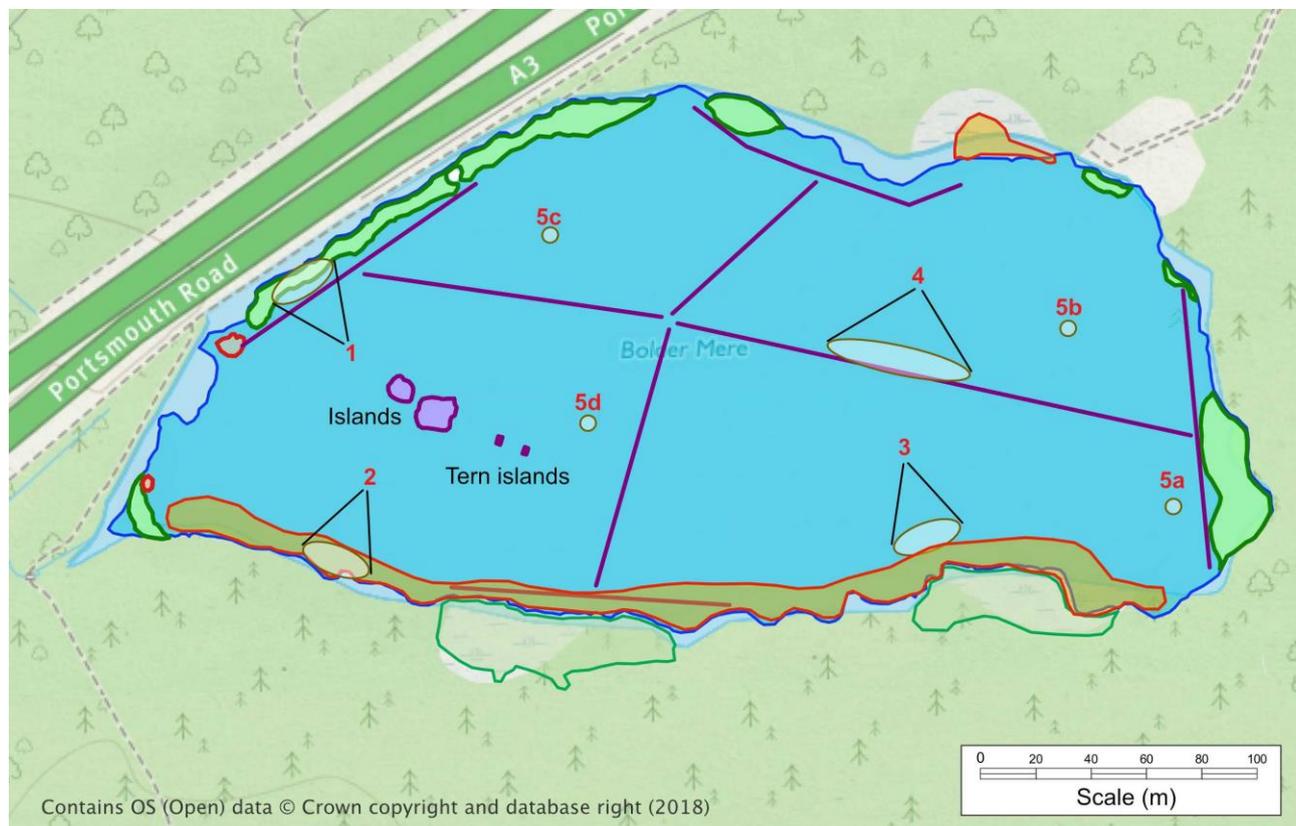
Figure 7.1.3 Map of Bolder Mere showing aquatic macro-invertebrate sampling locations (red)

- 7.1.3.19 Five distinct habitats were identified within Bolder Mere and sampled for aquatic macro-invertebrates. These are described below, and the locations shown on Figure 7.1.3.

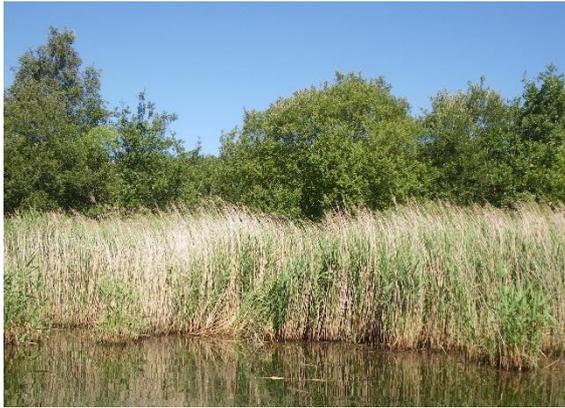
- Sample 1 - Northwest shore (TQ0748358430)

Sample taken within the submerged stems of dense Common reed *Phragmites australis*.

Substrate was mainly organic silts and leaf-litter overlying hard “rocky” material, the latter assumed to be part of the artificial shore that orders the A3.

A series of short kick and sweep samples were made at a number of points in approximately 15 m of similar habitat. Total time of one minute.

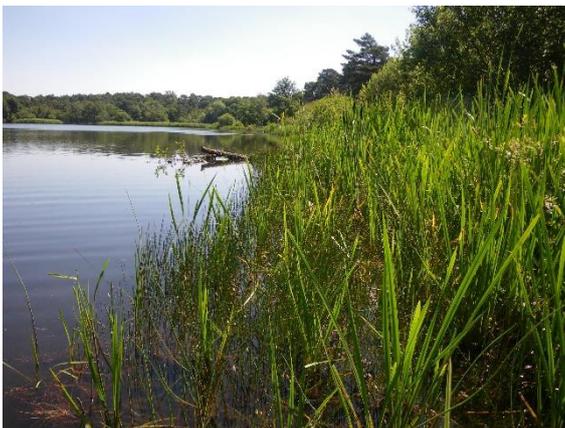
- Sample 2 - Southwest shore (TQ0749158328)

Sample taken within the shallow littoral zone amongst emergent stands of Common spike-rush *Eleocharis palustris* and Branched bur-reed *Sparganium erectum*. Submerged plants included shallow-growing *Myriophyllum alterniflorum*, *Elodea nuttallii* and *Crassula helmsii*.

Substrate was a mix of loosely consolidated pebbles and gravel mixed with fine organic silt and leaf litter.

A continuous kick and sweep sample was made through approximately 10 m of similar habitat. Total time of one minute.

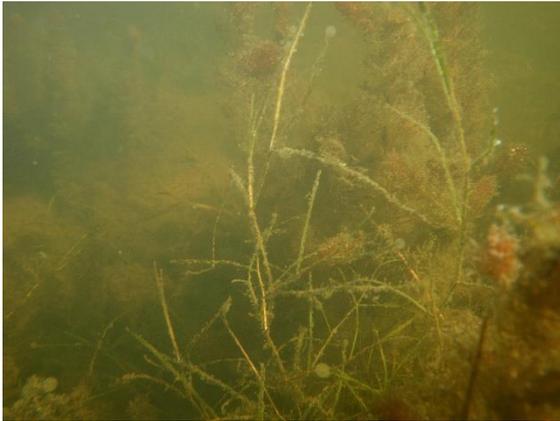
- Sample 3 - South shore (TQ0771758330)

Sample taken in 30 – 50 cm water depth within beds of submerged aquatic vegetation dominated by *Myriophyllum alterniflorum* and *Potamogeton pusillus*. *Elodea nuttallii* and *Crassula helmsii* were also present, but rare. This area had no emergent vegetation and was typical of the shallow littoral around the south shore.

Substrate consisted of fine silt overlying consolidated gravel.

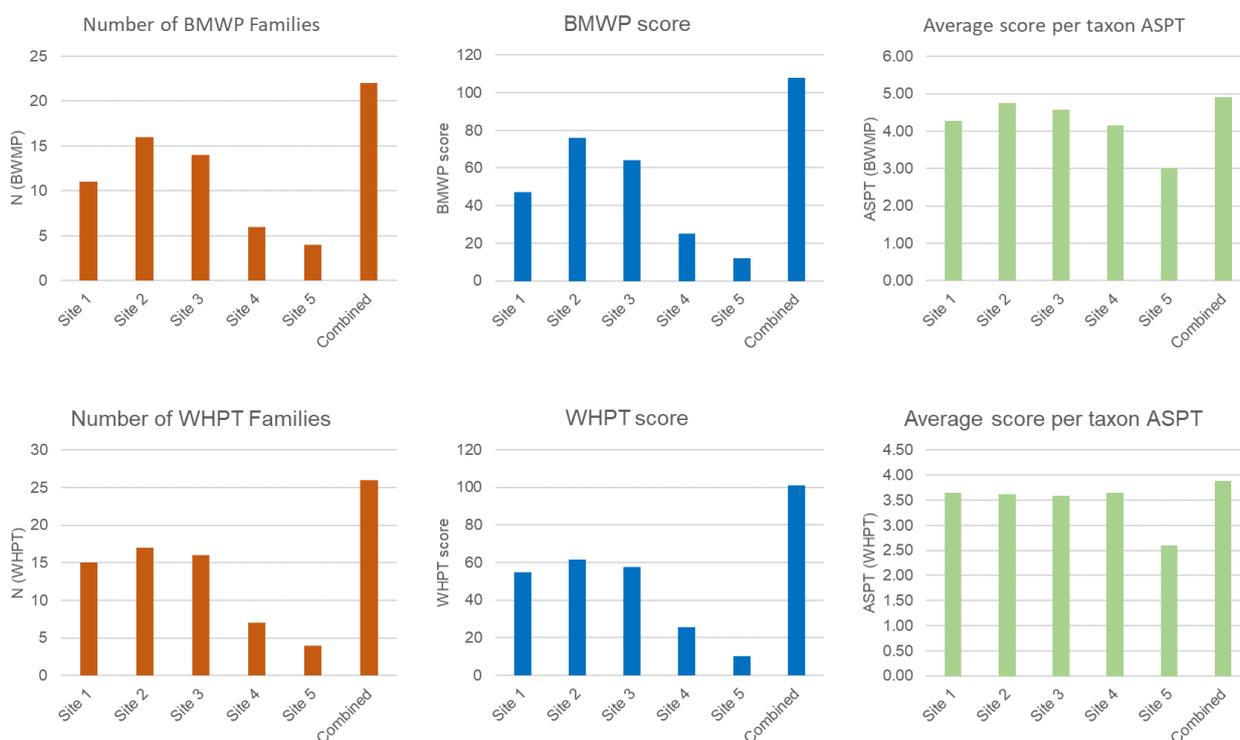
Figure 7.1.4 Aquatic macro-invertebrate BMWP and WHPT metrics from Bolder Mere

- 7.1.3.24 When the data from the different habitats are combined, the BMWP score is 108, which classifies the site as “very good” in terms of its macro-invertebrate fauna.

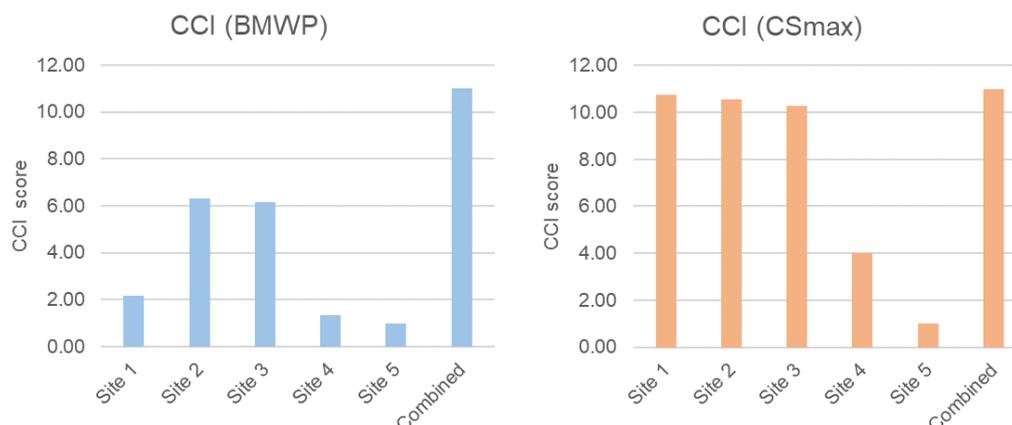
Figure 7.1.5 Community Conservation Index scores for the Bolder Mere meso-habitats

7.1.3.26 The conservation scores for each species were used to calculate a community conservation index (CCI, Chadd & Extence 2004). This metric can be expressed relative to either the highest conservation value (CSmax) of any one species, or to the BMWP score; these are shown in Figure 7.1.5. Both metrics show the conservation value of marginal habitats to be higher than the open water areas.

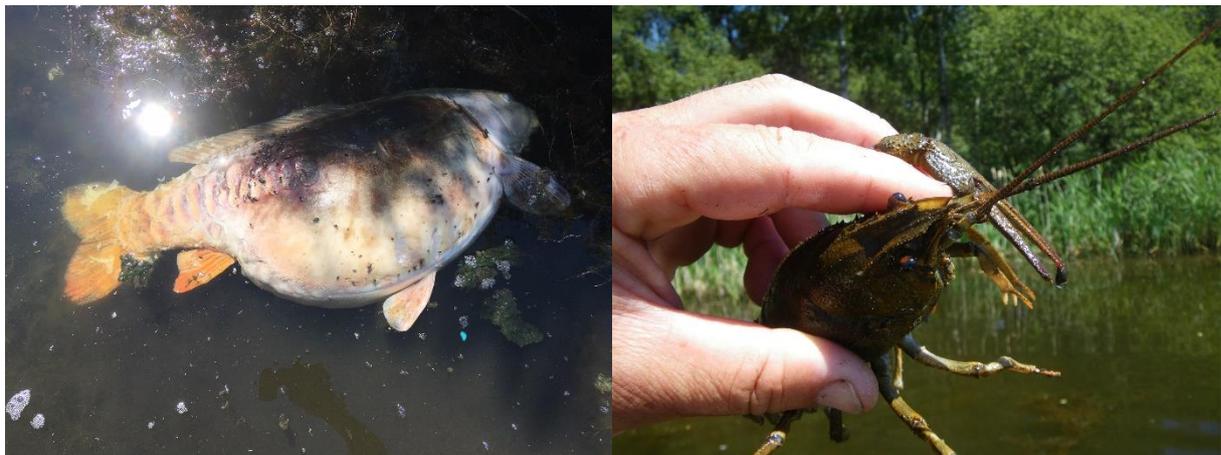
Figure 7.1.9 Large (dead) carp and Turkish crayfish recorded at Bolder Mere

7.1.4.10 Two other INNS were recorded during the survey; carp and Turkish (long-clawed) crayfish *Astacus leptodactylus*. It is understood that a significant effort was made to remove carp from Bolder Mere in 2012, and angling is now prohibited at the site.

7.1.4.11 As with any fish removal, success is rarely 100%, and the presence of large carp in such a shallow site will be damaging due to their foraging behaviour. 6 -10 individuals were observed during the survey, including one dead fish measuring over 80 cm long and 45 cm deep (Figure 7.1.7). The shallow, warm water, provides potential conditions for recruitment and thus further management and control should be a priority.

7.1.4.12 Several mature adult Turkish (long-clawed) crayfish *Astacus leptodactylus* were seen during the survey (Figure 7.1.9). This species is not considered to be as environmentally destructive as the Signal Crayfish in terms of burrowing, but it is a very generalist omnivore, and as such can pose a threat to a wide range of plant and macro-invertebrate species, including larval stages of Odonata. Control and eradication should feature in the management plan for the site.

- 7.1.6.14 In addition to the *Crassula* (see above), two other non-native species are present in Bolder Mere and would benefit from the implementation of control measures.
- 7.1.6.15 Carp *Cyprinus carpio* are potentially damaging to the flora and fauna within the lake and significant numbers of large Carp remain in the lake. The shallow water warms quickly in the spring making this a potential site for successful recruitment and survival of Carp eggs and fry. A fish survey and removal of Carp (and bream if present) is therefore recommended. Annual monitoring of the fish population will be important to establish the success of fish removals.

7.1.6.16 Turkish (Narrow-clawed) crayfish *Astacus leptodactylus* appear to be well established in the site with a number of individual adults observed. Advice on control of this species is rather limited due to its relatively low impact on physical disturbance and susceptibility to crayfish “plague”. This species is omnivorous however and at Bolder Mere it may well present a threat to the aquatic macro-invertebrate population, which include a number of rare species. Control is therefore recommended and further advice should be sought on the most effective methods.

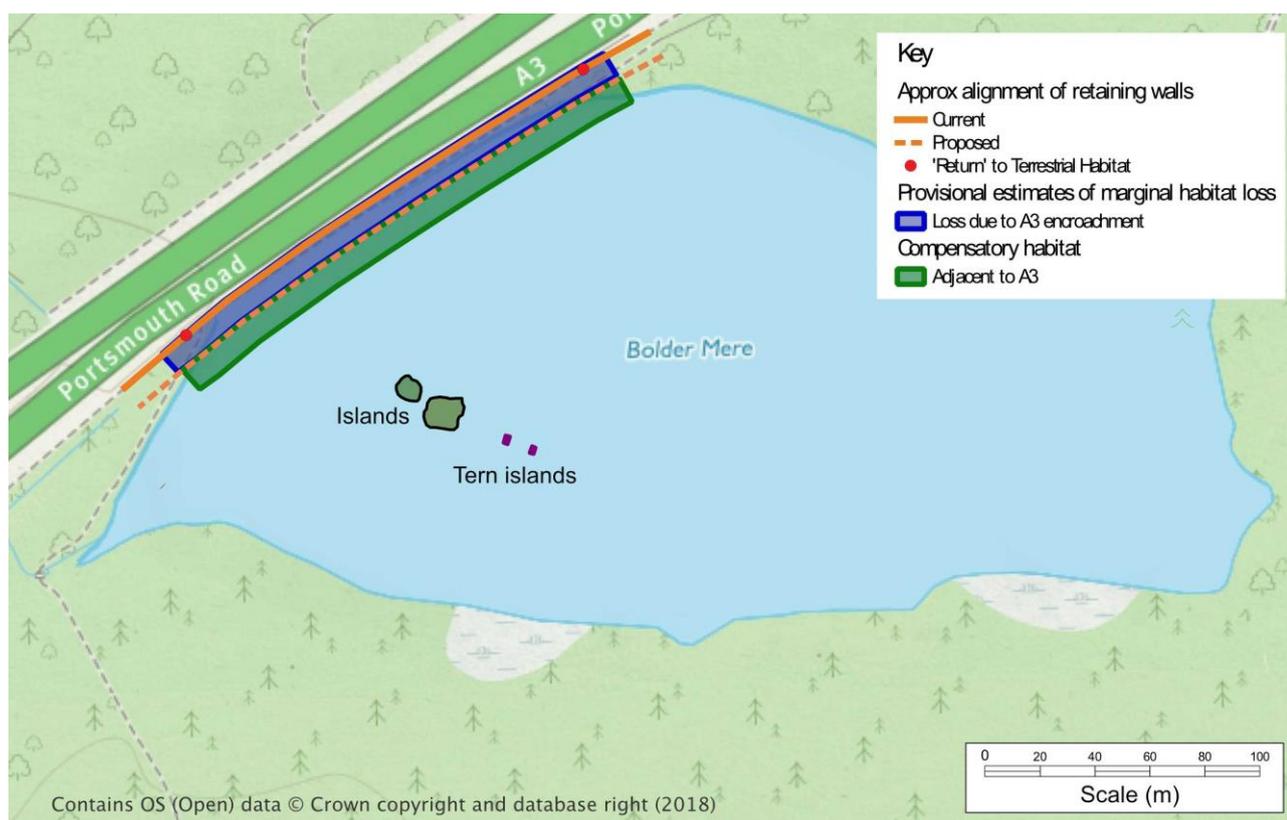
Figure 7.1.10 Map of Bolder Mere showing the proposed re-alignment

7.1.6.1 It is understood from Atkins that the proposal to improve the M25 / A3 road network will include the re-alignment of the northwest shore of Bolder Mere. The proposal at Bolder Mere is to move the current retaining embankment that lies adjacent to the A3 approximately 10 m into the lake, thus losing a 10 m wide strip of the lake margin and associate habitats therein (Figure 7.1.10). This involves the potential disruption to approximately 180 m of shoreline along the northwest side of Bolder Mere. The proposal is to replace any loss of habitat within this region with a like-for-like replanting and / or translocation of the existing habitats.

7.1.6.2 With the possible exception of 10 - 20 m at the eastern, this stretch of shoreline is all artificial, much of it having been created during the original building of the A3 dual carriageway. The eastern end is terrestrial habitat comprising regenerated broadleaf woodland with a range of different age-class willow and alder trees overhanging the lake.

- 7.1.6.3 Similarly, approximately 30 - 40 m of the western end of the proposed re-alignment is also terrestrial broadleaf woodland and includes large alder and a mature oak tree on the lake bank. The impact relating to the loss of terrestrial habitats are not covered in this report.

- 7.1.6.6 The proposed re-alignment works and habitat re-creation will result in a loss of surface area of the open water habitat, assumed to be approximately 1200 m² (0.12 ha = c. 1.5% of lake area). This impacts on the SSSI condition assessment for the lake, whereby any loss of extent to the open water due to active management is deemed to be unfavourable.

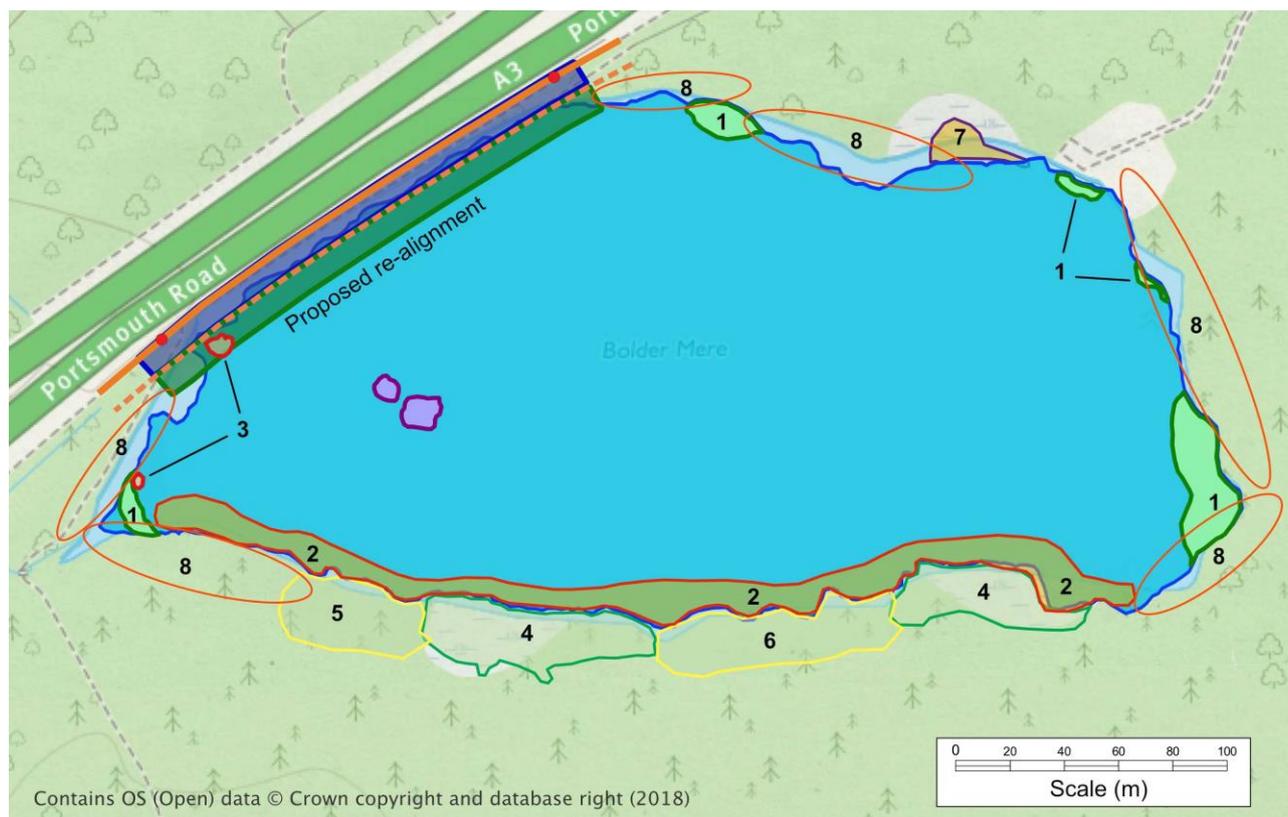
Figure 7.1.11 Potential habitat improvement areas at Bolder Mere

7.1.6.13 A number of key areas are identified in Figure 7.1.11 where the management recommendations are focussed.

- 1. Reed bed. Dominated by *Phragmites australis* with occasional Greater reedmace *Typha latifolia*. These areas, including the future development of the re-aligned shore, provide good habitat for birds and invertebrates and are important within the site. The current extent (to include the future re-aligned area) is considered suitable for the site. No additional management is required, but future control would be necessary if there is any evidence of any significant spread into adjacent habitat types or open water.

- 3. The water lilies *Nymphaea* sp. are confined to two beds at the western end. These provide good habitat for some Odonata species during egg-laying and should be maintained within the site. One population is likely to be within the re-alignment areas and it is recommended that it is translocated to remain as close as possible to its current location.

- 9. Open water habitat remains important for the site and will be best maintained by ensuring catchment sources of nitrogen and phosphorous are below target values for this lake type (1.5 mg l⁻¹ N and 30 µg l⁻¹ P) and sediment loads are low. It is important that the lake does not receive run-off from the adjacent A3. A catchment nutrient budget is recommended to identify any potential sources of nutrients reaching the lake and where possible, reduce nutrient inputs.
