# M25 junction 10/A3 Wisley interchange TR010030 5.4 Water framework directive compliance assessment report

### M25 junction 10/A3 Wisley interchange

#### 5.4 WATER FRAMEWORK DIRECTIVE ASSESSMENT REPORT

<b>Regulation Number:</b>	Regulation 5(2)(q)
<b>Planning Inspectorate Scheme Reference</b>	TR010030
<b>Application Document Reference</b>	TR010030/APP/5.4
<b>Author:</b>	M25 junction 10/A3 Wisley interchange Project Team, Highways England

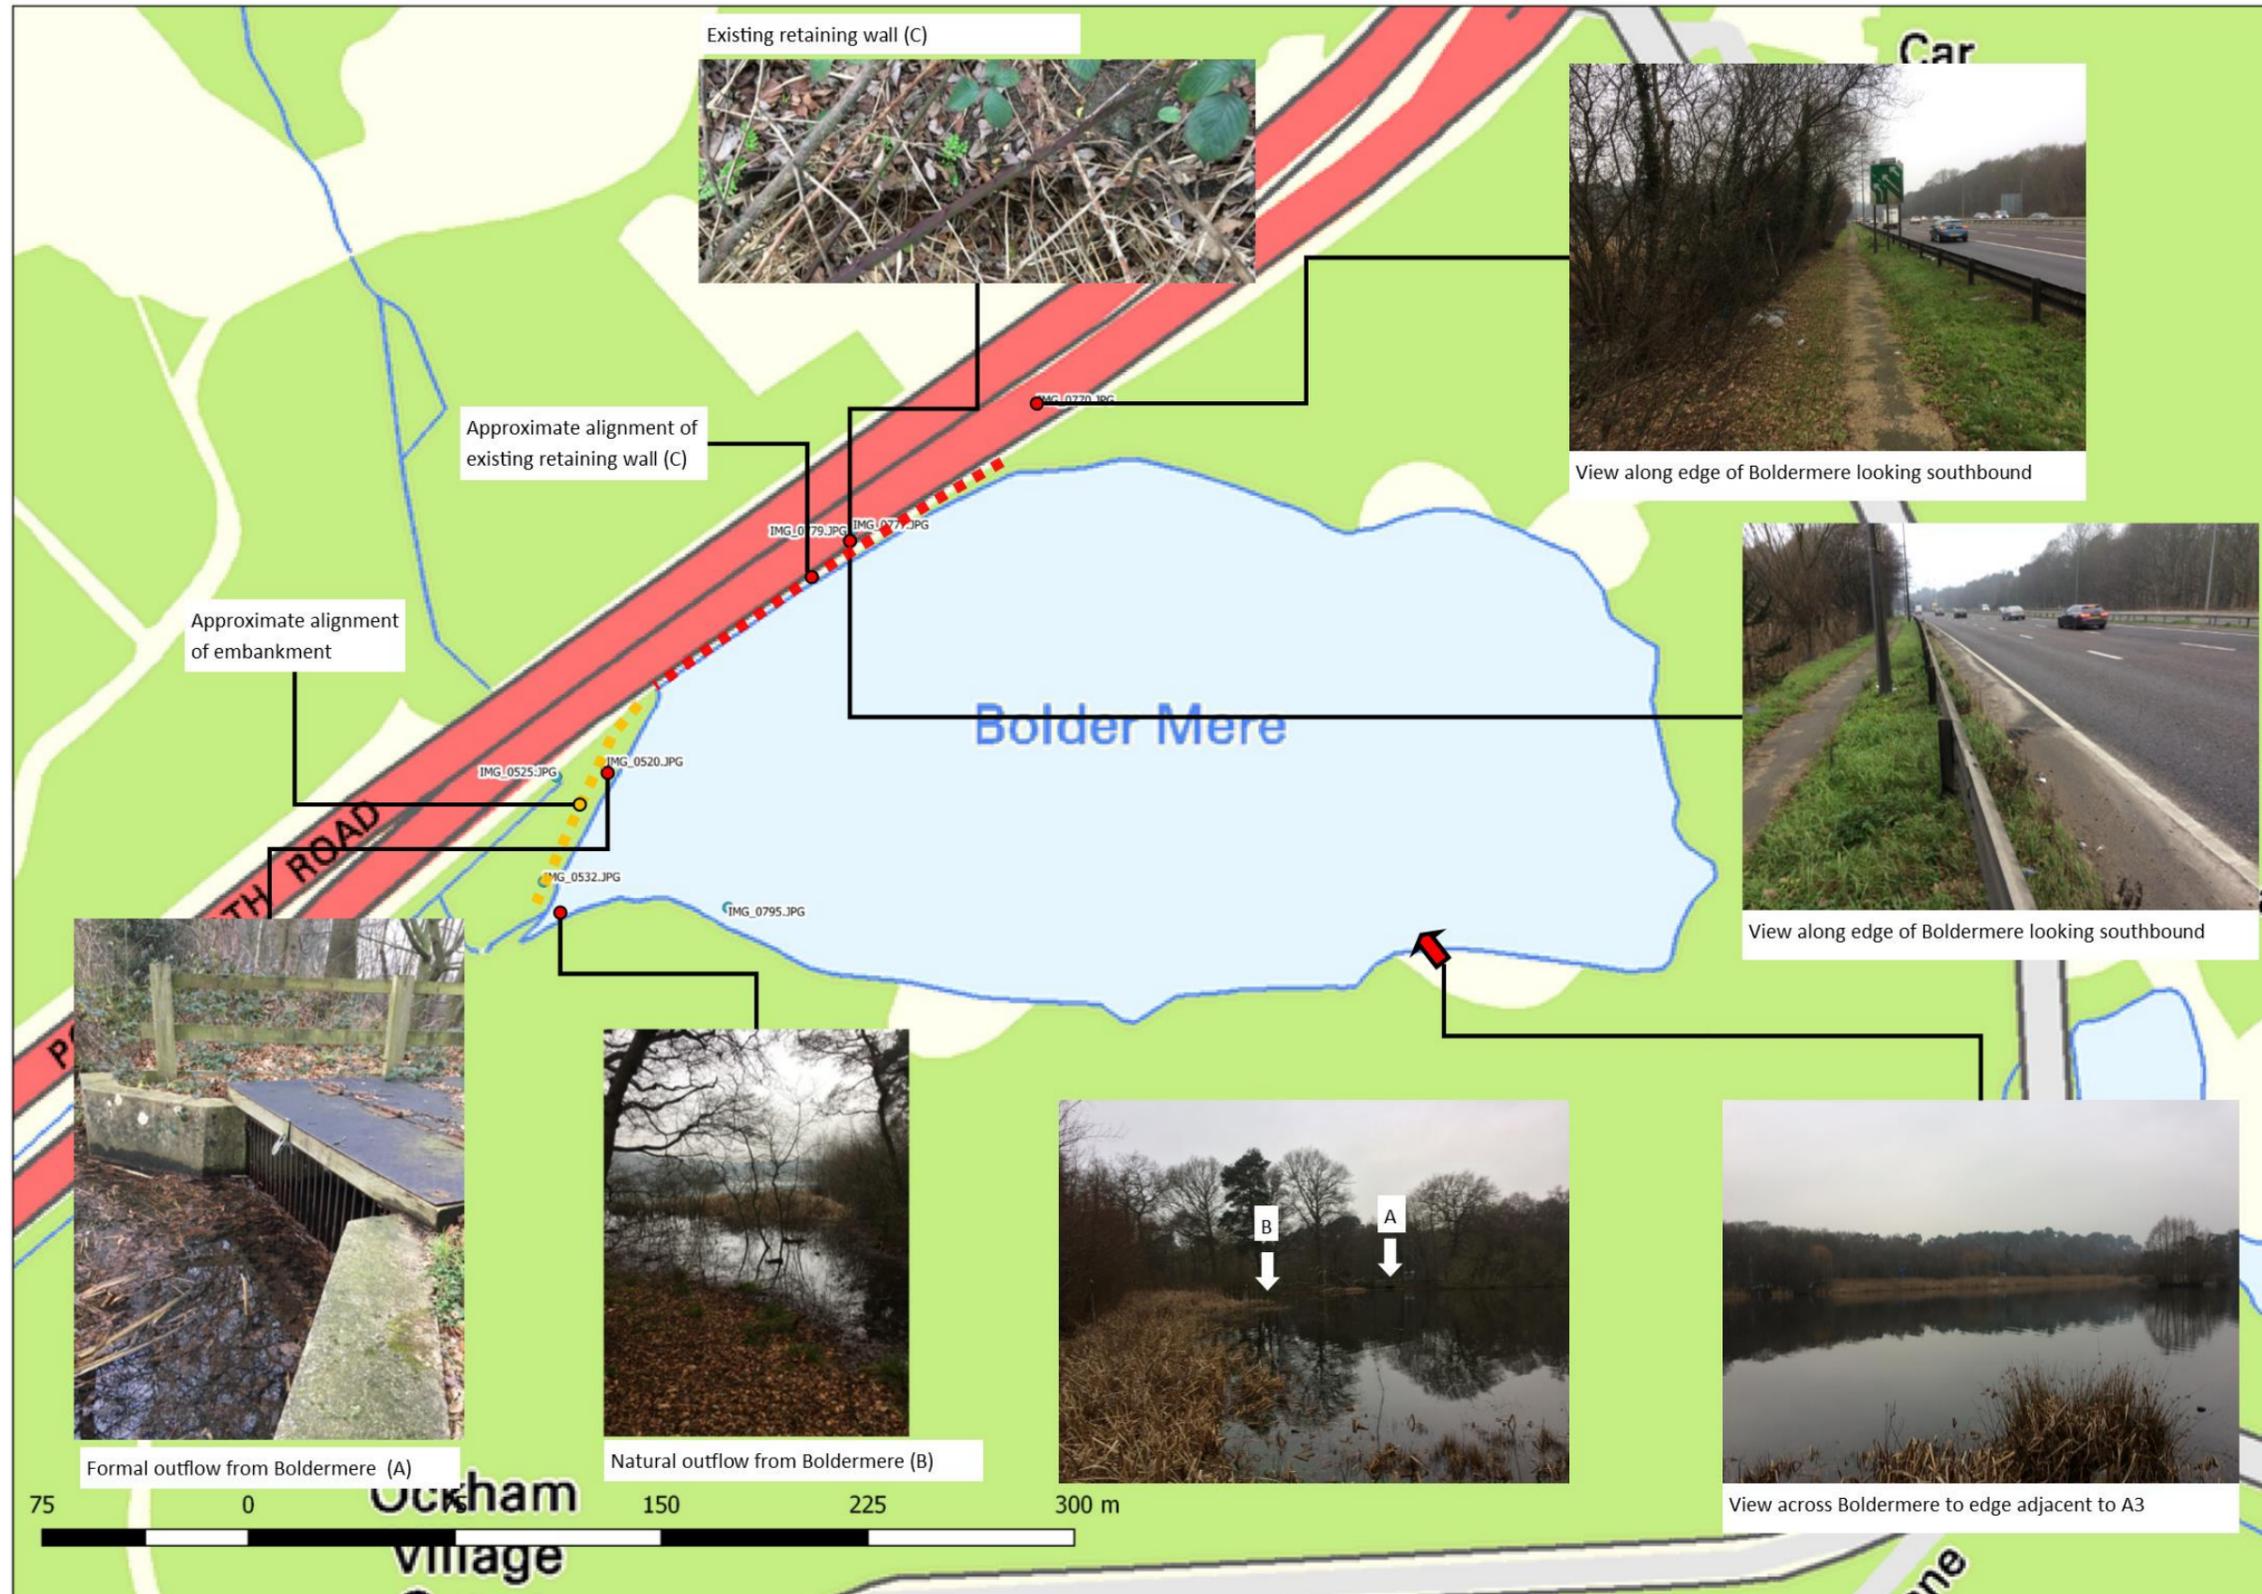
Figure 4.4: Bolder Mere: modifications resulting in HMWB status and photos of key features

- 4.6.52 A literature review of common chemical components of road runoff (Appendix D.3) suggests that the A3 is unlikely to be a direct source of phosphorus to Bolder Mere. The same review shows that the road is an unlikely pathway for phosphorus to the lake from common sources such as arable land.
- 4.6.53 Although the A3 is probably not contributing to the failure of the Bolder Mere water body to comply with phosphorus standards, provisional drainage survey records collected for this study and file records at NE indicate that runoff (and potential associated pollutants) from the A3 discharges direct to Bolder Mere, without treatment. The NE records refer to “ponded water on the road and lake merged into one” suggesting that either the road drainage system becomes overwhelmed or that high lake levels flood the road.

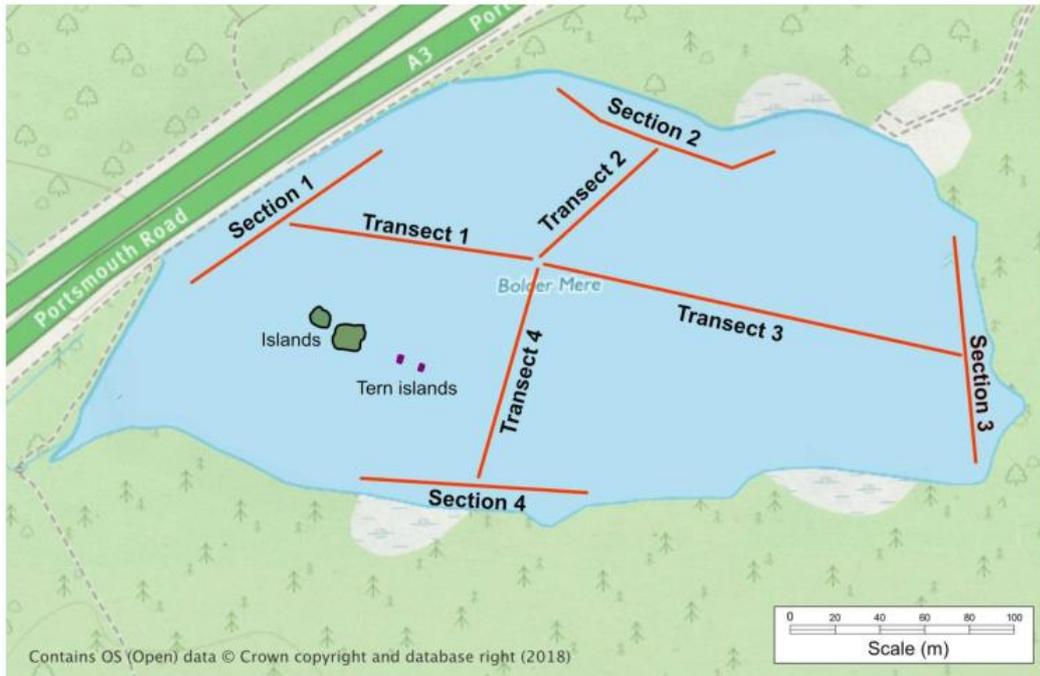
Figure 1 Map of Boldermere showing CSM transect locations

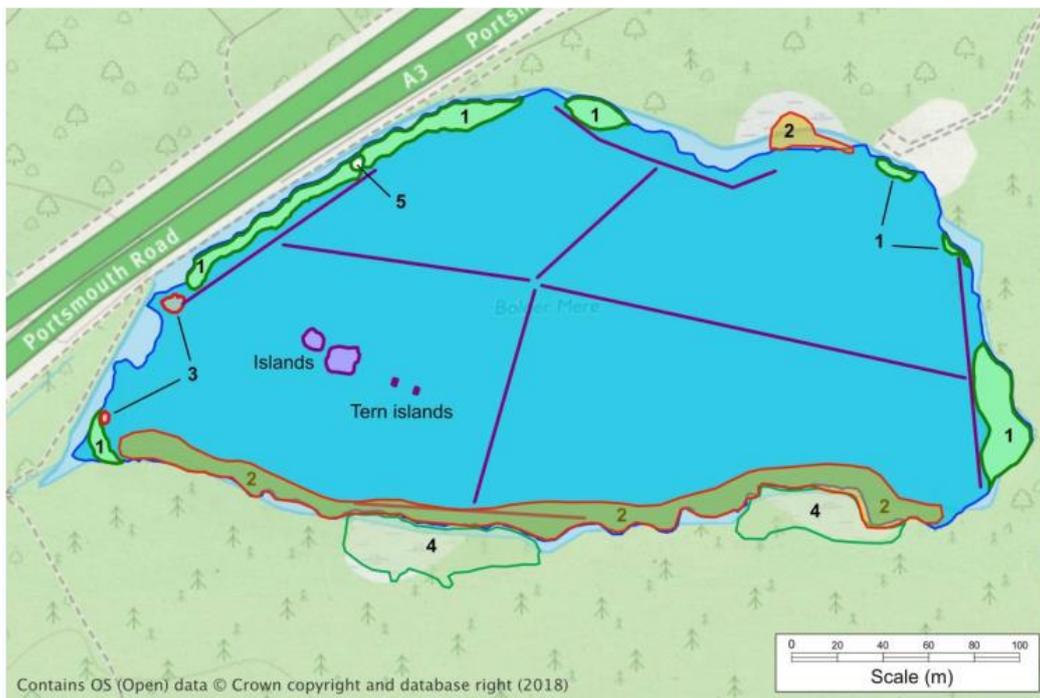
Figure 2 Boldermere habitats map

This habitat is of moderate conservation interest. It provides important shelter and nesting habitat for water fowl and dragon / damselflies. There is a well-used mute swan nest site within the A3 reed margin (5 on Figure 2). *Phragmites* reed is a common habitat in this area and at Boldermere is relatively species poor in terms of other wetland plants due to the reed out-competing most other plant species. Very few aquatic macrophytes grow beneath the *P. australis* stands.

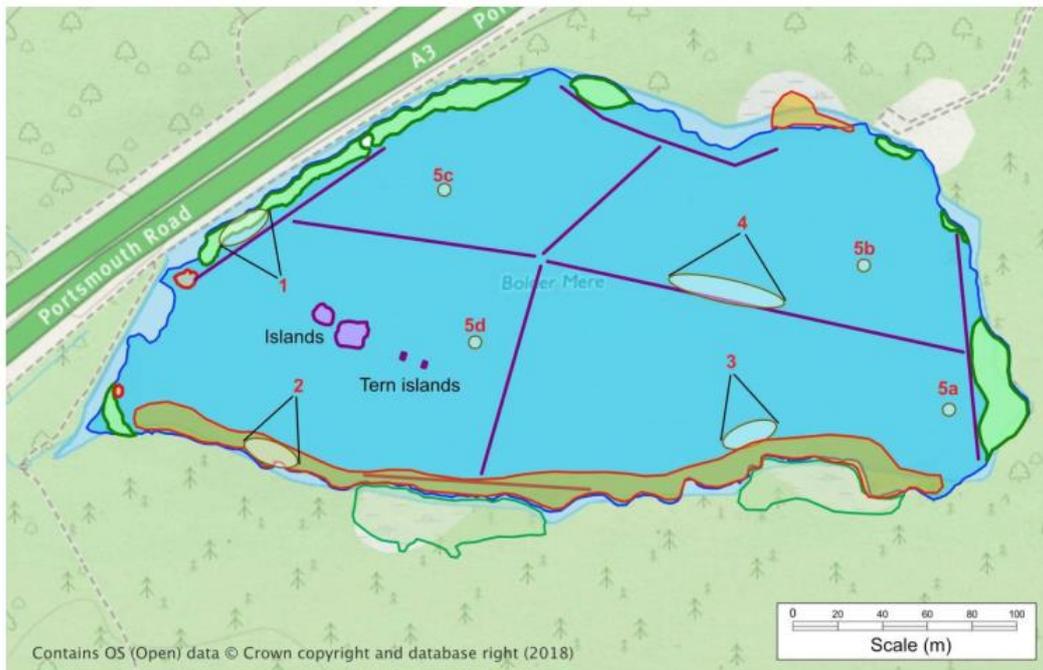
Figure 3 Map of Boldermere showing aquatic macro-invertebrate sampling locations (red)

Five distinct habitats were identified within Boldermere and sampled for aquatic macro-invertebrates. These are described below, and the locations shown on Figure 3.

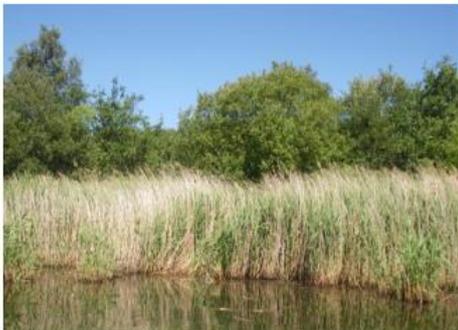
#### Sample 1 - Northwest shore (TQ0748358430)

Sample taken within the submerged stems of dense Common reed *Phragmites australis*.

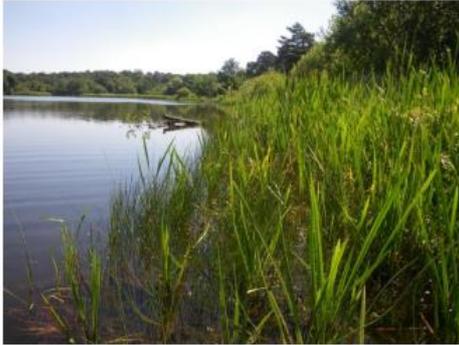
**Sample 2** - Southwest shore (TQ0749158328)

Sample taken within the shallow littoral zone amongst emergent stands of Common spike-rush *Eleocharis palustris* and Branched bur-reed *Sparganium erectum*. Submerged plants included shallow-growing *Myriophyllum alterniflorum*, *Elodea nuttallii* and *Crassula helmsii*.

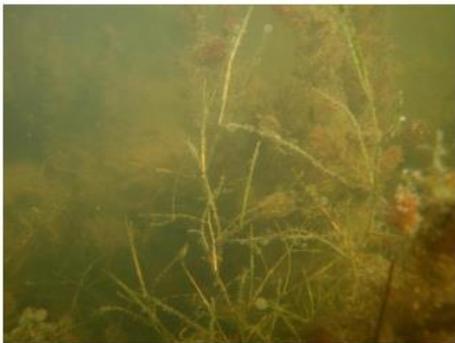
**Sample 3** - South shore (TQ0771758330)

Sample taken in 30 – 50 cm water depth within beds of submerged aquatic vegetation dominated by *Myriophyllum alterniflorum* and *Potamogeton pusillus*. *Elodea nuttallii* and *Crassula helmsii* were also present, but rare. This area had no emergent vegetation and was typical of the shallow littoral around the south shore

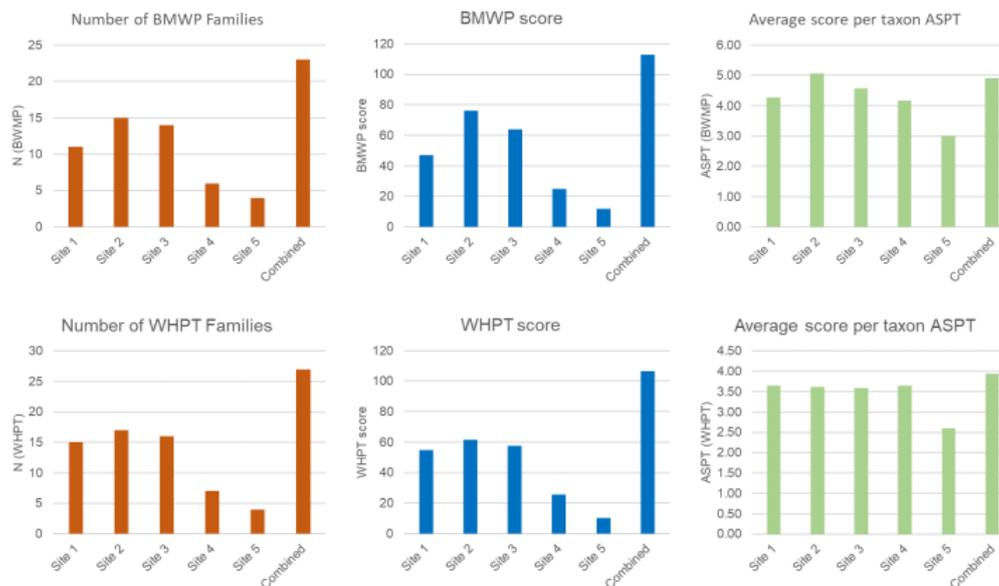
Figure 4 Aquatic macro-invertebrate BMWP and WHPT metrics from Boldermere

When the data from the different habitats are combined, the BWMP score is 113, which classifies the site as “very good” in terms of its macro-invertebrate fauna.

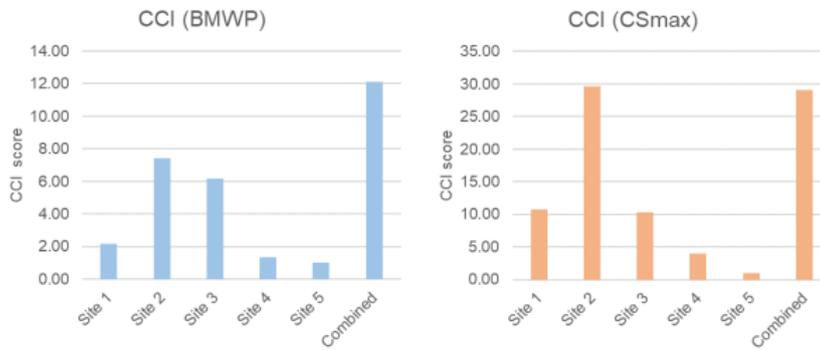
either the highest conservation value (CSmax) of any one species, or to the BMWP score; these are shown in Figure 5. The CSmax derived CCI score for site 2 is skewed heavily by the single occurrence of *Stenelmis canaliculata*, but nonetheless, both metrics show the conservation value of marginal habitats to be higher than the open water areas.

Figure 5 Community Conservation Index scores for the Boldermere meso-habitats

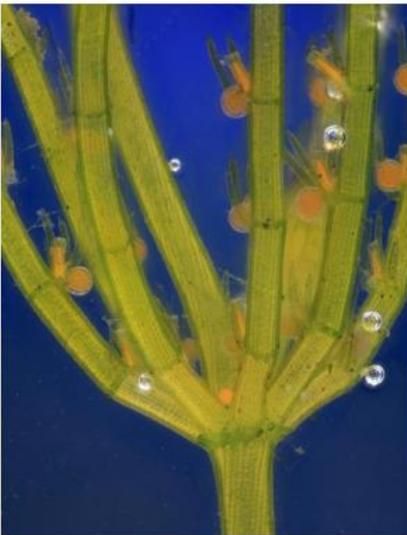
Figure 6 *Chara globularis* (x10) from Boldermere

Other macrophyte species recorded are more generalist in their habit, occurring across a wide range of ecological and trophic gradients. The occurrence of the Stonewort *Chara globularis* (Figure 6) suggests nitrogen concentrations are not excessive. Stoneworts are particularly sensitive to nitrates, and rarely persist in sites where nitrate is high.

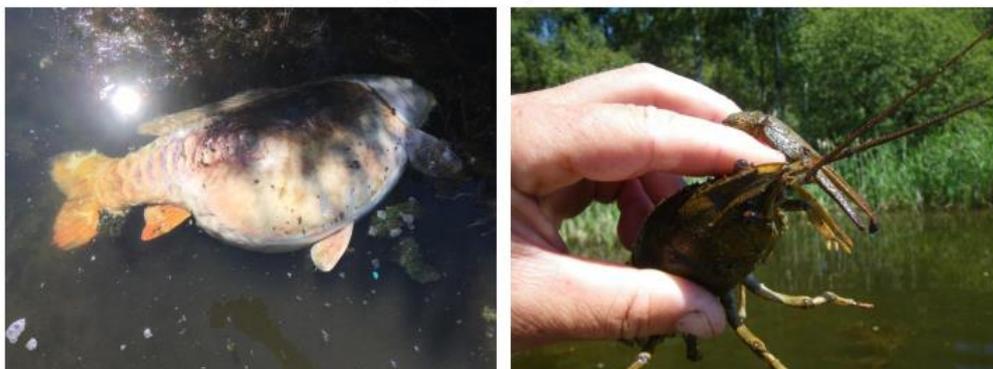
Figure 9 Large (dead) carp and Turkish crayfish recorded at Boldermere

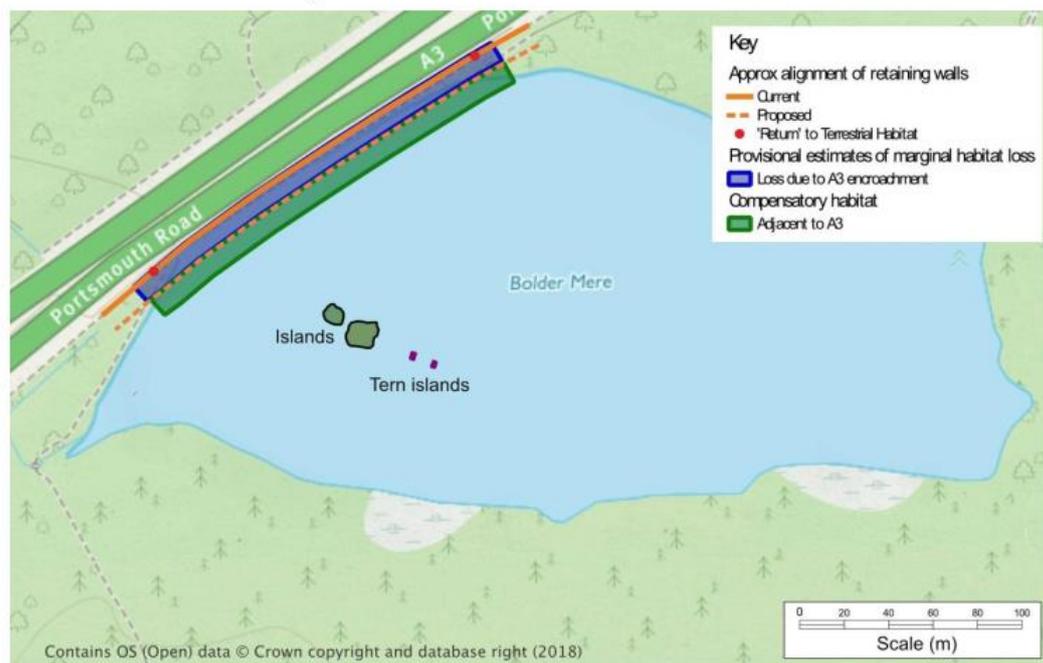
Figure 10 Map of Boldermere showing the proposed re-alignment.

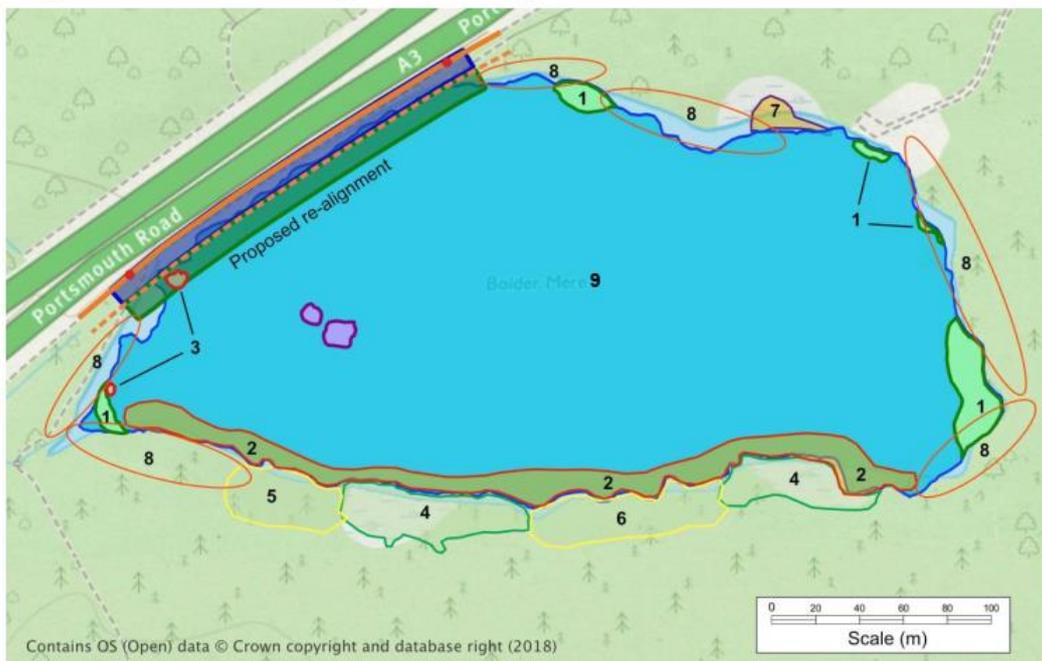
Figure 11 Potential habitat improvement areas at Boldermere

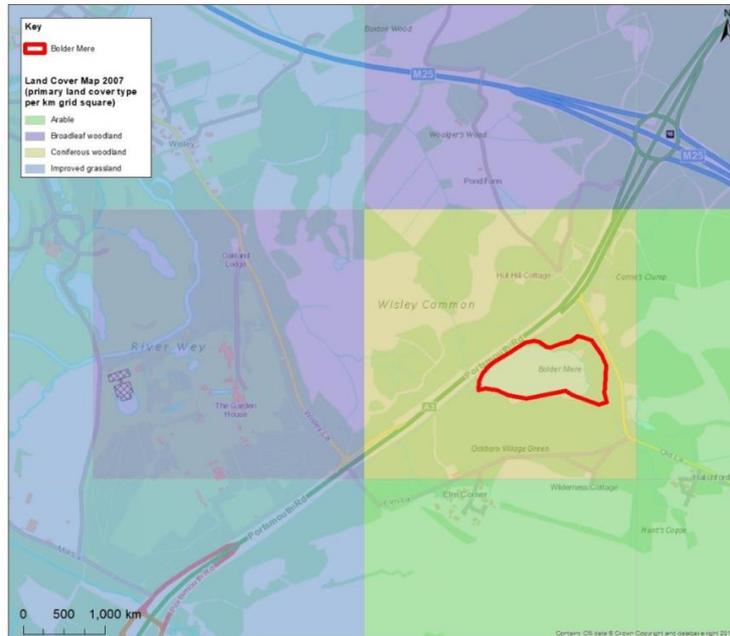
Figure 2 Primary land cover type per km grid square in the vicinity of Boldermere (source: Land Cover Map 2007)

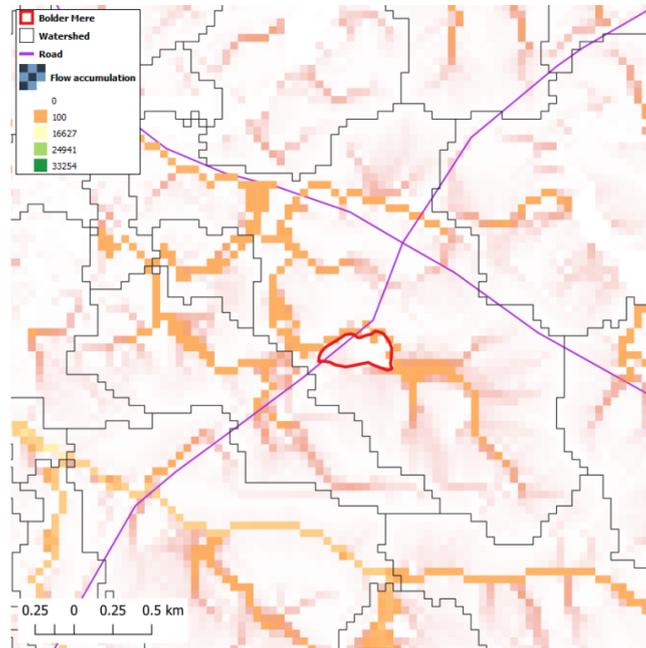
Figure 3 Flow accumulation per 50m grid square in the vicinity of Boldermere

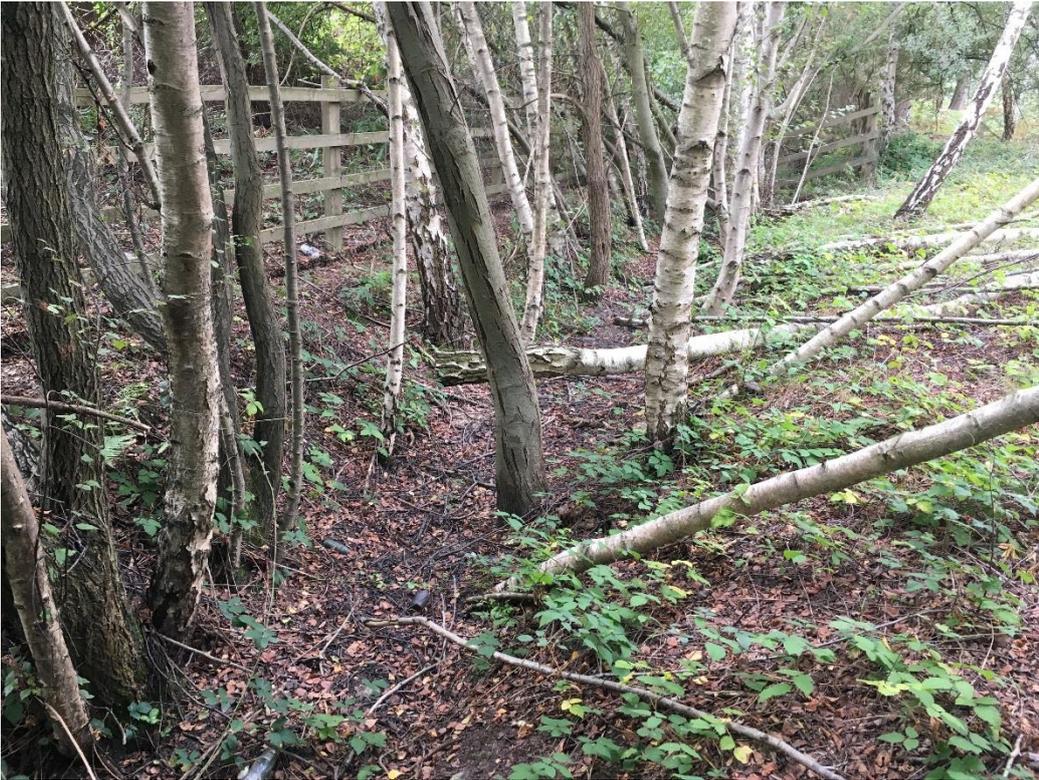
**Figure F.4: Ephemeral headwater ditch adjacent to current M25 alignment on the southern side of the proposed Sandpit Hill overbridge (Ockham Common Ditch)**

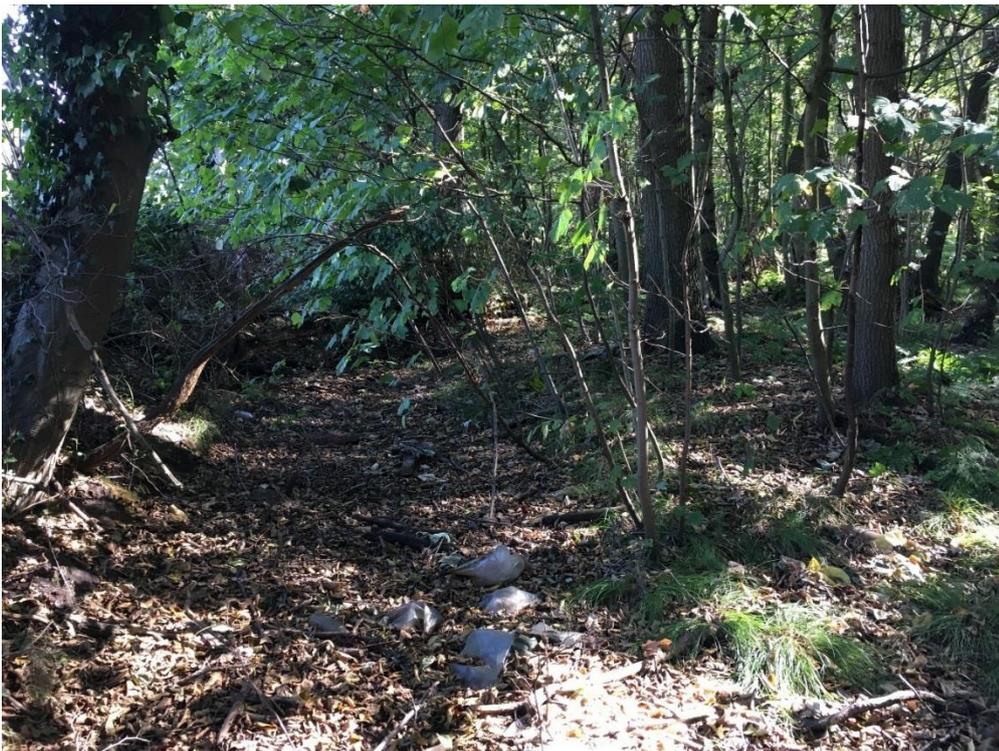
F.5.2 The scheme component that has the most substantial effect on ephemeral headwater ditches in the Wey catchment is the widening of the A3 between Bolder Mere and Elm Lane (WY2). This will result in the displacement c. 570 m of existing channel into a new pre-embankment drain. This drain is a heavily modified section of a natural drainage network (serving a catchment of c. 0.7 km<sup>2</sup>) that currently also receives runoff from the A3. An indicative photo is presented in Figure 6 below.

**Figure F.6: Ephemeral headwater ditch to the south of A3 between Bolder Mere and Elm Lane**
