Tree value and root investigations for trees adjacent to the A3

RHS Wisley, Surrey

RHS REP10-xxx - Appendix 5 - Barrell Tree Consultancy - Report - Tree value and root investigations for trees adjacent to the A3 2 June 2020_

2nd June 2020

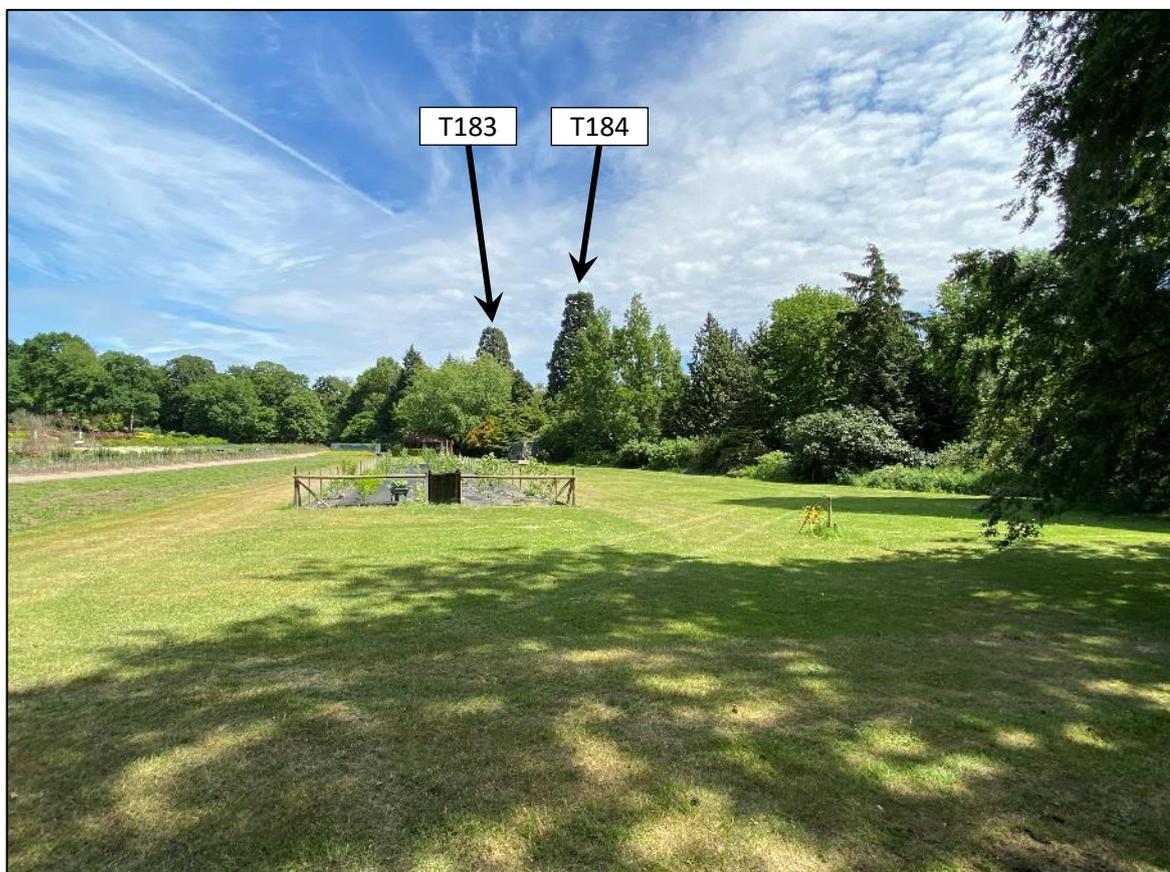
These trees are both redwoods (*Sequoiadendron gigantea*) estimated to be about 80–90 years old. They are visually prominent and seen daily by thousands of motorists travelling along the adjacent A3 from both directions because they are so tall (24 and 27m), standing much taller than all the surrounding tree cover. They are also prominent within the RHS Gardens, which is a Grade II* Listed Park and Garden laid out in 1878 to 1902 and acquired by the RHS in 1903. They dominate the skyline in the views from within the Gardens out towards the south and east (Figure 1).

Figure 1: View of the Garden boundary looking towards the east visually dominated by the redwood trees 183 and 184.

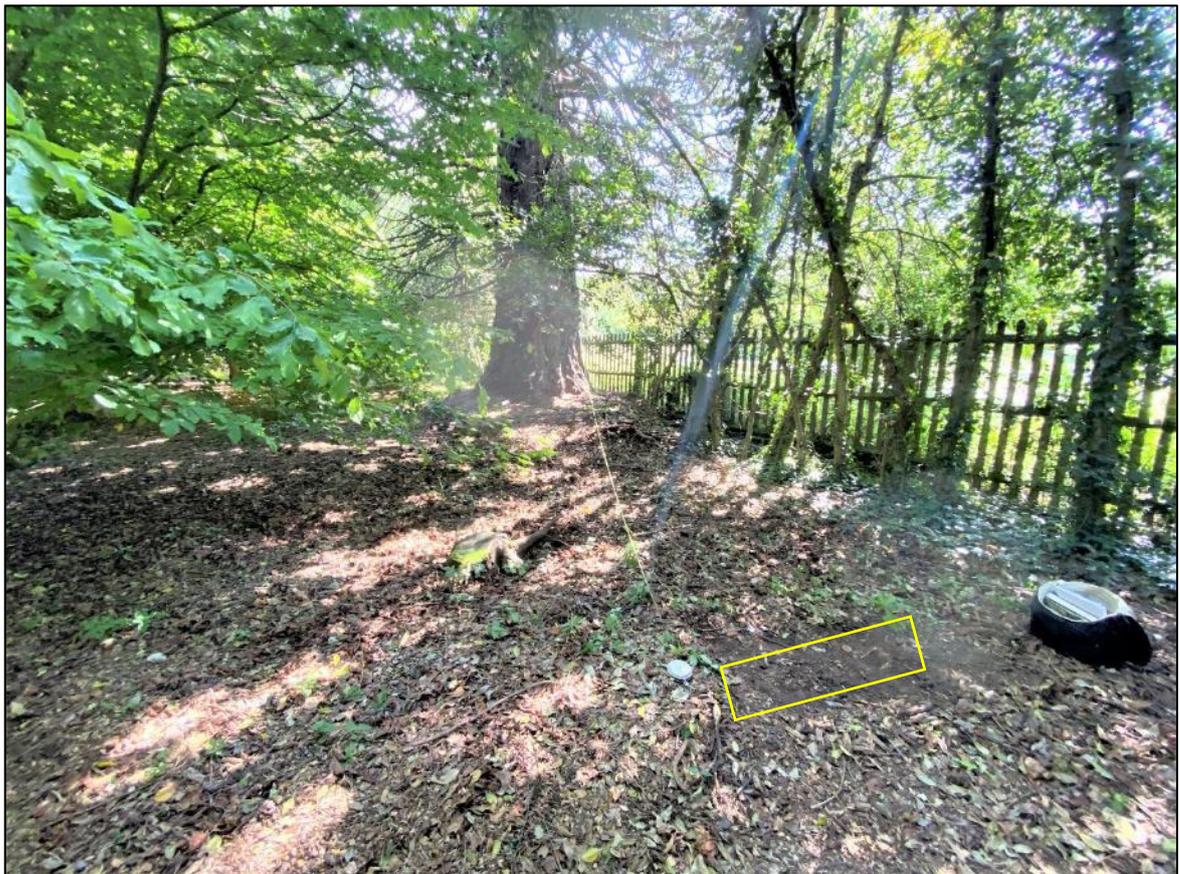
At T184, I located an area roughly to the west of the trunk, and at 8.5m from its centre, that was free from other nearby large trees (Figure 2), and excavated a trench that is approximately shown on an extract of the root morphology graphic (Figure 3). At this point, the trench was excavated perpendicular to the radius from the tree about 2m in length, 0.5m in width, and 1m depth (Figure 4). Within that trench at about 30–40cm below ground level, I uncovered three substantial roots that were measured at about 7–10cm diameter (Figure 5). I confirmed that these were alive by noting the bark was firmly attached and that they were likely to be from T184 because of the red colour of the bark and wood beneath, a known root characteristic of this species. I also noted smaller fibrous roots at the bottom of the pit at about 1m depth, that I also identified as likely to be from the subject tree (Figure 6). I did not take samples for laboratory confirmation of the species, but this could be easily done if the findings are disputed. The trench was filled in following the excavation, but it would be possible to easily open it up again if any of my observations needed to be verified.

Figure 2: Location of the trench (yellow box) before excavation, 8.5m west of the centre of T184.

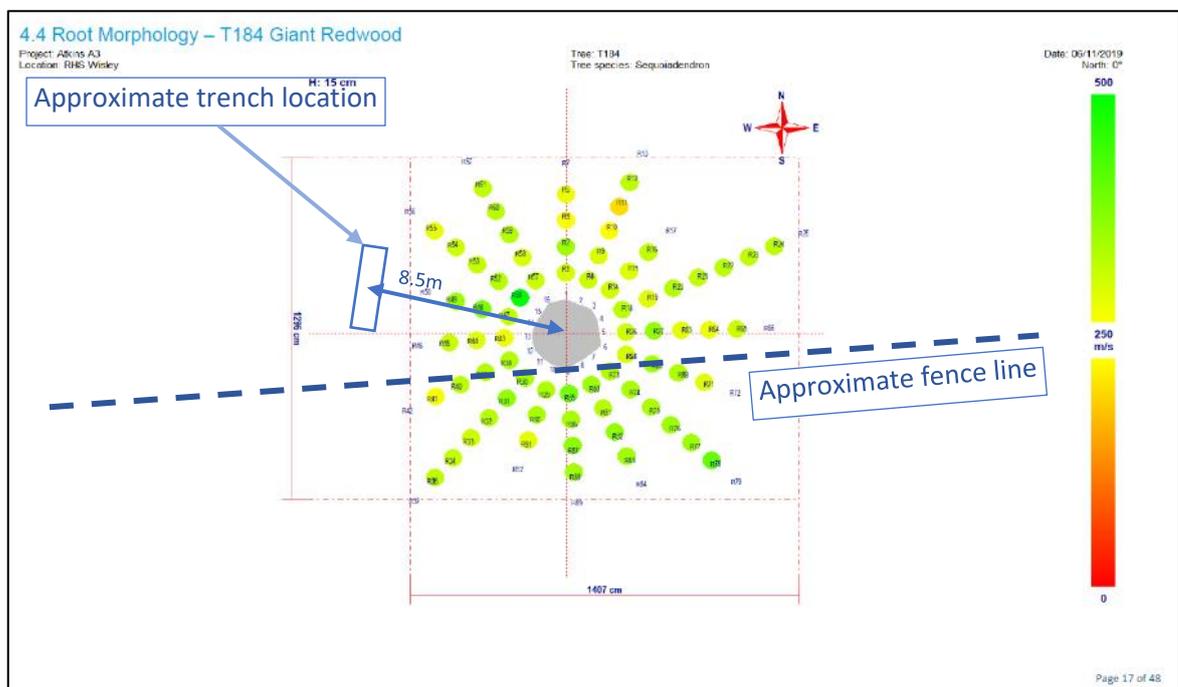
Figure 3: Copy of the root morphology graphic for T184 with additional annotation in blue, showing the approximate fence line, the distance of the centre of the trench to the centre of the tree being 8.5m, and the approximate trench location.

In the absence of supporting explanations or a published record of any verification process, I decided to check the results shown on the graphic in Figure 3 by excavating in an area where the graphic indicated there would be no significant roots of greater than 2.5cm diameter. This location is shown on Figures 3 and 4, and is 8.5m from the centre of the tree, about 2.5m from the last indicated location on the graphic of any significant roots in excess of 2.5cm. The reason for choosing this location was to check the results shown in the graphic.

If this statement is correct, then the advice to HE on the impact of the proposals must be flawed because it is based on the unreliable Arboradix data. In turn, this casts serious doubts on the reliability and credibility of the HE assessments.

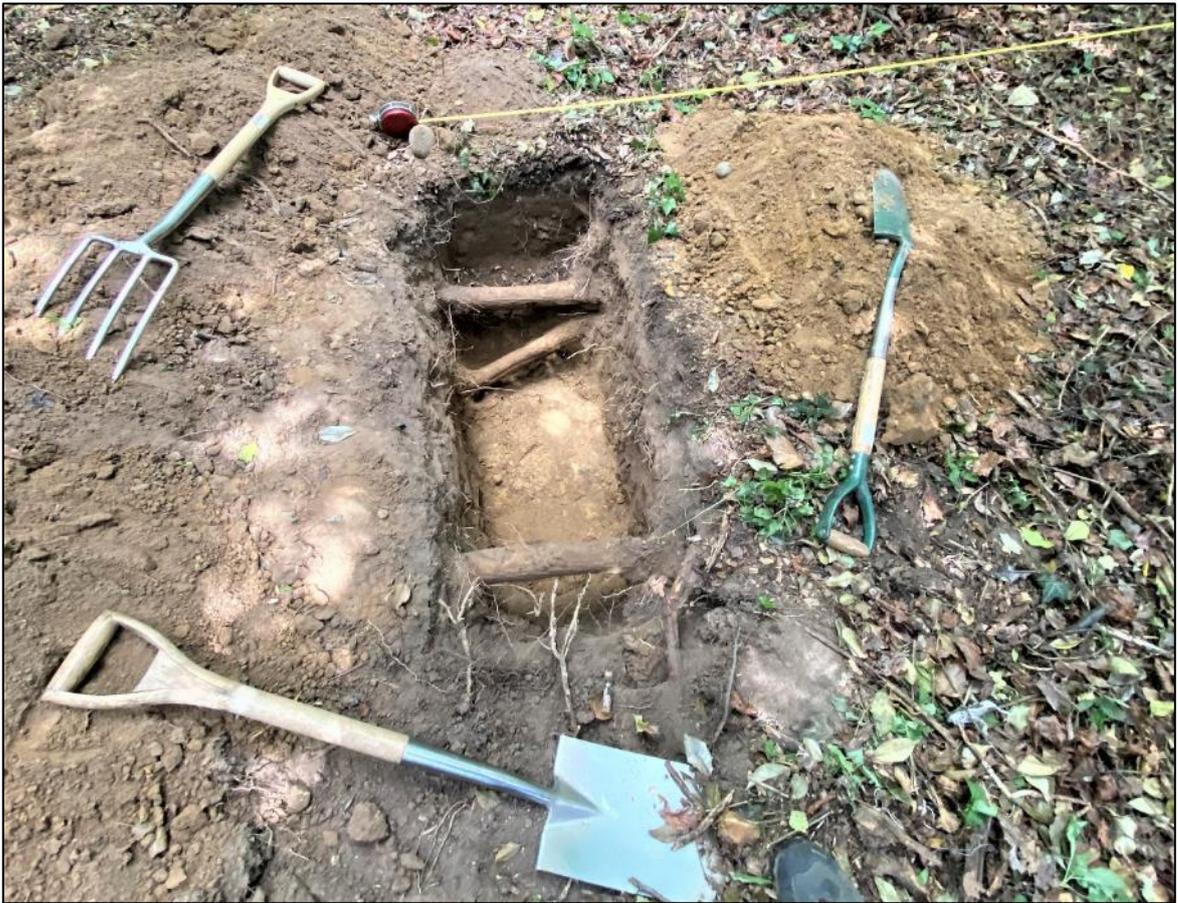
Figure 4: Excavated trench down to about 50cm depth showing three roots about 7–10cm in diameter.

As can be clearly seen from Figures 4, 5, and 6, three roots of 7–10cm were uncovered, which is a size three to four times larger than the minimum size claimed to be identified by this technology. The Arboradix investigation did not identify these roots. Although I have only checked one tree, the unreliability of the data was so startling that it must throw into significant doubt the data for the rest of the trees. This simple investigation has confirmed that the results shown in this graphic, and possibly all the other graphics, are not reliable and cannot be credibly used as the basis for advising on any adverse impact on any of the trees without further investigations.

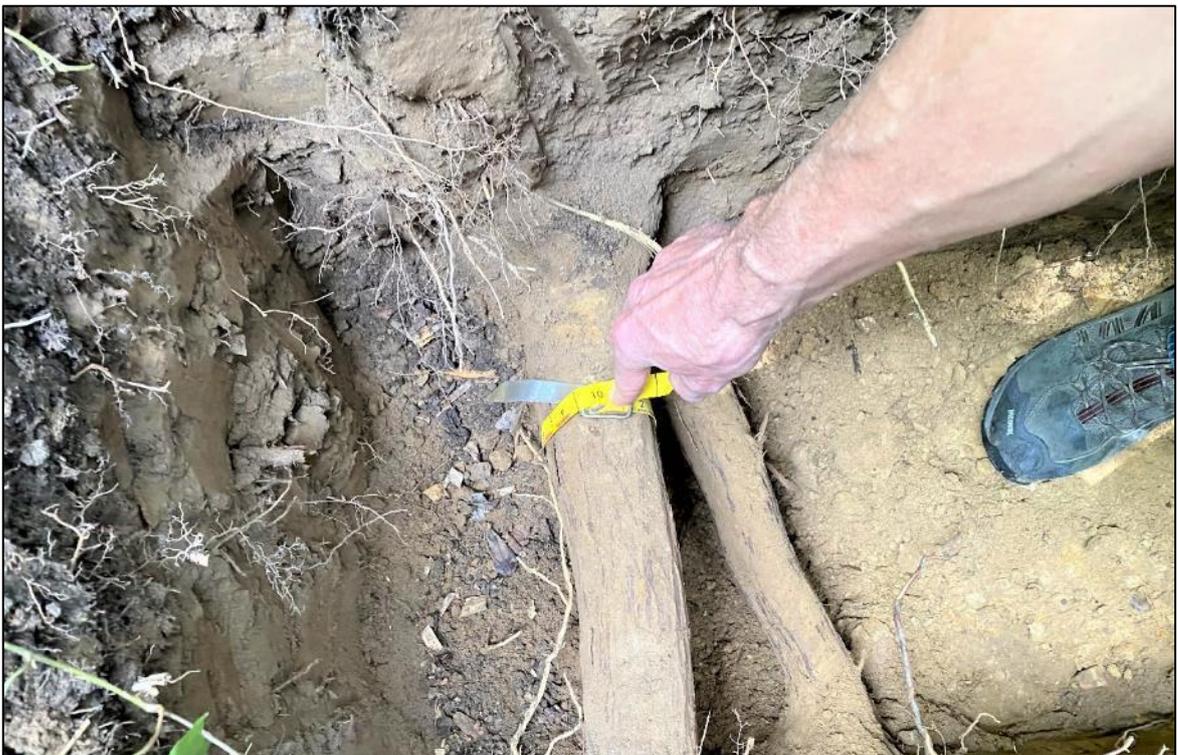
Figure 5: Close up of one of roots being measured at about 10cm diameter.

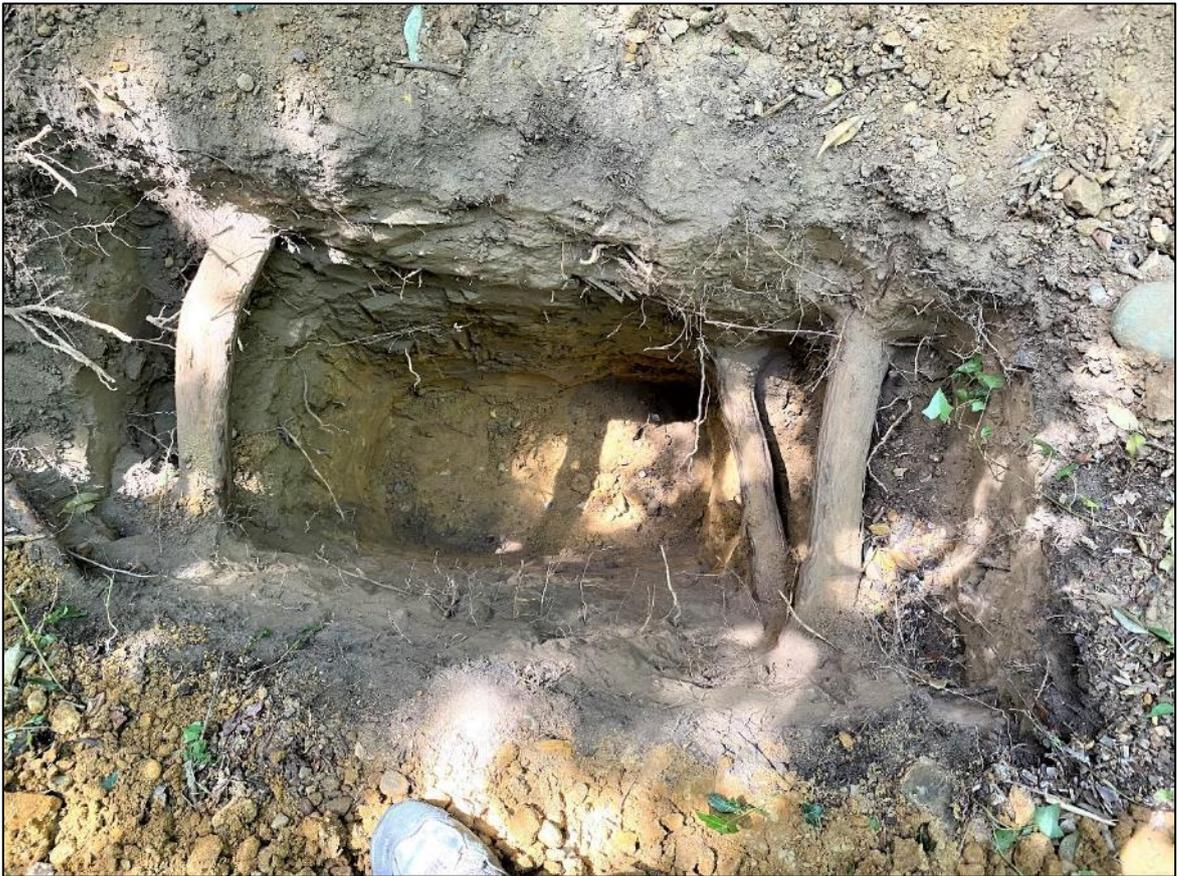
Figure 6: Trench excavated down to about 1m depth showing obvious smaller roots at the bottom with species characteristics associated with T184.
