A1 Birtley to Coal House

Scheme Number: TR010031

6.3 Environmental Statement – Appendix 8.14 Draft European Protected Species Licence

Licence Application Form

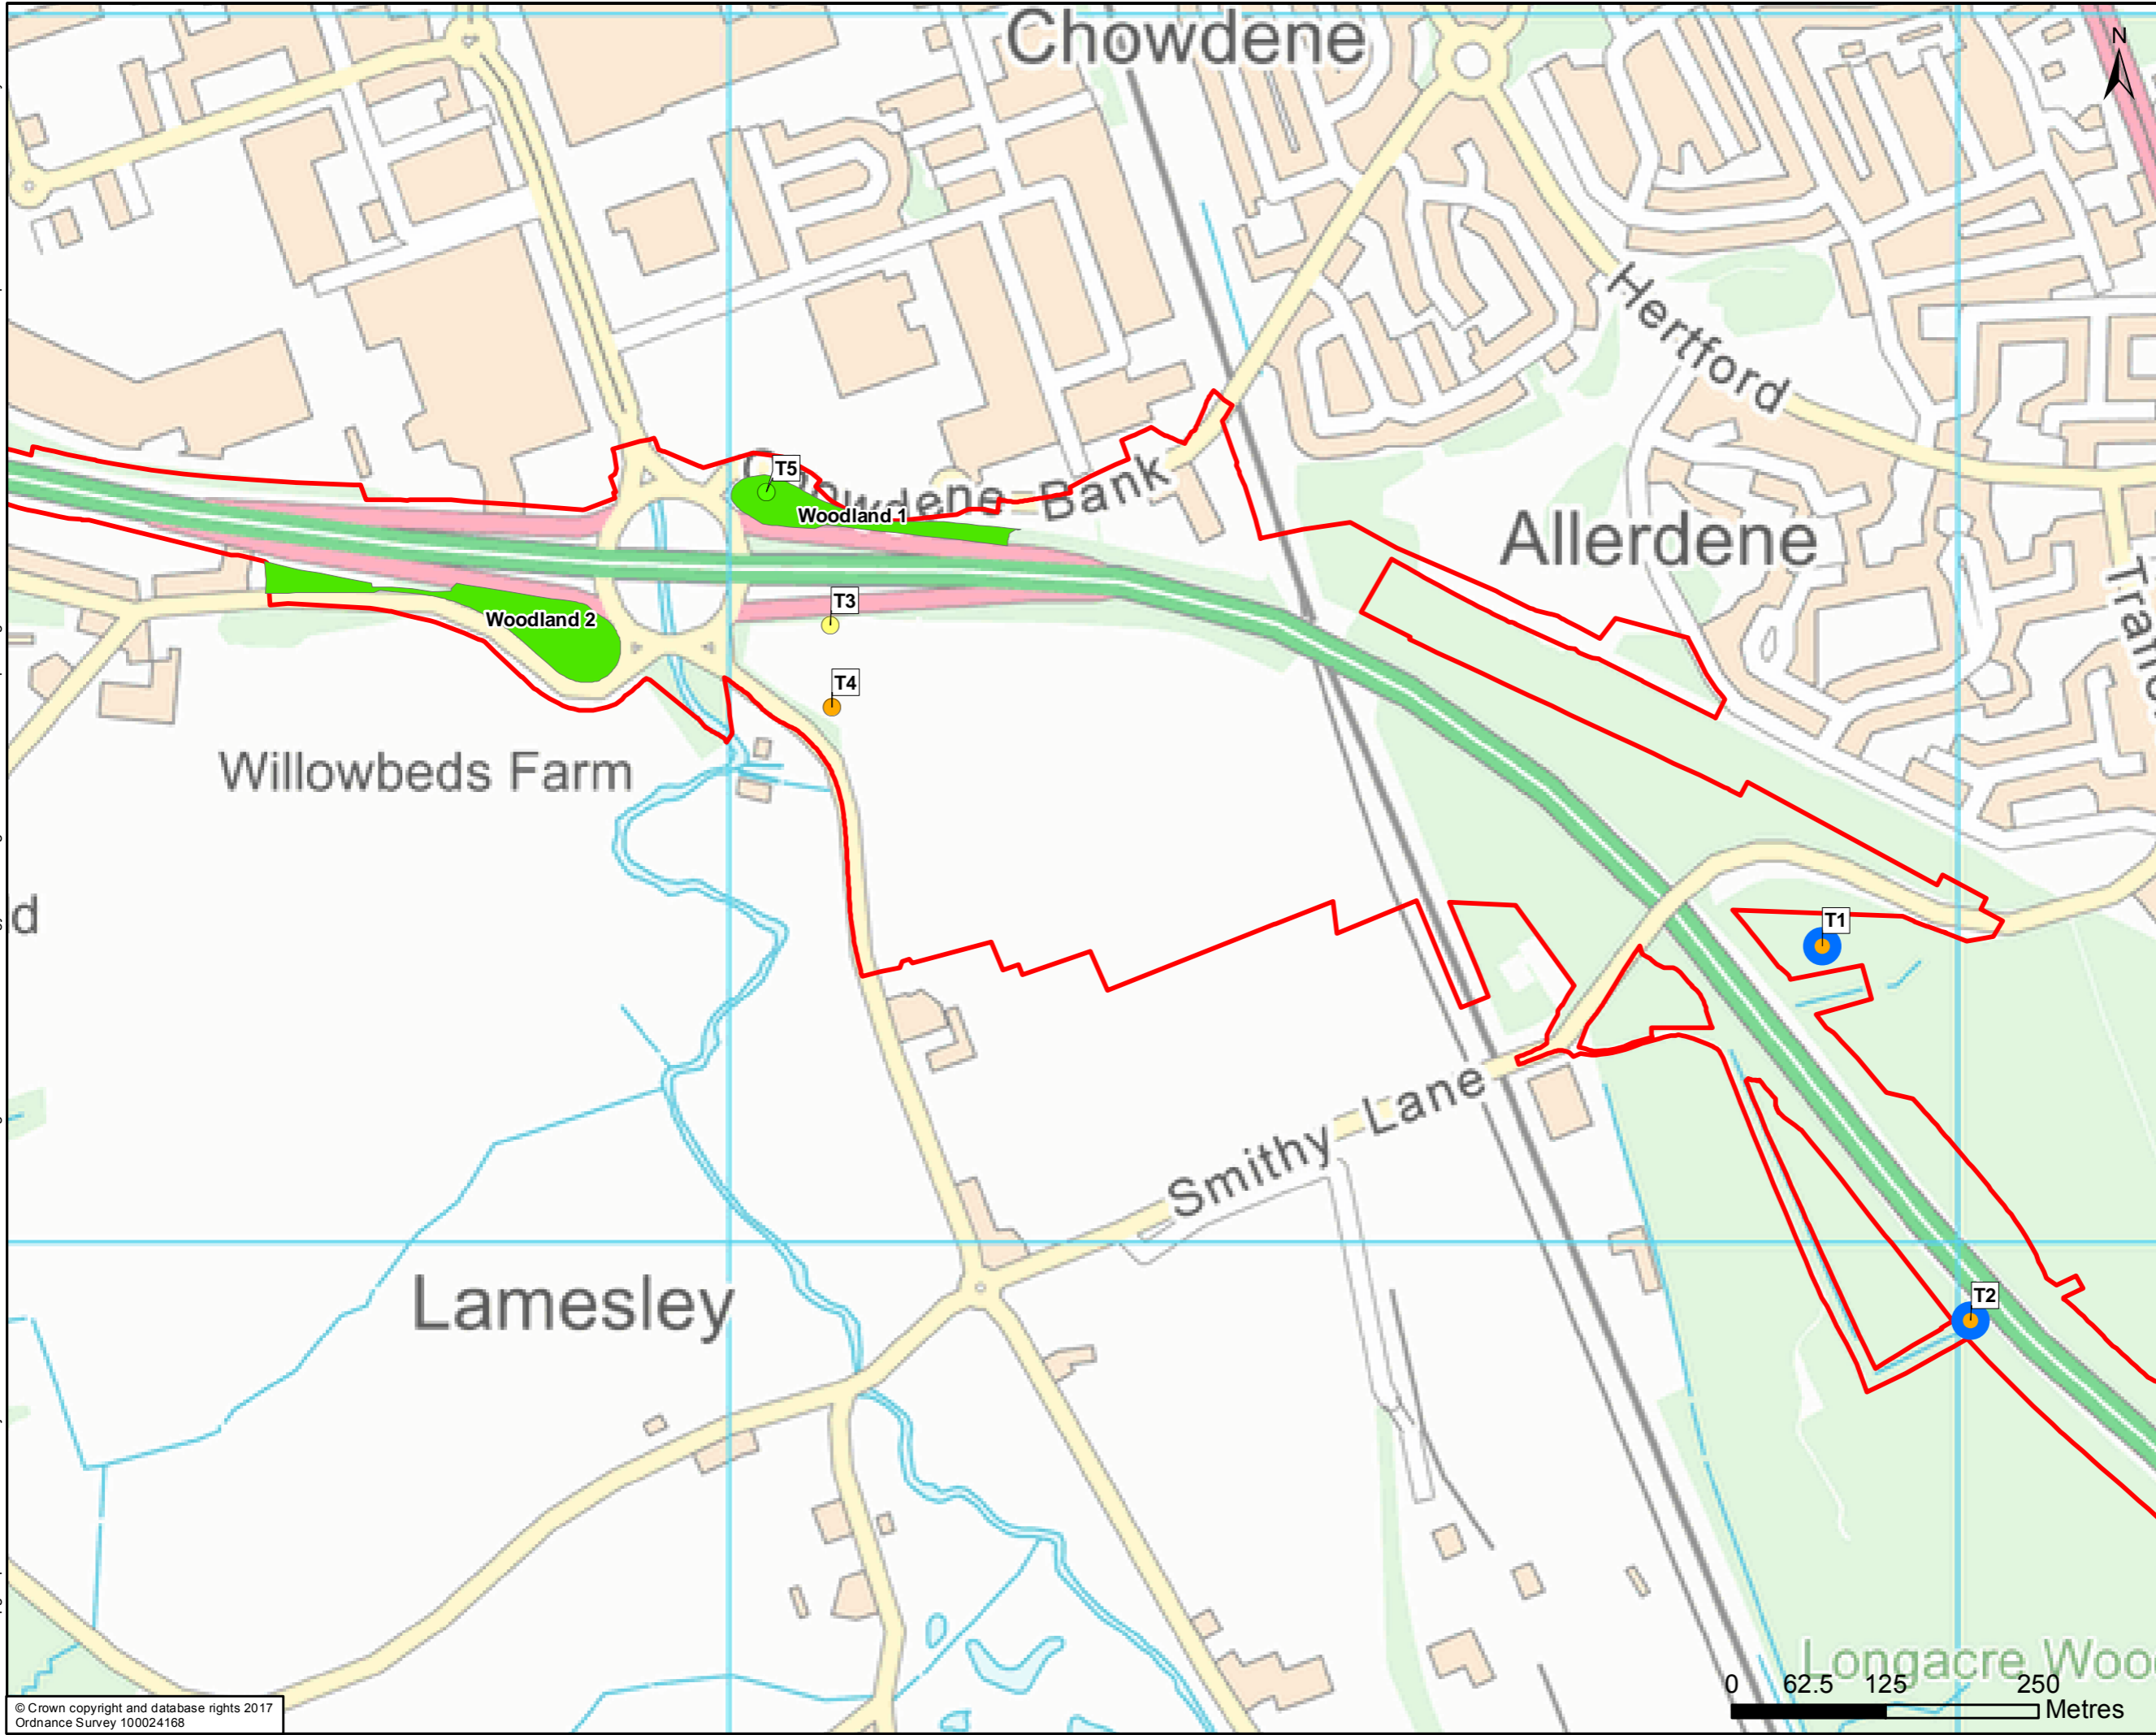
File name: \\uk.wspgroup.com\central_data\Projects\700419\70041947 - A1BCH.PCF Stage 3 and 4\02.WIPEC Ecology\02.Drawing\GIS\Mxd\BatRoost\Figure 6 - Tree locations and Results.mxd
 printed on: 29 March 2018 by: DeSouza

- Scheme Footprint
- Trees with Bat roost potential
 - Low potential
 - Moderate potential
 - Negligible potential
 - Scoped Out
- Woodland with Bat roost potential
 - Negligible potential

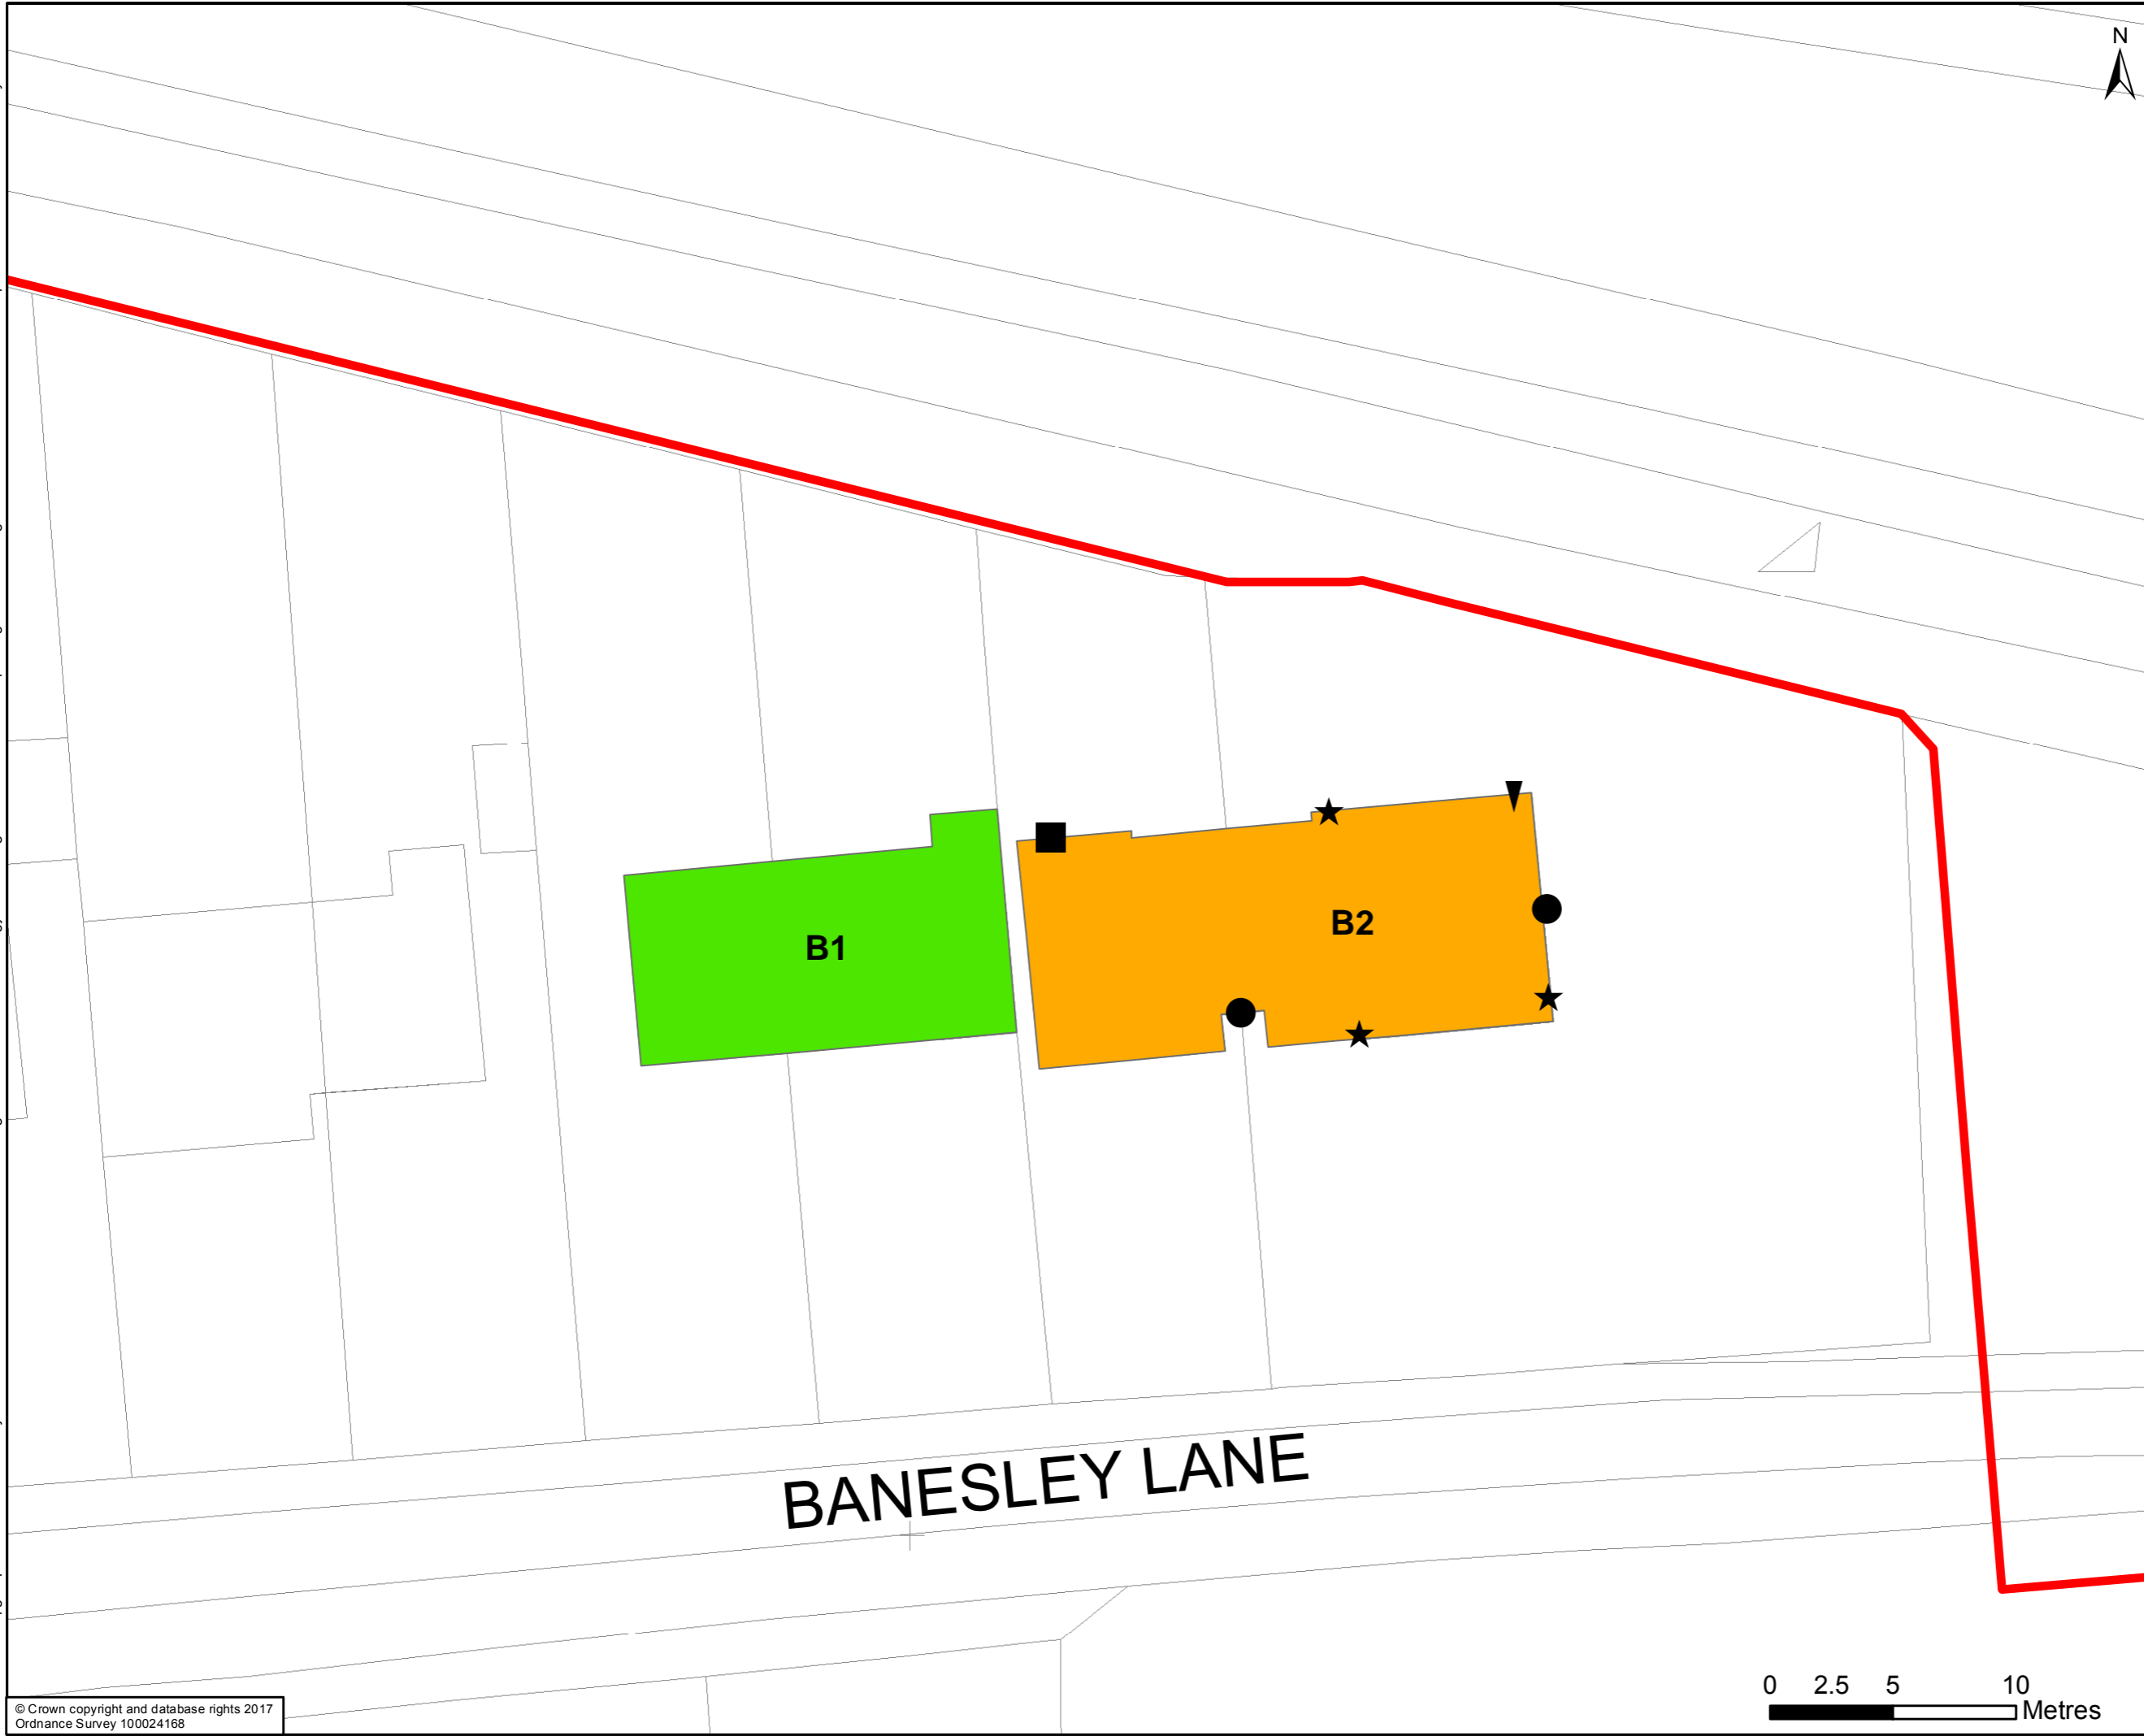
File name: \\uk.wspgroup.com\central_data\Projects\700419xx\70041947 - A1BCH.PCF Stage 3 and 4\02.WPIEC Ecology\02.Drawing\GIS\Mxd\Bat Roost Report\Figure 5 - Building Locations and Results.mxd printed on: 29 March 2018 by: DeSouzaJ

- Scheme Footprint
- Building location in relation to scheme footprint
- Gaps under bricks
- Gap under eave
- Missing Timber
- Potential bat droppings
- Bat Roost Potential**
- Moderate Potential
- Negligible Potential

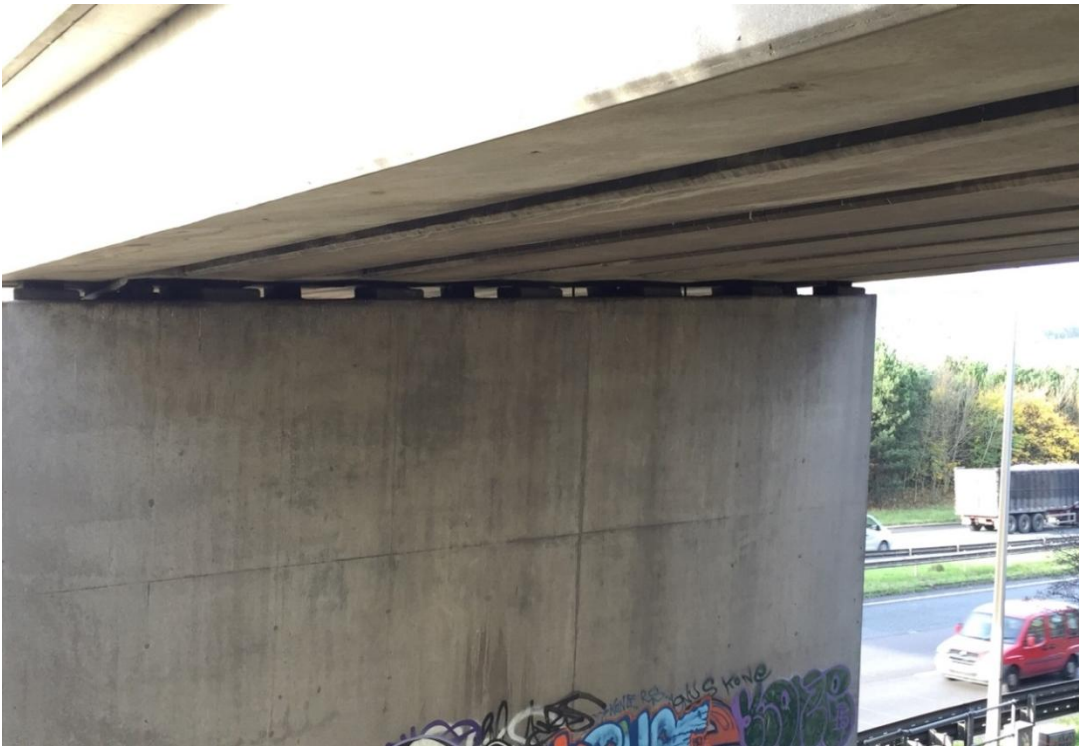
Photo 2- Potential roosting feature of the gaps between abutments and bridge deck on Smithy Lane Overbridge, as well as the gaps between the concrete beams on the underside of the bridge deck

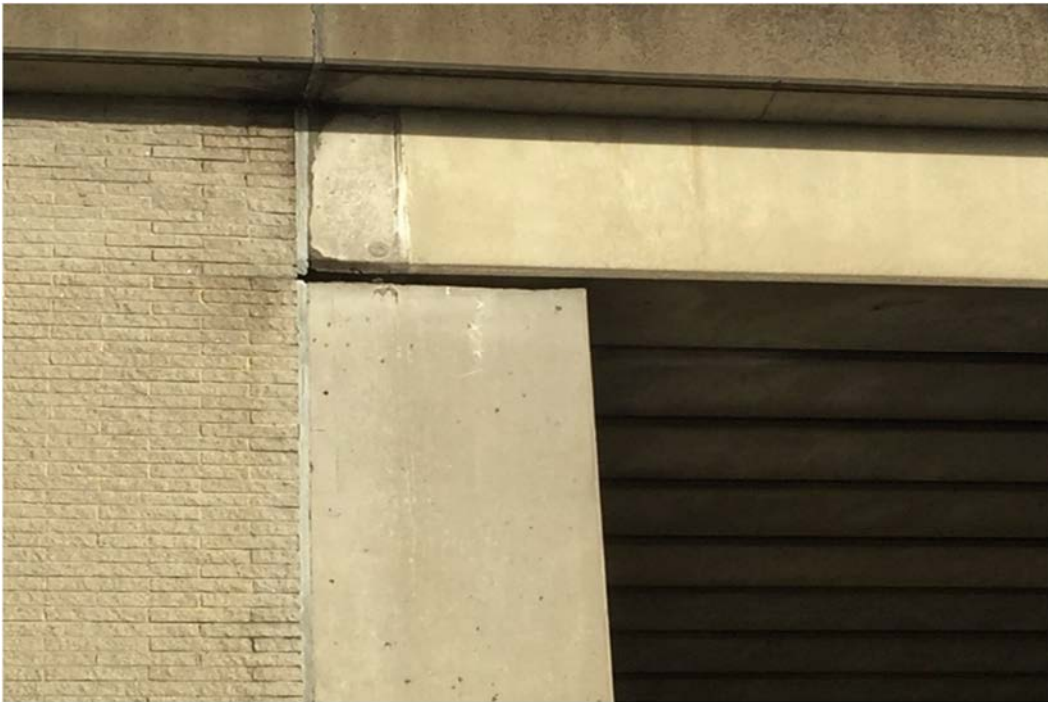
Photo 7- Potential roosting feature of the gap between the abutment and bridge deck on the north-east side of Eighton Lodge north Underbridge

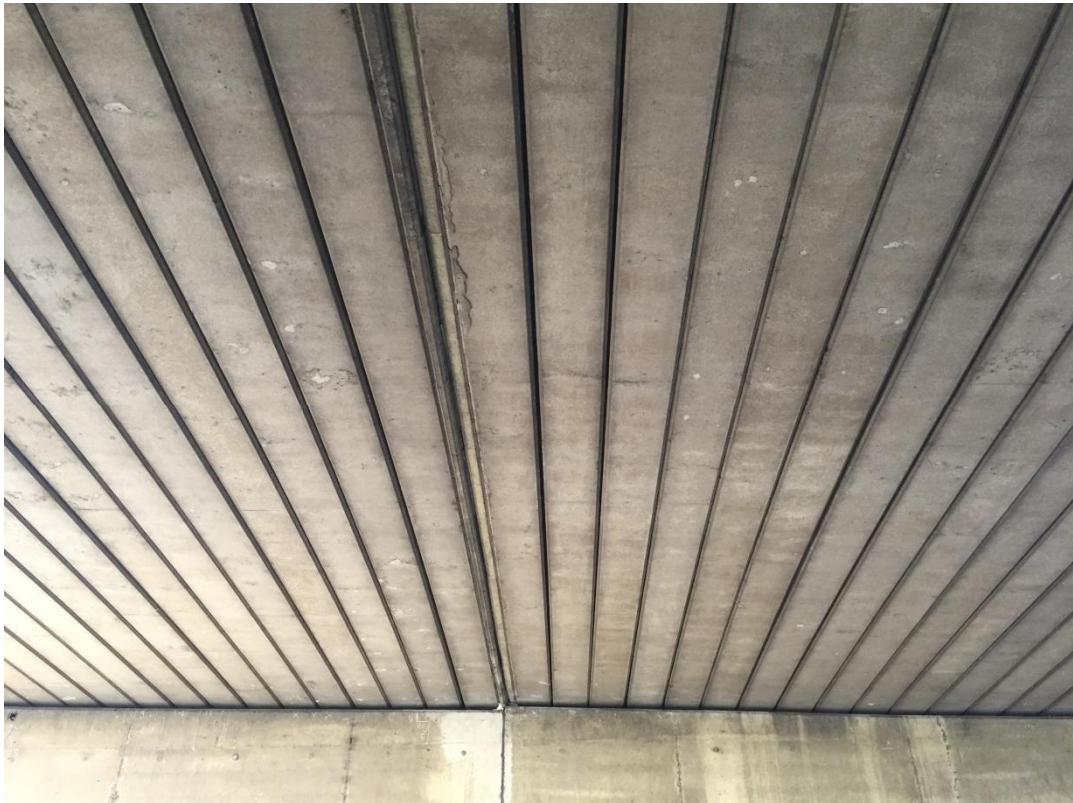
Photo 10 -

Bridge Name	Highways England Structure Key	Grid Reference	Description of Bridge	Description of Potential Roosting Features	Evidence of Roosting Bats Recorded?	Overall Assessment of Suitability to Support Bat Roosts	Further Survey Effort Required?
				<ul style="list-style-type: none"> The bridge is situated 2 m from the surrounding woodland vegetation. 			
Eighton Lodge north Underbridge	16440	NZ 26684 57518	Concrete deck overbridge. See Photo 6 in Appendix A .	<ul style="list-style-type: none"> Gaps between the deck and the bridge at the top of both piers. Gaps between the concrete beams on the underside of the bridge deck (see Photos 7 & 8). These features are located throughout these areas and are at a height of 8 m and are directly above the Durham road with street lighting beneath. The bridge is situated 5 m from the surrounding woodland vegetation. 	None	Moderate	Yes
Eighton Lodge south Underbridge	8883	NZ 26796 57459	Concrete deck overbridge See Photo 9 in Appendix A .	<ul style="list-style-type: none"> Gaps between the deck and the bridge at the top of both piers. Gaps between the concrete beams on the underside of the bridge deck (see Photo 10). 	None	Moderate	Yes

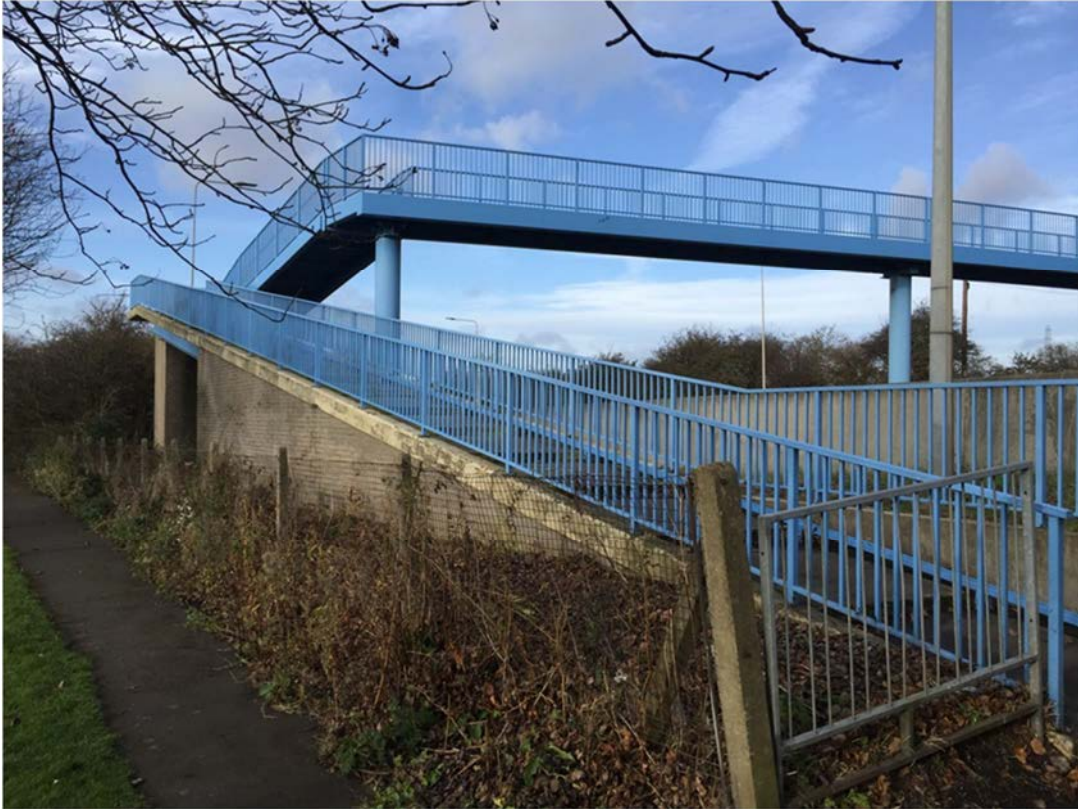
Photo 11- Lay out of North Dene Footbridge

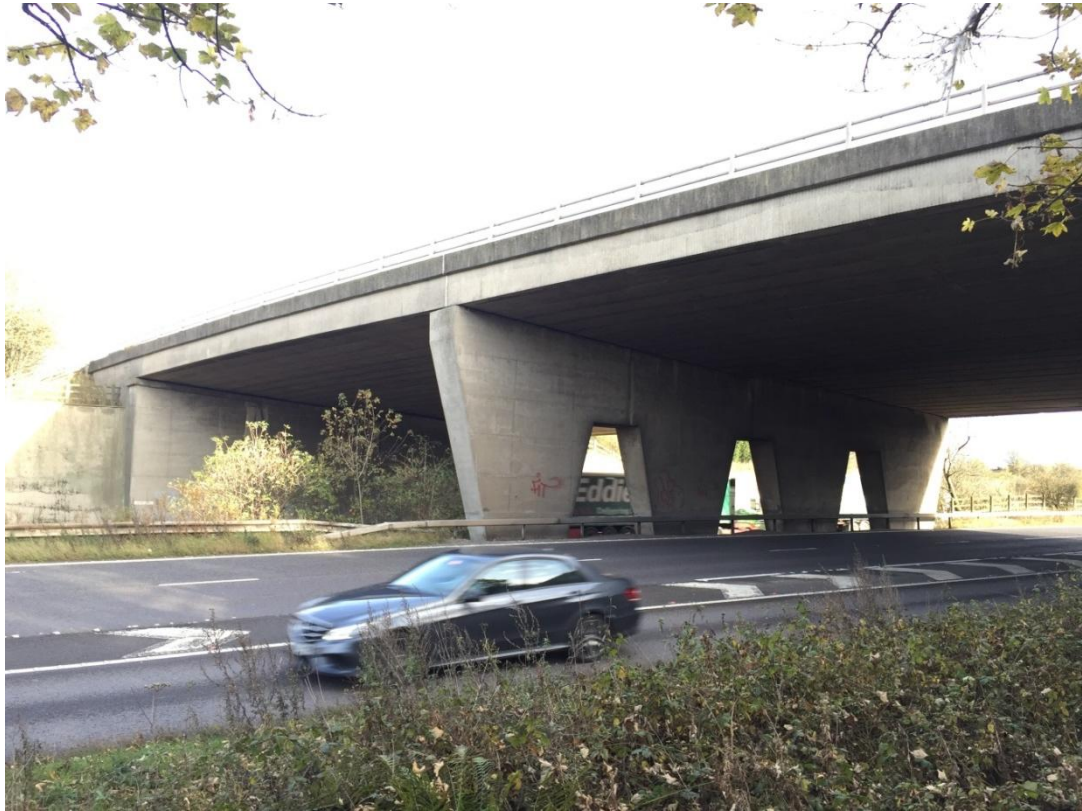
Photo 13- Lay out of North Side Overbridge

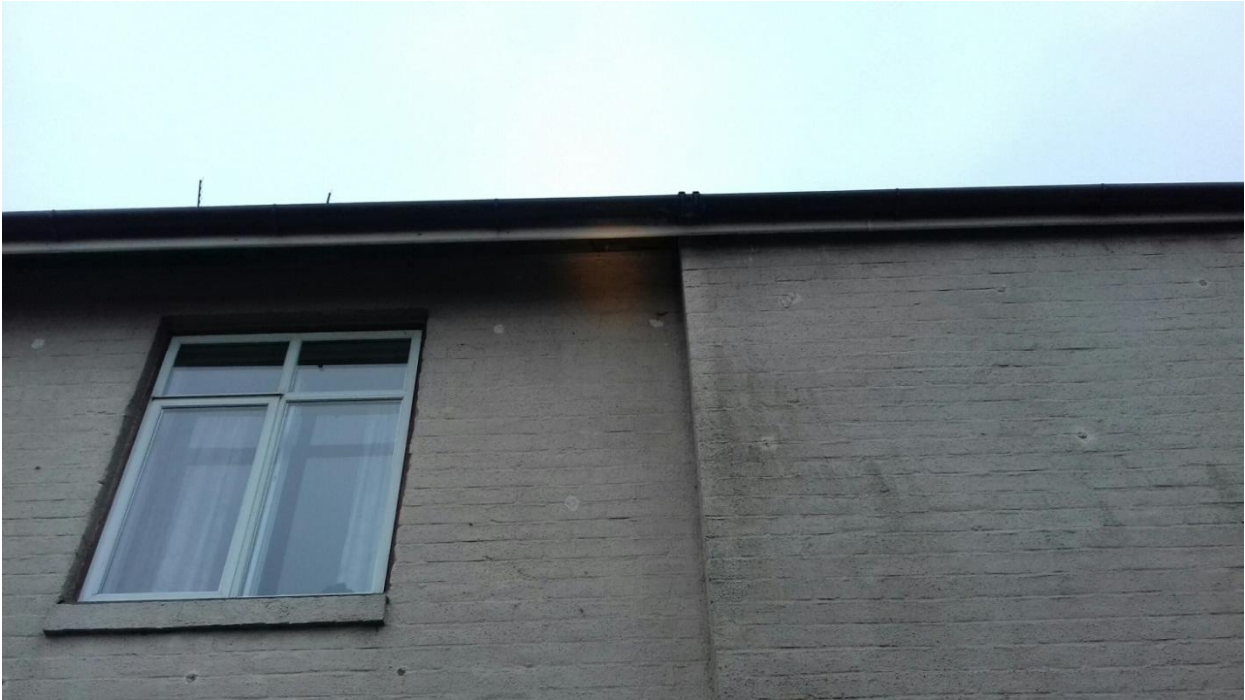
Photo 15 – North facing elevation of Building B2

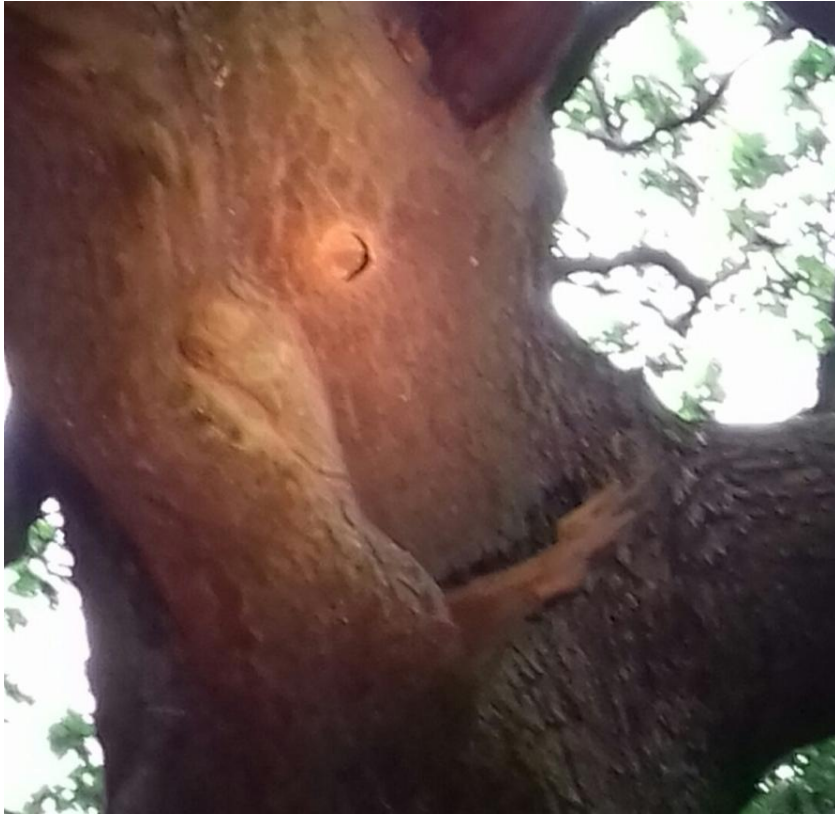
Photo 19 – Woodpecker hole on underside of trunk in Tree T2

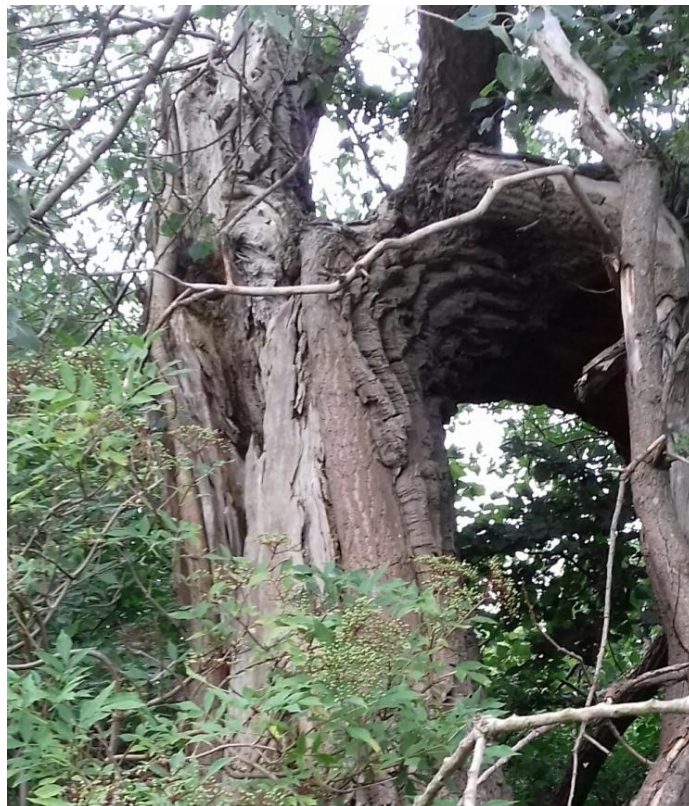
Photo 20 – Large cavity/hollow in trunk of Tree T3, likely as a result of a tear out.

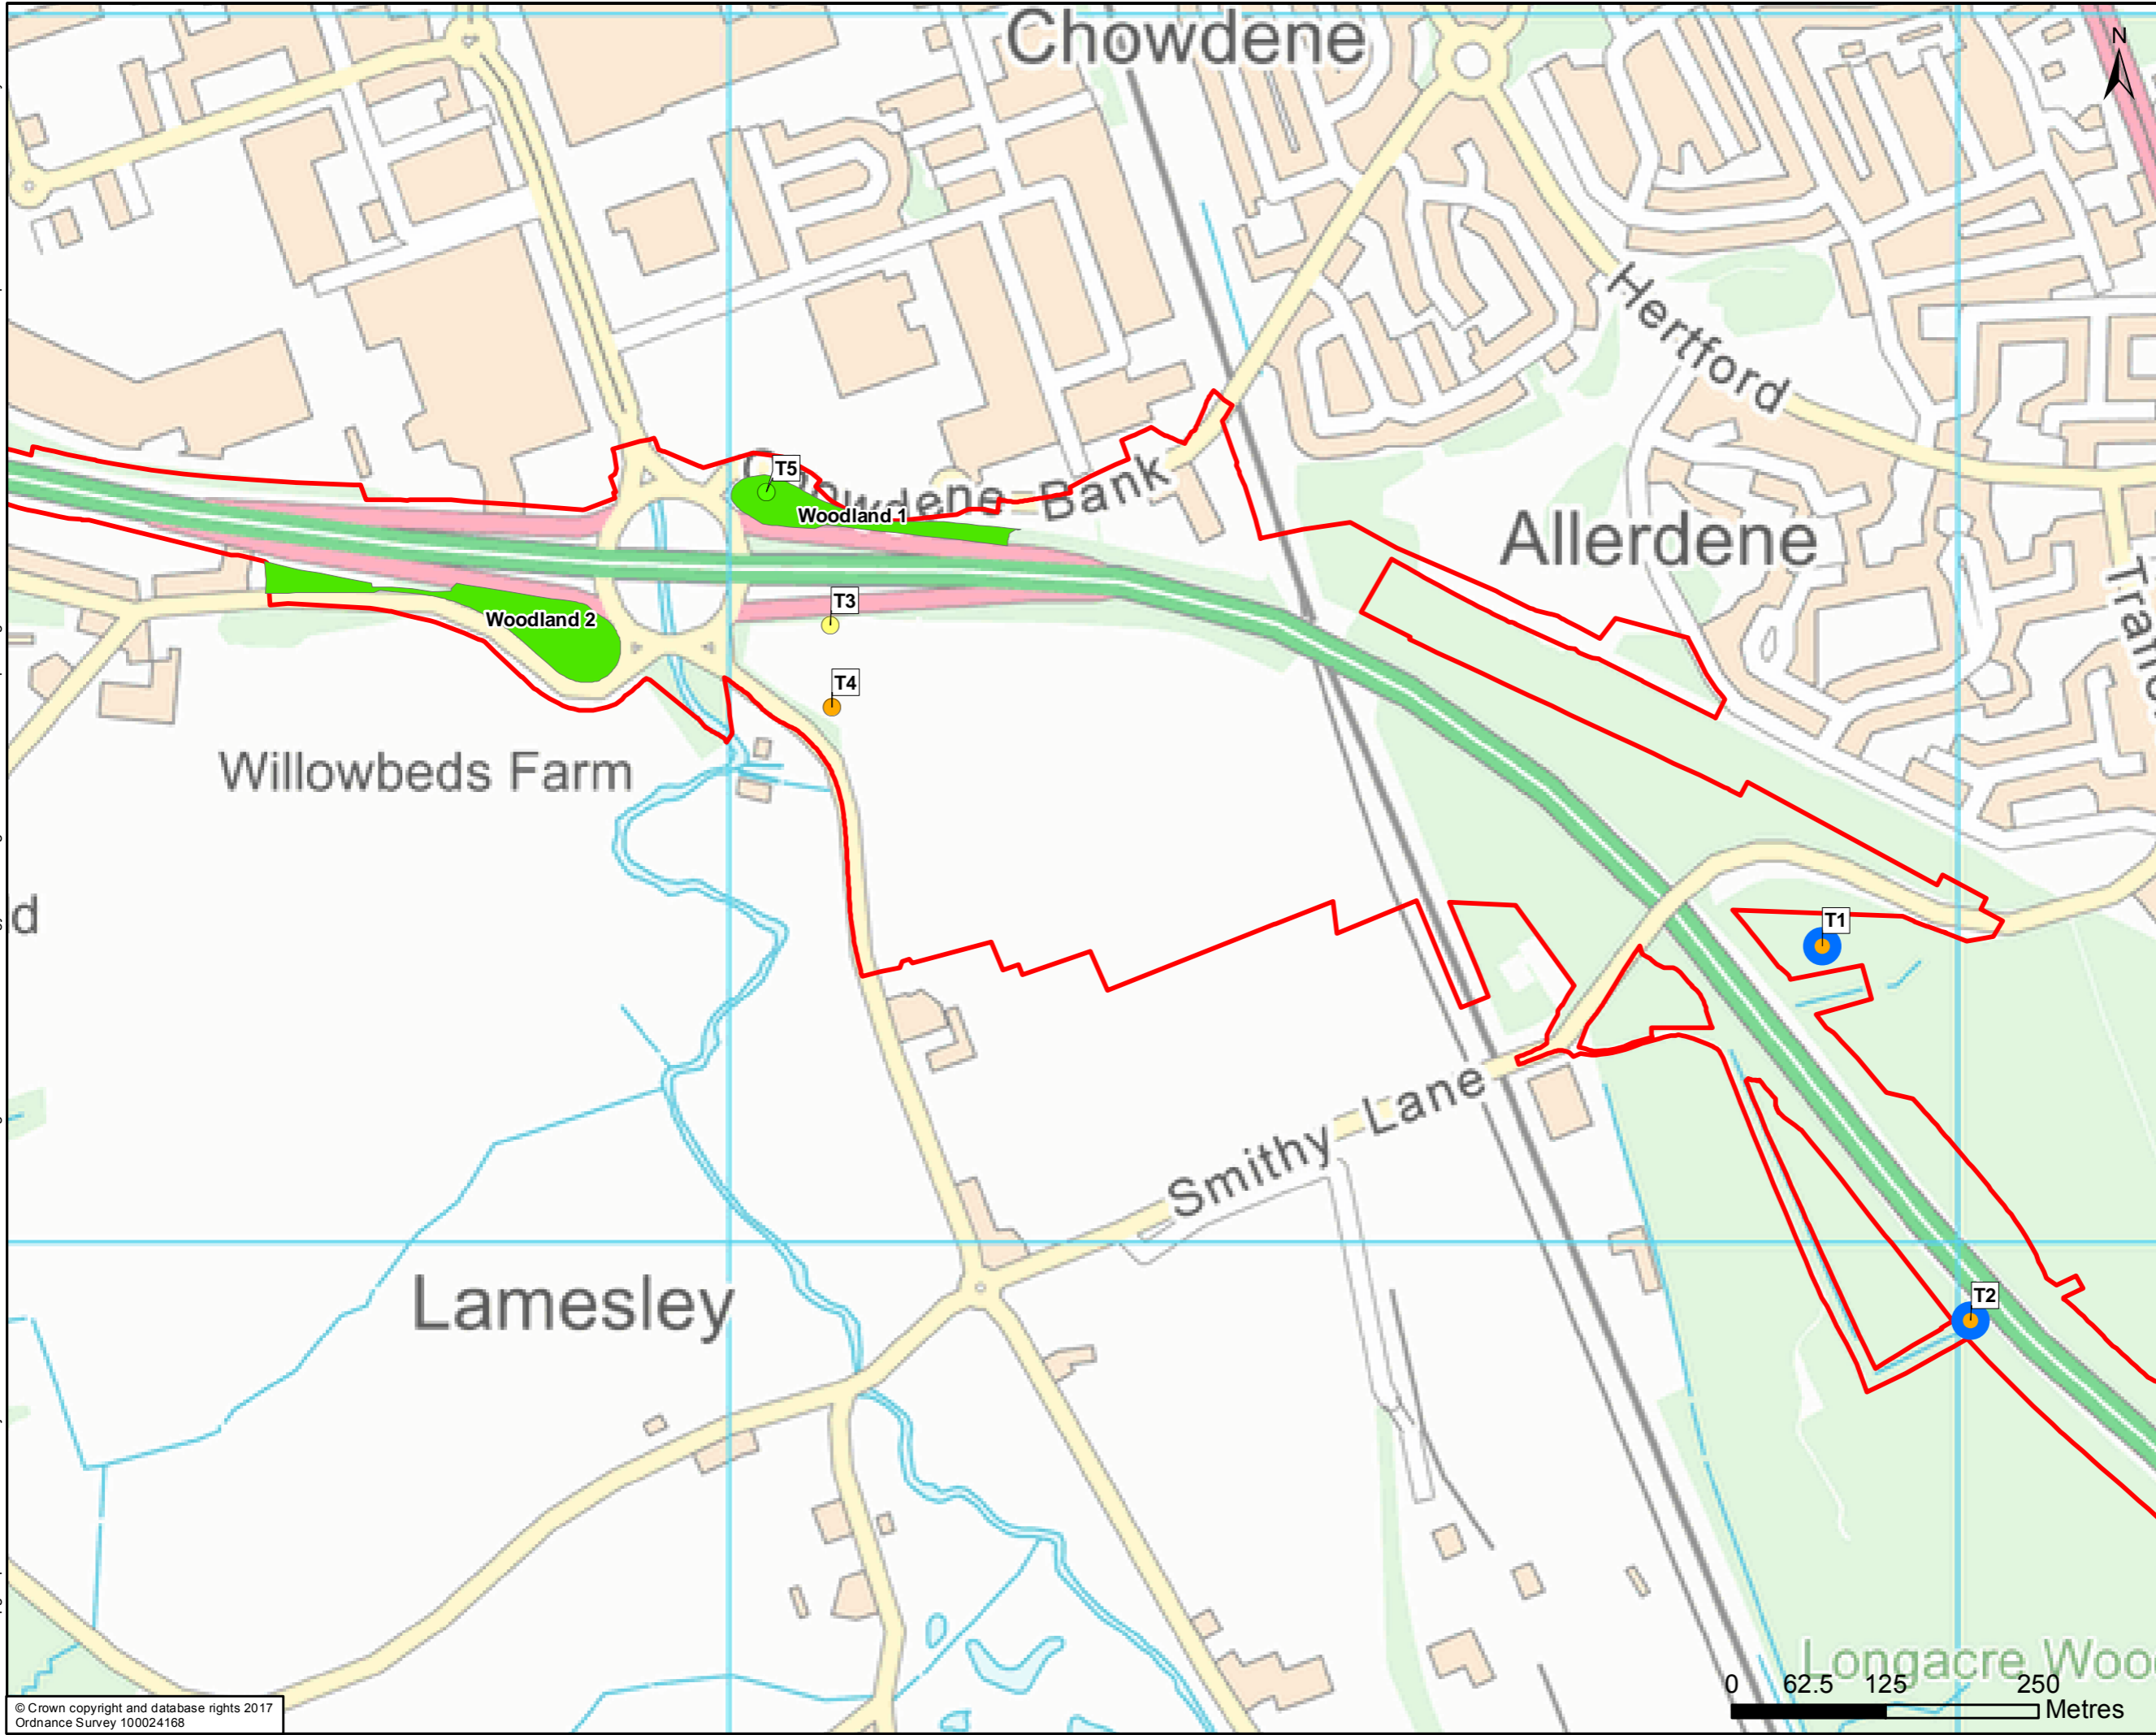
File name: \\uk.wspgroup.com\central_data\Projects\700419\70041947 - A1BCH.PCF Stage 3 and 4\02.WIPEC Ecology\02.Drawing\GIS\Mxd\Bat Roost Report\Figure 6 - Tree locations and Results.mxd
printed on: 29 March 2018 by: DeSouza

- Scheme Footprint
- Trees with Bat roost potential**
 - Low potential
 - Moderate potential
 - Negligible potential
 - Scoped Out
- Woodland with Bat roost potential**
 - Negligible potential

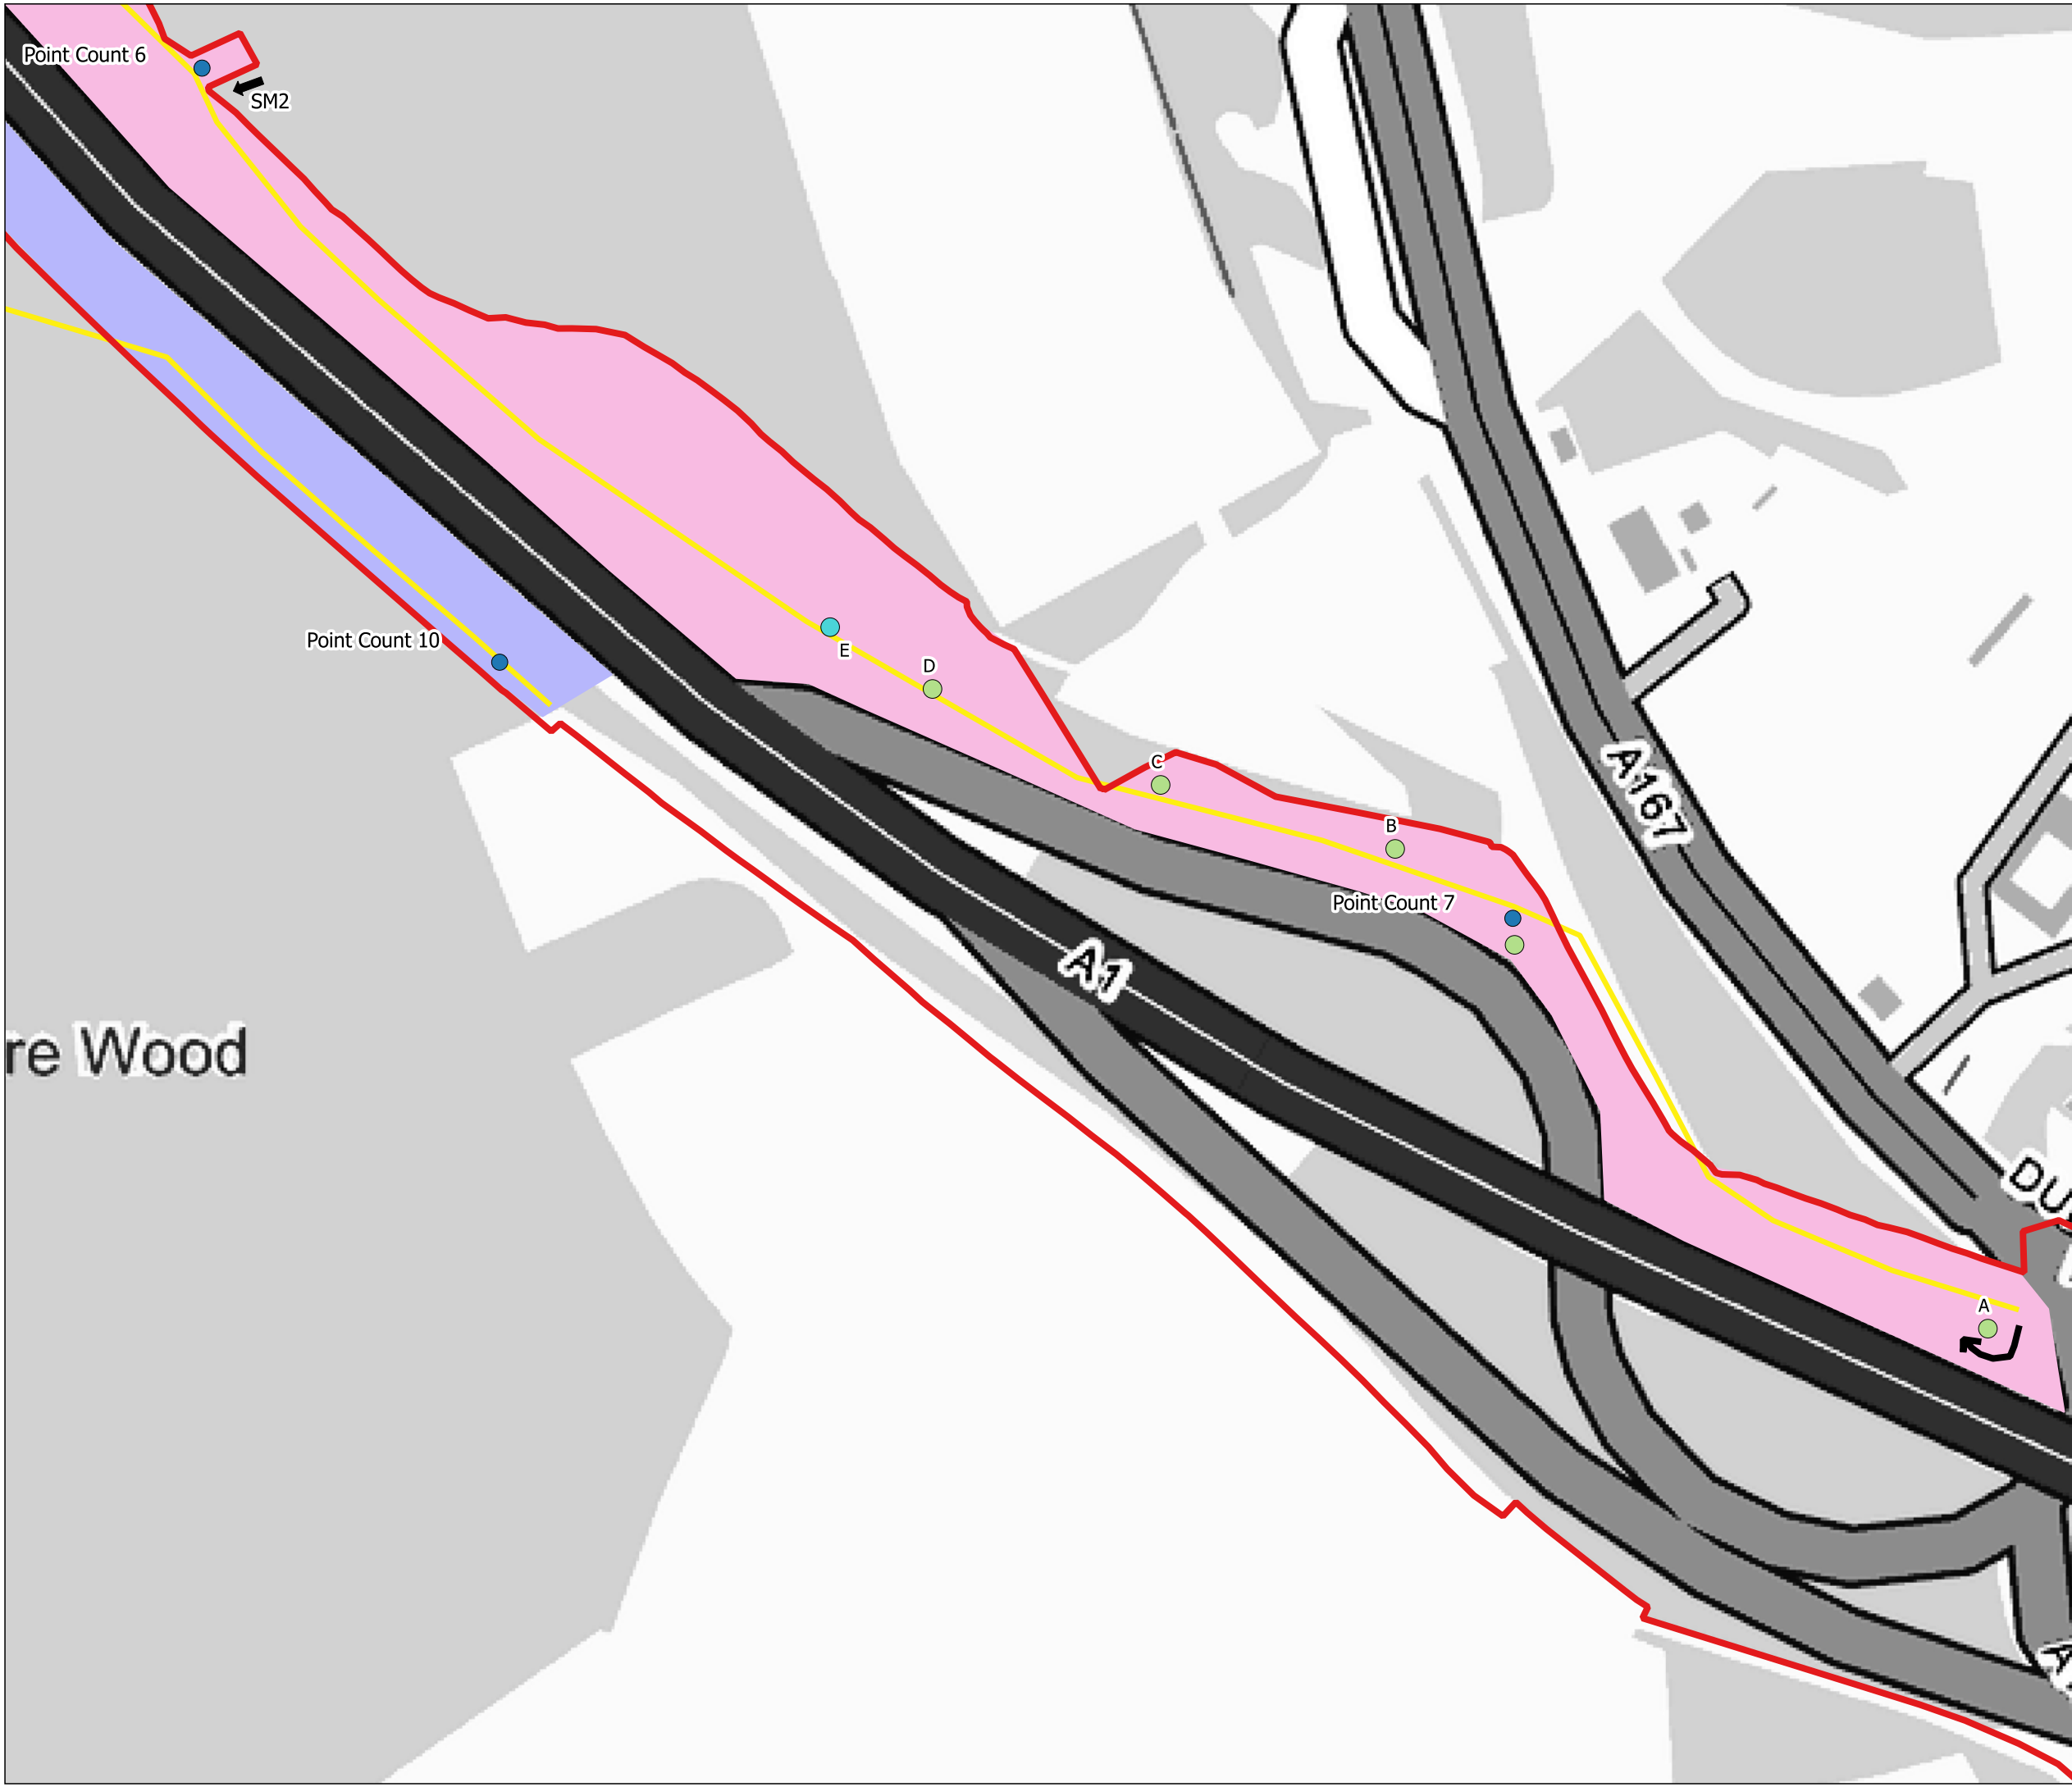
- LEGEND:**
- Scheme Boundary
 - Point Counts
 - C. Pip
 - S. Pip
 - Flight Path
 - ↙ SM2
 - Activity Transect Route
 - Survey Section 1
 - Survey Section 2
 - Survey Section 3
