A1 Birtley to Coal House

6.3 Environmental Statement – Appendix 9.1 Agricultural Land Assessment

Agricultural Land Classification

Reference No: wsp9001(4)/1010277

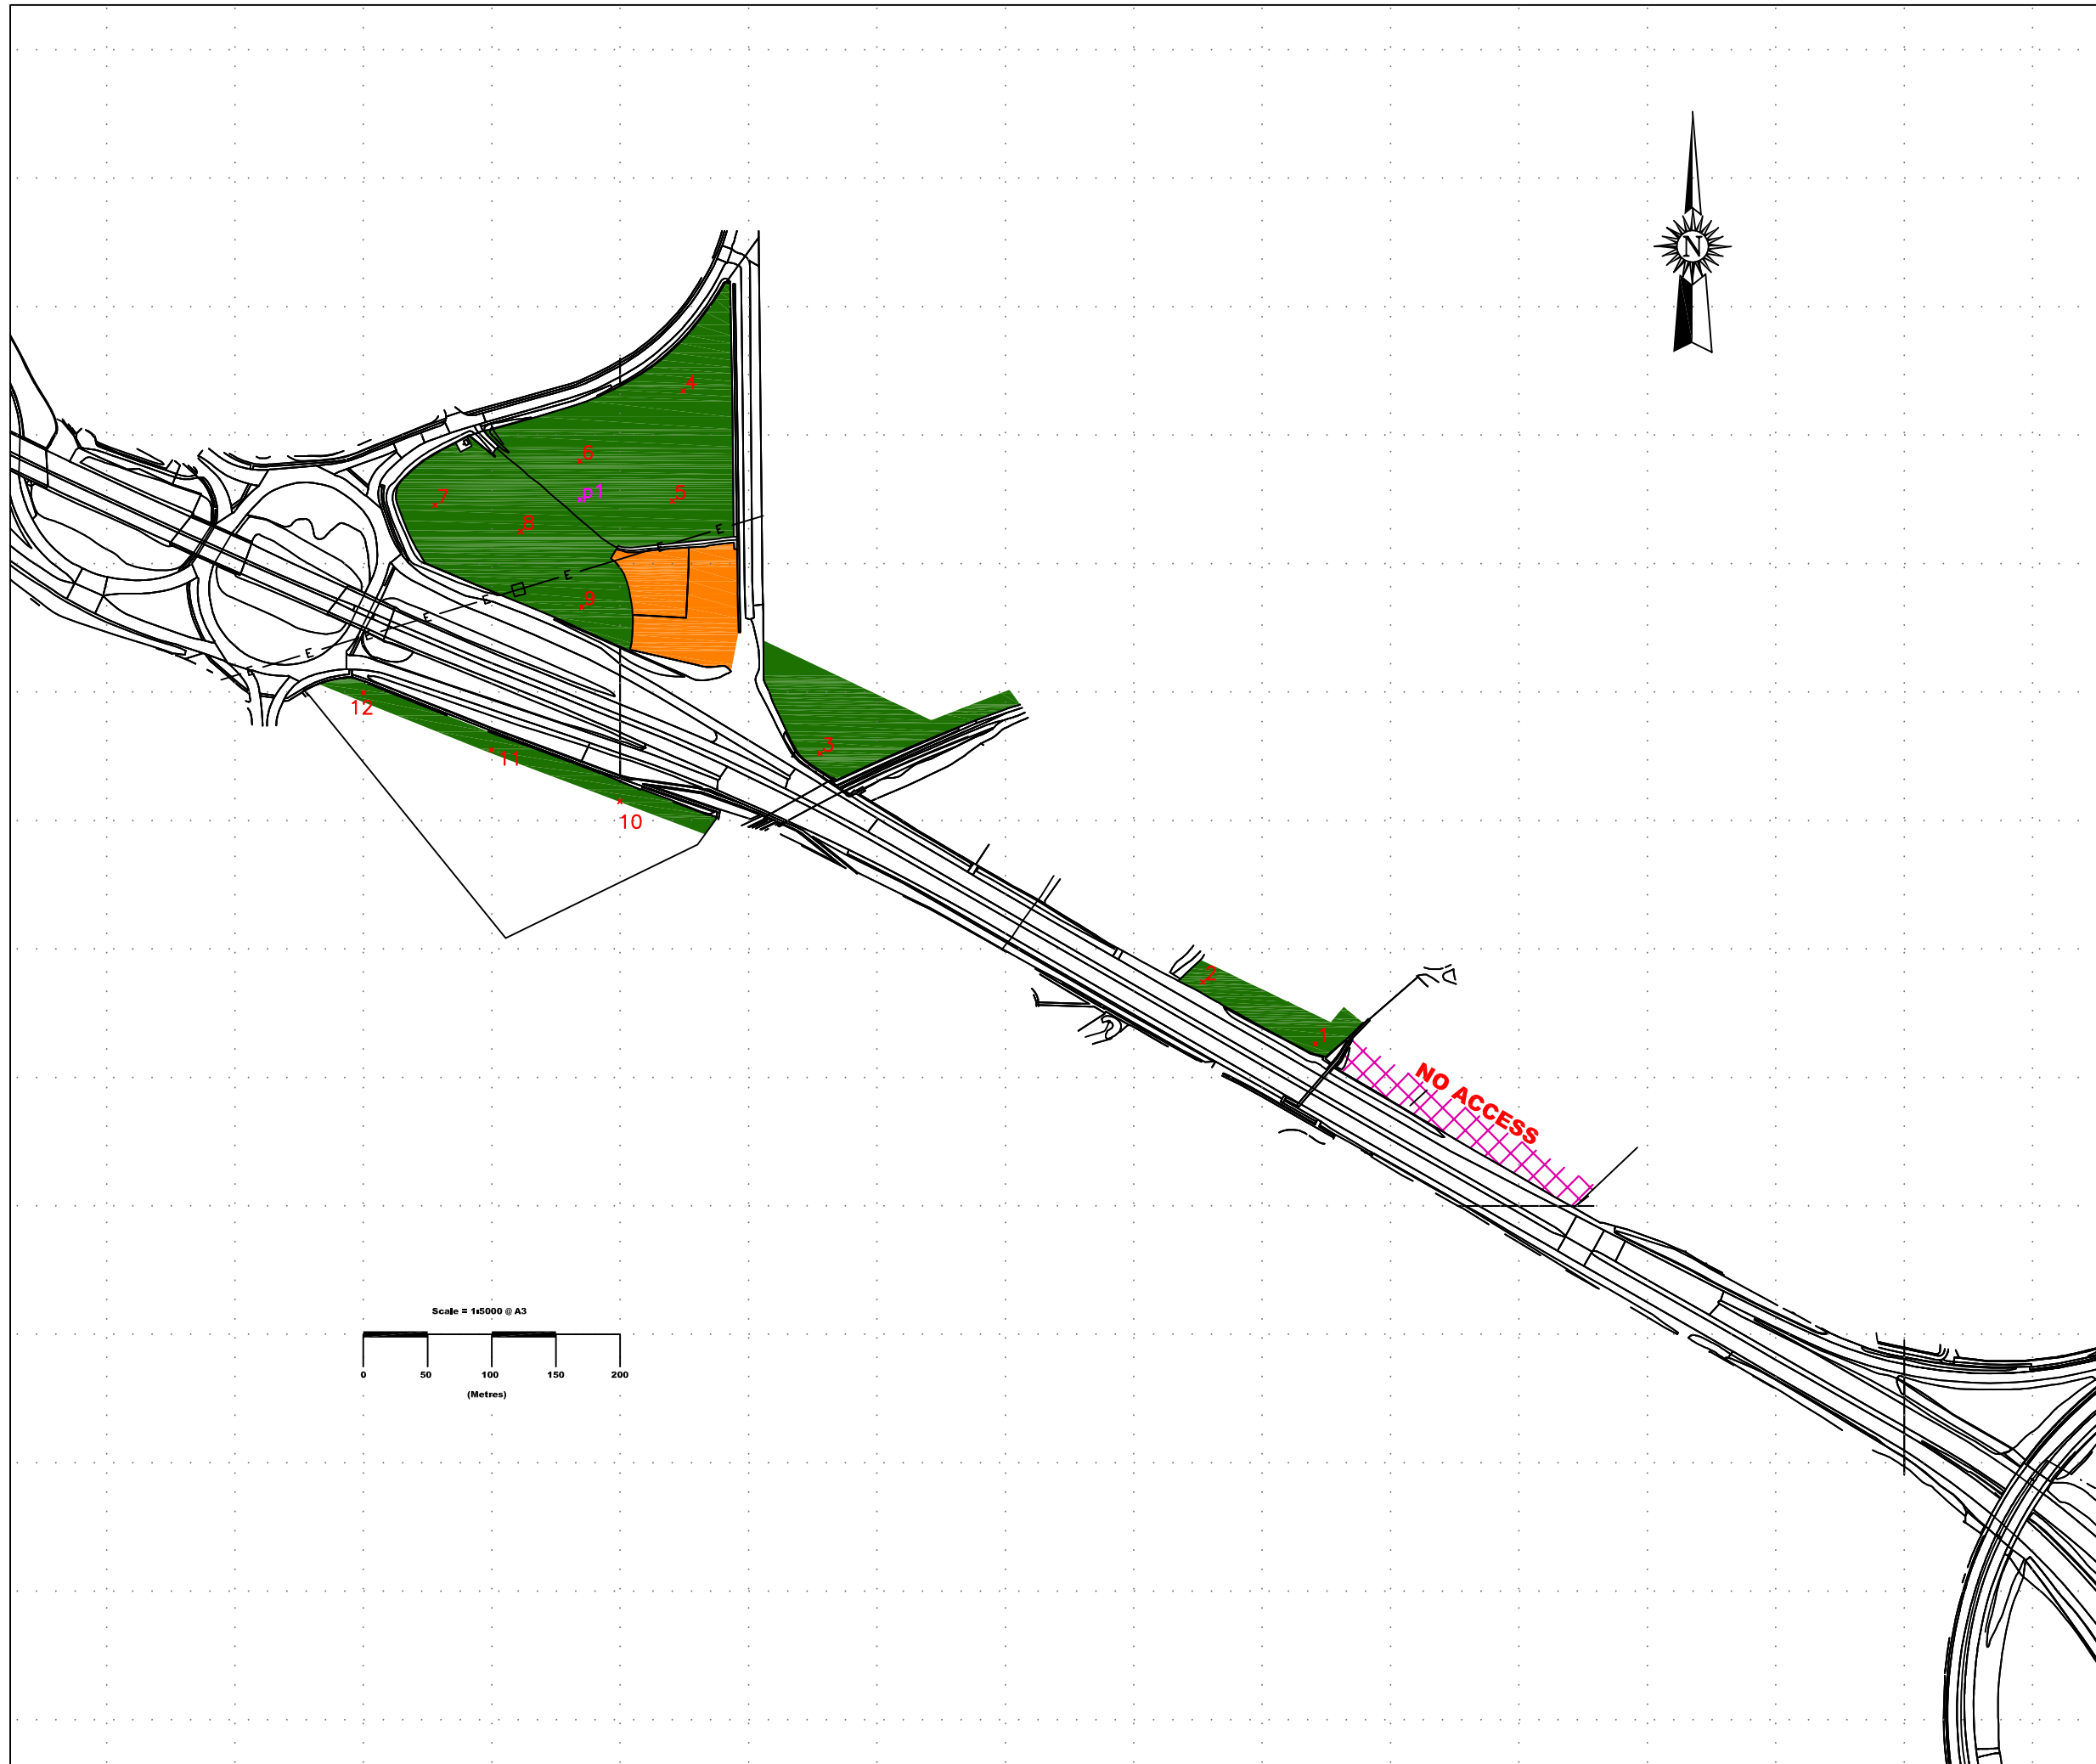
SCALE	1/5000	MASTER SIZE	A3
DRAWING NO.	WSP9001/1010277/ALC 01		
ISSUE	A

A1 BIRTLEY to COALHOUSE AGRICULTURAL LAND CLASSIFICATION

The land quality of the site is shown on the attached plan (**Appendix 1**).

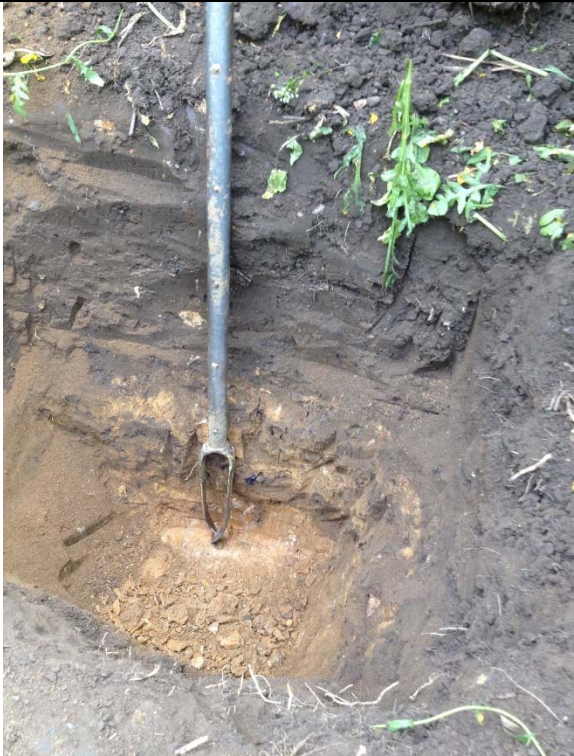
Pit	Depth (mm)	Colour	Texture	Structure	Drainage /Porosity (0.5% pores)	Total Stone %
1	310	10YR3/2 brown	MSL/SCL	M,M,SAB	-	<2
	500	10YR6/6 yl br	SCL, pockets of topsoil mixed in	Platy, firm and dry	Och com / >	<2 Sst. Coal frags com.
	650+	10YR5/1 gr and 10YR5/4 br	SCL	Massive to PR	Och many /<	<2
Slightly Gleyed at: 310	Gleyed at: 500	SPL at: 500	Wetness class: 3	Wetness grade: 3a	Comments: Disturbed layer at 310-500mm	
		MB wheat: MB pot:	DR Grade:	Main limitation. WE		ALC grade 2/3a

<p>Over deep topsoil with coal fragments to 500mm</p>

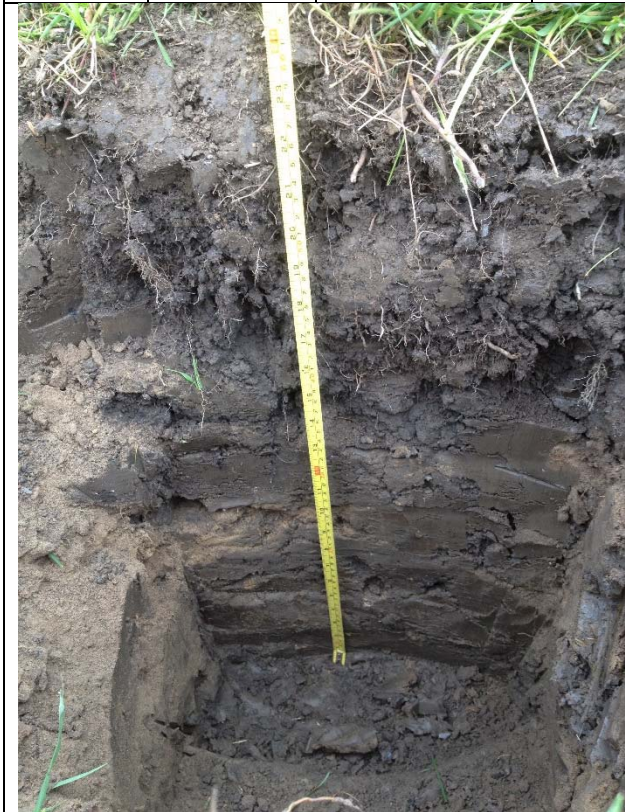
Slightly Gleyed at: 310	Gleyed at: 500	SPL at: 500	Wetness class: 4	Wetness grade: 3b	Comments: Disturbed layer at 310-500mm	
		MB wheat: MB pot:	DR Grade:	Main limitation. WE		ALC grade 3b

Heavy clay soil with pockets of silty clay loam and fine sand at one end of the pit

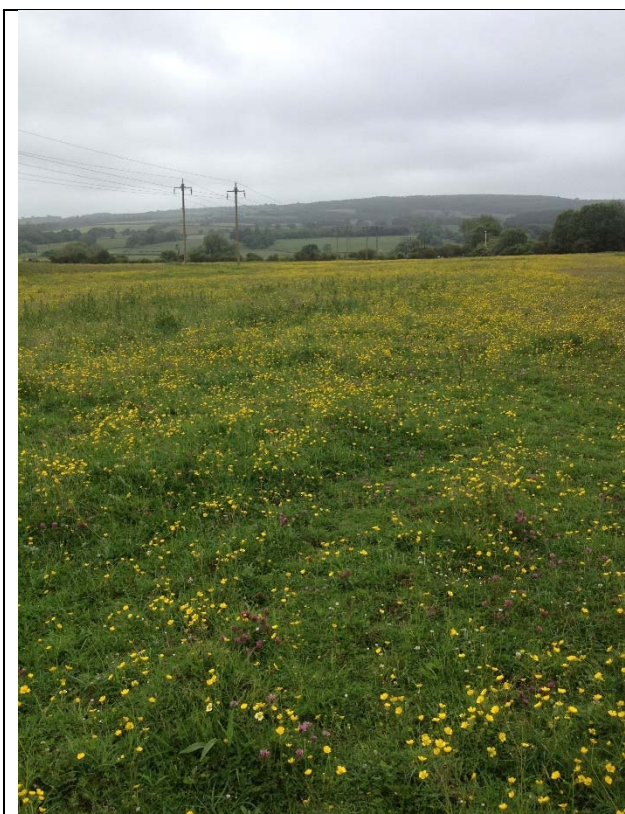
General view over main field (borings 13-19)

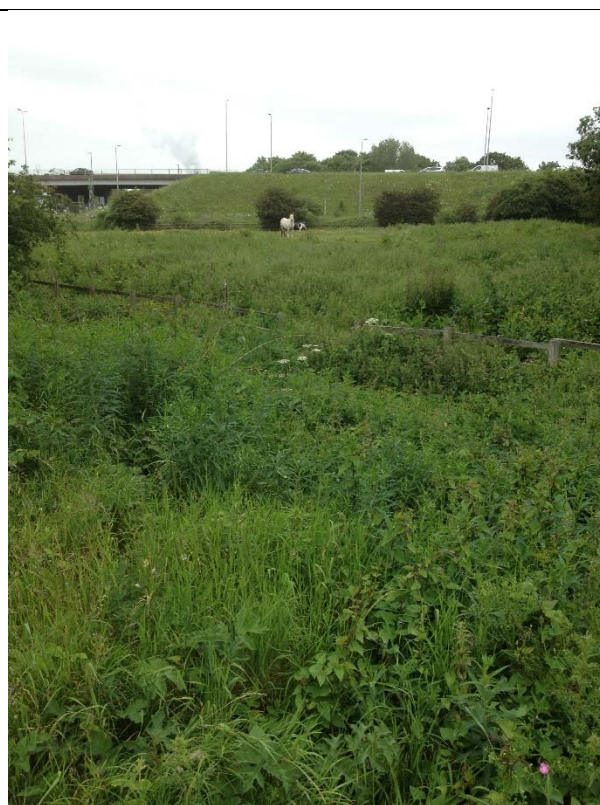
Small field adjacent, access unavailable

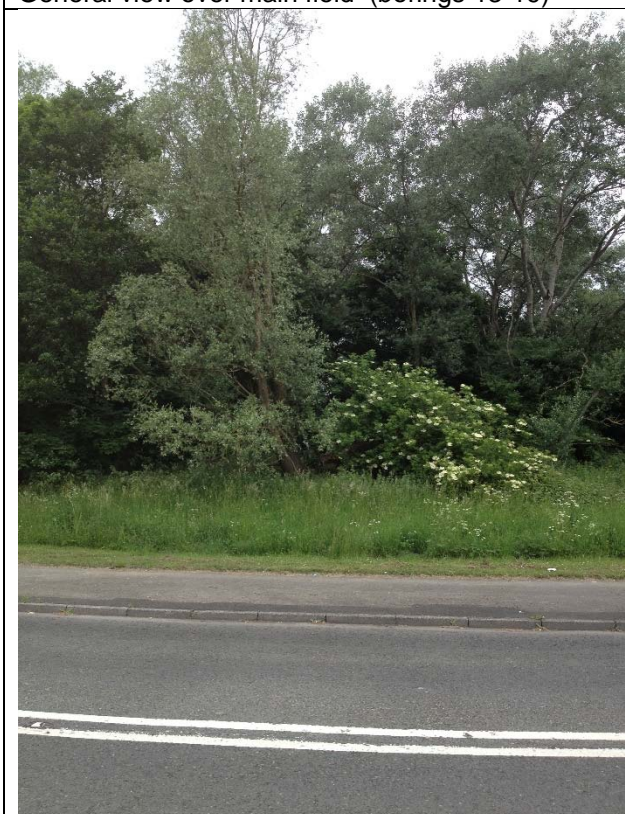
Location of point 20. Non agricultural use ie woodland.
