A1 Birtley to Coal House

Scheme Number: TR010031

6.3 Environmental Statement – Appendix 12.1 Walking Cycling and Horse Riding Assessment

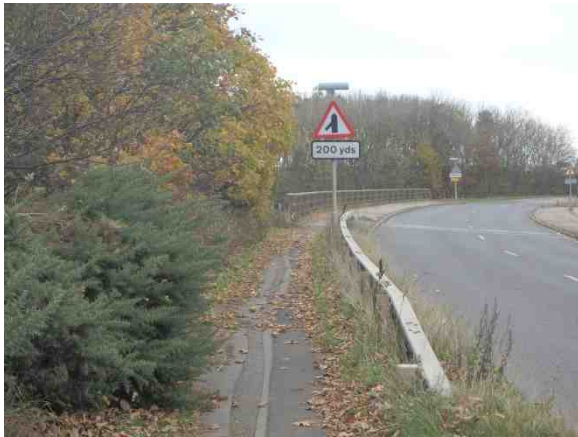
F.1 – A photo from the western side looking eastwards

In the foreground of both photos, it is shown that the footway provision is substandard in width and the condition of the pavement surface is poor. On the left-hand side of photo F.1, the vegetation on the verge encroaches onto the existing footway. Both photos show that no lighting, no directional signage and no dedicated cycle facilities are available along this route.

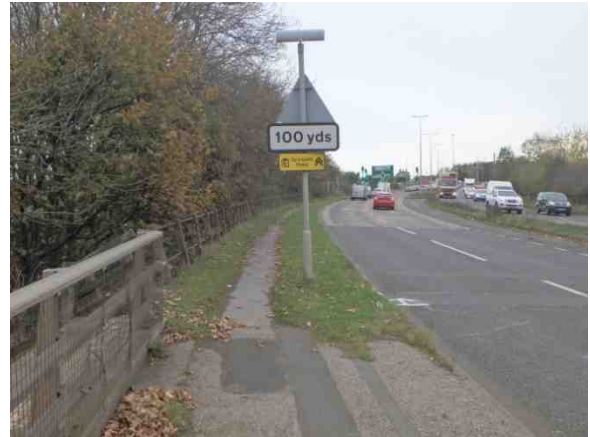
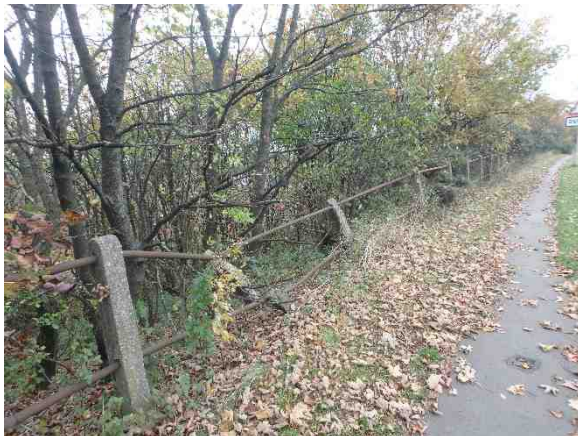
F.2 – A photo from the eastern side looking eastwards

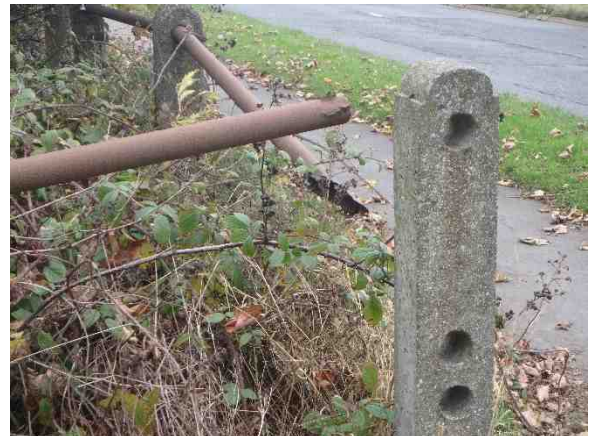
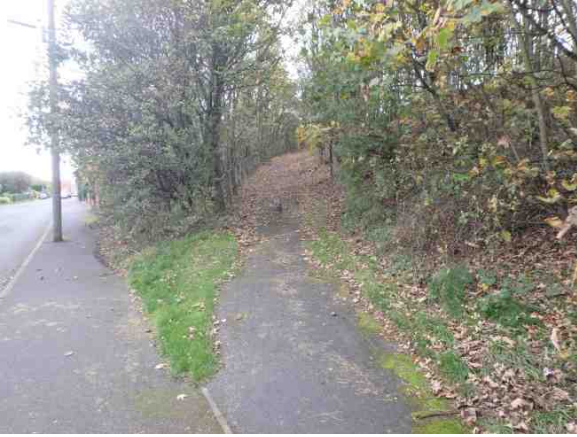
F.3 – A photo focusing in on the fencing on the western side

F.4 – A photo with a zoomed extent of the fencing

Photos F.3 and F.4 were taken to highlight the poor condition of the current concrete post and tubular pole fencing.

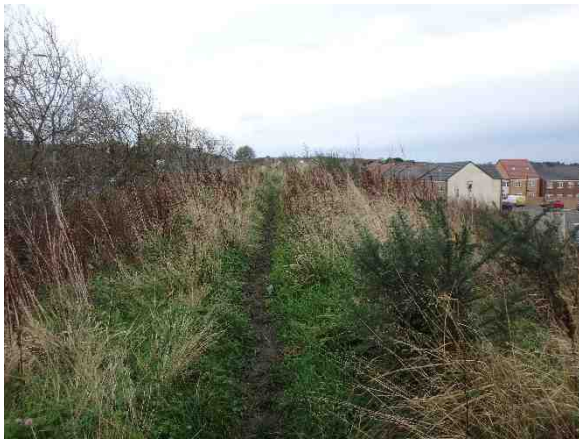
F.6 – A photo looking south (west of the A1 mainline) along Northside Footway

Photo F.6 demonstrates that Northside Footway is unlit as well as there being no physical fence that would prevent people and animals accessing the A1 mainline. The deck and ramp shown in the foreground of photo F.7 is substandard in width.

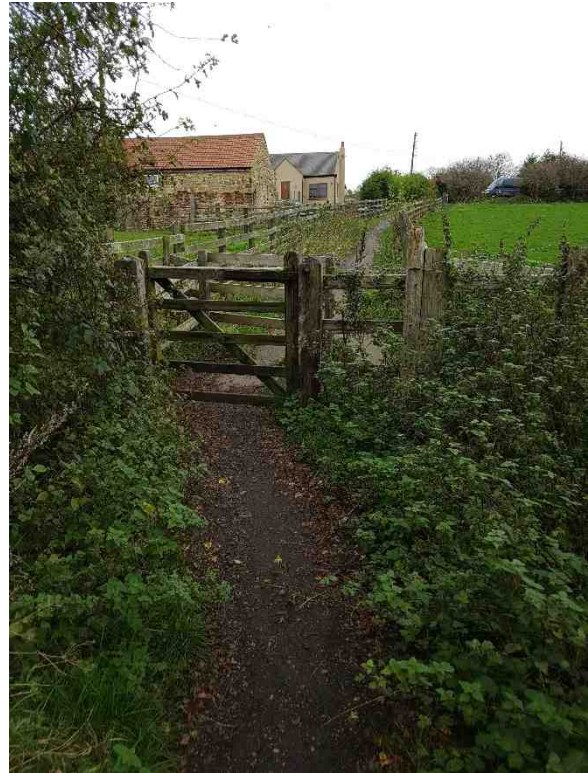
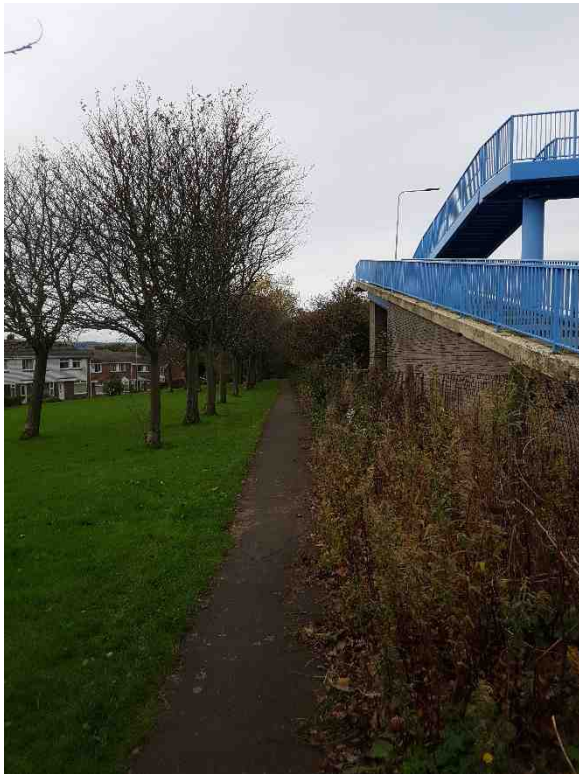
F.8 – A photo taken from North Dene Footbridge looking eastwards

F.9 – The 'Kissing Gate' and unmade footpath on the eastern side of North Dene Footbridge

Photo F.8 further highlights the substandard width of the deck and ramp on North Dene Footbridge and no tactile paving is provided. Photo F.9 shows the unmade footpath and a 'kissing gate' which is unsuitable for cyclists. No directional signage is provided in any of the four above pictures.

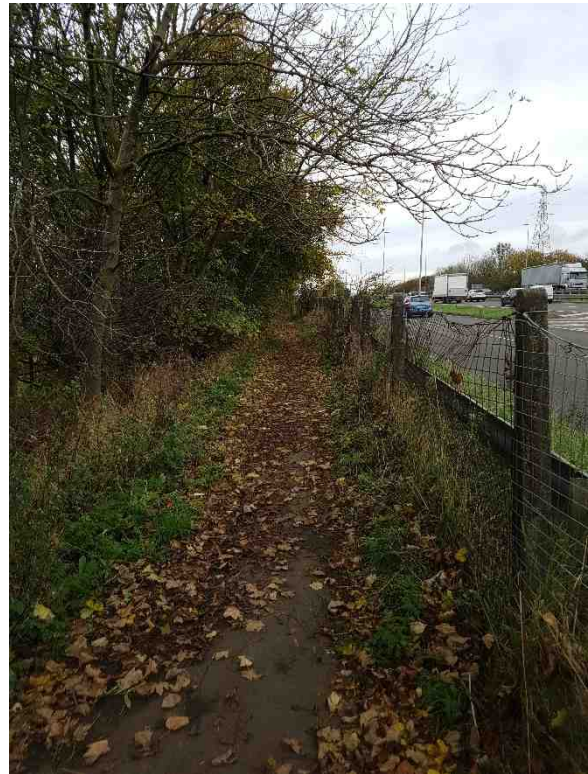
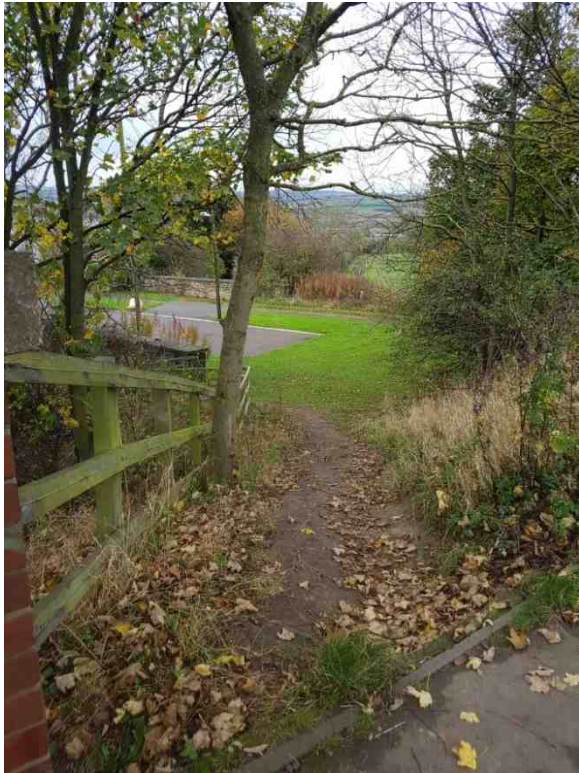
F.10 – A photo looking north from North Dene Footbridge to Longbank Footway

F.11 – A photo looking north and on the western side of the A1 mainline of Longbank Footway

In the foreground of both photos it is shown that footway provision is substandard in width for the usage from cyclists and it can also be seen that vegetation in the verges encroaches onto the existing footway. Both photos show that this footway is unlit with no directional signage. Photo F.11 highlights the poor outdated condition of the concrete post and wire-mesh fencing which acts as a barrier to the A1 mainline.

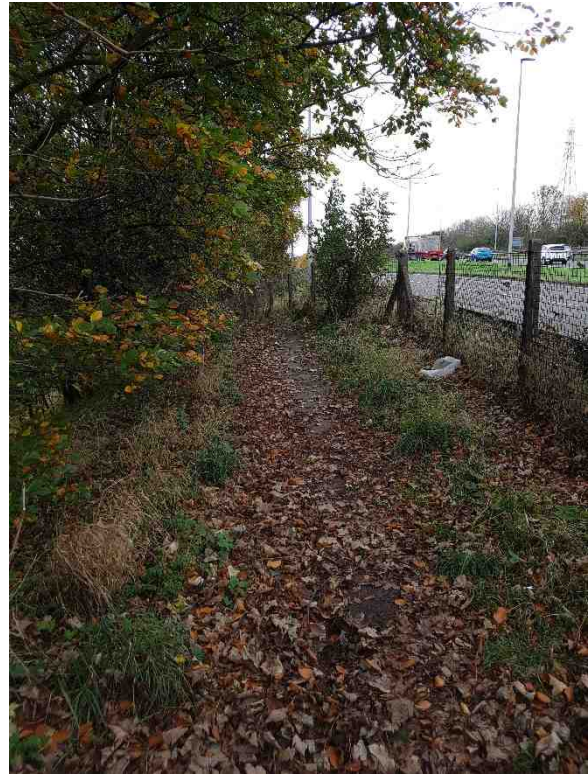
F.17 – The Footway from Longbank to Eighton Lodge taken looking north

- The condition of the concrete post and wire-mesh fencing between the Longbank to Eighton Lodge Footpath and the A1 mainline is poor.
- No directional signage is available on either end of the Longbank to Eighton Lodge Footpath.

F.18 – The concrete post and wire-mesh fencing on the western side of the A1 mainline on the Footway from Longbank to Eighton Lodge

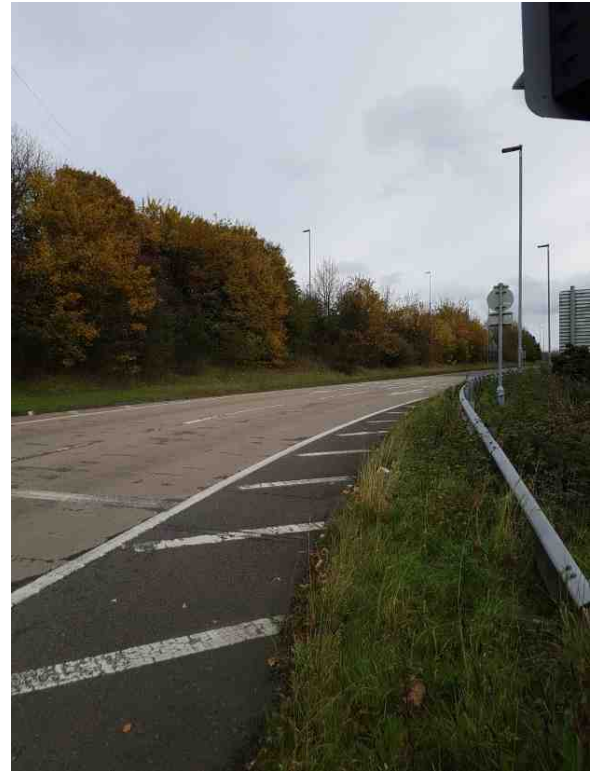
F.20 – This photo was taken from the crossing point looking southwards up the A1 northbound slip road

Photos F.20 and F.21 both demonstrate the impact the signage has on the visibility for people crossing the roads.

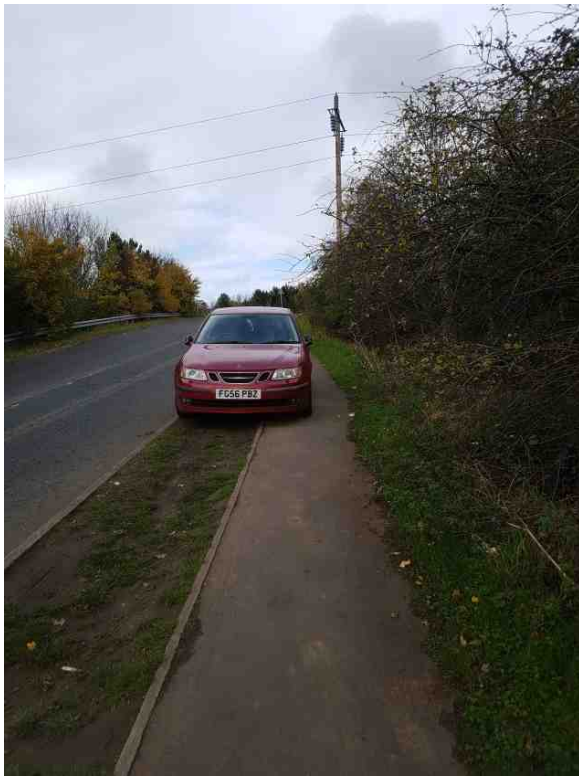
F.22 – Western side of Smithy Lane Bridge

F.23 – Eastern side of Smithy Lane Bridge

Photo F.22 was taken looking north-east along Smithy Lane on the approach to the Bridge, this photo is a good example of firstly the narrow footway and secondly how motorists park indiscriminately along this part of the road, which reduces the width further. Photo F.23 further supports this argument of a narrow footway. Both photos are unlit.

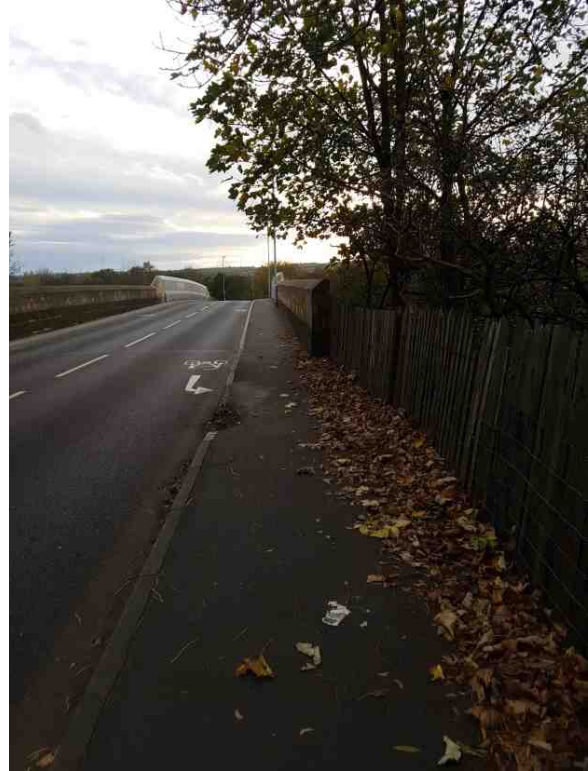
F.24 – The Angel Cycleway

F.25 – South-westerly for Chowdene Bank Bridge

Photo F.24 was taken walking south along The Angel Cycleway, as shown in the photo the cycleway is well lit with a well maintained pavement surface. Photo F.25 is looking south-west down Chowdene Bank Bridge, in the forefront of the photo is a narrow footway which is only on one side of the bridge.

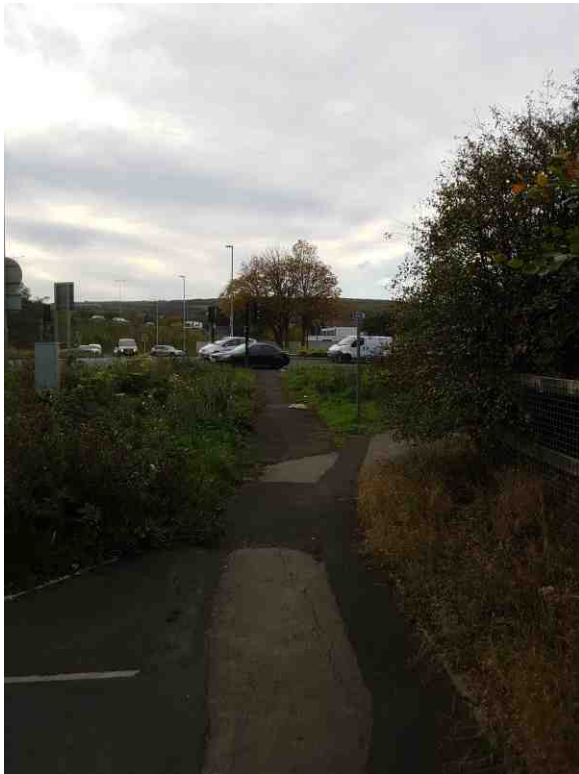
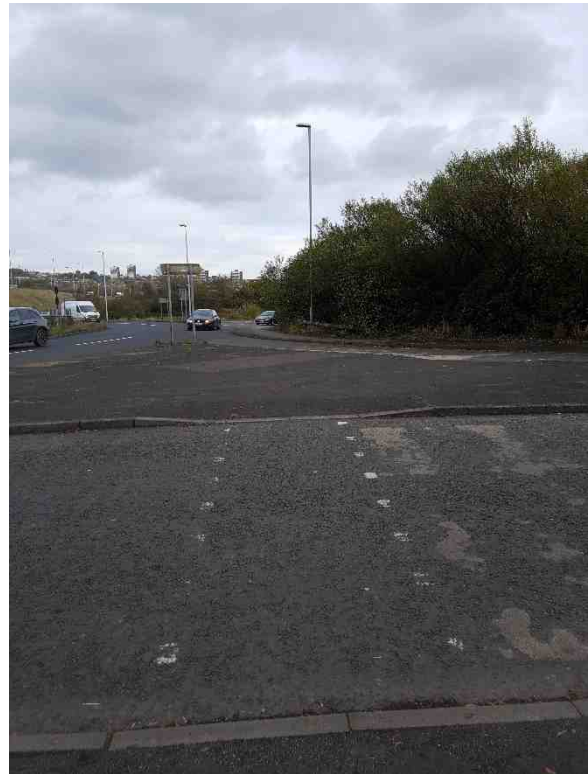
F.26 – Western view from Chowdene Bank to Kingsway

F.27 – Crossing facilities at the Banesley Lane Arm of Lamesley Roundabout

Photo F.26 was taken looking west across the Kingsway Arm of Lamesley Roundabout, this photo in particular highlights that footway provision is substandard in width and this is a reoccurring theme around the roundabout. Photo F.27 was taken at the crossing point on Banesley Lane Arm of Lamesley Roundabout and is a typical example of how there is a varying degree of physical pedestrian infrastructure at crossing points. In this photo there are dropped kerbs and white line markings however there is no tactile paving.
