# Lower Thames Crossing

## 6.3 Environmental Statement Appendices Appendix 10.6 – Preliminary Risk Assessment Report

## Appendix 10.6 – Preliminary Risk Assessment Report

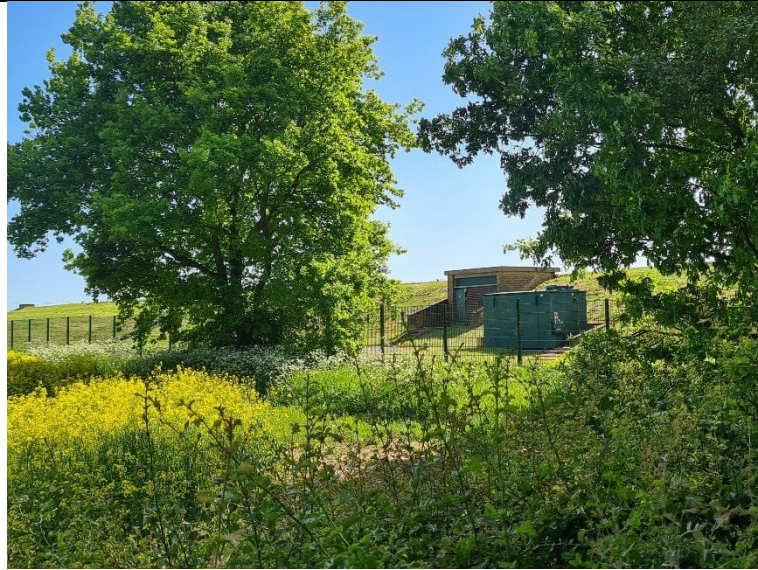
Fields in the north-eastern section and small buildings and transformer associated with Westfield Sole Reservoir – signage indicates that the site is managed by Southern Water. Electrical infrastructure and above ground storage tanks were observed.

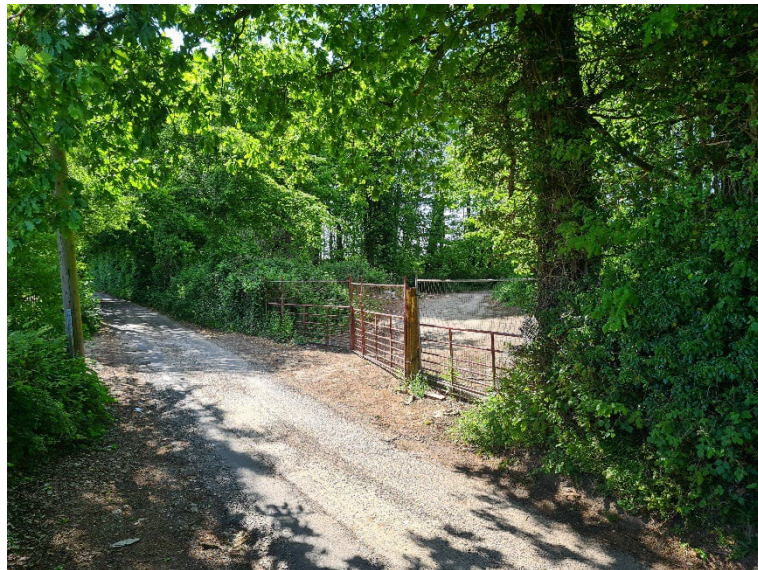
Gated entrance to scrap /waste storage area north of site (not in the nitrogen deposition compensation site) – no drainage or interceptor was observed.

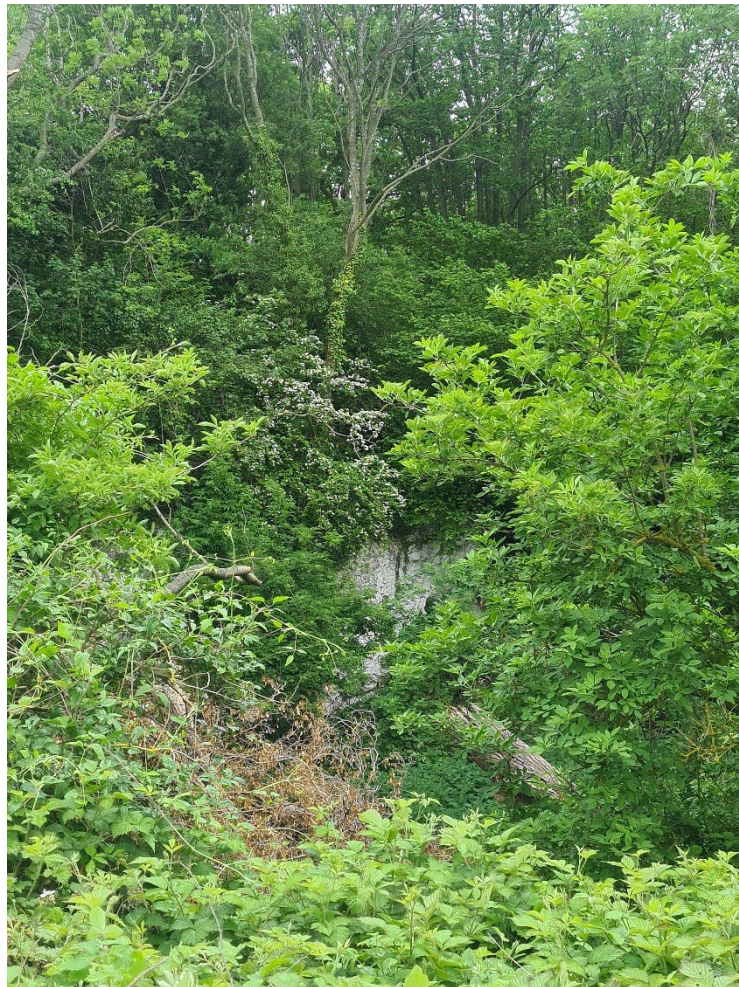
Some evidence of small-scale historic quarrying activity noted in the forested area to the north eastern corner of the site. Mapping data indicates that the area currently contains a small pond – this was not visible due to mature vegetation.
