Lower Thames Crossing

6.3 Environment Statement Appendices Appendix 8.22 – Terrestrial Ecology Surveys at Nitrogen Deposition Compensation Sites

Planning Inspectorate Scheme Ref: TR010032
Application Document Ref: TR010032/APP/6.3

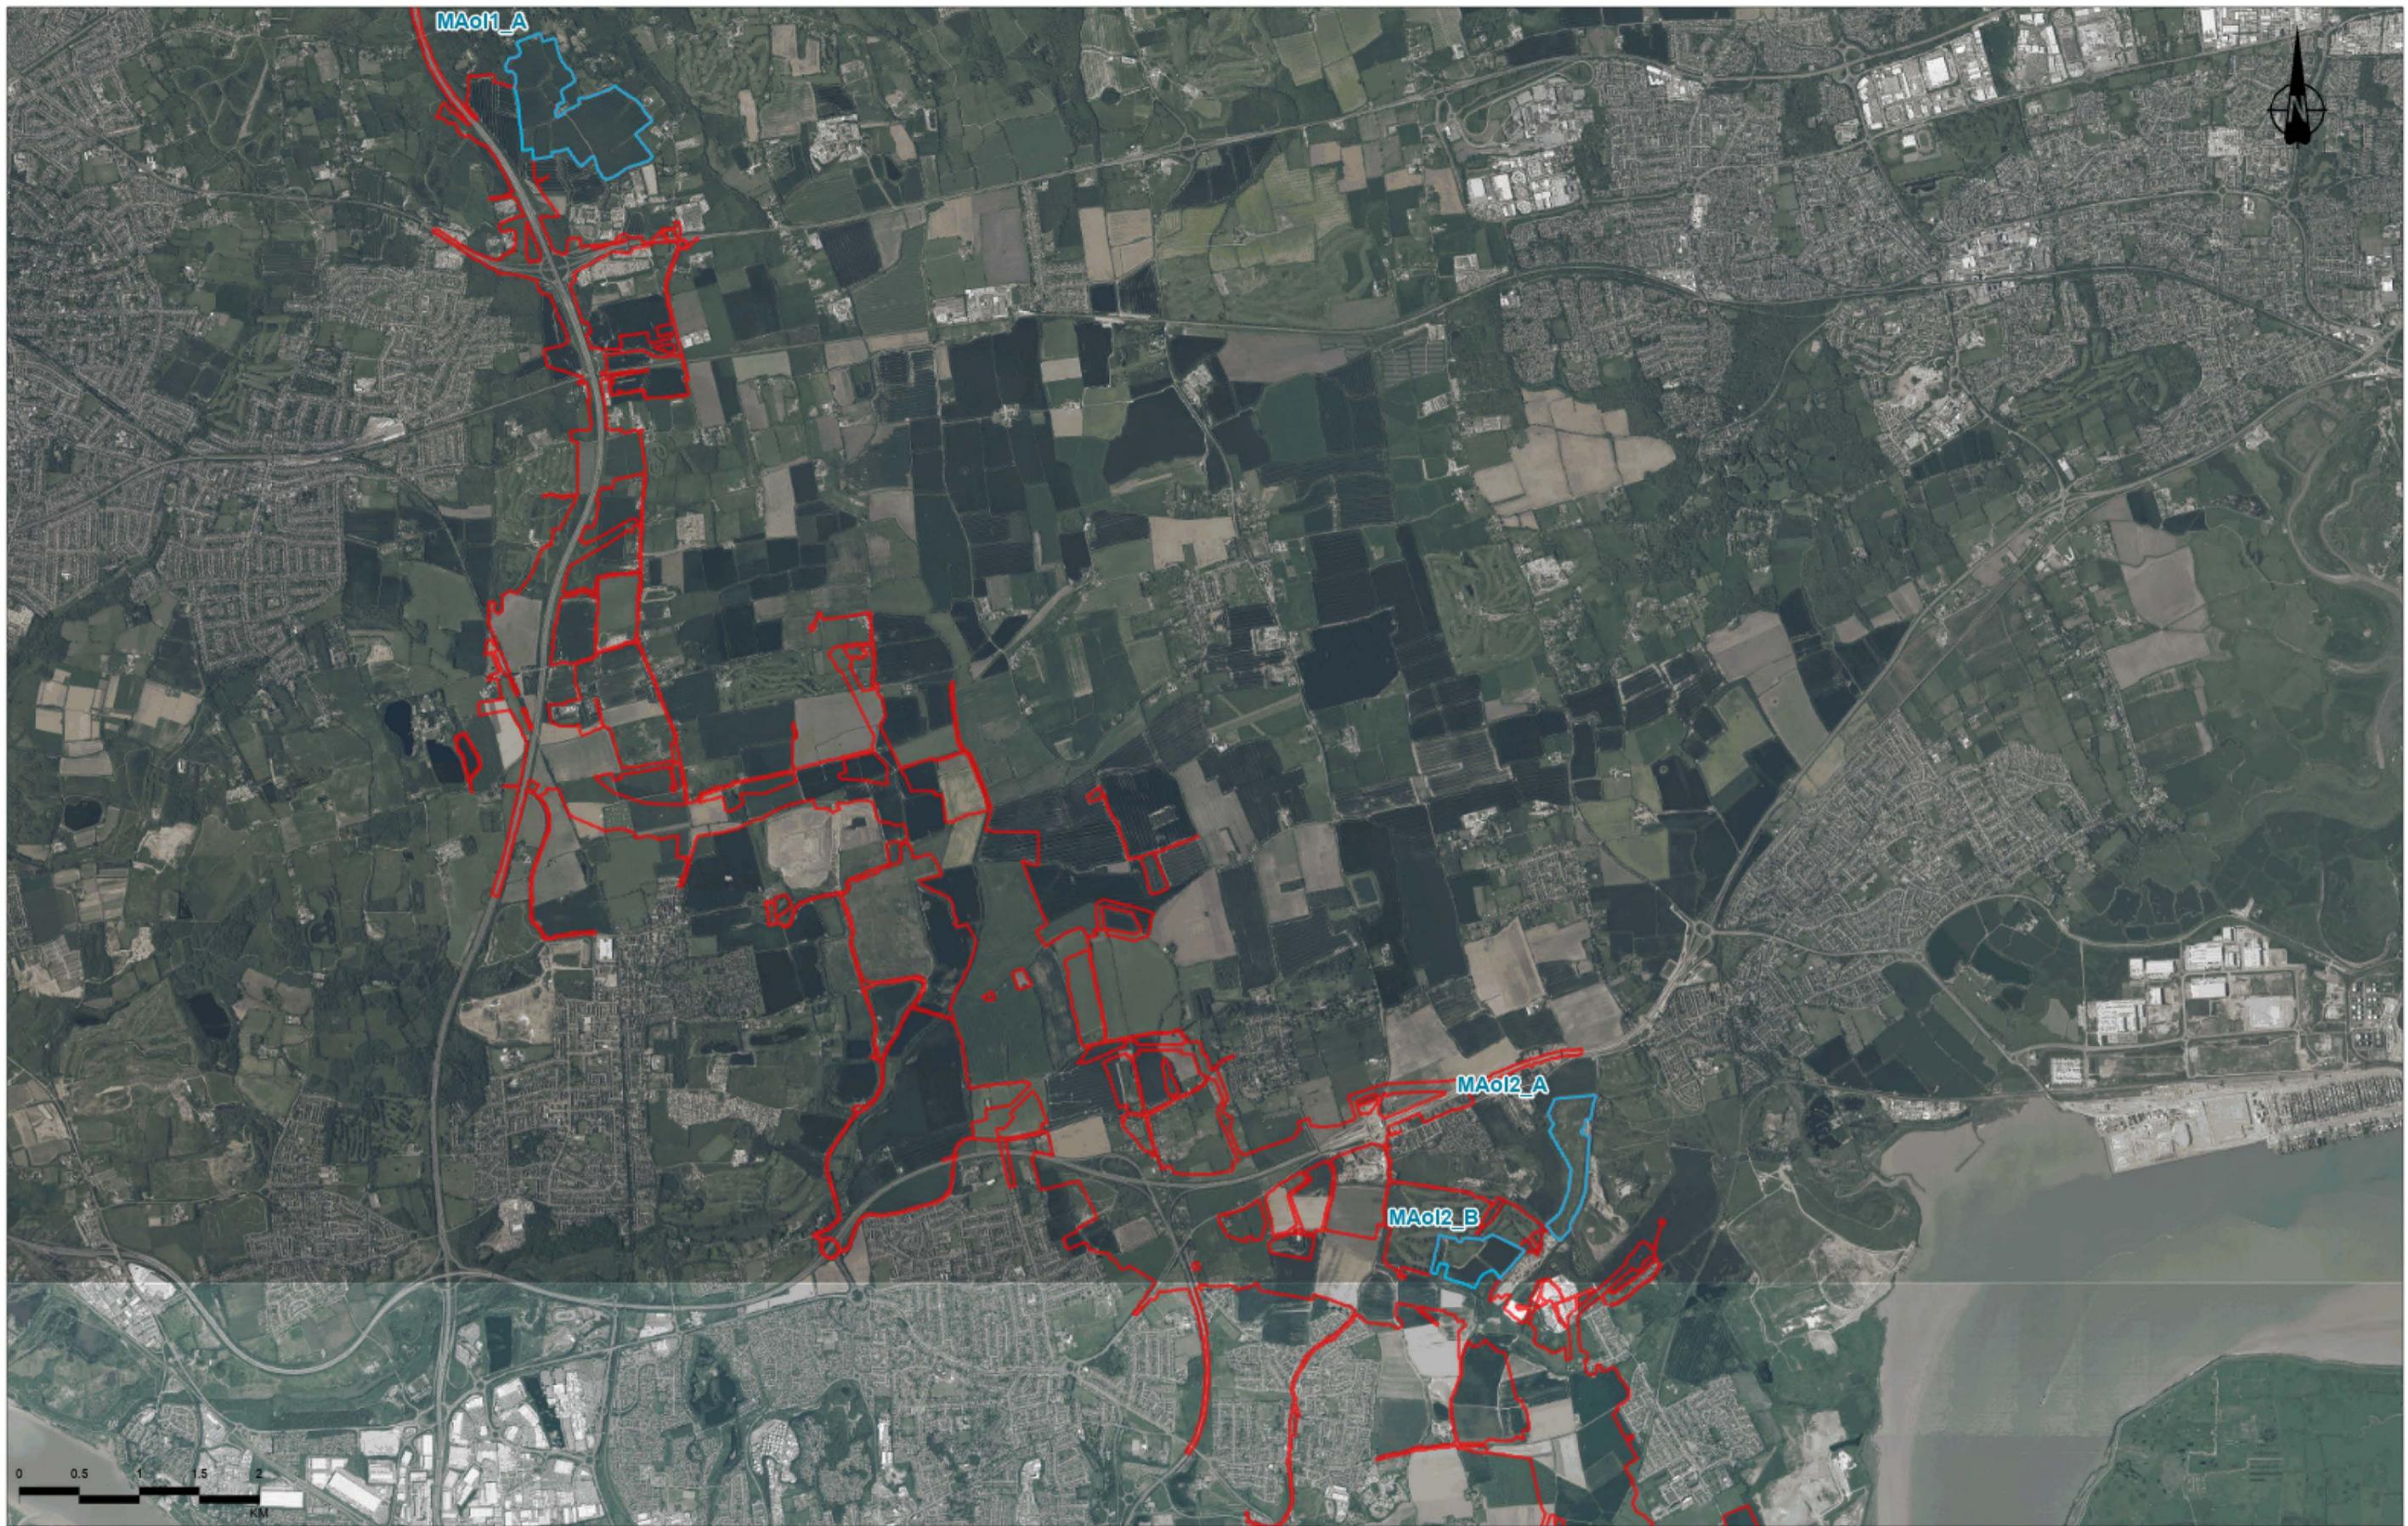
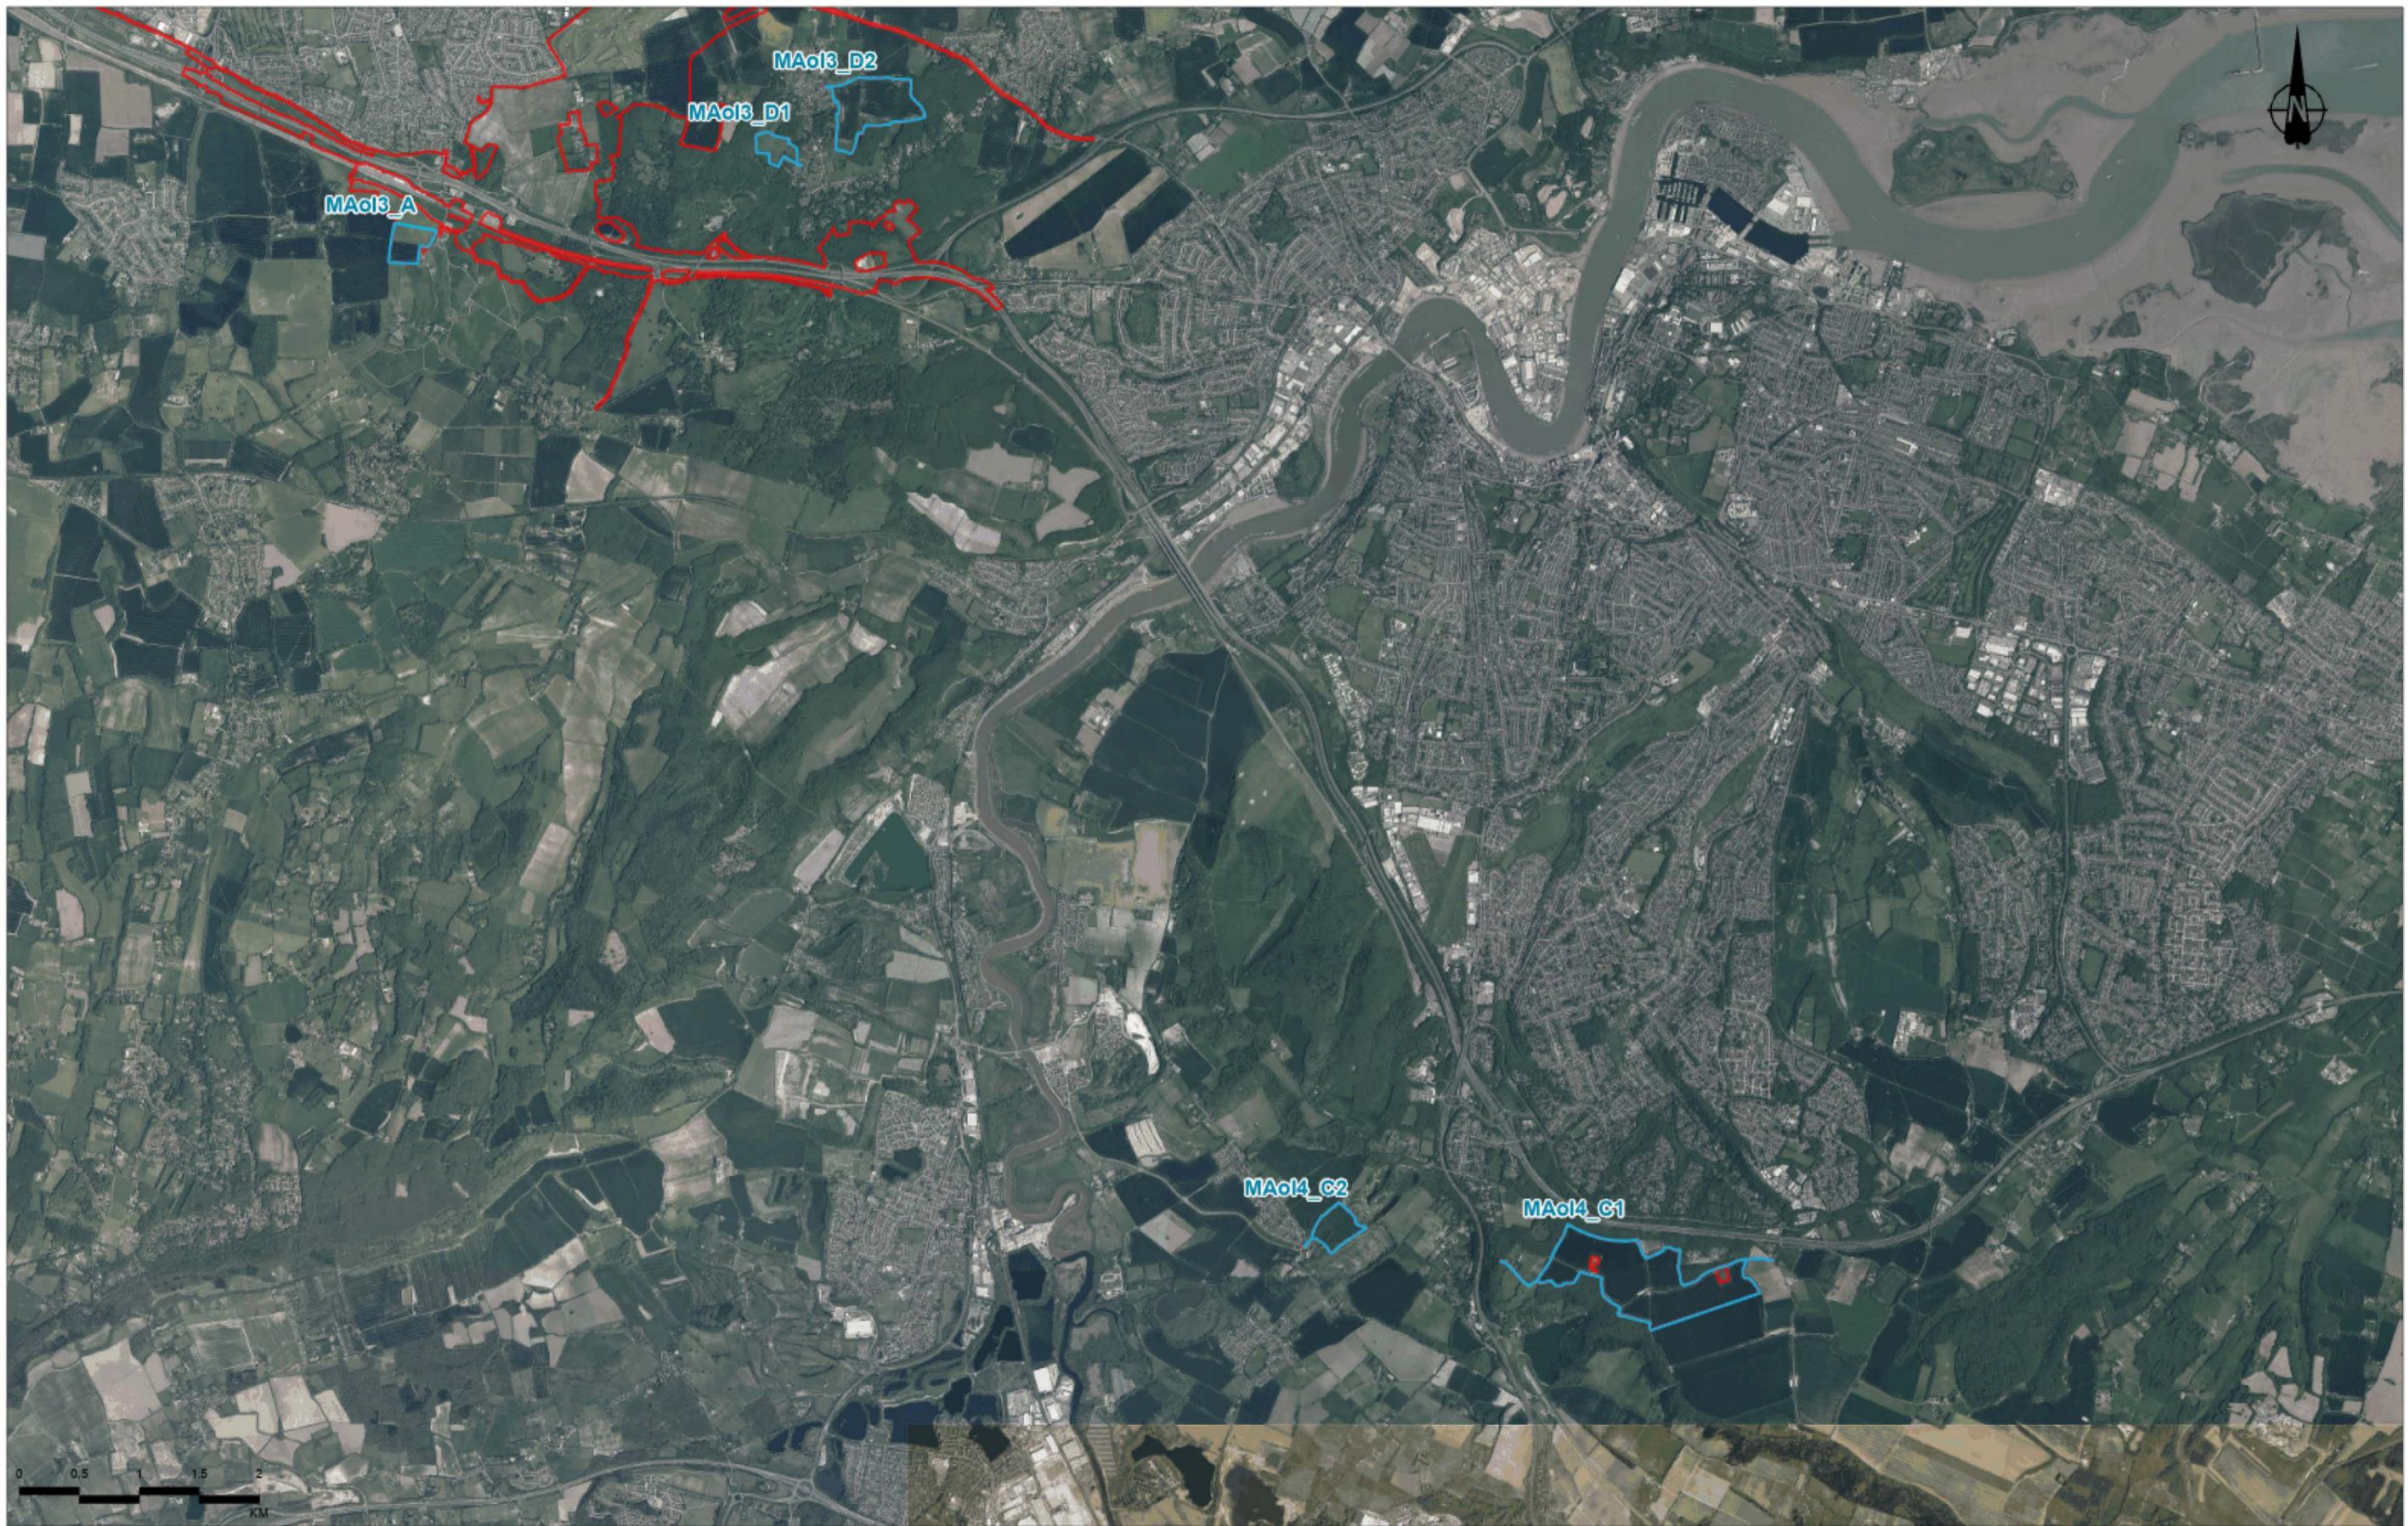
Status	DCO APPLICATION	Original Size	A3	Revision	1/02
Application Document Number	TR010032/APP/6.3	Scale	1:95,000		
Drawing Title	Figure 1 - Overview of Nitrogen Deposition Compensation Sites South of the River Thames Page 2 of 2				
Drawing Number	HE540039-CJV-EBD-SZP_EGNE00000000-DR-LE-60100

1.1.1 This document presents the findings of the UK Habitat Classification (UKhab), great crested newt (GCN; *Triturus cristatus*) and badger (*Meles meles*) surveys of the eight nitrogen deposition compensation sites. These surveys will henceforth be collectively referred to as the ‘ecology surveys’. The ecology surveys were undertaken from April to June 2022. This report forms an appendix to Chapter 8: Terrestrial Biodiversity (Application Document 6.1) of the Environmental Statement and provides baseline ecological data which informs the terrestrial biodiversity impact assessment detailed within Chapter 8. As part of the Environmental Impact Assessment (EIA) of the A122 Lower Thames Crossing (the Project), eight sites (hereafter referred to as “compensation sites”) have been identified as suitable areas to provide compensation for the adverse effects of nitrogen deposition on designated sites as a result of the Project’s construction and operation. The methodology used to identify these sites, and detail on the overall compensation strategy, is provided in the Project Air Quality Action Plan (Appendix 5.6, Application Document 6.3). Details regarding the compensation sites are presented in Table 1.1 and their locations are shown in Figure 1 of this report.
