Lower Thames Crossing

6.3 Environment Statement Appendices Appendix 8.22 – Terrestrial Ecology Surveys at Nitrogen Deposition Compensation Sites

Planning Inspectorate Scheme Ref: TR010032
Application Document Ref: TR010032/APP/6.3

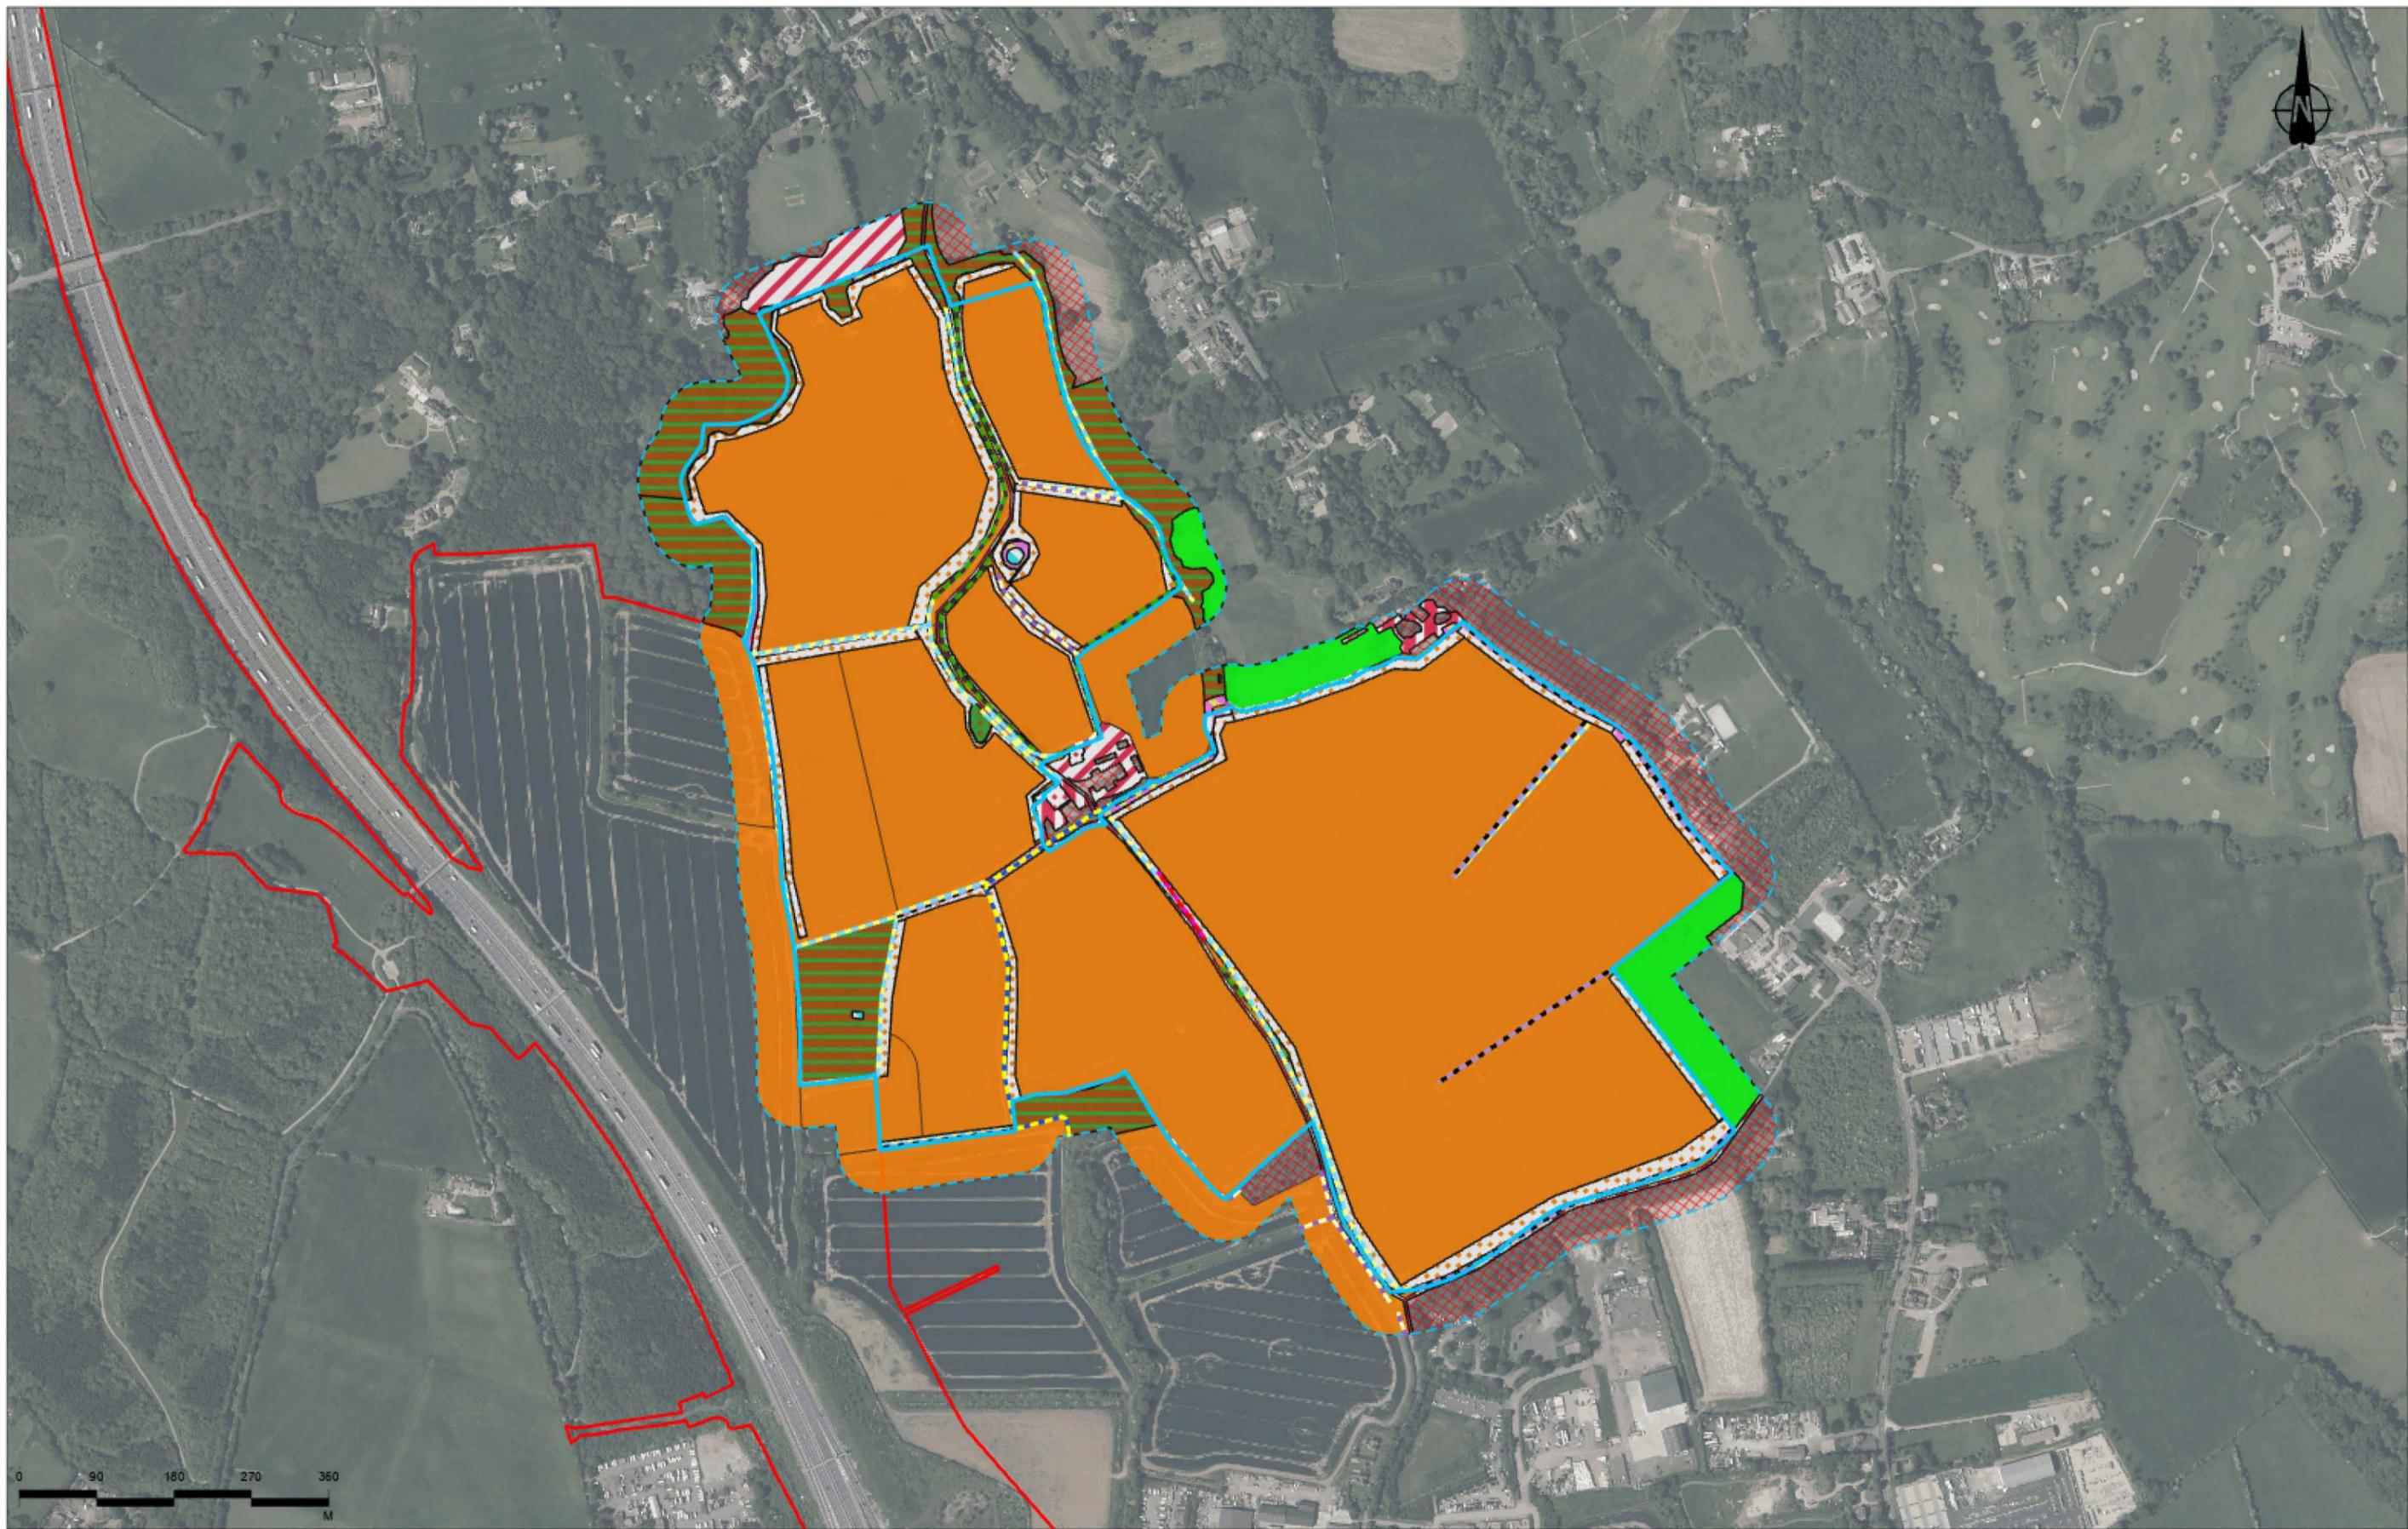
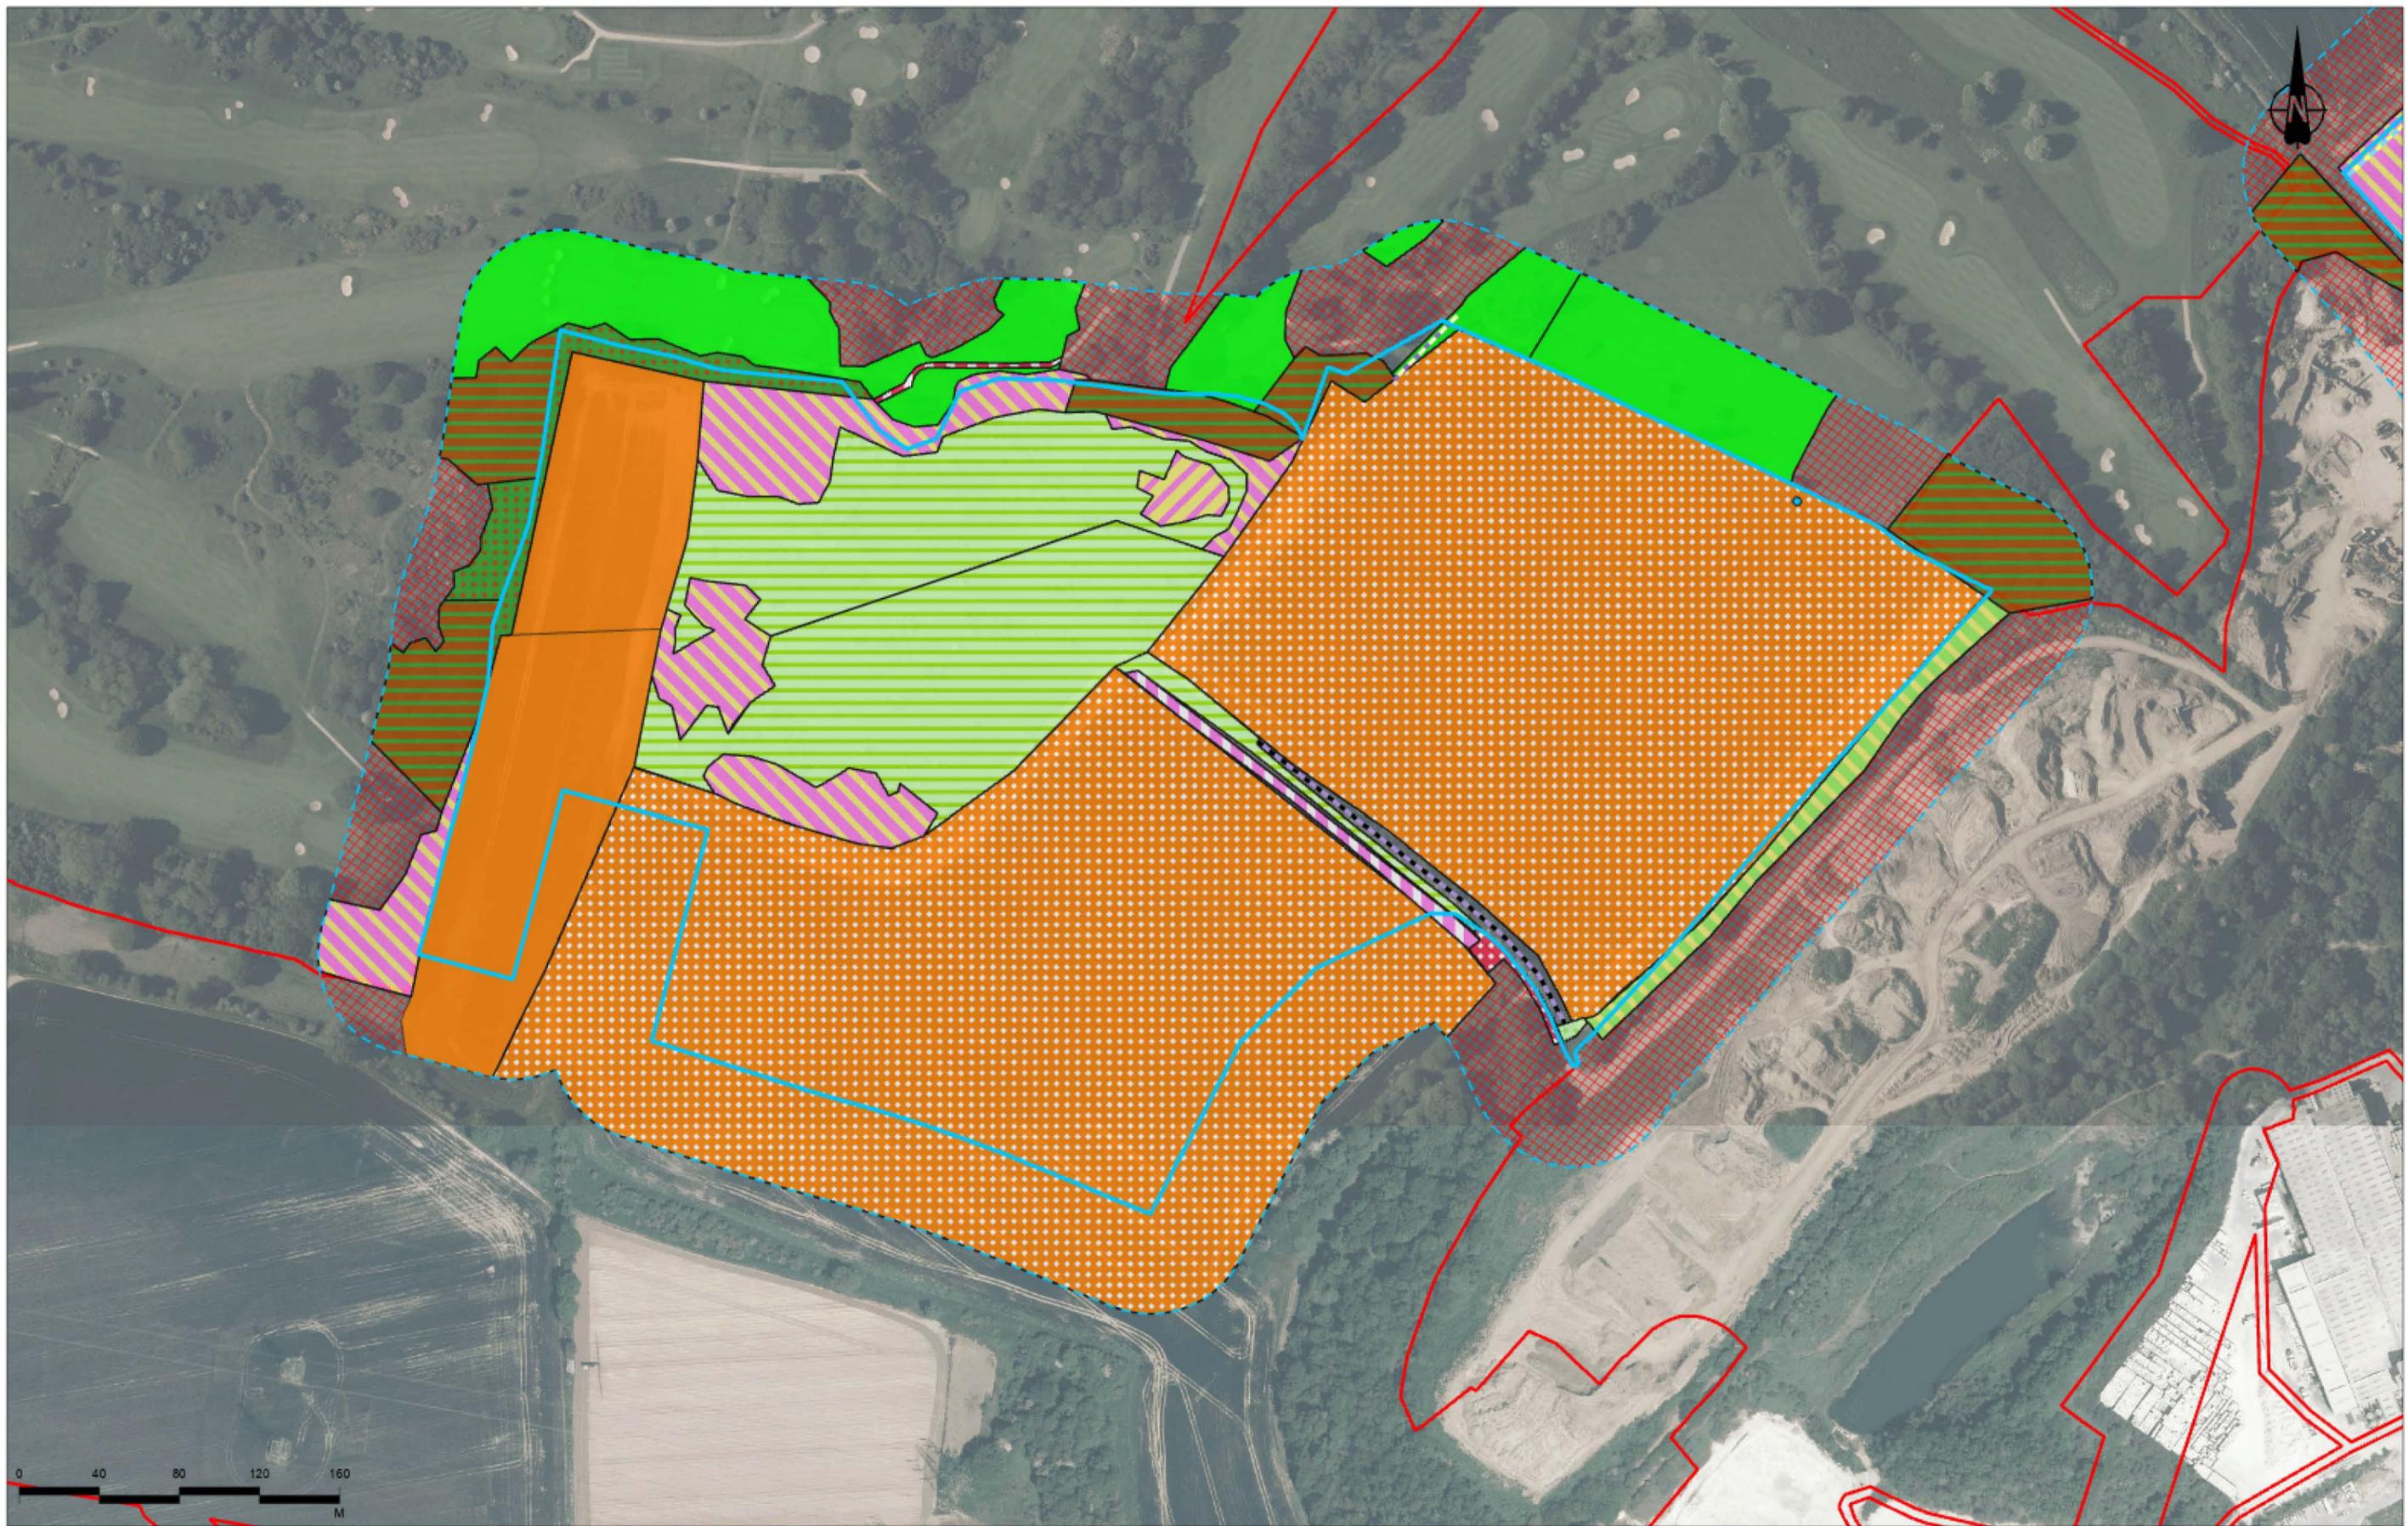
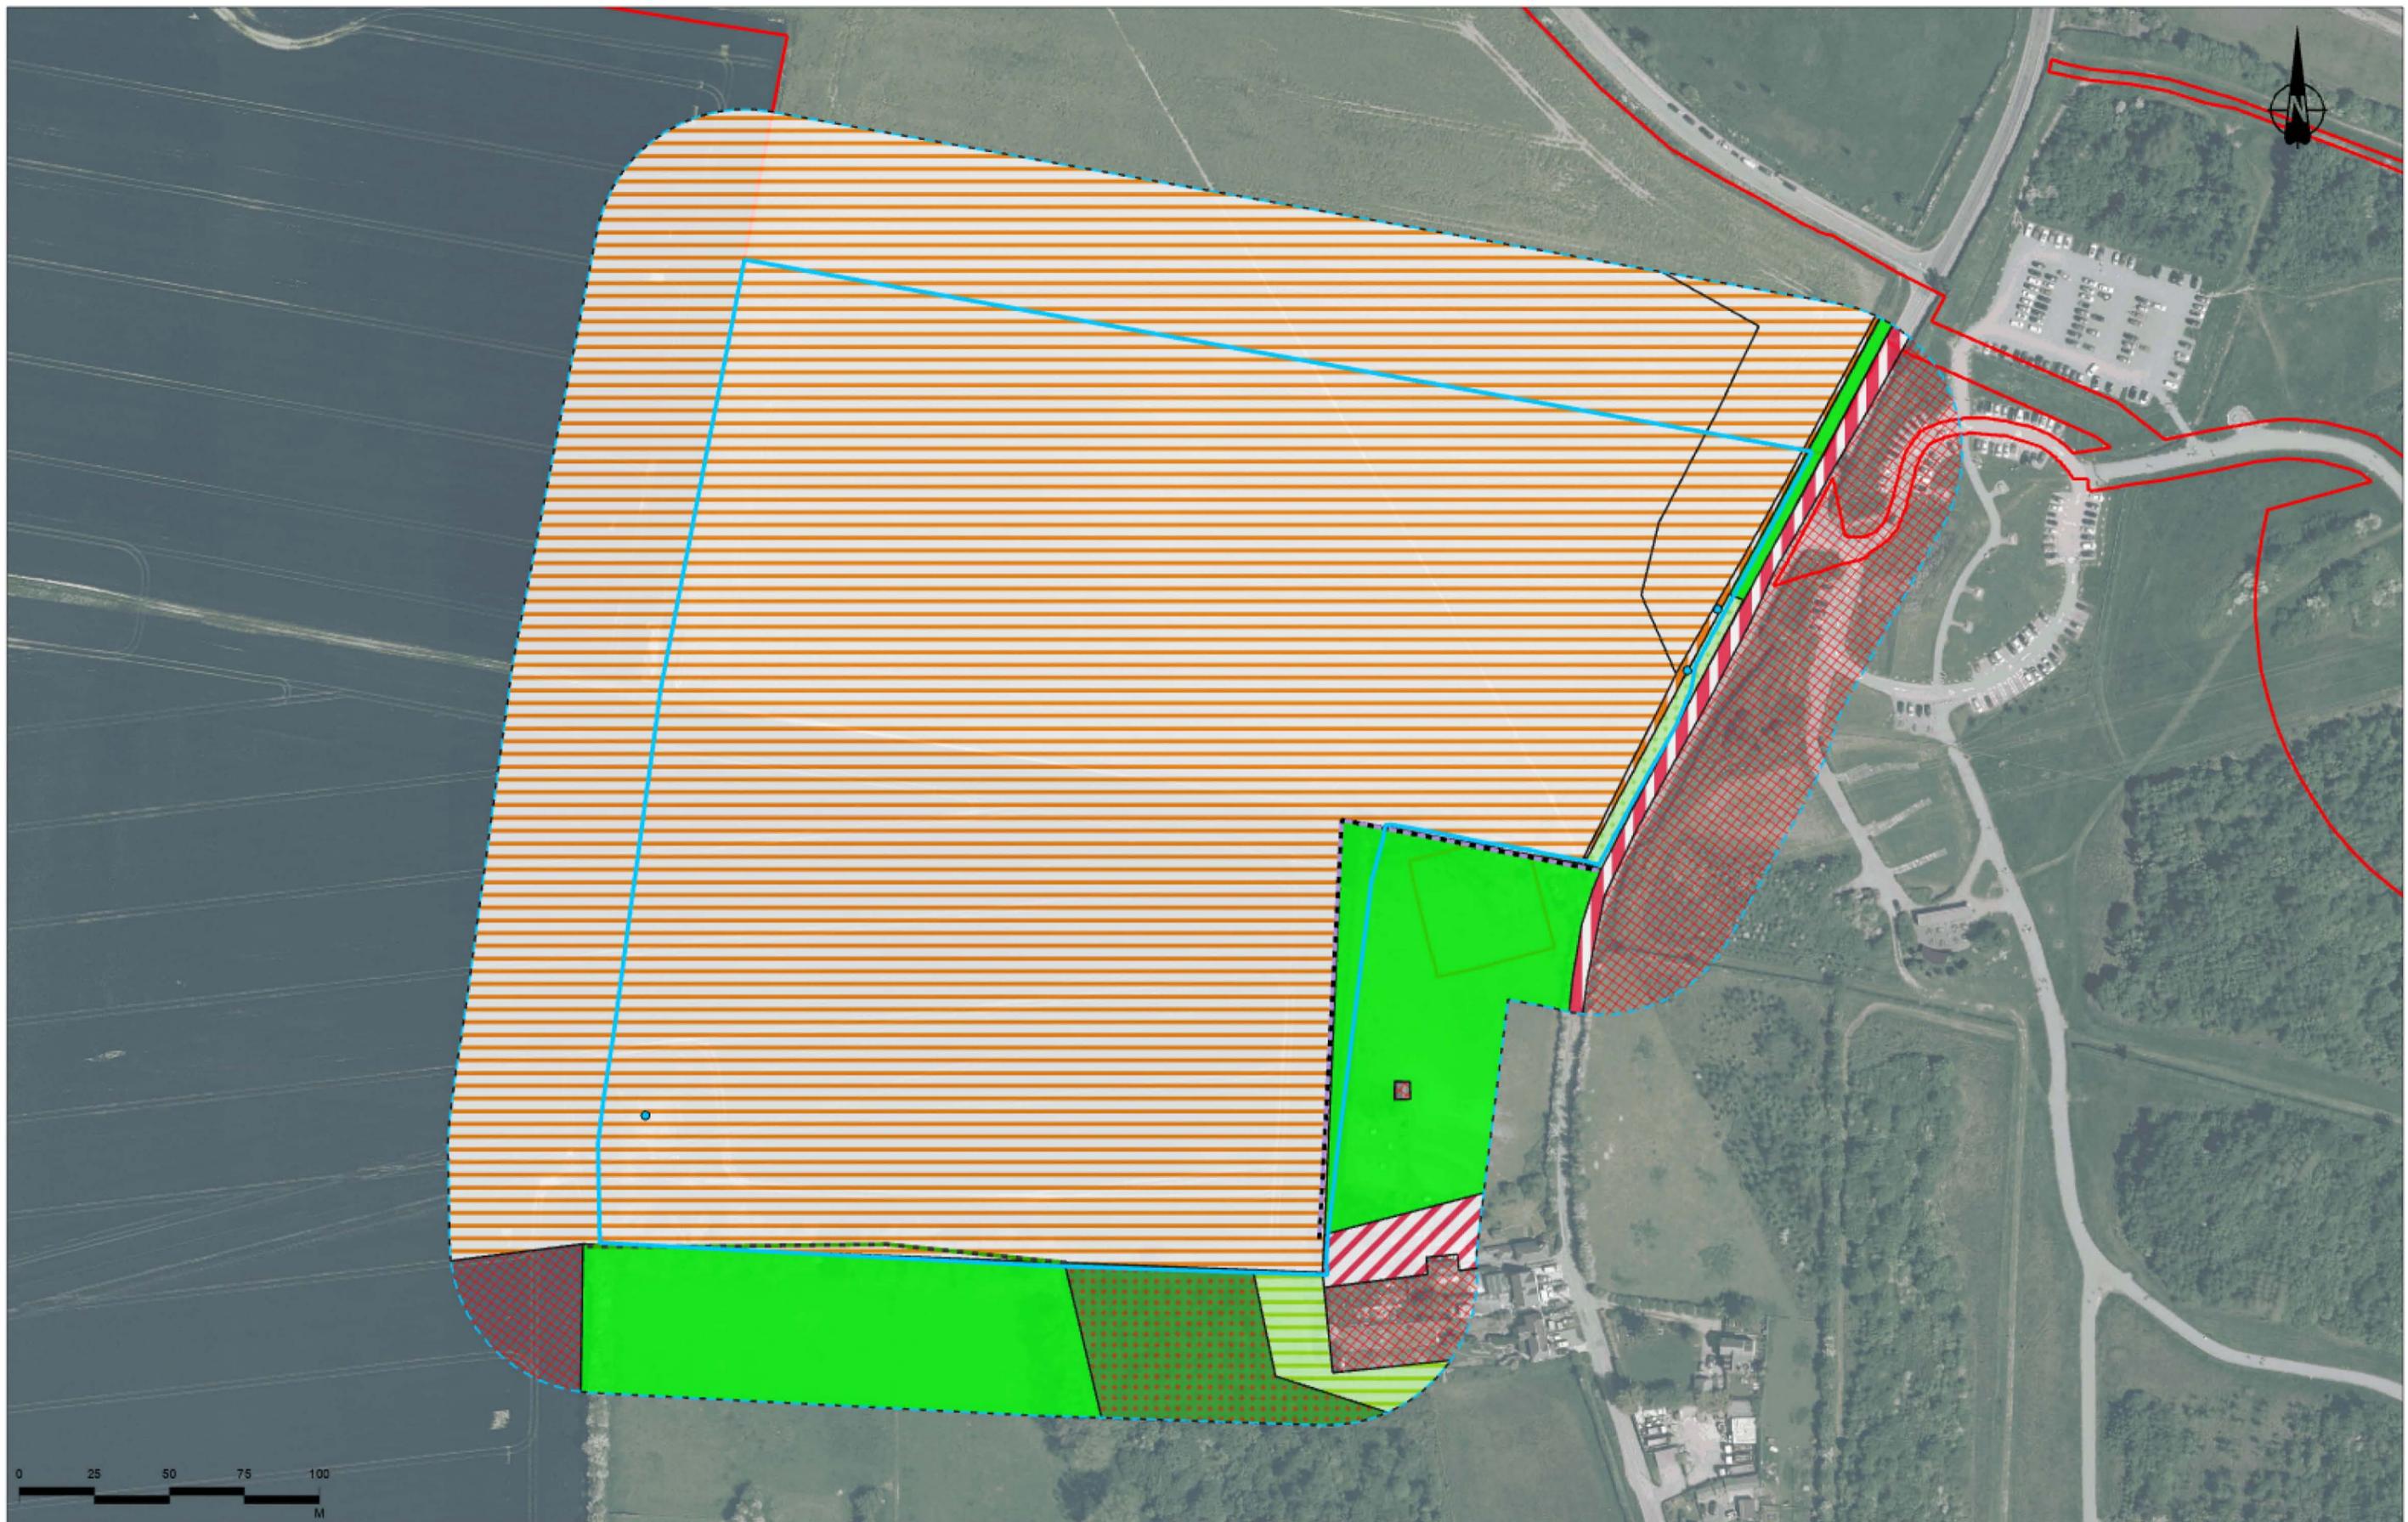
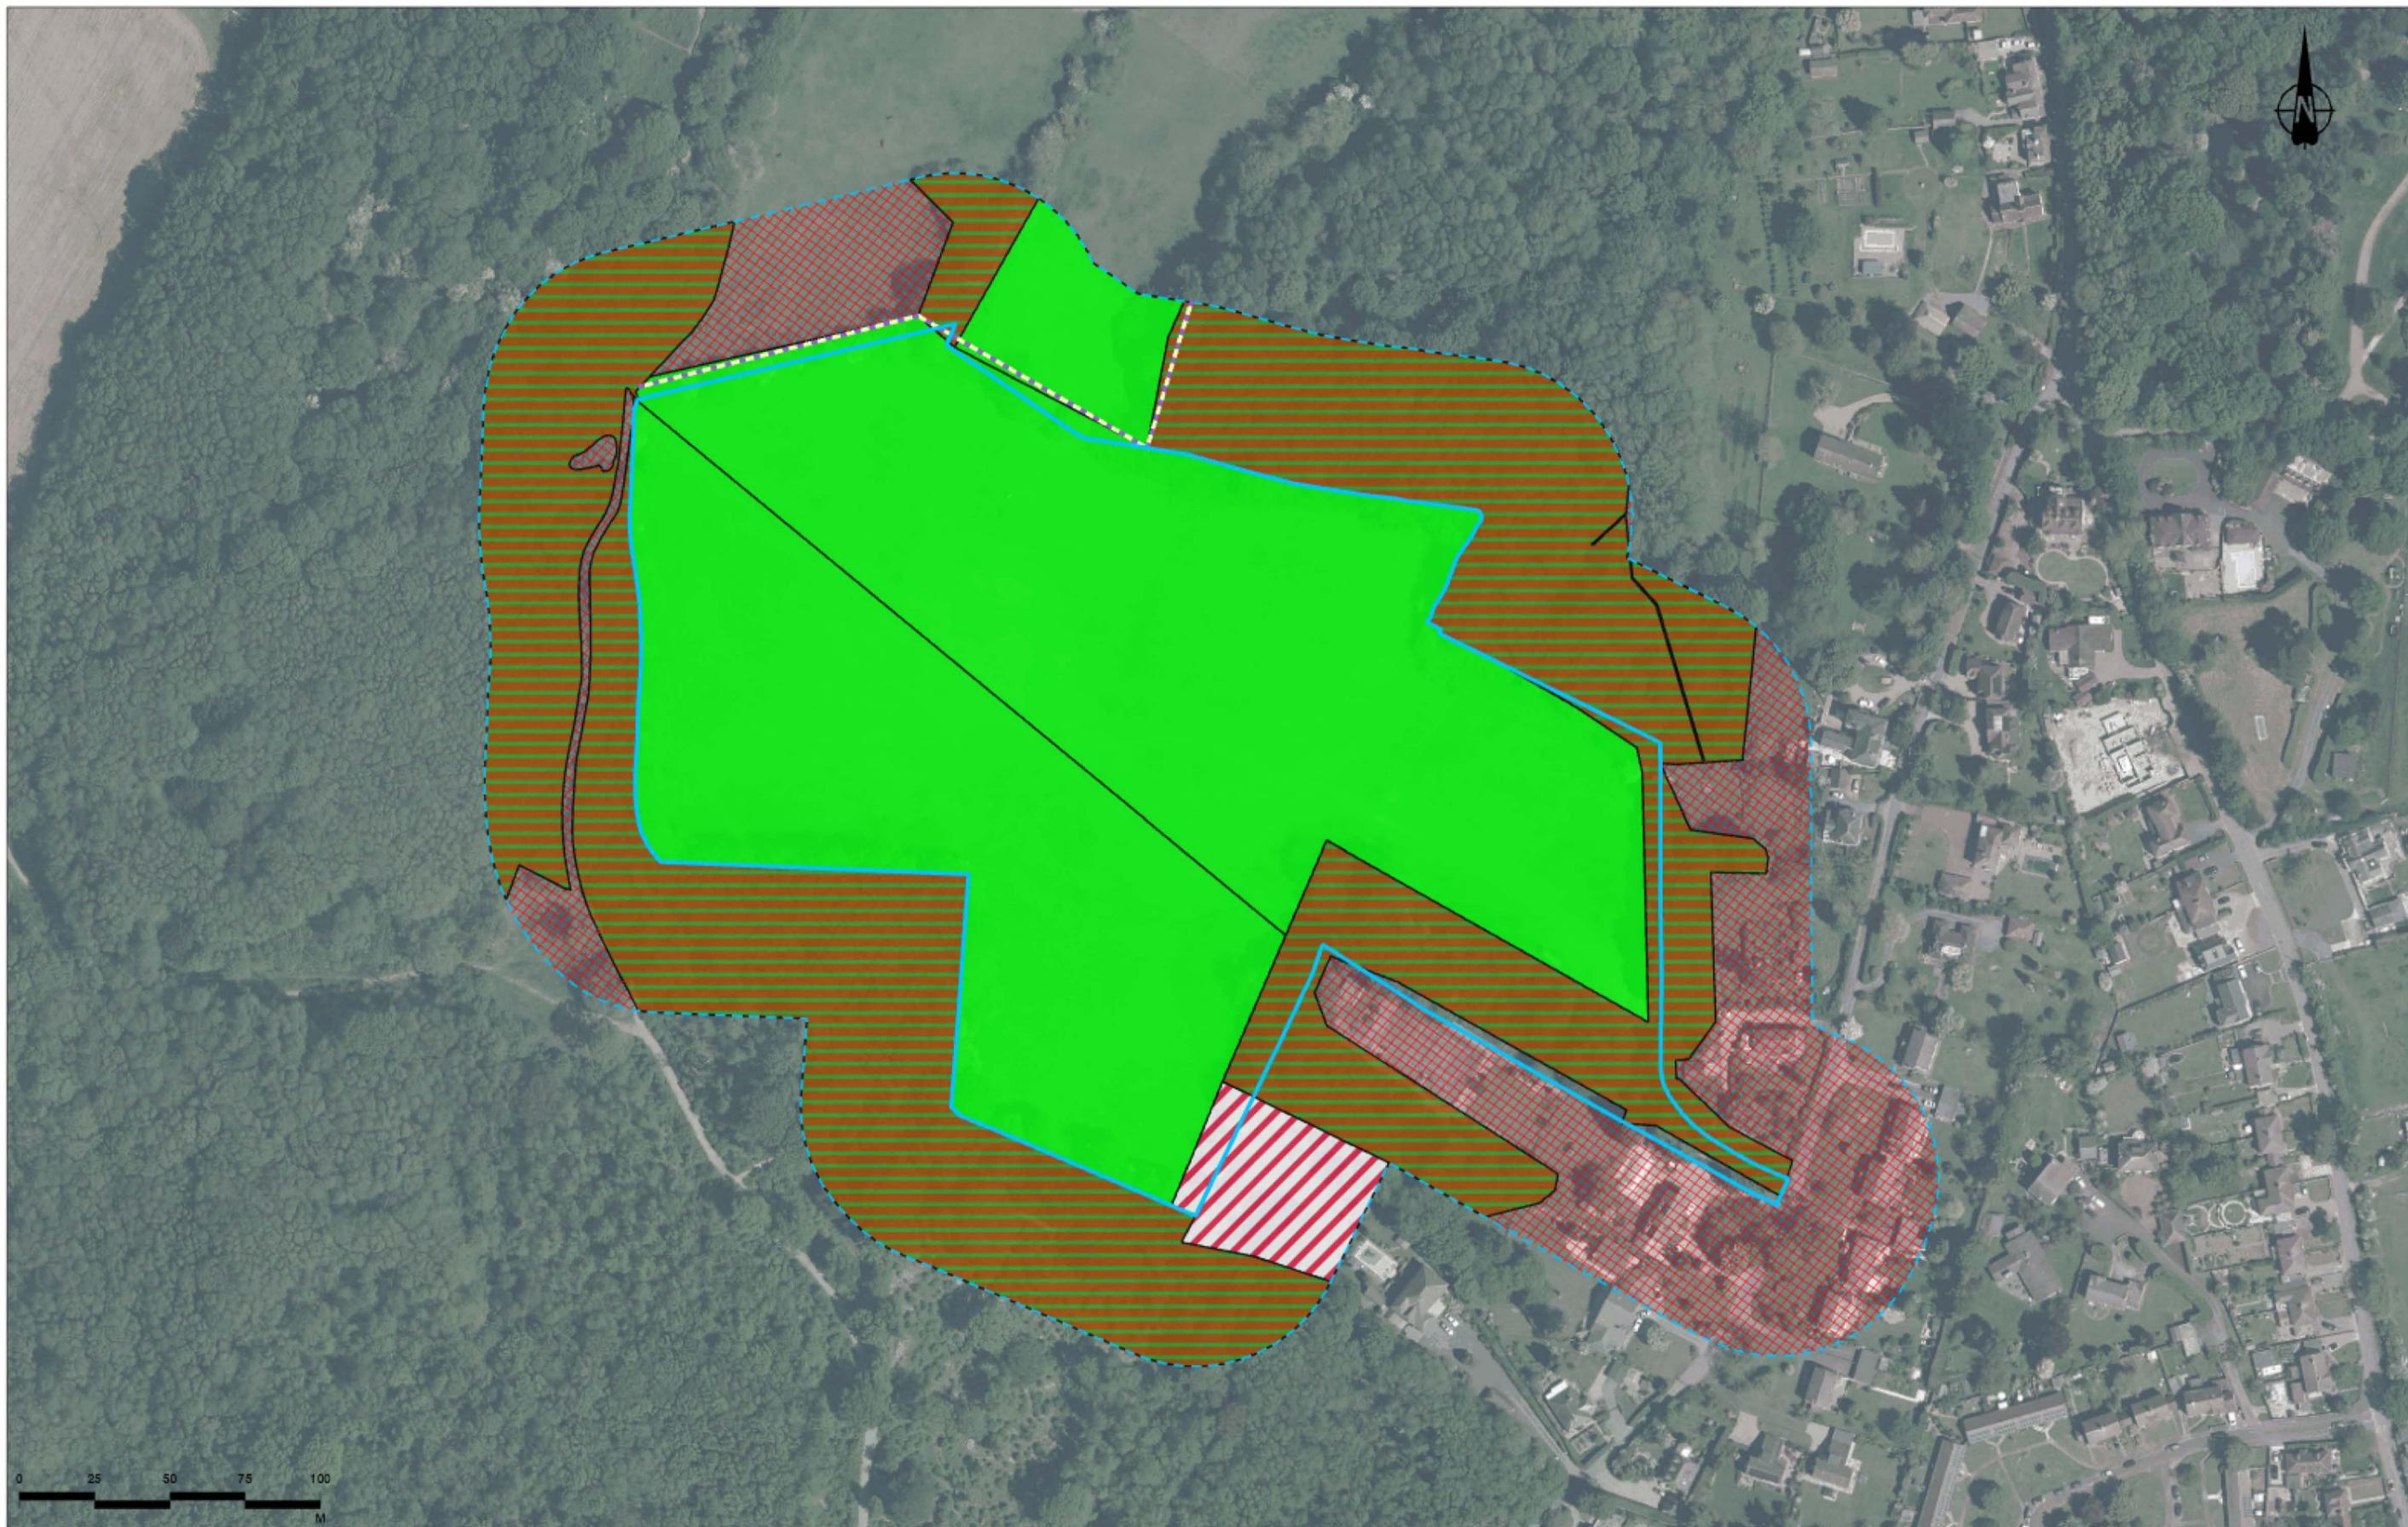
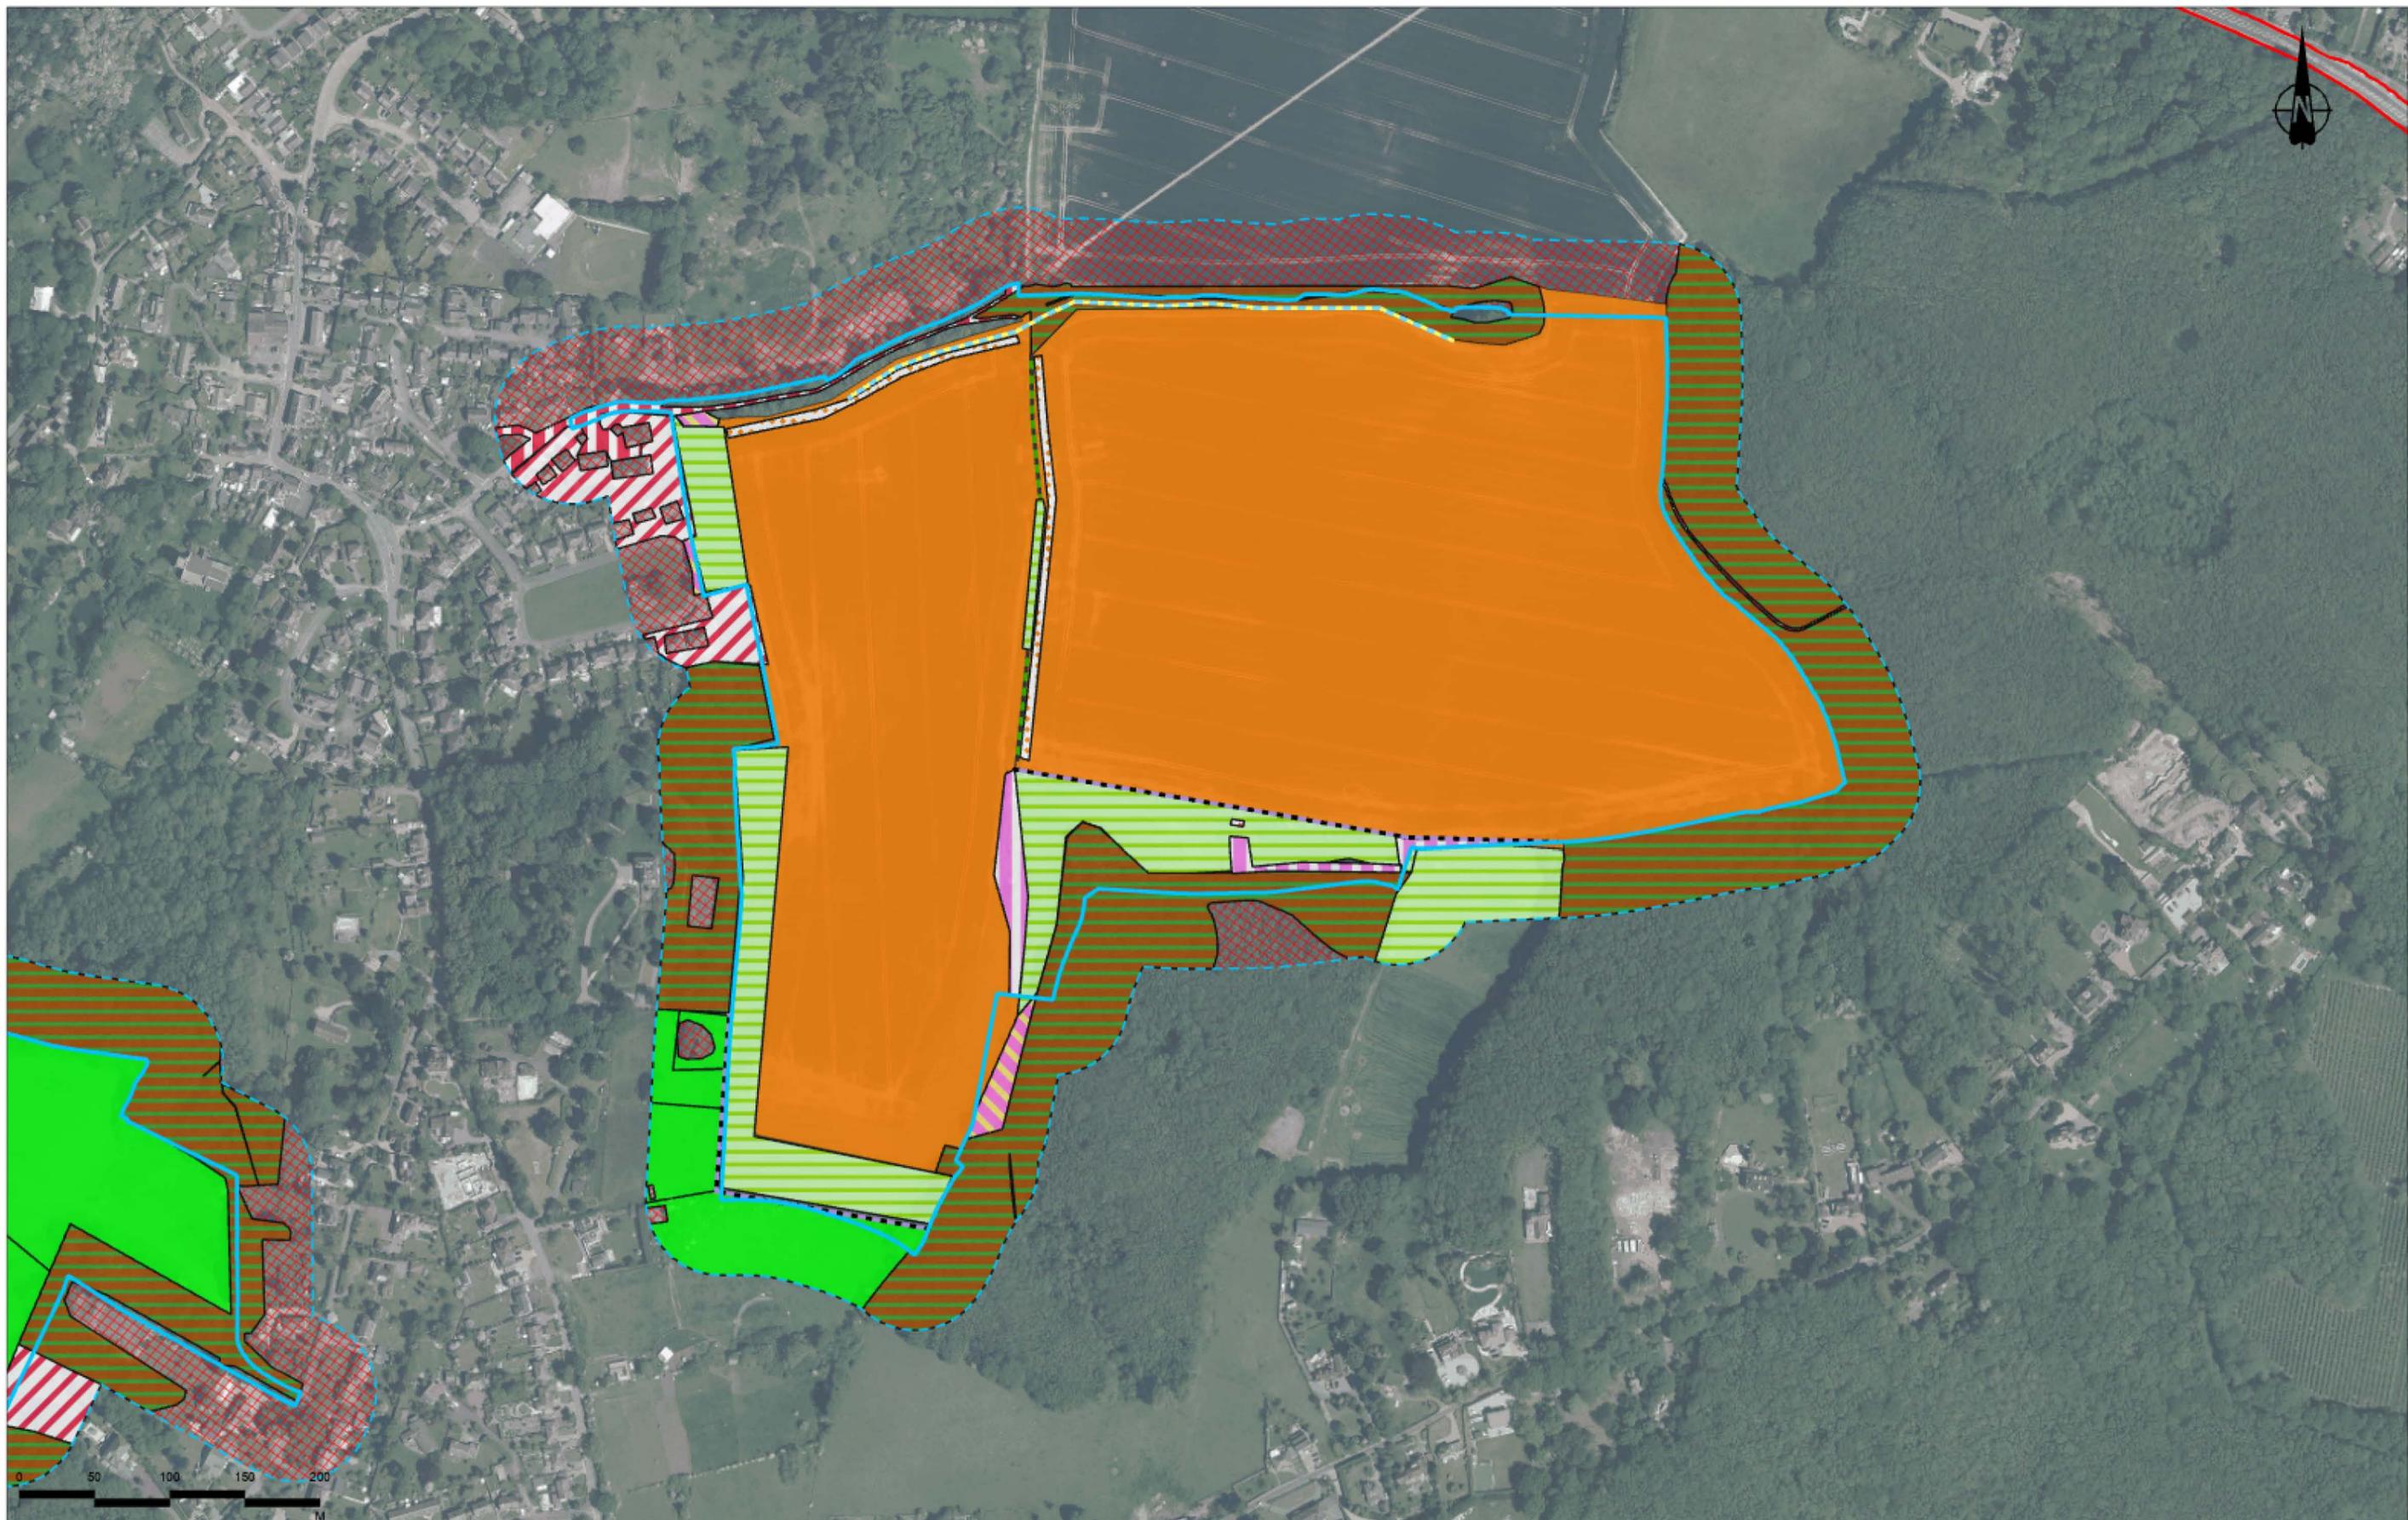
Status	DCO APPLICATION	Original Size	A3	Revision	1/02
Application Document Number	TR010032/APP/6.3	Scale	1:2,000		
Drawing Title	Figure 2 - UKHab of N Dep Compensation Sites Site Name: MA03_D1 - Shorne and Ashenbank Woods Page 5 of 8				
Drawing Number	HE540039-CJV-EBD-SZP_EGNE00000000-DR-LE-60101

5.1.1 The UKhab habitat types for South of the River Thames compensation sites are outlined below. Some condition assessments are missing from the results due to access restrictions identified during the site visits and are labelled N/A. Where habitat types, such as cereal crops, have no condition assessment criteria within the Biodiversity Metric v3.1 guidance, these are also marked as N/A. The distribution of these habitats is provided in Figure 2 of this report. Figures show the habitats within the compensation sites, but also include the surrounding habitats within a 50m radius for better comprehension of the surrounding habitats. Further details pertaining the condition assessments for each habitat type are provided in Annex A of this report.

5.1.2 The UKHab habitat types for North of the River Thames compensation sites are outlined below. Some condition assessments are missing from the results due to access restrictions identified during the site visits and are labelled N/A. Where habitat types, such as cereal crops, have no condition assessment criteria within the Biodiversity Metric v3.1 guidance, these are also marked as N/A. The distribution of these habitats is provided in Figure 2 of this report. Figures show the habitats within the compensation sites, but also include the surrounding habitats within a 50m radius for better comprehension of the surrounding habitats. Further details pertaining the condition assessments for each habitat type are provided in Annex A of this report.
