Lower Thames Crossing

Appendix 6.16 - Historic Buildings Recording

1-2 Grays Corner Cottages

Historic Building Investigation and Recording

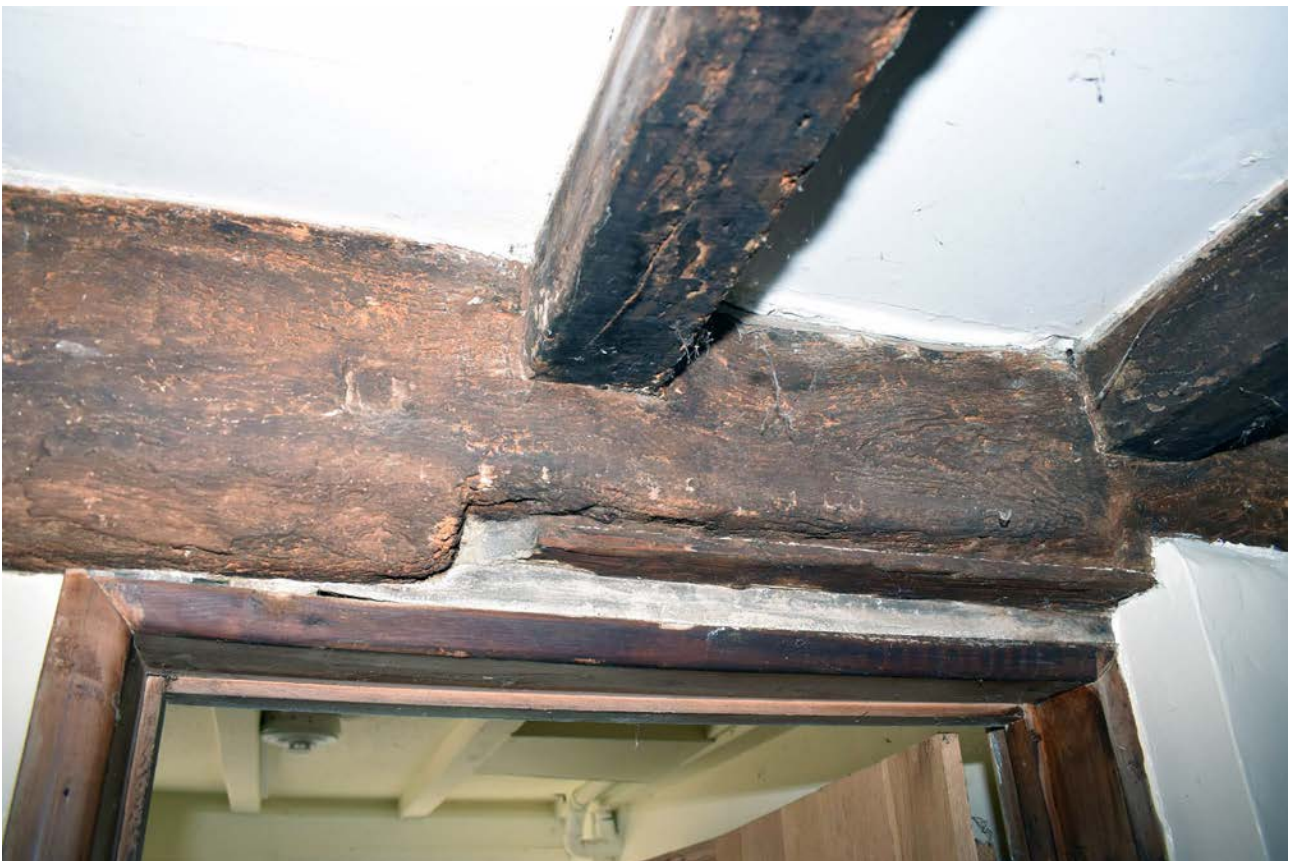
Plate 17: Principal joist in the hallway above the kitchen doorway

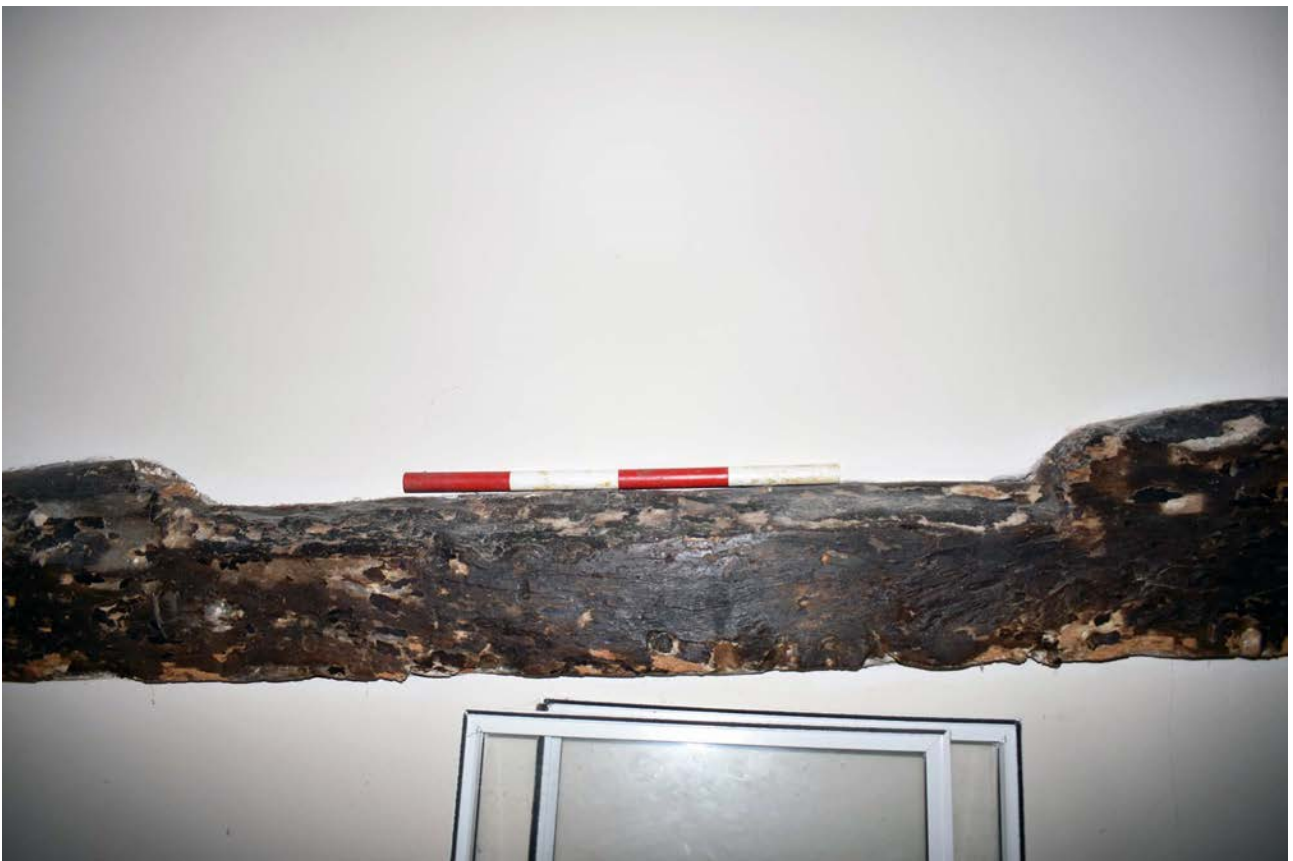
Plate 24: Indent on the tie beam of principal bedroom in The Thatches

- 3.3.16 **The principal bedroom** (plate 22) spans the full width of the east bay. A tie beam is visible on the east wall and has a large indent in the centre of its top side, possibly for seating a pair of braces (plate 23). On the north wall, the wall plate is exposed, as are the rafters and studs making up the dormer. The wall plate on the south wall is a modern replacement. The casements have curly tail swing fasteners and stays. The floor is carpeted and there are modern skirting boards.

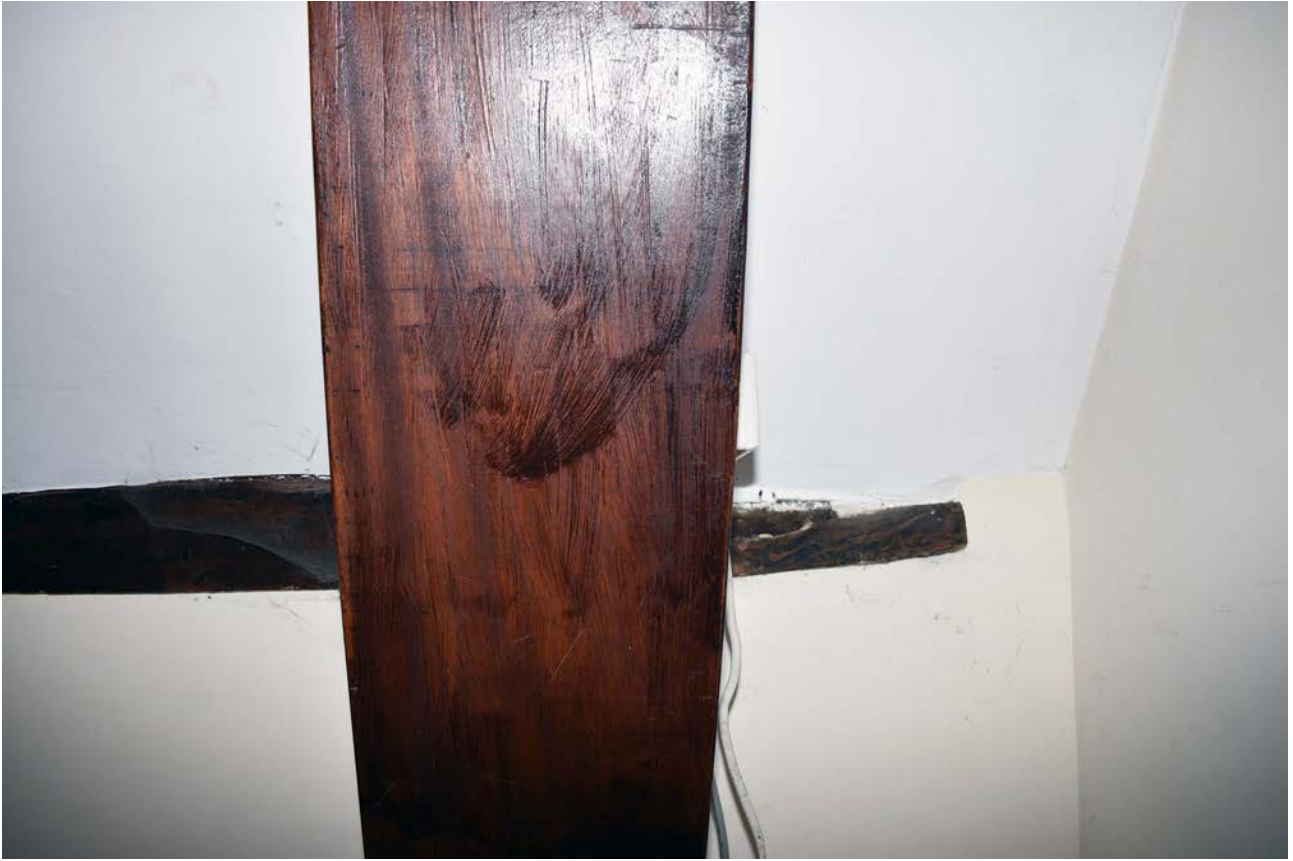
Plate 30: Encased timber and terminating wall plate in the south-west bedroom

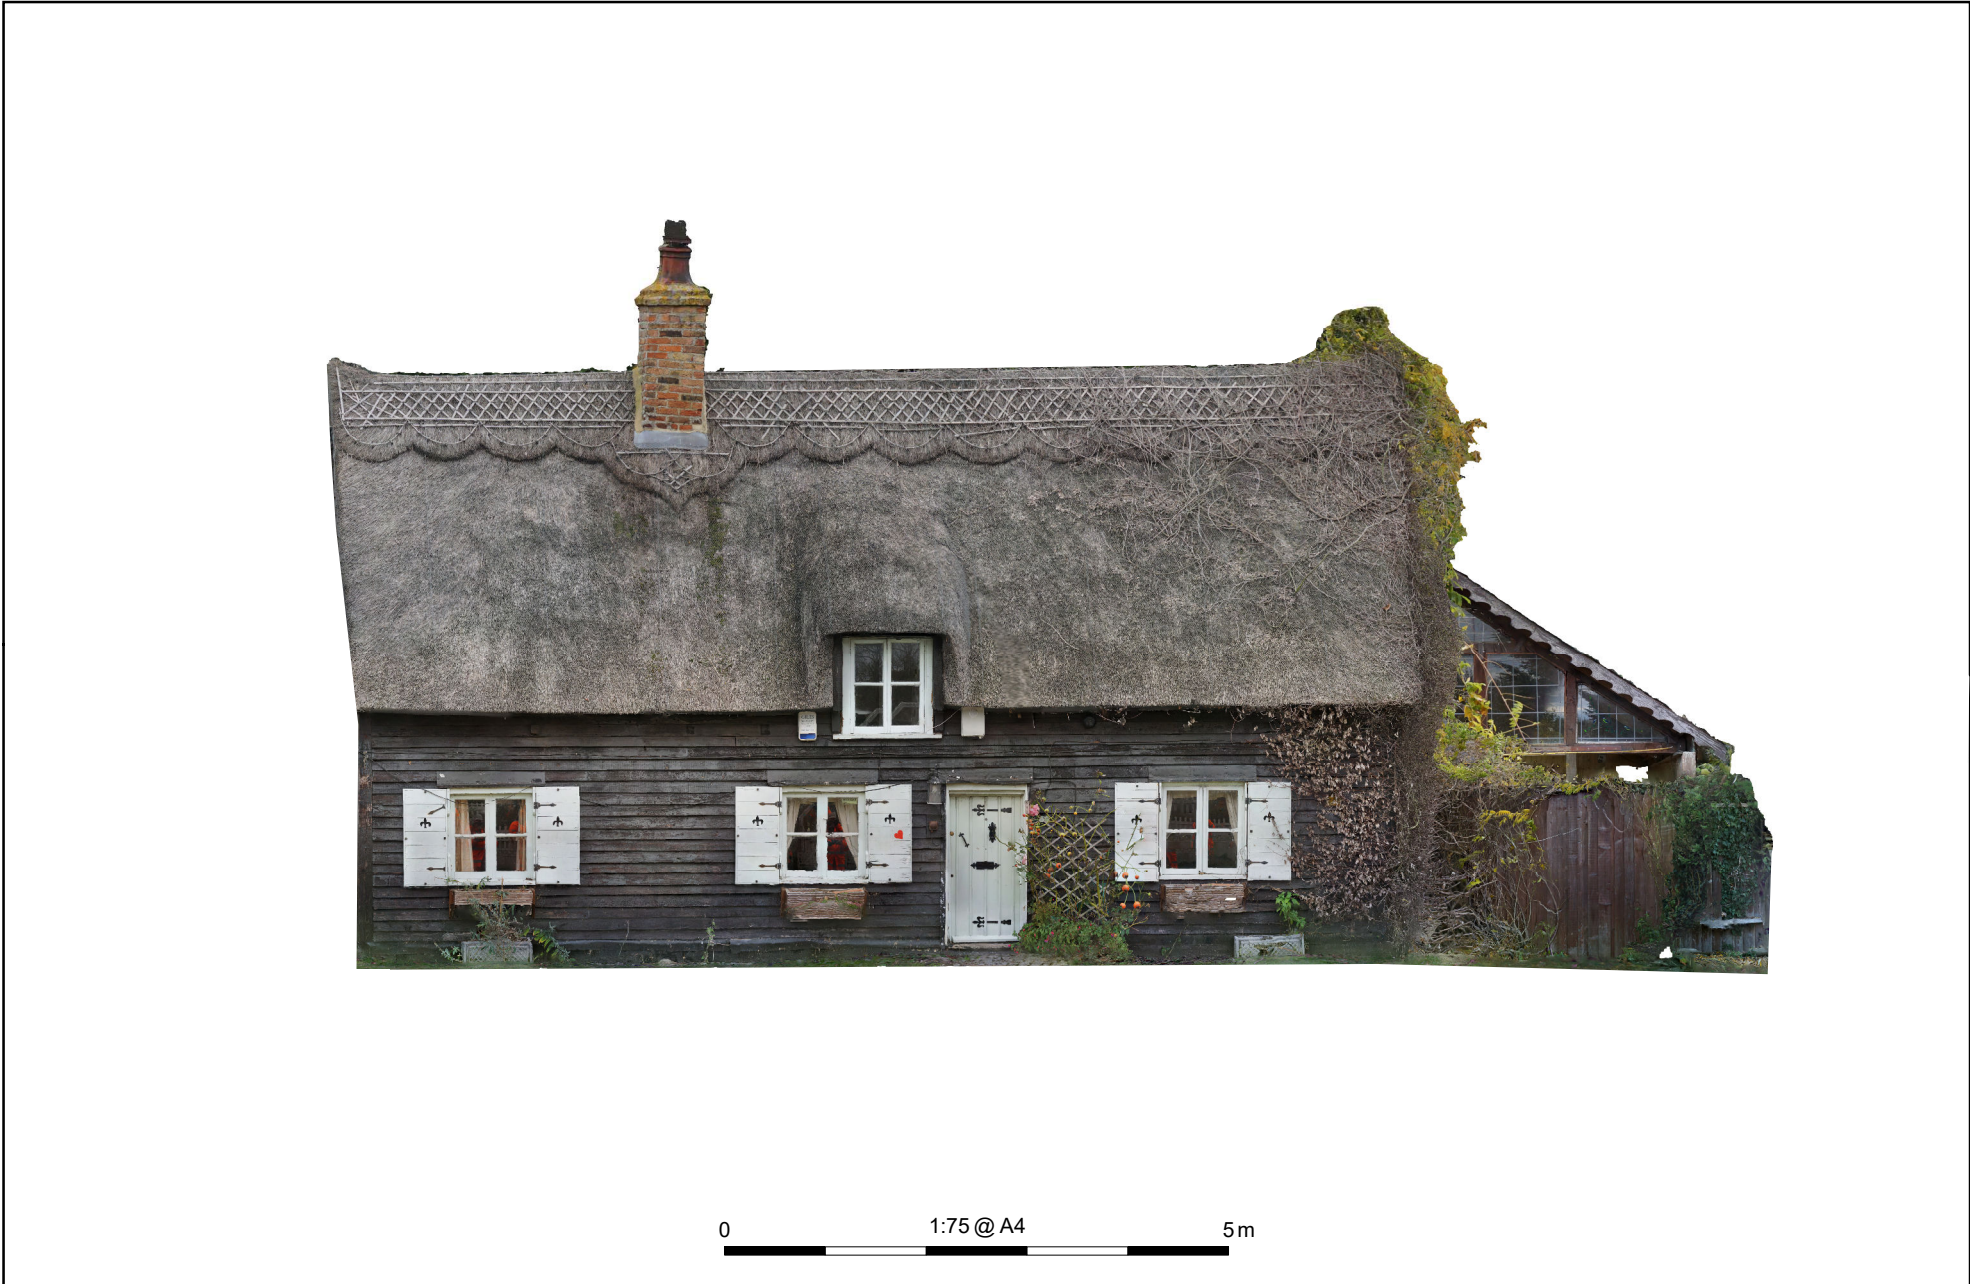
Figure 11: West elevation, Thatched Cottage

Produced using photogrammetry data collected by Oxford Archaeology (2021)

- 3.2.4 *The west elevation* is the main façade of the building (Fig. 11) and incorporates three 19th century casement windows at ground floor as well as a doorway to the south side of centre. The windows are casements with two 2-pane lights, and feature rustic boarded shutters with fleur-de-lis motif strap hinges. The front door is made up of vertical boards with applied mouldings to the joints and fleur-de-lis strap hinges, as well as fleur-de-lis to the handle and letter box. The door has horizontal braces to the inner side. All joinery is modern and painted white. A rectangular brown wooden planter hangs under each of the windows. Additionally, under the outer windows, there are plastic planters in grey colour with flowers at each window. There is a wooden trellis panel between the entrance door and the south window of the façade. In the central bay is an eyebrow dormer window. It is a casement like those on the ground floor but slightly larger and painted white. The house sits on what is probably a brick plinth, but this has been covered over with plaster and painted black. There are no rafter feet beneath the thatched eaves. The boards and lintels over the windows have lead sheeting applied and are painted black, matching the walls of the building (Plate 2).

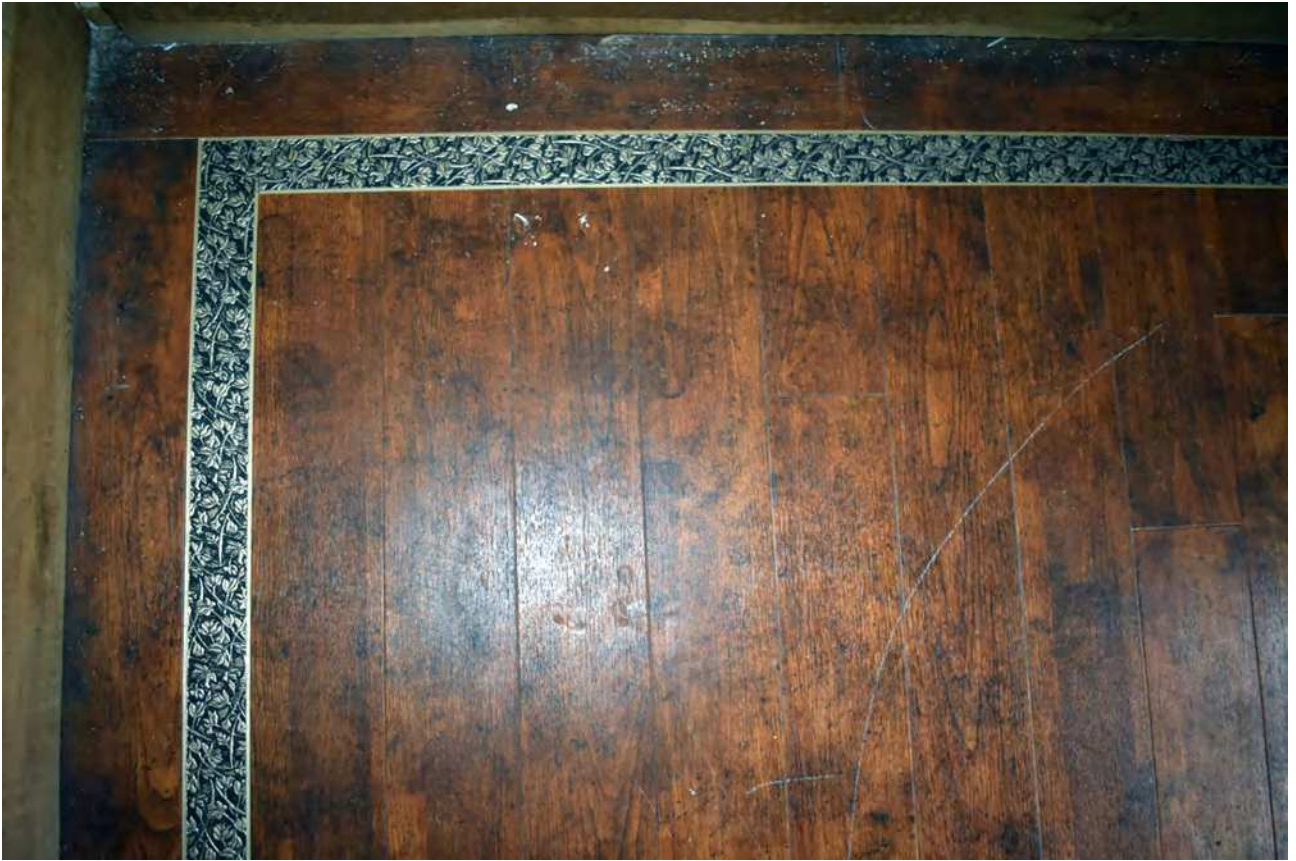
Plate 96: Extension, north bay, detail of the floor

- 3.3.44 Like the central and south bays, it is open to apex and its structure is the same. It has stained glass windows and the collar on the north and south sides. It has large, plain skirting over the tongue and groove paneling and modern, brown boarded floor with a floral border (Plate 93, 94 95, 96).
