Hole Farm Community Woodland, B186 Great Warley Street, Road Safety Audit Stage 1

Road Safety Audit – Stage 1

Document no: B2428401.LT.00-50 - Stage 1 RSA
Version: P03

Hole Farm Community Woodland
B186, Great Warley Street

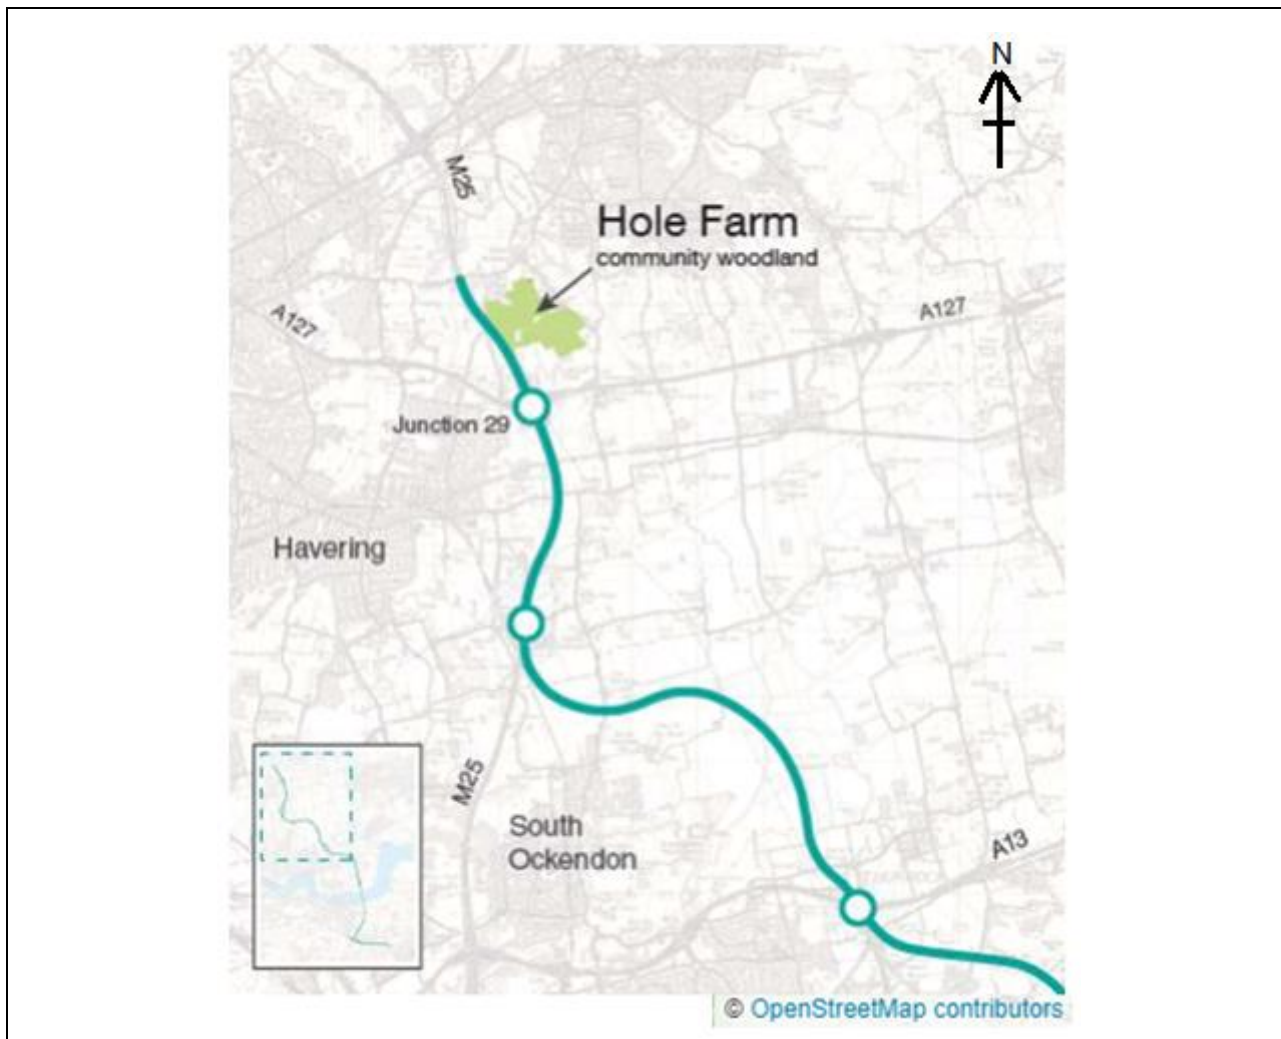
Figure 1. Location overview plan of this Audit.

The proposed access to the car park is placed on B186 Great Warley Street, an uphill gradient driving northbound and a 40mph mandatory speed limit. The proposed access to the car park is a Simple Priority Junction.

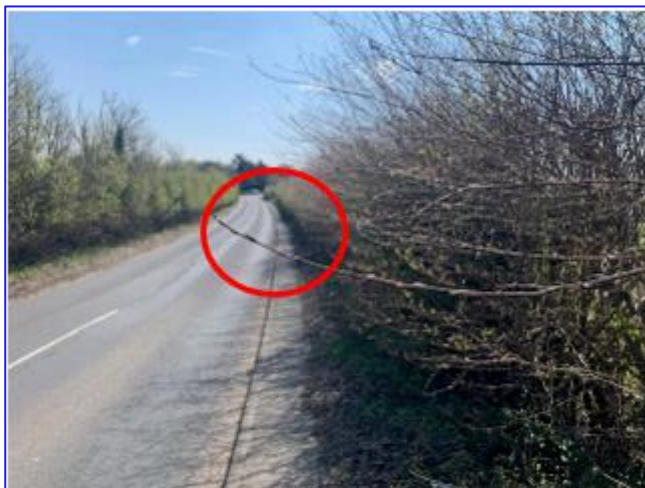
Problem 3.2

Location: Proposed new access off Great Warley Street.

Summary: Insufficient visibility of junction from the south.

Although the Hole-Farm_Highways.002.3 drawing identifies the extents over which the vegetation is to be cut back, on site observations confirmed a difference in vertical alignment and potential vehicle speeds, which raised concerns that the length of vegetation to be cut back for vehicles exiting the car park access would be insufficient. There is a risk that traffic emerging from the junction is obscured by vegetation and is not seen in sufficient time by vehicles travelling northbound along Great Warley Street. This could lead to emerging vehicles being struck by northbound vehicles, leading to potential serious injuries for vehicle occupants.

Figure 3. Image showing the limited visibility of the proposed junction from the south.

Recommendation: Ensure that the appropriate Stopping Sight Distance (SSD) in both directions along Great Warley Street, as indicated on the Hole-Farm_Highways.003.2 drawing, can be achieved and where required, the design is revised to take account of the change in vertical alignment and potential higher vehicle speeds travelling along Great Warley Street.
