Hole Farm Woodland Creation Project

Bat Survey Report (November 2022)

Hole Farm, Great Warley

Bat Survey Report

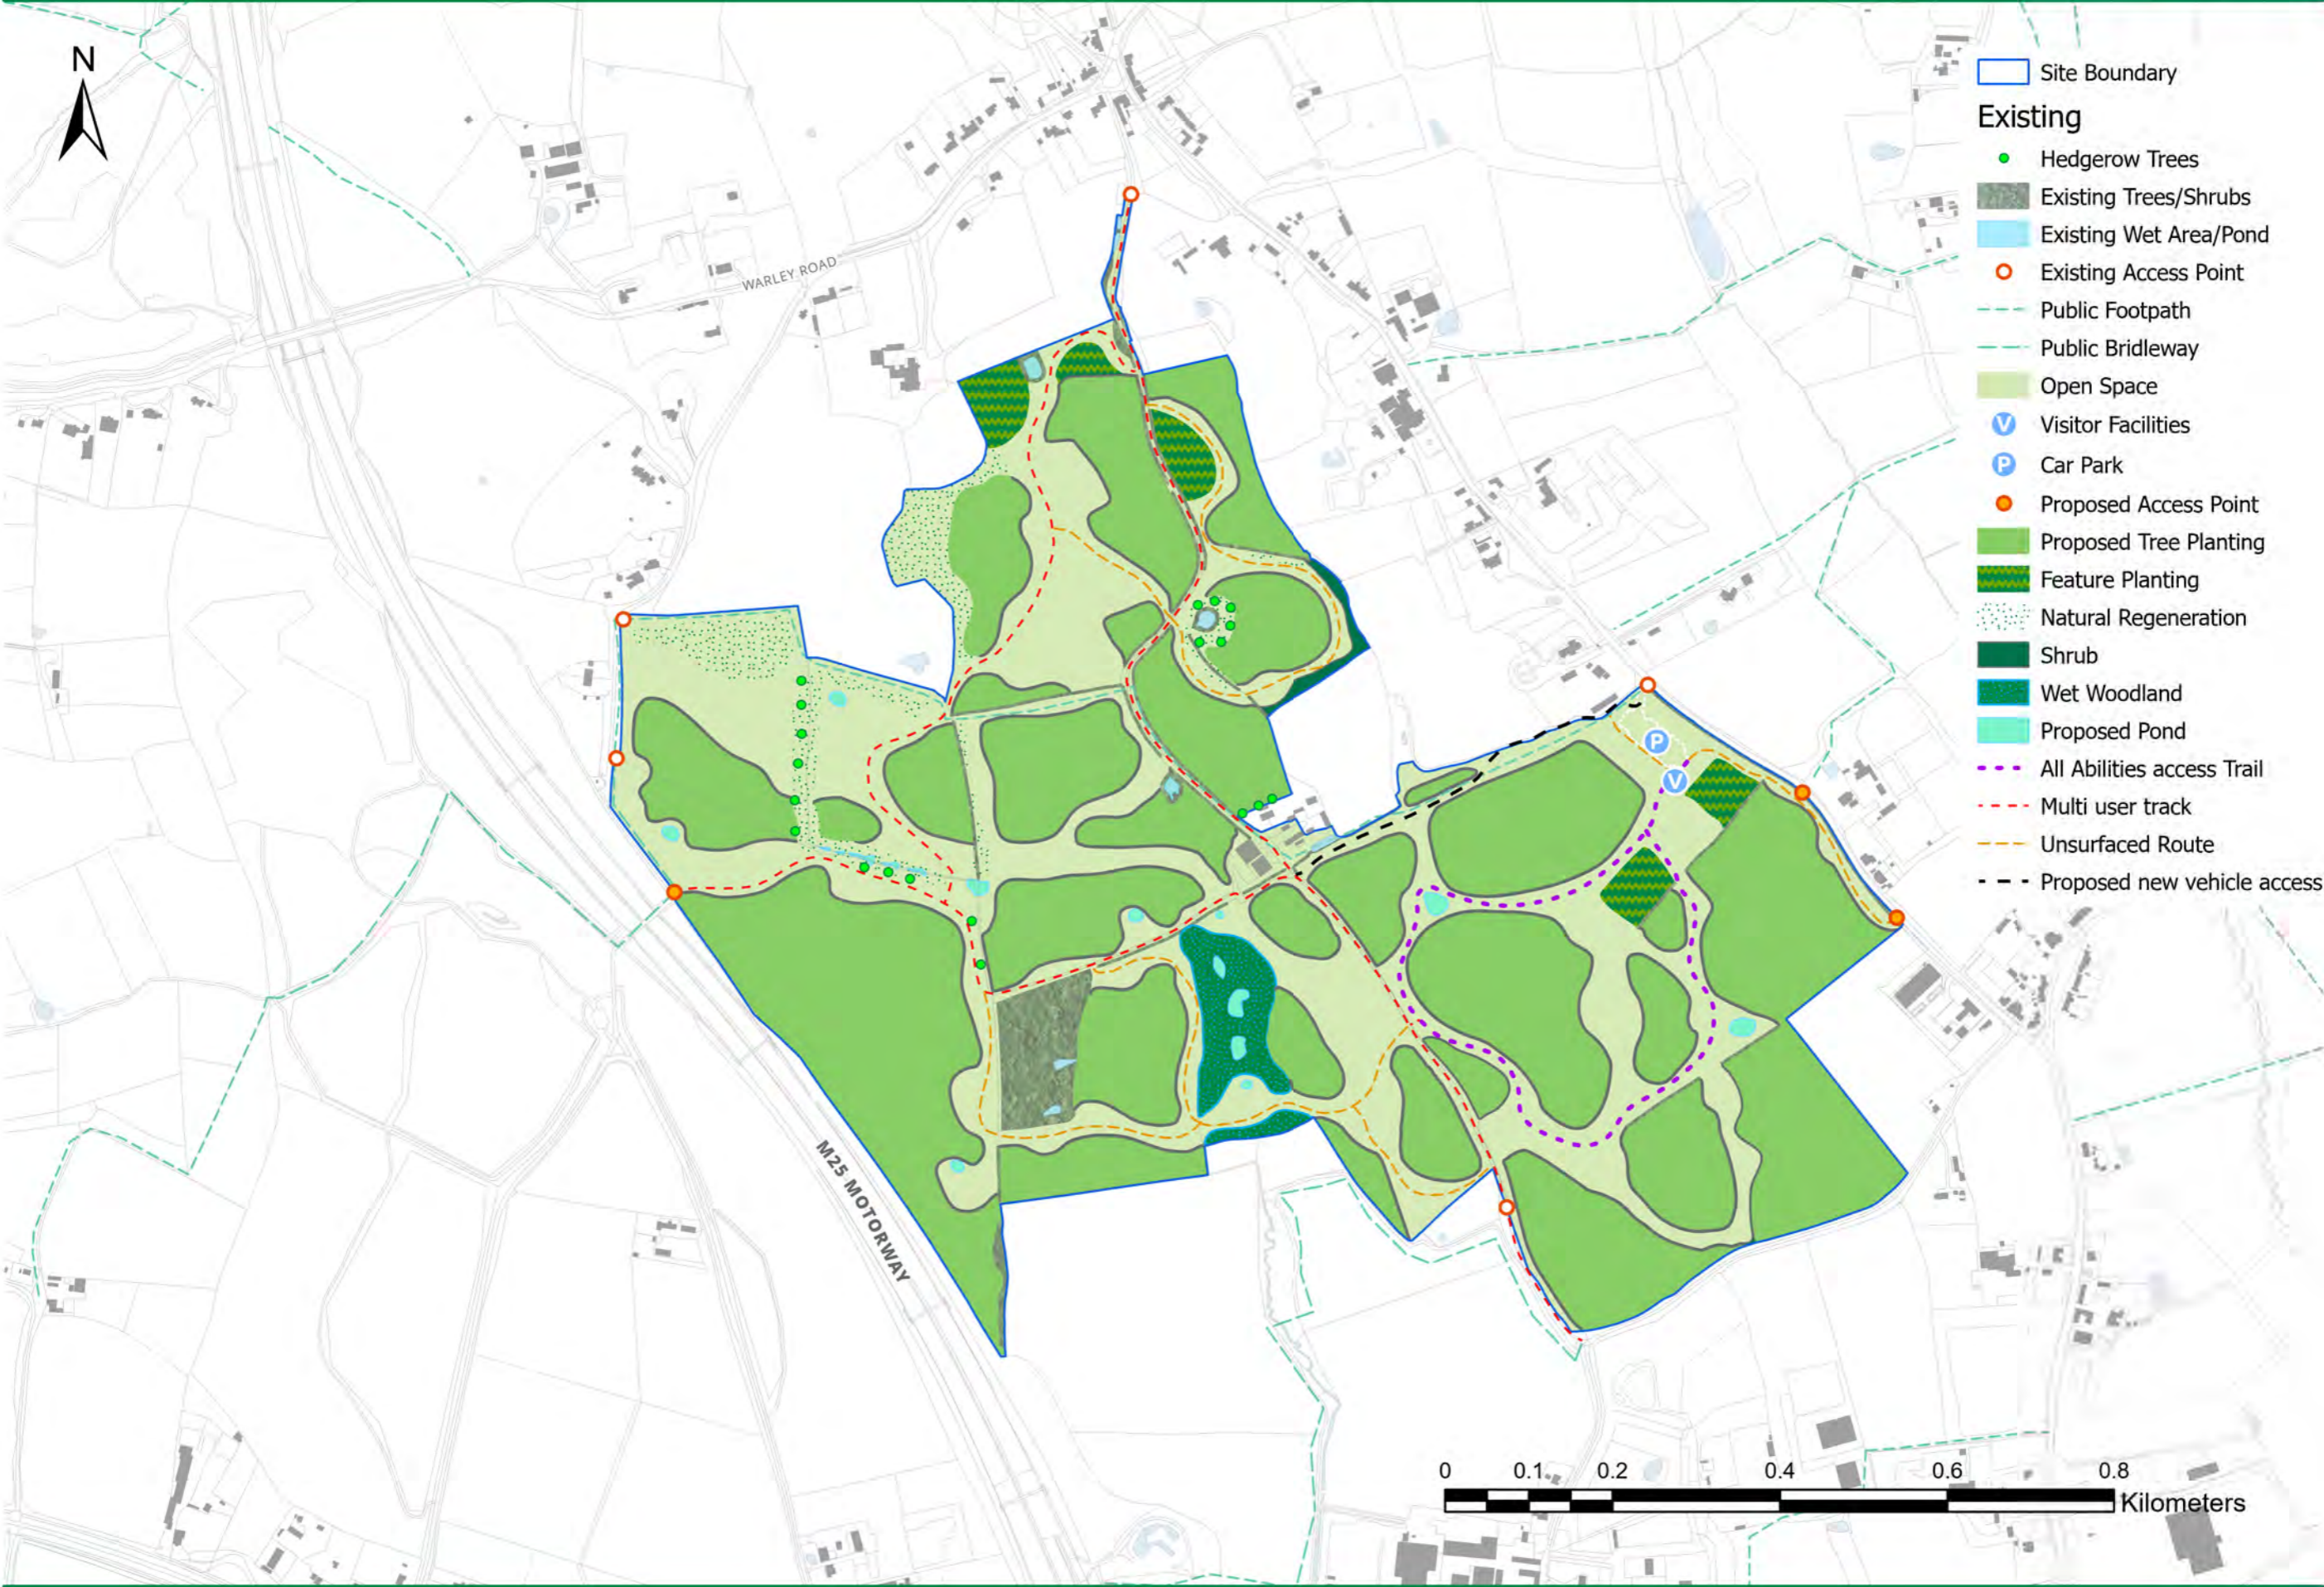
Figure A-2 - Landscape Concept Plan

- 1.7. Approximately 70% of the Site equating to approximately 67 hectares is proposed for planting resulting in the change in land use of 100% of the arable habitat. The woodland will be predominantly broadleaf in nature and made up of a range of species carefully selected for their resilience and adaptability to tree pests and diseases and climate change and designed to complement the landscape character of the locality. The planting scheme design will be informed by the ecological surveys undertaken to date and any subsequent mitigation that is recommended. The aim of the initiative is to create a multi-purpose woodland that provides bigger, better and more connected wildlife-rich habitats and provides opportunities for people to connect with nature and improve health and wellbeing. Details of the Scheme are shown on Figure A-2 in Appendix A.

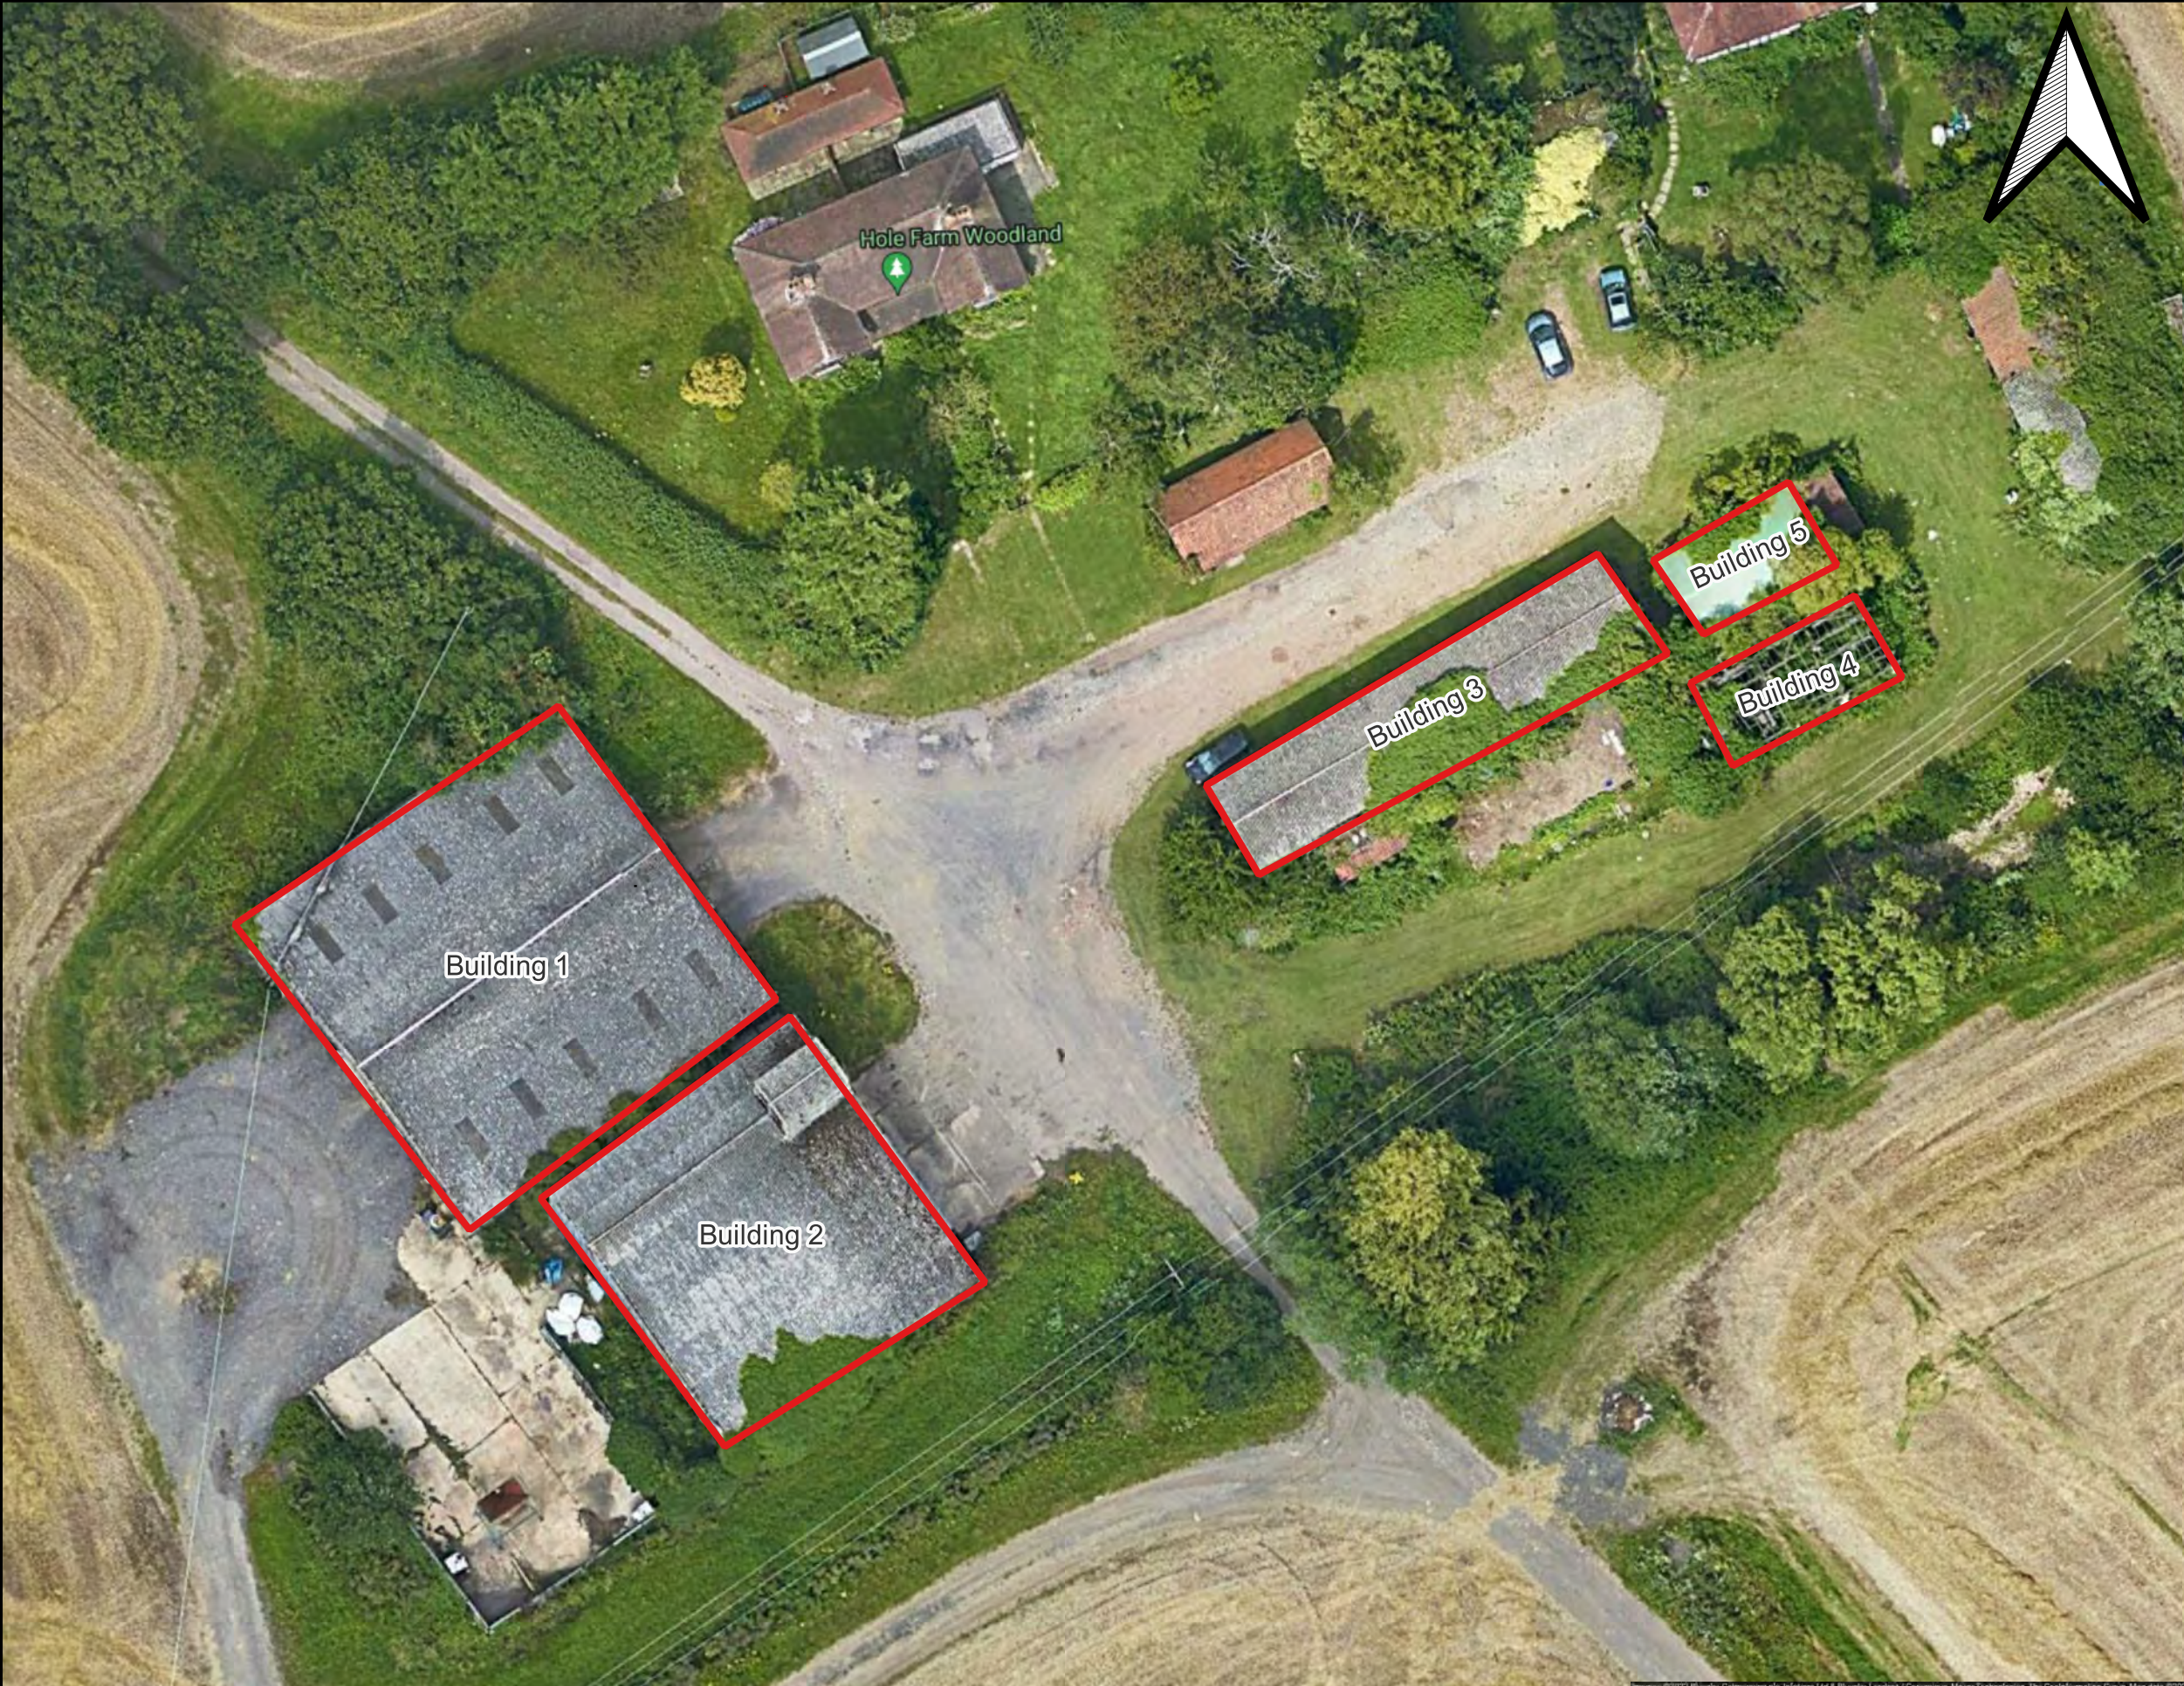
Figure A-3 – Original Building Locations

- 2.6. Since the Sonar Ecology PEA report all of the buildings have been re-numbered by the client. Buildings 1, 2, 3, 4, and 5 (Figure A-3 in Appendix A), are now known as buildings 2, 1, 4, 6, and 7 respectively. A plan showing the building locations is shown in Figure A-4 in Appendix A.

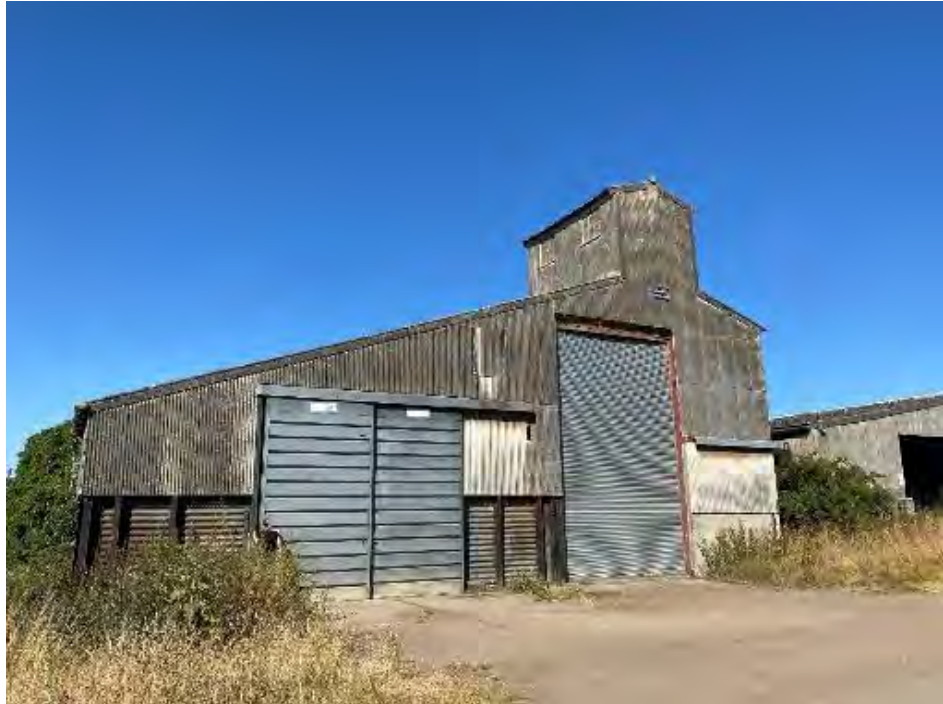
- 3.1. A pitched building constructed of a mixture of breeze blocks, metal panels, and asbestos panels, with a corrugated asbestos roof. Two large doors were slightly open on the eastern face of the building. The southern face of the building included dense ivy coverage.
- 3.2. Building 1 was assessed to have moderate potential to support roosting bats due to a number of gaps in the asbestos cladding and the soffit board, as well as openings in the doors on the eastern and north-eastern faces of the building.
- 3.3. No internal inspection was possible as the doors of this building were locked, and as such no evidence of roosting bats was identified.

An inaccessible large agricultural building that was found to support a day roost used by a single common pipistrelle bat (Confirmed roost). Building 2 is shown to the far right of the picture

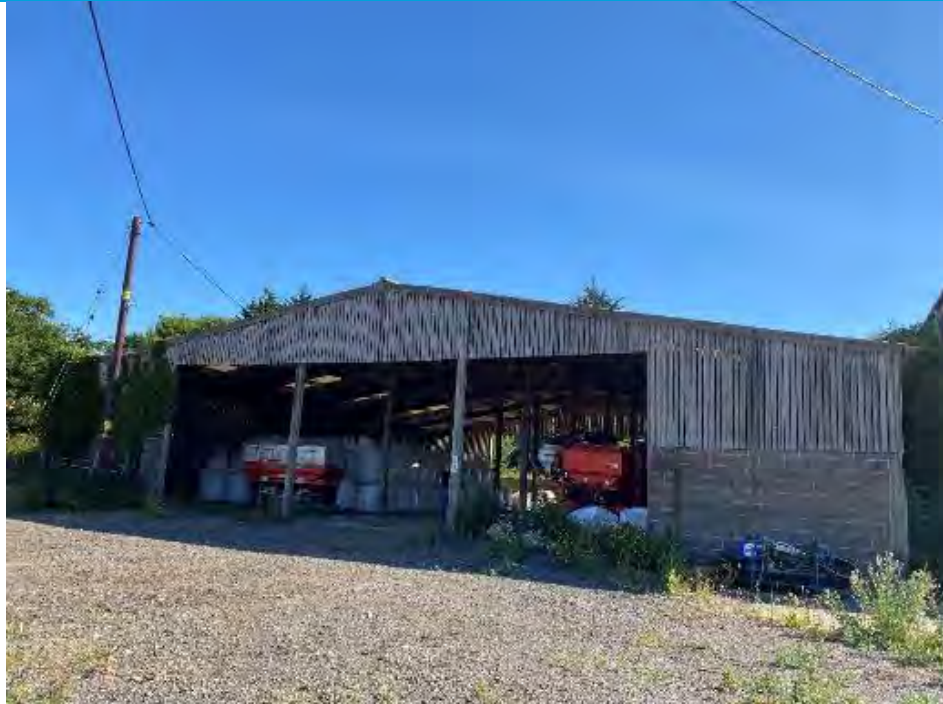
Building 2

- 3.4. Building 1 is a farm building constructed of breeze blocks to a height of three meters, and then wooden panelling above this, with a corrugated asbestos roof. The building is open on two sides (north-east and south-west) and has eight skylights in the roof. One internal corner includes dense ivy. There were a number of gaps in the wooden panelling that allow access into the building.
- 3.5. No roosting bats were observed during the inspection, and no signs of roosting bats were observed.
- 3.6. Building 1 was assessed to have low potential for small numbers of common species of crevice dwelling bats due to crevice features within the ivy and wooden panelling.

An open large agricultural building in use that was found to support a day roost used by two common pipistrelle bats (Confirmed roost)

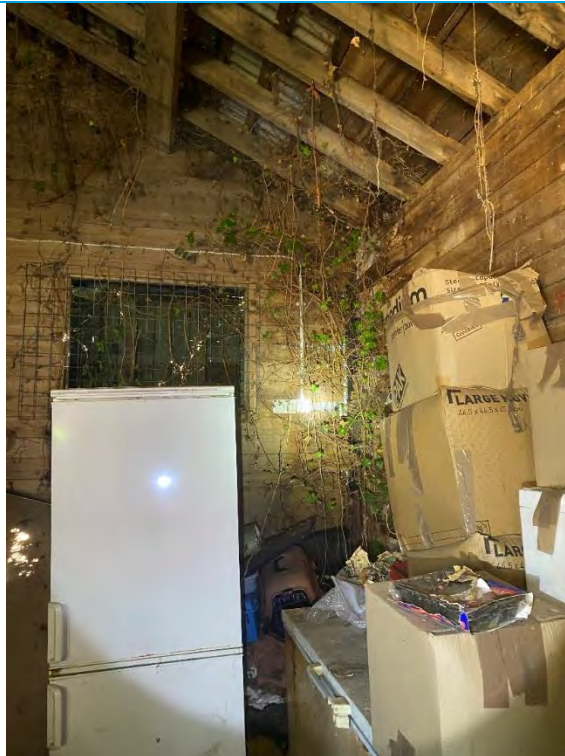
Building 6

- 3.9. A farm building constructed of brick and corrugated metal, with a corrugated asbestos roof. The building has a large window on the western side of the building, with two panes missing. There is dense ivy on the western side of the building.
- 3.10. There are a number of gaps between the wooden soffit and the asbestos roof, as well as an open door on the northern side of the building, that provides access to the building.
- 3.11. A number of bat droppings, and some feeding remains, were found within the building, confirming it as a roost. There were insufficient droppings to undertake DNA analysis, but they appeared to be from a long-eared bat.

A largely wooden building used for storage adjacent to building 4 that contained evidence of use as a feeding perch for brown long-eared bat (Confirmed roost)
