Hole Farm Woodland Creation Project

Archaeological Desk-based Assessment (April 2023)

Hole Farm, Great Warley Archaeological Desk-based Assessment

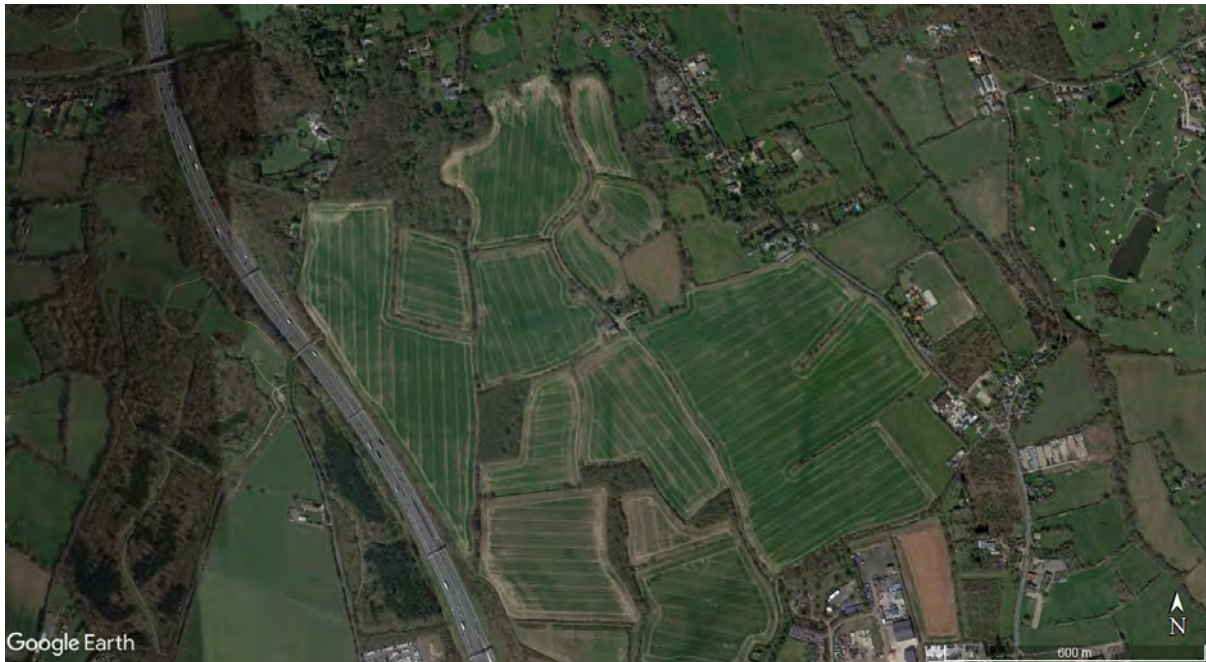
Figure 2 - Aerial view of site 2022. © Google Earth.

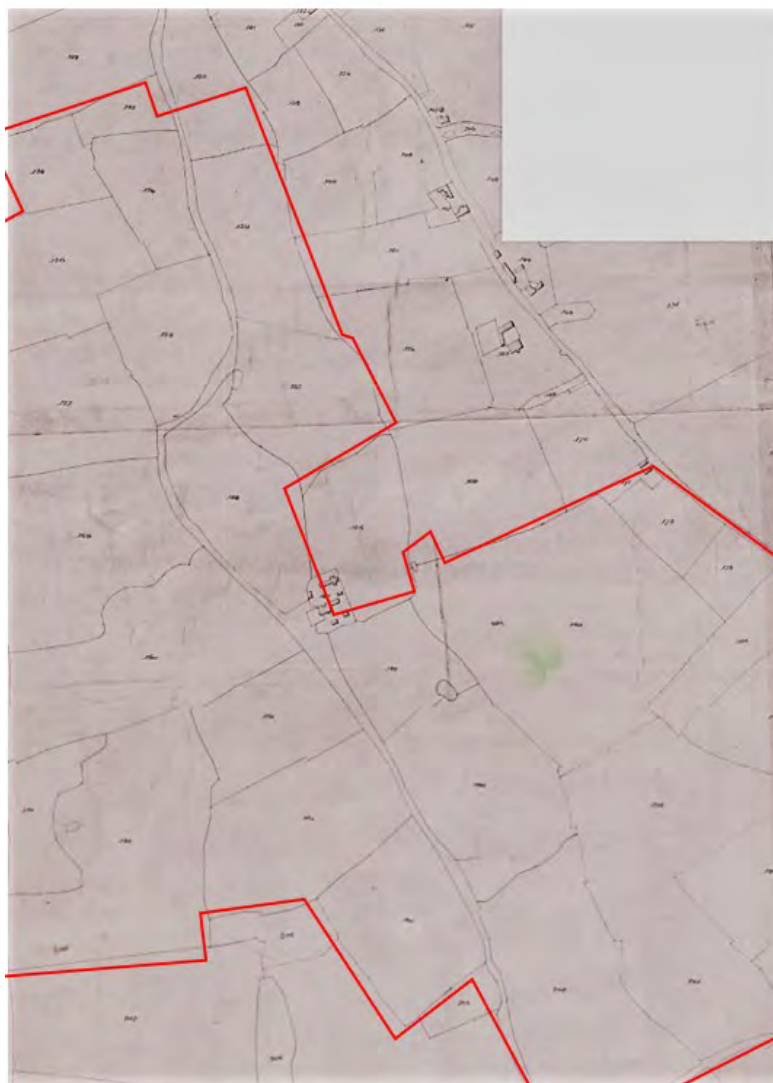
Figure 7 Great Warley Tithe Map 1837 © TheGenealogist

- 3.3.21 The tithe map, dating from 1837 (Figure 7), shows that the Site is located within the historic parish of Great Warley. Much of the Site was owned by Edward Thomas and Richard Chambers as part of 'Holy Farm' comprising meadows, plantation, the homestead and further acres. 'Holy Farm', now Hole Farm, had several buildings and outbuildings at this time forming a large homestead-farm complex. The tithe map shows a fieldscape of irregular enclosure but with a slight linear pattern mimicking the nearby linear parish forms of Little Warley, Childerditch and West Horndon, originally early medieval in date. The homesteads and farmsteads of Goldings and Warley Elms are evident lining Great Warley Street (EHER 27349, LUID 1297230). The historic routeway, which linked Great Warley to Hole Farm and further south to Latchets Shaw, was located to the west of the farm with a green in front of it. Properties are located on the road frontage of Great Warley Street just inside the Site.

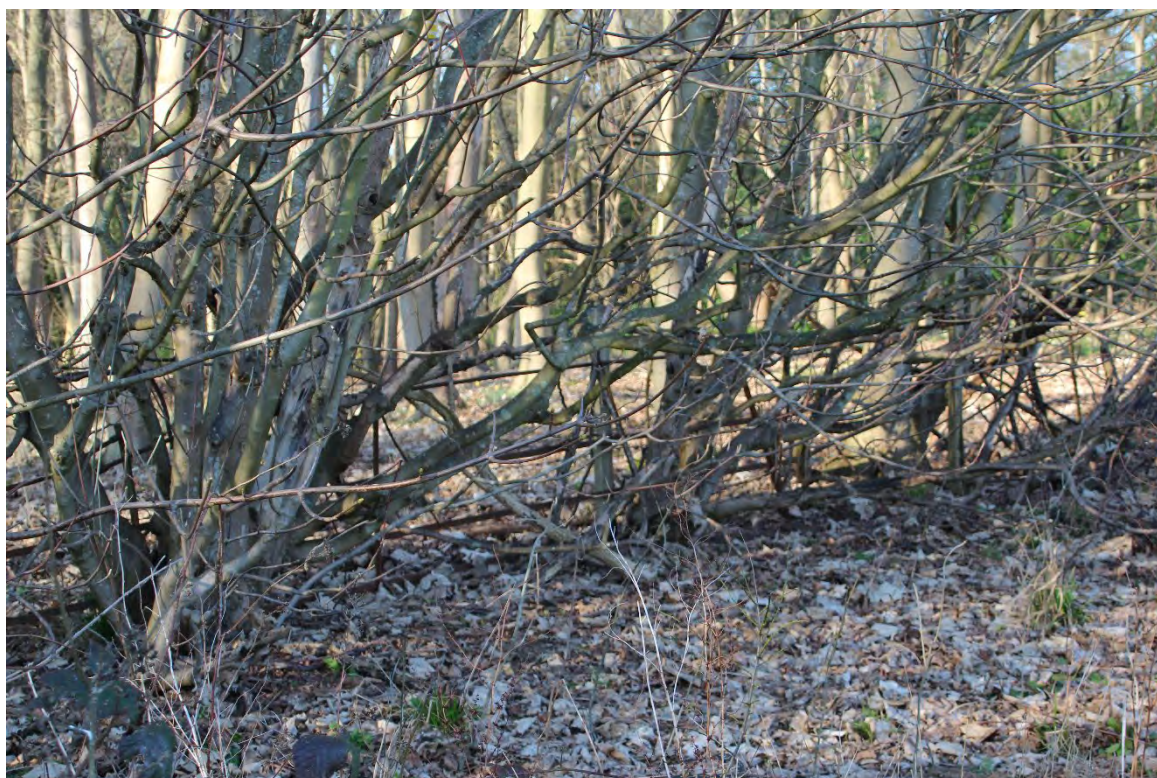
Figure 12 Metal fencing, potentially nineteenth century in date, relating to the woodland pasture/parkland in the northern part of the Site

- 4.5 On the northern and eastern edges of the Site there are two areas of informal historic parkland of 18th or 19th century date, created by the removal of hedgerows and the retention of standard trees (Figure 12).

- 4.6 Potential elements of this woodland pasture/parkland still survive with metal fencing still present on some areas with the boundary with Coombe Wood

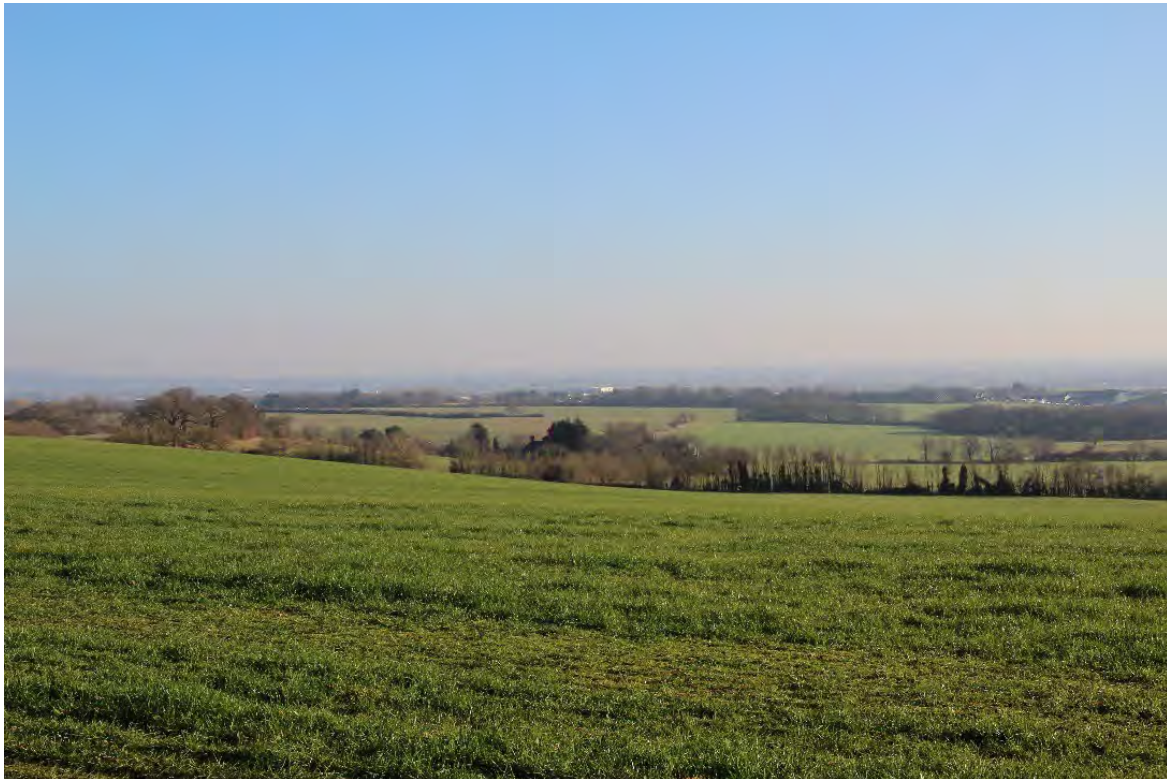
- 5.2 The Site is largely bounded by trees and hedgerows which form former or current field boundaries. This is only interrupted by an area of the M25 to the west, where the replacement boundary is extant but juvenile in nature, and to the southeast where a modern field boundary exists.
- 5.3 The land across the Site comprises a natural incline sloping upwards towards the northwest and Great Warley in the north. It slopes southwards towards Parkers Shaw and other areas of historic woodland outside of the Site (Figure 11).
- 5.4 The ground across the Site comprises a natural incline sloping downwards towards the south and west. The Site comprises largely agricultural land and has been

consistently so since at least the eighteenth century, and probably since the medieval period.

Figure 14 – View 1, looking South from the northern boundary of the Site

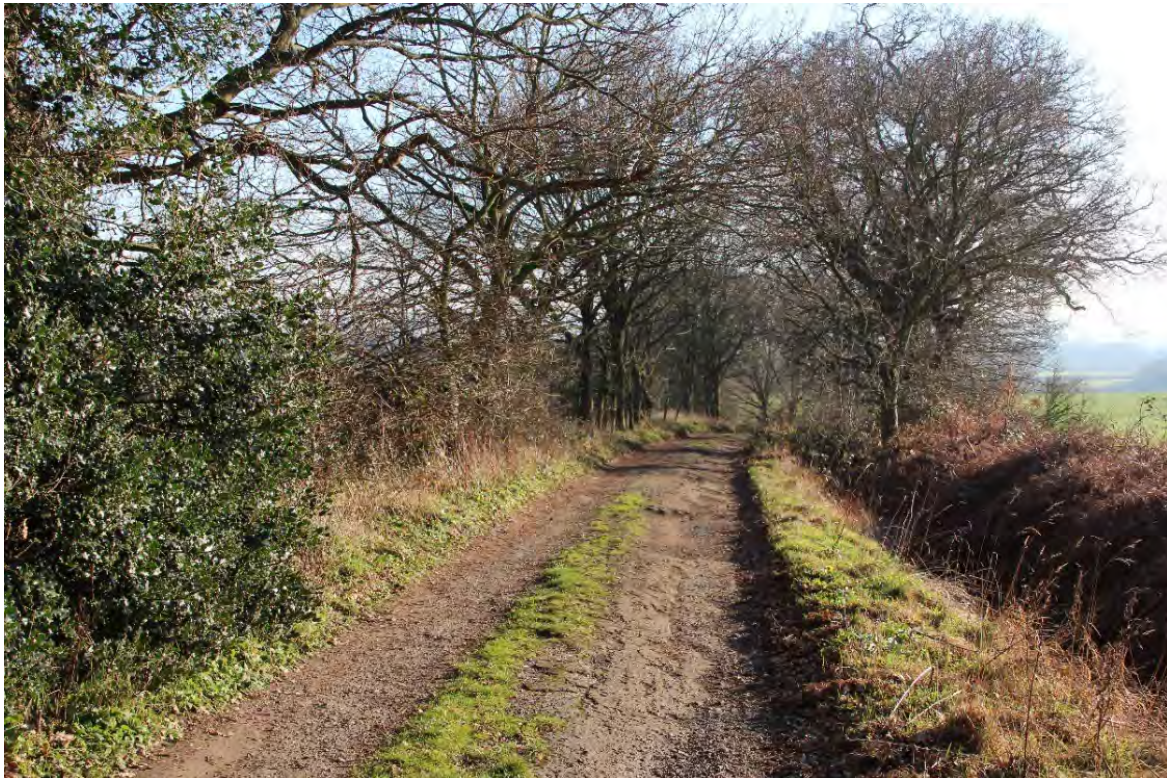
Figure 15 – View 2, Hole Farm Lane looking south towards the farm complex

- 5.5 An access road for Hole Farm, from Warley Road in the north traversing the Site to Codham Hall Lane in the south, has been extant since at least 1840, but if the date of Hole Farm is correct this is likely to be significantly older. The road is a private access to the farm and although tarmacked has probably changed very little since its original construction. It has ditches and hedges surviving along its length which are potentially related to its original construction (Figure 15).

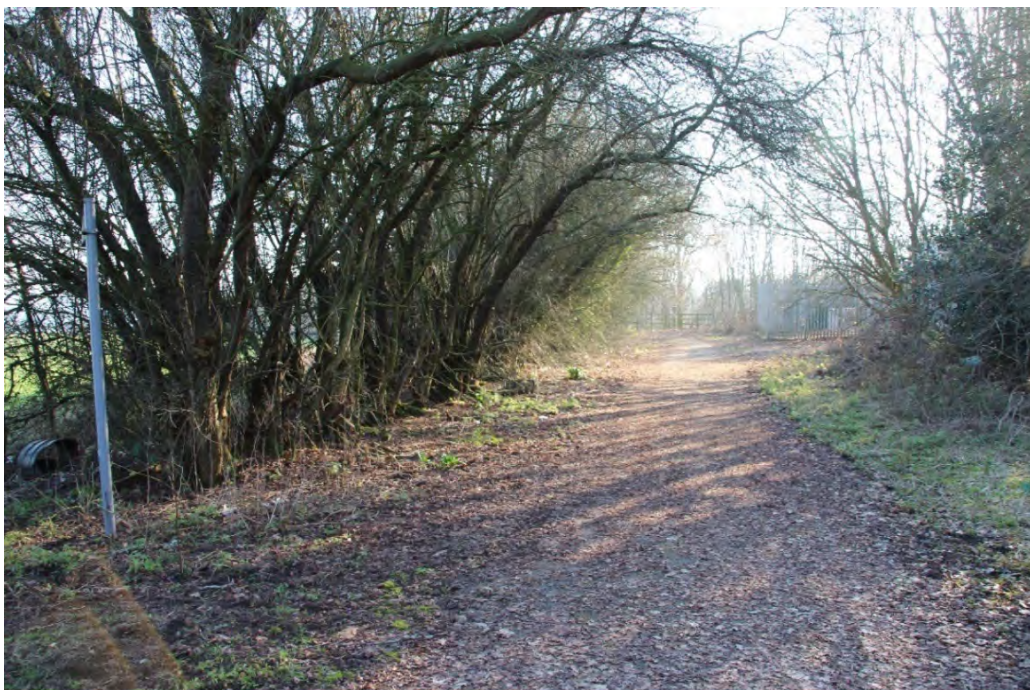
Figure 16 View 3 Grown out coppiced hedge on edge of Beredens Lane

5.6 The north western part of the Site abuts the historic Beredens Lane which led to Beredens Farm from Warley, now a dead end road and track cut by the M25. Coppiced hedges are visible on the road edge (Figure 16).

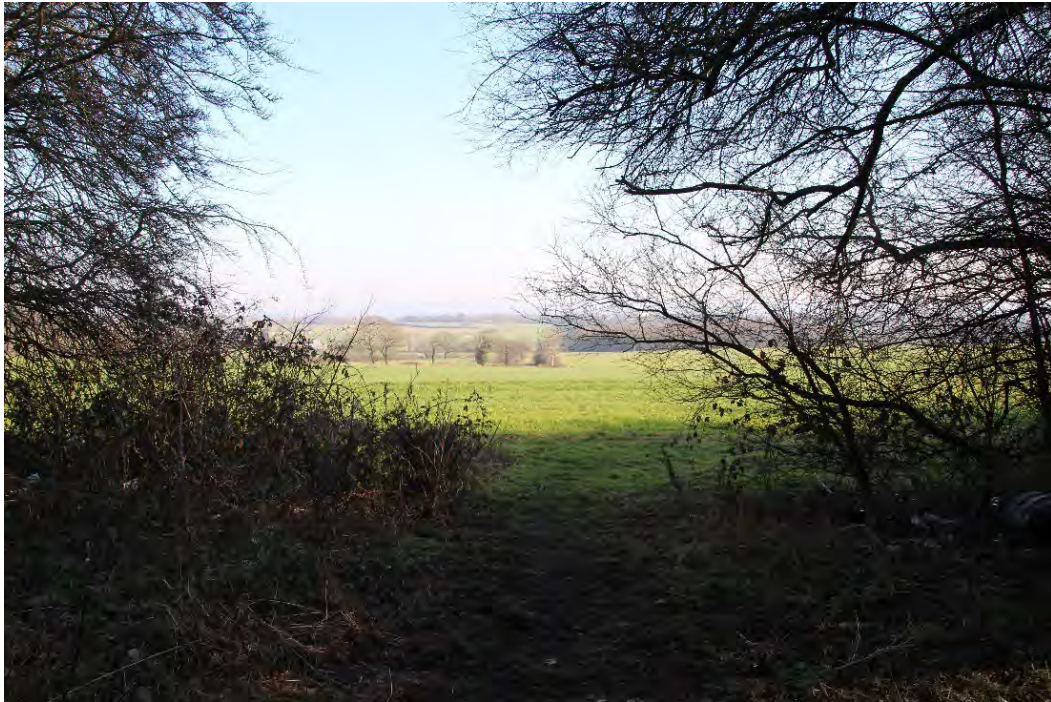
Figure 17 View 4 from Beredens Lane looking along historic route down to corner of hedge in centre of photo

The western section of the footpath, linking the former Beredens farmstead with Hole Farm and Warley Elms, is still in existence with the position of the access to Beredens Lane still present in the hedge (Figure 17).

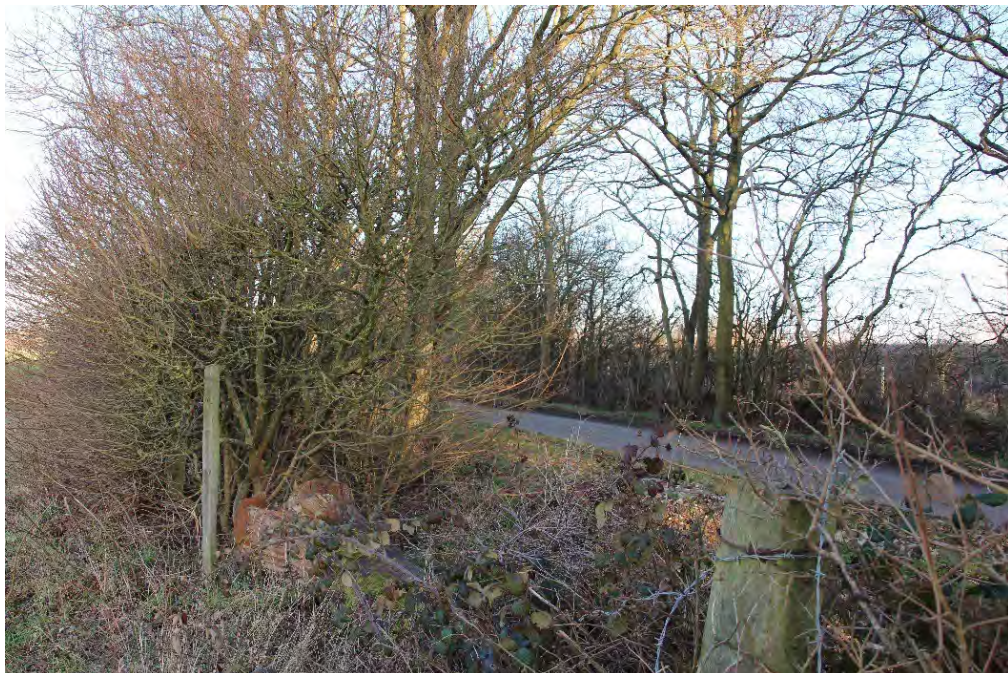
- 5.7 The southern boundary of the Site abuts the historic lane of Cobham Hall Lane which historically led to Cobham Hall.

Figure 18 View 5, onto Cobham Hall Lane looking SE from the Site

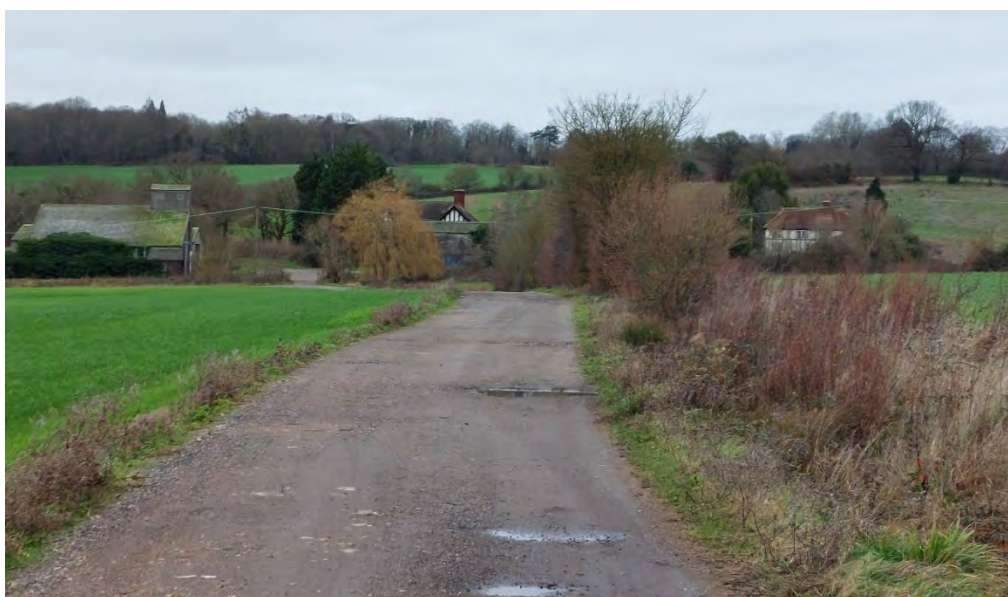
Figure 19 View 6, Hole Farm looking north-west along Hole Farm Lane

- 5.8 Hole Farm lies at a low point within the landscape with land from all sides sloping towards the farm complex (Figure 19).
- 5.9 The historic part of Hole Farm is visible just outside of the Site boundaries (right hand side of Figure 19 along with the listed farmhouse of Hole Farm (LUID1250606). The complex retains some of the mid nineteenth century buildings that formerly made up the historic farmstead. The buildings within the Site (Left hand side of Fig 19) date to the late twentieth century.

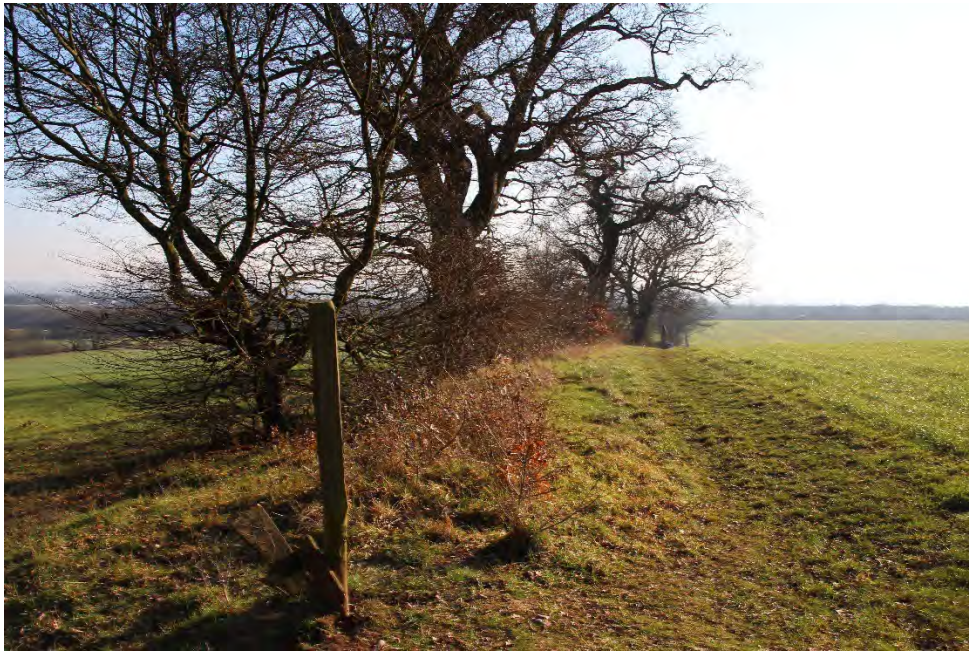
Figure 20 View 7 Lynchet looking south from Combe Wood

- 5.10 The majority of the fields within the Site are under agricultural production apart from one which has been planted already. In general the Site comprises a very rolling landscape. All fields slope gently with those around Hole Farm sloping towards the farm and those to the south of the Site sloping south eastwards to the M25 and A127 (Fig 13).
- 5.11 A number of fields within the northern part of the Site retain lynchets some with old pollards within the hedge line (Figures 20 and 21).

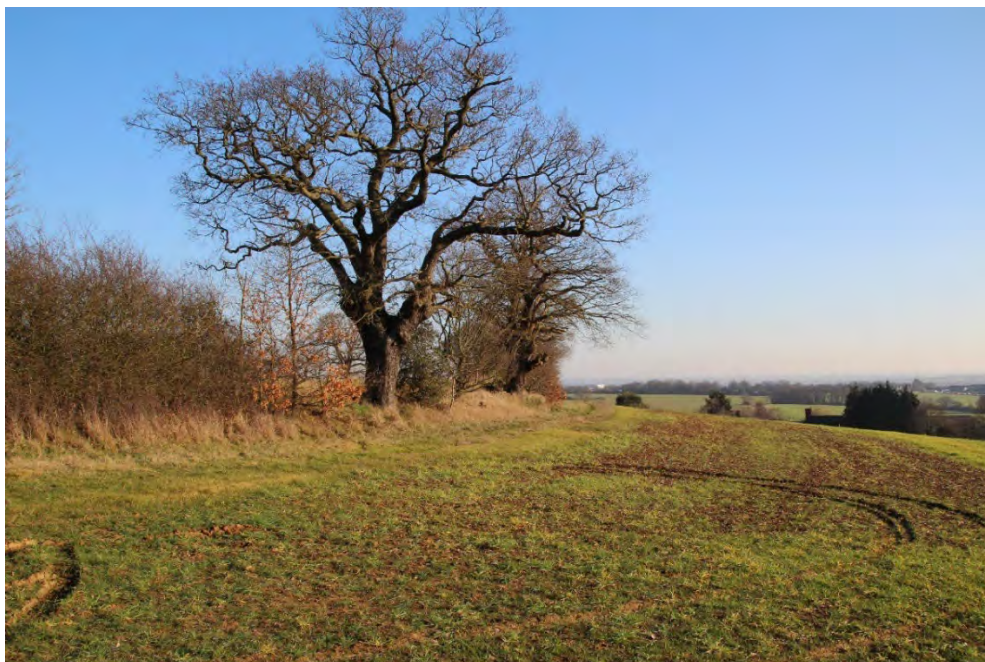
Figure 21 View 8 Old pollards sitting on lynchet to north of Hole Farm

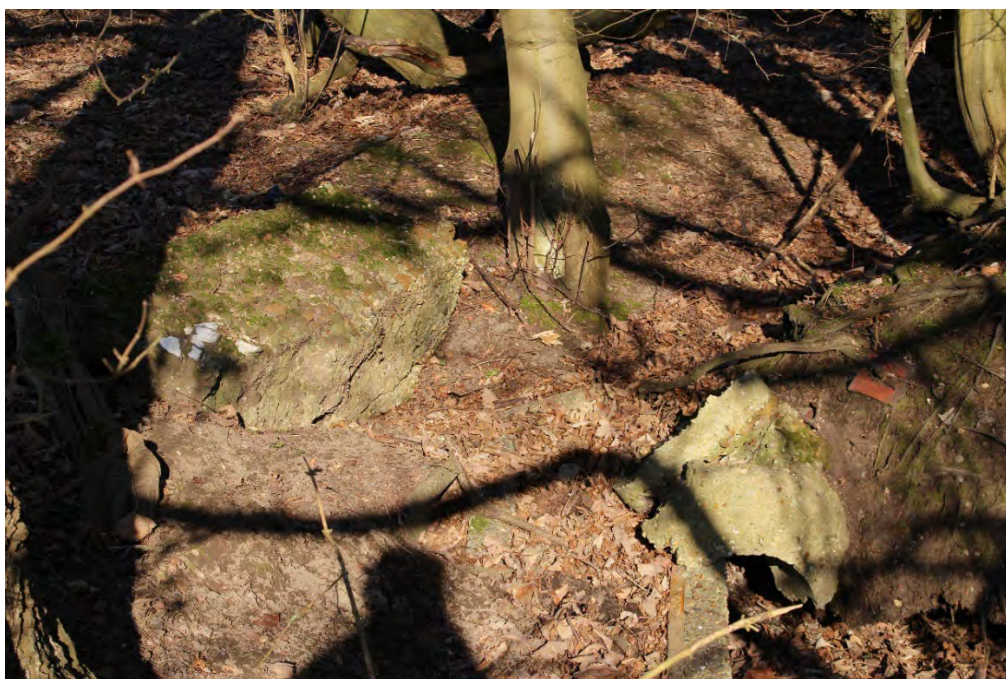
Figure 22 View 9, Concrete lying within northern part of pond, possibly drainage structure.

- 5.12 A number of ponds are present on the Site. One on the northern boundary contains large pieces of concrete and sherds of possible drainage pipe (Figure 22). The location of this pond on the northern edge of the Site lies to the immediate south of the cricket Pitch, and it is possible that this concrete forms part of the drainage system for the cricket pitch. It was partially water filled on the day of the visit.

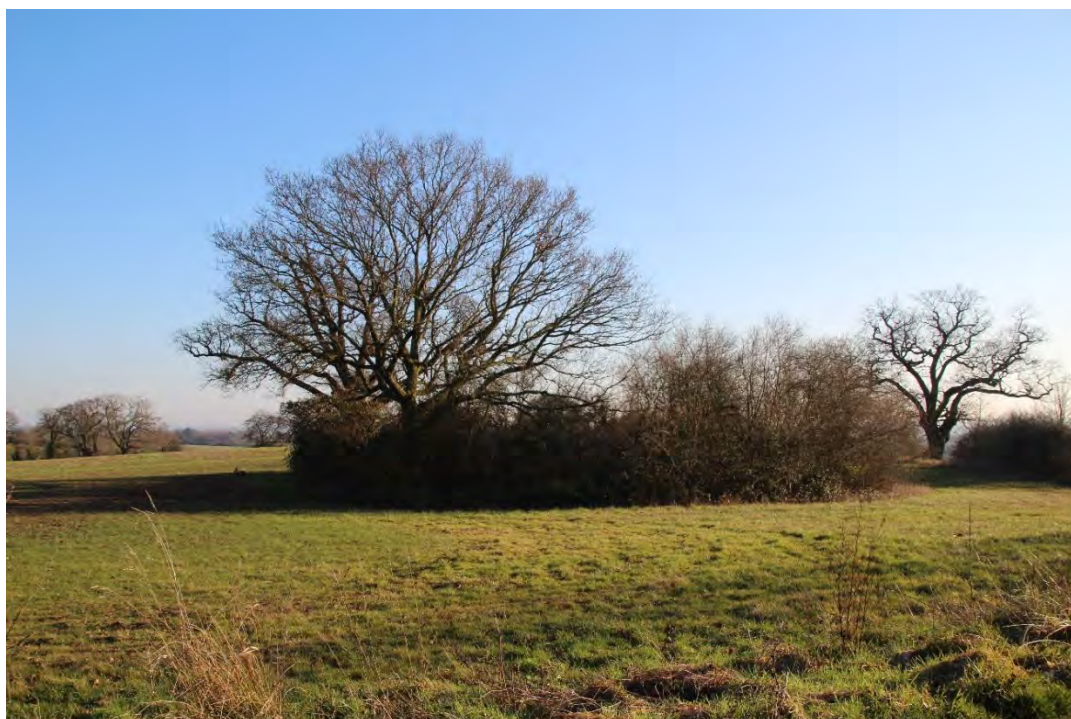
Figure 23 View 10, View of pond looking south from edge of Hole Lane

5.13 A second pond lay directly to the north of Hole Farm, virtually circular in shape (Figure 23). Cartographic evidence indicates this was originally located on a field boundary or ditch line running south from Hole Farm Lane to Hole Farm.

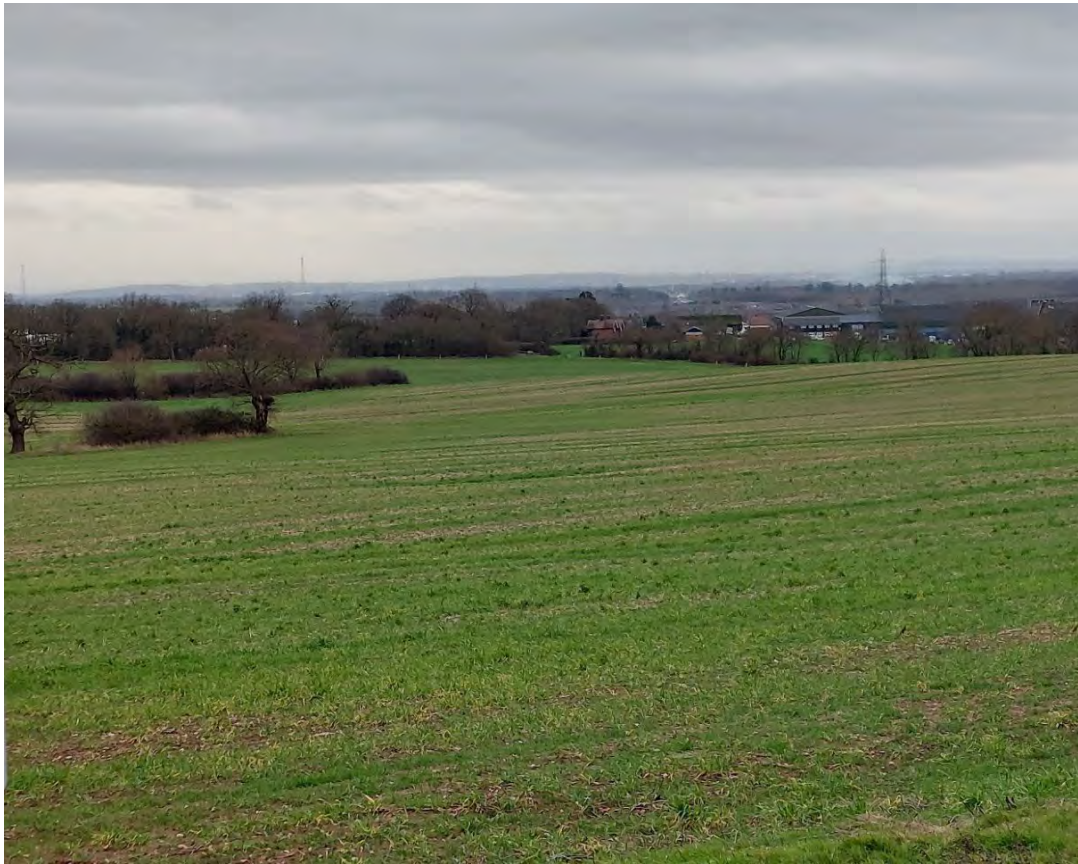
Figure 24 – View 11, Looking south west towards the M25/A127 junction from the Warley Road entrance to Hole Farm

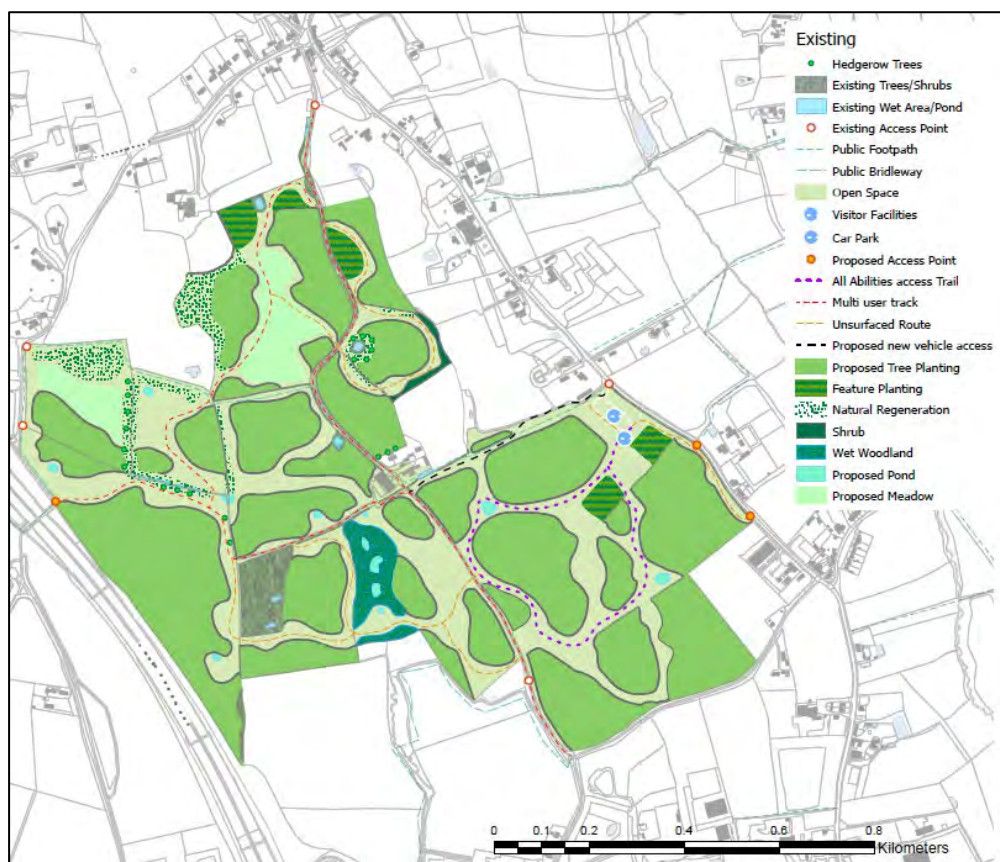
Figure 25 – Overall layout of Hole Farm community Woodland

- 5.19 The new design proposes a number of paths to criss-cross the Site; to increase the accessibility of the new woodland. There are four new routes comprising an all abilities access trail, a multi user track and unsurfaced route and a new vehicle access. Both the all abilities access trail and the multi user track will require a surface to be created with terracing which has the potential to have an impact on below ground remains.

- 5.20 The proposed ponds would have the potential to have a similar impact on any surviving archaeological deposits. These will be excavated to a depth of c. 1 to 2m which as is shown by work of the Lower Thames Crossing evaluation would remove the majority of archaeological deposits if present. The ponds are largely in the south, west and eastern areas of the site; the only original ponds are located north of Hole Farm.

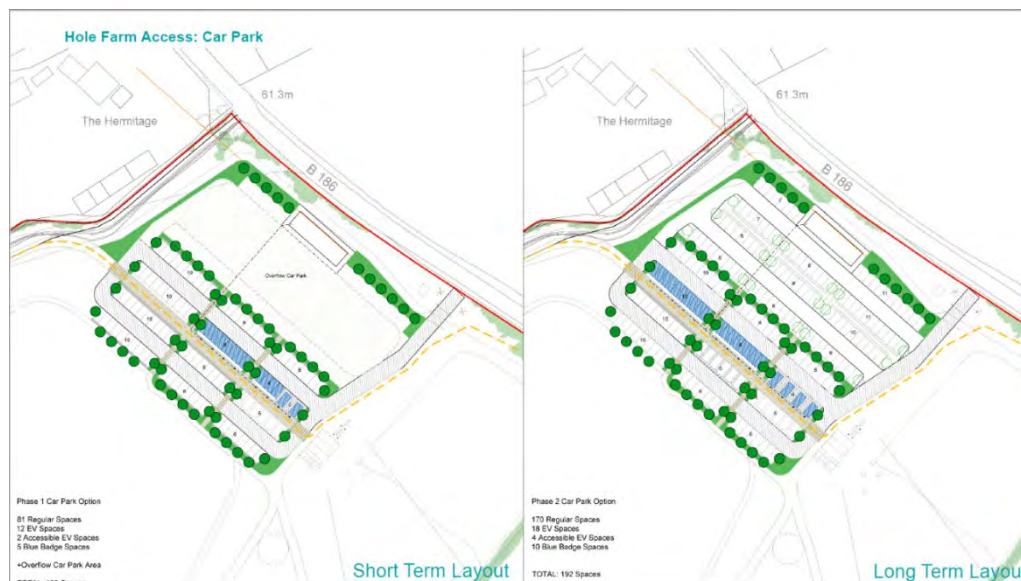
Figure 26 –Layout of Hole access and public car park

- 5.21 The area proposed as a car park and visitor facilities (which will include a modular-style takeaway café and some toilets, Figure 26) will require groundworks for the creation of the car park and any associated drainage and services. Cartographic evidence and finds in the field indicate the potential of a post medieval structure within this area.

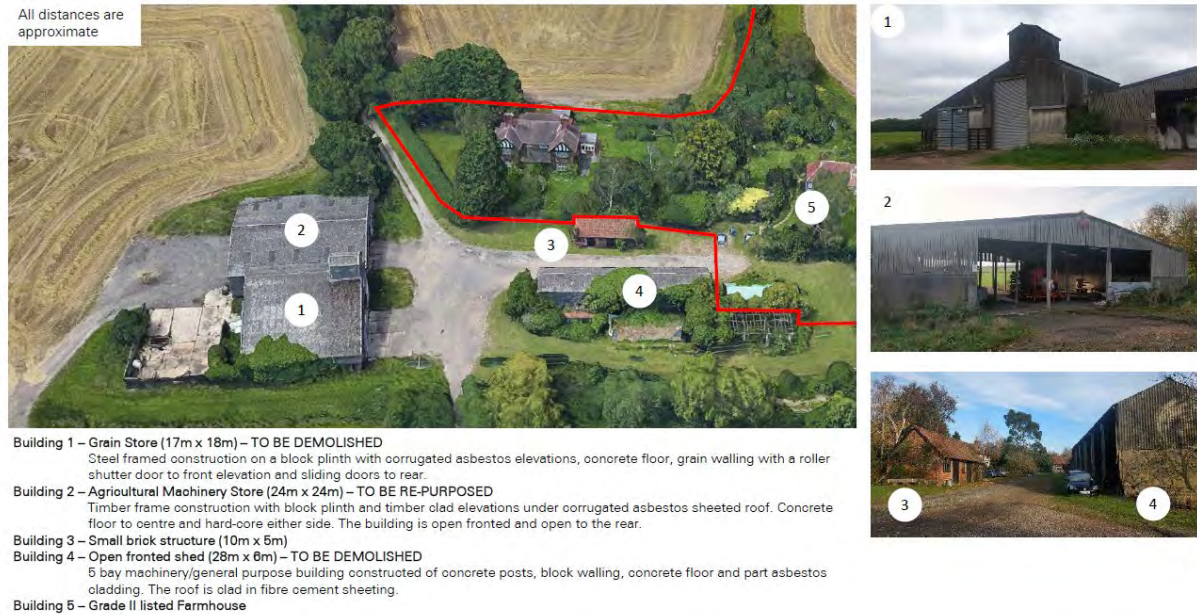
Figure 27–Changes to the present structures at Hole Farm

- 5.22 Development is proposed to the west of the Home Farm complex on and adjacent to the site of existing buildings. Some of the buildings within the farm complex will be curtilage listed and advice should be sought from the Brentwood Conservation Officer regarding the setting of the designated asset.

- 5.23 To the west of the historic farm complex the present buildings are proposed to be converted or demolished with a new tree nursery and building complex being proposed (Figure 27). Considering its close location to the present farm there is the potential of identifying earlier phases of structure relating to Hole Farm some being visible on the cartographic evidence assessed for this report.

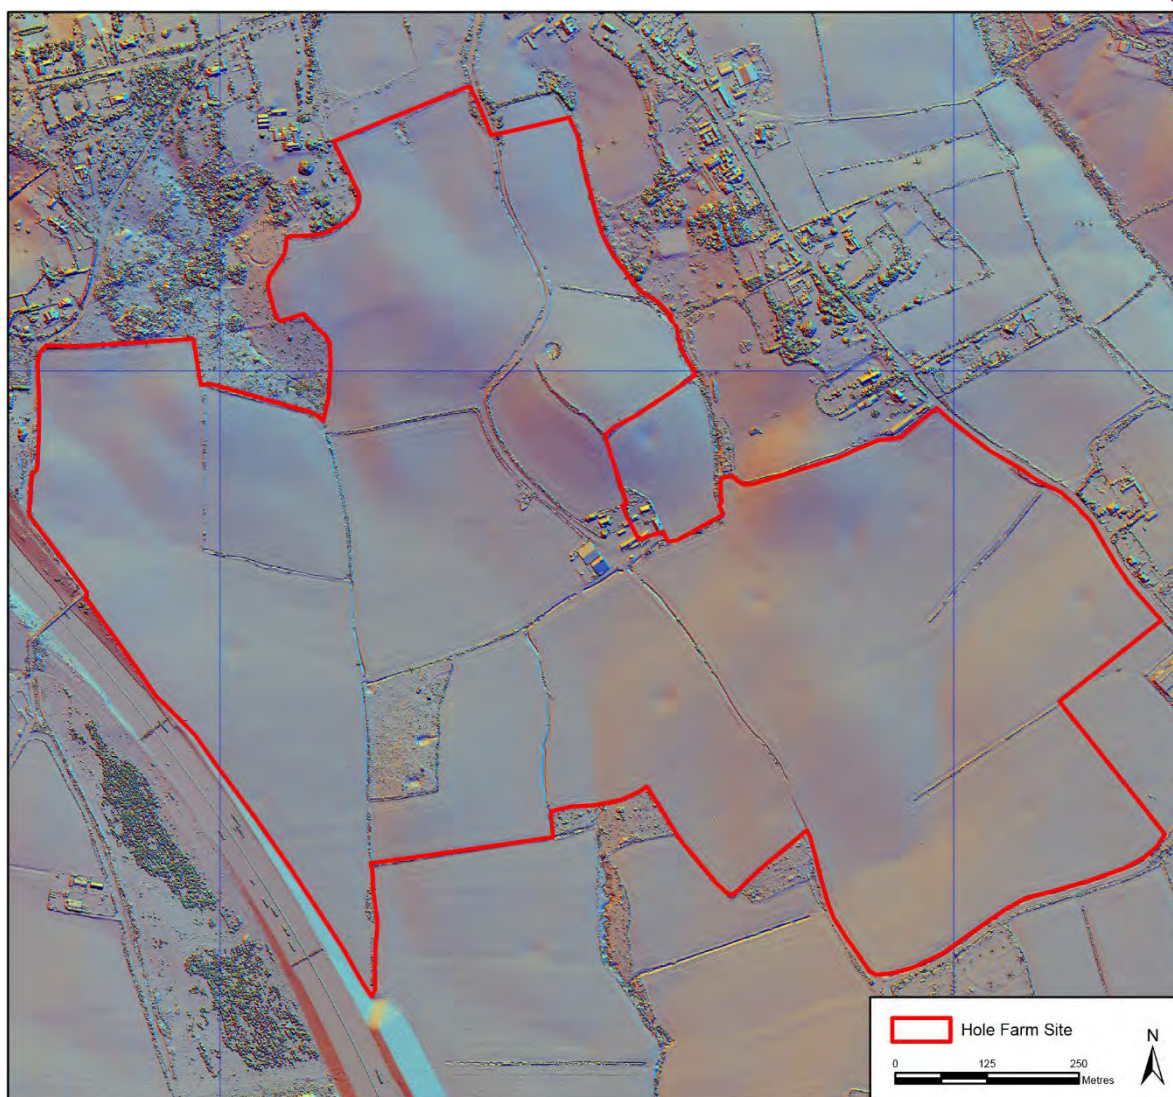
Figure 28 - Extract from EA Lidar Archive showing data availability across The Site. Image shows multiple hill shade visualisation created using 1m DSM data from 2016.

level earthworks showing where the fields boundaries were located (Figure 28). The field pattern can be detected on either side of the M25 (which marks the western boundary of the study area) demonstrating the post-medieval landscape layout still exists despite modern infrastructure development (Figure 29).

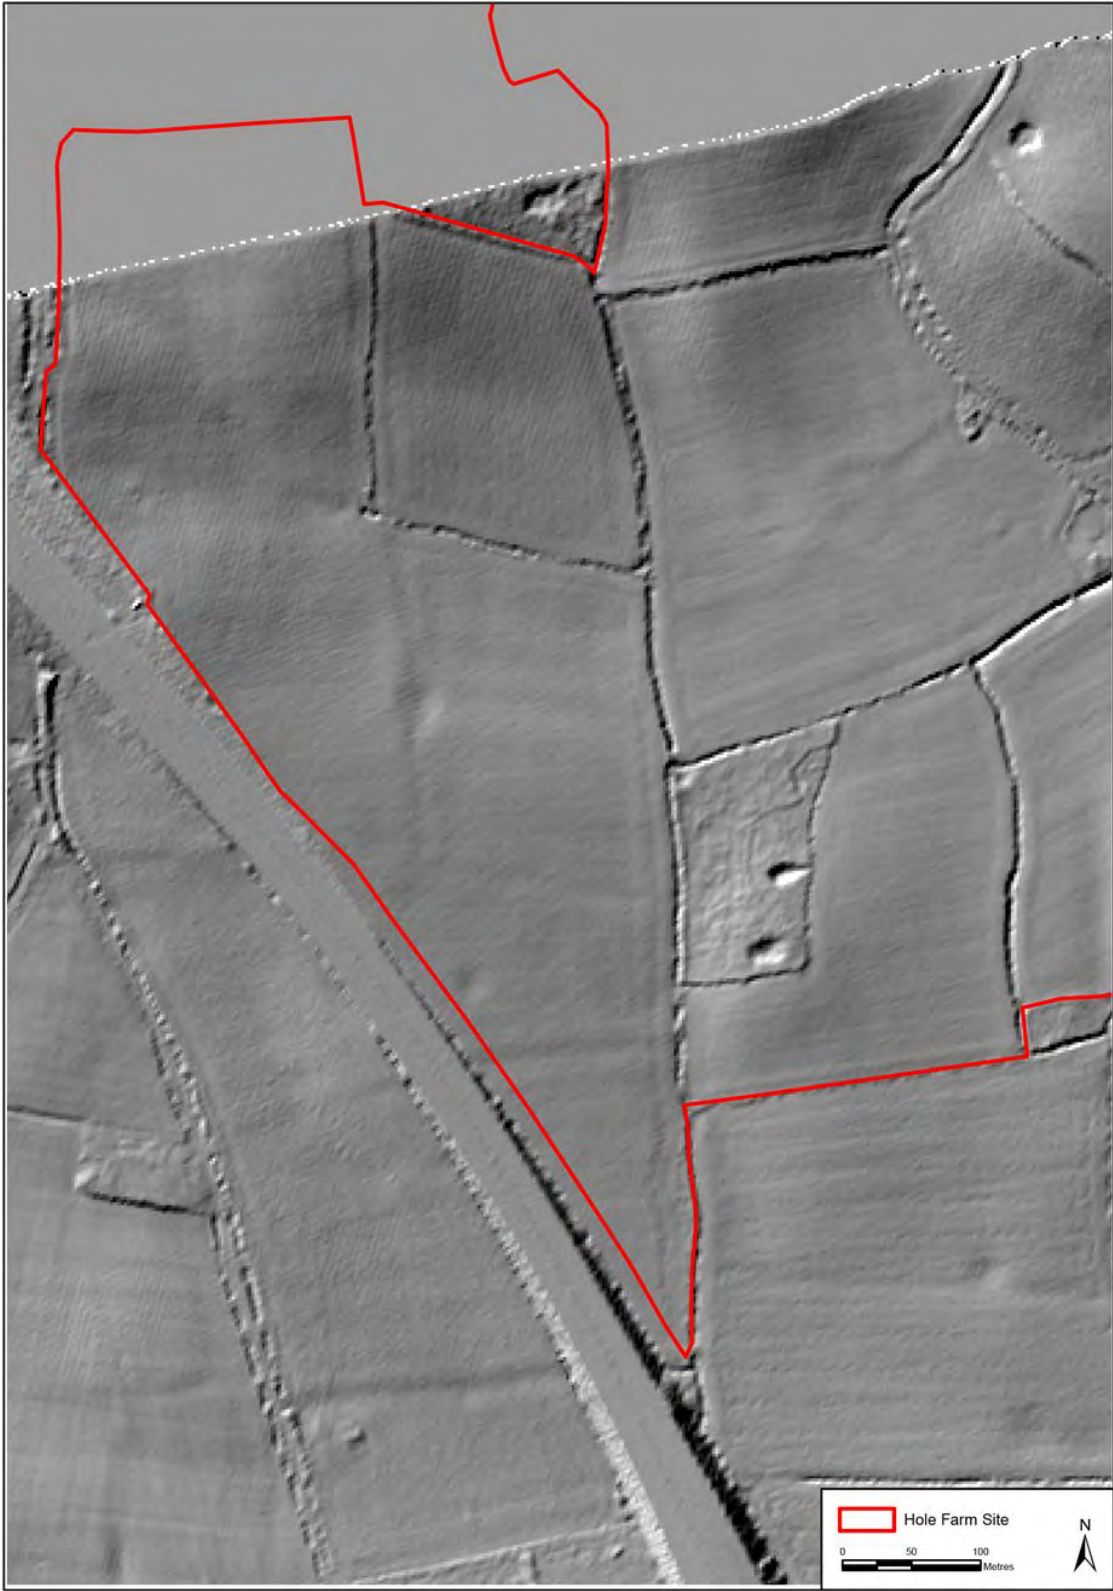
Figure 29 Hill shade visualisation of 2006 2m DTM data showing Parkers Wood with 2 ponds, the M25 and the continuation of low-level earthworks showing the location of former field boundaries.

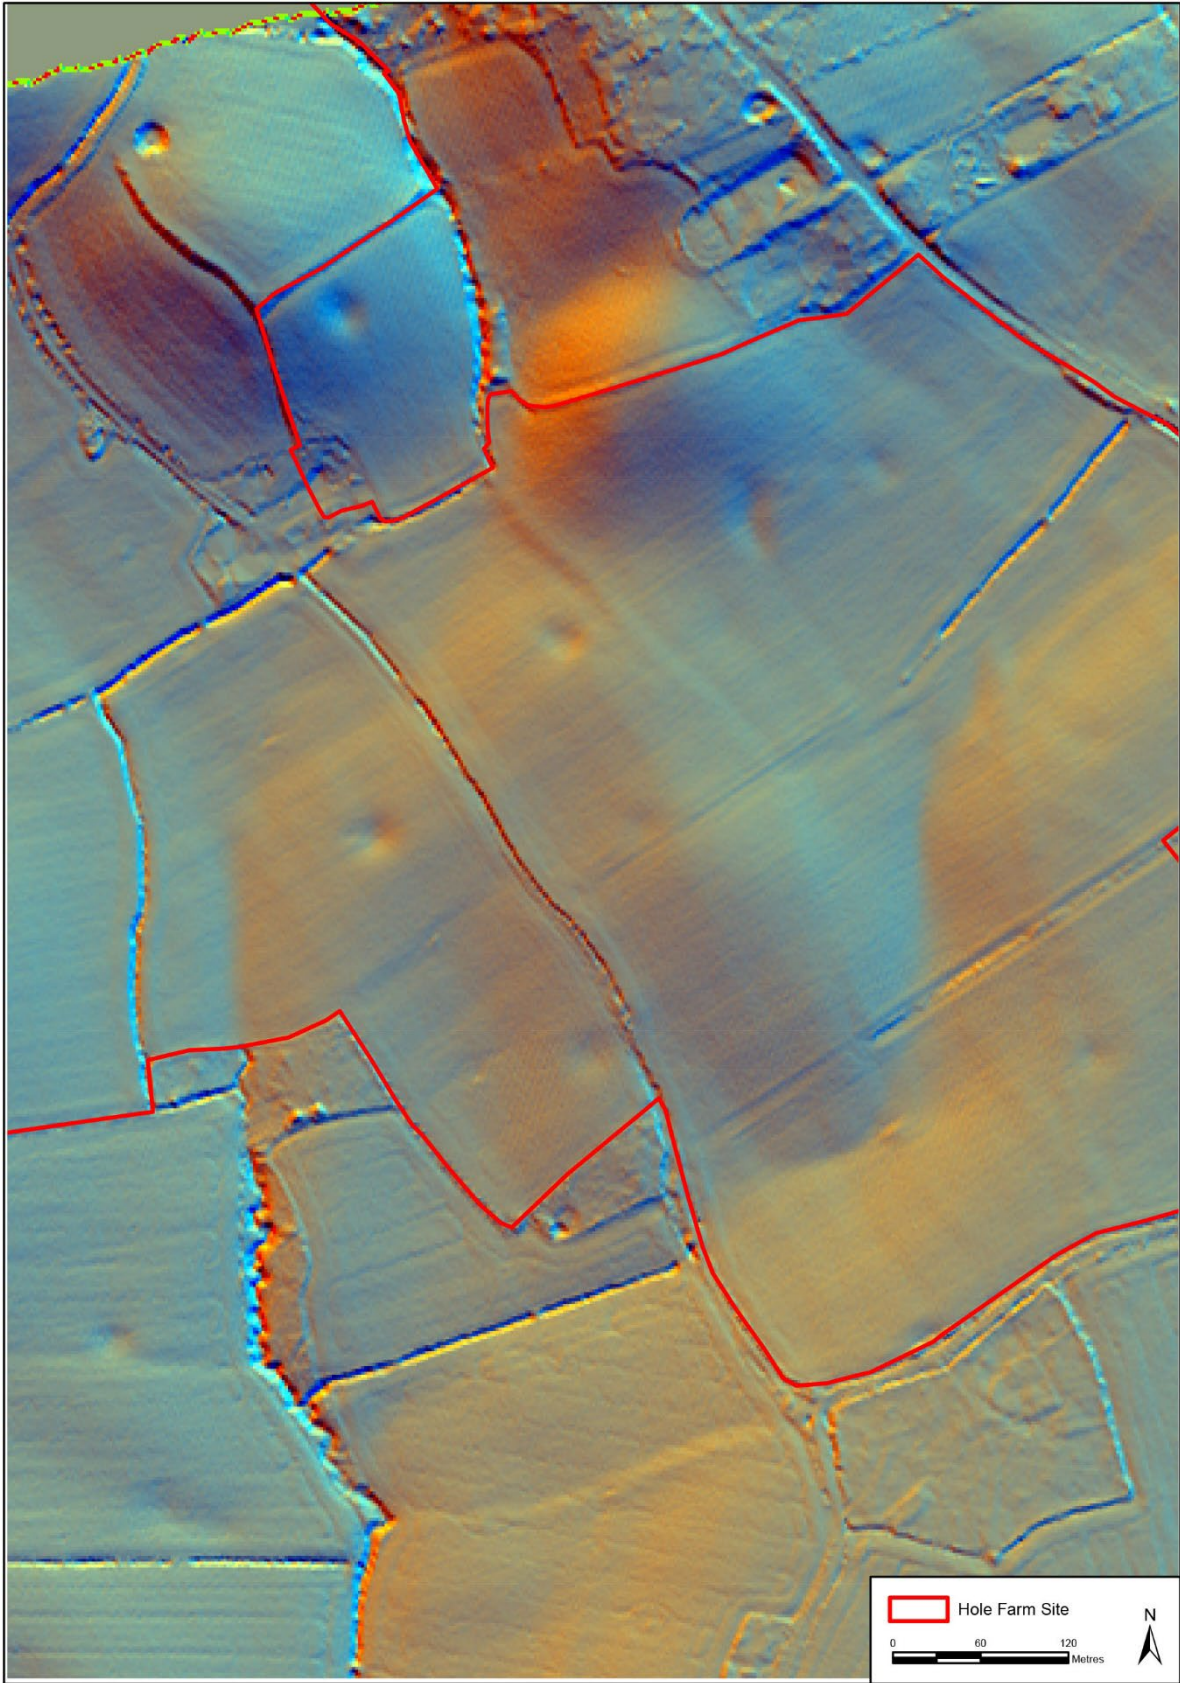
Figure 30 - Multi-hill shade visualisation of 2006 2m DTM data

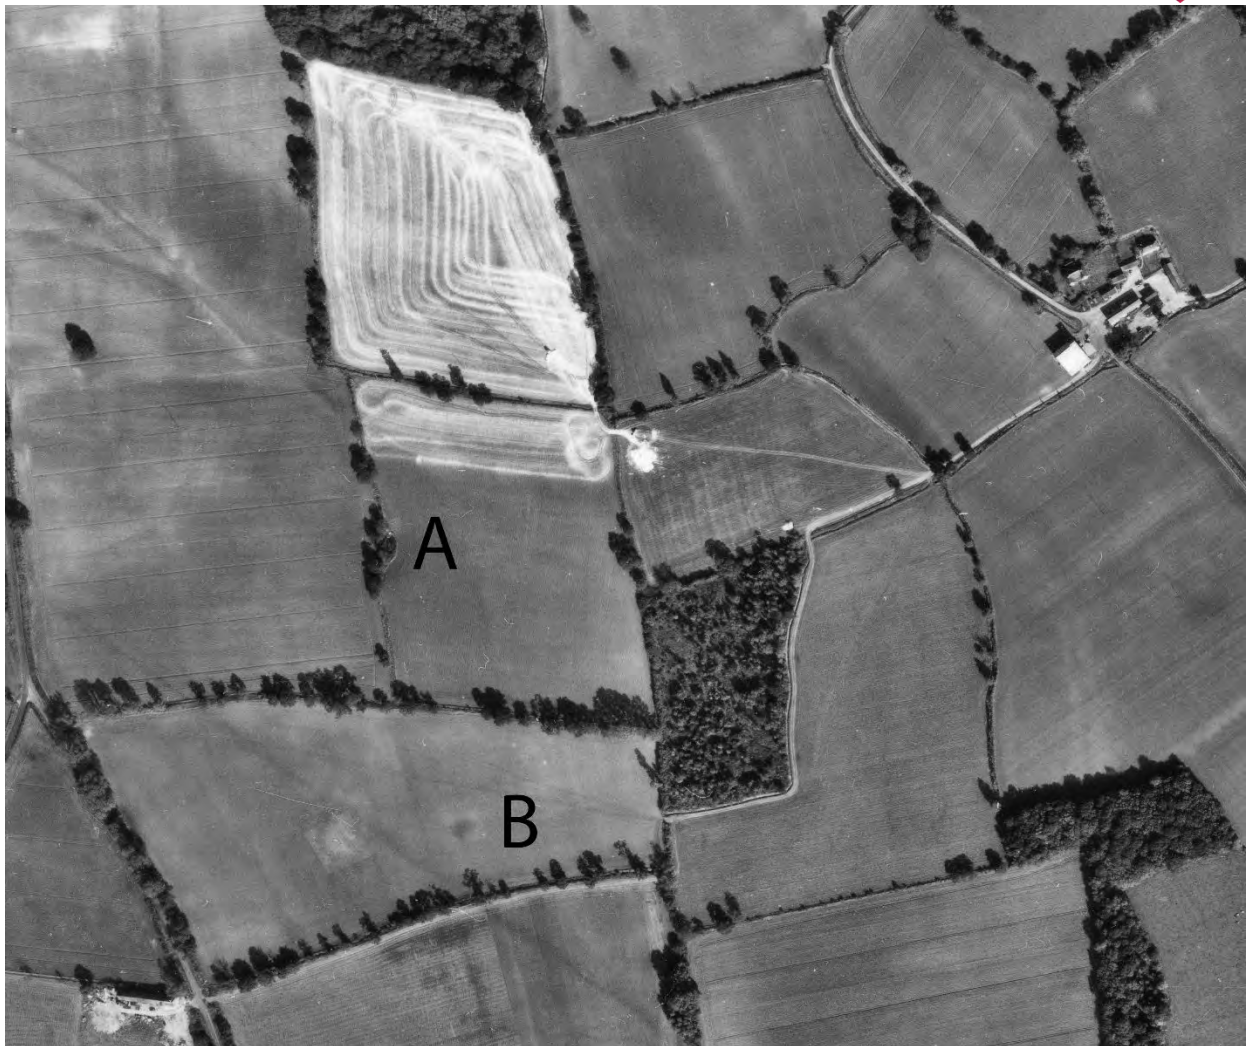
Figure 31 Extract from 1970 ECC vertical photograph showing a former field boundary with small pond (A) and a cropmark (B) which correspond with features visible on the lidar

- 6.11 Other features visible on the lidar include a series of shallow depressions across the site. Four of these depressions are located to the south of Hole Farm (Figure 30). While it is unclear if these depressions are of archaeological origin, they could be former ponds. The OS maps from 1880 show a series of ponds in the vicinity, include one to the north of Hole Farm which is still an extant water-filled pond today and these depressions are of a similar size.
- 6.12 Figure 31 shows an extract from an ECC vertical photograph taken in 1970 where a former field boundary and pond are still extant and to the south of this a darker mark in the crops is visible. These features correspond with shallow depressions visible on the lidar (Figure 31)
