Lower Thames Crossing

6.3 Environmental Statement Appendices Appendix 8.20 - Draft water vole conservation licence application (Clean version)

DATE: December 2023
DEADLINE: 8

Planning Inspectorate Scheme Ref: TR010032
Application Document Ref: TR010032/APP/6.3

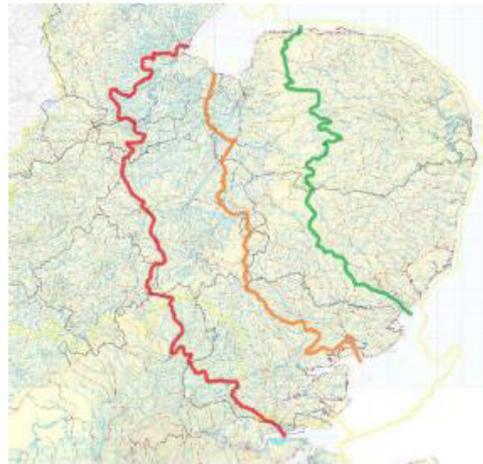
Map 1 WRE Project area initial proposal
Green: eradication pilot
Orange 30km inner buffer – eradication
Red 60km full buffer, eradication but mink incursions likely

By integrating with a Regional Scale mink eradication pilot, previously unviable habitat can be released for water vole translocation from the LTC. The potential risk is that the overall scheme fails to attract the level of funding required to roll it out regionally, however the existing work of the Eastern Region Mink Control Group over the past 20 years, has kept mink numbers down and does secure some protection from the Suffolk border even should the WRE project fail to materialise during the life of the LTC project.

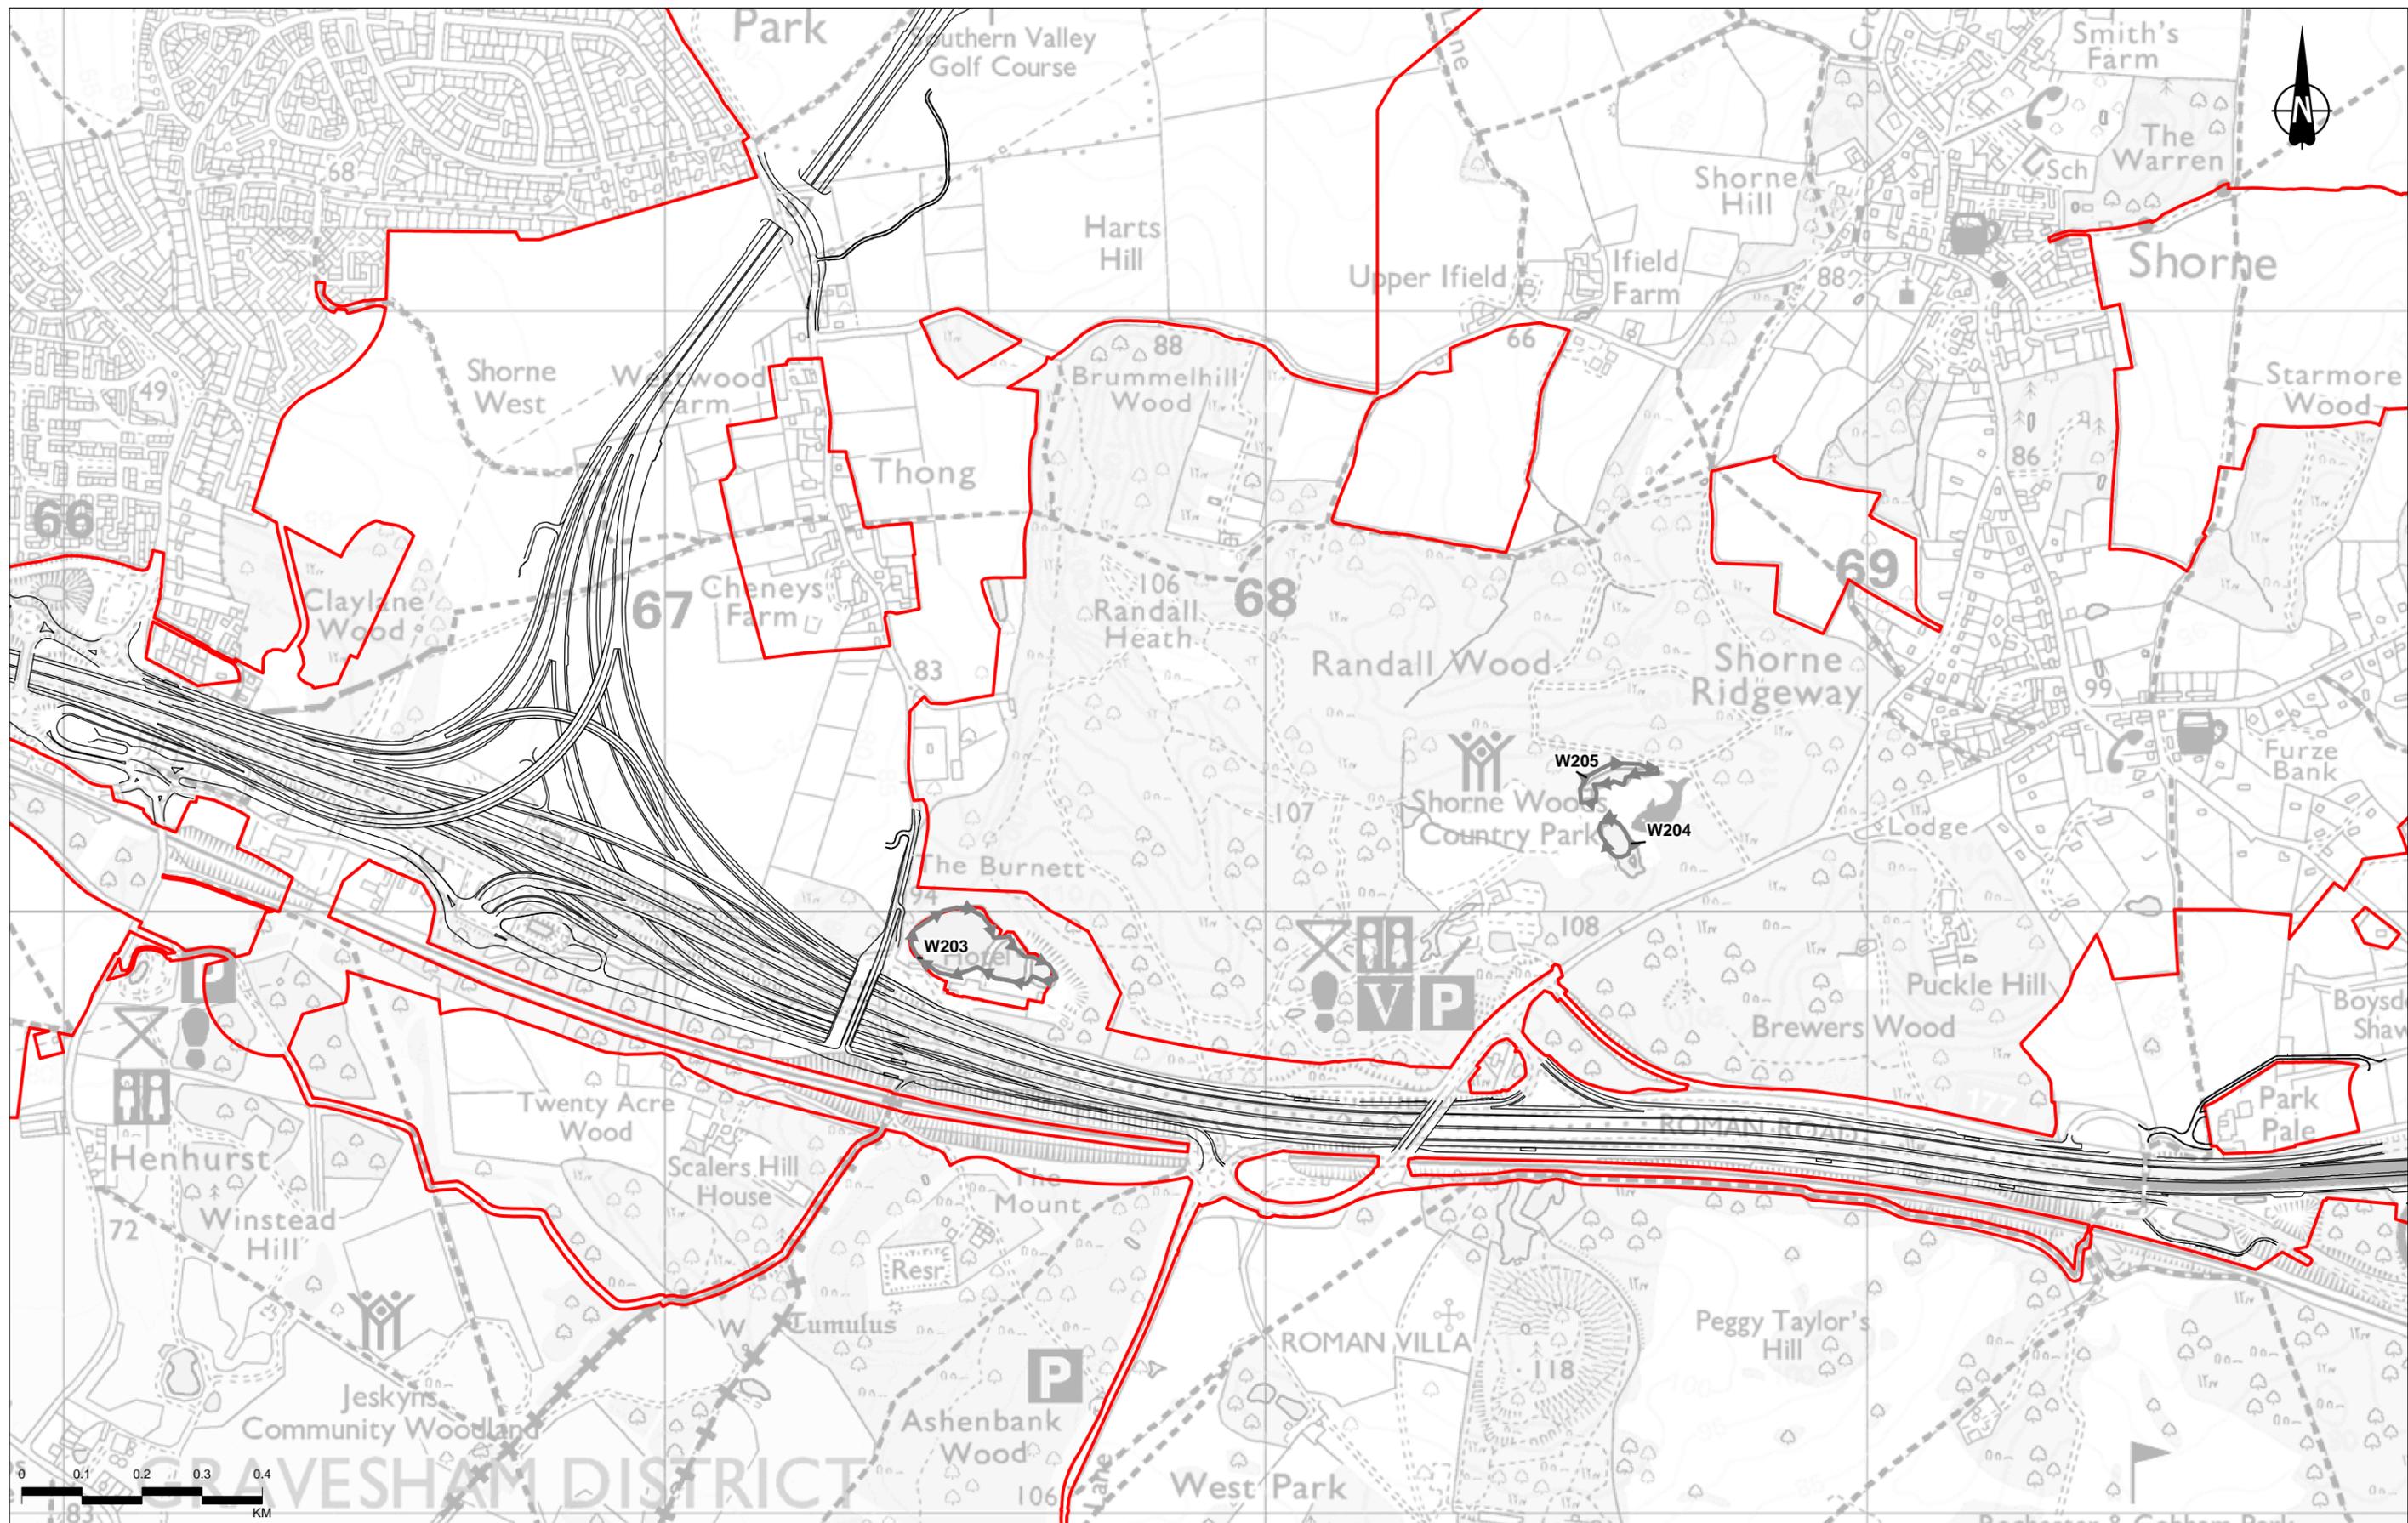
Status	DCO APPLICATION	Original Size	A3	Revision	P02
Application Document Number	TR010032/APP/6.2	Scale	1:10,000		
Drawing Title	Figure 2 - Water Vole Survey Results				
Drawing Number	HE540039-CJV-EBD-SZP_EGNE0000000-DR-LE-60018				
Page 1 of 10

- 2.4.7 A total of seven waterbodies were found to have high populations of water vole to the south of the River Thames, over a total length of 2.4km. An additional 13 waterbodies were found to have medium water vole populations, over a total length of 4.3km. A total of 26 waterbodies encompassing 8.6km had a low population of water vole. The remaining 17 waterbodies were found to either have no water vole field signs or were dry during every survey undertaken and were therefore considered to be of negligible suitability for water vole. All waterbodies with water vole populations were located either within, or adjacent to, the South Thames Estuary and Marshes SSSI (see Figure 2).

- 2.4.8 To the north of the River Thames a total of six waterbodies encompassing a length of 2.5km had a high water vole population. An additional 21 waterbodies had a medium population across a total length of 12.1km and 31 waterbodies had a low population across a total length of 17km. Fifteen waterbodies had burrows recorded but no confirmed water vole signs. For this assessment these waterbodies have been assessed as having no water vole present as without any other confirmed water vole signs the burrows were considered most likely to be rat burrows. The remaining 84 waterbodies were found to have no water vole field signs or were dry during every survey undertaken and were therefore considered to be of negligible water vole suitability (see Figure 2).

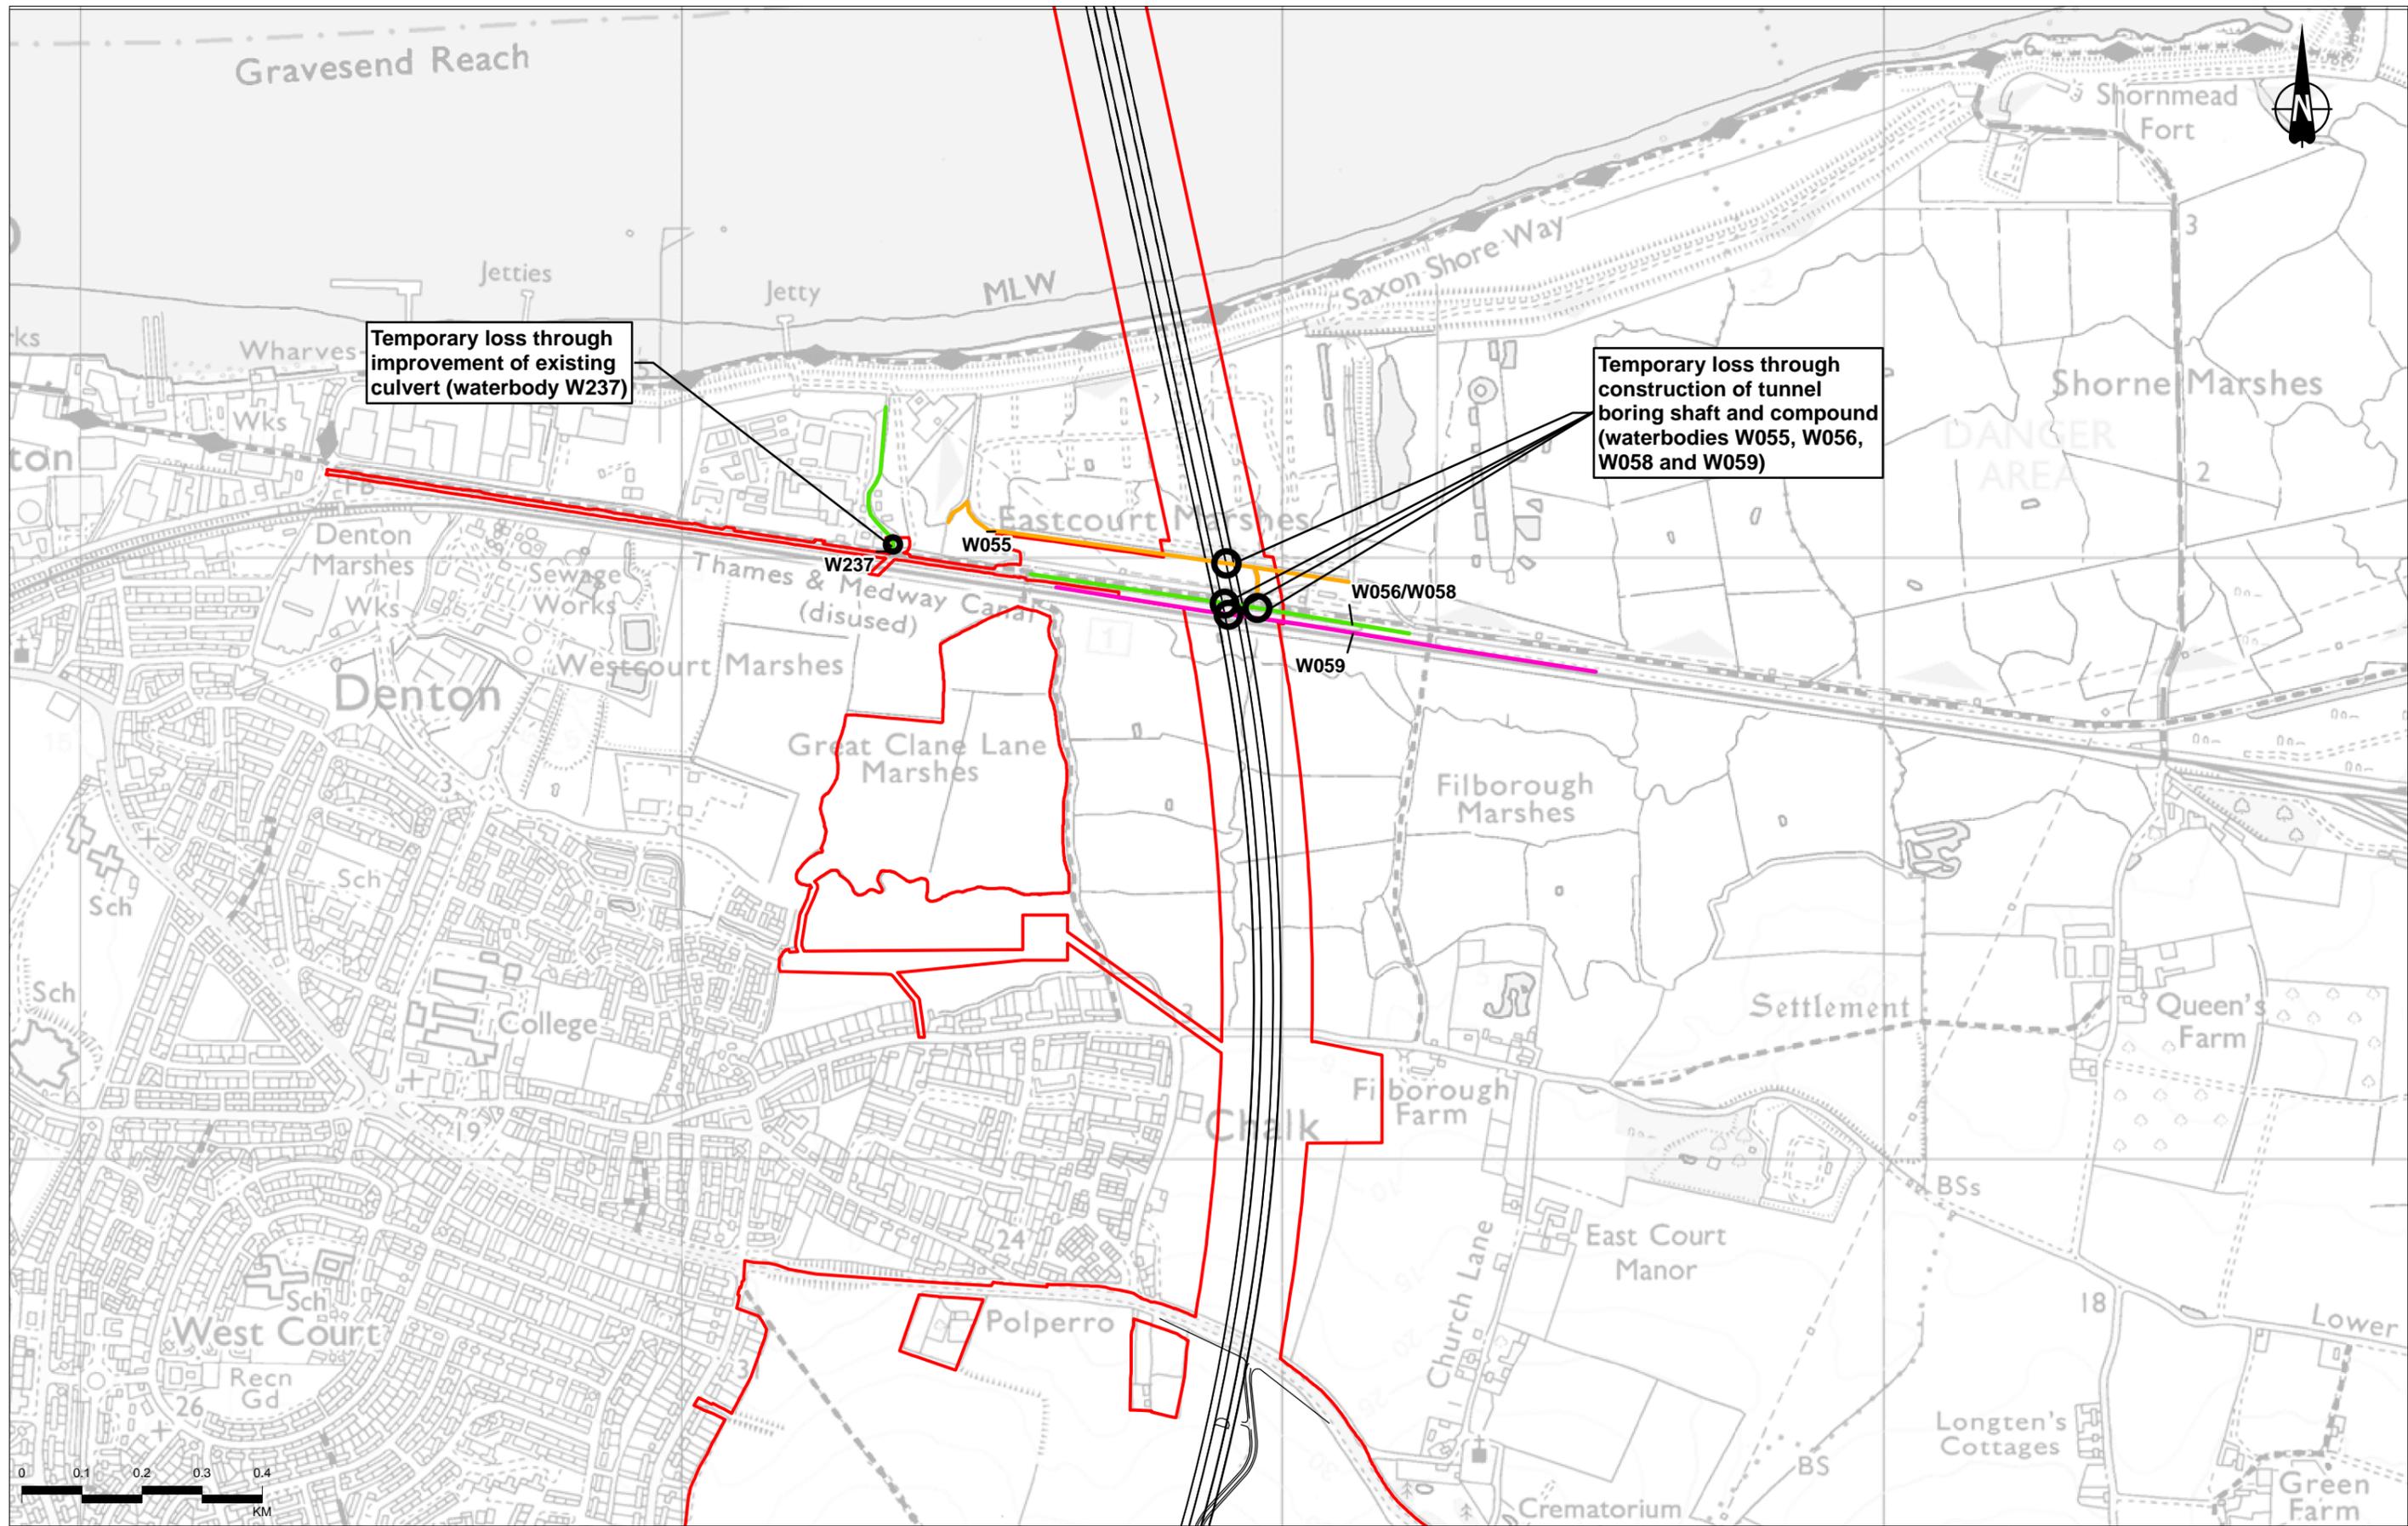
Temporary loss through improvement of existing culvert (waterbody W237)

Temporary loss through construction of tunnel boring shaft and compound (waterbodies W055, W056, W058 and W059)

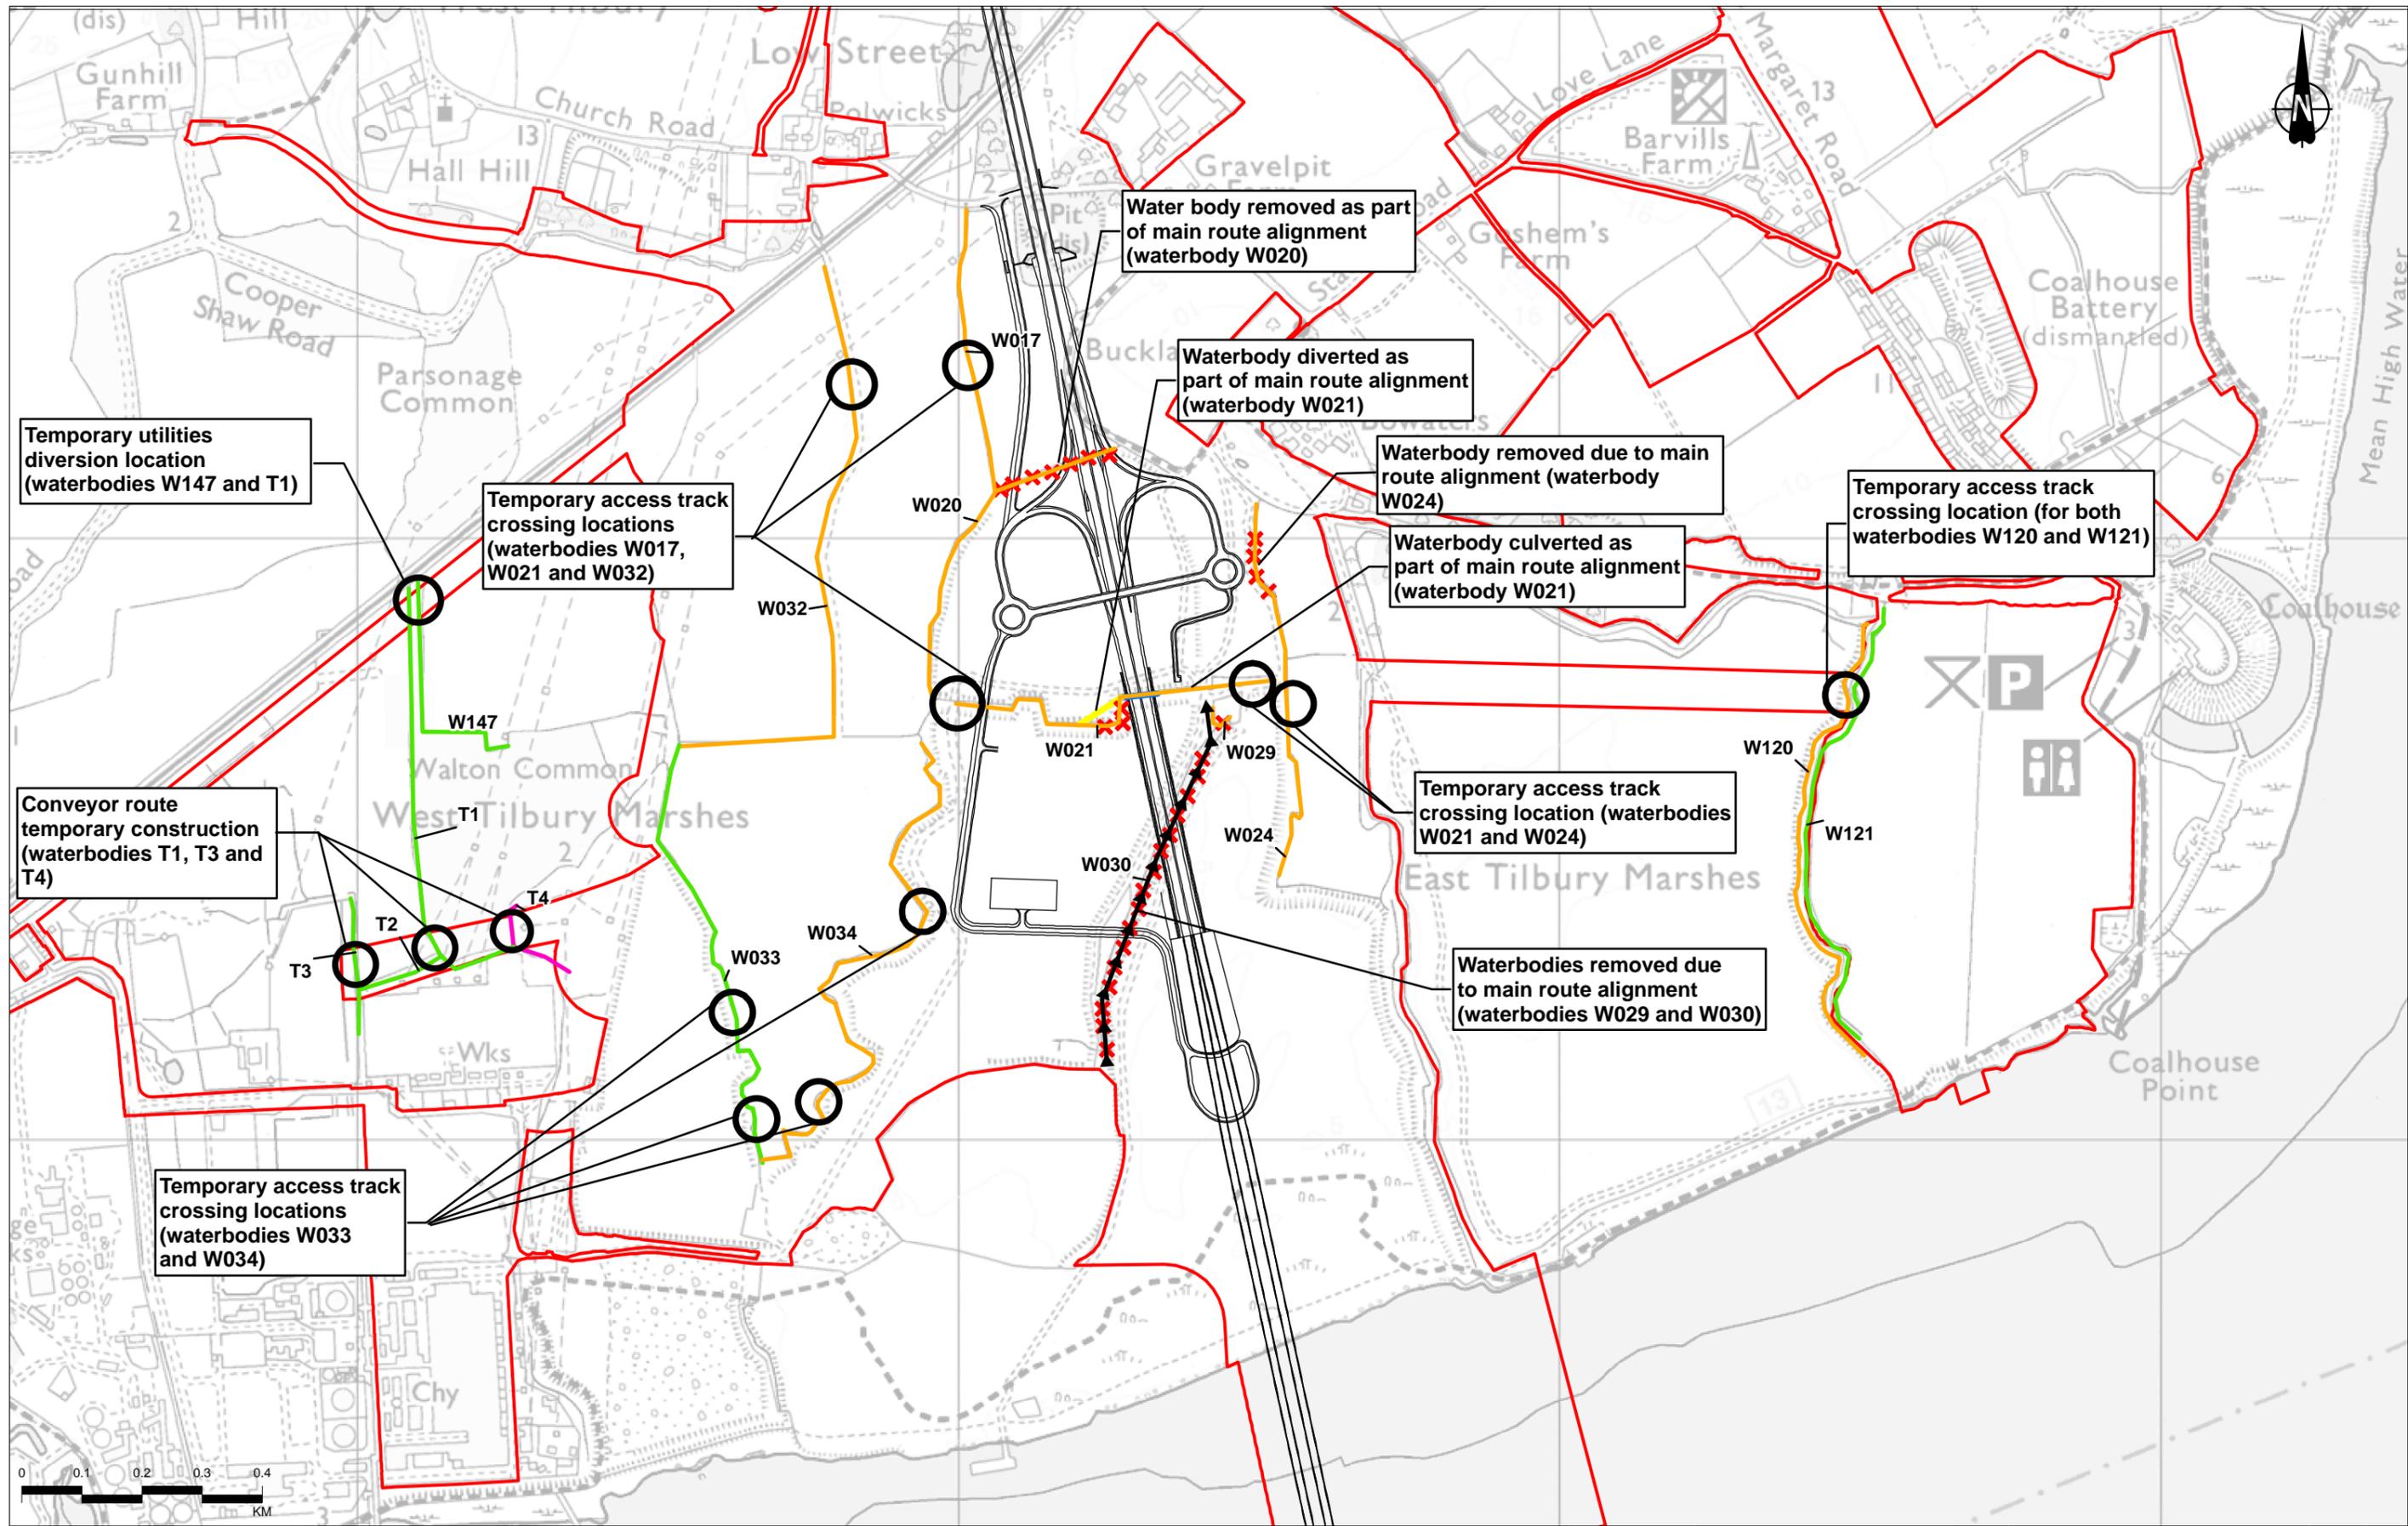
Temporary utilities diversion location (waterbodies W147 and T1)

Temporary access track crossing locations (waterbodies W017, W021 and W032)

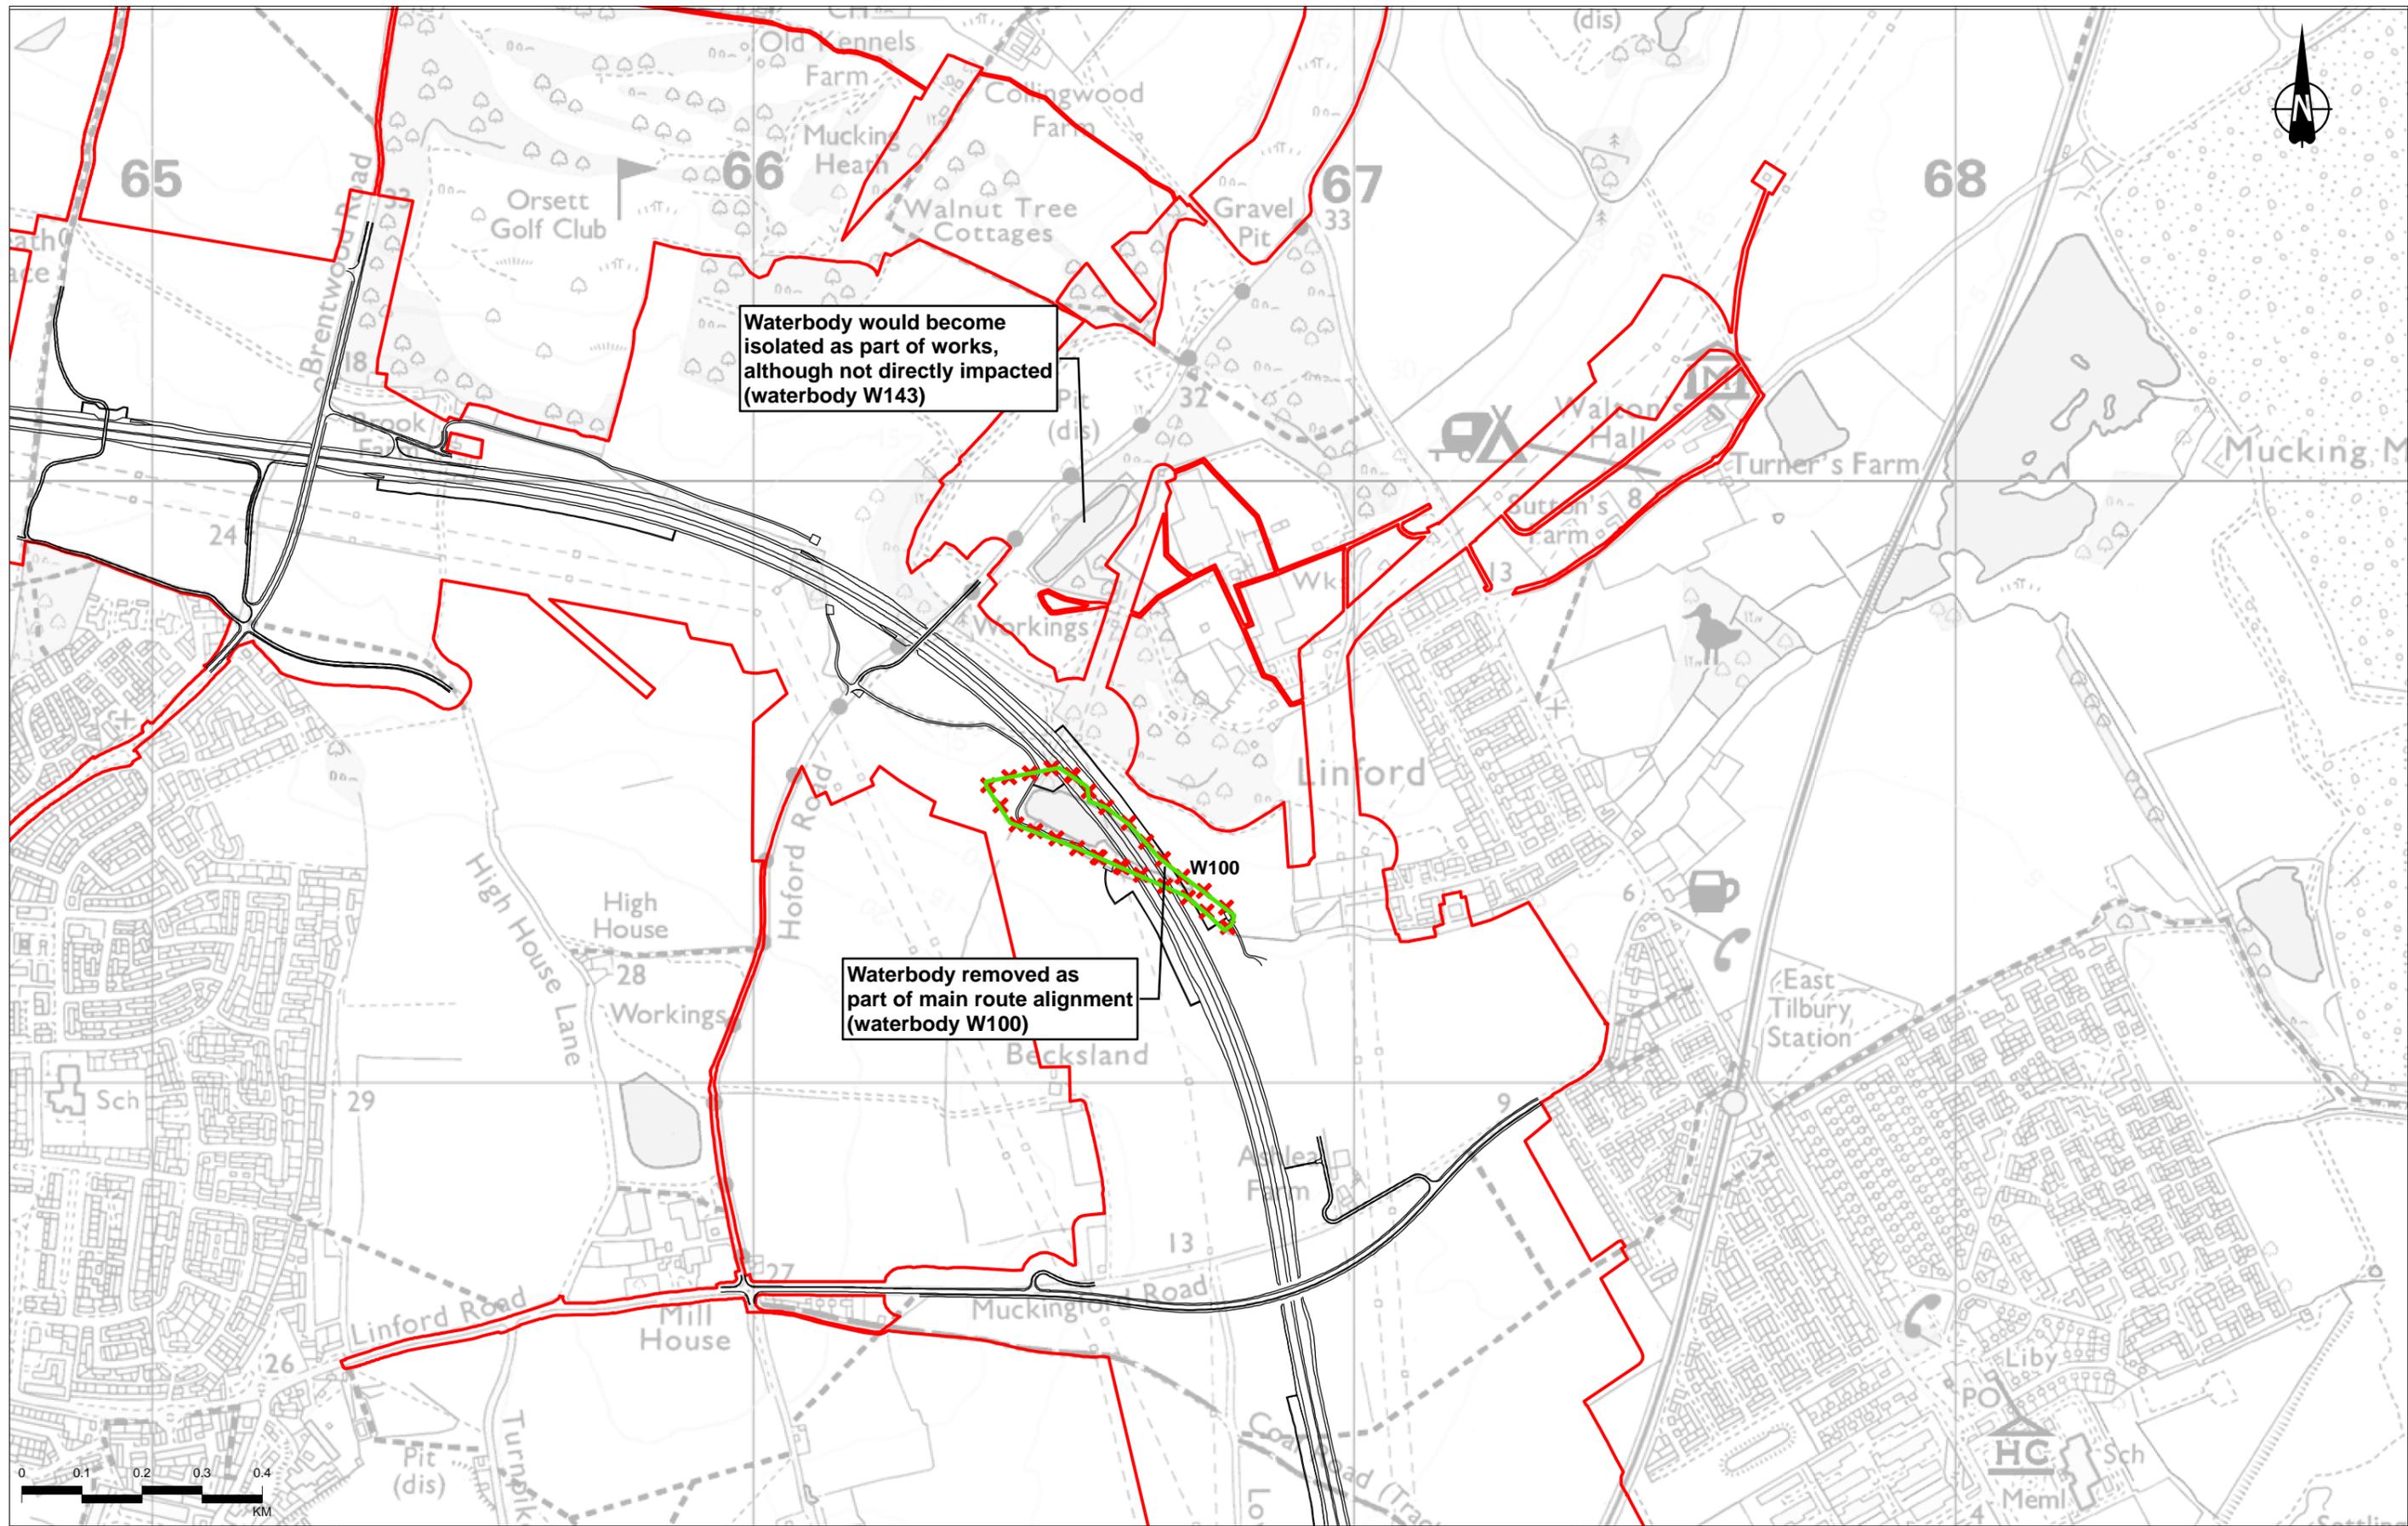
Waterbody would become isolated as part of works, although not directly impacted (waterbody W143)

Waterbody removed as part of main route alignment (waterbody W100)

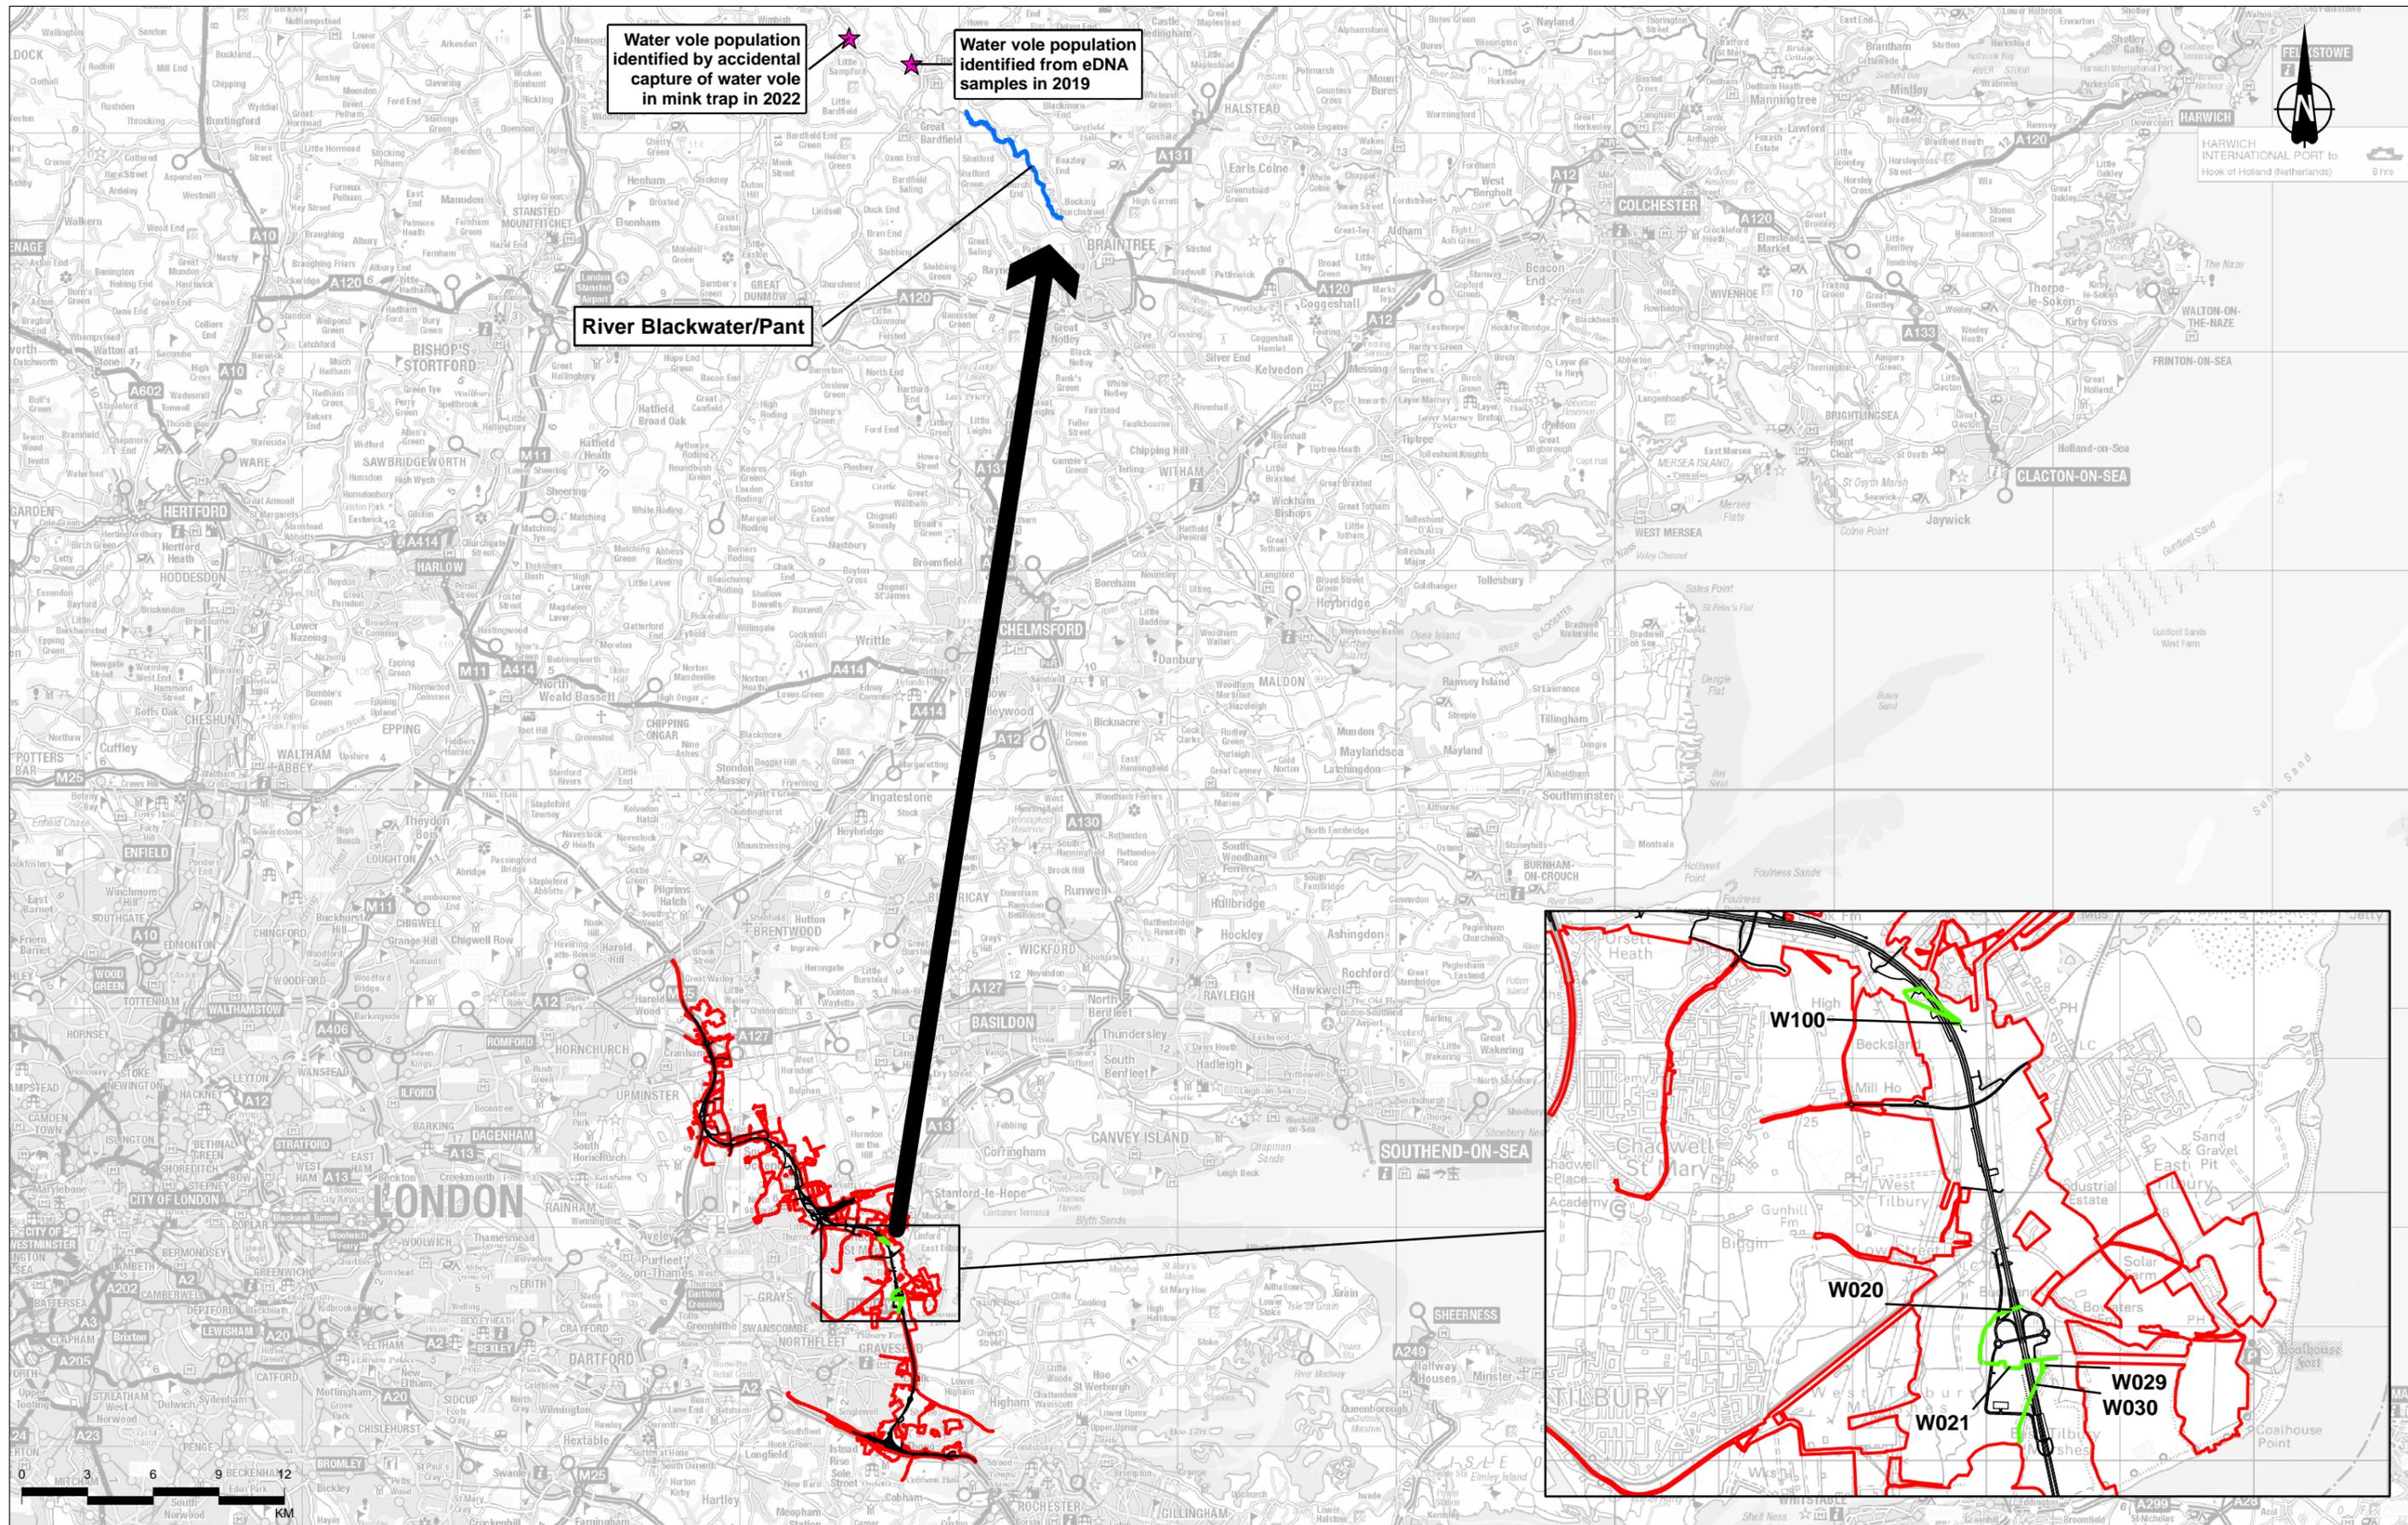
Status	DCO APPLICATION	Original Size	A3	Revision	P03
Application Document Number	TR010032/APP/6.2	Scale	1:275,000		
Drawing Title	Figure 6 - Vole Receptor Sites				
Drawing Number	HE540039-CJV-EBD-SZP_EGNE0000000-DR-LE-60039
