Lower Thames Crossing

6.3 Environmental Statement Appendices Appendix 8.20 - Draft water vole conservation licence application (Clean version)

DATE: December 2023
DEADLINE: 8

Planning Inspectorate Scheme Ref: TR010032
Application Document Ref: TR010032/APP/6.3

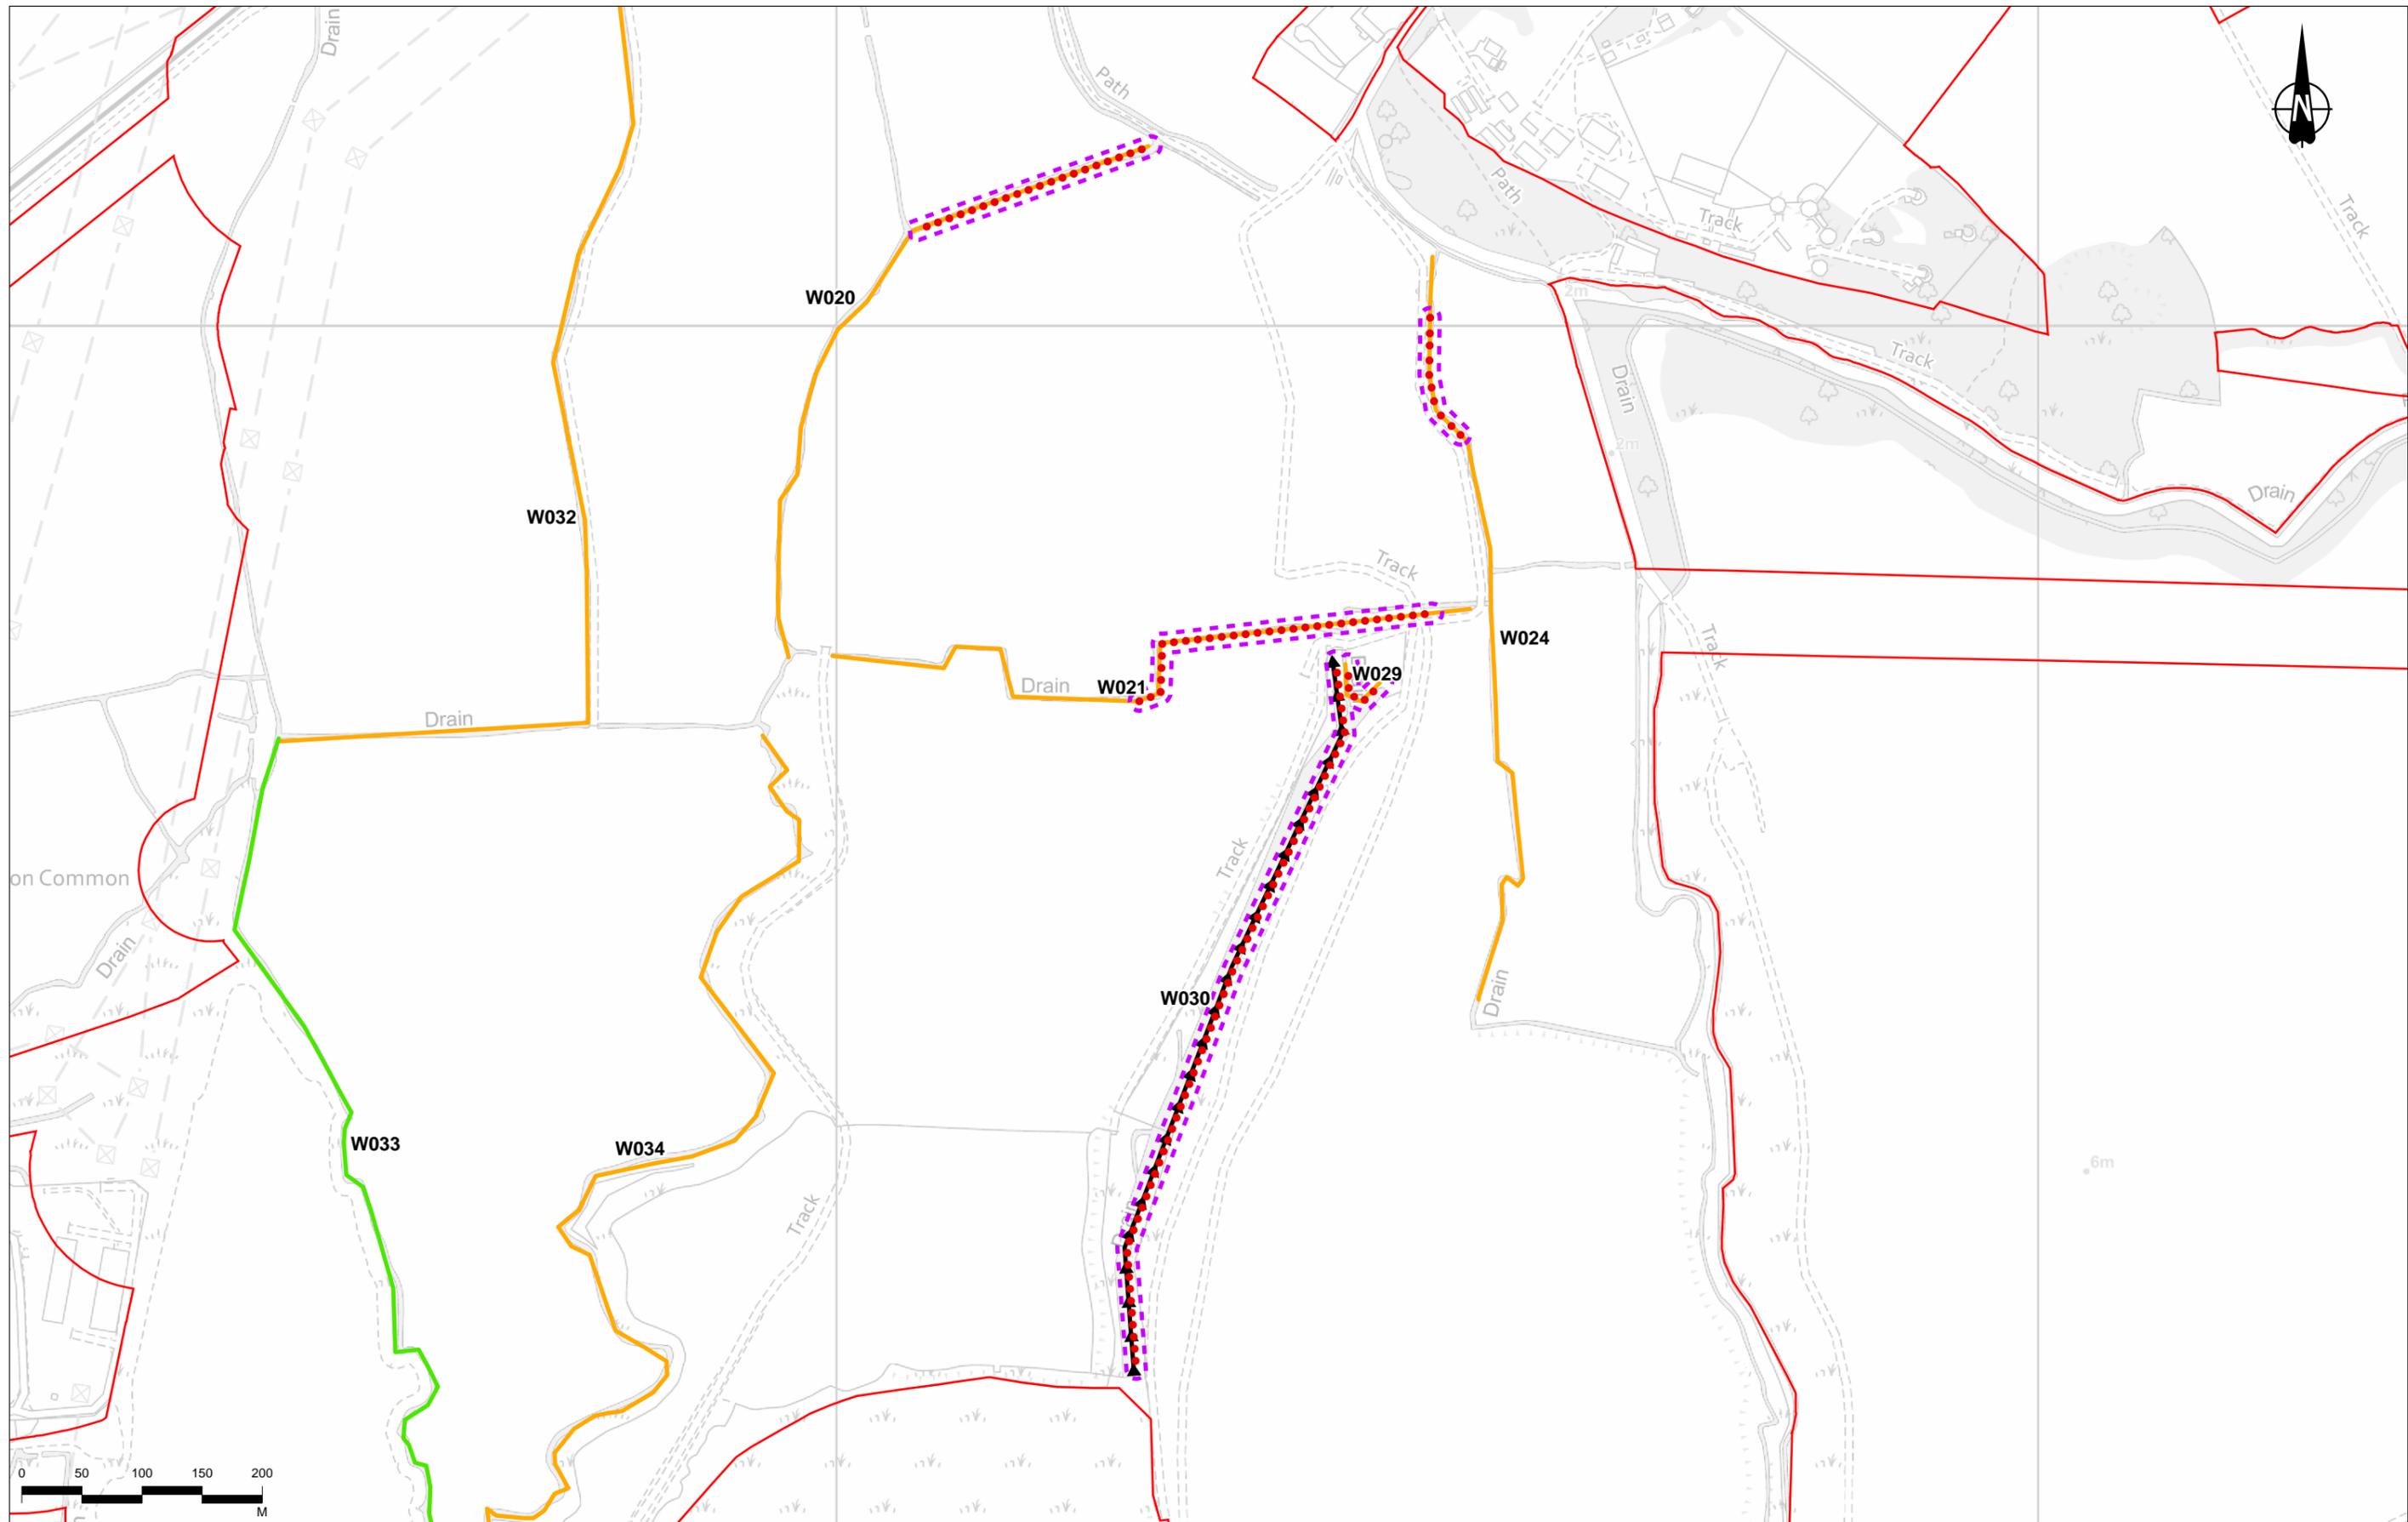
Status	DCO APPLICATION	Original Size	A3	Revision	P03
Application Document Number	TR010032/APP/6.2	Scale	1:5,000		
Drawing Title	Figure 7 - Water Vole Trapping Plan				
Page 1 of 2					
Drawing Number	HE540039-CJV-EBD-SZP_EGNE0000000-DR-LE-60110

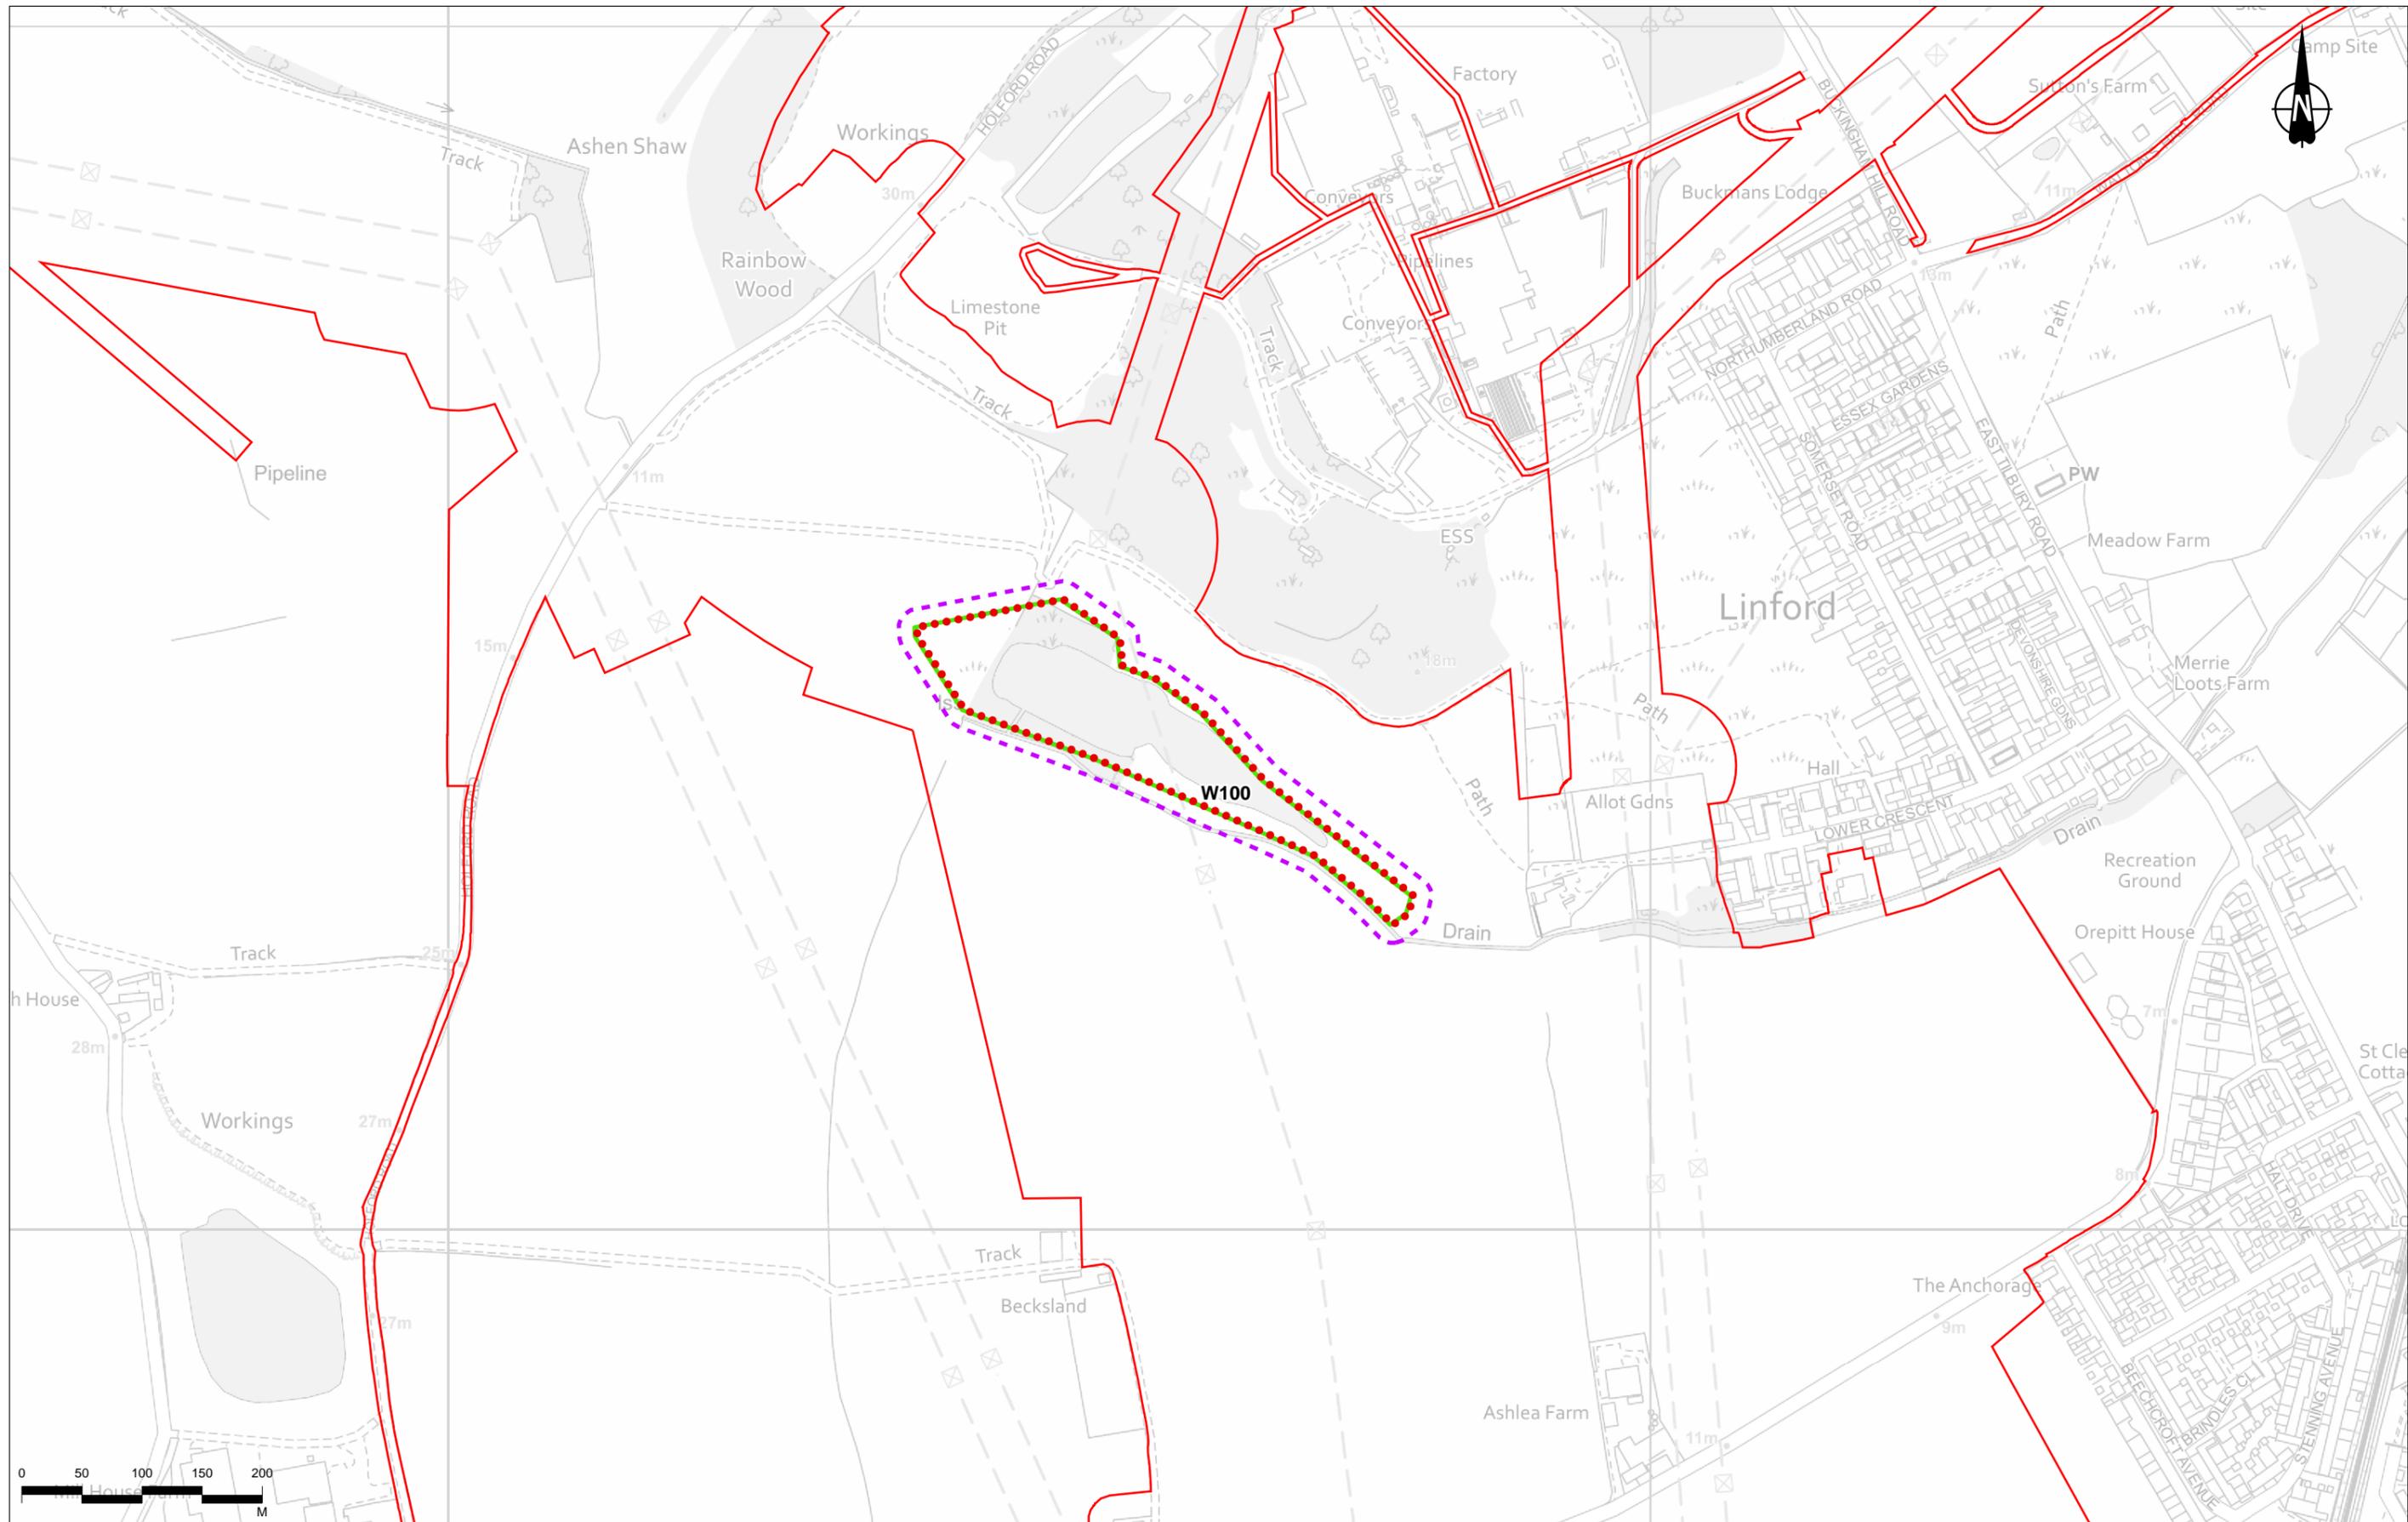
Status	DCO APPLICATION	Original Size	A3	Revision	P03
Application Document Number	TR010032/APP/6.2	Scale	1:5,000		
Drawing Title	Figure 7 - Water Vole Trapping Plan				
Page 2 of 2					
Drawing Number	HE540039-CJV-EBD-SZP_EGNE0000000-DR-LE-60110
