A57 Link Roads TR010034 7.6 Ground Investigation Report

A57 Link Roads Scheme

7.6 GROUND INVESTIGATION REPORT

Regulation Number:	Regulation 5(2)(q)
Planning Inspectorate Scheme Reference	TR010034
Application Document Reference	TR010034/APP/7.6
Author:	A57 Link Roads Scheme Project Team, Highways England

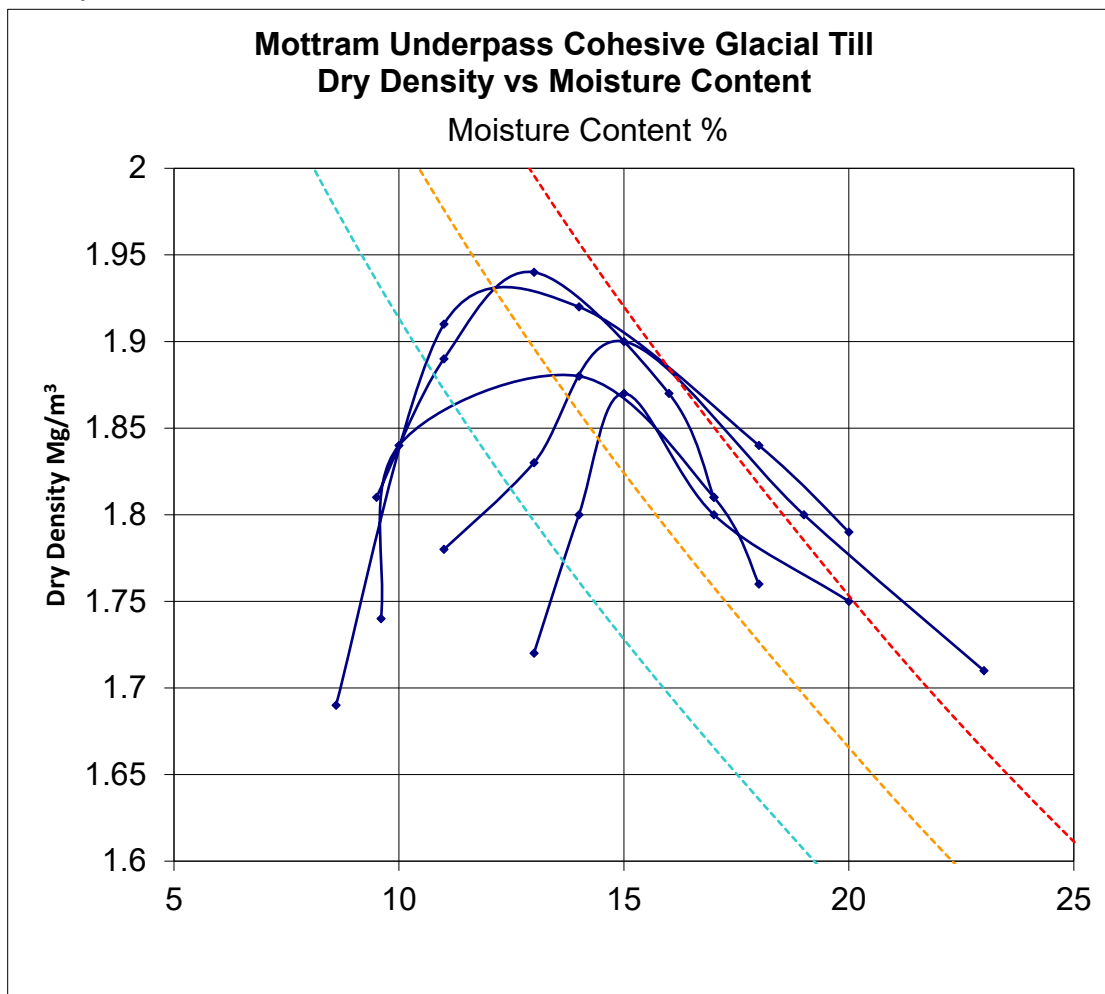
Figure 6.7.4. Mottram Underpass Cohesive Glacial Till Maximum Dry Density and Optimum Moisture Content.

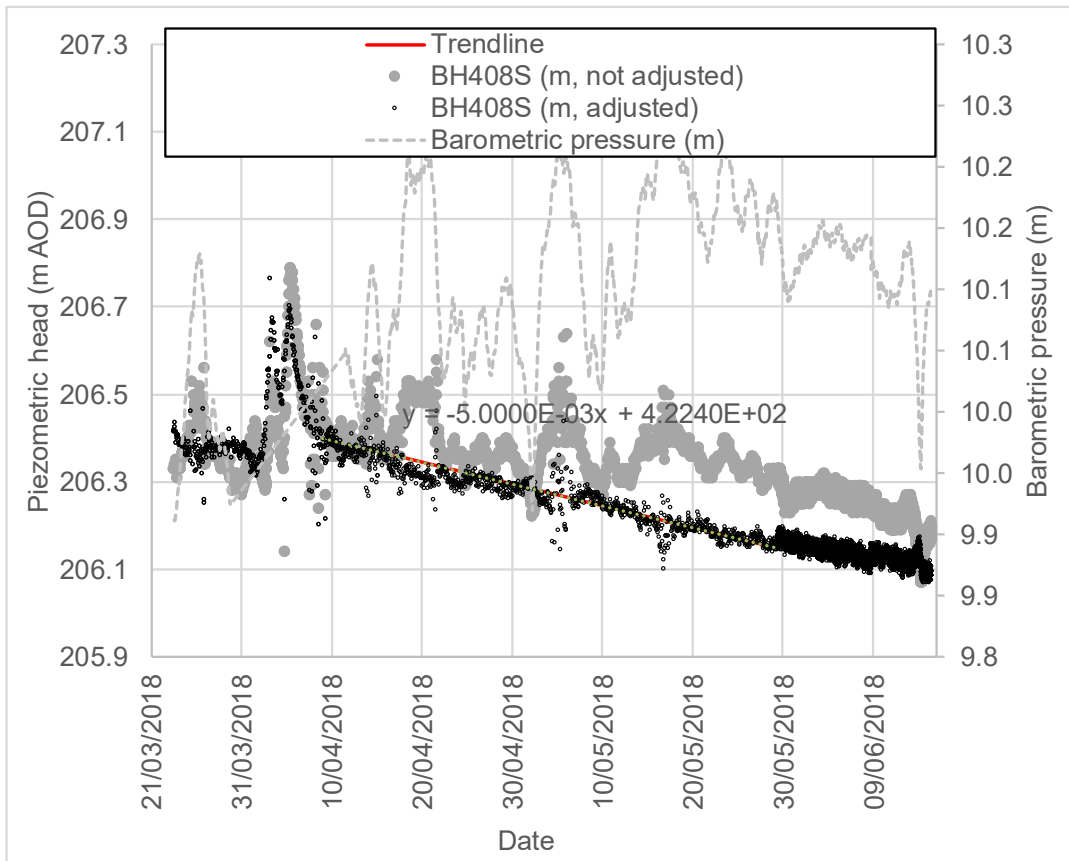
Figure A-6: BH408S Water level in the Glacial Till (Shallow).
