**A57 Link Roads
TR010034**

**6.5 Environmental Statement
Appendix 7.3 Arboricultural Impact
Assessment**

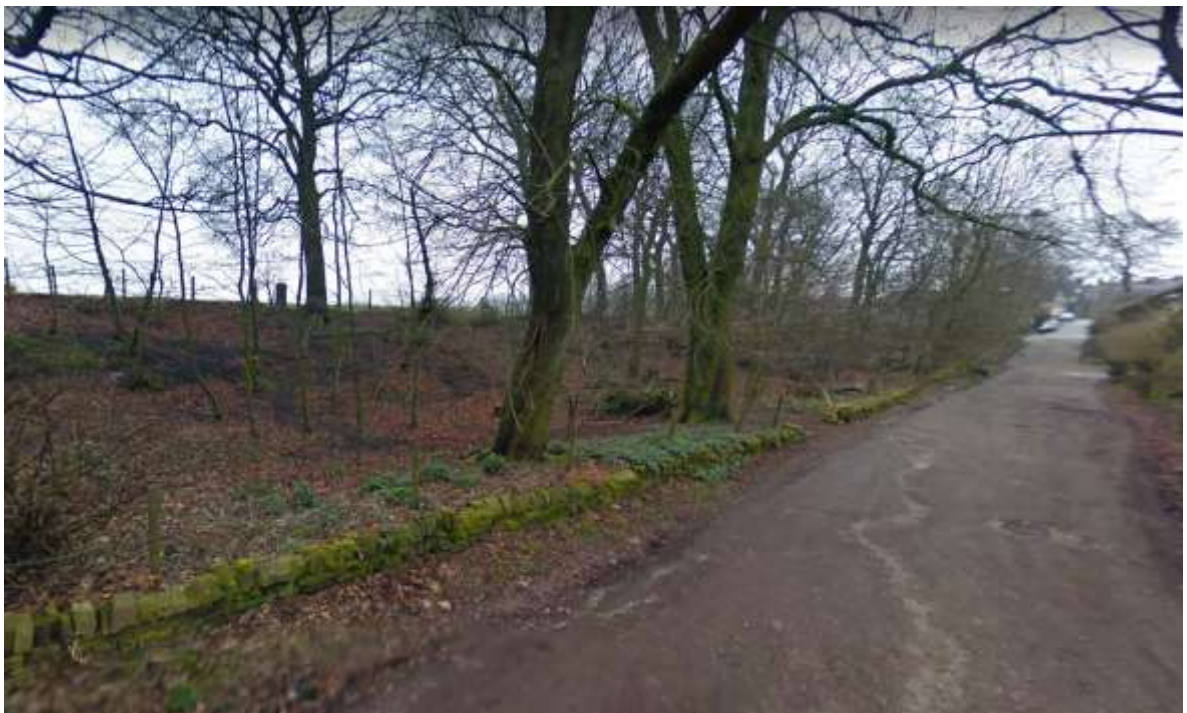
Insert 3-1: woodland W042 adjacent to Old Hall Lane (image from Google Street View)

- 3.1.4 There is a woodland group (W042) and sporadic early-mature to mature trees growing adjacent to Old Hall Lane close to the centre point of the Scheme. The woodland itself is dominated by sycamore as it extends in a south east direction from Old Hall Lane, with an understory of holly. In the area directly adjacent to Old Hall Lane it contains a variety of broad leaf species including horse chestnut, ash and beech with limited understory - see Insert 3-1 for reference.

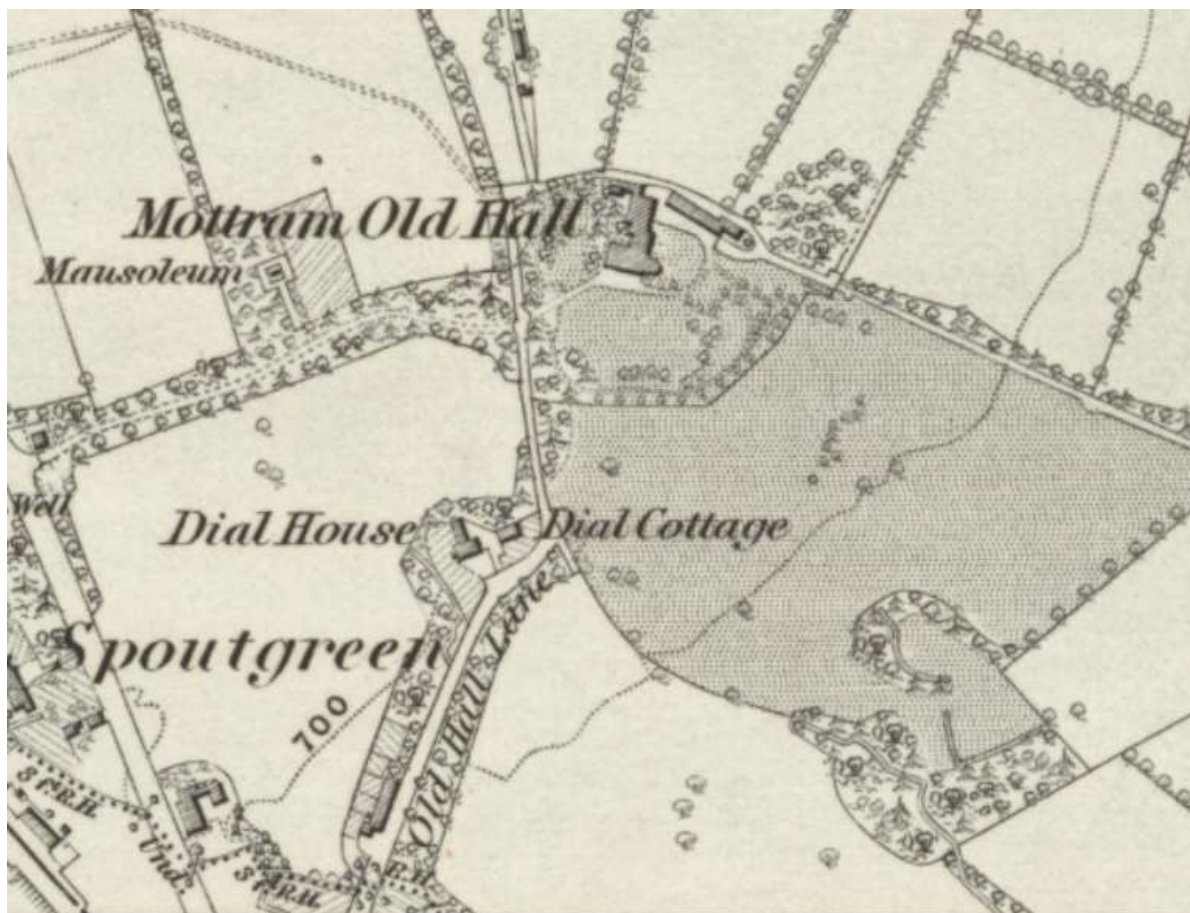
Insert 3-2: extract from 1882 ordnance survey mapping

- 3.1.5 A review of available online mapping resources indicates that Old Hall Lane has been tree-lined for many years. Insert 3-2 is an extract from the 1882 ordnance survey map. It shows Old Hall Lane having a woodland group along its east extents.

- 3.1.8 The 1882 map also shows the area within the former Mottram Show Ground to the east of Old Hall Road that is still tree-covered. The layout of the trees is influenced by the local changes in topography. The trees are a mixture of broad leaf species including sporadic mature oaks. The oldest of the oak trees is estimated (using 'Mitchell's Rule') to be up to 120 years old. There are also younger trees present with sycamore appearing to self-established in several locations.
- 3.1.9 Insert 3-4 shows an aerial view of the current layout of the trees in this location. The area can be separated into distinct areas based on the tree species and assemblage.

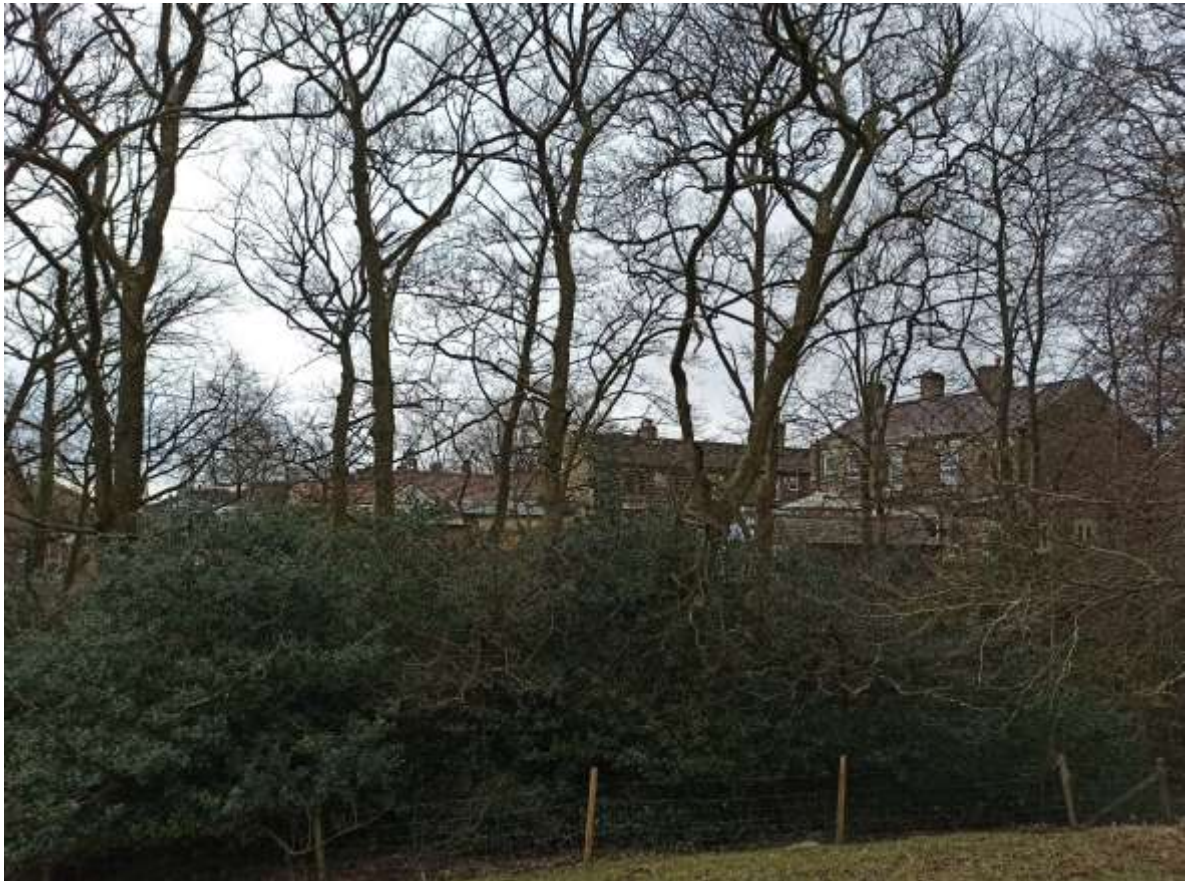
Insert 3-3: southern section of W042 adjacent to Old Hall Road

- 3.1.6 The woodland has mixed species and mixed age classifications. The mature trees include the horse chestnut reference W042A, but these are limited. Self-sown semi-mature sycamore is dominant. The mean growth in girth of most trees *with a full crown* is one inch (25 mm) a year. The estimated age of tree W042A using 'Mitchell's Rule' (Mitchell, 1974) is a minimum of 140 years old.
- 3.1.7 Insert 3-3 shows the typical woodland composition as it extends south east from Old Hall Lane, showing the presence of trees that are semi-mature to early mature and dominated by sycamore trees.

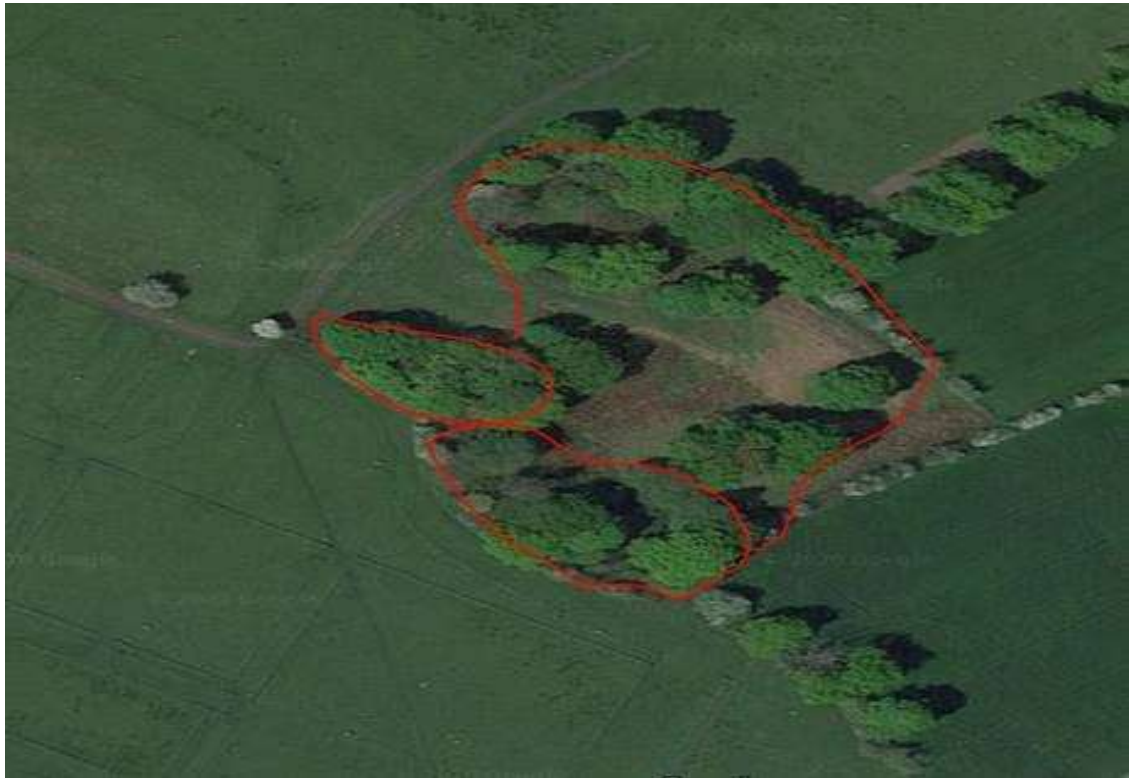
Insert 3-4: former Mottram Show Ground trees, the red outlines distinguishing the different stands (image taken from google maps)

- 3.1.10 The west section is a stand of early mature sycamore growing either side of a small drainage channel. The trees have slender drawn stems and occluded crown growth. The close spacing between the trees has induced variable quantities of dieback in crowns with up to 30% in some trees. There has been historic browsing of lower crowns by sheep and there is no understorey vegetation present.

- 3.1.12 The remaining area includes intermittent mature common oak and occasional ash, alder and sycamore specimens. The understorey includes grazing pasture and an area of saturated ground.

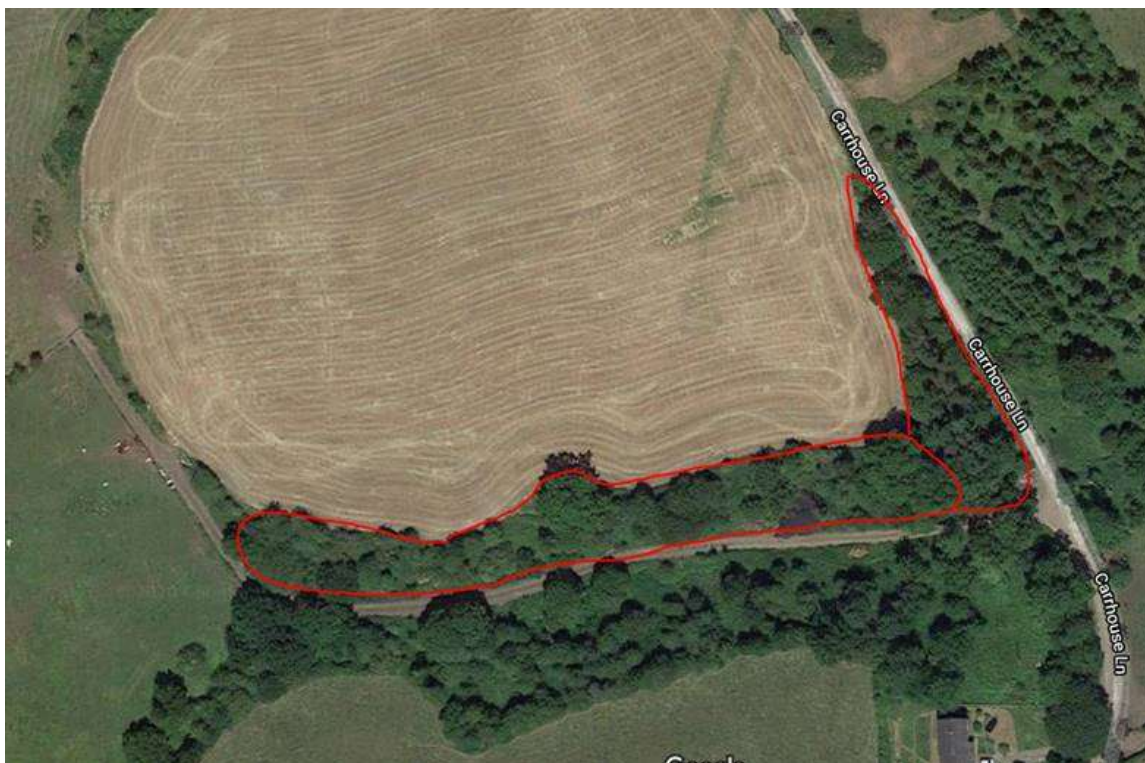
Insert 3-5: woodland area to west of Carrhouse Lane, the red outline distinguishing the different stands (image taken from google maps)

- 3.1.13 Further woodland areas are located to the south of the Scheme to the east and west of Carrhouse Lane.
- 3.1.14 The woodland to the west of Carrhouse Lane is illustrated on Insert 3-5.

- 3.1.15 The western section is an informal linear group that includes young to semi mature trees. There are mixed broadleaf species present including goat willow, ash, silver birch, hazel, cherry, hawthorn. The trees are growing on sloped bank with dense bramble present. There is a mature ash tree at the east extents of the group reference T111. A high-quality tree that is to be retained as part of the Scheme.
- 3.1.16 The eastern section is also an informal linear group containing semi-mature to early mature trees. There are mixed broadleaf and pine species present, including hybrid black poplar, Scots pine, ash, oak, hazel, hawthorn. The close spacing between the trees has led to mutual crown suppression.
- 3.1.17 The woodland to the east of Carrhouse Lane is illustrated on Insert 3-6.

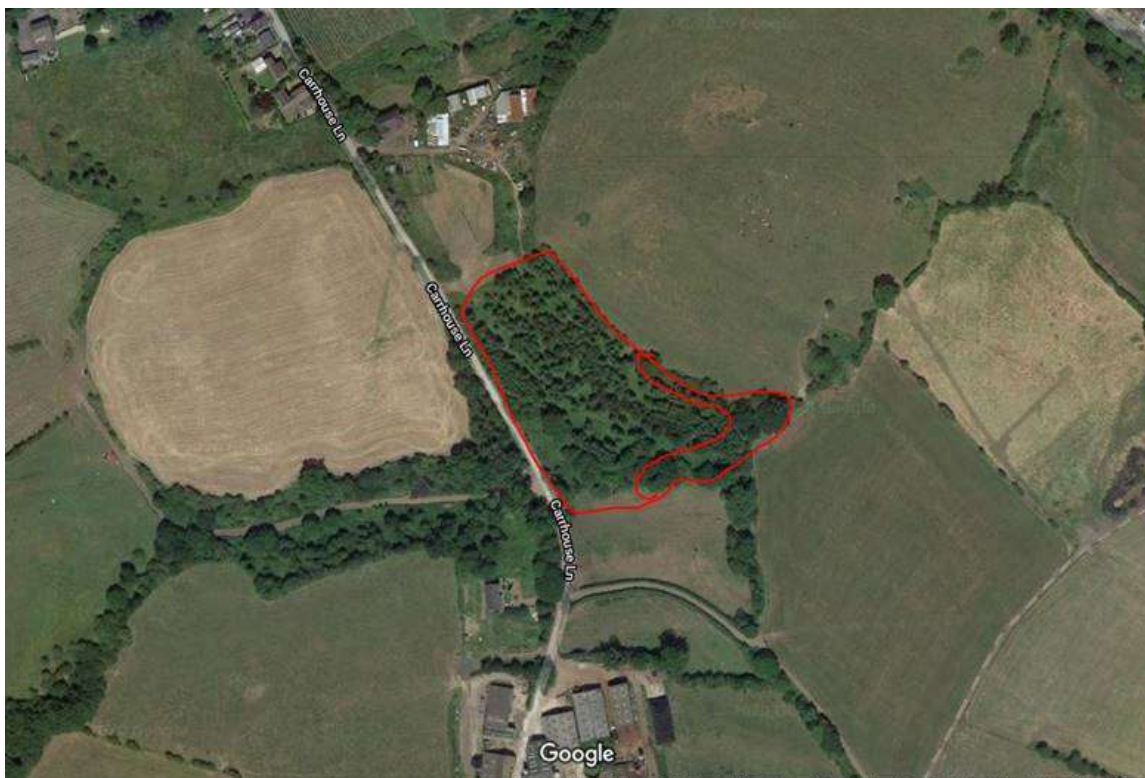
Insert 3-6: woodland area to east of Carrhouse Lane, the red outline distinguishing the different stands (image taken from google maps)

- 3.1.18 The main stand of trees covering its west extents is a Norway spruce tree plantation that also includes Scots pine and infrequent Nordmann fir. These trees are semi-mature to early-mature. There are intermittent hawthorn and saplings of ash, oak on an earth bank along the west edge.
- 3.1.19 The area to the east contains intermittent mature oak along the edge of woodland. These are trees T114, T115 and T116, which are to be retained as part of the Scheme.
- 3.1.20 The remaining trees in the south extents of the Scheme include further informal linear groups and sporadic mature trees growing on field boundaries and along the banks of the River Etherow. In some cases, the trees have been identified for preliminary management recommendations. These works being in relation to visible defects and managing the risk of harm to adjacent people or property.

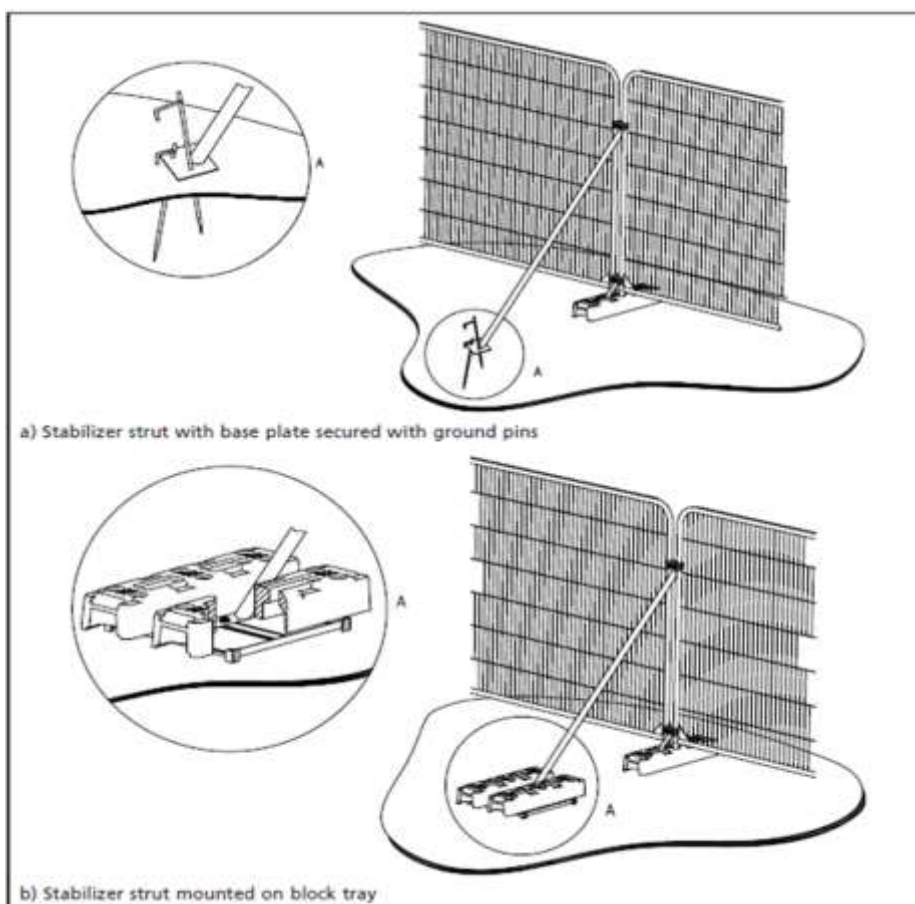
Insert 5-1: Illustrative tree protection fencing

- 5.8.4 The default specification for the protective barriers could comprise 2 m tall welded mesh panels on rubber or concrete feet or other similar protection measures. The panels would be joined together using a minimum of two anti-tamper couplers, installed so they can only be removed from inside the fence. The distance between the fence couplers is to be at least 1m and is to be uniform throughout the fence; the panels are to be supported by inner side stabiliser struts attached to a base plate secured on a block tray. See Insert 5.1 below.

- 5.8.5 For any tree or areas deemed to be of high risk to adjacent trees for extensive construction activity, the use of rigid fencing shall be considered in accordance with default specification set out in BS5837:2012, with the stabiliser strut to be fixed to a post that is set in concrete. Any excavation for supporting post is to be undertaken by hand and surrounded by an impermeable geotextile as curing cement is toxic to tree roots.
