**A57 Link Roads**

**TR010034**

**6.5 Environmental Statement  
Appendix 8.3 Aquatic Ecology**

January 2022

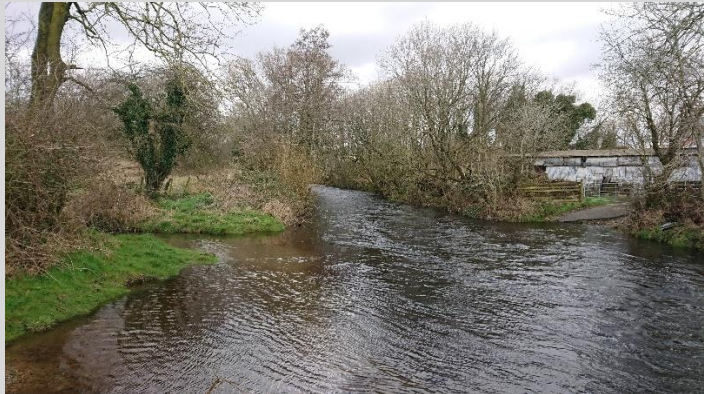
**Table 3.4: River Etherow (WC\_100) baseline**

<p data-bbox="300 1281 826 1346">Photo DSC_0960 – River Etherow past ford (SK 00906 95652).</p>	<p data-bbox="1034 882 1417 1128"><b>Baseline Ecological Valuation:</b> The River Etherow (WC_100) is a mainstem river, providing principal aquatic habitat connectivity for fish and other aquatic species throughout the region and has been ascribed a value of Regional importance.</p>
<p data-bbox="300 1361 576 1395"><b>WFD Characterisation:</b></p> <p data-bbox="300 1402 1358 1462">Note: The River Etherow is split into two WFD water bodies within the study area, both of which were classified in 2019.</p> <ul data-bbox="300 1473 1414 2058" style="list-style-type: none"> <li>• Classified WFD Waterbody – Etherow (Woodhead Res. to Glossop Bk.) – Heavily Modified Water Body (HMWB)           <ul style="list-style-type: none"> <li>– Overall Water Body Status – Moderate</li> <li>– Overall Ecological Status of WFD Waterbody – Moderate</li> <li>– Macrophytes and Phytobenthos Combined classification – Good</li> <li>– Fish classification – Poor</li> <li>– Invertebrate classification – Good</li> <li>– Reasons for Not Achieving Good: Physical modification and invasive non-native species</li> </ul> </li> <li>• Classified WFD Waterbody – Etherow (Glossop Brook to Goyt) – HMWB</li> <li>• Classified WFD Catchment – Etherow (Glossop Brook to Goyt)           <ul style="list-style-type: none"> <li>– Overall Water Body Status – Poor</li> <li>– Overall Ecological Status of WFD Waterbody – Poor</li> <li>– Macrophytes and Phytobenthos Combined classification – Moderate</li> <li>– Fish classification – Poor</li> <li>– Invertebrate classification – Good</li> </ul> </li> </ul>

- Spot check location: SK 00906 95652
- Summary: The 250 m walkover survey of the River Etherow measured a wetted width of 8.0 m, a bankfull width of 12.0 m and an unknown depth due to inability to survey and no visibility of the bed. The banks are predominantly comprised of earth. The channel planform has some sinuosity and the flow type at time of survey was rippled. Over the survey reach, one artificial ford was observed, along with overhanging boughs and urban trash. There are semi-continuous trees on both banks. The valley form is U-shaped.

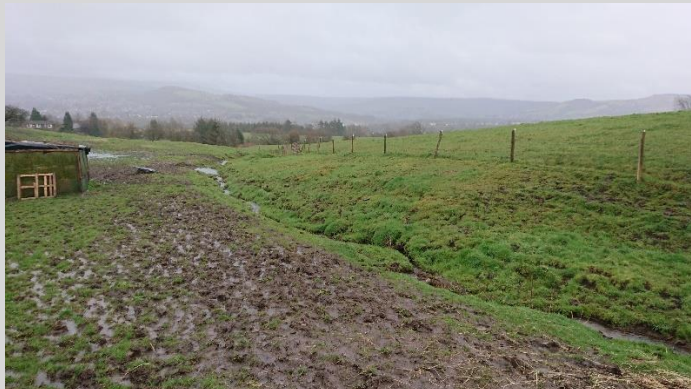
**Table 3.5: Tara Brook (WC\_200) baseline**

<p>Photo DSC_0927 – Typical view upstream reach within DCO boundary (SJ 99814 95771)</p>	<p>Baseline Ecological Valuation: Tributary system of the River Etherow (WC_100). Upper reaches are heavily poached and not suitable for fish or other truly aquatic species. No notable aquatic macroinvertebrate species were recorded, and extensive invasive Himalayan balsam further reduces condition of the reach within the DCO boundary. However, further downstream the feature exhibits greater diversity and quality of habitat and potential for fish. Overall, the feature is considered to provide an important aquatic linear corridor within the local agricultural landscape and is considered to be of Local importance.</p>
  <p>Photo DSC_0933 – Typical view downstream reach outside DCO boundary (SK 00757 95749)</p>	
<p>WFD Characterisation:</p> <ul style="list-style-type: none"> <li>• Classified WFD Waterbody – No</li> <li>• Classified WFD Waterbody Catchment – Etherow (Woodhead Res. to Glossop Bk.)</li> <li>• Overall waterbody status – Moderate</li> </ul>

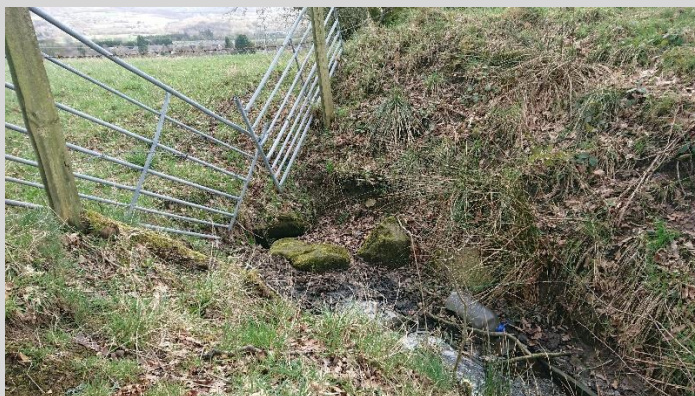
Photo DSC\_0973 – WC\_212 (SJ 99513 96082)

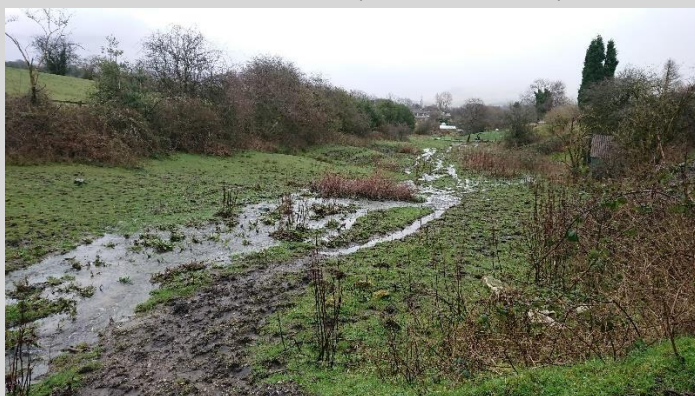
Photo DSC\_0919 – View of WC\_210, immediately downstream of WC\_211 where there is no clear channel form (SJ 99744 95895).

- Spot check location: SJ 99746 95893
- Summary: Watercourse WC\_210 was identified as having no clear banks, therefore having a wetted width and bankfull width of 1.8 m, with a wetted depth of 0.18 m. The bed substrate is 85 % sand and 10 % gravel, and the predominant bank material is earth. The channel planform is characterised as braided irregular meanders and the flow type was 90% rippled. The channel contained trash and trees were observed on both banks, set back from the channel. The valley form is U-shaped.
- Survey limitations: Access was restricted during the walkover survey so a rapid assessment proforma (spot check) was only undertaken on WC\_210. Previous project data (namely RCS) are considered to provide adequate detail of these watercourses for assessment.

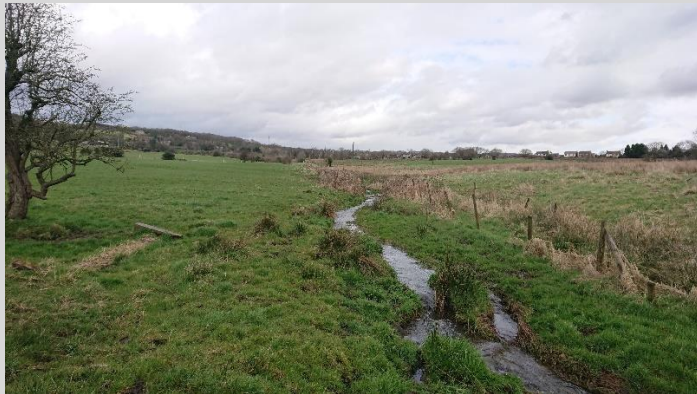
**Table 3.7: Hurstclough Brook (WC\_300) baseline**

<p data-bbox="300 714 908 777">Photo DSC_0877 – Downstream near existing A57 (SJ 98668 95445)</p>	<p data-bbox="1027 315 1422 622">Baseline Ecological Valuation: No notable aquatic macroinvertebrate species were recorded. However, Hurstclough Brook is an important feature for dispersal and connectivity for a limited range of aquatic species within the local context and has been ascribed a value of Local importance.</p>
<p data-bbox="300 795 576 826">WFD Characterisation:</p> <ul data-bbox="300 837 1217 947" style="list-style-type: none"> <li>• Classified WFD Waterbody – No</li> <li>• Classified WFD Waterbody Catchment – Etherow (Glossop Brook to Goyt)</li> <li>• Overall waterbody status – Poor</li> </ul>	
<p data-bbox="300 969 863 1001">River Corridor Survey (RCS2; May/June 2018):</p> <ul data-bbox="300 1010 1390 1232" style="list-style-type: none"> <li>• Location: between SJ 98888 96228 and SJ 98666 95441.</li> <li>• Summary: The Hurstclough Brook is a small meandering stream through cattle grazed grassland, in which the lower sections of the stream were cattle poached. The upper sections of the channel were vegetated with floating sweet-grass (<i>Glyceria fluitans</i>) and brooklime. Vegetation on the banks included water figwort, Himalayan balsam and spear thistle (<i>Cirsium vulgare</i>). The adjacent land-use was improved, and semi-improved acid grassland used for grazing.</li> </ul>

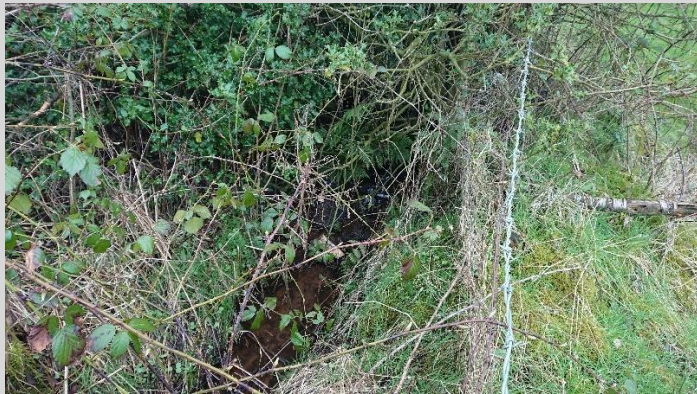
**Table 3.8: Unnamed watercourse (WC\_340) baseline**

<p>Photo DSC_0896 – Typical view of overgrown scrub across the channel (SJ 98569 95411).</p>	<p>Baseline Ecological Valuation:            Minor tributary system of the Hurstclough Brook (WC_300). Field boundary ditch &lt;1 m wide. Not suitable for fish and limited potential for other truly aquatic species. However, the feature does provide an important aquatic linear corridor within the local agricultural landscape and are thus is considered to be of Local importance.</p>
<p>WFD Characterisation:</p> <ul style="list-style-type: none"> <li>• Classified WFD Waterbody – No</li> <li>• Classified WFD Waterbody Catchment – Etherow (Glossop Brook to Goyt)</li> <li>• Overall waterbody status – Poor</li> </ul>	
<p>River Corridor Survey (RCS1; May/June 2018):</p> <ul style="list-style-type: none"> <li>• Location: between SJ 98414 95550 and SJ98574 95410.</li> <li>• Summary: The river corridor of the WC_340 at Grange Farm is a narrow drainage ditch flowing along a field margin and very overgrown. The channel has steep banks at approximately 1.5 m and is approximately 0.5 m wide. The channel and banks contained species such as common hogweed and Himalayan balsam. A hedgerow also shaded much of the channel. The banks were fenced off and tall ruderal vegetation had developed. Overhanging silver birch was also present. The adjacent land-use on either side of the channel was improved grassland; this was a marshy grassland used for grazing.</li> </ul>

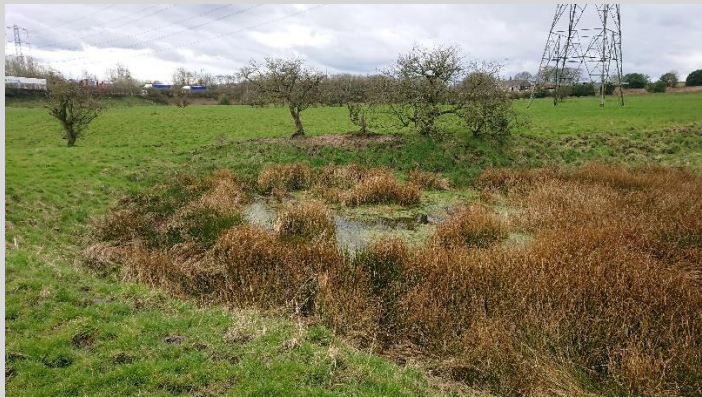
**Table 3.10: Pond 2 baseline**

<p>Baseline Ecological Valuation: Local importance</p>
<p>Photo DSC_0888 (SJ 98648 95559)</p>	
<p>Existing data sources</p> <ul style="list-style-type: none"> <li>• Designated sites: None</li> <li>• Ecological records: None</li> </ul>	
<p>PSYM (18 August 2020)</p> <ul style="list-style-type: none"> <li>• Summary: relatively small (100m<sup>2</sup>) semi-permanent pond resembling a small quaking bog in parts, located in the bottom of the valley within grazing pasture. One inflow was recorded at the time of survey and is considered likely to remain wet throughout the year, although was recorded as almost dry in April/May 2017. Emergent plant cover was low (5%) comprising soft-rush. Despite an absence of shading only two other plant species were recorded, common duckweed (<i>Lemna minor</i>) and a moss (<i>Sphagnum</i> sp.). Water quality sampling shows the pond to be alkaline (pH8).</li> <li>• Priority Habitat Assessment: The pond does not meet published criteria for definition as Priority Habitat.</li> </ul>

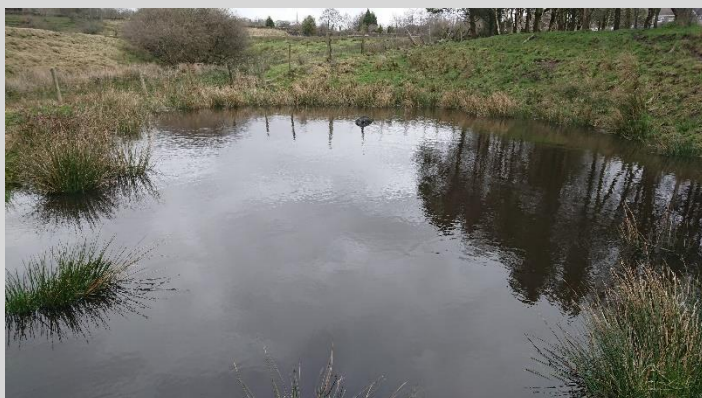
**Table 3.11: Pond 5 baseline**

<p>Baseline Ecological Valuation: Local importance</p>
<p>Photo DSC_0907 (SJ 98904 95935)</p>	
<p>Existing data sources</p> <ul style="list-style-type: none"> <li>• Designated sites: None</li> <li>• Ecological records: None</li> </ul>

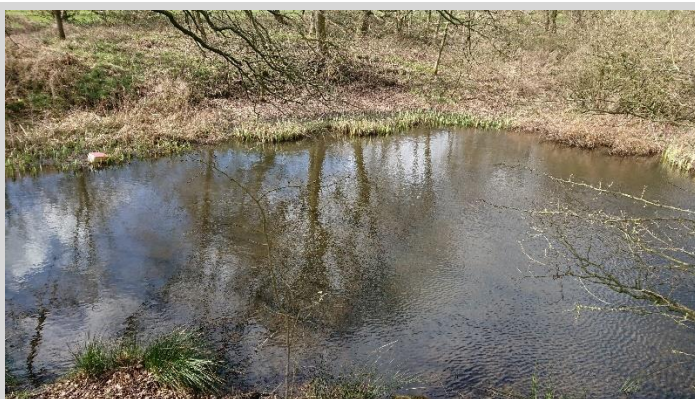
**Table 3.12: Pond 7 baseline**

Photo DSC\_0970 (SJ 99513 96082)

Baseline Ecological Valuation:  
 Local importance

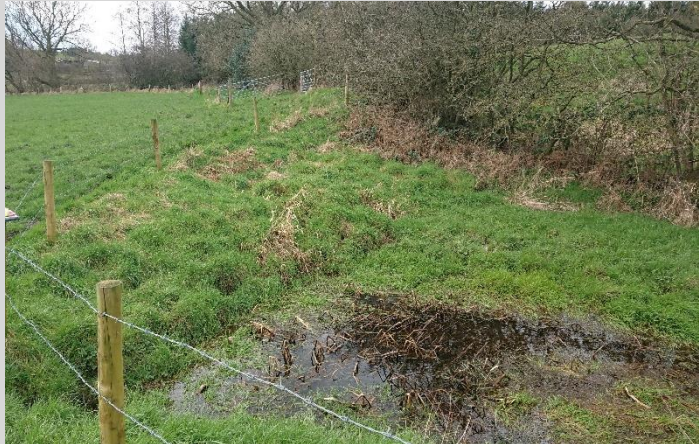
**Table 3.13: Pond 30 baseline**

<p data-bbox="300 772 738 801">Photo DSC_0956 (SK 00433 95633)</p>	<p data-bbox="1034 322 1398 389">Baseline Ecological Valuation: Local importance</p>
<p data-bbox="300 826 560 855">Existing data sources</p> <ul data-bbox="300 864 635 931" style="list-style-type: none"> <li>• Designated sites: None</li> <li>• Ecological records: None</li> </ul>	
<p data-bbox="300 956 593 985">PSYM (18 August 2020)</p> <ul data-bbox="300 994 1428 1245" style="list-style-type: none"> <li>• Summary: pond with an open water area of 150 m<sup>2</sup> located within grazing pasture. The pond is partially fenced but does not limit livestock access. Predominantly terrestrial grasses present suggesting either temporarily/recently wetted or raised level. No inflow recorded at the time of survey, but groundwater input is considered likely. No shading or emergent vegetation were recorded. Three submerged and marginal species were recorded but none were noted as uncommon. Water quality sampling indicates the pond is alkaline (pH8.36).</li> <li>• Priority Habitat Assessment: the pond does not meet published criteria for definition as Priority Habitat.</li> </ul>
