A57 Link Roads

**9.33 Environmental Statement
Appendix 8.3 Aquatic Ecology
(Tracked)**

9.33 Environmental Statement Appendix 8.3 Aquatic Ecology (Tracked)

Regulation Number:	Rule 8(1)(k)
Planning Inspectorate Scheme Reference	TR010034
Application Document Reference	TR010034/APP/9.33
Author:	A57 Link Roads Project Team, National Highways and Atkins

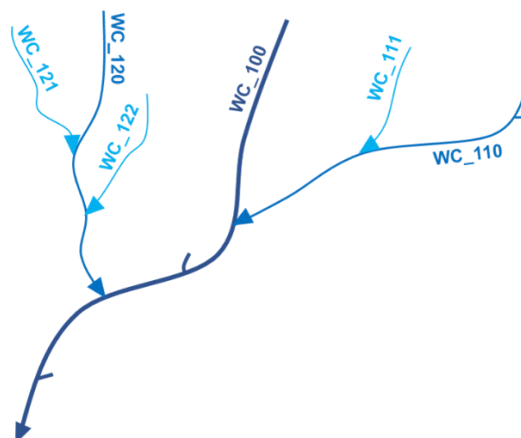
Insert 2.1: Watercourse identification code convention

- 2.4.7 The approach also accommodates ordering of incoming tributaries from upstream to downstream (e.g. WC_110 joins WC_100 upstream of WC_120). Where there are very short (< 100 m in length) tributaries of a watercourse, these are incorporated into the code for the watercourse they are joining as one combined functional receptor. Watercourses which are located within 1km of the DCO boundary (a study area applied within Chapter 13: Road Drainage and the Water Environment), but flow into a major named watercourse outside of this buffer, are given the first digit 0 (i.e. “WC_0xx”).

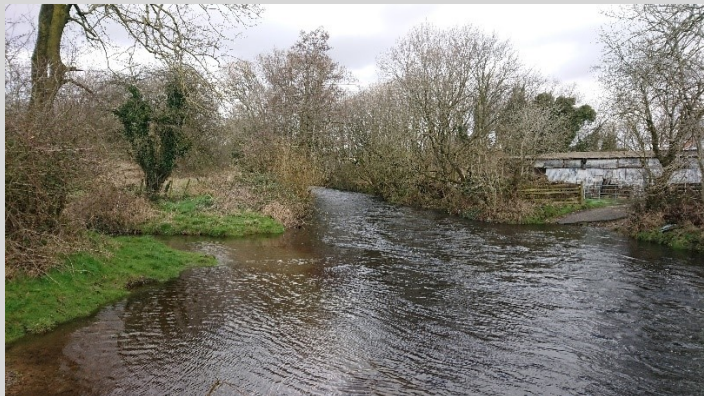
Table 3.4: River Etherow (WC_100) baseline

<p>Baseline Ecological Valuation: The River Etherow (WC_100) is a mainstem river, providing principal aquatic habitat connectivity for fish and other aquatic species throughout the region and has been ascribed a value of Regional importance.</p>
<p>WFD Characterisation: Note: The River Etherow is split into two WFD water bodies within the study area, both of which were classified in 2019.</p> <ul style="list-style-type: none"> • Classified WFD Waterbody – Etherow (Woodhead Res. to Glossop Bk.) – Heavily Modified Water Body (HMWB) <ul style="list-style-type: none"> – Overall Water Body Status – Moderate – Overall Ecological Status of WFD Waterbody – Moderate – Macrophytes and Phytobenthos Combined classification – Good – Fish classification – Poor – Invertebrate classification – Good – Reasons for Not Achieving Good: Physical modification and invasive non-native species • Classified WFD Waterbody – Etherow (Glossop Brook to Goyt) – HMWB • Classified WFD Catchment – Etherow (Glossop Brook to Goyt) <ul style="list-style-type: none"> – Overall Water Body Status – Poor – Overall Ecological Status of WFD Waterbody – Poor – Macrophytes and Phytobenthos Combined classification – Moderate – Fish classification – Poor – Invertebrate classification – Good

Photo DSC_0960 – River Etherow past ford (SK 00906 95652).

- Spot check location: SK 00906 95652
- Summary: The 250 m walkover survey of the River Etherow measured a wetted width of 8.0 m, a bankfull width of 12.0 m and an unknown depth due to inability to survey and no visibility of the bed. The banks are predominantly comprised of earth. The channel planform has some sinuosity and the flow type at time of survey was rippled. Over the survey reach, one artificial ford was observed, along with overhanging boughs and urban trash. There are semi-continuous trees on both banks. The valley form is U-shaped.

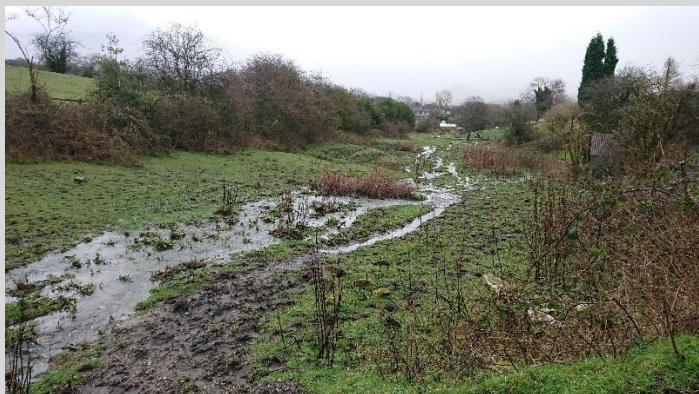
<p>Photo DSC_0919 – View of WC_210, immediately downstream of WC_211 where there is no clear channel form (SJ 99744 95895).</p>	<p>Baseline Ecological Valuation: Minor tributary systems of the Tara Brook (WC_200). Typically, field boundary ditches or modified semi-natural surface water flow paths draining hillsides <1 m wide. Limited potential for fish and other truly aquatic species. However, they provide an important aquatic linear corridor within the local agricultural landscape and are thus considered to be of Local importance.</p>
<p>WFD Characterisation:</p> <ul style="list-style-type: none"> • Classified WFD Waterbody – No • Classified WFD Waterbody Catchment – Etherow (Woodhead Res. to Glossop Bk.) • Overall waterbody status – Poor 	
<p>River Corridor Survey 3 (RCS3; May/June 2018):</p> <ul style="list-style-type: none"> • Location: between SJ 99265 96075 and SJ 99596 95877 • Summary: The river corridor (of WC_211) flows through a broad-leaved woodland, bordered by residential properties on the south-eastern bank. The channel is very steep sided and has been incorporated into gardens in some locations. Invasive plant species and badger setts were observed. There was no vegetation within the channel, however, Himalayan balsam was well-established on both banks along the lower course of the river. The northern bank was heavily vegetated with broad-leaved woodland overhanging the channel, particularly grey willow (<i>Salix cinerea</i>), silver birch, sycamore, horse chestnut (<i>Aesculus hippocastanum</i>) and beech (<i>Fagus sylvatica</i>). <p>River Corridor Survey (RCS4; May/June 2018):</p> <ul style="list-style-type: none"> • Location: between SJ 99504 96082 and SJ 99596 95877. • Summary: The RCS for the stream at Mottram Moor consists of drainage ditches (WC_212 and WC_213) along field margins, with a pond in the upper course (P7). Where water was present within the channel, there was a lack of vegetation. However, in dry reaches there were soft-rush (<i>Juncus effusus</i>), Yorkshire fog, Himalayan balsam, creeping buttercup, marsh thistle (<i>Cirsium palustre</i>), and great willowherb. On the banks of the channel were

- Spot check location: SJ 99746 95893
- Summary: Watercourse WC_210 was identified as having no clear banks, therefore having a wetted width and bankfull width of 1.8 m, with a wetted depth of 0.18 m. The bed substrate is 85 % sand and 10 % gravel, and the predominant bank material is earth. The channel planform is characterised as braided irregular meanders and the flow type was 90% rippled. The channel contained trash and trees were observed on both banks, set back from the channel. The valley form is U-shaped.
- Survey limitations: Access was restricted during the walkover survey so a rapid assessment proforma (spot check) was only undertaken on WC_210. Previous project data (namely RCS) are considered to provide adequate detail of these watercourses for assessment.

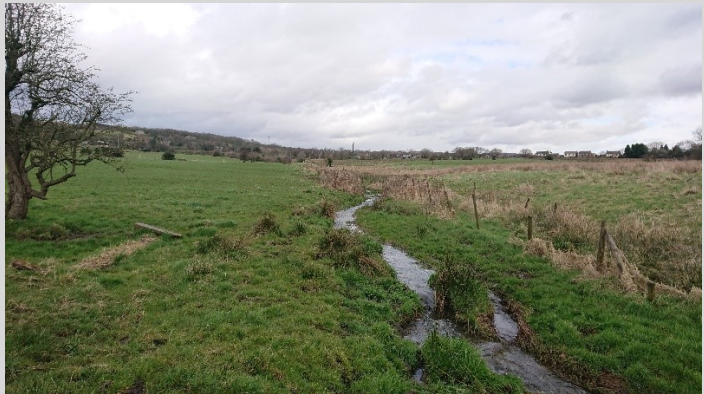
Table 3.7: Hurstclough Brook (WC_300) baseline

<p data-bbox="300 712 911 775">Photo DSC_0877 – Downstream near existing A57 (SJ 98668 95445)</p>	<p data-bbox="1026 315 1420 622">Baseline Ecological Valuation: No notable aquatic macroinvertebrate species were recorded. However, Hurstclough Brook is an important feature for dispersal and connectivity for a limited range of aquatic species within the local context and has been ascribed a value of Local importance.</p>
<p data-bbox="300 797 576 824">WFD Characterisation:</p> <ul data-bbox="300 835 1217 947" style="list-style-type: none"> • Classified WFD Waterbody – No • Classified WFD Waterbody Catchment – Etherow (Glossop Brook to Goyt) • Overall waterbody status – Poor 	
<p data-bbox="300 969 863 996">River Corridor Survey (RCS2; May/June 2018):</p> <ul data-bbox="300 1008 1385 1227" style="list-style-type: none"> • Location: between SJ 98888 96228 and SJ 98666 95441. • Summary: The Hurstclough Brook is a small meandering stream through cattle grazed grassland, in which the lower sections of the stream were cattle poached. The upper sections of the channel were vegetated with floating sweet-grass (<i>Glyceria fluitans</i>) and brooklime. Vegetation on the banks included water figwort, Himalayan balsam and spear thistle (<i>Cirsium vulgare</i>). The adjacent land-use was improved, and semi-improved acid grassland used for grazing.

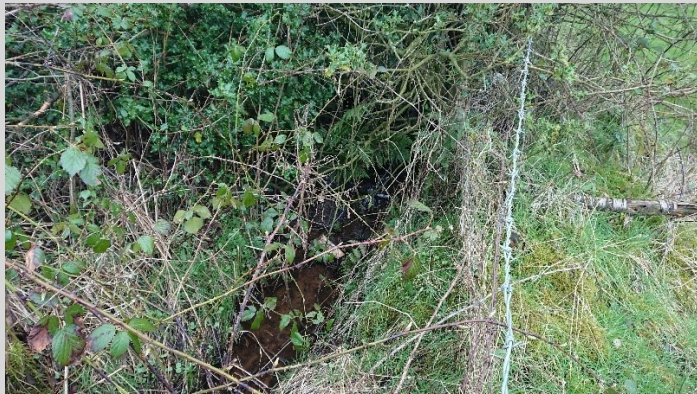
Table 3.8: Unnamed watercourse (WC_340) baseline

<p>Photo DSC_0896 – Typical view of overgrown scrub across the channel (SJ 98569 95411).</p>	<p>Baseline Ecological Valuation: Minor tributary system of the Hurstclough Brook (WC_300). Field boundary ditch <1 m wide. Not suitable for fish and limited potential for other truly aquatic species. However, the feature does provide an important aquatic linear corridor within the local agricultural landscape and are thus is considered to be of Local importance.</p>
<p>WFD Characterisation:</p> <ul style="list-style-type: none"> • Classified WFD Waterbody – No • Classified WFD Waterbody Catchment – Etherow (Glossop Brook to Goyt) • Overall waterbody status – Poor 	
<p>River Corridor Survey (RCS1; May/June 2018):</p> <ul style="list-style-type: none"> • Location: between SJ 98414 95550 and SJ98574 95410. • Summary: The river corridor of the WC_340 at Grange Farm is a narrow drainage ditch flowing along a field margin and very overgrown. The channel has steep banks at approximately 1.5 m and is approximately 0.5 m wide. The channel and banks contained species such as common hogweed and Himalayan balsam. A hedgerow also shaded much of the channel. The banks were fenced off and tall ruderal vegetation had developed. Overhanging silver birch was also present. The adjacent land-use on either side of the channel was improved grassland; this was a marshy grassland used for grazing.

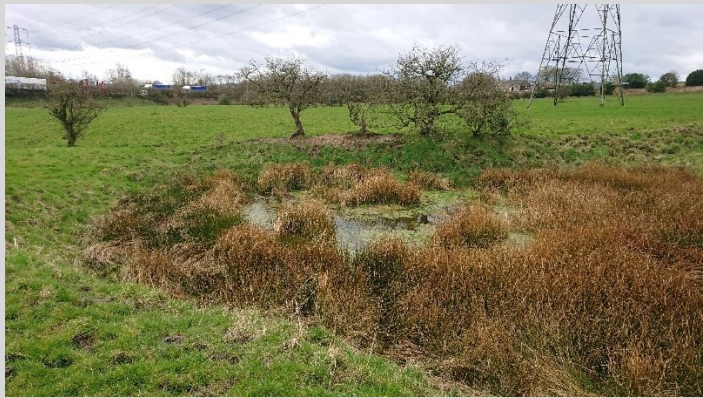
Table 3.10: Pond 2 baseline

<p>Baseline Ecological Valuation: Local importance</p>
<p>Photo DSC_0888 (SJ 98648 95559)</p>	
<p>Existing data sources</p> <ul style="list-style-type: none"> • Designated sites: None • Ecological records: None 	
<p>PSYM (18 August 2020)</p> <ul style="list-style-type: none"> • Summary: relatively small (100m²) semi-permanent pond resembling a small quaking bog in parts, located in the bottom of the valley within grazing pasture. One inflow was recorded at the time of survey and is considered likely to remain wet throughout the year, although was recorded as almost dry in April/May 2017. Emergent plant cover was low (5%) comprising soft-rush. Despite an absence of shading only two other plant species were recorded, common duckweed (<i>Lemna minor</i>) and a moss (<i>Sphagnum</i> sp.). Water quality sampling shows the pond to be alkaline (pH8). • Priority Habitat Assessment: The pond does not meet published criteria for definition as Priority Habitat.

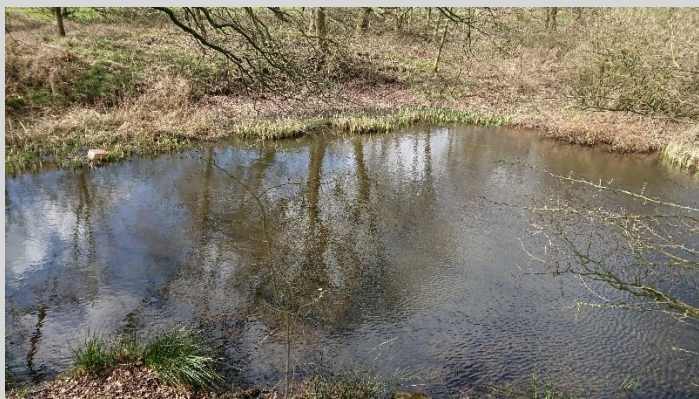
Table 3.12: Pond 7 baseline

Baseline Ecological Valuation: Local importance
Photo DSC_0970 (SJ 99513 96082)	
Existing data sources <ul style="list-style-type: none"> • Designated sites: None • Ecological records: None 	
PSYM (18 August 2020) <ul style="list-style-type: none"> • Summary: shallow pond with an open water area of 200 m² located within grazing pasture but fenced preventing livestock access. One inflow was recorded at the time of survey. Vegetation provides shade across 50% of the pond although no emergent plant cover was recorded. In total seven species of submerged and marginal plants were recorded with one noted as uncommon, flat-stalked pondweed (<i>Potamogeton friesii</i>). Water quality sampling indicates the pond is slightly alkaline (pH 7.8). • Priority Habitat Assessment: the pond does not meet published criteria for definition as Priority Habitat.

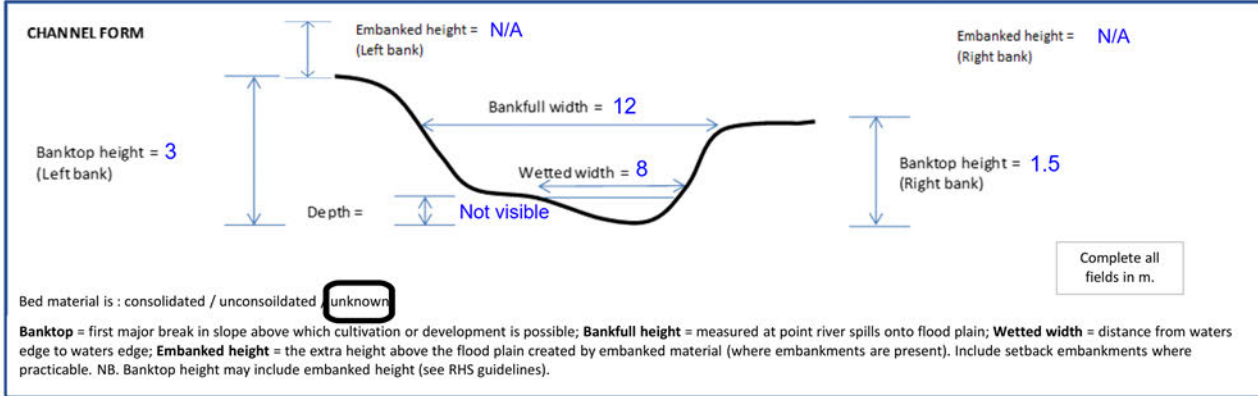
River habitat spot check form

Project/Site name: A57	Approx. survey reach length: 250 m	Photo no. DSC_960-963	NGR SK 00906 95652
Watercourse name: River Etherow (WC 100)	Adverse conditions? Yes / <input checked="" type="checkbox"/> No	DSC_964	SK 00920 95551
u/s NGR: SK0090695652	If yes, please state:		
	Surveyed from: LB / <input checked="" type="checkbox"/> RB Channel		
Survey date and time: 12/03/2020 11:20	Is bed of river visible? Yes / <input checked="" type="checkbox"/> No		
Surveyor name: NL + ED	River or artificial channel? River

Bed substrates	Tick if present	% area
Bedrock	<input type="checkbox"/>	---
Cobble	<input type="checkbox"/>	---
Boulder	<input type="checkbox"/>	---
Pebble	<input type="checkbox"/>	---
Gravel	<input type="checkbox"/>	---
Sand	<input type="checkbox"/>	---
Silt/clay	<input type="checkbox"/>	---
Peat	<input type="checkbox"/>	---
Earth	<input type="checkbox"/>	---
Artificial	<input type="checkbox"/>	---
Not visible	<input checked="" type="checkbox"/>	---

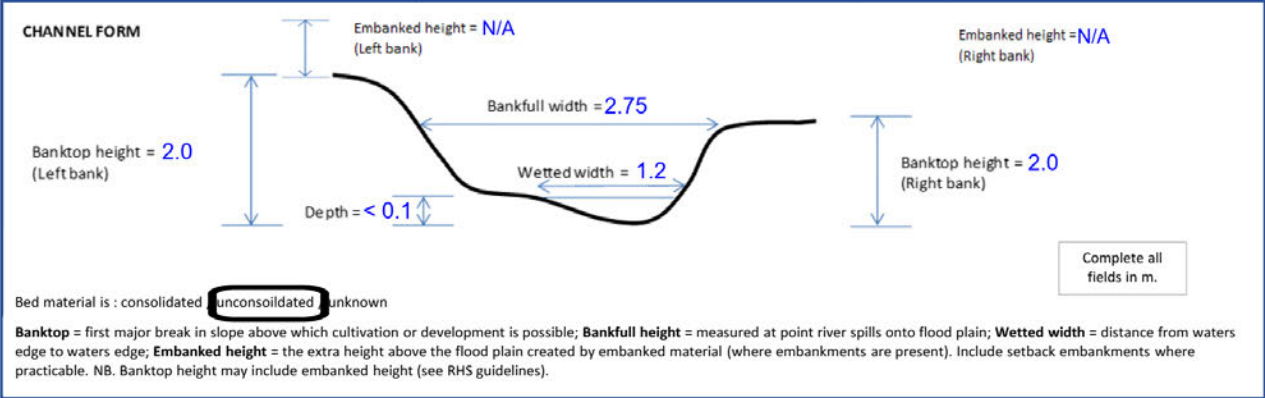
River habitat spot check form

Project/site name: A57	Approx. survey reach length: 50 m	Photo no. NGR
Watercourse name: WC_140	Adverse conditions? Yes / No	DSC_937 SK 00449 95396
u/s NGR: SK 00449 95396	If yes, please state:	
Reach aligned with RCS8	Surveyed from: (LB) RB / Channel	
Survey date and time: 12/03/2020 09:50	Is bed of river visible? Yes / No	
Surveyor name: NL + ED	River or artificial channel? Ditch

Bed substrates	Tick if present	% area
Bedrock	<input type="checkbox"/>	—
Cobble	<input checked="" type="checkbox"/>	80
Boulder	<input type="checkbox"/>	—
Pebble	<input type="checkbox"/>	—
Gravel	<input checked="" type="checkbox"/>	15
Sand	<input checked="" type="checkbox"/>	5
Silt/clay	<input type="checkbox"/>	—
Peat	<input type="checkbox"/>	—
Earth	<input type="checkbox"/>	—
Artificial	<input type="checkbox"/>	—
Not visible	<input type="checkbox"/>	—

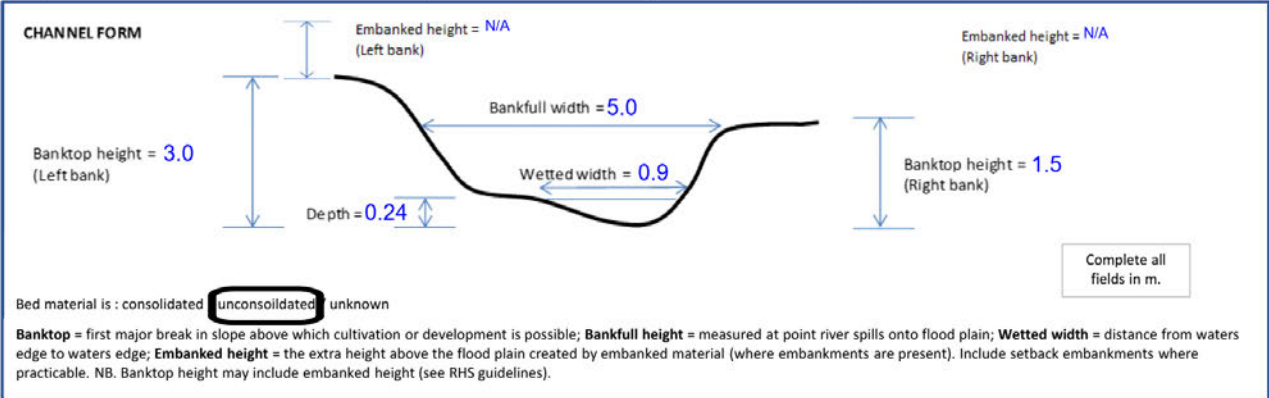
River habitat spot check form

Project/Site name: A57	Approx. survey reach length: 100 m	Photo no. NGR
Watercourse name: WC_140	Adverse conditions? Yes / No	DSC_949-950 SK 00250 95573
u/s NGR: SK 00222 95570	If yes, please state:	DSC_950-955 SK 00220 95568
Reach aligned with RCS9	Surveyed from: (LB) / RB / Channel	
Survey date and time: 12/03/2020 11:45	Is bed of river visible? (Yes) / No	
Surveyor name: NL + ED	River or artificial channel? Ditch

Bed substrates	Tick if present	% area
Bedrock	<input type="checkbox"/>	—
Cobble	<input checked="" type="checkbox"/>	80 Occasionally present
Boulder	<input checked="" type="checkbox"/>	—
Pebble	<input type="checkbox"/>	—
Gravel	<input checked="" type="checkbox"/>	15
Sand	<input checked="" type="checkbox"/>	5
Silt/clay	<input type="checkbox"/>	—
Peat	<input type="checkbox"/>	—
Earth	<input type="checkbox"/>	—
Artificial	<input type="checkbox"/>	—
Not visible	<input type="checkbox"/>	—

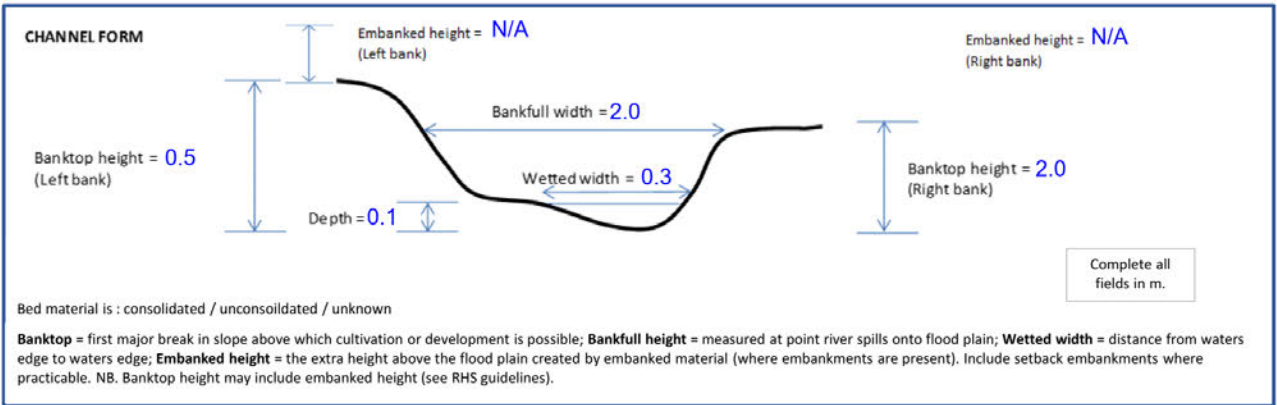
River habitat spot check form

Project/Site name: A57	Approx. survey reach length:	Spot check	Photo no.	NGR
Watercourse name: Tara Brook WC_200	Adverse conditions?	Yes / No	DSC_927-930	SJ 99814 95771
u/s NGR: SJ 99814 95771	If yes, please state:			
Upstream reach (in line with RC6)	Surveyed from:	LB / RB / Channel		
Survey date and time: 11/03/2020 17:00	Is bed of river visible?	Yes / No*		
Surveyor name: NL + ED	River or artificial channel?	River (ditch like at survey location)

Bed substrates	Tick if present	% area
Bedrock	<input type="checkbox"/>	—
Cobble	<input type="checkbox"/>	—
Boulder	<input type="checkbox"/>	—
Pebble	<input checked="" type="checkbox"/>	5
Gravel	<input checked="" type="checkbox"/>	5
Sand	<input checked="" type="checkbox"/>	90
Silt/clay	<input type="checkbox"/>	—
Peat	<input type="checkbox"/>	—
Earth	<input type="checkbox"/>	—
Artificial	<input type="checkbox"/>	—
Not visible	<input type="checkbox"/>	—

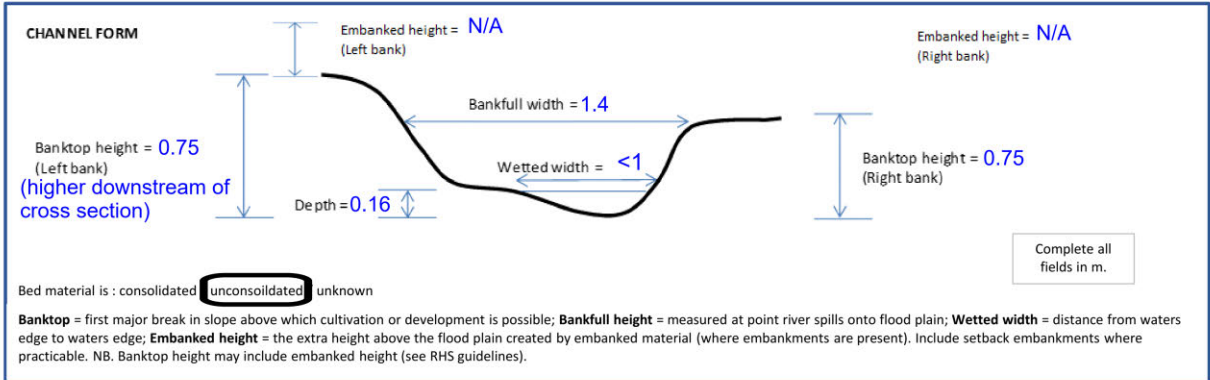
River habitat spot check form

Project/Site name: A57	Approx. survey reach length: 100 m	Photo no.	NGR
Watercourse name: Tara Brook WC_200	Adverse conditions? Yes / <input checked="" type="checkbox"/> No	DCS_934-936	SK 00754 95752
u/s NGR: SK 00757 95396	If yes, please state:	DCS_936	SK 00767 95715
Downstream reach (in line with RC7)	Surveyed from: <input type="checkbox"/> LB <input checked="" type="checkbox"/> RB <input type="checkbox"/> Channel		
Survey date and time: 12/03/2020 09:00	Is bed of river visible? <input checked="" type="checkbox"/> Yes / No		
Surveyor name: NL + ED	River or artificial channel? River

Bed substrates	Tick if present	% area
Bedrock	<input type="checkbox"/>	—
Cobble	<input checked="" type="checkbox"/>	85
Boulder	<input type="checkbox"/>	—
Pebble	<input checked="" type="checkbox"/>	10
Gravel	<input checked="" type="checkbox"/>	2.5
Sand	<input checked="" type="checkbox"/>	2.5
Silt/clay	<input type="checkbox"/>	—
Peat	<input type="checkbox"/>	—
Earth	<input type="checkbox"/>	—
Artificial	<input type="checkbox"/>	—
Not visible	<input type="checkbox"/>	—

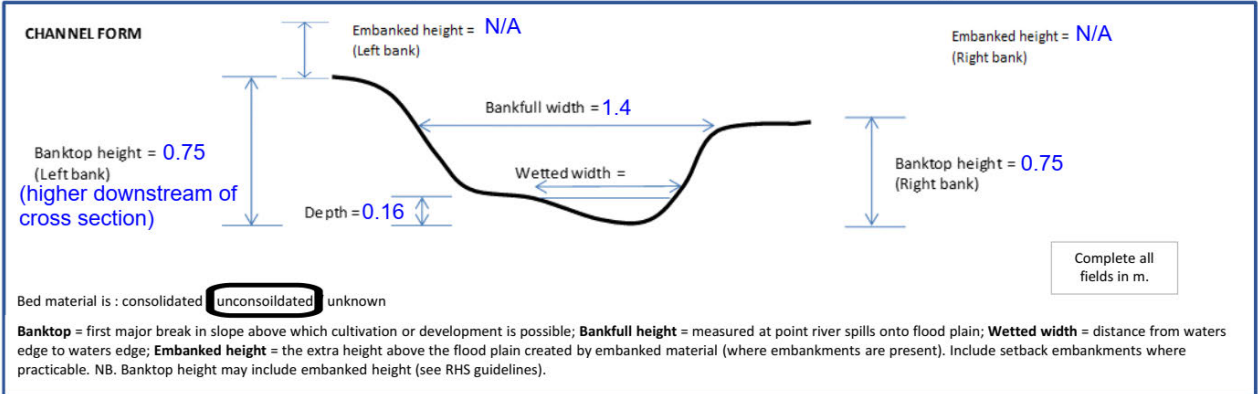
River habitat spot check form

Project/Site name: A57	Approx. survey reach length: 100 m	Photo no. NGR
Watercourse name: Tara Brook WC_200	Adverse conditions? Yes / No	DCS_934-935 SK 00754 95752
u/s NGR: SK 00757 95396	If yes, please state:	DCS_936 SK 00767 95715
Downstream reach (in line with RC7)	Surveyed from: (LB) (RB) Channel	
Survey date and time: 12/03/2020 09:00	Is bed of river visible? Yes / No	
Surveyor name: NL + ED	River or artificial channel? River

Bed substrates	Tick if present	% area
Bedrock	<input type="checkbox"/>	_____
Cobble	<input checked="" type="checkbox"/>	85
Boulder	<input type="checkbox"/>	_____
Pebble	<input checked="" type="checkbox"/>	10
Gravel	<input checked="" type="checkbox"/>	2.5
Sand	<input checked="" type="checkbox"/>	2.5
Silt/clay	<input type="checkbox"/>	_____
Peat	<input type="checkbox"/>	_____
Earth	<input type="checkbox"/>	_____
Artificial	<input type="checkbox"/>	_____
Not visible	<input type="checkbox"/>	_____

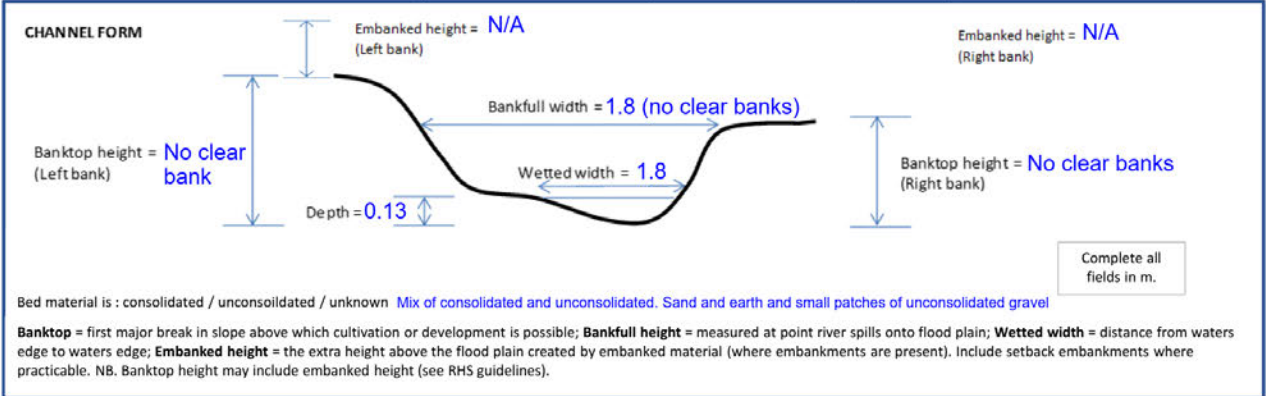
River habitat spot check form

Project/Site name: A57	Approx. survey reach length:	N/A	Photo no.	NGR
Watercourse name: WC 210	Adverse conditions?	Yes / No	DSC_917	SJ 99732 95871
u/s NGR: SJ 99746 95893	If yes, please state:		DSC_918-919	SJ 99744 95895
	Surveyed from:	LB / <u>RB</u> / Channel		
Survey date and time: 11/03/2020 16:32	Is bed of river visible?	Yes / No		
Surveyor name: Naomi Lowden	River or artificial channel?	Ditch

Bed substrates	Tick if present	% area
Bedrock	<input type="checkbox"/>	—
Cobble	<input checked="" type="checkbox"/>	3
Boulder	<input type="checkbox"/>	—
Pebble	<input checked="" type="checkbox"/>	2
Gravel	<input checked="" type="checkbox"/> (rubble)	10
Sand	<input checked="" type="checkbox"/>	85
Silt/clay	<input type="checkbox"/>	—
Peat	<input type="checkbox"/>	—
Earth	<input type="checkbox"/>	—
Artificial	<input type="checkbox"/>	—
Not visible	<input type="checkbox"/>	—

No clear channel, tried to record substrates within wet area, but earth also present.

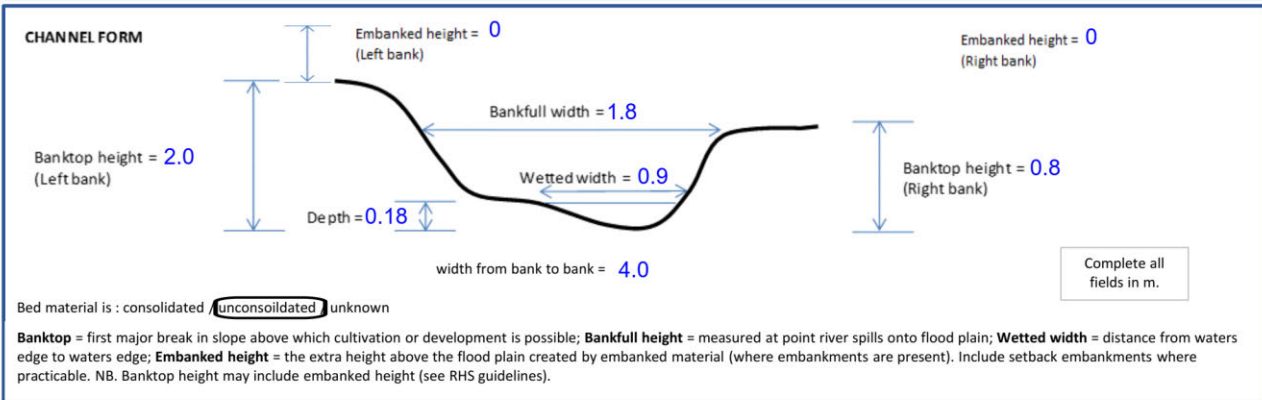
River habitat spot check form

Project/Site name: A57	Approx. survey reach length: 100 m	Photo no. DSC_877-881	NGR SJ 98668 95445
Watercourse name: Hurtscloagh Brook (WC_300)	Adverse conditions? Yes / No		
u/s NGR: SJ 98686 95462	If yes, please state:		
	Surveyed from: LB / RB / Channel		
Survey date and time: 11/03/2020 12:25	Is bed of river visible? Yes / No		
Surveyor name: Naomi Lowden	River or artificial channel? River (small natural flow path)

Bed substrates	Tick if present	% area
Bedrock	<input type="checkbox"/>	—
Cobble	<input type="checkbox"/>	—
Boulder	<input type="checkbox"/>	—
Pebble	<input checked="" type="checkbox"/>	5
Gravel	<input type="checkbox"/>	—
Sand	<input checked="" type="checkbox"/>	95
Silt/clay	<input type="checkbox"/>	—
Peat	<input type="checkbox"/>	—
Earth	<input type="checkbox"/>	—
Artificial	<input type="checkbox"/>	—
Not visible	<input type="checkbox"/>	—

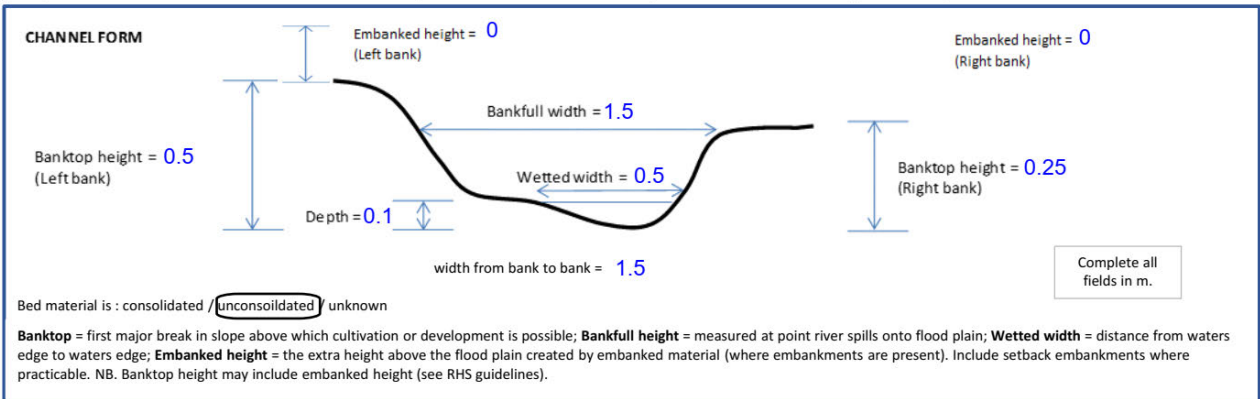
River habitat spot check form

Project/Site name: A57	Approx. survey reach length: 50 m	Photo no.	NGR
Watercourse name: WC_340	Adverse conditions? Yes / <input checked="" type="checkbox"/> No	DSC_890-892	SJ 98544 95419
u/s NGR: SJ 98544 95419	If yes, please state:	DSC_893-897	SJ 98569 95411
Surveyed from:	<input checked="" type="checkbox"/> LB <input type="checkbox"/> RB / Channel		
Survey date and time: 11/03/2020	Is bed of river visible? Yes / <input checked="" type="checkbox"/> No		
Surveyor name: NL + ED	River or artificial channel? River/Ditch

Bed substrates	Tick if present	% area
Bedrock	<input type="checkbox"/>	—
Cobble	<input type="checkbox"/>	—
Boulder	<input type="checkbox"/>	—
Pebble	<input type="checkbox"/>	—
Gravel	<input checked="" type="checkbox"/>	10
Sand	<input checked="" type="checkbox"/>	90
Silt/clay	<input type="checkbox"/>	—
Peat	<input type="checkbox"/>	—
Earth	<input type="checkbox"/>	—
Artificial	<input type="checkbox"/>	—
Not visible	<input type="checkbox"/>	—

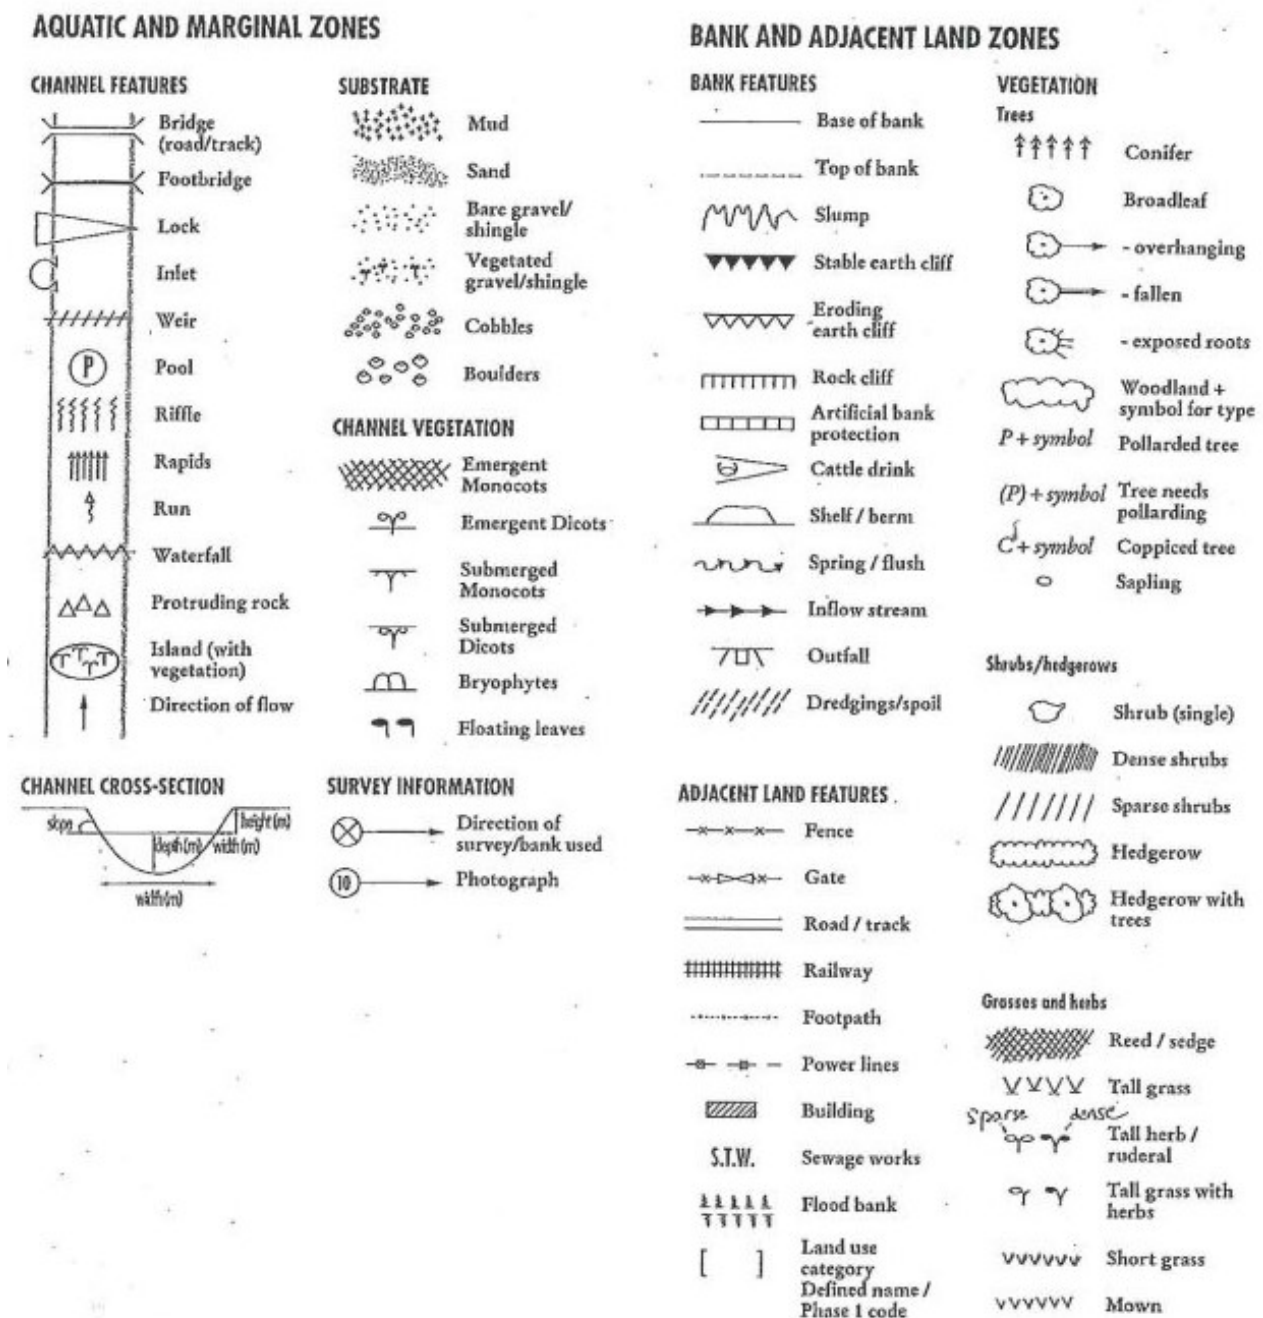
Standard symbols used in River Corridor Survey

A.4.2 Plant species are recorded using an abbreviated version of their scientific name, using the following convention: first letter of the generic name followed by the first three letters of the species name.
