A57 Link Roads

**9.71 Supplementary Ground Investigation
Report**

9.71 Supplementary Ground Investigation Report

Rule Number:	Rule 8(1)(k)
Planning Inspectorate Scheme Reference	TR010034
Application Document Reference	TR010034/EXAM/9.71
Author:	A57 Link Roads Project Team, National Highways and Atkins

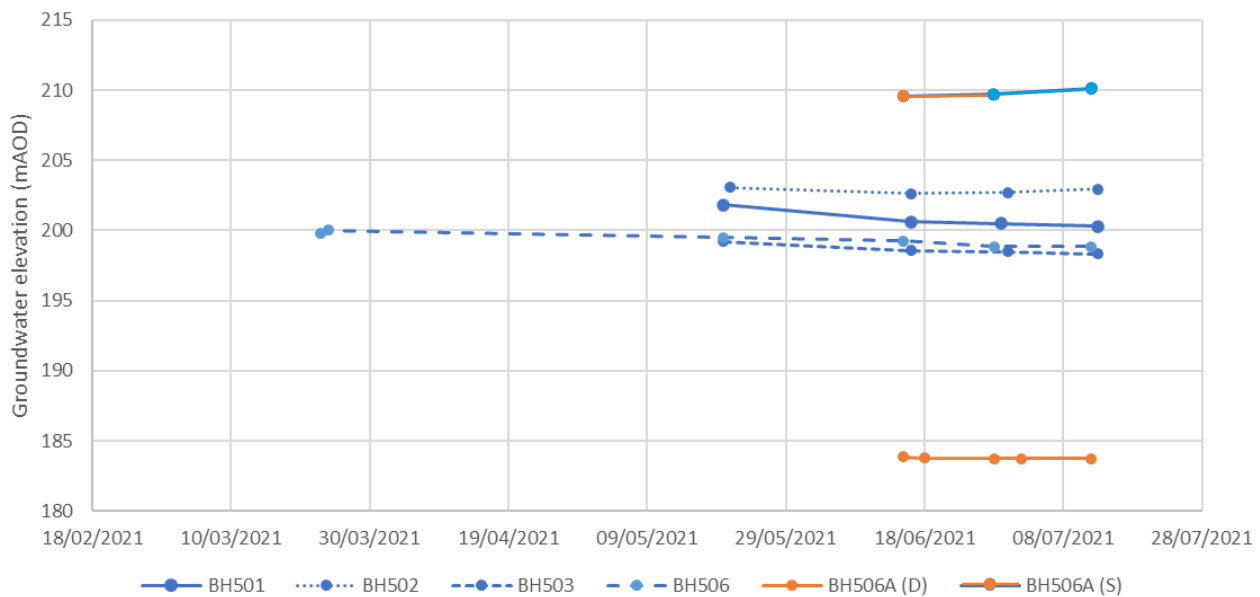
- 6.2.9. Groundwater levels within the Millstone Grit are below the rockhead surface, therefore any groundwater in the overlying Glacial Till is likely to be perched lenses. These lenses may have lateral connectivity to some degree, and connectivity with the Brook, as well as providing limited recharge to the underlying Millstone Grit. Groundwater within the Millstone Grit is unlikely to have any connectivity with the Brook at this location due to the thickness of overlying till. Groundwater levels and inferred flow direction within bedrock do imply that groundwater is likely discharging to the Hurstclough Brook in its lower reaches down gradient. Groundwater levels in this area are approximately 15 m lower than those in equivalent strata to the east of the fault zone. This is likely due to the fact that the fault zone is a barrier to flow and blocking recharge from up-gradient in the area of Millstone Grit outcrop to the north of the scheme around Hollingworth hall Moor.

Boreholes installed in Glacial Till are shown in blue, and those installed in Millstone Grit shown in orange. BH506A is at CH830 but is the furthest west location installed in Millstone Grit and has been included here to demonstrate the relationship between water levels in the Millstone Grit and the overlying Glacial Till in this area

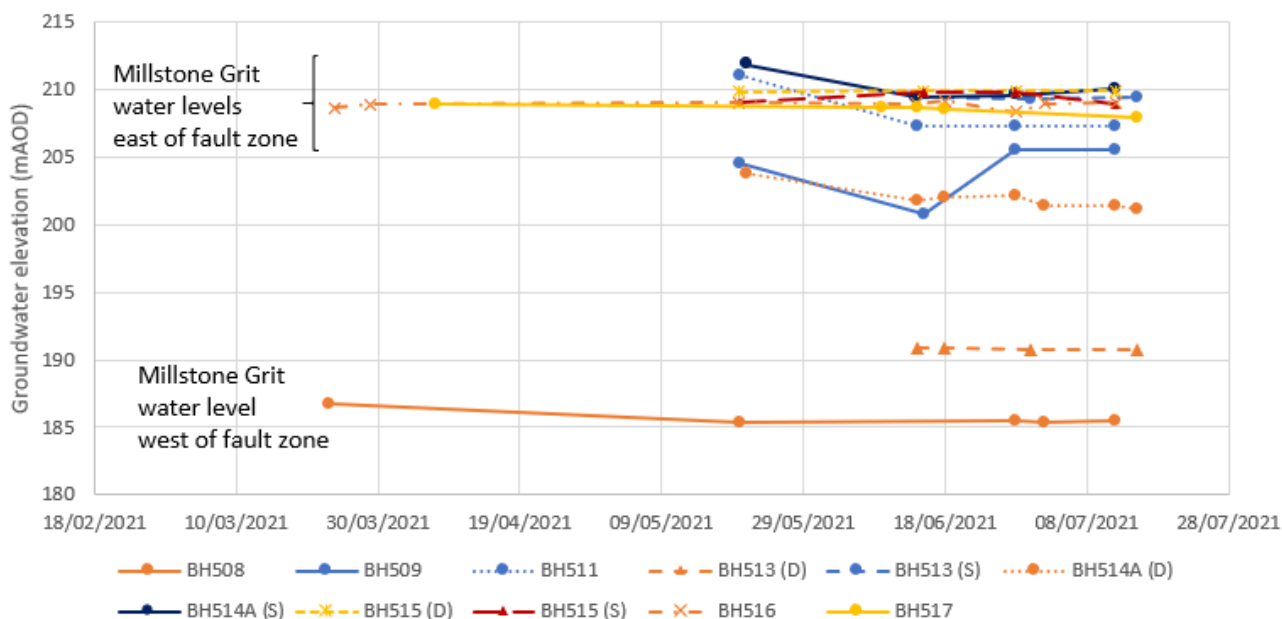
the juxtaposition of shallow low permeability Glacial Till against the sandstone, siltstone and mudstones of the Millstone Grit will also act as a barrier to flow.

Boreholes installed in Glacial Till are shown in blue, and those installed in Millstone Grit shown in orange/yellow/red

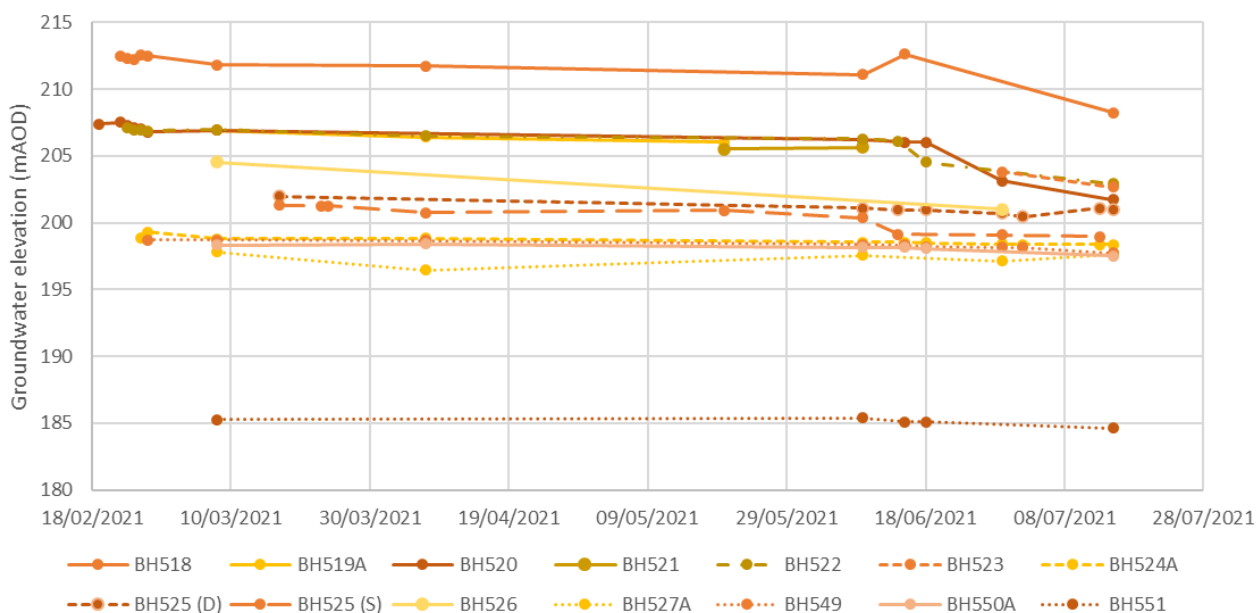
6.2.13. Groundwater levels within this section are shown on Figure 6.4. All monitoring wells are installed within the Millstone Grit, with the exception of BH522 and BH525(S) which are installed partly in the Millstone Grit and partly within the Glacial Till.

Boreholes installed in Millstone Grit shown in orange/yellow

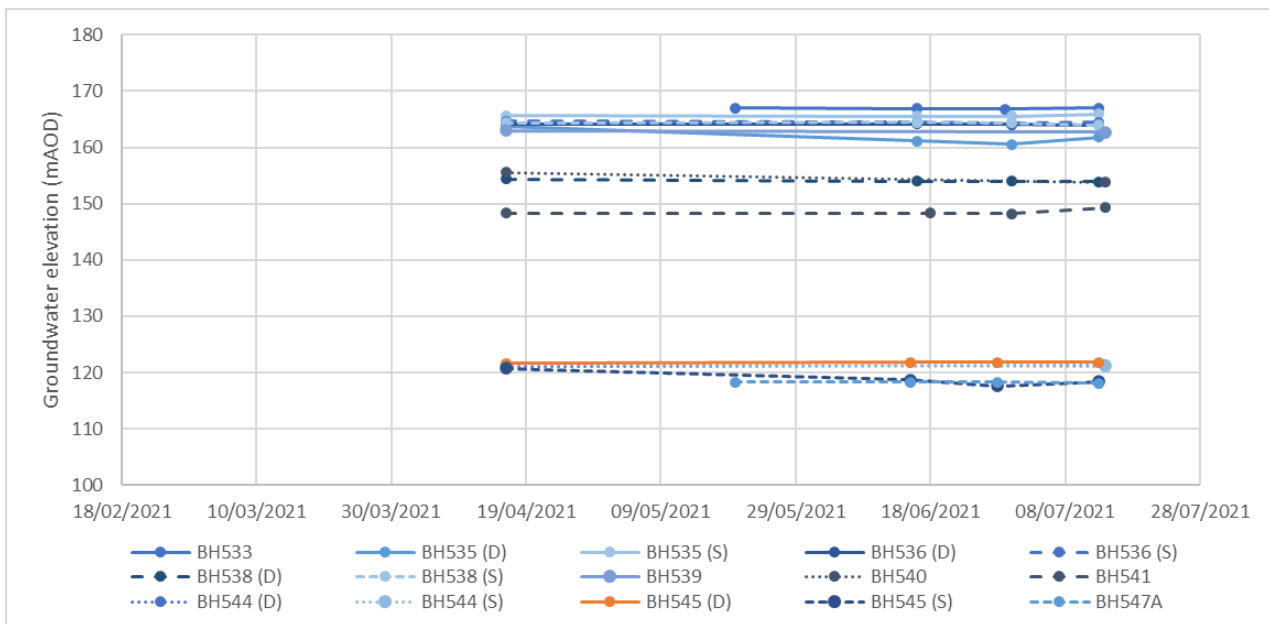
Figure 6.5 – Observed groundwater levels in boreholes in section 4

6.2.18. Groundwater levels within this section are shown on Figure 6.5. Boreholes installed in Glacial Till are shown in blue, and those installed in Millstone Grit shown in orange.

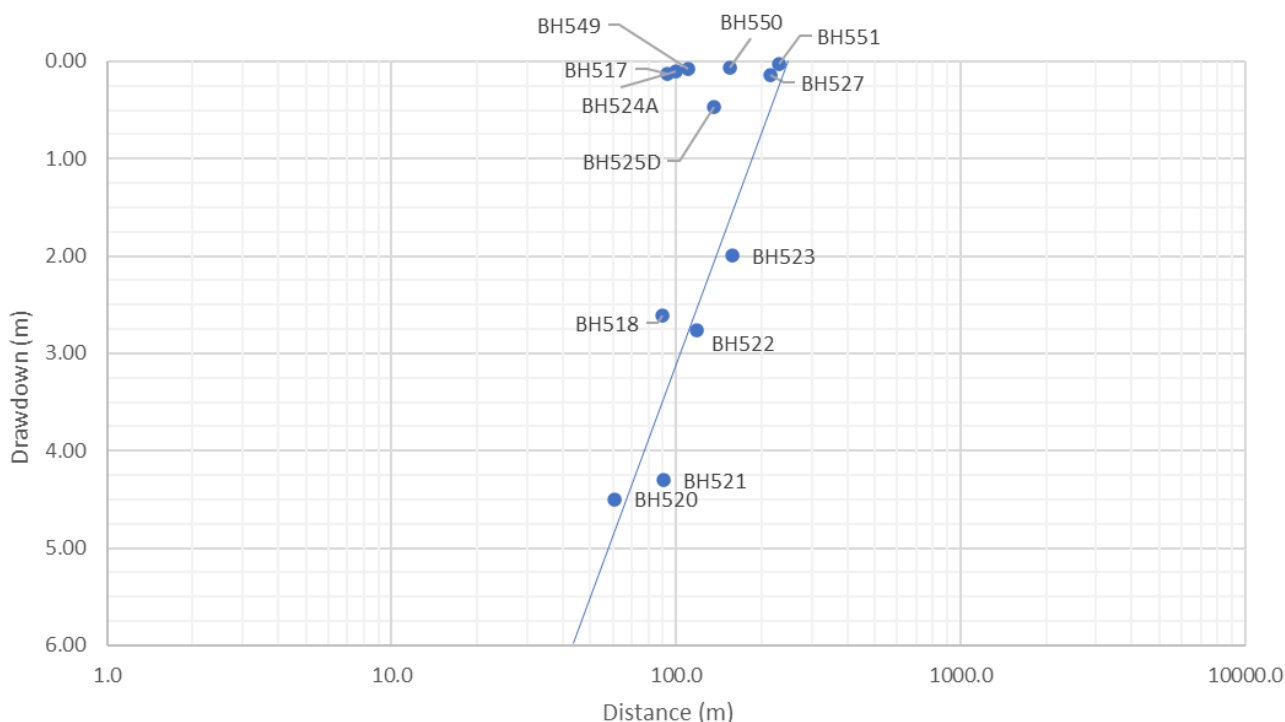
Figure 6.9 – Thiem distance drawdown

6.4.21. Observed steady-state drawdown from all of the monitoring wells was compiled to carry out a Thiem distance-drawdown analysis, as shown in . It is clear that the degree of drawdown response is not uniform across the monitoring wells, likely because flow is dominated by fracture flow and, to a lesser degree, flow in granular sandstone horizons, therefore the response is dependent on the well screen intersecting flowing fractures, and connectivity between sandstone layers.

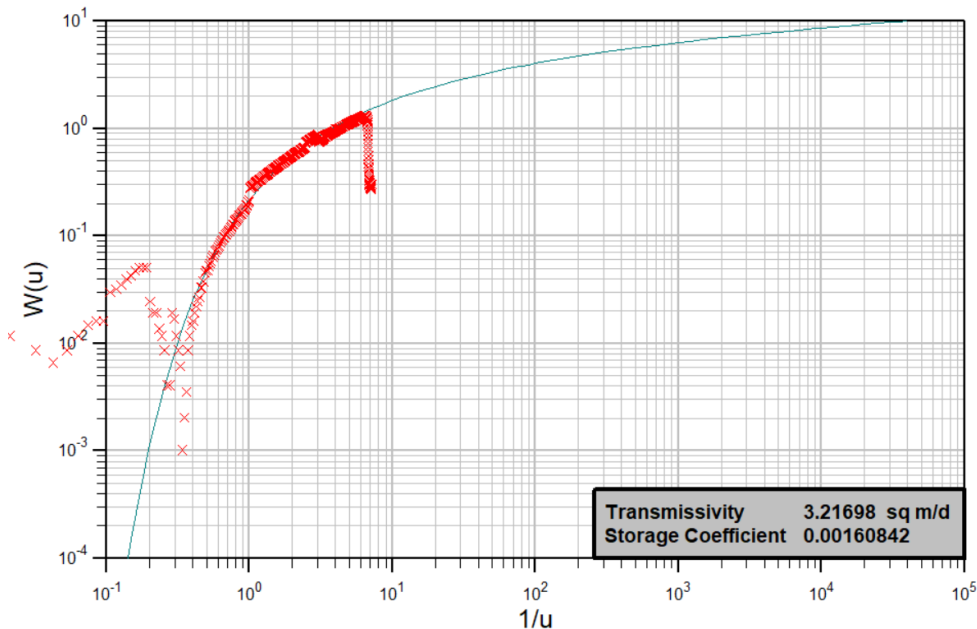
Figure 6.13 – Theis analysis at BH518 using average pumping rate of 0.94 l/s

6.4.31. Unusual behaviour was observed at BH518 during the constant rate test, attributed to surface water ingress at this location. This can be seen in Figure 6.13. Curve matching has been done based on the overall trend and a good match can still be obtained.

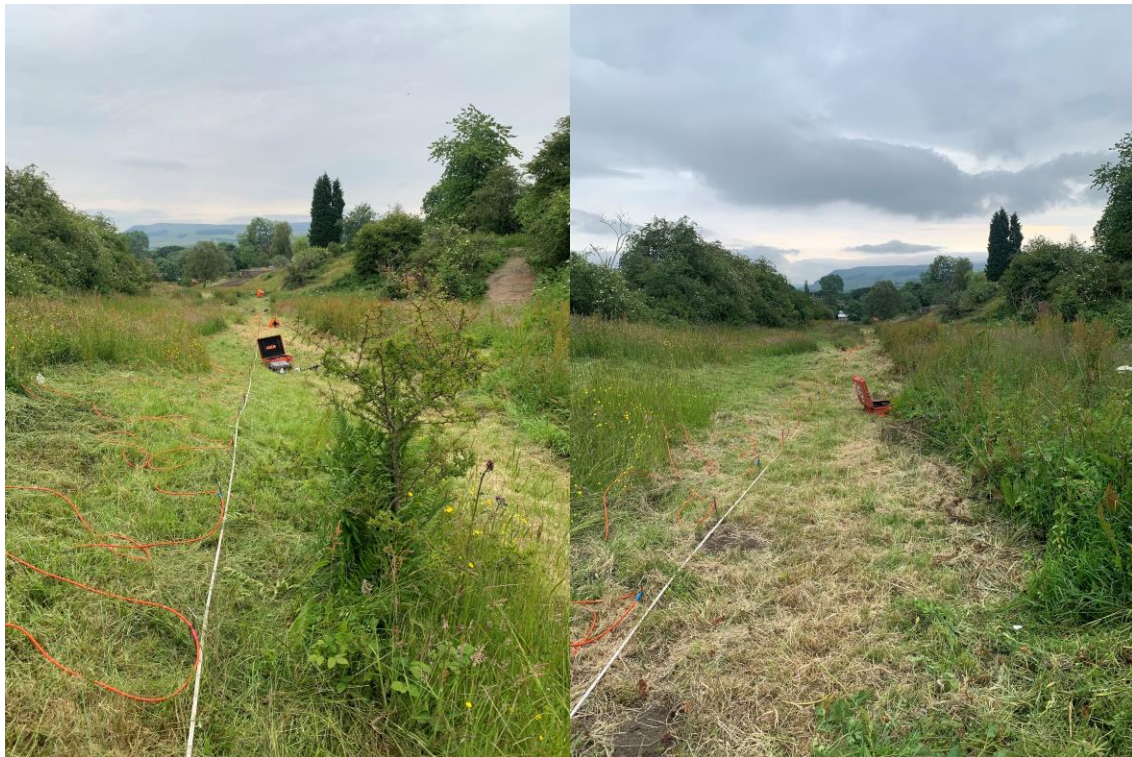
Figure 1: Photos taken on site showing the ERT line setup.

In June of 2021 a geophysical survey was undertaken at the Mottram site by SOCOTEC. The survey was undertaken to identify the position of an aqueduct known to be within the valley, at a suspected depth of 8 metres below the ground. To meet the survey objectives Electrical Resistivity Tomography (ERT) surveys were undertaken in a series of 3 lines.

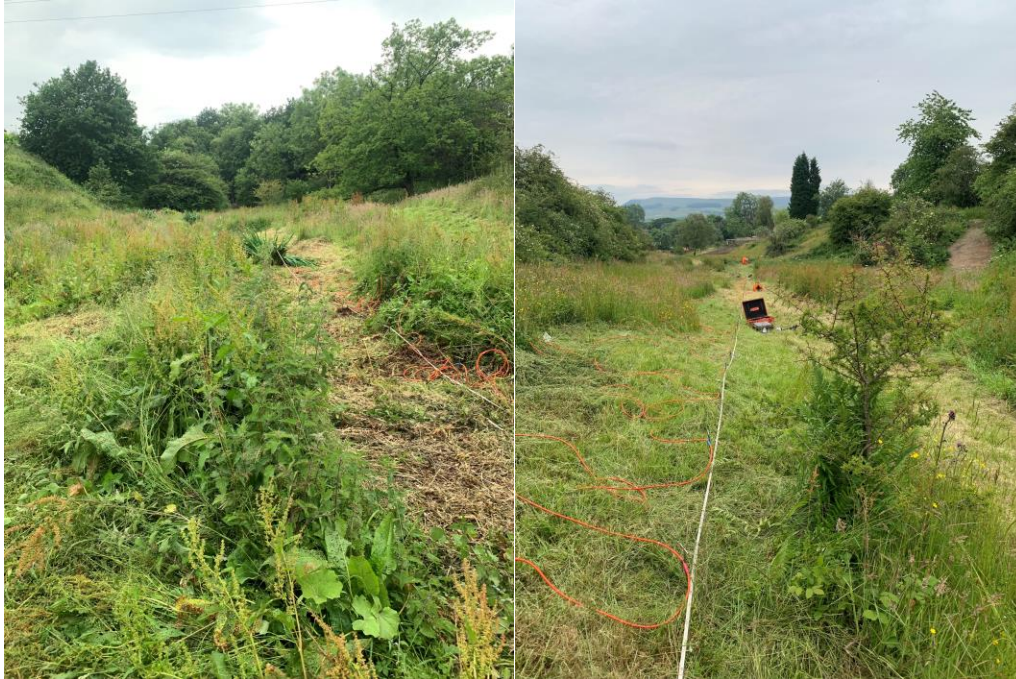
Figure 1: Position of ERT lines across the site.

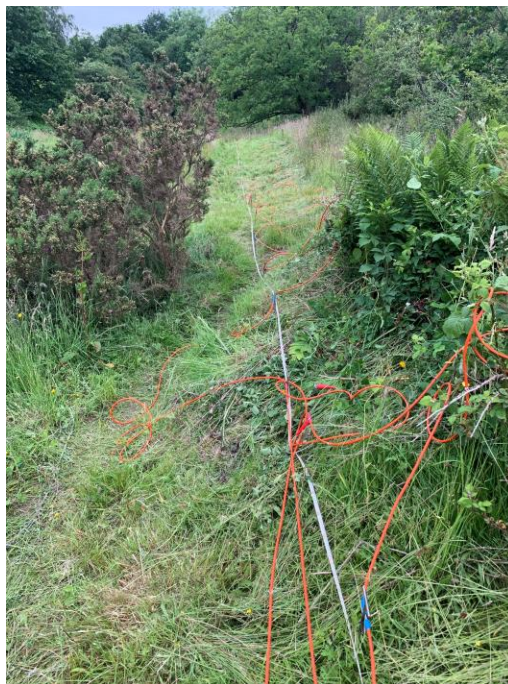
Figure 2: Picture showing how lines were orientated to fit through gaps in bushes and other vegetation.

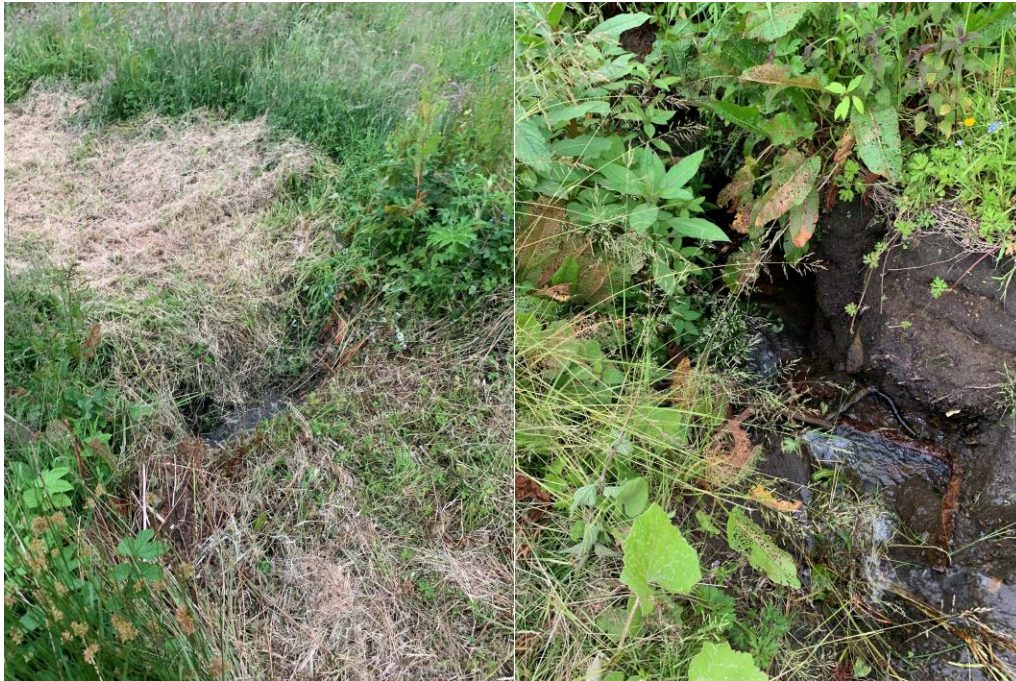
Figure 3: Pictures showing running water at the surface on site. The stream was quite deep in places.

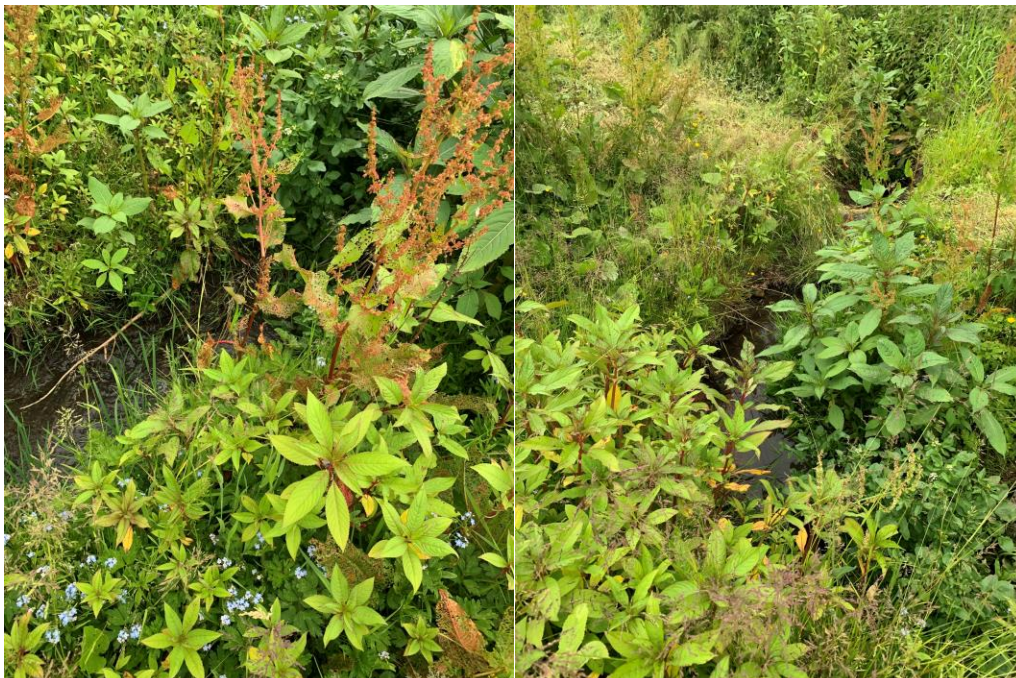
Figure 4: Japanese knotweed was identified on site affecting the positioning of the ERT lines.

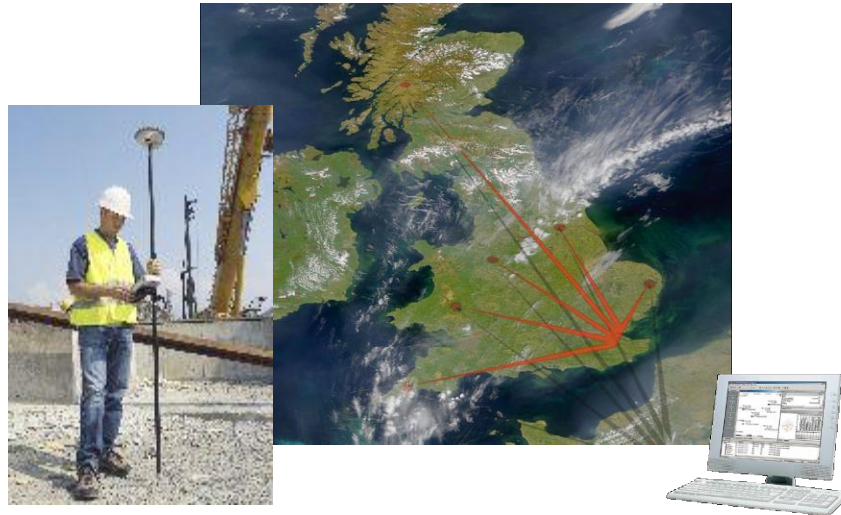
Leica SmartNet Commercial RTK Network for Great Britain

Leica SmartNet is a broadcast correction service introduced in 2006 as a partnership between Leica Geosystems and Ordnance Survey.

Leica SmartNet is enabled by the network of Ordnance Survey base stations to create a high density, high redundancy network which is able to deliver corrections at the centimetre level in RTK mode or sub-metre DGPS and with raw data for post processing. This network of base stations, known as OS Net, comprises around 90 permanent nationally deployed GPS reference stations.

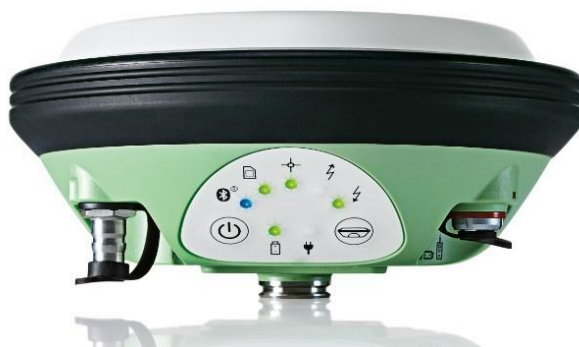
GS14 is a high specification RTK GNSS Surveying Receiver, providing high accuracy, reliability and flexibility. The system consists of the Leica GNSS AS05 Antenna and the Leica GS14 GNSS Receiver with an internal Li-ion battery charger and ruggedized casing providing environmental protection to IP67 standards.

The GS14 Receiver is built to allow many setup options and connection to a variety of devices and data download facilities. Having Windows CE™ user interface and support software, together with Bluetooth™ wireless technologies, GSM, UMTS or radio options, it does not require external configuration or communication devices. This allows direct contact via the internet to control the system and to upload/download data.

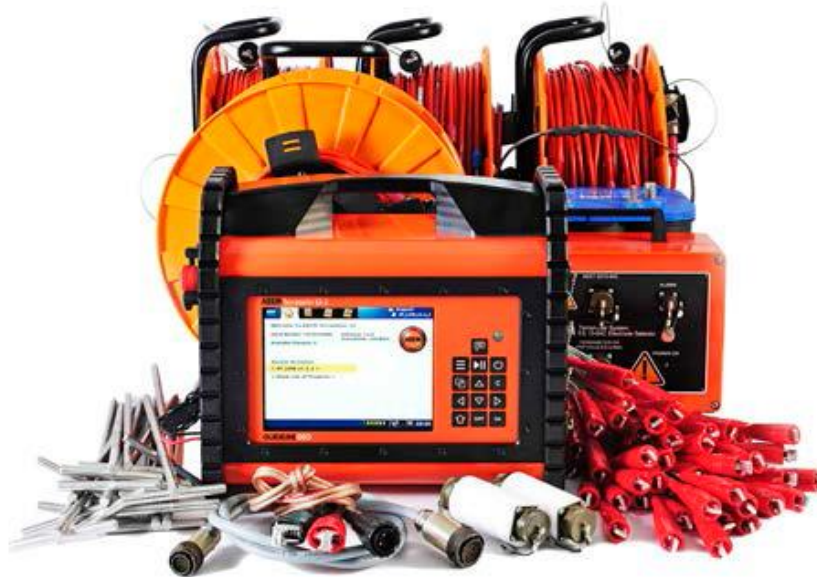
ABEM Terrameter LS 2 is a world leading resistivity/IP instrument which can be used for a wide range of applications. With its software licensing system, it is available in multiple configurations to best match your requirements.
