A303 Sparkford to Ilchester Dualling Scheme TR010036 6.3 Environmental Statement Appendix 6.2 Hazlegrove House Registered Park and Garden Statement of Significance

6.3 Environmental Statement Appendix 6.2 Hazlegrove House Registered Park and Garden Statement of Significance

Regulation Number:	Regulation 5(2)(a)
Planning Inspectorate Scheme	TR010036
Reference:	
Application Document Reference:	6.3
Author:	A303 Sparkford to Ilchester Dualling Scheme Project Team, Highways England

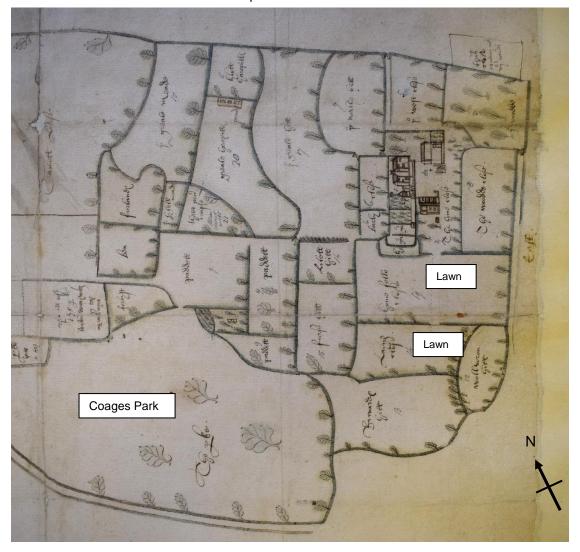
Figure 4.2: An annotated portion of the 1573 Queen Camel Map showing Hazlegrove, with surrounding enclosures and southern extent of the map

- 5.3.2 The 1573 plan shows the "demeasnes of East Camel inclosed" and the land forming the estate belonging to Hazlegrove House (Figure 4.2). The map shows the main house, believed to have been built the 16th century, with surrounding structures and formal gardens in its immediate vicinity. The collection of smaller buildings near the house are believed to potentially represent the former Hazel Grove medieval village. Part of the Tudor house remains incorporated into the current Hazlegrove House, and during a site walkover it was noted that an earlier porch feature faces north from the rear of the house. This suggests that the house previously faced and was approached from the north, which is

- confirmed by the 1573 map that shows a northern approach to the property with no access through the enclosures to the south.
- 5.3.3 To the south, the 1573 map shows the land associated with the Manor of Hazlegrove House, was divided into enclosures separated by hedgerows and rows of trees. An avenue or promenade is shown to the southeast of the house, through 2 enclosures terminating at the border of the southernmost which is labelled 'Lawn'. This map implies that the southern border of the land associated with the Hazlegrove estate terminates with a track, and potential park pale, that runs to the south of the large enclosure known as Coages Park.

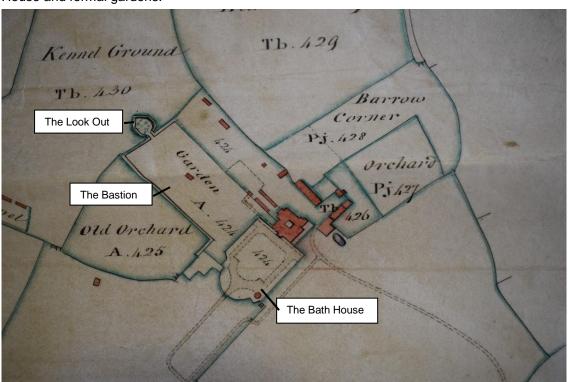
Figure 4.3a: A annotated portion of the 1795 Queen Camel Enclosure Map showing Hazlegrove House and formal gardens.

5.4.3 Carew Hervey Mildmay's additions and alterations transformed the former 16th century layout of the house and surrounding landscape, and upon his death in 1784 without a male heir, his estate passed to Jane, the daughter of Carew Mildmay of Shawford. Jane married Sir Henry Paulet of Dogmersfield Park in 1786, who changed his name by Royal Warrant to add Mildmay in 1790. The estate remained largely unchanged during this period of ownership, with the 1795 Queen Camel Enclosure Map (Figure 4.3a and 4.3b) showing the bastion, kennels and orchard constructed during Carew Hervey Mildmay's ownership of Hazlegrove.

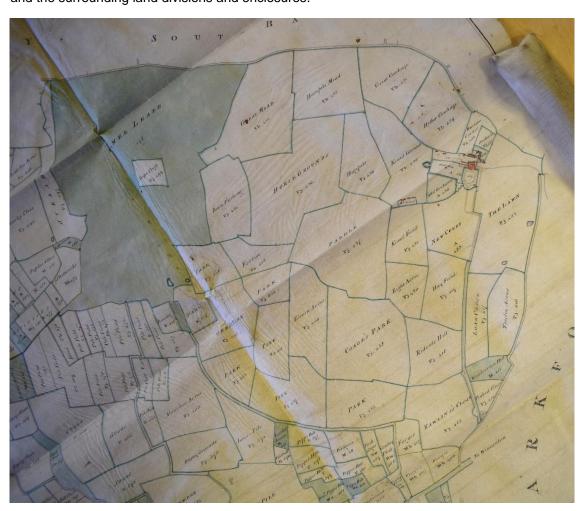
Figure 4.3b: A portion of the 1795 Queen Camel Enclosure Map showing Hazlegrove House and the surrounding land divisions and enclosures.

5.4.4 Compared to the 1573 map, the 1795 Enclosure Map shows additional fields or enclosures to the south of Coage's Park (Figure 4.4). These additional enclosures form what is now a large arable field and adjacent wooded area in the southeast of the RPG. The enclosures comprise a large field labelled 'Rawlins's Close', 3 smaller enclosures labelled 'Furges', and 2 further small enclosures labelled 'Woolverton Hill' and 'Peaked Close', the latter of which contains a small cluster of trees. An earlier 1794 draft of the 1795 Enclosure Map notes that Woolverton Hill may have been used for timber production,

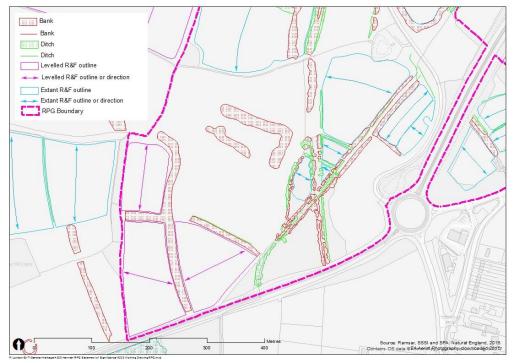
Figure 4.5: A drawing showing the aerial survey transcription for the southern portion of the RPG. The transcription shows the former driveway, as well as bank features and levelled ridge and furrow in the location of the former Furges enclosures, now incorporated into one large arable field.

- The field boundaries for the 3 Furges enclosures and alignment of the new 5.4.6 driveway on the 1795 map, match features identified in the aerial survey transcription (Figure 4.5) undertaken as part of this scheme (a full aerial survey transcription for the scheme area can be found in appendix A). The aerial survey also shows a ridge and furrow was present within these enclosures suggesting arable use. No evidence of ridge and furrow was present in Rawlins's Close.

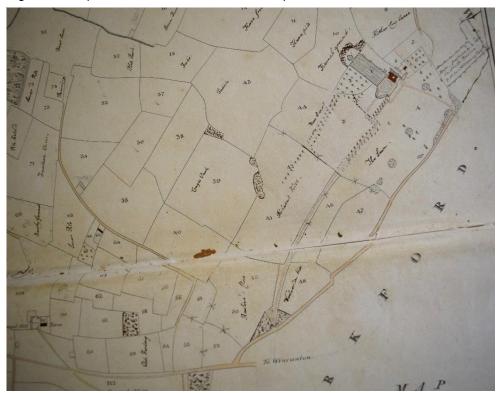
Figure 4.6: A portion of the 1827 Enclosure Map of Queen Camel.

5.5.1 Hazlegrove was inherited by Paulet St John Mildmay in 1808. The 1827 Enclosure Map of Queen Camel shows the house and estate at the beginning of his residence at Hazlegrove House, which commenced in 1826 (Figure 4.6). The layout of the enclosures and features appears largely unchanged since the 1795 Enclosure Map. However, a few additional features can be seen, including new clusters of trees through The Lawn and planting surrounding the observation point to the west of the house. A new avenue of trees running south from the western border of the kitchen gardens and orchard, although no driveway or path appears to run through it. Compared to the 1795 map, this

- 5.5.2 On the 1827 map, the southern end of the park shows few changes, with Rawlins's Close continuing to be separate of the 3 smaller enclosures, formerly labelled Furges. Rawlins's Close contains 2 numbers, 49 and 50, which correspond to entries 'Rawlins's Close' and 'Pail of Rawlins's Close' respectively, in the map accompaniment. In addition, further planting has taken place around the entrance to the estate and driveway.

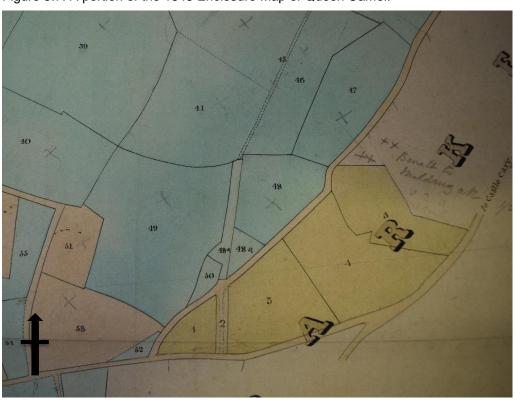
Figure 5.7: A portion of the 1848 Enclosure Map of Queen Camel.

5.5.4 An 1848 Plan of Queen Camel (Figure 4.7) shows the Hazlegrove House and the surrounding enclosures, although in less detail that the earlier 1827 map. Nonetheless, the plan shows some changes in the enclosure boundaries and driveway in the southern portion of the park. The map also provides an indication of land use, with blue indicating pasture lifehold, orange indicating arable, and yellow indicating land within Sparkford. Two of the former Furges fields have been joined to form 1 larger arable field, whilst the majority of the land within the RPG was pasture at this time. Some smaller enclosures of land have been formed around the driveway to the south, which may indicate that the Hazlegrove estate was acquiring parcels of land in this area as they became available. In addition, the driveway itself has been extended south through land in Sparkford (coloured yellow) removing the curve to the west. This driveway extension was also identified in the aerial survey transcription (Figure 4.5:). Earthworks for both routes of the driveway are still extant within the wooded area in the southern portion of the RPG.

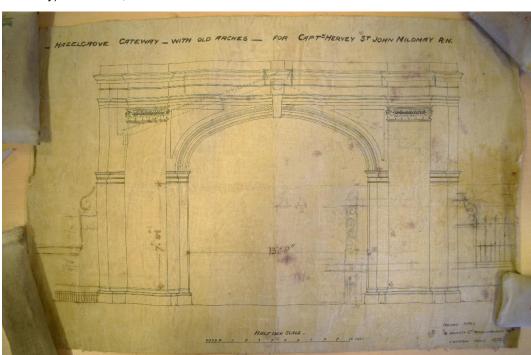
Figure 4.8: A photograph of a diagram of the Hazlegrove Gateway (Triumphal Arch Gateway) from 1875, which was installed as a new entrance to the estate.

5.6.1 The house passed into the hands of Hervey George Mildmay in 1858, who made further changes to the southern portion of the park. The driveway alignment from the 1848 map was discontinued and was diverted to the southeast from the centre of the park, along its current alignment. A new grand entrance to the park was installed on the southeast in the form of the grade II* listed Triumphal Arch Gateway (Figure 4.8). The gateway was acquired from

Low Ham Manor, near Somerton; a mammoth 17th century estate which was never finished. The gateway is formed of a single archway, constructed of local grey lias ashlar with Ham stone dressings, and finished with wrought iron gates from the 20th century. A lodge was also constructed in the southeast portion of the park near to the gateway, on the land shown as forming park of Sparkford on the 1848 map.

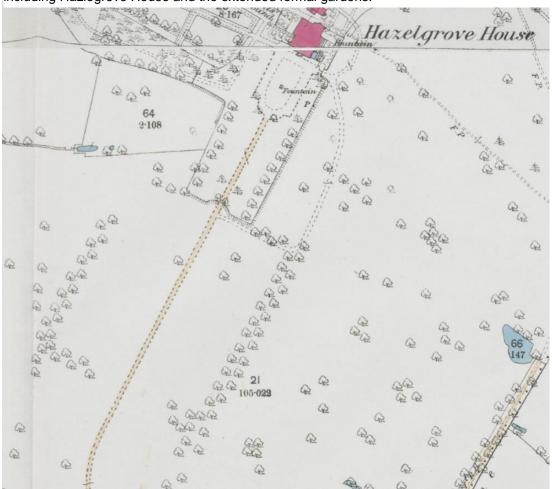
Figure 4.9: A portion of the 1888 first edition OS map showing the northern portion of the RPG including Hazlegrove House and the extended formal gardens.

5.7.1 In 1882 Hervey George Mildmay died, with the estate passing to his living family. The 1888 first edition OS map provides a detailed overview of the layout of Hazlegrove House and the surrounding parkland. It reveals that the majority of the enclosures surrounding the driveway on the approach to the house have been removed. The map shows clusters of, and stand alone, trees spread throughout this landscape, representing the open parkland. The formal gardens have been extended and bordered with an avenue of trees, whilst former tree avenues have been mirrored to form a wider avenue of trees extending from the formal gardens, which would have framed the main façade of the house on the approach (Figure 4.9).

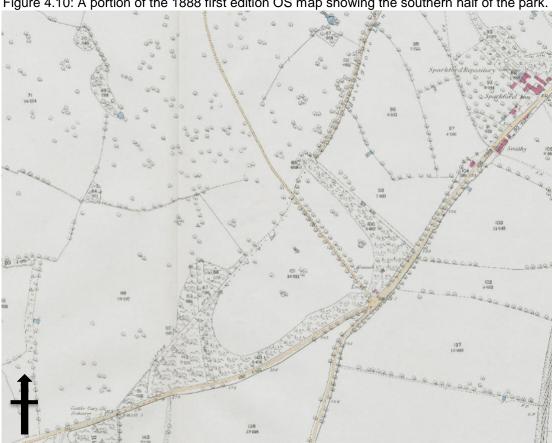
Figure 4.10: A portion of the 1888 first edition OS map showing the southern half of the park.

- 5.7.2 The main driveway remained unaltered at this time, with the entrance through the Triumphal Arch Gateway in the southeast corner of the park (Figure 4.10). Significant planting along the southern border of the park has taken place since the 1827 map, perhaps to screen the property and parkland from the road to the south. The planting along the border protrudes into the parkland to encompass the former driveway entrances, perhaps deliberately to conceal the former entrances to the park and highlight the new, higher status entrance and driveway.

- 5.7.3 Figure 4.10 also illustrates that the former Rawlins's Close and Furges enclosures in the southwest corner of the park formed 1 large enclosure by 1888. Where a large portion of the hedgerows and enclosure boundaries have been removed in the main portion of the parkland, hedgerow and trees remain along the northern extent of the field. This historic field boundary appears to completely separate the field from the rest of the parkland, however clusters of trees have been mapped across the field suggesting parkland planting similar to the rest of the landscape.

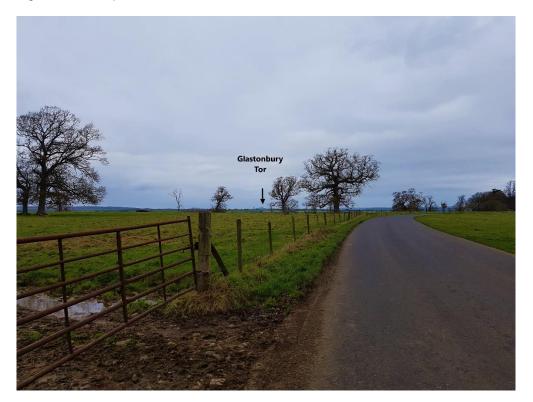
Figure 6.1: Viewpoint 2

6.2.3 From the mid-19th century, the driveway was realigned with the main entrance to the park being through the newly installed Triumphal Arch Gateway. From here the driveway entered the park through an avenue of trees on a northwest alignment, before climbing the gradual hill within the park. When cresting the hill, the viewers eyes would be cast over the wider Somerset landscape to the west of the RPG, with Glastonbury Tor forming the central focal point (viewpoint 2, Figure 5.1Figure 6.1)

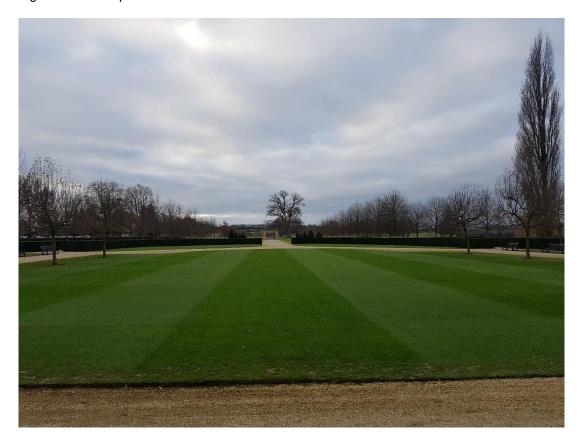
Figure 6.3 - Viewpoint 4

6.2.5 These views towards the house are also of significant value in reverse; when viewed from the front of Hazlegrove House through the formal gardens and across the parkland to the south. From the front of the house, which forms 1 of the highest points of the RPG, this vantage point would have provided a largely uninterrupted view of the parkland and estate belonging to the manor to the top of camel hill (viewpoints 4 and 5). Today, this view terminates with the A303 Camel Hill Services, which unfortunately draws the eye from the otherwise rural setting of the house and parkland (Figure 5.3 and Figure 5.4).

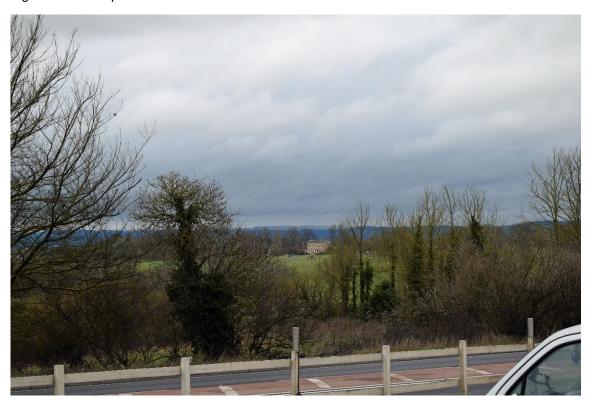
- 6.2.7 A modern view of Hazlegrove House from the A303 also has significance in terms of communal value (viewpoint 7). The house appears as a landmark, or waymarker on journeys taken along the A303 (Figure 5.5). Given the association of the A303 as the route holiday makers took to the south west, this communal value arguably should be seen in a national context.

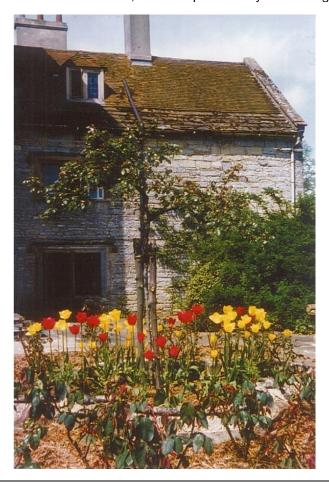
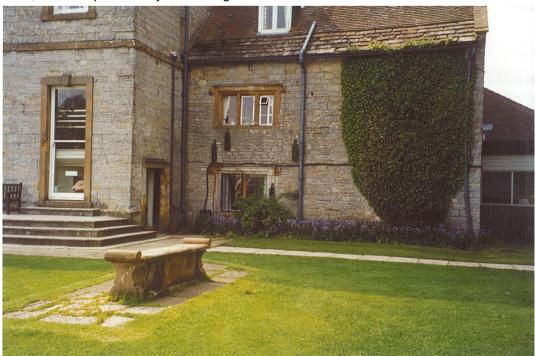
Figure 6.6 - A photograph taken outside the Tudor part of Hazlegrove House, dated to between 1963-1999; held and provided by the Hazlegrove Trust

Figure 6.7 - A photograph taken outside the Tudor part of Hazlegrove House, dated to May 2000; held and provided by the Hazlegrove Trust.

6.2.9 Hazlegrove House also retains remnants of the former 16th century Tudor building (Figure 5.6 and Figure 5.7). A porch feature survives on the north facing side of the house, providing evidence for the original orientation and entrance to the house from the north. In addition, a Tudor wing to the building survives and several other features from this date can been viewed throughout the property. Whilst historic fabric survives within and around Hazlegrove House and the formal gardens, the current use of the building as a school has resulted in a number of alterations to the property. The installation of the sports pitches, the car park, and modern school and residential buildings, has resulted in the removal of historic fabric, including the kitchen gardens.

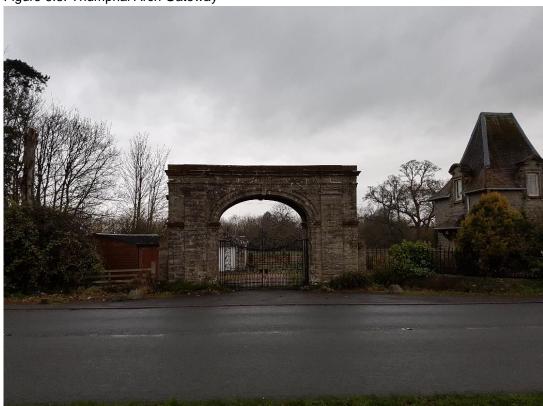
Figure 6.8: Triumphal Arch Gateway

6.3.1 The grade II* Triumphal Arch Gateway formed the new grand entrance to the park when the driveway was diverted to the southeast corner in the mid-19th century (Figure 5.8). The gateway was acquired from Low Ham Manor, near Somerton, and dates to the 17th century. Hazlegrove Lodge was also constructed in the southeast portion of the park near to the gateway. Today, the gateway is separated from the majority of the RPG by the A303 that was constructed in the 1990s. Whilst this part of the RPG remains included in the RPG listing, it is completely separated by the bypass and retains few of the former park features, other than the gateway and lodge.

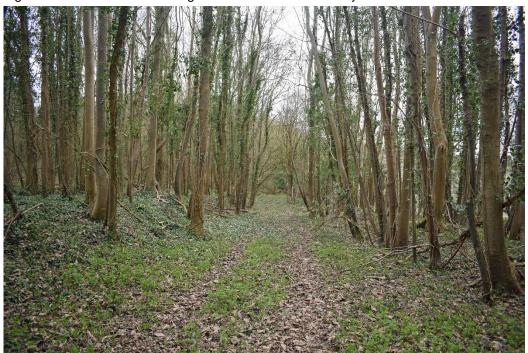
Figure 6.9 - Earthworks showing location of former driveway

6.4.2 The evidential value for the historic driveways to Hazlegrove House largely derives from surviving historic fabric. Within the wooded area along the southern border of the RPG, surviving earthworks of 2 phases of driveway alignment remain extant (Figure 5.9). Embankment features which follow the line of the drives shown on the historic mapping are also apparent on the aerial survey undertaken as part of this assessment (see appendix A). The first of these driveways is shown on historic maps between 1795 and 1827 with the second phase extension of the driveway to the south being shown on historic maps since 1848. The 1795 driveway appears to be a north turn off the existing lane which led to Hazlegrove House, the extension shown on the 1848 plan appears to connect the entrance to the principal route, bypassing the lane which followed the line of the existing public footpath. The alignment of these driveways has been mapped as a series of ditch and back features following an aerial survey undertaken for this scheme. A number of veteran trees within in the RPG also appear to follow the alignment of the former driveway, and may represent the remnants of the former trees avenues shown on historic maps to flank the driveways. A new tree avenue has been planted along the route of the existing drive, however, this has no evidential value as it is a modern introduction. The surviving historic fabric and visibility of the remains in the landscape adds to the evidential value of the driveways to Hazlegrove House, which provides a valuable insight into the progressive development of Hazlegrove House RPG.

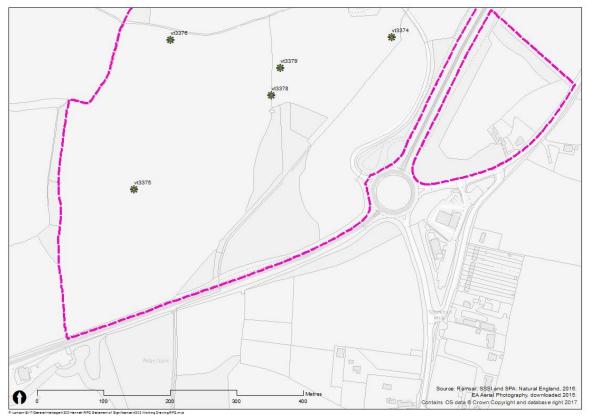
Figure 6.10 - Veteran Trees in Rawlins's Close

- 6.6.4 There are a number of specimen trees retained within Rawlins's Close, important evidence of the former parkland character. Five specimen trees survive in Rawlins's Close, designated as veteran trees, 4 oaks and 1 pedunculate oak (Figure 5.10)²⁴
