A303 Sparkford to Ilchester Dualling Scheme TR010036

6.3 Environmental Statement

Appendix 8.10 Water Vole and Otter Technical Report

**A303 Sparkford to Ilchester Dualling
Scheme**

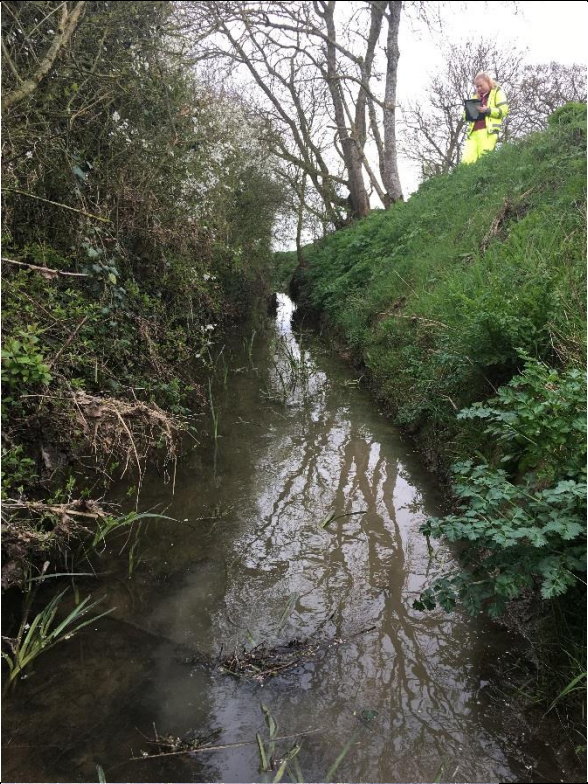
Photo Number	Description	Photograph
1	Survey area A- Dyke Brook. Deeply incised channel

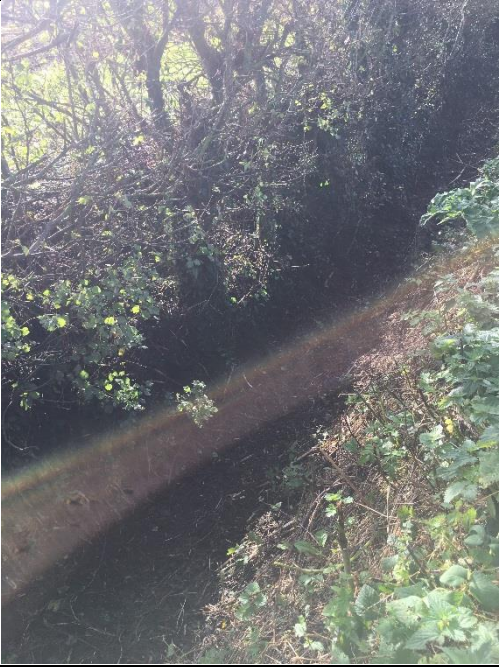
2	Survey area B

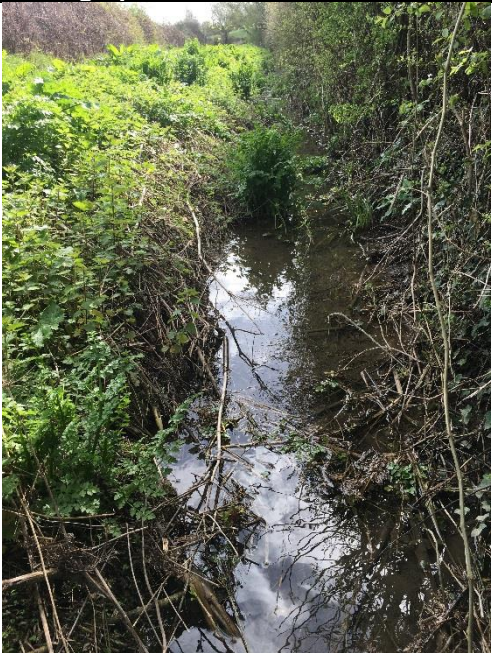
Photo Number	Description	Photograph
3	Survey area C

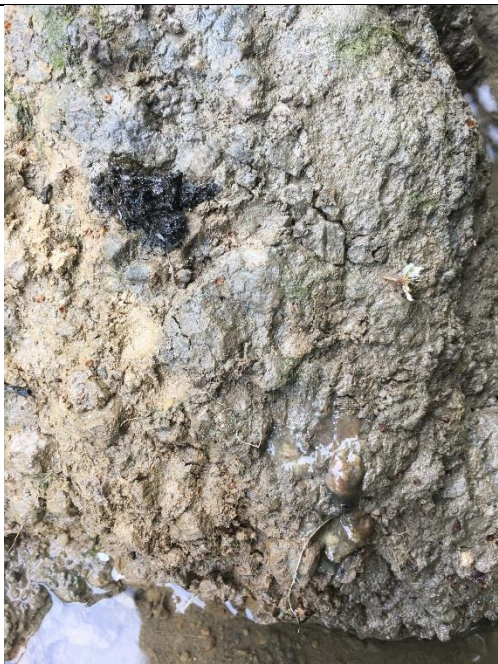
4	Survey area D Deep channel obscured by trees and bramble.	Not applicable
5	An example of a spraint and anal jelly found on the Dyke Brook

- 3.3.1 Otter field signs were prevalent at the time of the survey. Signs were found along the extent of Dyke Brook but a greater level of activity was recorded to the west of Steart Bridge. Within this area, 5 spraints were found as well as 1 secretion of anal jelly. Over 5 spraints were also recorded under Steart bridge (Photo 6, appendix D). Otter footprints were also noted (Photo 5, appendix D). The location of these records is described in appendix B.

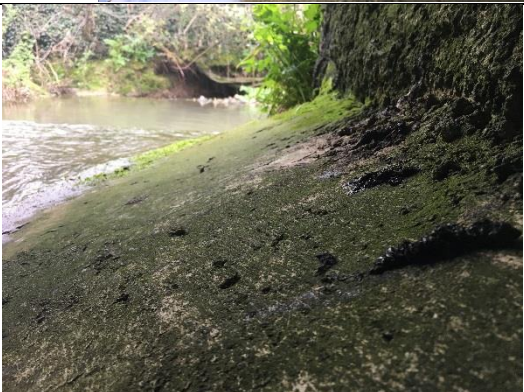
6	Multiple spraints found at Steart Bridge on the Dyke Brook

- 3.3.3 Although only 1 field survey was completed; incidental checks for otter signs were made during the second water vole survey. Spraints were found again under the bridge but no other signs were noted.

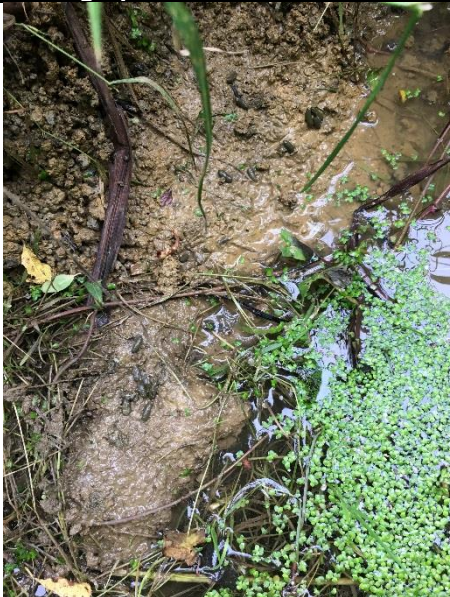
Photo Number	Description	Photograph
7	Water vole signs found on the Dyke Brook

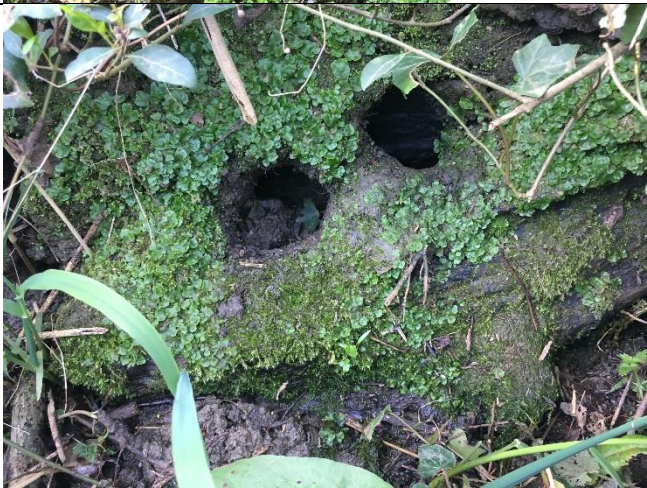
8	Unoccupied burrows at survey area B

- 3.5.6 Water vole presence was confirmed in survey areas A, C and D. Although potential burrows were found at area B no feeding signs were found.
- 3.5.7 Surveys of area A recorded water voles on both visits but the distribution of the animals changed over the year. At the time of the first visits the signs were limited to east of Steart Bridge and to the southern stretch of the watercourse. Later in the year the signs were found over a wider area including to the west of Steart bridge. This greater distribution will reflect water voles breeding throughout the summer months and the young dispersing into unoccupied territories as they mature.

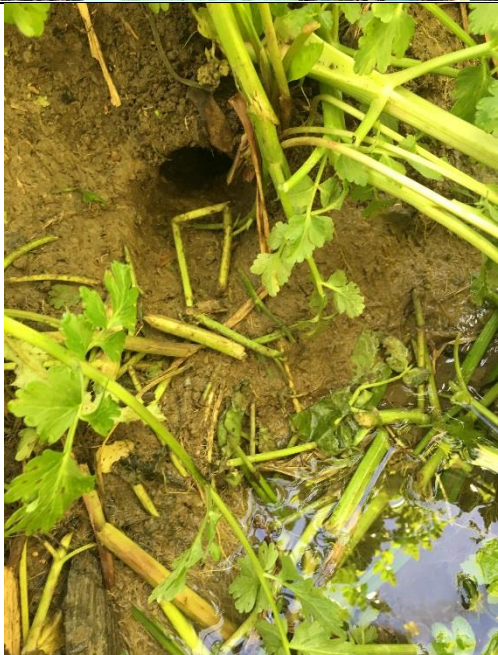
9	Water vole burrow and feeding signs, survey area C

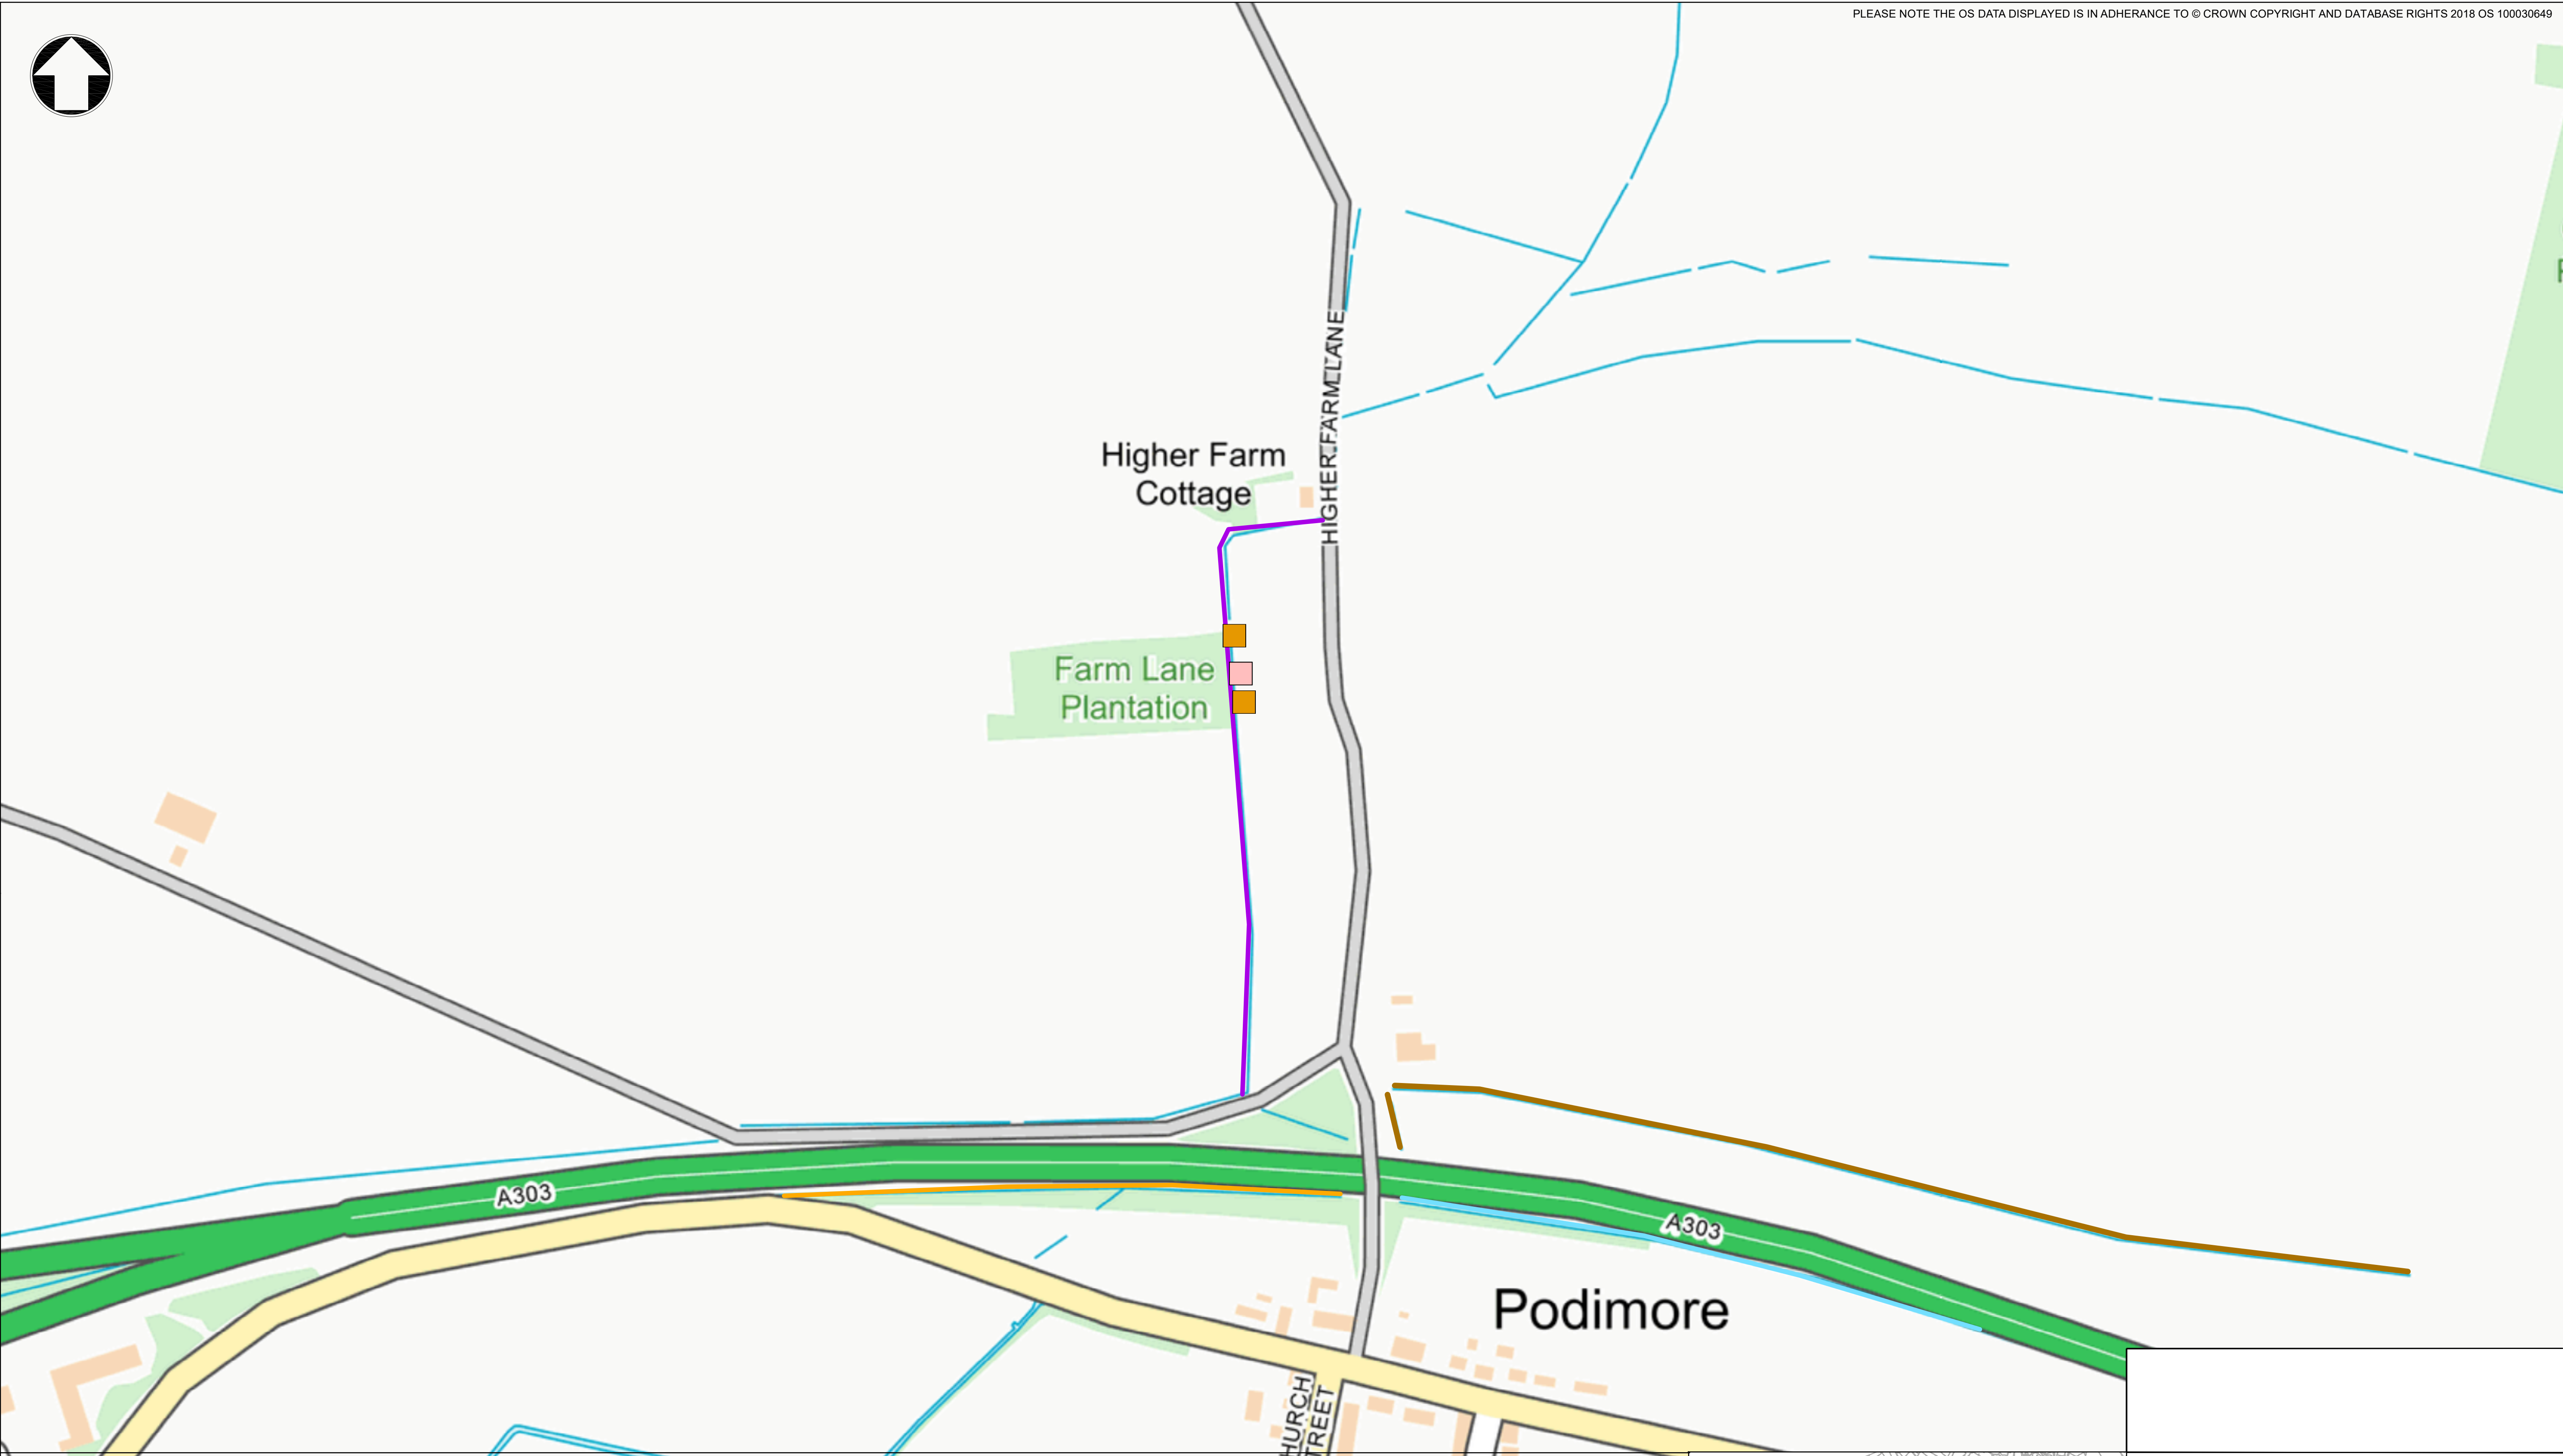
Appendix G: Water vole results April 2017

- UNKNOWN BURROW
 - UNKNOWN FOOTPRINT
- SURVEY AREAS**
