## A47/A11 Thickthorn Junction

# 6.3 Environmental Statement Appendices Appendix 7.7 – Lighting Assessment

## LIGHTING IMPACT ASSESSMENT

PROJECT: A47/A11 THICKTHORN JUNCTION

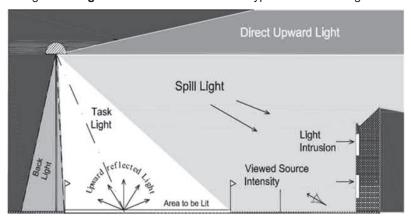
Figure 2 Obtrusive light diagram (GN01:2020, Figure 1)

- 3.1.3 Consideration is given to light intrusion, direct upward light (sky glow) and glare within the context of varying environmental zones.
- 3.1.4 Light intrusion refers to the spilling of light beyond the boundary of the area to be lit. This includes the intrusion of light into bedroom windows.

- 3.1.5 Sky glow refers to the brightening of the sky above towns cause by direct or reflected upward light.
- 3.1.6 Glare refers to the uncomfortable brightness of a light source when viewed against a dark background. **Figure 2** illustrates the different types of obtrusive light.

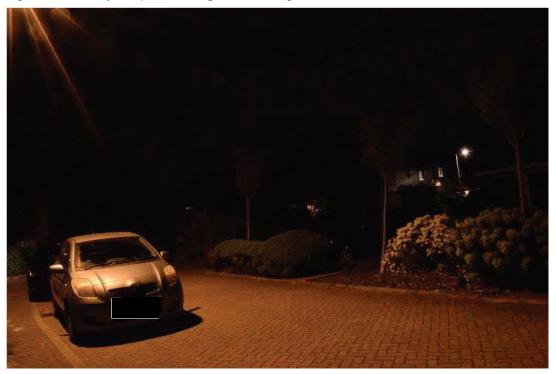
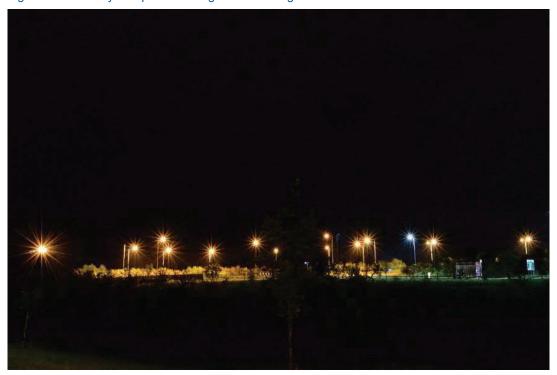
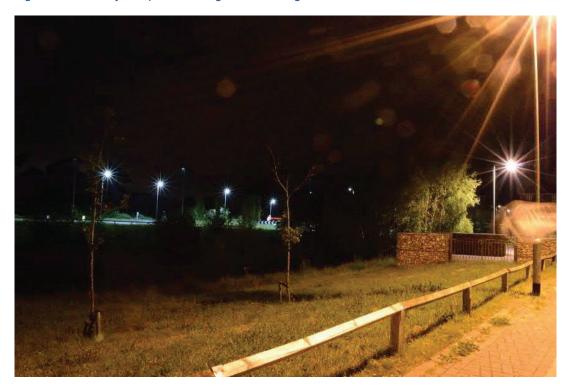
- 6.3.6 The baseline conditions of the majority of the key lighting related viewpoint locations are described as dark, with the exception of Viewpoint 11, which measured ambient light levels of up to 13.19 Lux from residential floodlighting present on the back of properties on Meadow Farm Drive.
- 6.3.7 The baseline conditions of the majority of the ecological survey locations are described as dark, as indicated by the light measurements recorded.
- 6.3.8 Notable levels of obtrusive light were recorded at Viewpoint number 21, due to light spill from lighting associated with the highway maintenance compound located at the end of Cantley Lane.
- 6.3.9 Full baseline survey results are available in **Annex 2**.
