# A47/A11 Thickthorn Junction

**Scheme Number: TR010037**

## **6.3 Environmental Statement Appendices** **Appendix 13.5 – Geomorphology Assessment** **Report**

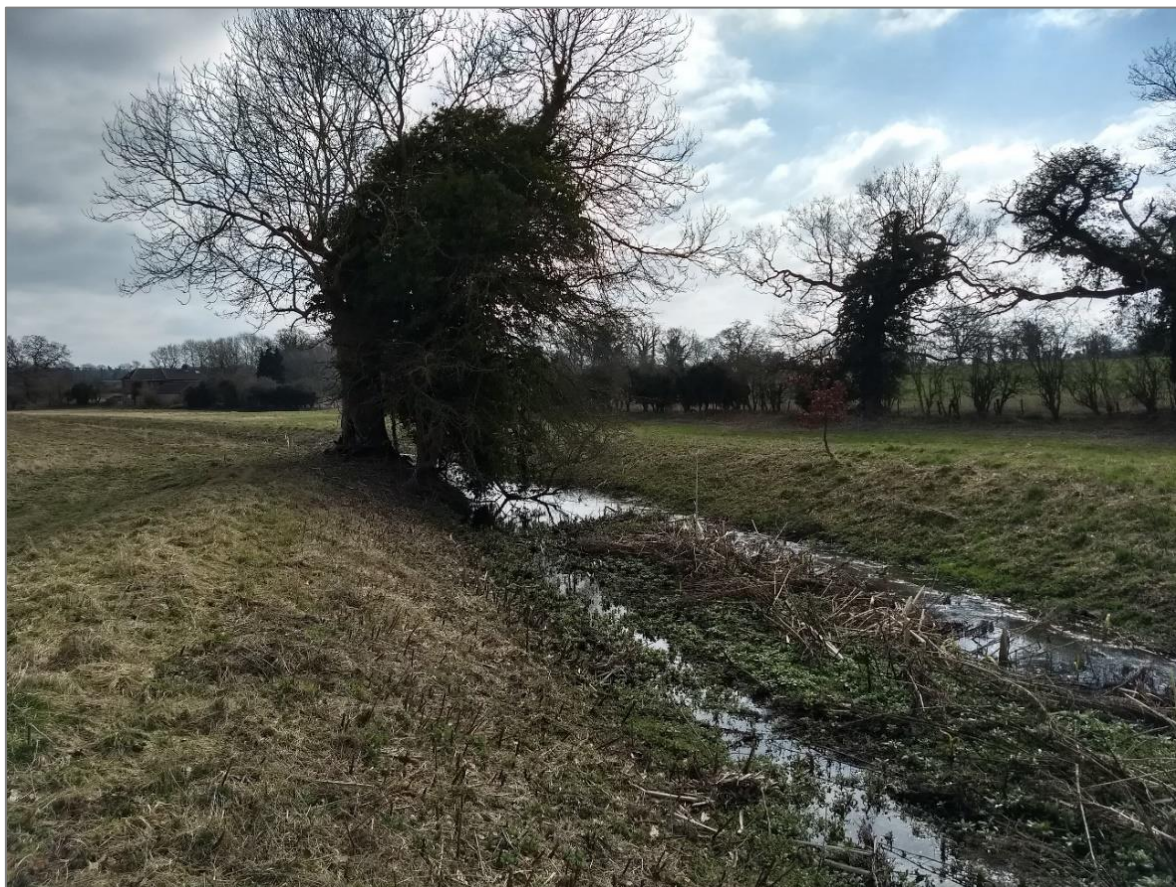
Caption 3.1 Typical view of Cantley Lane Stream (upstream of Cantley Lane), looking downstream.

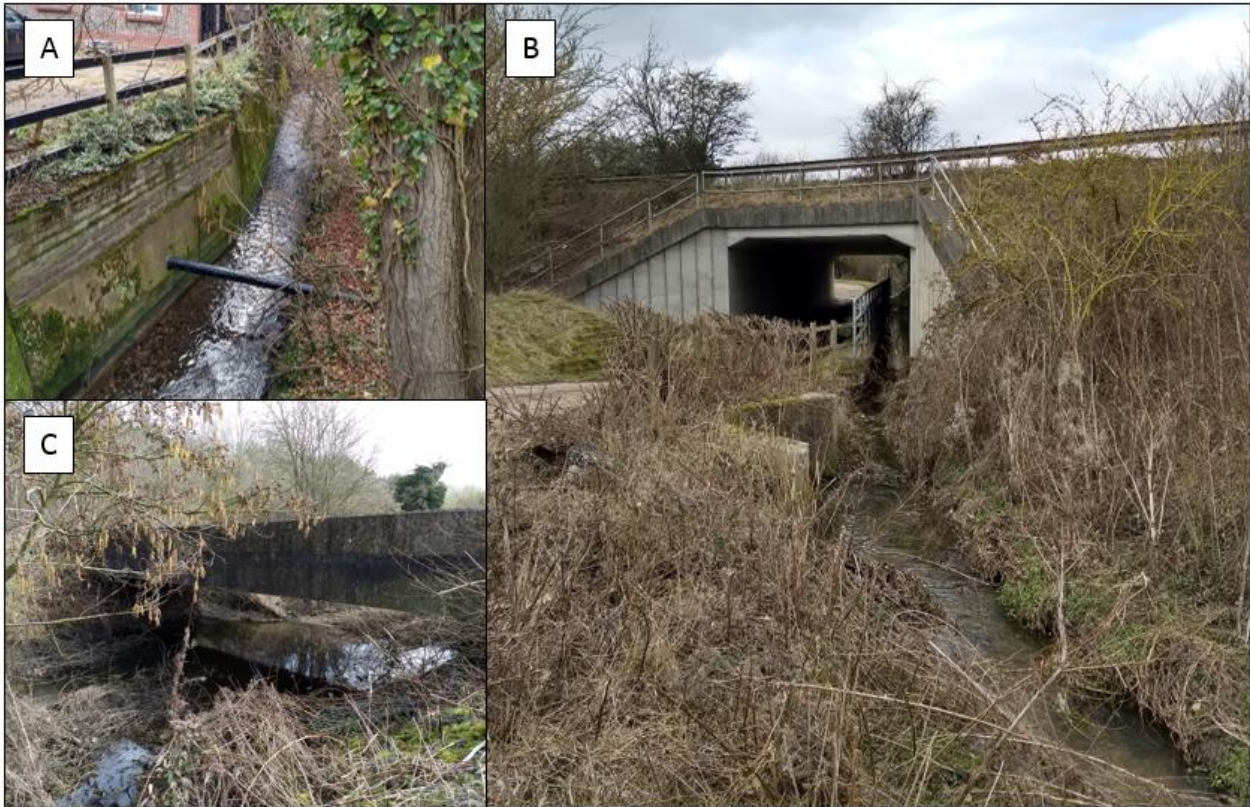
- 3.5.3. Cantley Stream has been culverted at four road crossings (the A11, the A47, Cantley Lane South and Intwood Road). Additionally, there are three footbridge crossings on the reach (Caption 3.2).

Caption 3.2 Photos of bridge crossings on the surveyed reach of Cantley Stream (A) Photo taken from the Intwood Road bridge, looking upstream; (B) the A11 crossing; (C) Foot bridge approximately 20 m east of the A11.

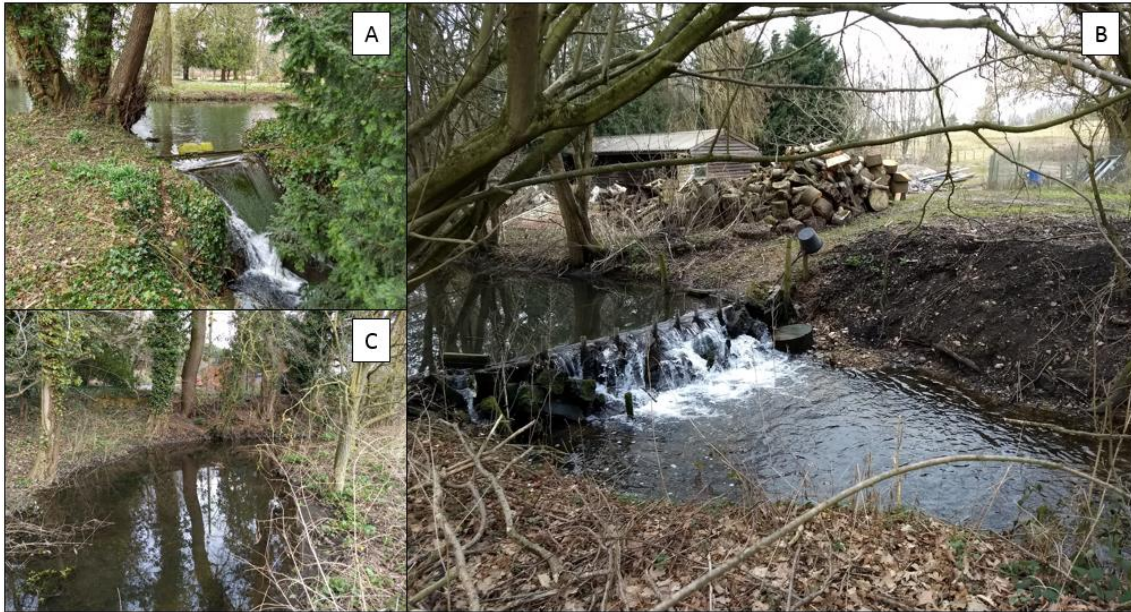
- 3.5.4. Two weirs and one partial-blockage of large woody debris, acting in a similar manner to a weir, are present on the surveyed reach which have impounded water forming in-line ponds (Caption 3.3, photo C). Of the two weirs one forms the upstream boundary of the reach (Caption 3.3, photo A), and the other is located just upstream of where the channel aligns with the northern edge of the railway (Caption 3.3, photo B). The large woody debris acting as a weir is located immediately to the east of Cantley Lane South.

Caption 3.3 Photos of weirs on the surveyed reach of Cantley Stream. (A) Shows the man-made upstream weir (Cantley Stream Pond); (B) Shows a man-made weir upstream of the A47 culvert, (C) Shows water ponding behind the naturally formed weir just east of Cantley Lane South.

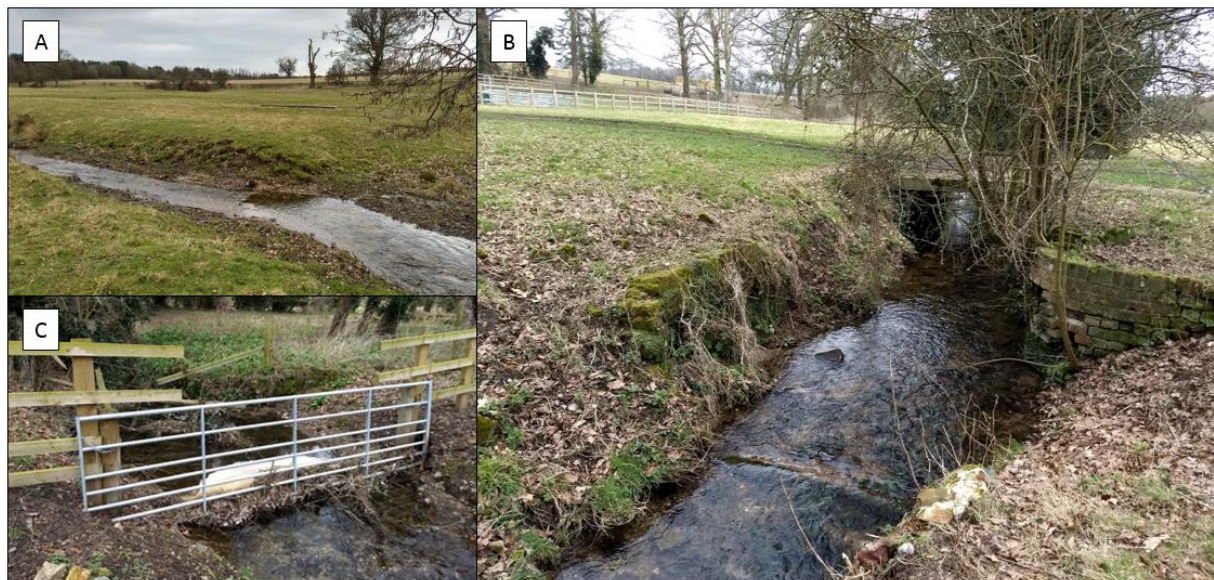
- 3.5.5. Other morphological pressures on the channel include occasional bank protection. The most extensive area of bank protection is located downstream of Cantley Stream Pond and is composed of brick walls lining both banks (Caption 3.4, photo B). The brick walls are collapsing in places, adding brick debris to the channel. Downstream of this area, two gates cross the channel which have caused a build-up of debris behind them. Upstream of the A11, there is minor bank erosion on the right bank (looking downstream) as a result of livestock poaching, which may be a source of fine sediments entering the channel. Other than this, there was only minor area of bank erosion observed along the surveyed reach and a small section of bedrock is exposed in the lower left bank (looking downstream), upstream of the A11, displaying evidence of basal scour.

Caption 3.4 Photos of additional morphological pressures on the surveyed reach of Cantley Stream. (A) Bank erosion due to poaching by sheep on the right bank; (B) Collapsing brick wall bank protection downstream of the Cantley Stream Pond; (C) Partial blockage of the channel due to debris build up behind a gate crossing the channel.
