### A47 North Tuddenham to Easton Dualling

Volume 6
6.3 Environmental Statement Appendices
Appendix 6.3 – Archaeological Evaluation

#### **ARCHAEOLOGICAL EVALUATION:**

#### A47 North Tuddenham to Easton: An Archaeological Evaluation

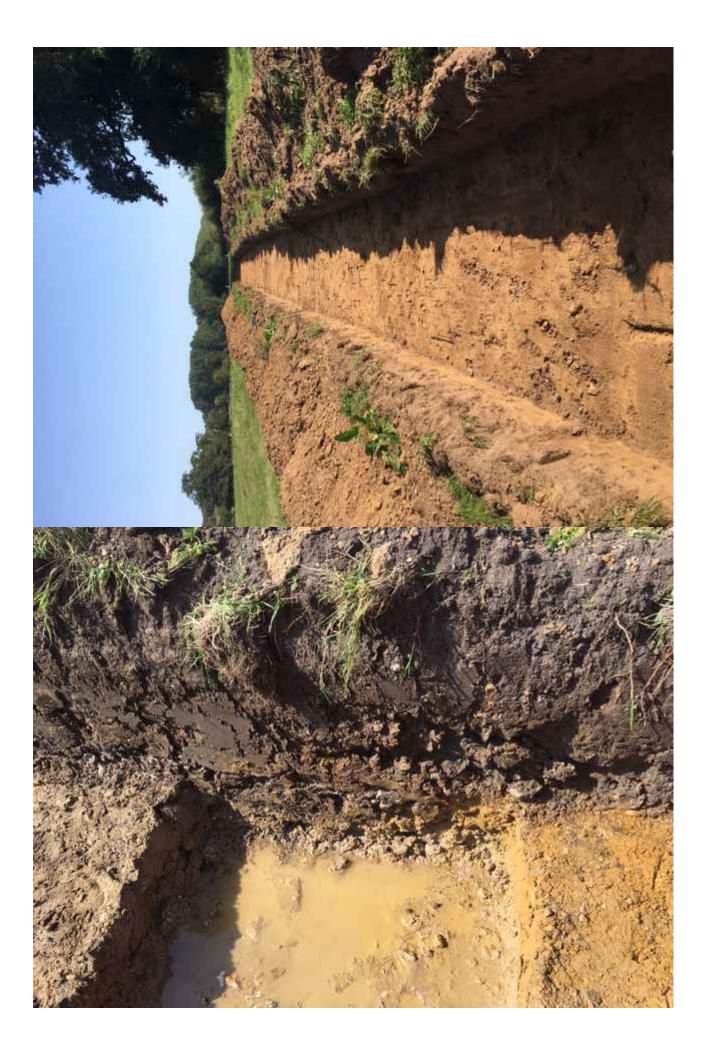
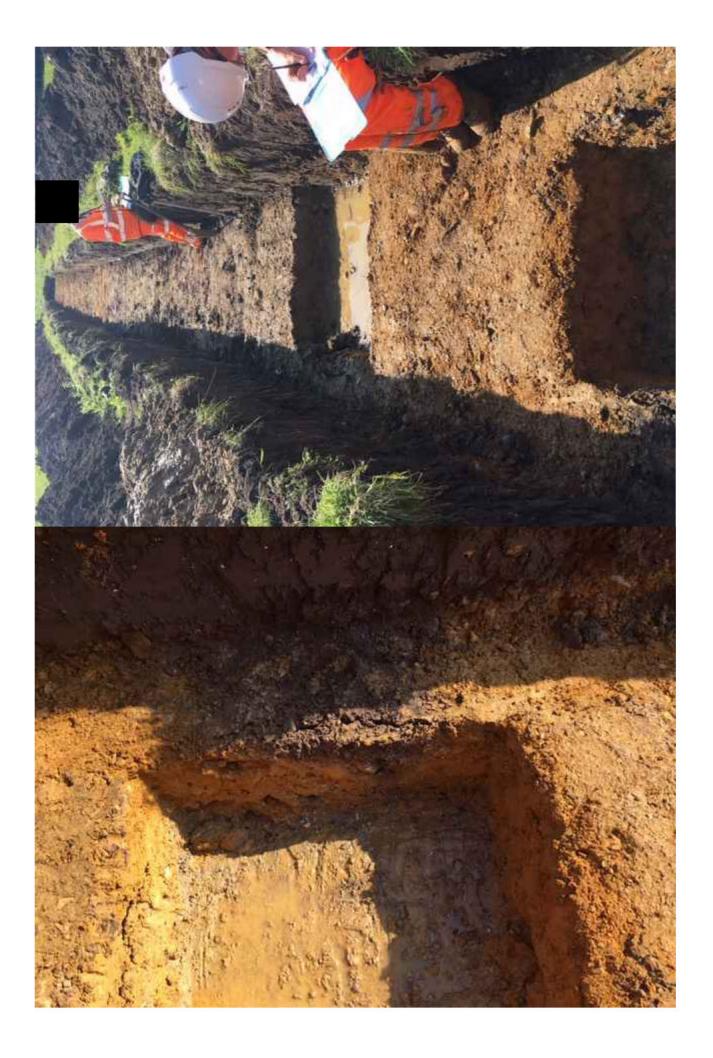
Attached are the photos from the 3 trenches in area 39- one is blank, the other two (538 and 539) are partially covered by a large pit (pond?). I have testpitted the feature and retrieved some samples as far as I can- but I have hit safe depths and am losing a battle with the water table in each. It has produced some brick fragments so probably not particularly old unfortunately. Please let me know if you would like anything else.

- 6.18.3 Area 39 (Trenches 538, 539 and 540) contained a large (c. 20m+ wide) pond feature, located in Trenches 538 and 539. The feature was visible as an earthwork prior to trenching, which may have formed a part of the NHER 28552 reference noted as extending into the area.
