A47 North Tuddenham to Easton Dualling

Scheme Number: TR010038

6.3 Environmental Statement Appendices **Appendix 13.5 – Geomorphology Assessment** **Report**

ENVIRONMENTAL STATEMENT APPENDICES
Appendix 13.5 - Geomorphology Assessment Report

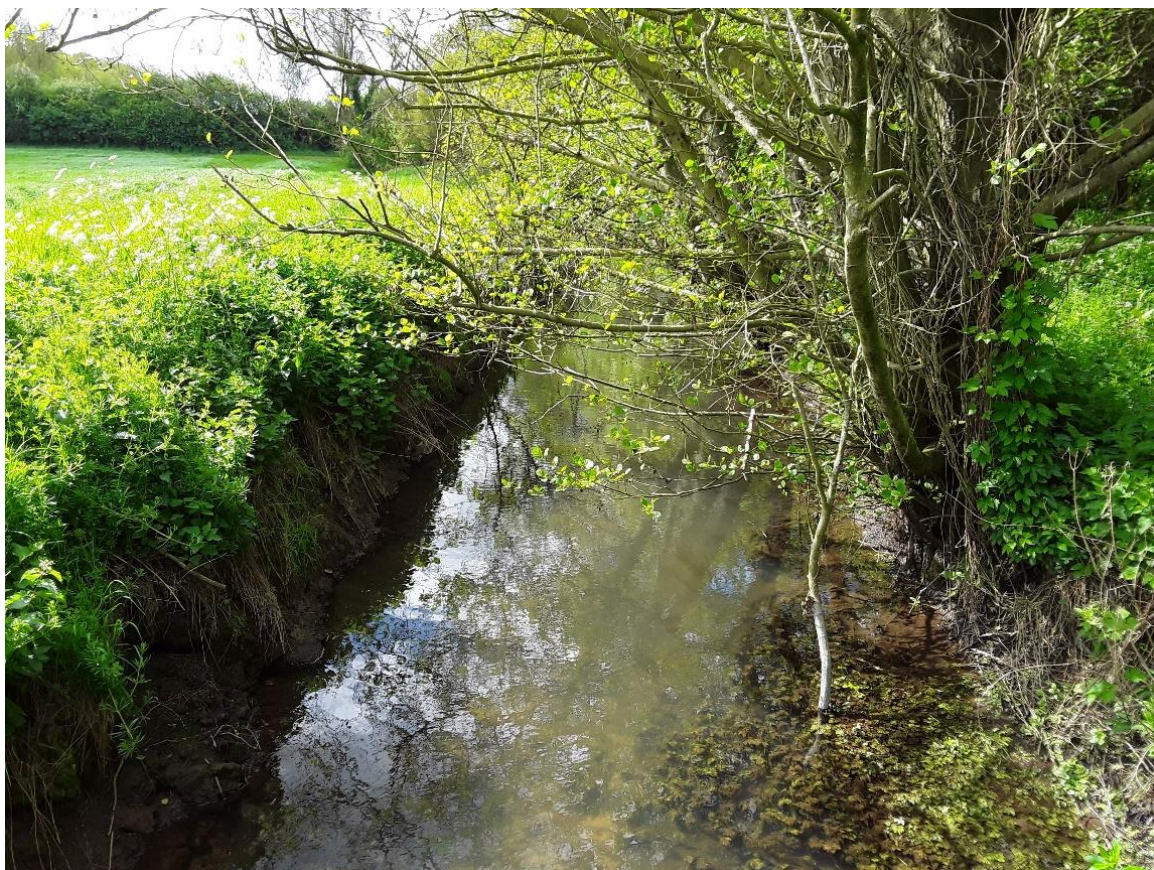
- 3.5.4. The reach between the start of the survey and Whitford Bridge appears relatively natural with few anthropogenic pressures present. There is evidence of some agricultural realignment with the channel appearing over deepened in places, however this is limited in scale. The substrate varies between clear gravel, which would be expected in a natural chalk stream, and uniform silt. The origin of the silt was not clear; however, it is likely to be a product of both bank erosion and runoff from surrounding land (Caption 3.1).

Caption 3.1 Looking upstream between Mattishall and Whitford Bridge.

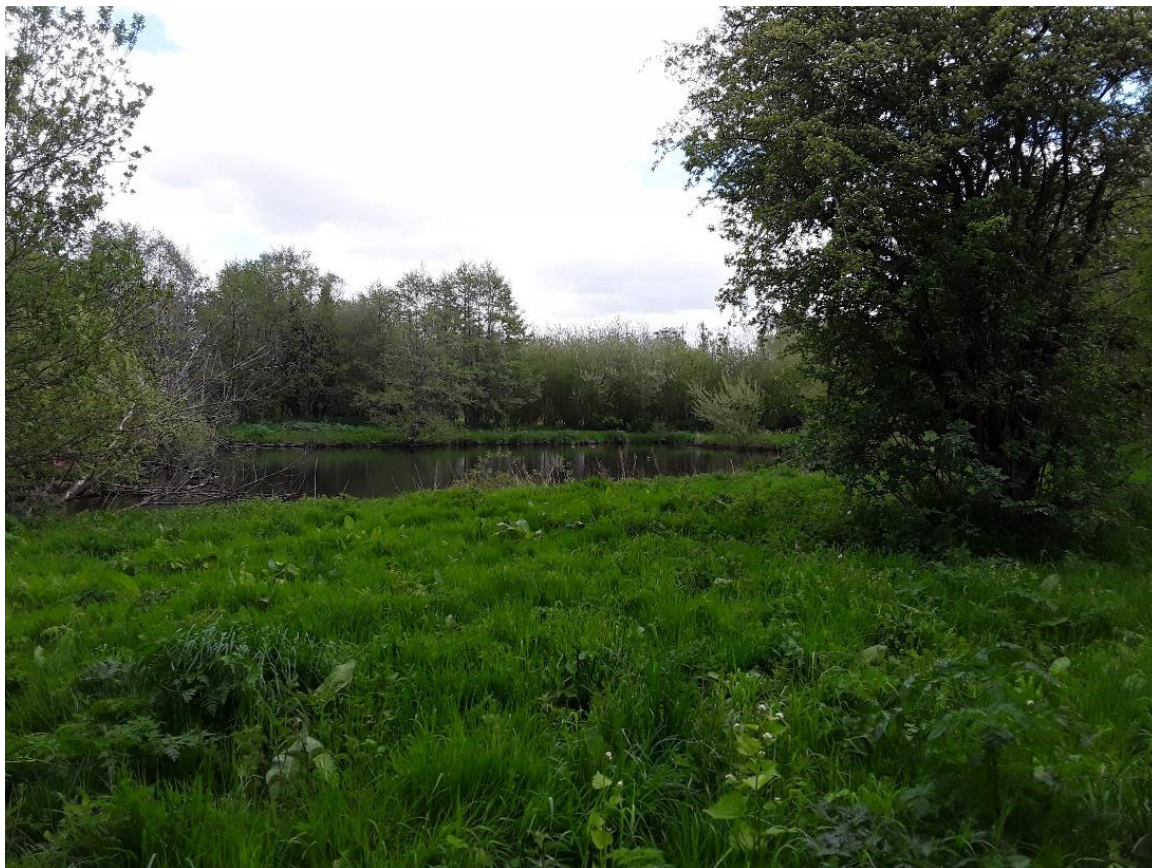
- 3.5.5. Beyond Whitford Bridge, the watercourse flows through a deciduous woodland with a continuing planform of meanders, expected from a pool - riffle typology. The substrate in the woods is primarily silt, with several areas of large woody debris caused by tree fall. Some areas of bank erosion are present. The watercourse exits the woodland after approximately 600m and enters pastoral farmland. An artificial pond is close to the left bank of the watercourse in this field, thought to be used as a duck shooting pond. An abstraction point next to the channel appears to be used to refill the pond (Caption 3.2).

Caption 3.2 - Artificial pond on left bank, fed with water abstracted from the Tud.

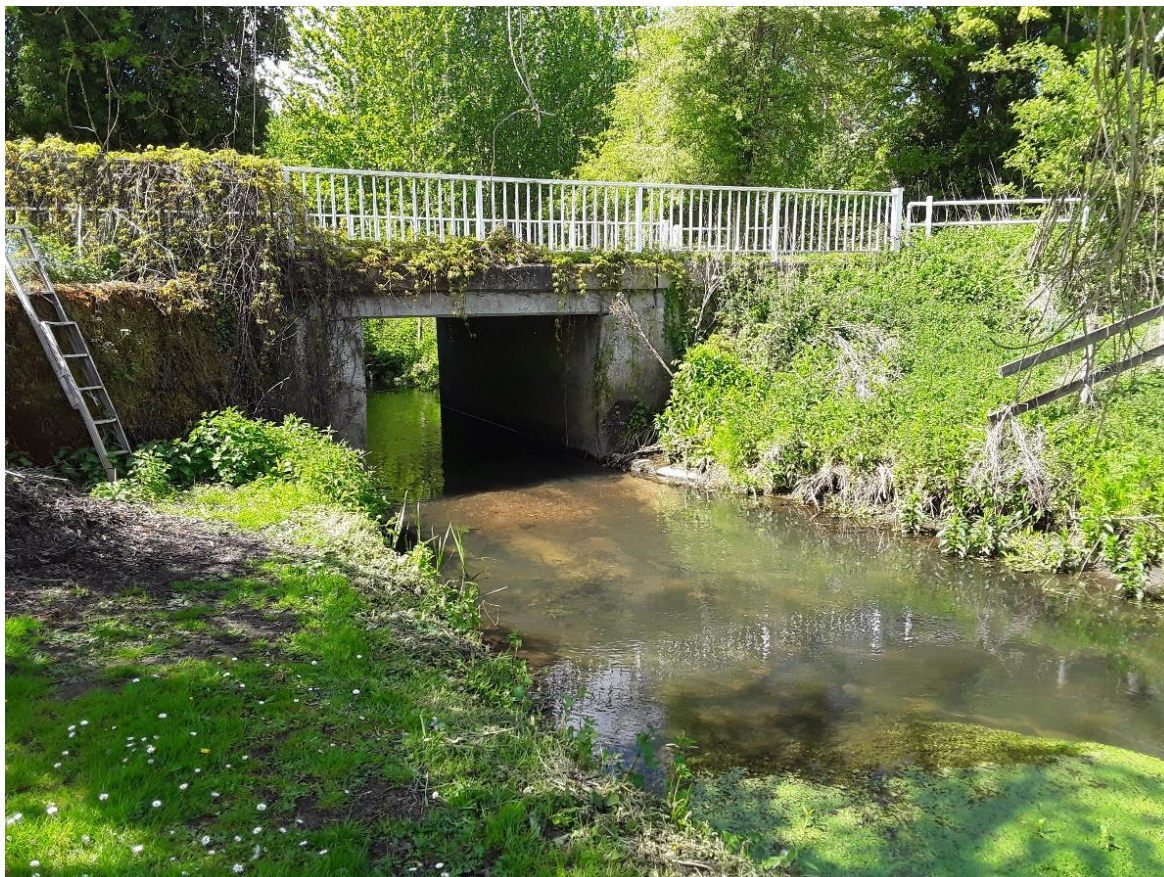
- 3.5.7. After the ford, a weir is present in the channel, however it appears to have negligible impact on sediment transport. The channel continues through agricultural fields before entering private gardens as it approaches Blois Bridge. Anecdotal evidence from a local resident who had lived in the area since the early 1970s suggests that Church Lane acts as a flow pathway for silt runoff from the existing A47 and surrounding land during periods of rainfall, which then deposits into the watercourse near the bridge (Caption 3.3). The channel bed in this reach was covered with a layer of silt for some distance downstream of the bridge, although the provenance of this silt could not be determined.

Caption 3.3 - Blois Bridge, looking upstream.

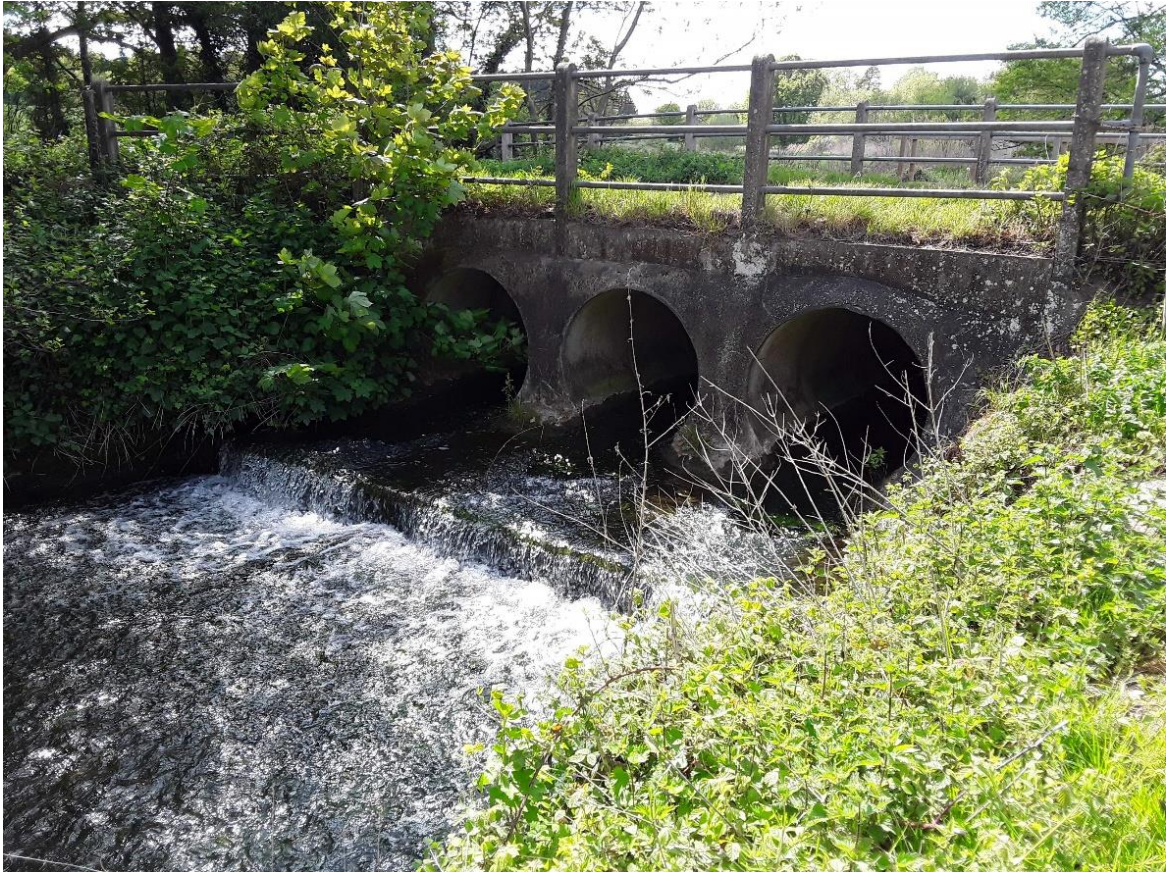
- 3.5.8. The channel continues flowing roughly east towards Honingham through unimproved pastureland, with evidence of channel realignment present. Some recovery has taken place, with evidence of gravel riffles and sinuosity in the channel. However, the over deepening of the channel below the floodplain prevents any major recovery from taking place.
- 3.5.9. At Berry's Bridge, there are large weir structures upstream and downstream of a triple culvert (Caption 3.4). The upstream weir has a sluice gate with an offtake channel, which appears to have been originally used as a mill lade.

Caption 3.4 – Berry's Bridge, looking upstream.

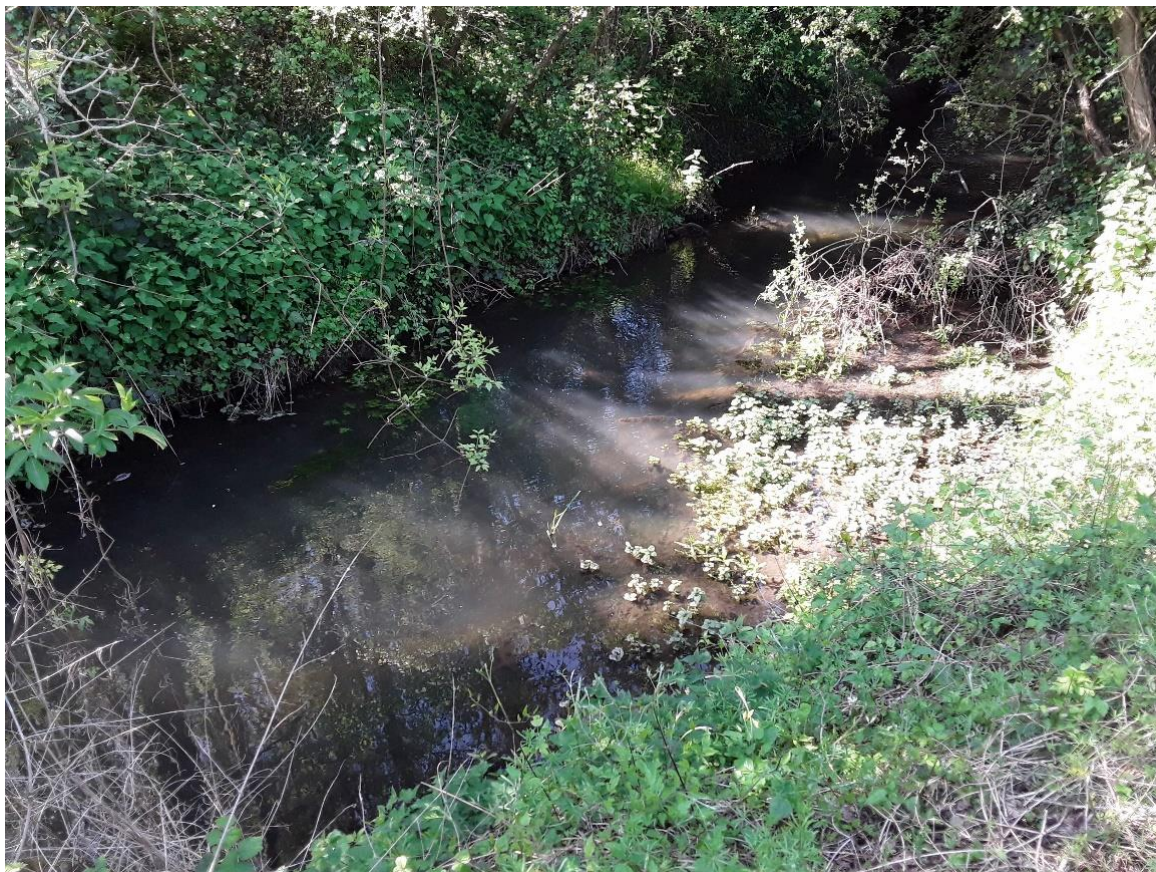
- 3.5.10. The watercourse runs through gardens as it passes through the village of Honingham. The mill lade channel re-enters the main watercourse just downstream of The Street in the centre of Honingham. The main watercourse then passes underneath the existing A47 and enters estate land (Caption 3.5).

Caption 3.5 - Downstream of A47, looking upstream under A47 bridge.

- 3.5.11. The watercourse has undergone approximately 300m of significant realignment for the construction of the existing A47, according to historic OS mapping. The channel flows north-east under the A47 bridge and turns at a 90 degree angle towards the south east. The channel appears over deepened and shows no signs of any natural geomorphological features that would be associated with a chalk stream as observed upstream in the survey. The bed is uniformly covered in silt. Caption 3.5 shows significant over deepening and siltation within the channel.

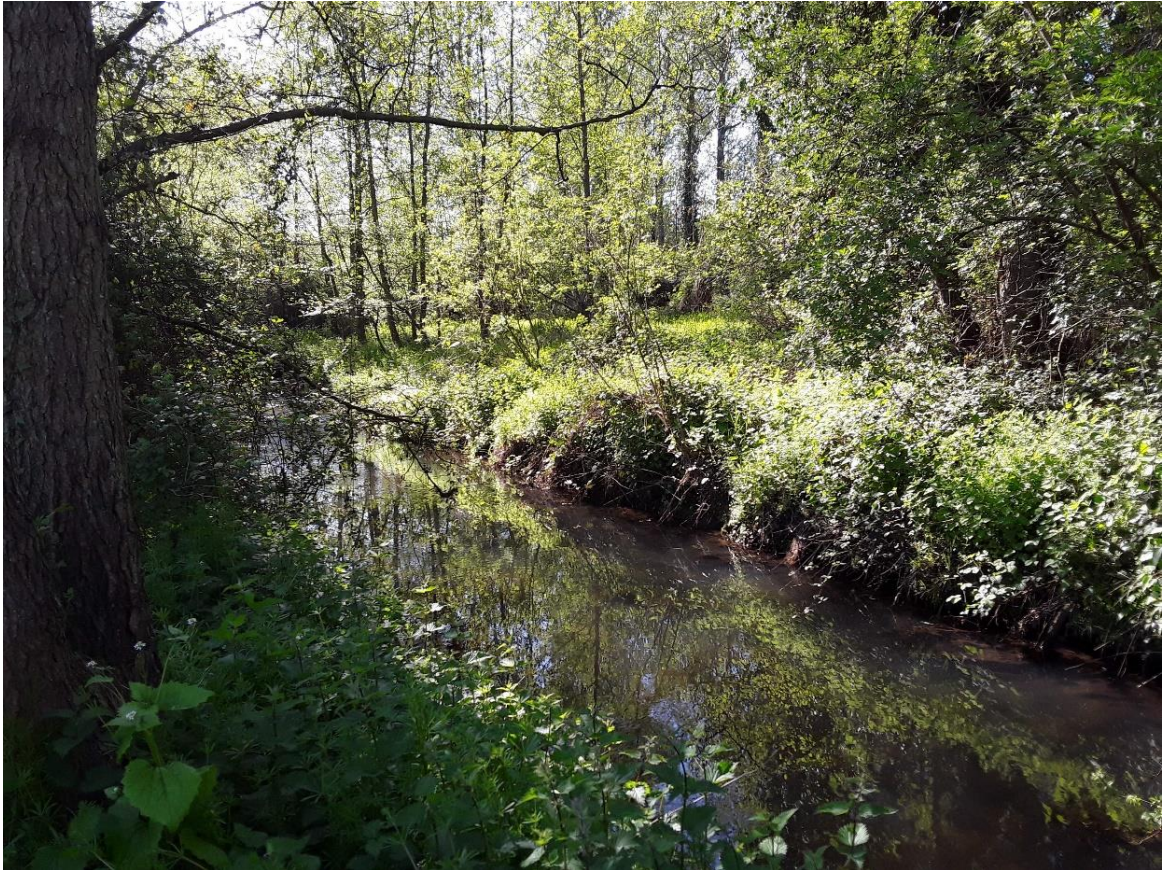
Caption 3.6 - River Tud through estate land, looking upstream.

- 3.5.12. Approximately 100m downstream of the A47 bridge, the channel returns to a more natural morphology (Caption 3.6). The elevation of the bed is much closer to the elevation of the floodplain, and a gravel bed relatively clear of silt. The channel passes through unimproved pastureland on the left bank and woodland on the right bank in a realigned reach, until it turns to flow south on a relatively natural course through pastureland.

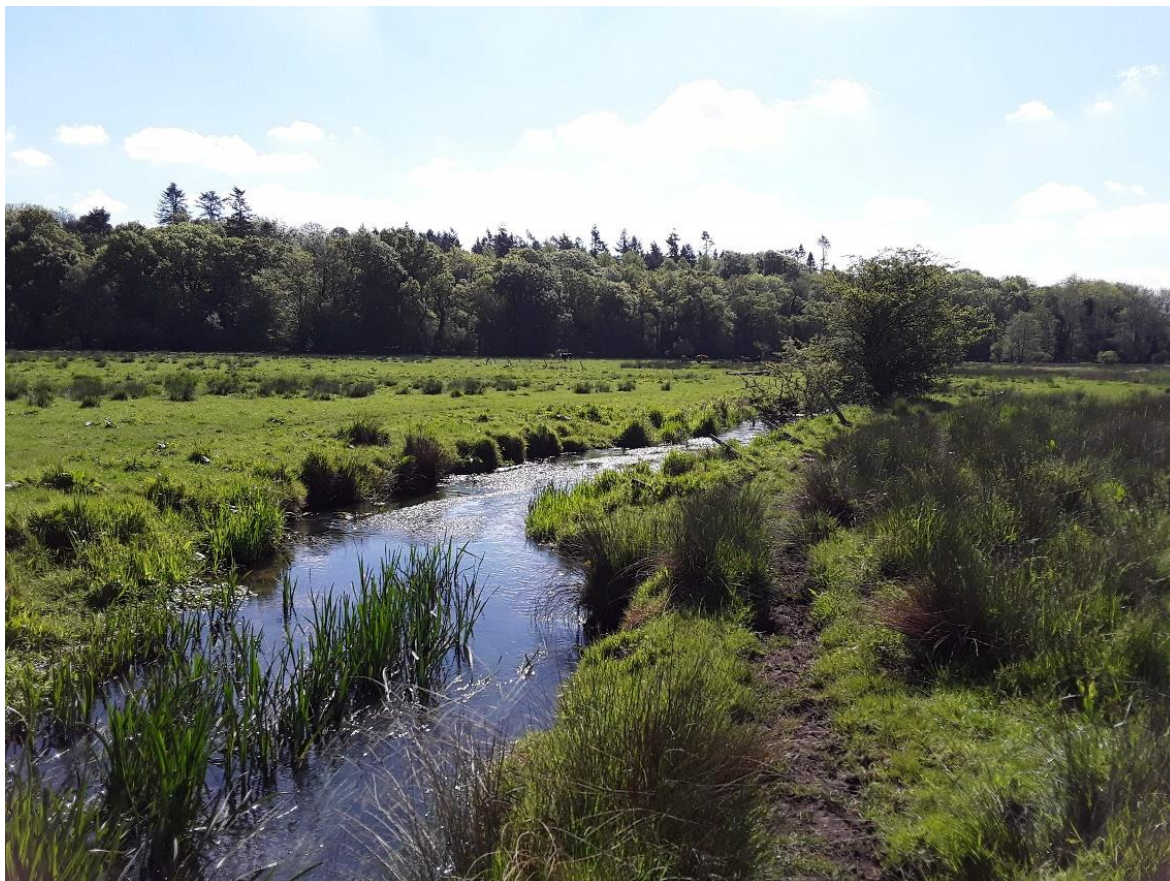
Caption 3.7 - River Tud through estate land, looking downstream.

- 3.5.13. The channel in this reach appears relatively natural (Caption 3.7), with bank erosion and some pool and riffles present in the gravel bed channel.
- 3.5.14. Close to Church House Farm, a side channel enters the main channel on the left hand side. After this, the channel bed becomes uniformly covered in silt again for approximately 200m the river turns to flow east again and passes under Taverham Road bridge.
- 3.5.15. The channel continues to show evidence of agricultural realignment as it passes into pasturelands beyond Taverham Road. There was evidence of sinuosity and some bank erosion and gravel bedforms that would be expected from a chalk stream with a pool - riffle typology. The survey ended approximately 700 m downstream of Church House Farm.

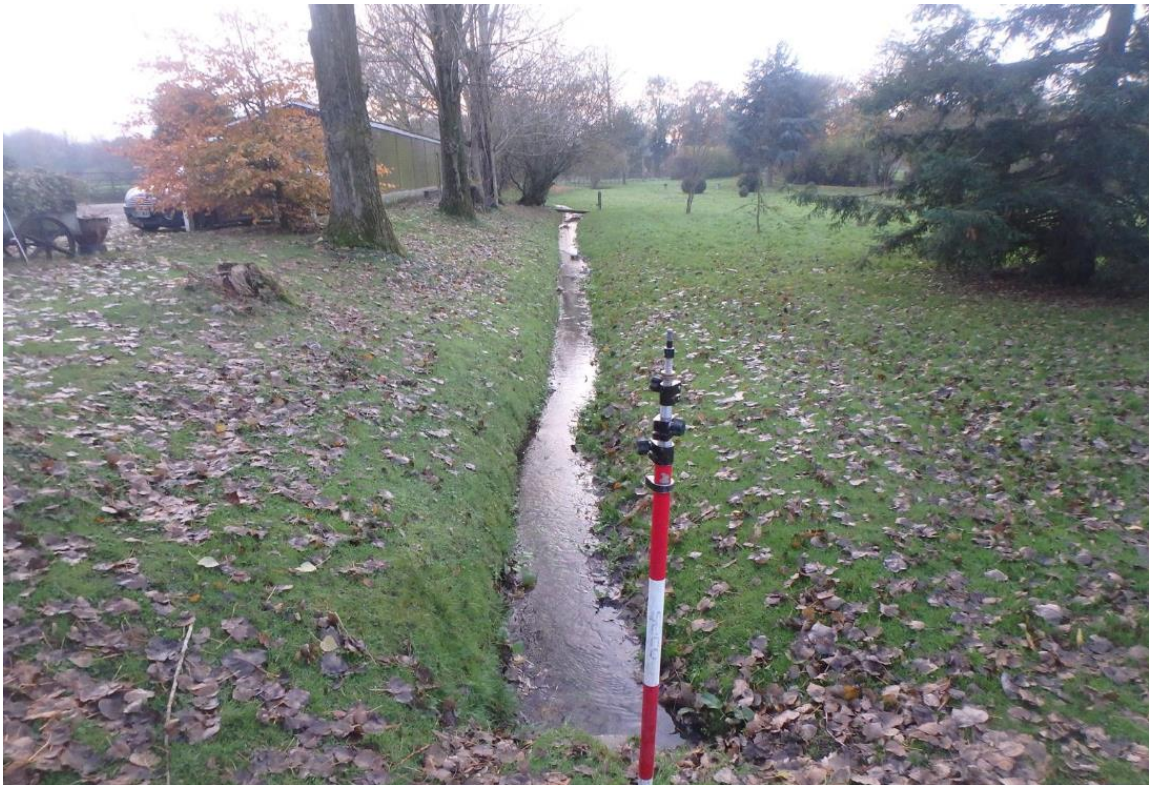
- 3.5.16. The Oak Farm tributary in the vicinity of the planned A47 extension is a heavily modified field drain passing under the road in a pipe culvert. Upstream of the culvert is a straightened agricultural channel flowing south before turning south-west just before the culvert. Few natural geomorphic features are present in the channel (Caption 3.8).

Caption 3.8 - Typical cross section of Oak Farm tributary, looking downstream - heavily modified channel with few natural features.

- 5.3.3. For planned culverting on the Oak Farm and Hockering tributaries, habitat restoration measures such as riparian buffer strips / planting, re-meandering and leaky dams must be considered to ensure no reduction in WFD status. At least length for length mitigation must be provided to offset the impact of additional culverting.

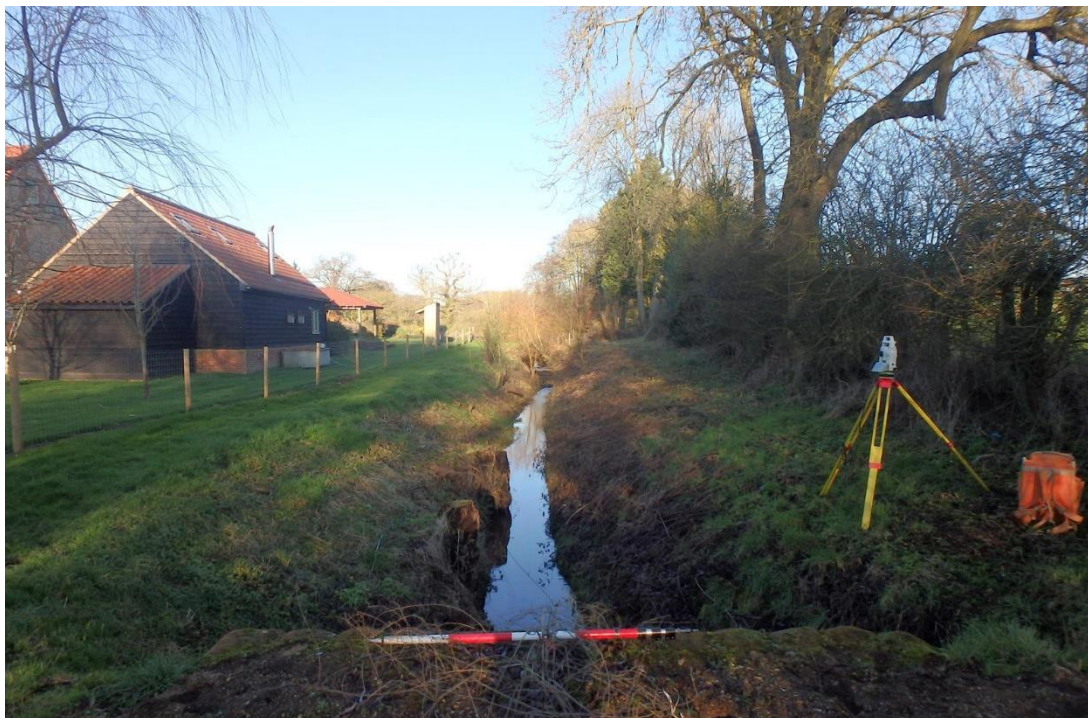
- 3.5.18. The Hockering tributary in the vicinity of the Proposed Scheme is also a heavily modified field drain, flowing south towards the River Tud. The tributary flows out of a series of online ponds approximately 200m to the north of the existing A47. It then flows through farmland, passing under the A47 and through a series of private properties before joining the River Tud. Very few natural geomorphic features are present in the channel (Caption 3.89).

Caption 3.9 - Typical cross section of Hockering tributary, looking upstream - heavily modified channel with few natural features.
