A47 North Tuddenham to Easton Dualling

6.3 Environmental Statement Appendices **Appendix 8.5 - White-clawed Crayfish Survey** **Report**

White-Clawed Crayfish Survey along the River Tud, Norfolk

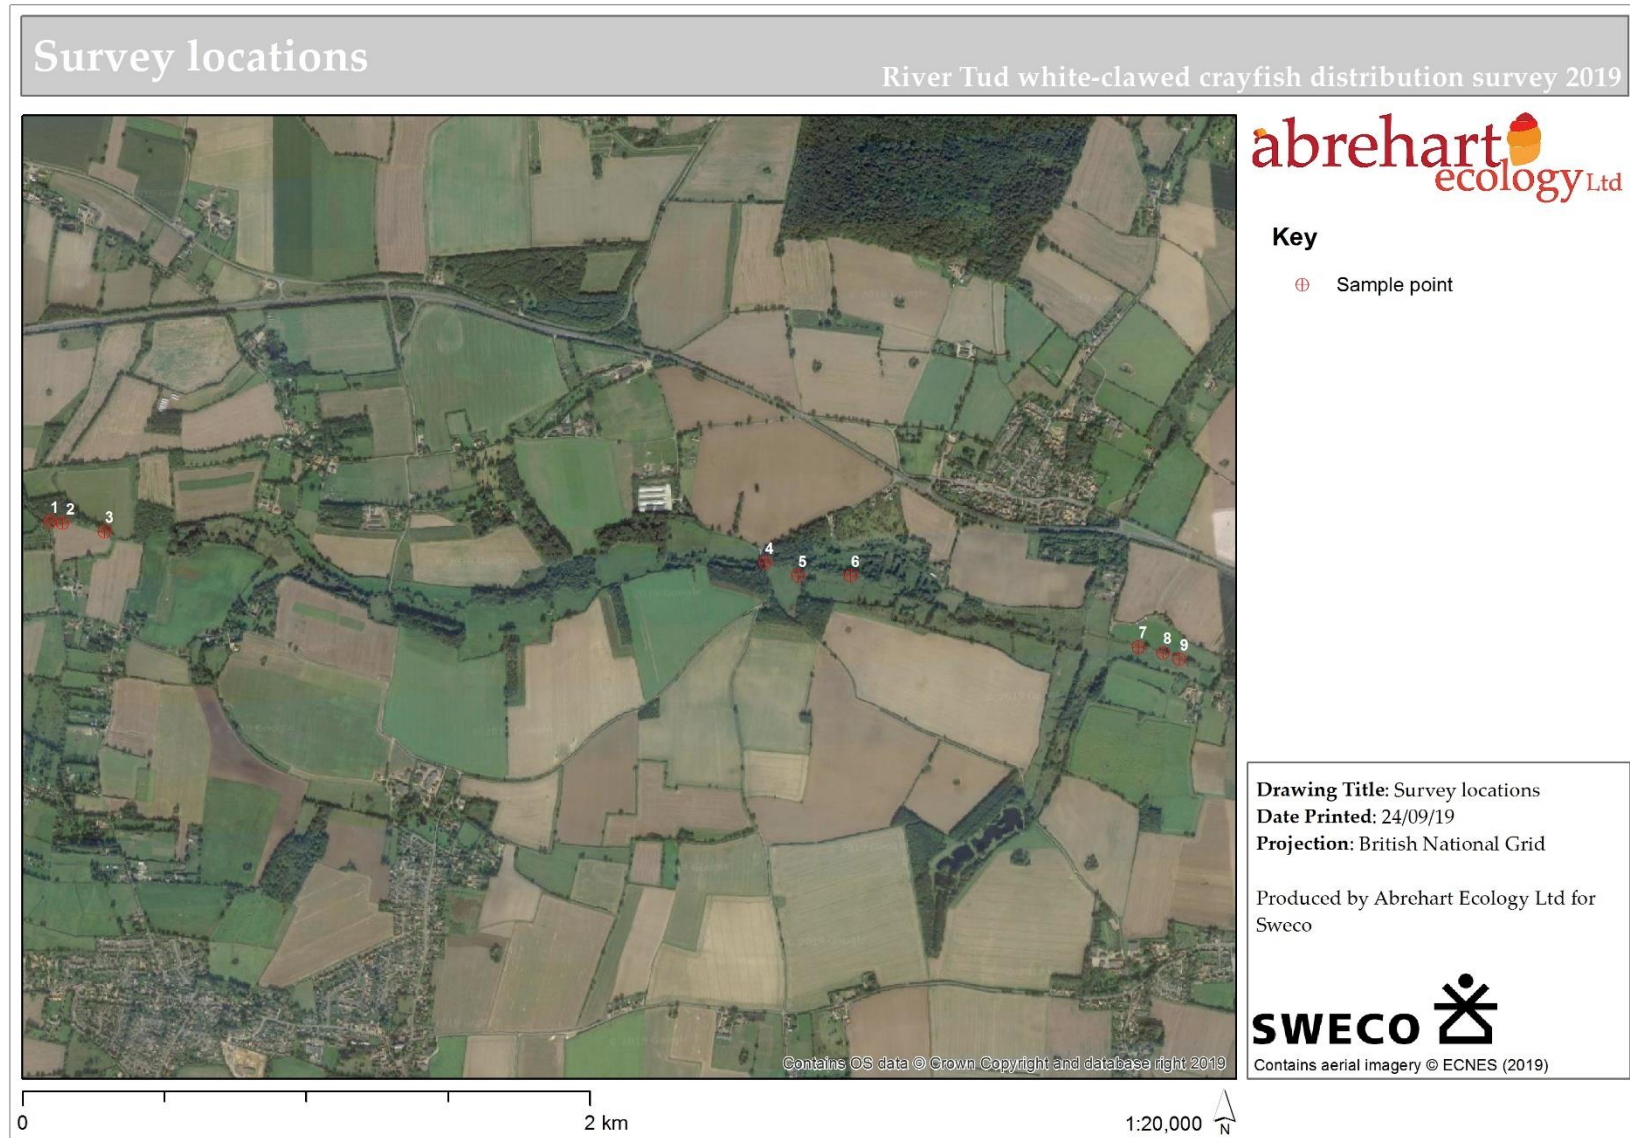
Figure 2. Locations of sampling points along the River Tud (west)

Sampling points were distributed along the 7km stretch of the River Tud adjacent to the potential works along the A47 (Figure 2). Sample sites comprised surveying within seven 500m sections with extensive sampling undertaken within each section.

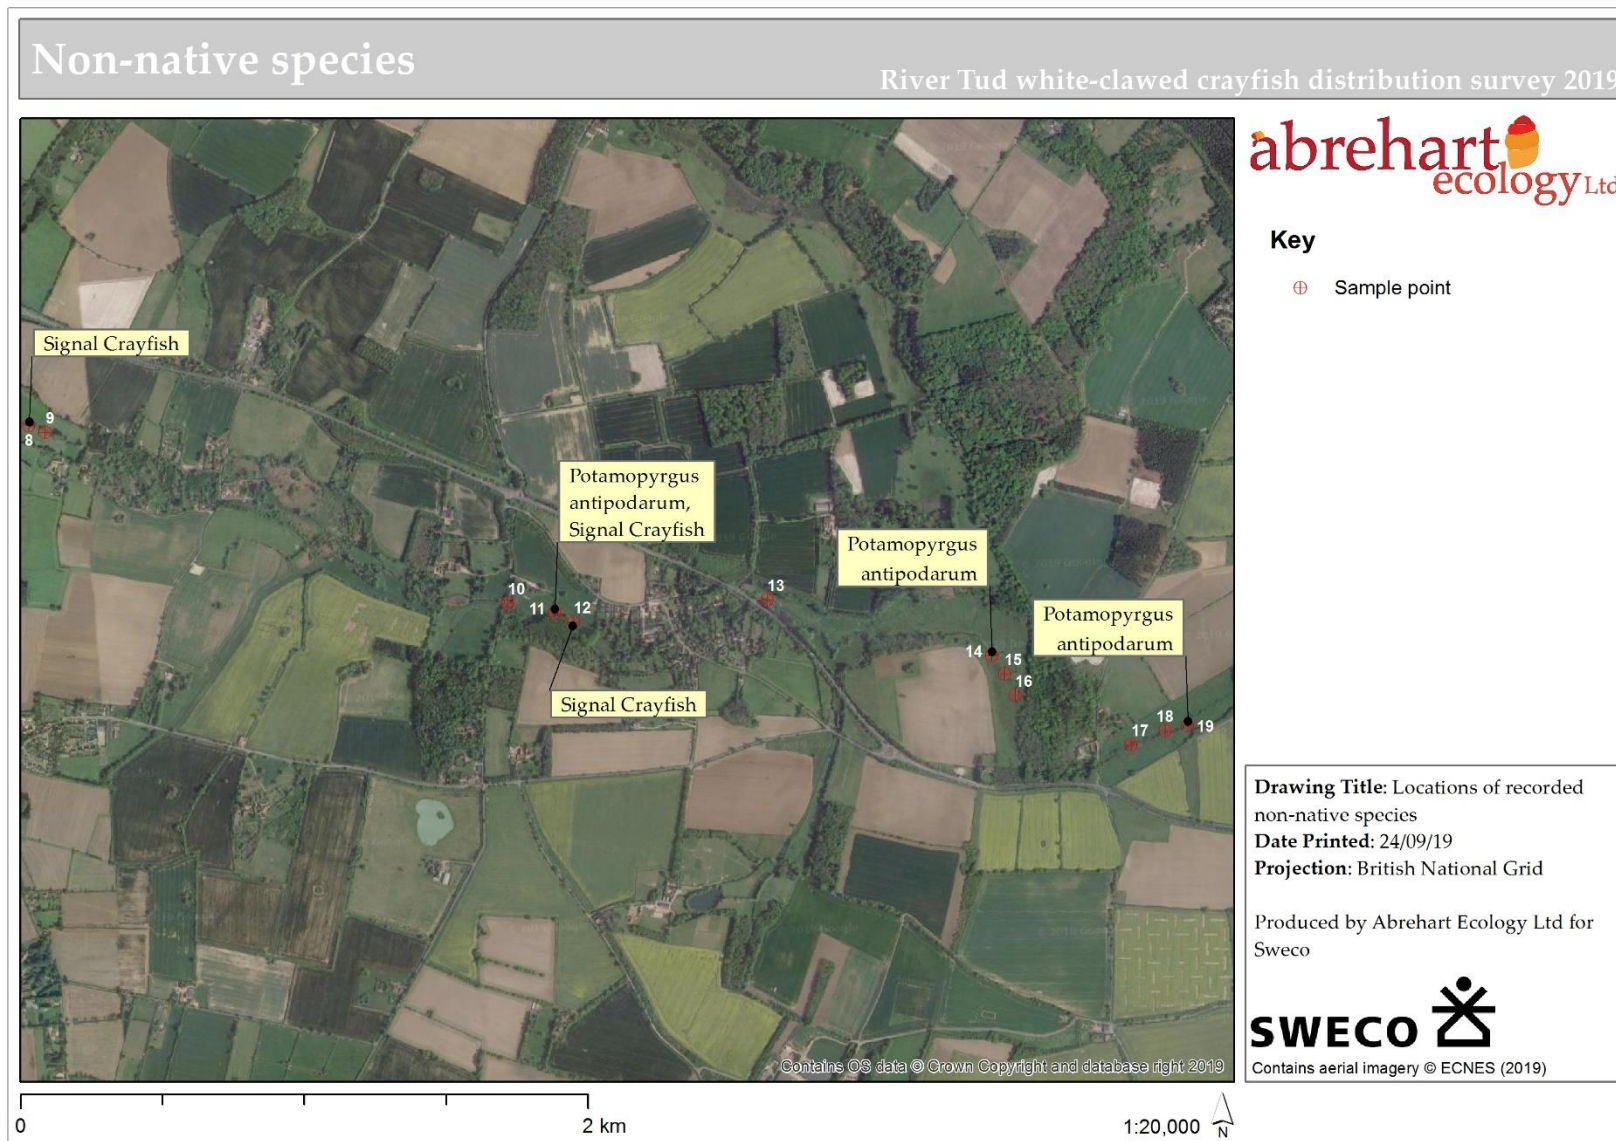
Figure 6. Non-native species recorded at sample points (west).

Three invasive species, the crustacean *Pacifastacus leniusculus*, the mollusc *Potamopyrgus antipodarum*, and the plant *Impatiens glandulifera* were found within the survey area. All three were found to be widespread across the survey area. *P. antipodarum* created a layer of 'gravel' on the riverbed - which was found in nets during kick sampling and netting, *I. glandulifera* was frequently noted along the riverbanks, and *P. leniusculus* was found within all submerged areas of the river channel – within tree roots, beneath undercut banks, within emergent vegetation, beneath large cobbles,

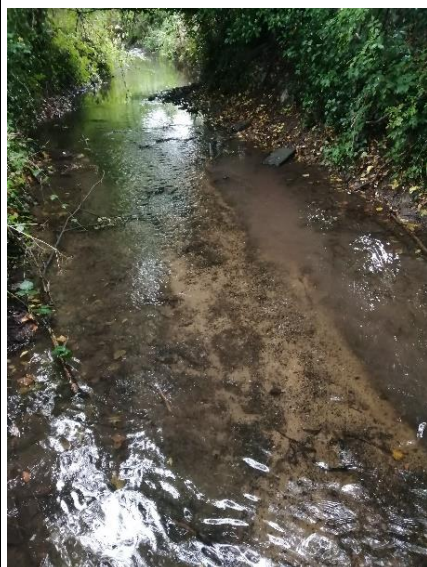
The sample was taken at the most westerly point of the survey area and was a shaded section of the River Tud near to the bridge crossing of Mill Road in Mattishall. This section of the river had a shallow water depth and sandy/gravelly substrate. Along the riverbed were occasional large rocks and boulders. The banks of the channel were steep (>45°) and were predominantly earthen, providing ample opportunity for crayfish to create burrows. Other refugia noted at this location were small cobbles, fine tree roots, and large tree roots. The shading was from abundant bankside trees that had limited woodland/shade tolerant flora growing beneath.

American signal crayfish were observed from the bridge prior to the start of the survey effort. Once sampling began, a total of three signal crayfish were found – two large adults and one juvenile that had missing chelipeds.

Sample area 1 -
To the east of Mill
Lane

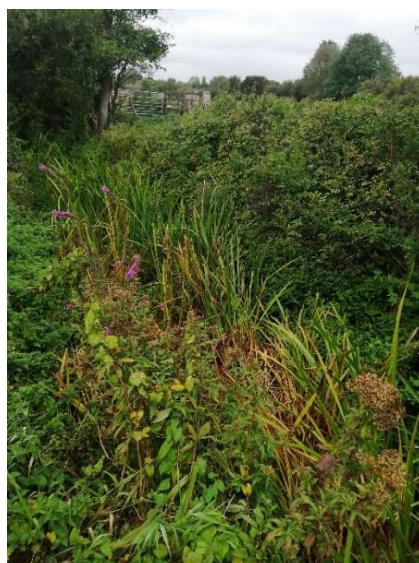
A more shaded area of this section that had fewer large cobbles or boulders and no emergent vegetation. This coincided with a much-reduced aquatic invertebrate fauna. Although crayfish burrows were noted, these were less frequent than in Sample Point 6. Refuges were provided by woody and urban debris, including a particularly large collection of branches that had accumulated against a fallen tree.

One adult American signal crayfish was seen during the sampling. This was not sexed as it moved beneath dense debris and was only observed, not caught.

Sample area 5 -
A section to the
north of Riverside
Farm Holidays

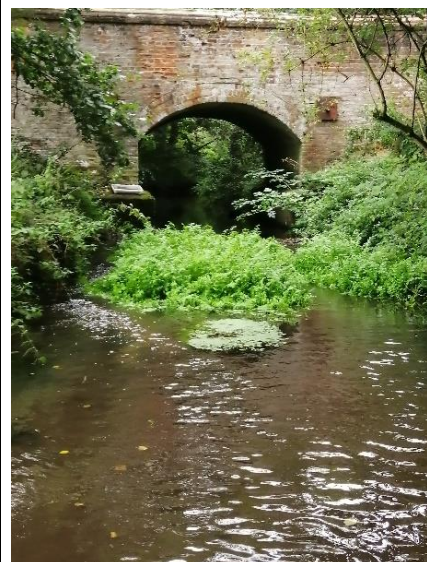
This section of the River Tud began at the bridge crossing of Mattishall Lane. The water depth here varied from <10cm to over >50cm and included several areas of fast-flowing riffles. Despite having abundant tree growth along the banks, there was a good amount of watercress growing near to the bridge. Refugia was abundant across the width of the river – within the banks, margins, and mid-channel. These refuges included cobbles, fine tree roots, large tree roots, undercut banks, and crayfish burrows.

Seven American signal crayfish were recorded within this section; four juveniles, two adult males, and a large adult female. Most of these animals were healthy; however, the large female had a missing cheliped. The crayfish were found in dense

Sample area 4 -
To the east of
Mattishall Lane

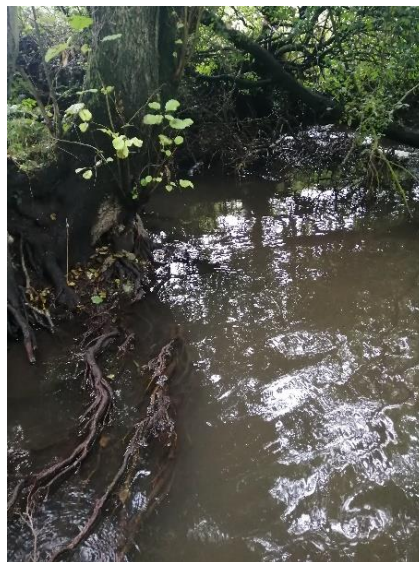
Further downstream the river became deeper and flow much more steady – near to this Sample Point the water was almost static. There was no aquatic vegetation and banksides were dominated by trees and stinging nettle (*Urtica dioica*). The meadows adjacent to the steep-sided banks were cattle grazed, although cattle were not in the fields at the time of survey. Crayfish refugia included undercuts on the banks, large tree roots, and woody debris.

Two male and one female American signal crayfish were found during the sampling effort. The large males were seen moving across the riverbed and the smaller female was found on top of the tree roots. One male had a damaged cheliped and the female had a missing cheliped.

Sample area 6 -
To the east of
Mattishall Lane

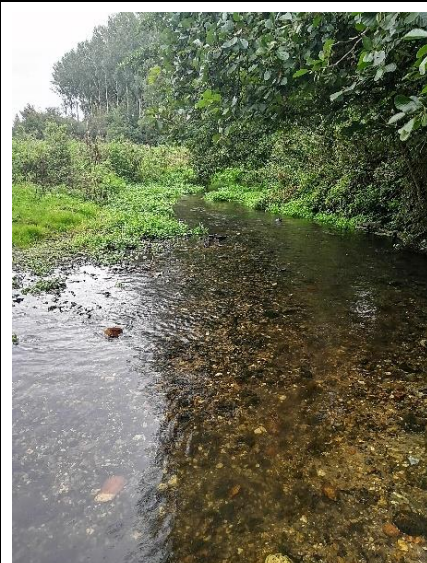
This sampling area was adjacent to a sluice with very fast-flowing water. This water ranged in depth from a few centimetres to over 50cm. Bank composition and angle were also variable within this section of river: bank angle changed from flat (<10°) cobbled areas – where cattle enter the river - to steep-sided earth banks (>45°). The channel itself had a fine gravel sediment with occasional larger pebbles and cobbles. Aquatic vegetation was dominated by two species, water forget-me-not and watercress. Refuges were common across the river channel (including banks, margins, and mid channel) and included undercut banks, burrows, emergent vegetation, and filamentous algae.

There were no crayfish recorded within this stretch of river.

Sample area 10 -
To the east of
Berrys Lane

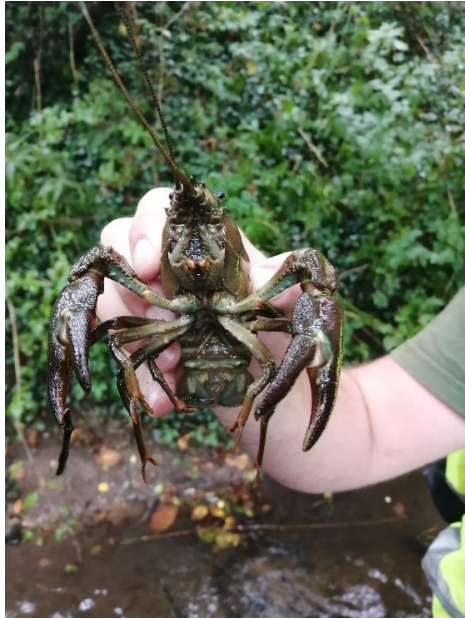
Signal Crayfish
Pacifastacus leiusculus
Found along the entire length of the survey area of the River Tud

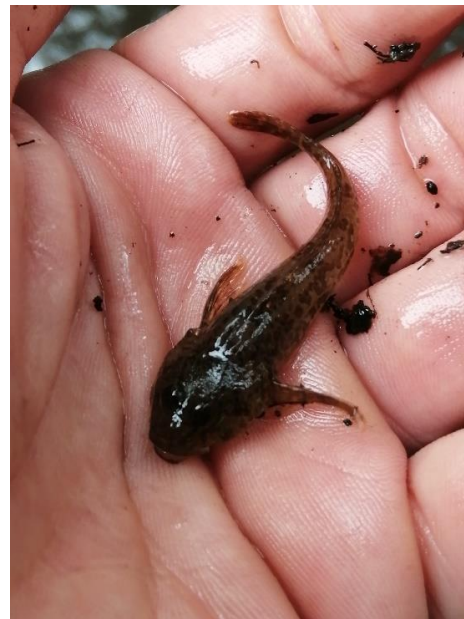
Bullhead
Cottus gubio
Found along the entire length of the survey area of the River Tud, the most frequent fish collected in the samples

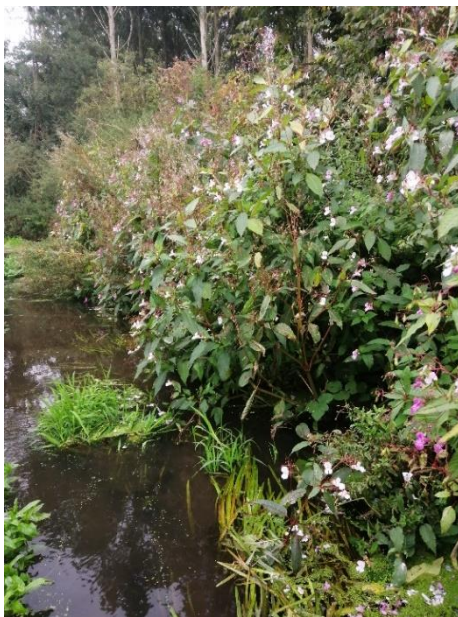
Downstream of the sluice gate, the water still had a good flow; however, this area was more consistently deep with steeper earth banks. There was dense Himalayan balsam (*Impatiens glandulifera*) on the banks and branched bur-reed, water parsnip (*Berula erecta*), and watercress in the channel. This section also had fewer cobbles than the sections upstream and downstream, with a finer, siltier substrate. Despite the differences in channel morphology, the river here still provided frequent crayfish refugia: woody debris, burrows, undercut banks, emergents, submerged vegetation, and occasional cobbles.

Himalayan balsam
Impatiens glandifera
Found from section 11 to 12 on both banks

Two further non-native species were identified during the survey; the New Zealand mud snail and Himalayan balsam. The New Zealand mud snail can reproduce rapidly and is now the most common freshwater gastropod in Britain (<http://archive.jncc.gov.uk/default.aspx?page=1713>). Himalayan balsam was noted along the banks at several Sample Points. This is a highly invasive species that can outcompete native species and which can spread up and downstream along a river – through its seed dispersal mechanism. It is possible to eradicate this species through proactive management (before seeds have set) within two or three years.

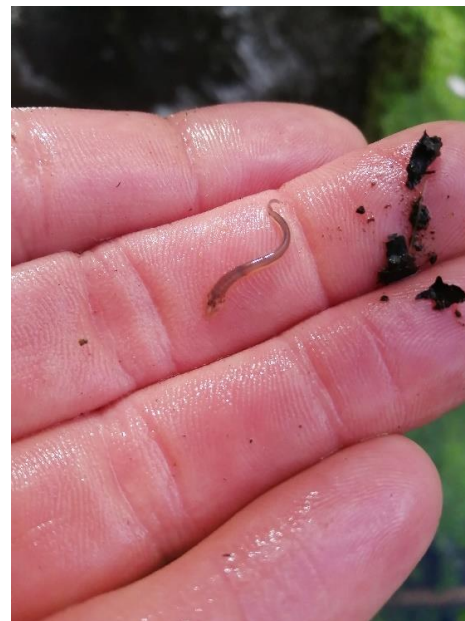
No crayfish were recorded at this location. Although the water quality appeared reduced and urban litter was greater, bullhead and a river lamprey (*Lampetra fluviatilis*) ammocoete were recorded within samples near to the bridge.

River lamprey
Lampetra fluviatilis
This single ammocoete was collected under the A47 bridge at sample site 13
