A47 North Tuddenham to Easton Dualling

Appendix 7.6 - Arboricultural Impact Assessment

ENVIRONMENTAL STATEMENT APPENDICES
Appendix 7.6 - Arboricultural Impact Assessment

Arboricultural Impact Assessment A47 – North Tuddenham to Easton

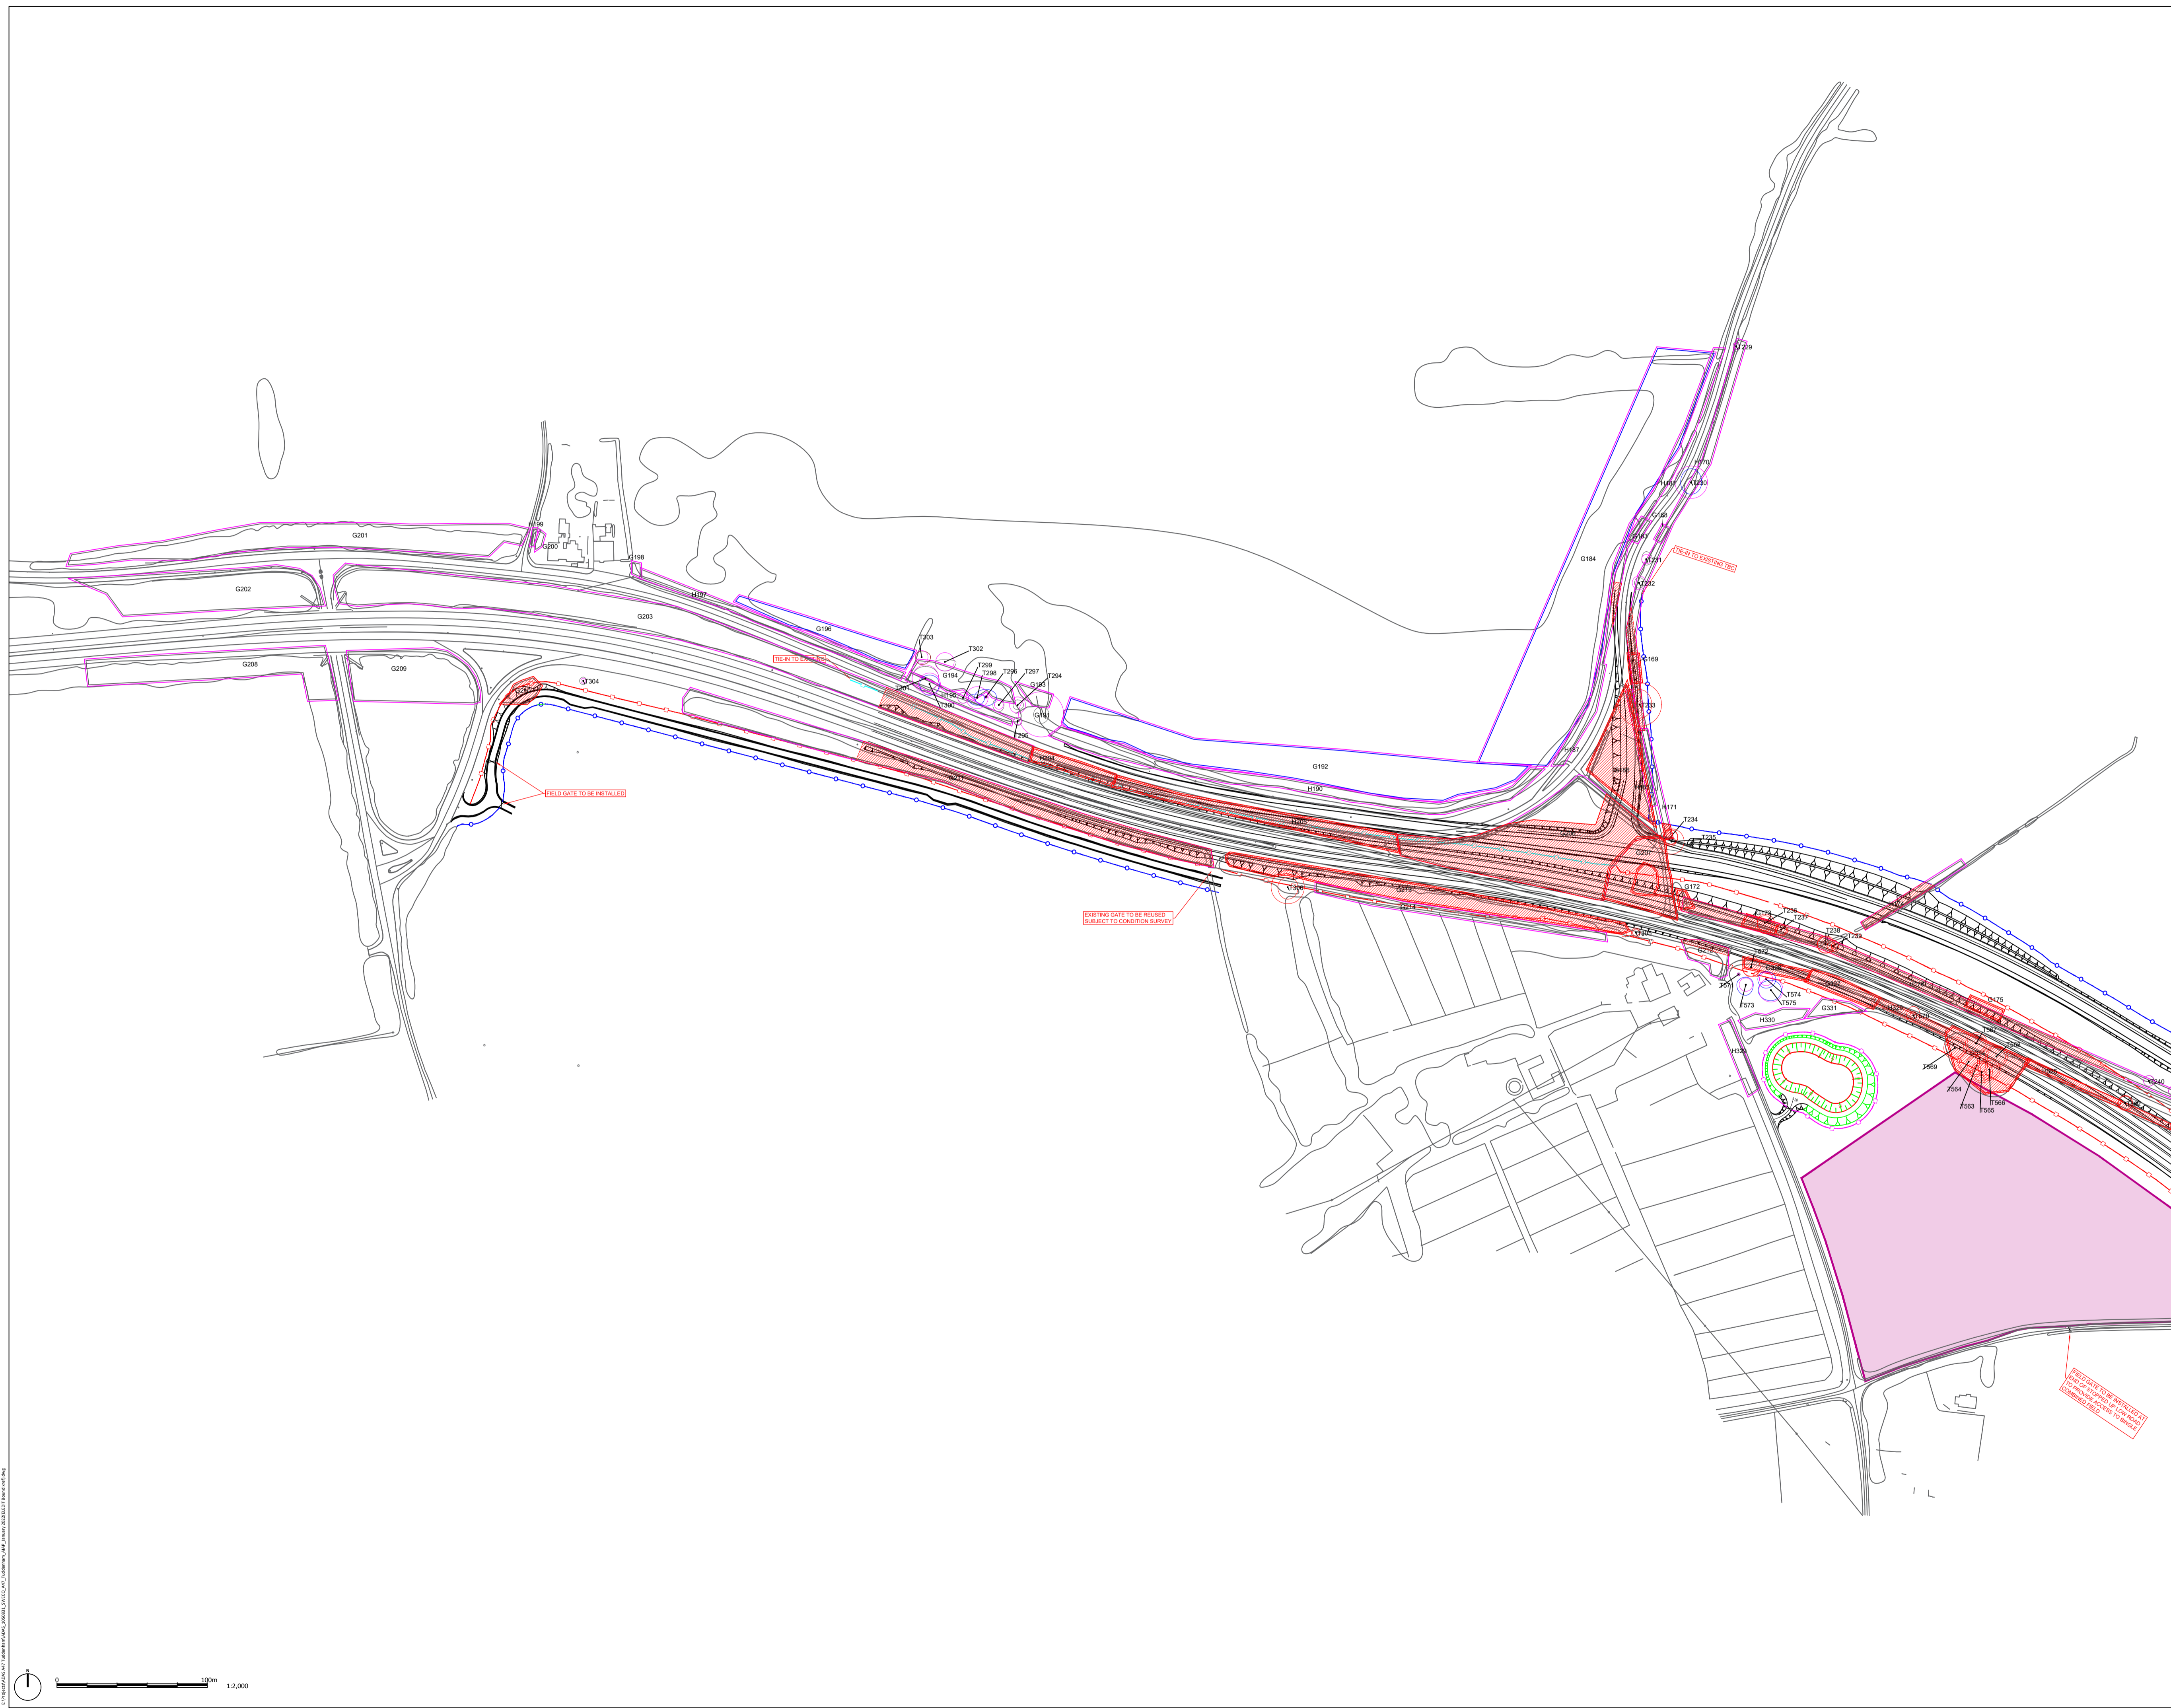
Client:
SWECO
 Project:
A47 Tuddenham
 Drawing Title:
Arboricultural Impact Assessment Plan 1/7
 Drawing No: ADAS_1050831_SWECO_Tuddenham_AIAP
 Scale: 1:2000 @ A1
 Drawn by: CS Date: 20/01/2021
 Checked by: RT Date: 21/01/2021

Appendix 2: Arboricultural Impact Assessment Plan

- Classification of groups (G), hedges (H) and individual trees (T).
- Amending Appendix 7 'List of Arboricultural impacts' to correctly reflect Appendix 2 Arboricultural Impact Assessment Plan.
- Minor adjustments to Appendix 2 Arboricultural Impact Assessment Plan to reflect responses during the Examination, such as:
 - Changing tree belt beside Merrywood House, Berrys Lane, to show not as 'felled'.
 - No longer showing tree groups north-west of the existing Taverham Road and A47 junction as 'felled'.
 - Adding small two sections of hedgerow as felled to reflect temporary removal and replacement for access within the Berry Hall Estate.
 - No longer showing some individual trees along Berrys Lane as 'felled' following detailed design and landowner discussions during the Examination.

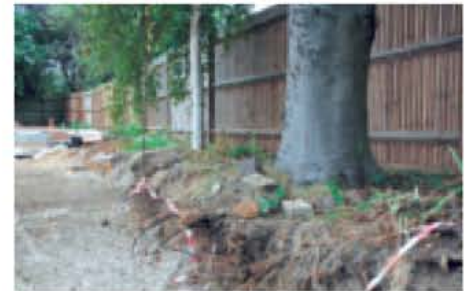
Potential loss of existing tree due to poor construction techniques.

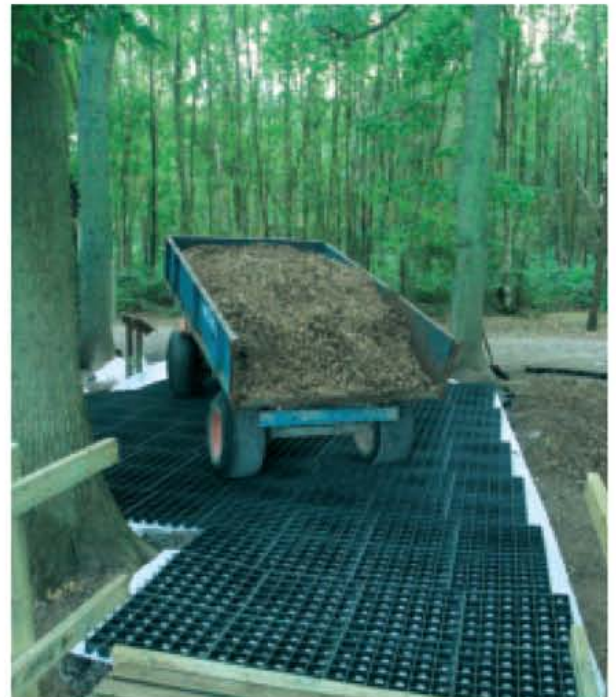
Glynebourne Wood.

Pedestrian path to recreational woodland built using a CellWeb™ foundation which was covered with DuoBlock and then filled with woodchip to create a porous surface.

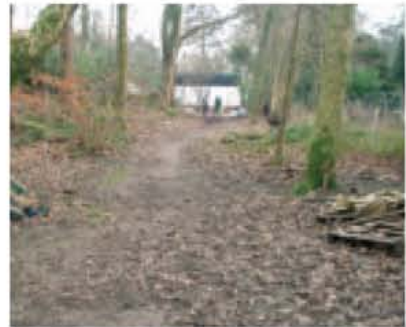
Site before construction pictured above.

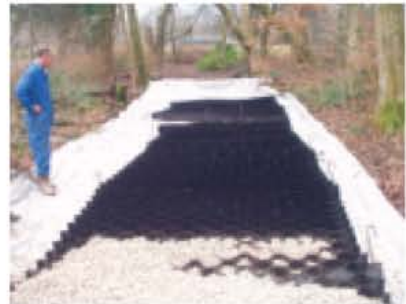
Installation of the CellWeb™ system.

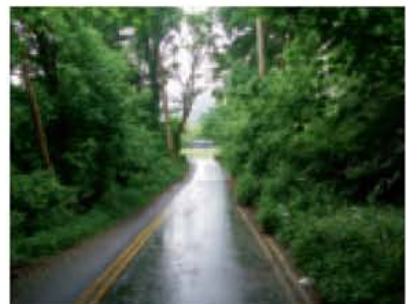
Four years later.
